FINAL REPORT

**Accident
on 24 July 2014
near Gossi (Mali)
to the McDonnell Douglas DC-9-83 (MD-83)
registered EC-LTV
operated by Swiftair S.A.**

Approved on 22 April 2016

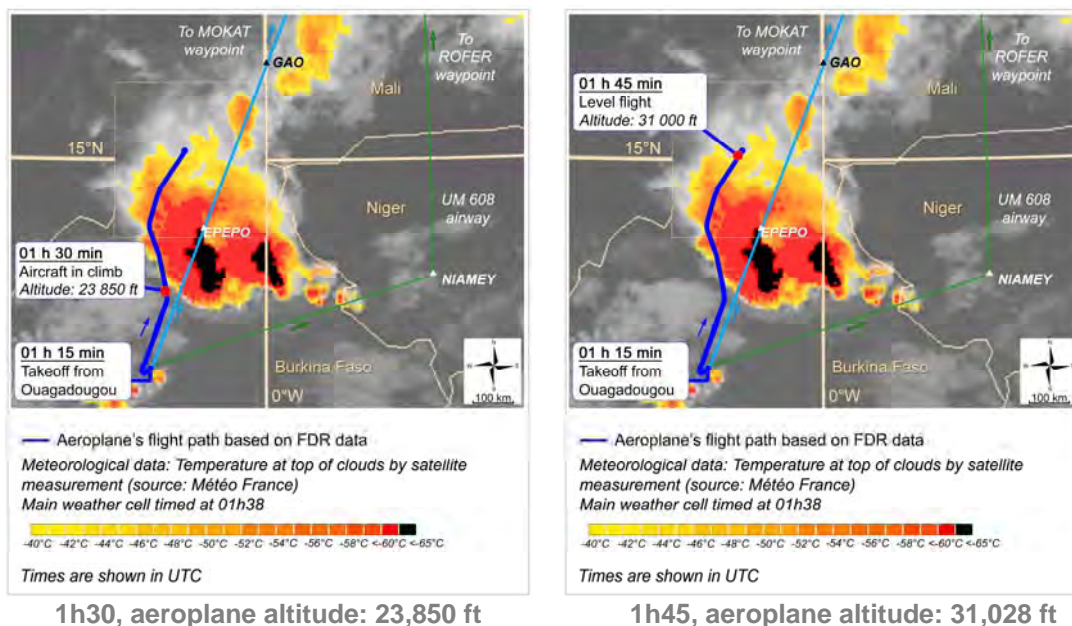
To the east, three storm cells grew quickly from 00h00 onwards. The images below represent infra-red images with the aeroplane flight path superimposed at 01h30 and 01h45. The aeroplane's position at these two moments is shown by a red dot.

After takeoff from Ouagadougou the aeroplane's change of heading would cause it to fly on the west edge of the convection area, without it being possible to determine whether or not the aeroplane was flying in a cloud layer. The temperatures encountered during the climb (from -16°C to -32°C) could be conducive to icing by supercooled water. However, analysis of the satellite imagery evolution did not indicate supercooled water was present. Additionally, the absence of significant turbulence on FDR data suggests that no updraughts that might have carried supercooled water were present on the aircraft flight path. The cell was in the "mature stage" when the aeroplane passed. The anvil cloud was then well developed and the updraughts in the cell core fed this anvil with ice crystals. Thus, the presence of ice crystals within the anvil cloud was very likely. These crystals could have spread under the anvil or be transported downwind from the cell, to the area that the aeroplane was flying in.

These elements led the investigation to consider icing caused by ice crystals more likely than icing caused by supercooled water. The concentration of ice crystals encountered is unknown.

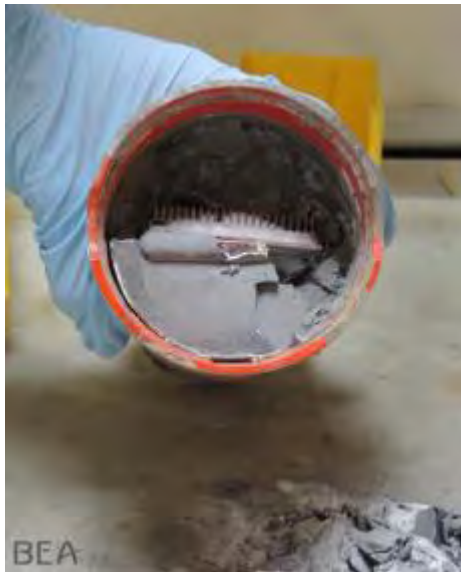
Figure 25 - Electronic card in the CSMU

Only the protected module (CSMU) was sent to the BEA. This module contains the electronic card that records the flight data. The protected casing was separated from its frame and the underwater locator beacon (ULB) was not present. It was slightly damaged and showed some signs of impacts.

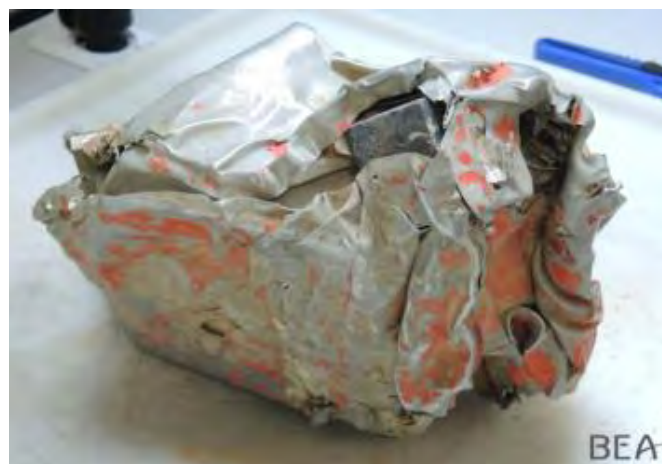
Figure 28 - Initial condition of the CVR

The CVR was seriously damaged. The recorder had been compressed and deformed during the accident. However it had not been exposed to fire.

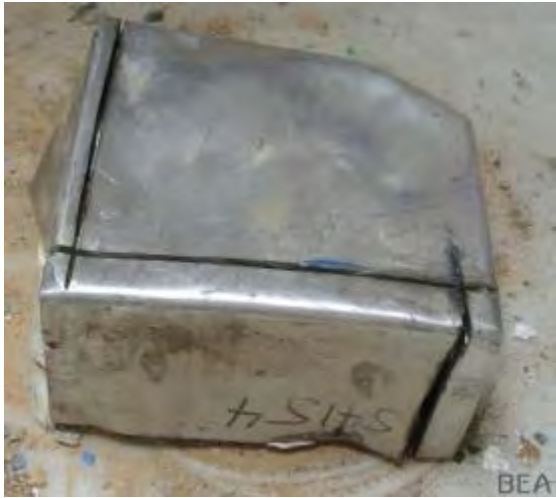
Figure 30 - Protected module after extraction

Visual examination of the protected module showed that it had been damaged during the accident.

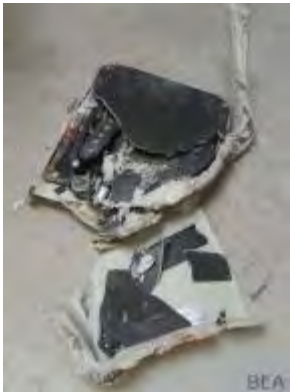
Figure 32 - Magnetic tape mechanism after

After opening the protected module and taking out the heat protection, visual inspection showed that the tape mechanism was destroyed and that the magnetic tape was damaged. The tape was broken in several places.

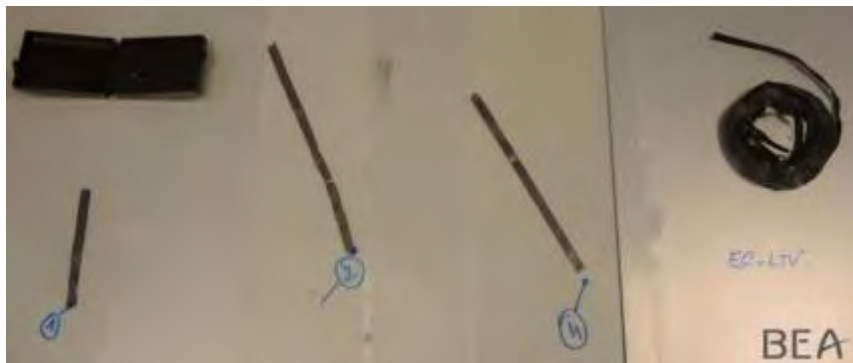
Figure 35 - Sections of magnetic tape recovered during the opening operations

The various sections of magnetic tape were identified and numbered. In order to read out the magnetic tape in its entirety, repair operations were required. These operations consisted of reinforcing the magnetic tape in the places where there was the most severe damage.

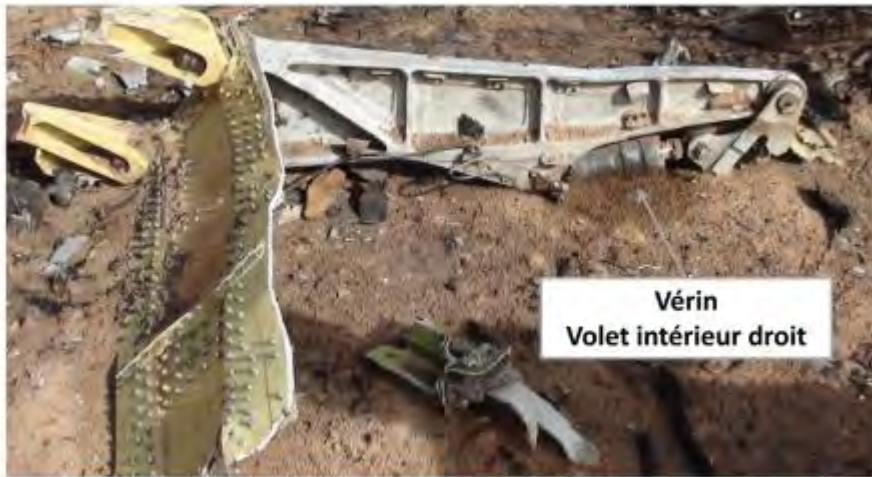
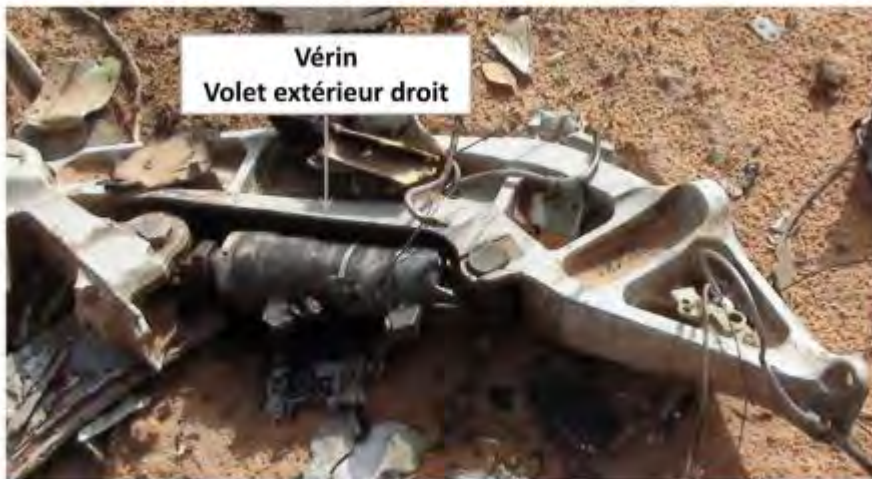
Their examination showed that they were in the retracted position. This information was consistent with the data read out from the FDR.

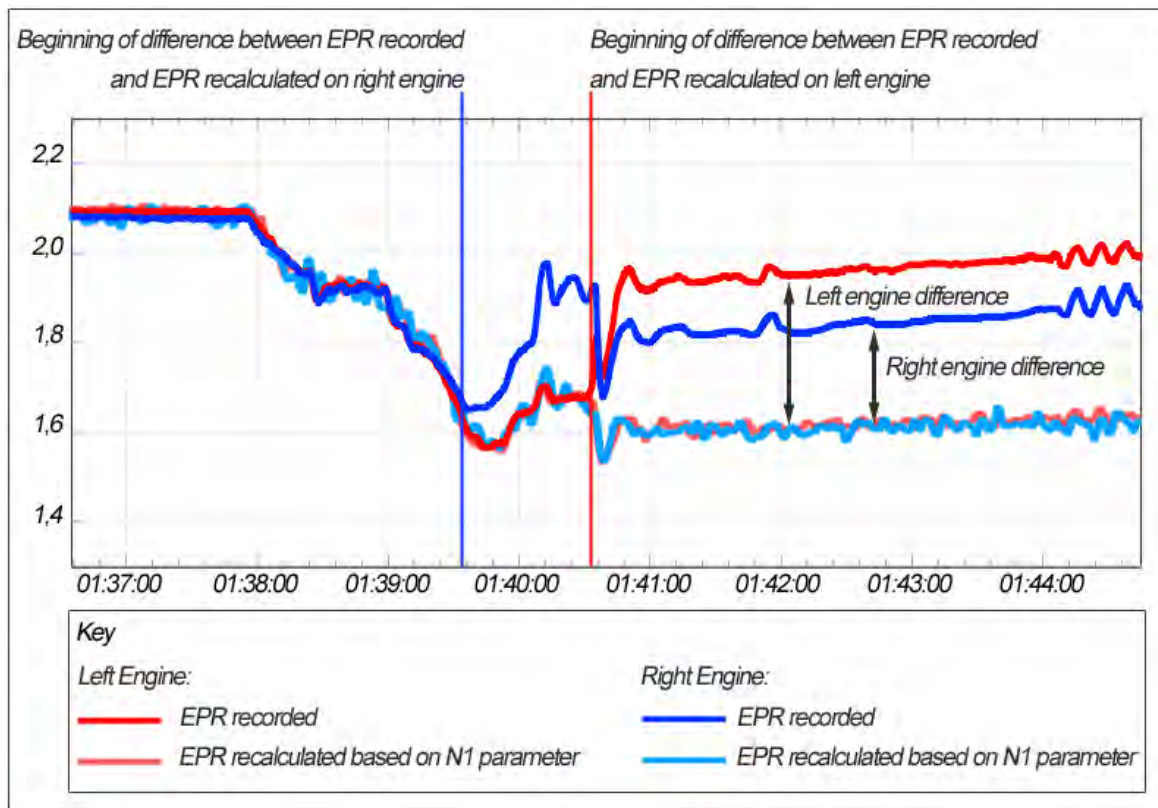
Figure 48 - Comparison between recorded EPR and recalculated EPR

The following graph shows the result of these calculations.

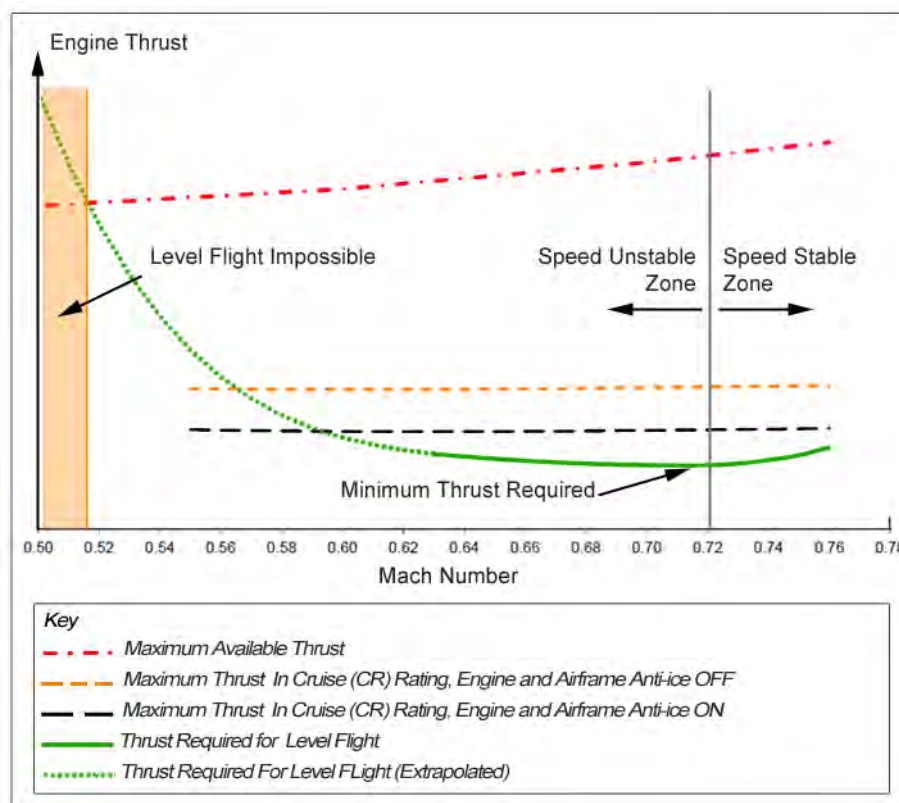
Figure 51 - Thrust required and thrust available

The following graph shows that the flying behind the power curve occurs when Mach is about 0.72. The aeroplane reached this speed at 01 h 41 min 52, that is to say 2 min 17 after the appearance of the first engine EPR measurement error. Although the engines were capable of providing enough power to accelerate the aircraft, this was not actually commanded by the autothrottle due to erroneous EPR values.
