COMMISSION D'ENQUETE SUR LES
ACCIDENTS ET INCIDENTS
D'AVIATION CIVILE

INTERIM REPORT

Accident
on 24 July 2014
in the region of Gossi in Mali
to the MD-83 registered EC-LTV
operated by Swiftair S.A.

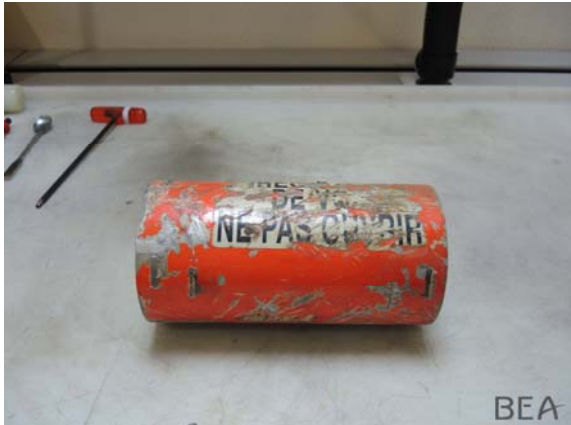
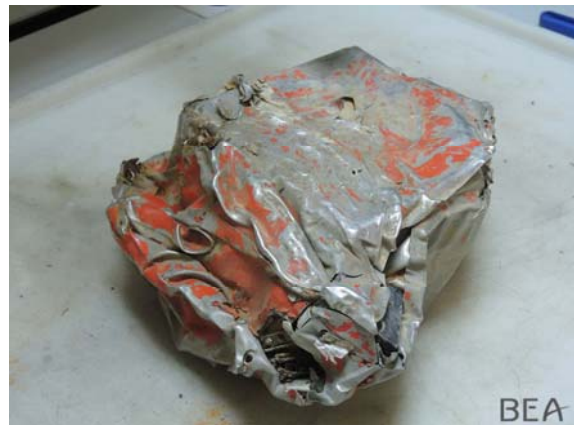
FDR (on the left) and CVR (on the right)

Only the protected housing (CSMU) was sent to the BEA. This module contains the electronic card that records the flight data. The protected enclosure was separated from its frame and the underwater locator beacon (ULB) was not present. It was slightly damaged and showed some signs of impacts.

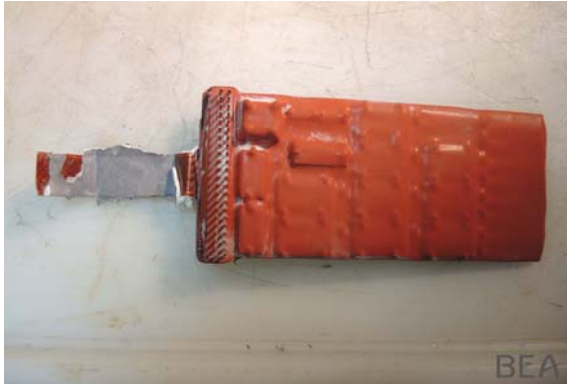
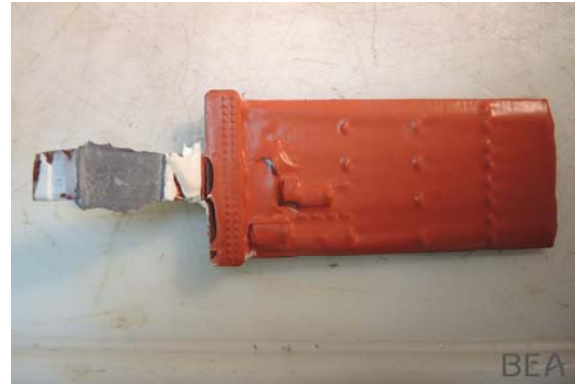
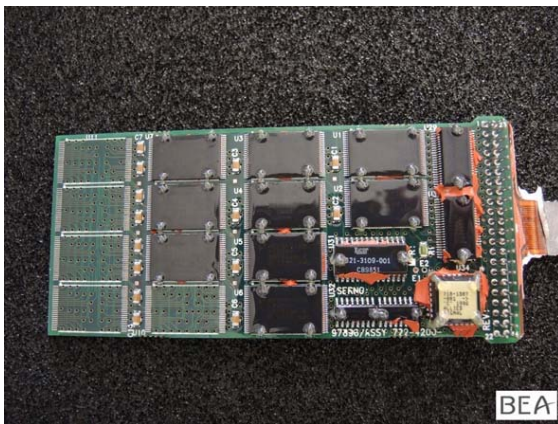
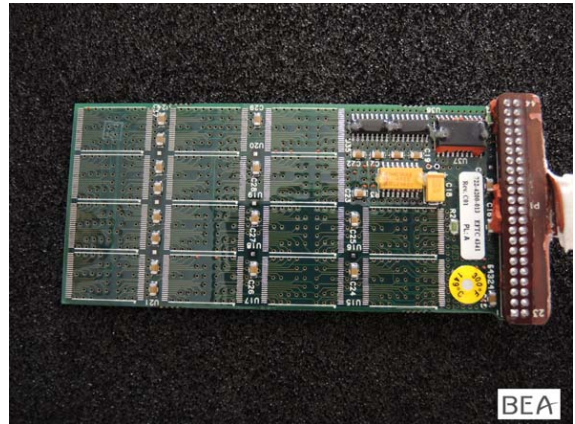
Electronic card with the protective layer

Electronic card without the protective layer

Visual examinations showed no apparent damage to the card. Entry impedance measurements on the electronic card were made. The values recorded were in accordance with Honeywell specifications.

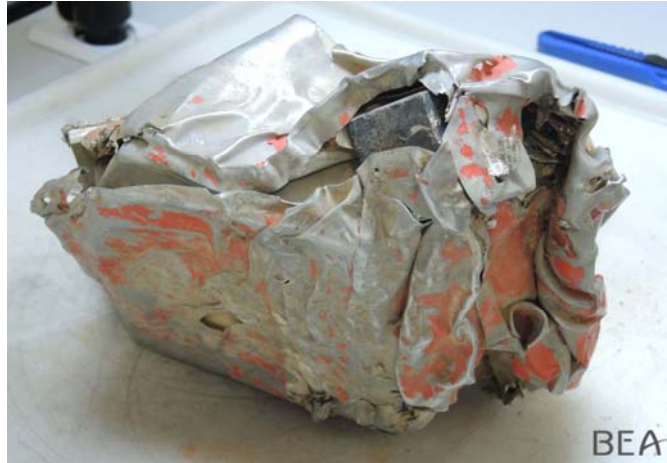
The CVR was significantly damaged. The recorder was compressed and deformed during the accident. However, it was not exposed to fire.

Initial state of the CVR

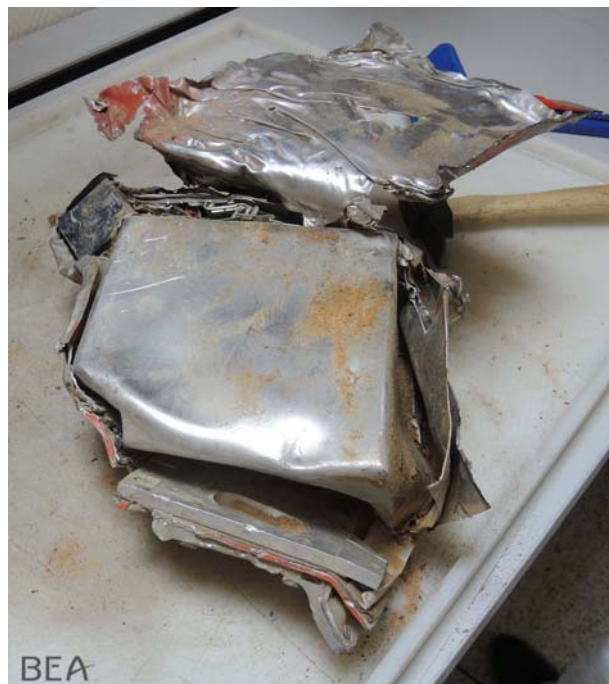
Given the condition of the recorder, access to the protected module was not possible using a conventional opening method. It was necessary to cut the chassis.

Opening of the chassis

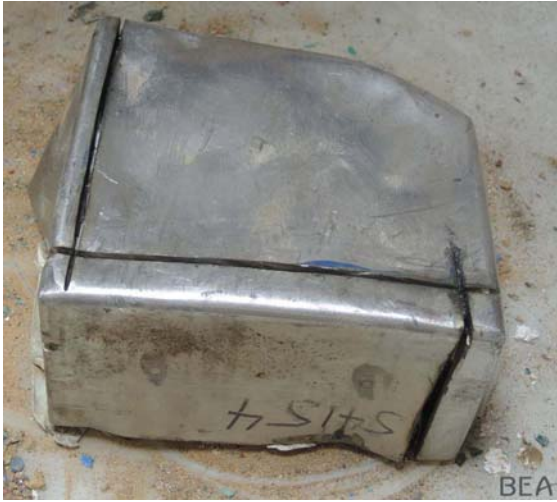
Visual examination of the protected module revealed that it was also damaged during the accident. In order to access the magnetic tape on which data are recorded, it was necessary to open the protected module using a grinder.

Protected Module after extraction

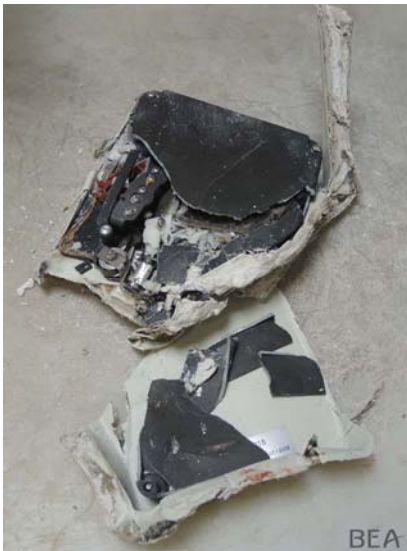
After removing the heat shield, it was noted that the tape mechanism had been destroyed and the tape was damaged. It was broken in several places.

*Magnetic tape mechanism
after extraction*

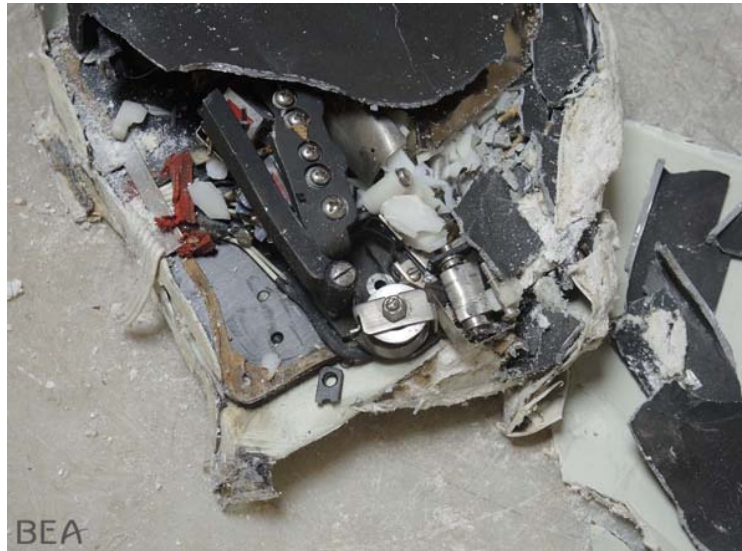
Zoom - Magnetic tape drive mechanism

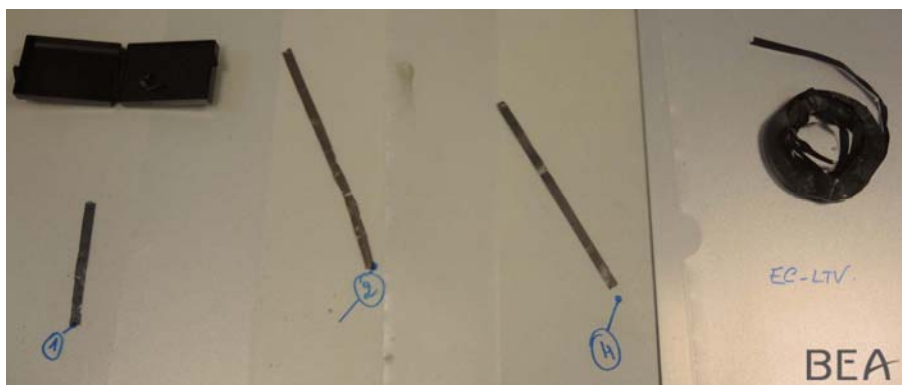
The various pieces of tape were identified and numbered. To read the tape in its entirety, repair operations were necessary.

Pieces of magnetic tape recovered during opening operations

These operations consisted in reinforcing the magnetic tape at the locations where damage was greatest.

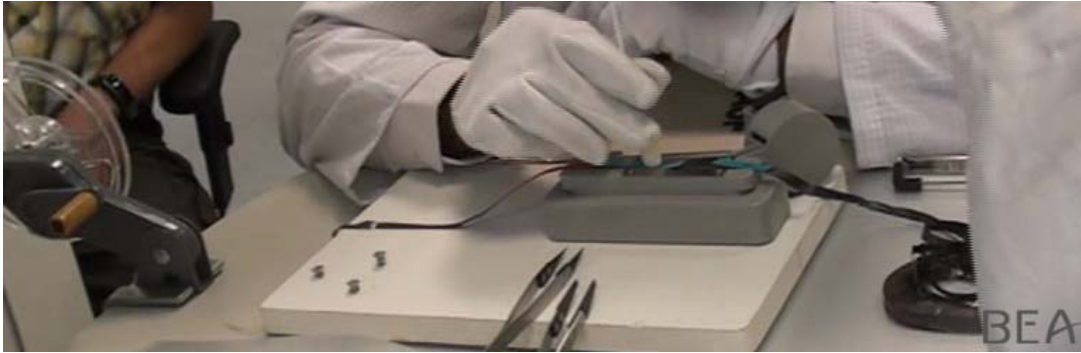
Reconstruction operations of the magnetic tape

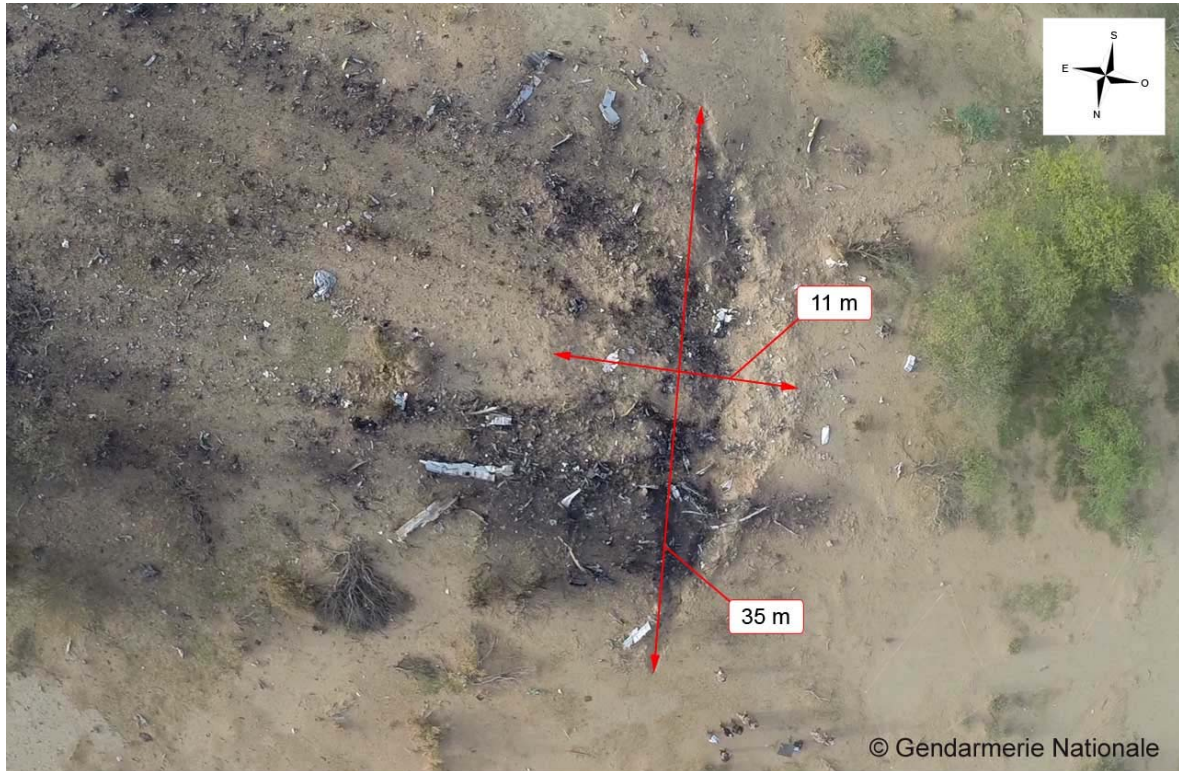
On aeroplane impact with the ground, a crater approximately 35 m long, 11 m wide and 1 m deep was formed¹³.

Top view of the crater

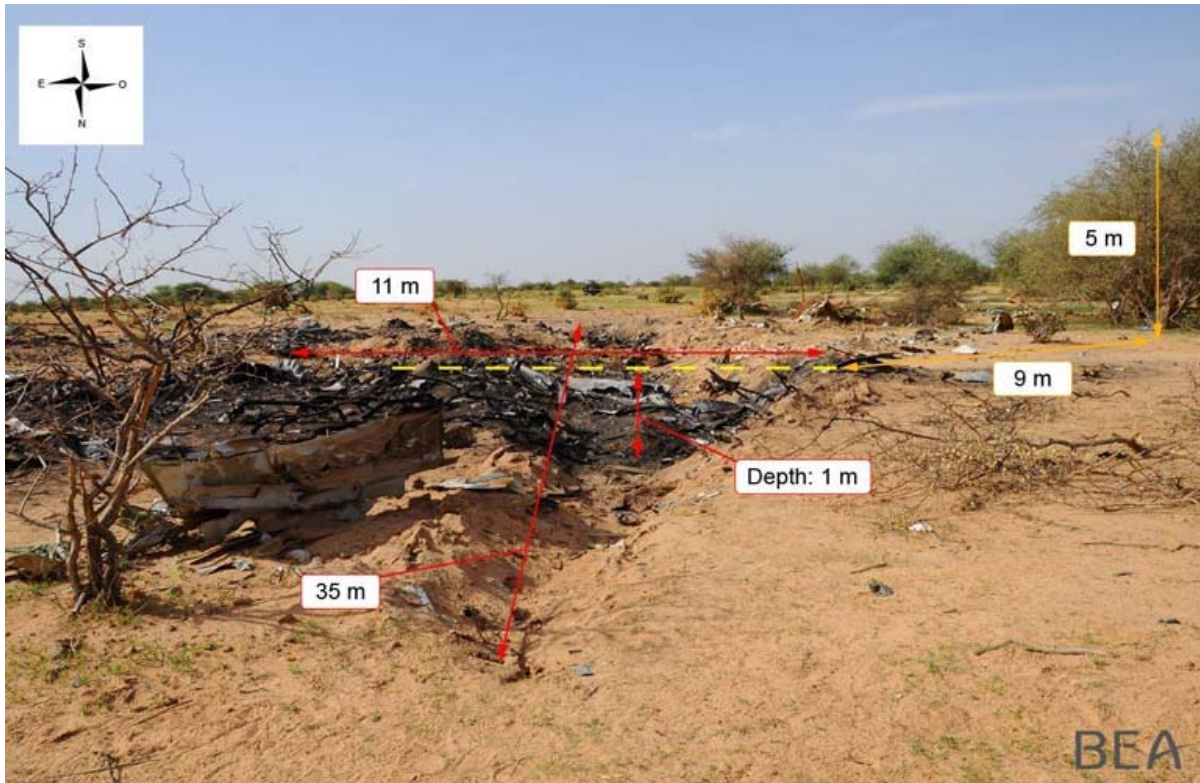
Trees, about 5 m high and located about ten metres before the impact point, were not cut off. A few elements of the tail section, as well as the rear door and the tail skid, were discovered near these trees.

Side view of the crater

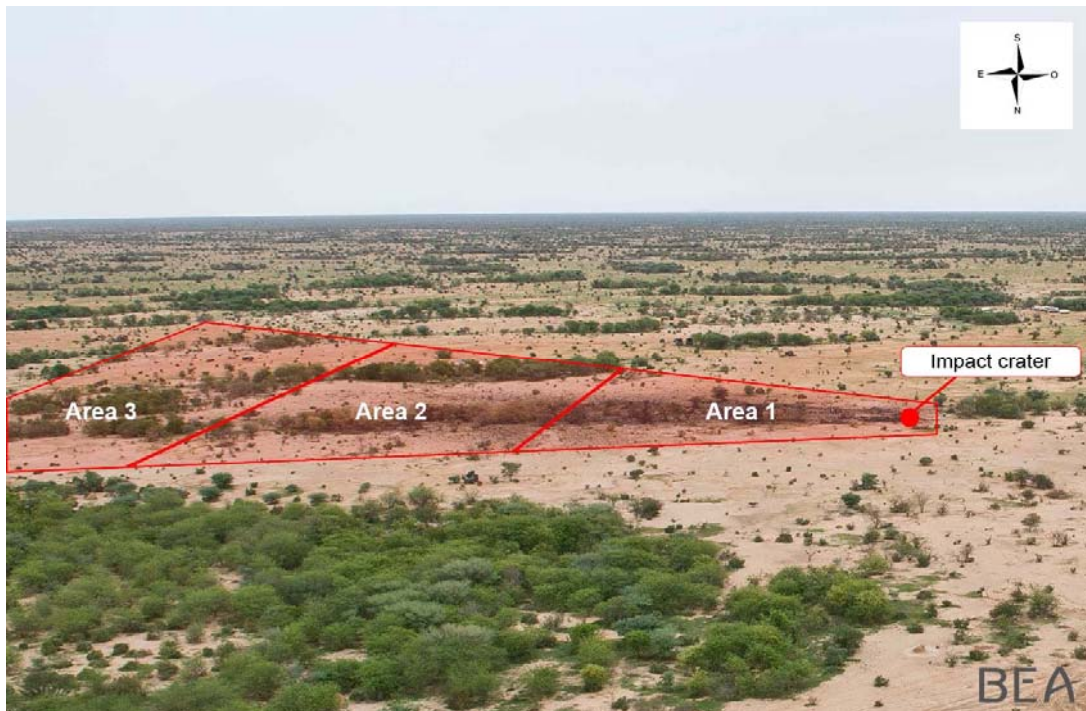
The wreckage was spread over a triangular area with a length of 420 m, the summit of which was the point of impact, which spread out to a width of 340 m. The general distribution of the debris was along a mean axis oriented at 090°.

- The first mainly had a concentration of large pieces of wreckage (around one metre or more) and of average density. The debris was mainly parts from the engines, the wings, the fin, the nose gear and the upper parts (shafts) from the main landing gear.
- In the second area, the size (of a few dozen cm) and density of debris were lower than previously observed. Most of the human remains as well as most of the elements from the instrument panel and the windshield were found in this area.
- Finally, in the third area, the debris was medium volume (decametric to metric) and high density. It consisted of engine pieces and lower parts (axles) of the main landing gear.

Aerial view of the debris field

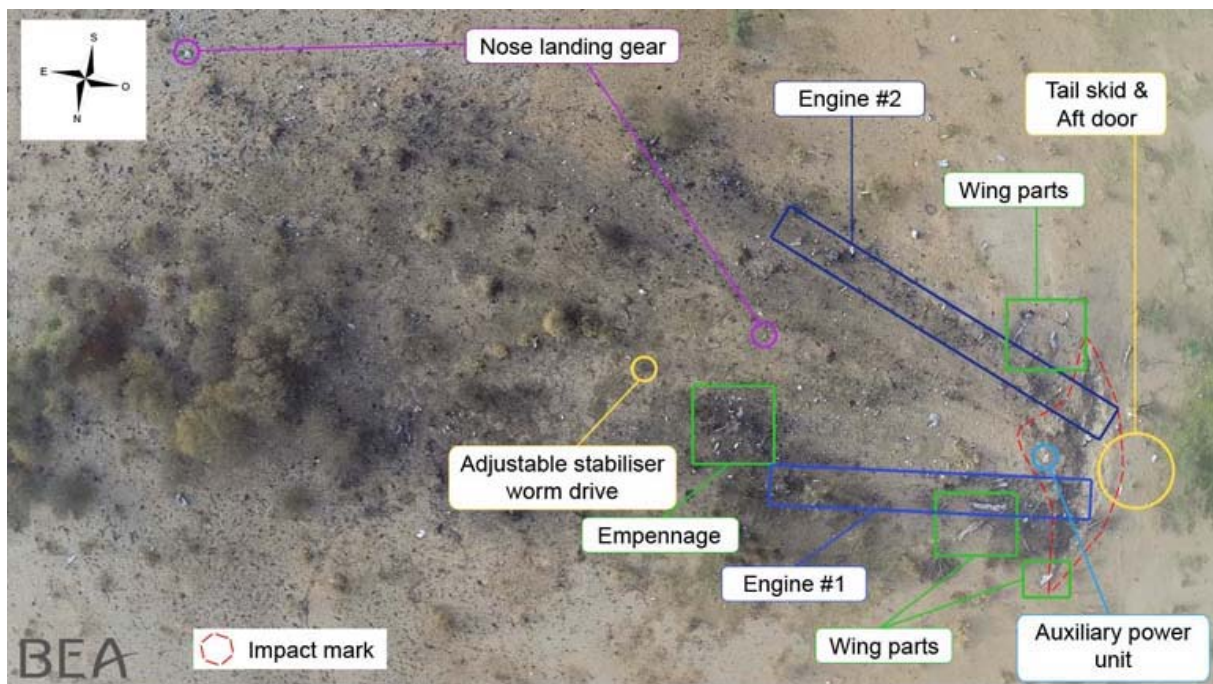
The debris found in the impact crater was mainly pieces from the wings, from the auxiliary power unit, as well as from the nacelles and engine accessories.

The upper parts of the nose gear were found 50 m away and its lower part, 125 m from the impact crater.

The fin was about 50 m away and the trimmable horizontal stabilizer (THS) jackscrew was about 65 m away.

Distribution of debris in the first area

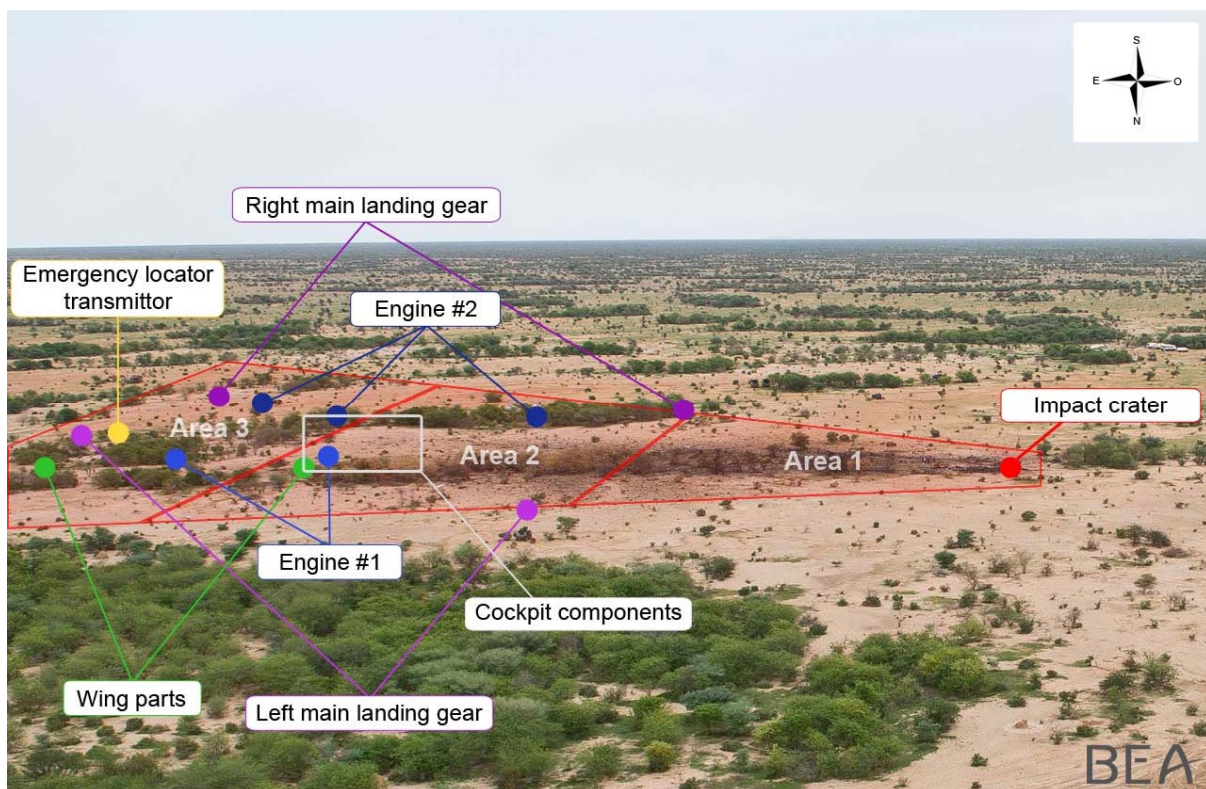
The upper parts of the main landing gear were found 120 m from the impact crater for the left gear and 205 m away for the right gear.

This area, between 170 m and 190 m from the impact crater contained parts of the instrument panel (altimeter, speed indicators, circuit breaker panel) and a piece of windshield.

Parts from engine n°1 were found 160 m and 230 m away. Parts from engine n°2 were found 185 m, 260 and 300 m away. Two pieces of the wing were found 140 m and 240 m away. The final parts belonged to the lower parts of the main landing gear; the left main landing gear was 295 m and the right 375 m away.

Distribution of wreckage in areas 2 and 3
