REPORT

THE BOARD OF INQUIRY

into the accident at

to Air Canada DC8-CF-TW aircraft

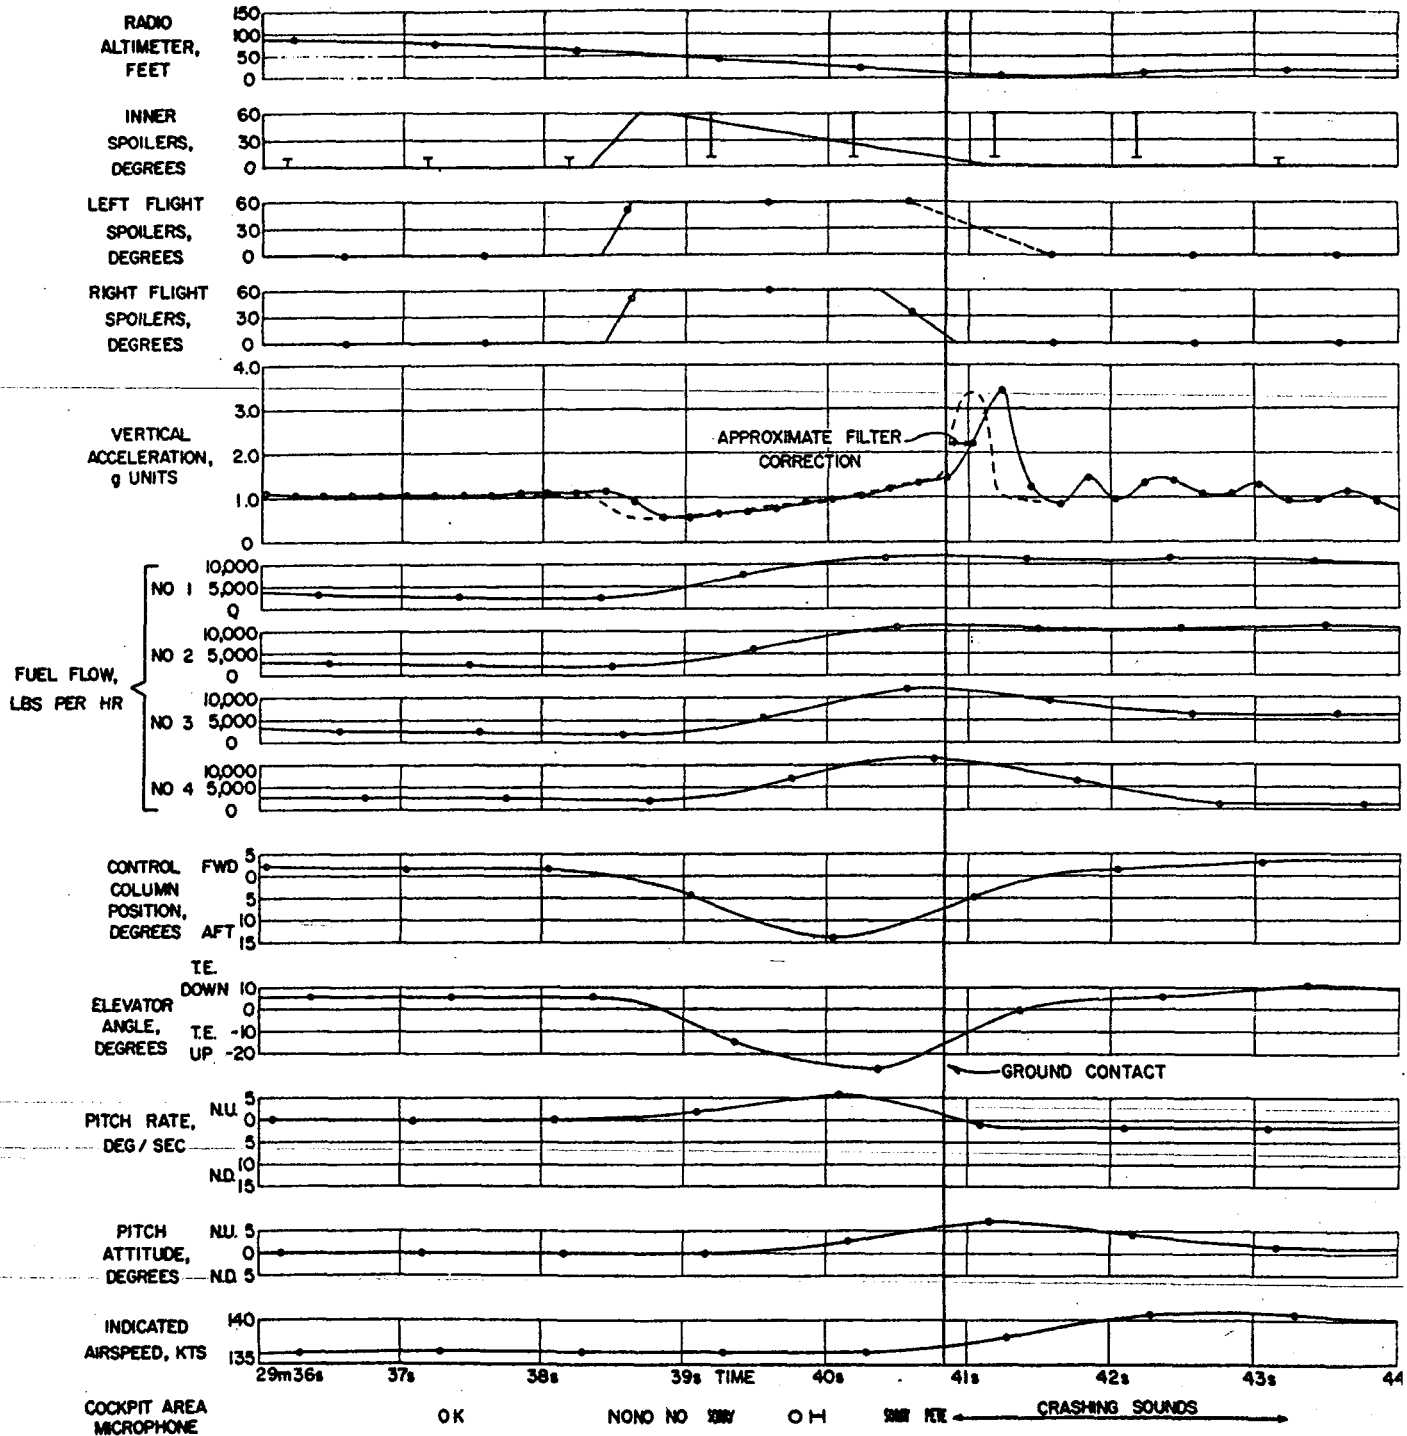
SCHEDULE 4 OF APPENDIX D

Immediately thereafter the First Officer instead of arming the ground spoilers by lifting up the knob of the spoiler actuating lever, pulled the lever aft to the aft extend position, which caused the ground spoilers to be deployed immediately thereafter. As a result, the aircraft lost lift immediately and developed an acceleration of approximately (-)  $\frac{1}{2}$ g.

VARIATION OF CRITICAL PARAMETERS DURING SPOILER DEPLOYMENT AND TOUCHDOWN WITH SYNCHRONIZED VOICE INFORMATION

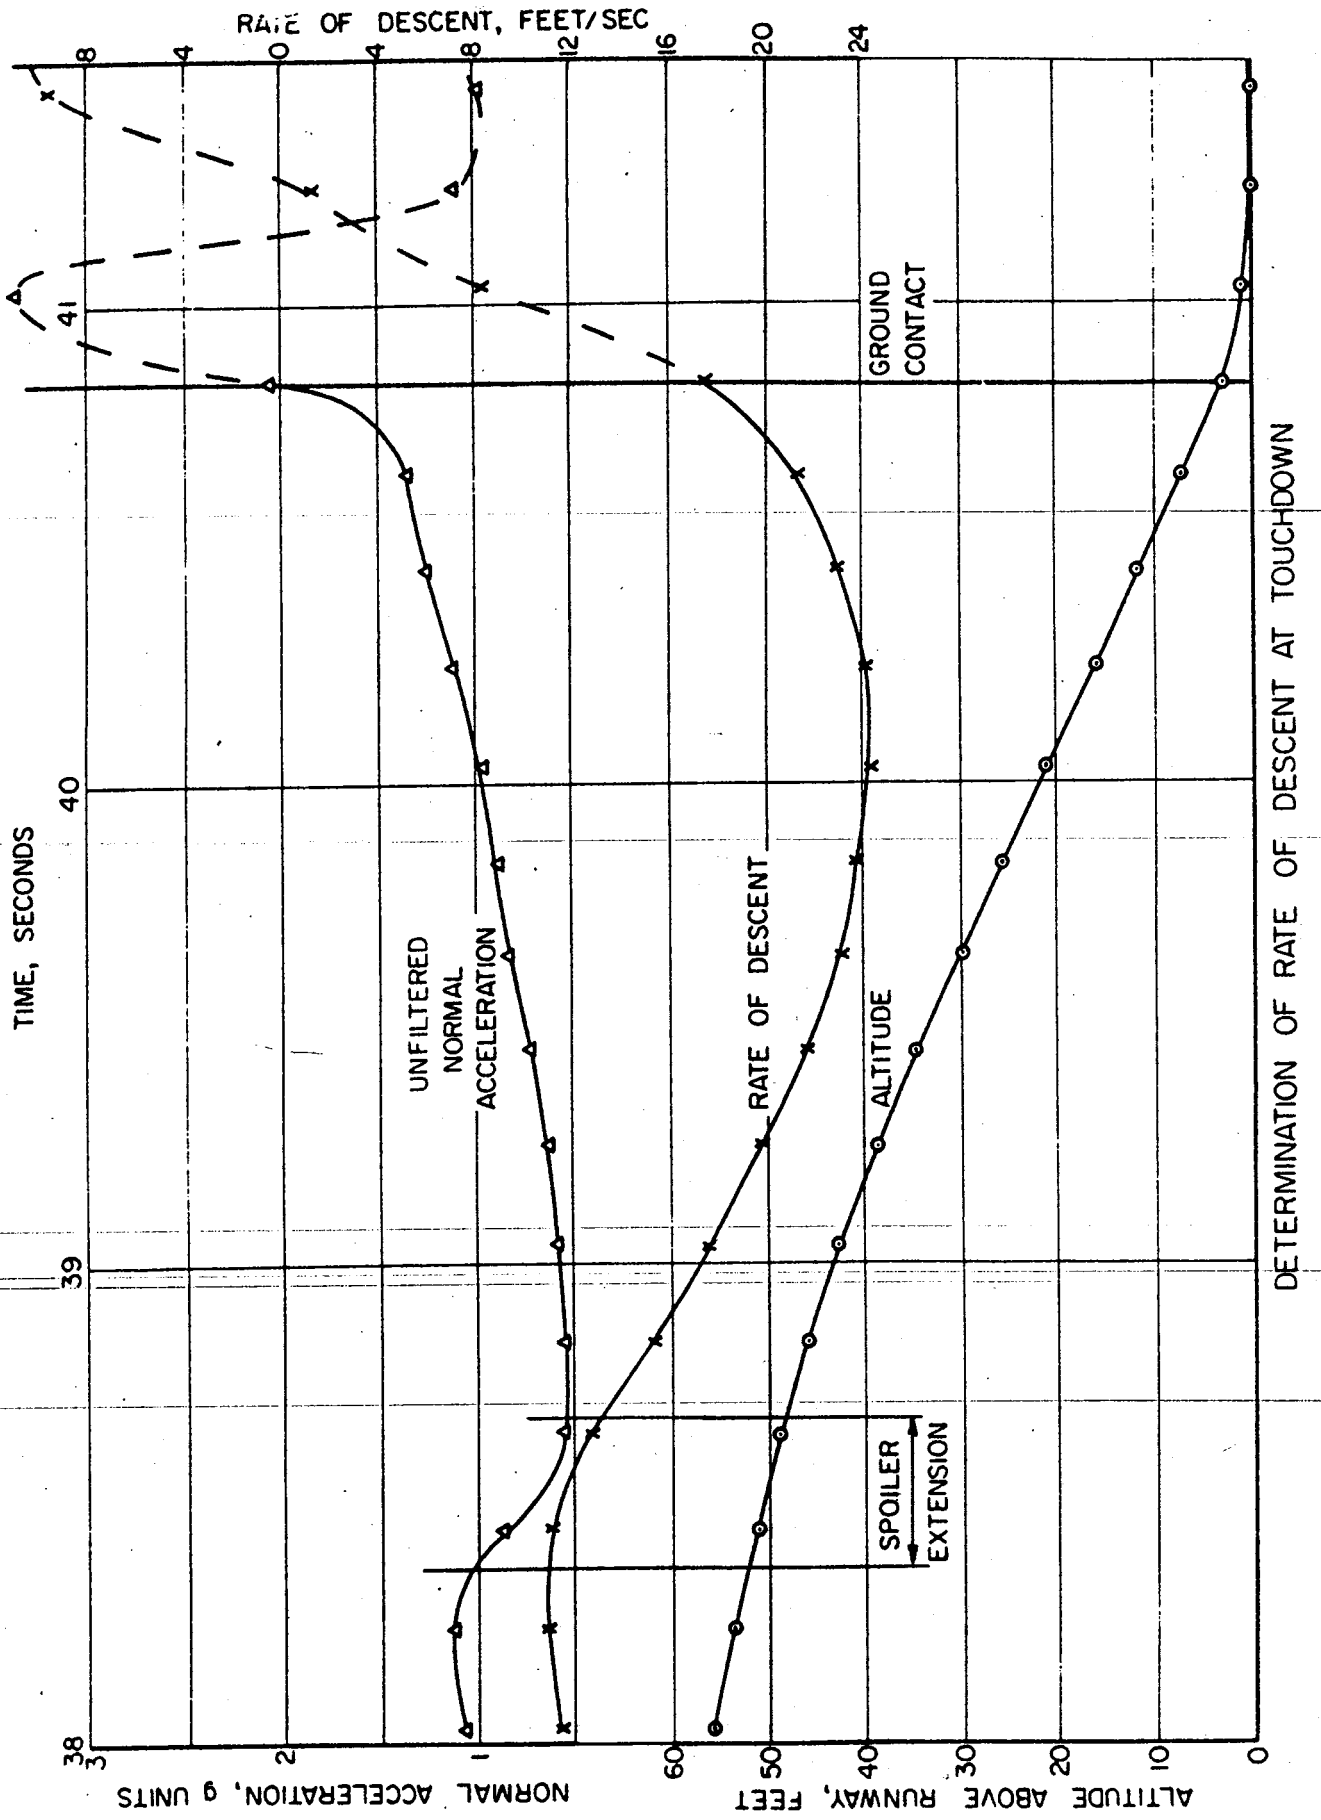
SCHEDULE 5 OF APPENDIX D

It should also be observed that if the Captain instead had not elected to check the rate of descent of this aircraft, in the final analysis the rate of descent would have exceeded 24 feet per second and the touch down on runway 32 would have been very substantially heavier and substantially in excess of the structural stress limits of this aircraft.)

DETERMINATION OF RATE OF DESCENT AT TOUCHDOWN

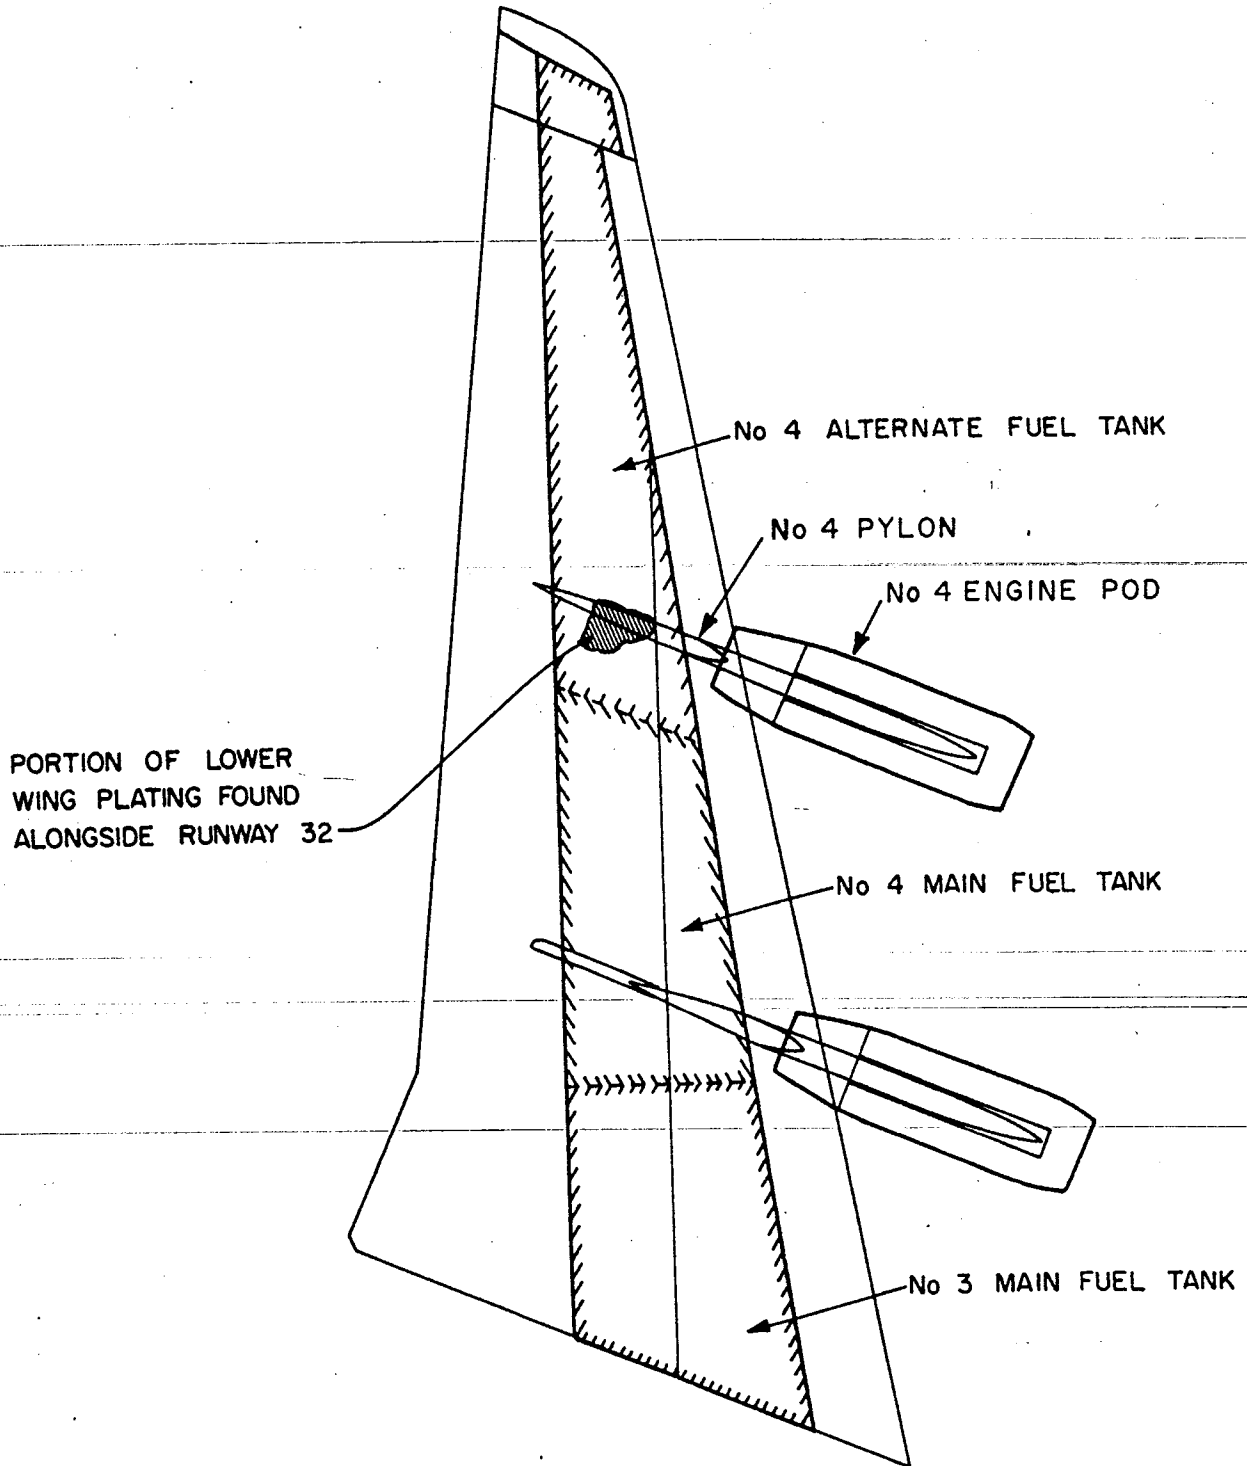
SCHEDULE 17 OF APPENDIX D

A heavy landing, with sufficient force to mark the runway at the point of contact of the wheels and tail bumper, caused number 4 engine pod, pylon and a portion of lower wing plating to break away from the aircraft (see Schedule 17 of Appendix "D"). There was fire on the ground, and fuel was observed streaming from the right wing in the climb segment of flight following the touch down. Fire and smoke were observed in the right wing during the climb. Approximately

The design philosophy of this aircraft included provisions for the separation of the engine pod and pylon from the aircraft structure when vertical loads of 7 g were experienced. This is accomplished by stressing the pylon-to-wing attachments so that the (shear) bracket at the front spar fails first, under vertical load, followed by a progressive failure of the bolts, front to rear, in the horizontal (thrust) attachment (see Schedule 18 of Appendix "D"). Unfortunately, in this accident the horizontal attachments did not perform in the manner prescribed. Some of the bolts at the rear did not fail, in sequence, and, as a result loads were transmitted to the wing which caused a portion of the wing plating - which is also the floor of the number 4 (alternate) fuel tank - to be carried away with the engine pod and pylon. From the evidence, it has been suggested that the number 4 pod did not fail directly downwards, a side component of the forces twisted the pylon to the right, and prevented the attachments from failing cleanly. As a result, a hole approximately four feet long and two feet wide forward, increasing to four feet at the rear, was left in the bottom of the wing plate of number 4 alternate fuel tank.

EXTRACT FROM ENQUIRY EXHIBIT 28 SHOWING PORTION OF LOWER RIGHT WING PLATING OF CF-TIW WHICH FAILED AT THE PYLON ATTACHMENT

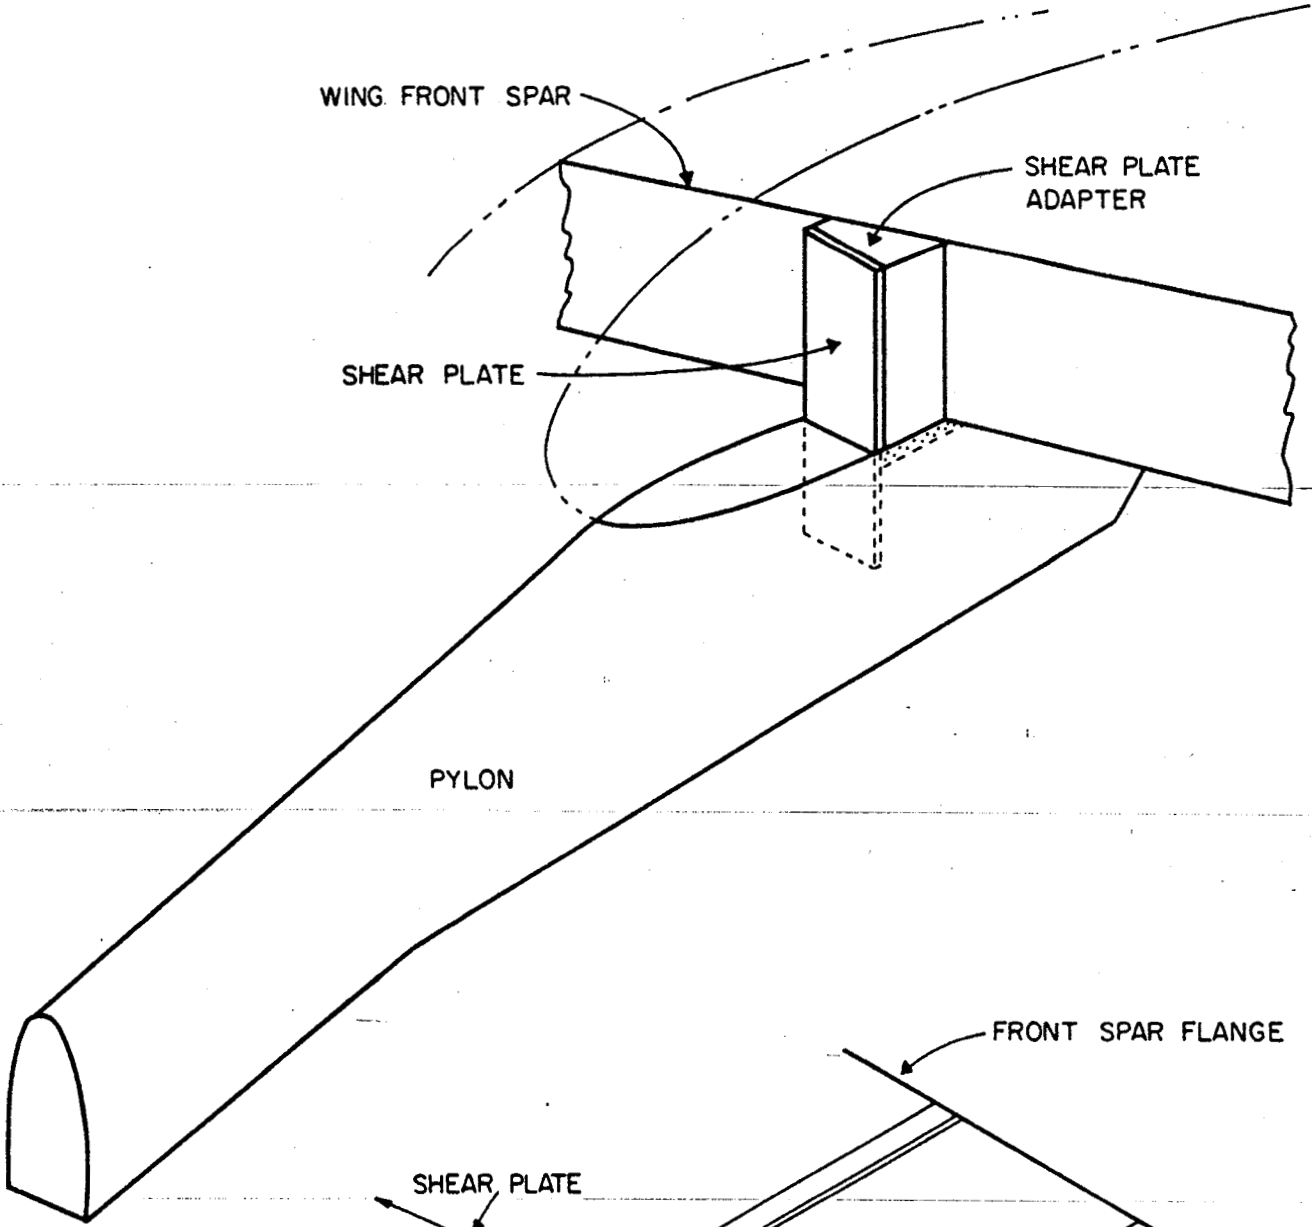
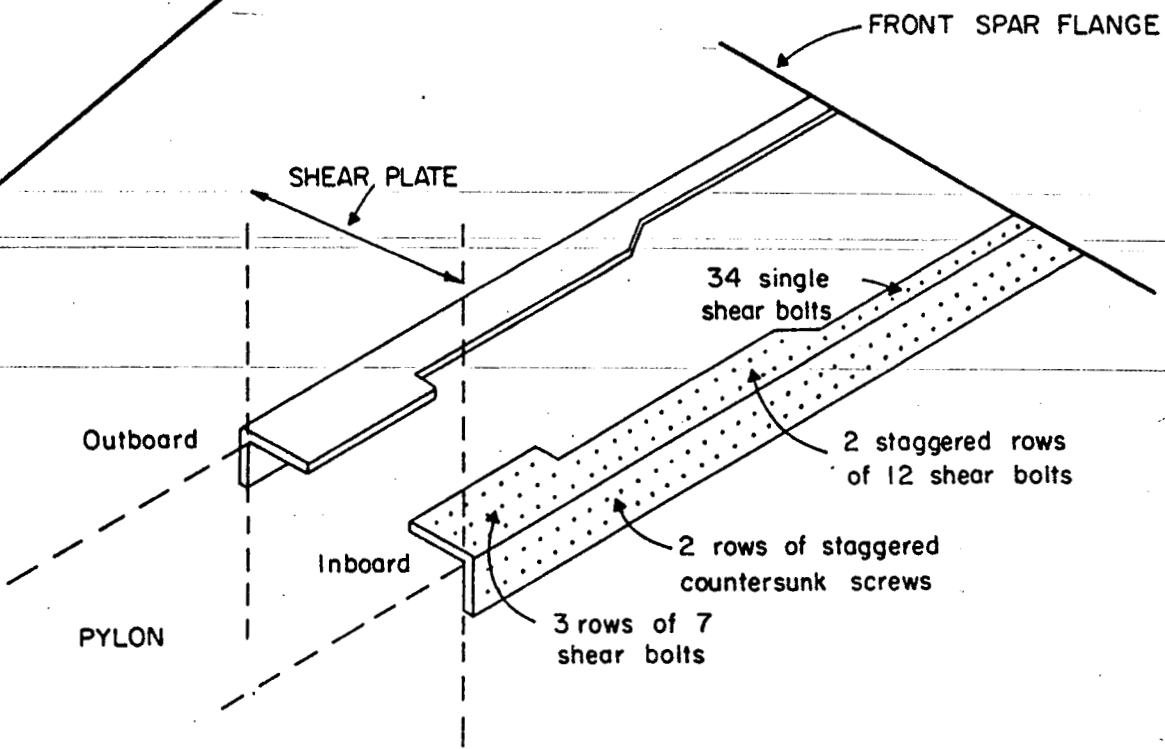
SCHEDULE 18 OF APPENDIX D  
SKETCH OF DETAILS OF PYLON TO WING ATTACHMENT FITTINGS

These numbers are consistent with the evidence on the sequence of failures in the structure, and a statement by the manufacturer on the loads required to fracture the engine pylon-to-wing attachments, in that the attachments of number 4 pylon fractured completely and those of number 3 pylon

were severely damaged in the landing touch down.

<sup>2</sup> The evidence from the wreckage showed that the vertical shear attachments of this engine were seriously damaged in the first landing impact.
