**Loss of Pitch Control During Takeoff
Air Midwest Flight 5481
Raytheon (Beechcraft) 1900D, N233YV
Charlotte, North Carolina
January 8, 2003**

Aircraft Accident Report
NTSB/AAR-04/01

Loss of Pitch Control During Takeoff

Air Midwest Flight 5481

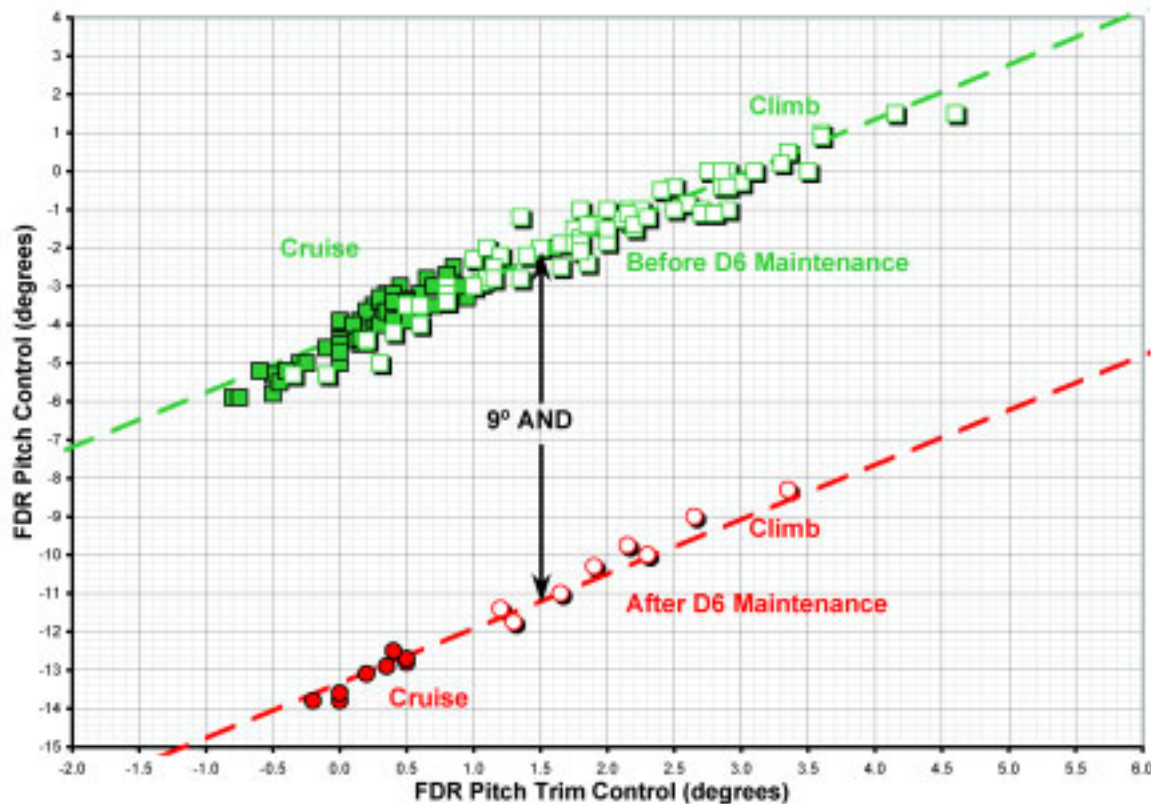
Figure 8. Flight data recorder pitch control and pitch trim control positions.

The position of the trim tab is the predominant predictor of elevator position during climb and cruise flight. Figure 8 shows that a strong correlation exists between elevator (FDR pitch control position) and trim tab (FDR pitch trim control) data. The figure shows two distinct data groups: the larger group represents flights before the D6 maintenance check, and the smaller group represents flights after the D6 maintenance check.

The larger group of data shown in figure 8 (that is, the flights before D6 maintenance) compared well with the Beech 1900D flight test certification data, indicating that the pre-maintenance FDR pitch control position data represented the actual elevator position to within about 1°. However, the smaller group of data (that is, the flights

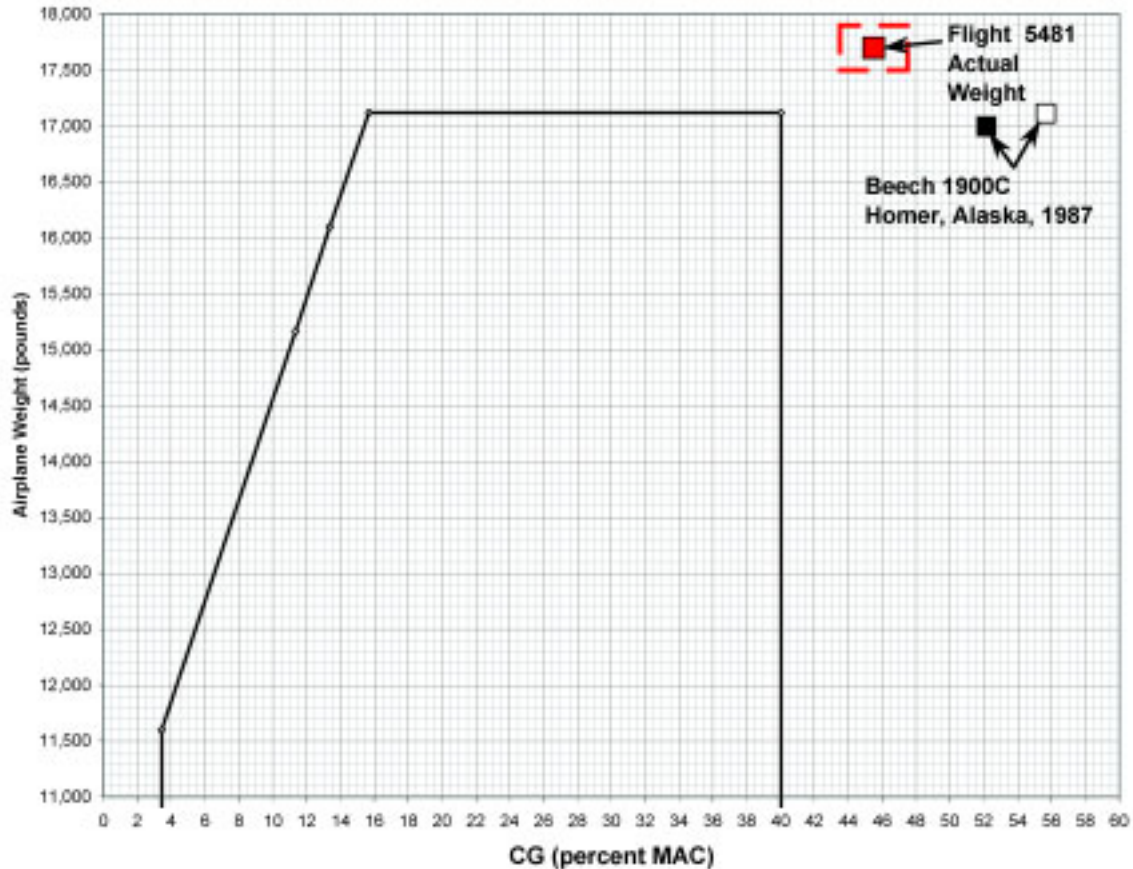
Figure 11. Flight 5481 weight and center of gravity information compared with flight 103 weight and center of gravity information.

Figure 11 shows flight 5481's weight and CG information compared with that for the flight 103 accident airplane. Two data points in the figure show the CG range for the flight 103 airplane.
