Aviation Investigation Final Report

Location:	Windsor Locks, Connecticut	Accident Number:	ERA20MA001
Date & Time:	October 2, 2019, 09:53 Local	Registration:	N93012
Aircraft:	Boeing B17	Aircraft Damage:	Destroyed
Defining Event:	Landing area undershoot	Injuries:	7 Fatal, 5 Serious, 2 Minor
Flight Conducted Under:	Part 91: General aviation - Other work use

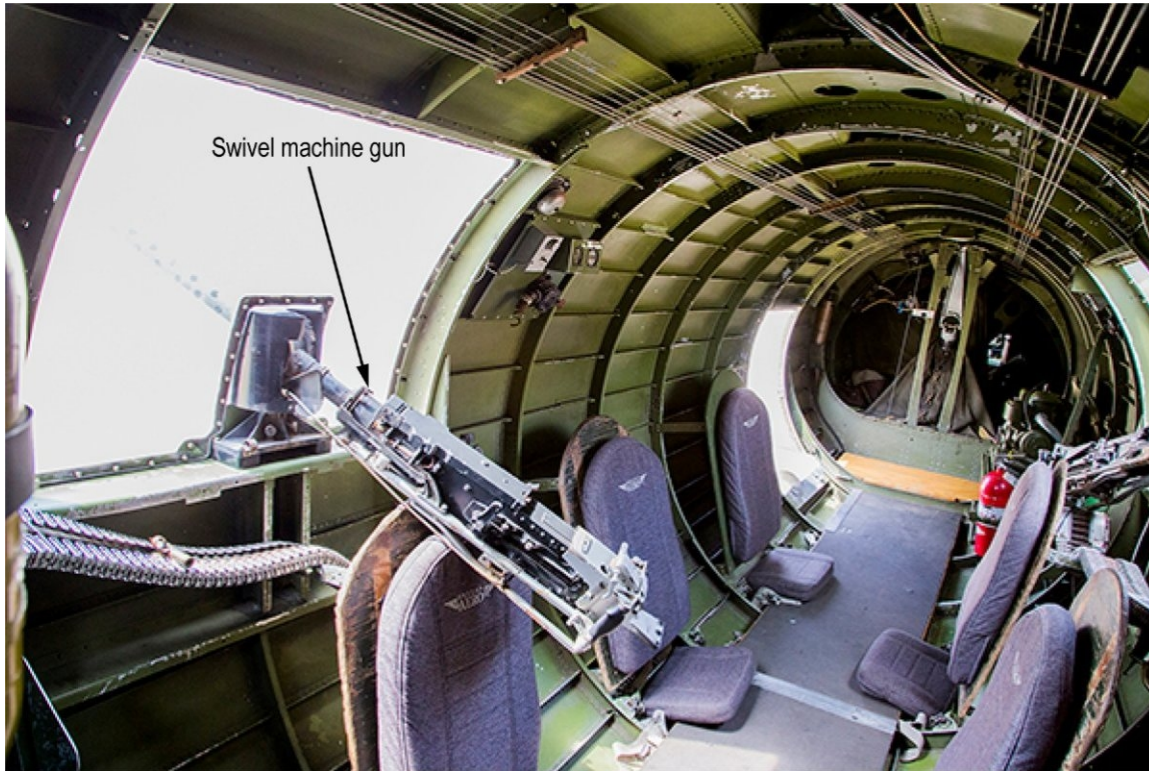
Figure 3. Accident airplane interior (forward looking aft)

The passenger seats that were not original equipment were installed in the airplane according to an engineering document that conformed with the structural requirements of *Civil Aviation Regulation 4b*. Some of the seats consisted of a 5/8-inch-thick plywood seatback attached to the airframe with aluminum angles and brackets, as shown in figure 3. The other seats were secured directly to the structure on an airplane sidewall or bulkhead. All of the passenger seats included a seatback cushion secured with hook and loop fasteners and a seat bottom cushion secured to a floor panel. The passenger seats were equipped with a two-point military/aerobatic-style lap belt affixed to either the seat or structural areas on or near the floor.

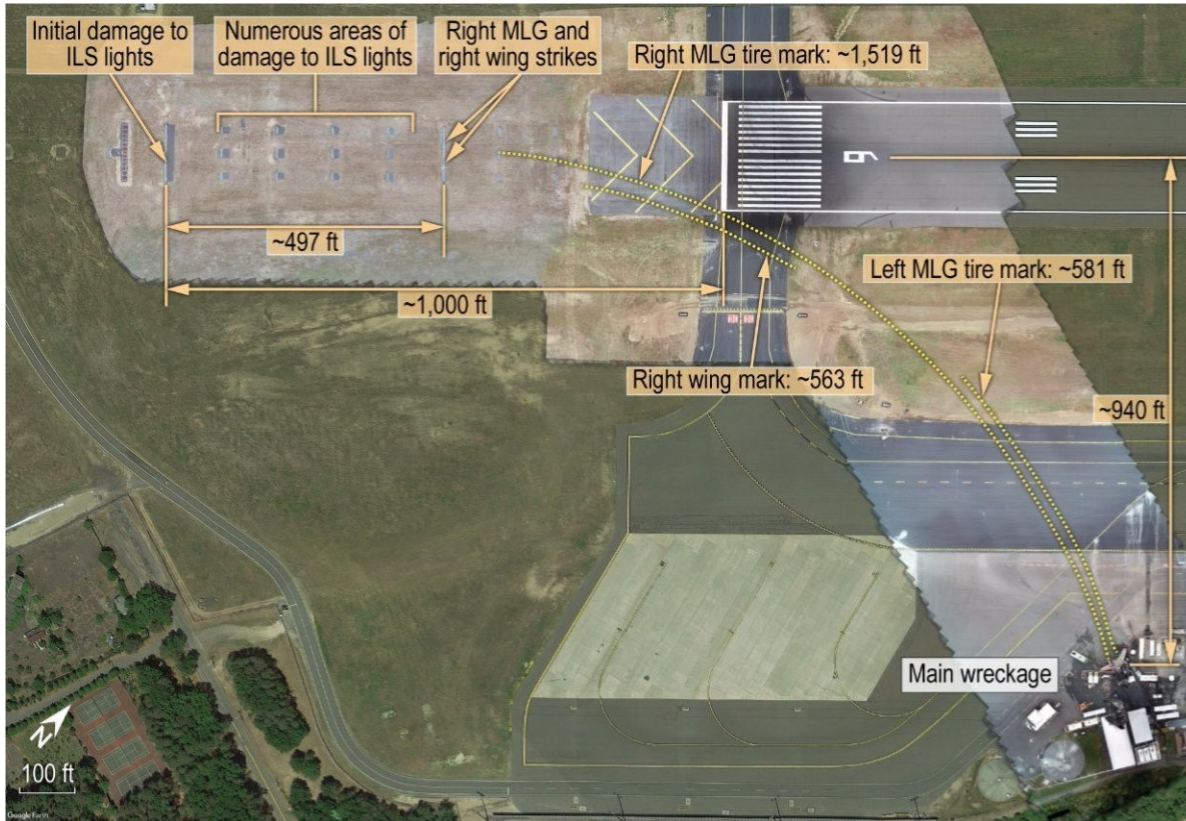
Figure 4. Overhead image depicting the airplane's path to final impact

Witness statements and video indicated that the airplane struck the runway 6 approach lights in a right-wing-down attitude about 1,000 ft before the runway. The airplane contacted the ground about 500 ft before reaching runway 6. The engine noise increased, and the airplane accelerated as it veered to the right of the runway. The airplane then collided with vehicles and a deicing fluid tank before coming to rest upright about 940 ft to the right of the runway 6 centerline and oriented to the east. A postcrash fire ensued.

Figure 4 is an overhead image that shows the runway 6 approach area, the areas of impact damage to the instrument landing system (ILS) lighting equipment, and the location of witness marks from the airplane's main landing gear (MLG) and right wing. The figure also shows the airplane's final resting position about 940 ft to the right of the runway 6 centerline. Most of the cabin, cockpit, and right wing were consumed by a postcrash fire, as shown in figure 5.

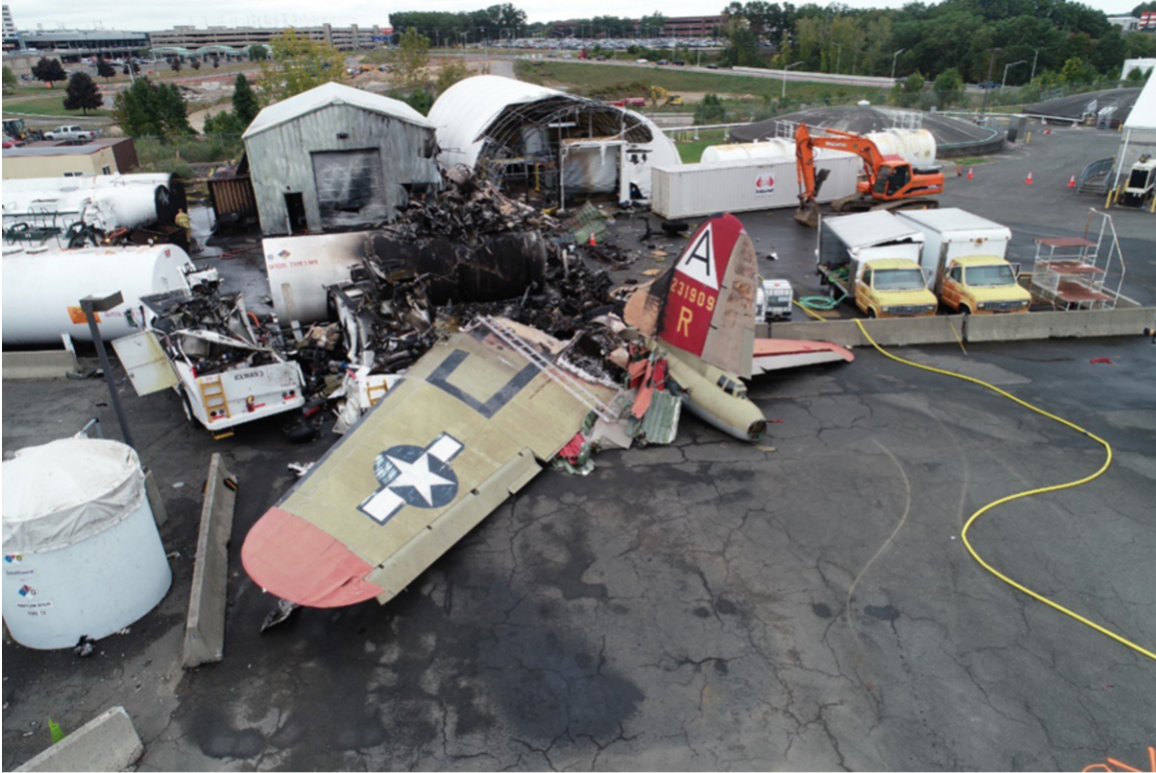
Figure 5. Airplane wreckage

Measurement of the left- and right-wing flap jackscrews corresponded to the retracted flap setting. The left-wing flap and aileron remained attached to the wing, and a section of the flap was consumed by the postcrash fire. The right-wing flap remained attached to the wing; the aileron was consumed by the postcrash fire. The empennage, elevator, and rudder remained intact.
