**Report on the accident to
Airbus A-320-231, G-MEDA
On approach to Addis Abeba Airport,
Ethiopia
31 March 2003**

Registered Owner and Operator: British Mediterranean Airways Limited

Aircraft Type: Airbus A-320-231

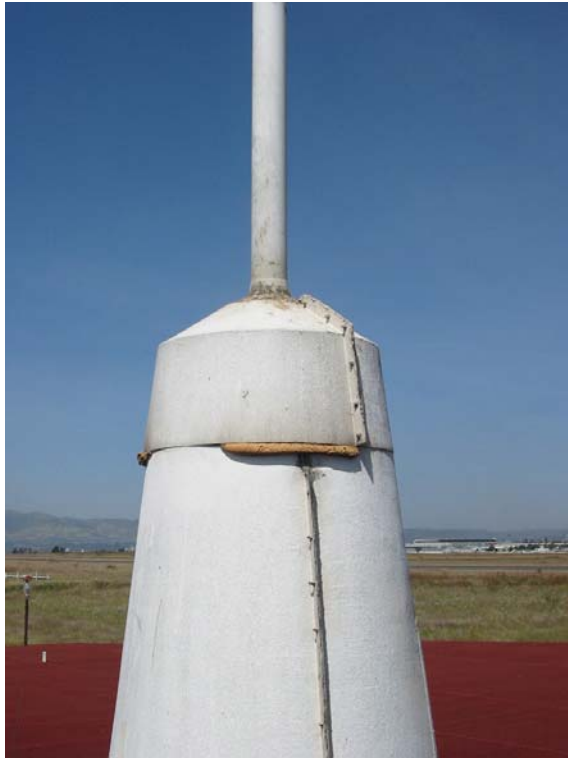
Figure 9

ADS VOR antenna radome on top of the ground plane

Physical inspection of the ADS VOR ground station, in the days after the incident involving G-MEDA, revealed water ingress in the capacitors used to couple the signal generators to the antennas. It was reported that the impedance matching capacitor of the NE/SW variable signal was full of water; the affected area was cleaned and dried. A transistor in the control unit was also found to be faulty and was replaced. Changing the characteristics of one of these capacitors will affect the power output and/or phase of the varying signal used to drive the corresponding antenna pair. Figure 10 illustrates the effects of changing the power and phase of the NE/SW antenna signal. The errors generated by these types of faults are not uniform. For some bearing ranges, large changes in actual bearing will result in relatively small changes in the bearing sensed at the aircraft.

The sealant used on the antenna assembly had been supplied by a contracting firm and was established to have been of an incorrect type; the sealant was replaced. Technicians used a hand-held receiver to test the signal strength, identification and navigation guidance of the ADS VOR. This test indicated normal operation; however, since the test was not conducted from a surveyed position the accuracy of the ADS VOR could not be determined. A serviceability report was requested from an aircraft in flight, which confirmed that the ADS VOR was operating.

The cause of the ADS VOR error was found to be water ingress into the antenna feeds due to poor maintenance practices; a faulty transistor was also identified. Following the incident, the rectification and subsequent testing that was carried out created the impression that the ADS VOR was now operating correctly and it was returned to service. The checks utilising the hand-held VOR receiver were not conducted from a surveyed position and could not validate the accuracy of the radiated pattern. Aircraft in flight were asked for serviceability reports but since these were not dedicated flight check aircraft they could only have provided limited information on the functionality of the ADS VOR. The only manner in which correct operation of the ADS VOR facility could have been ensured was through a calibration flight conducted by a suitably equipped aircraft, and none was available. The reports of ADS VOR bearing problems some days after the rectification

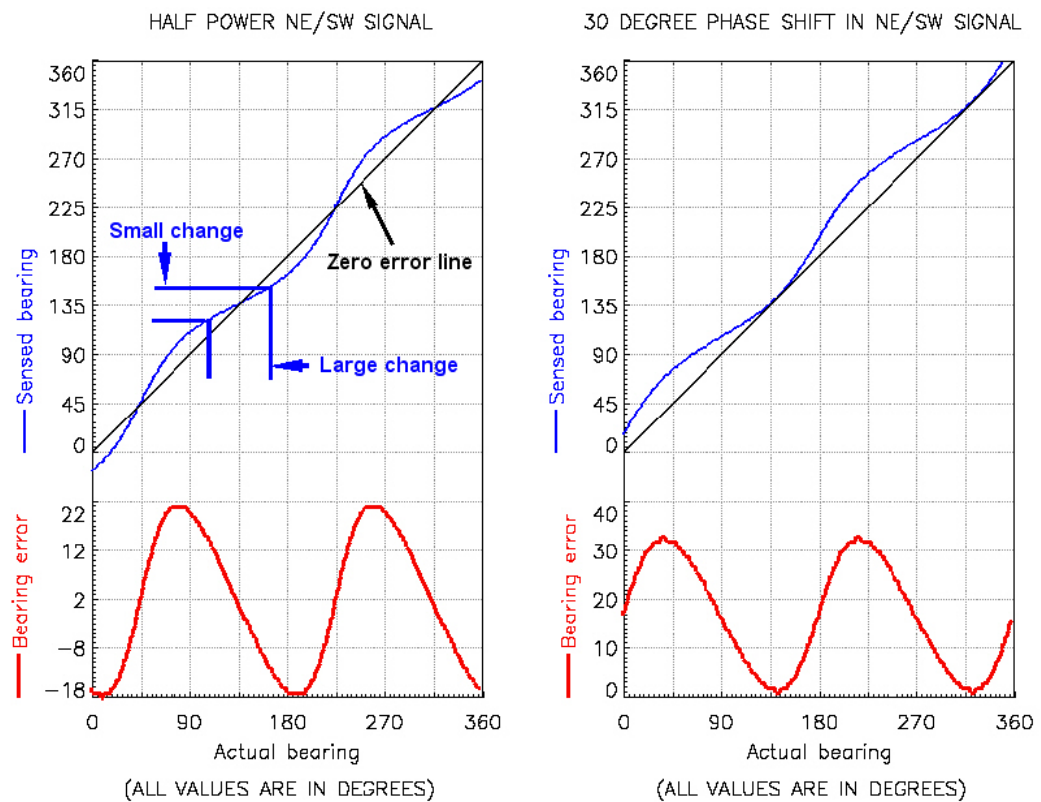
The day after the incident, with the aircraft outbound from the ADS VOR on a heading of 092°, the crew observed a 22° error. With the aircraft inbound on a heading of 249°, a VOR error of 30° was observed. The crew made these observations when in good visual contact with the runway and the surrounding terrain. These errors were reported to ATC.

Figure 10
Simplistic models of VOR behaviour with altered signal power and phase for the NE/SW VOR signal

No single simplistic model of VOR error matched all the observed ADS VOR deviations, however, observations were made at different times and it is likely that the effect of the water ingression on the radiated ADS VOR signal varied over time.

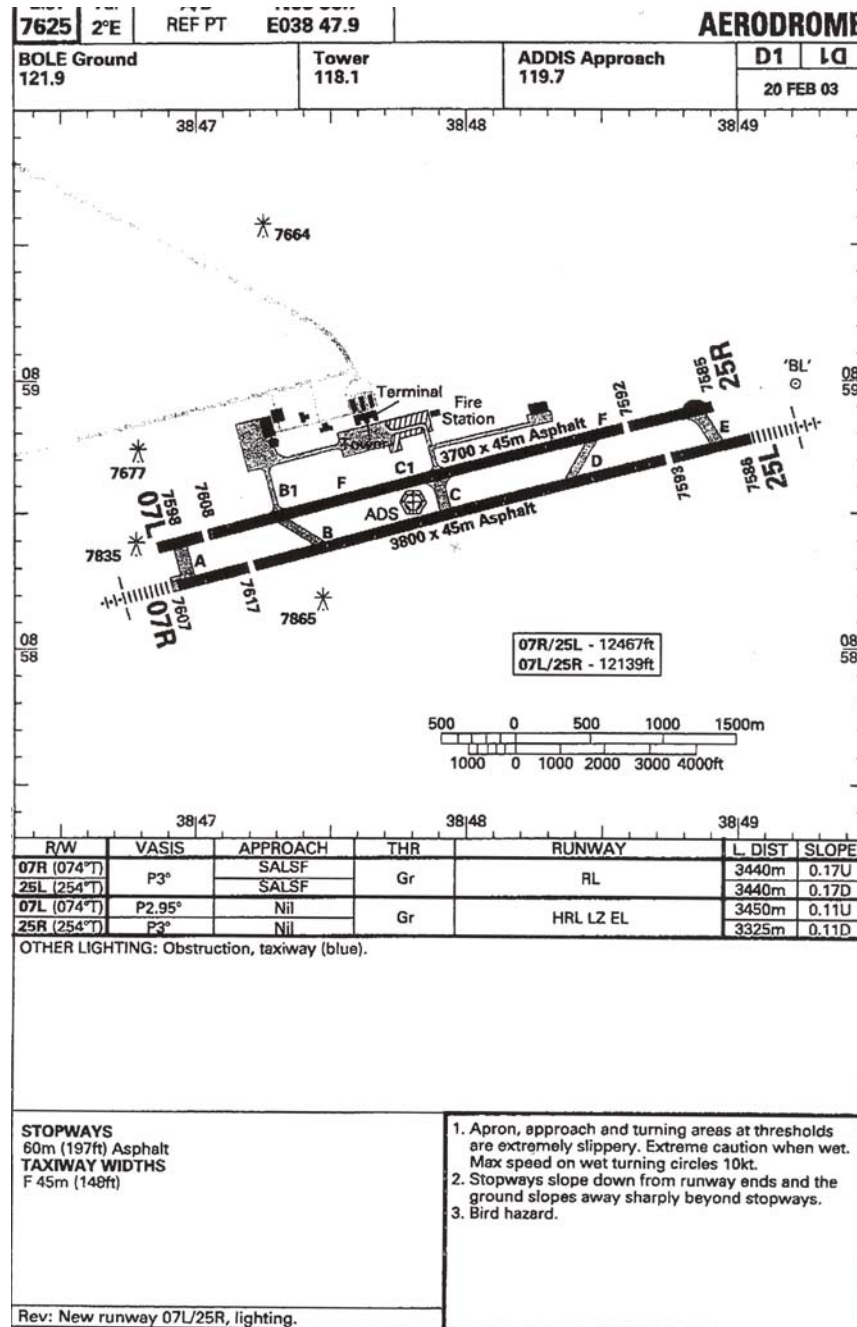
Figure 12
Addis Abeba aerodrome chart D1

A copy of the airfield (D1) chart is reproduced at Figures 12. The position of the ADS VOR relative to the runways is depicted incorrectly on chart D1; the ADS VOR was in fact located to the south of both runways.

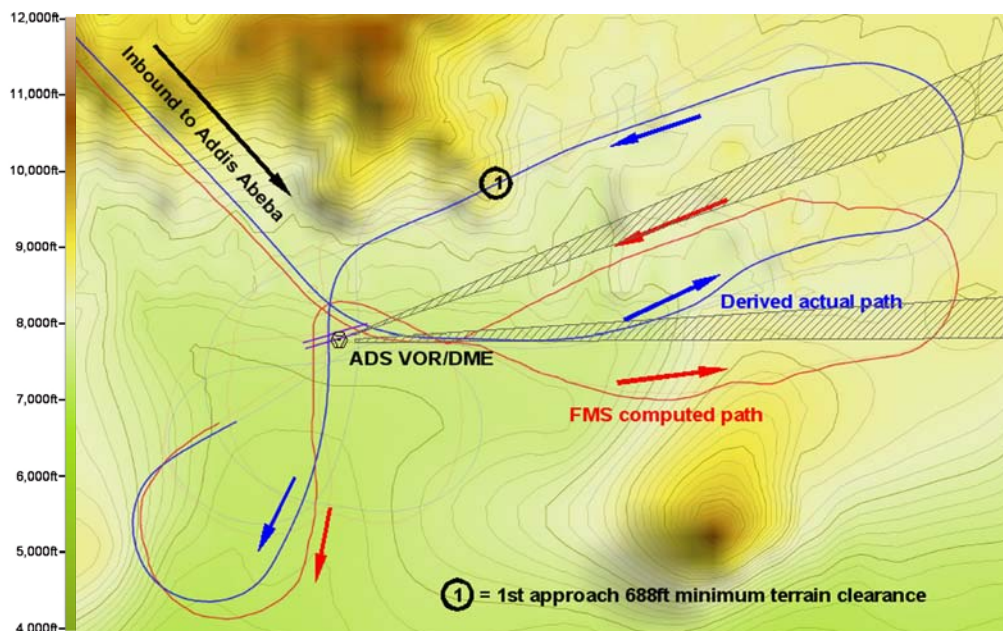
Figure 13

When the aircraft was in the latter stages of the approach the difference between the derived path and the FMS path rapidly reduced.

The go-around was initiated at 2323 hrs with the lowest recorded terrain clearance of 688 ft. The relationship between the FMS and actual flight paths fluctuated to a lesser extent during the go around.

First ADS VOR/DME procedural approach and go-around showing the FMS computed path and derived actual path (Hatched area = procedural ADS VOR bearings)

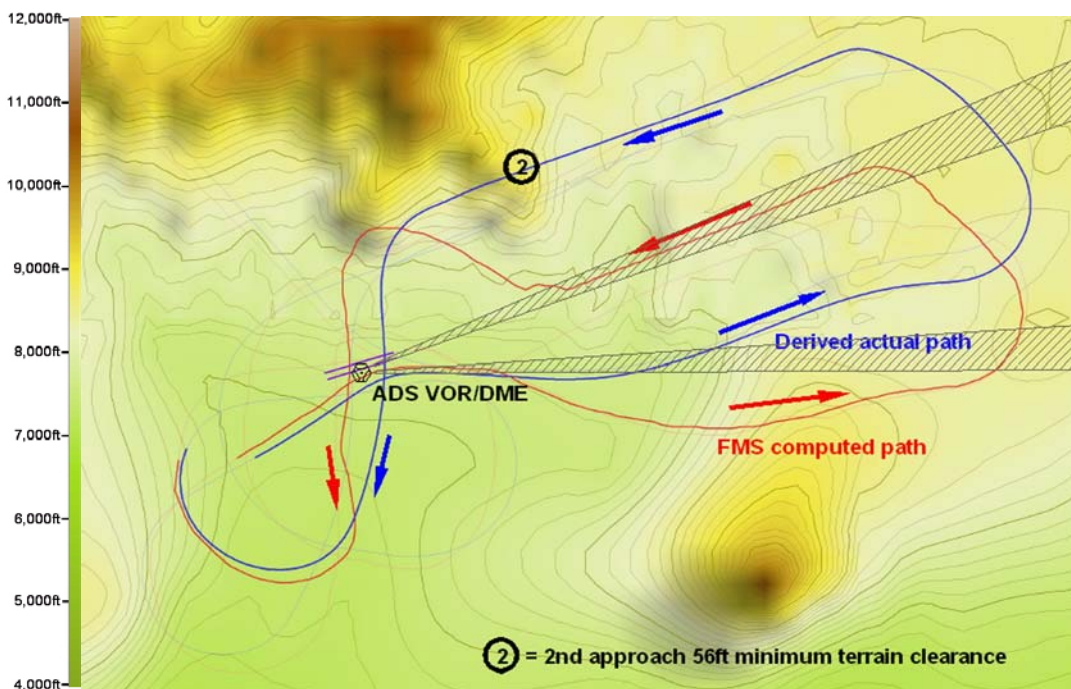
Figure 14

The second approach had similar lateral position characteristics as depicted in Figure 14. The aircraft completed the turn onto the inbound track and commenced the descent. The aircraft was then configured with the gear down and full flap. The rate of descent varied between 700 and 950 fpm, the indicated airspeed was maintained at about 135 kt, and the heading drifted from 240°M to 245°M. The autopilot was engaged throughout the second approach.

Second ADS VOR/DME procedural approach and go-around showing the FMS computed path and derived actual path (Hatched area = procedural ADS VOR bearings)

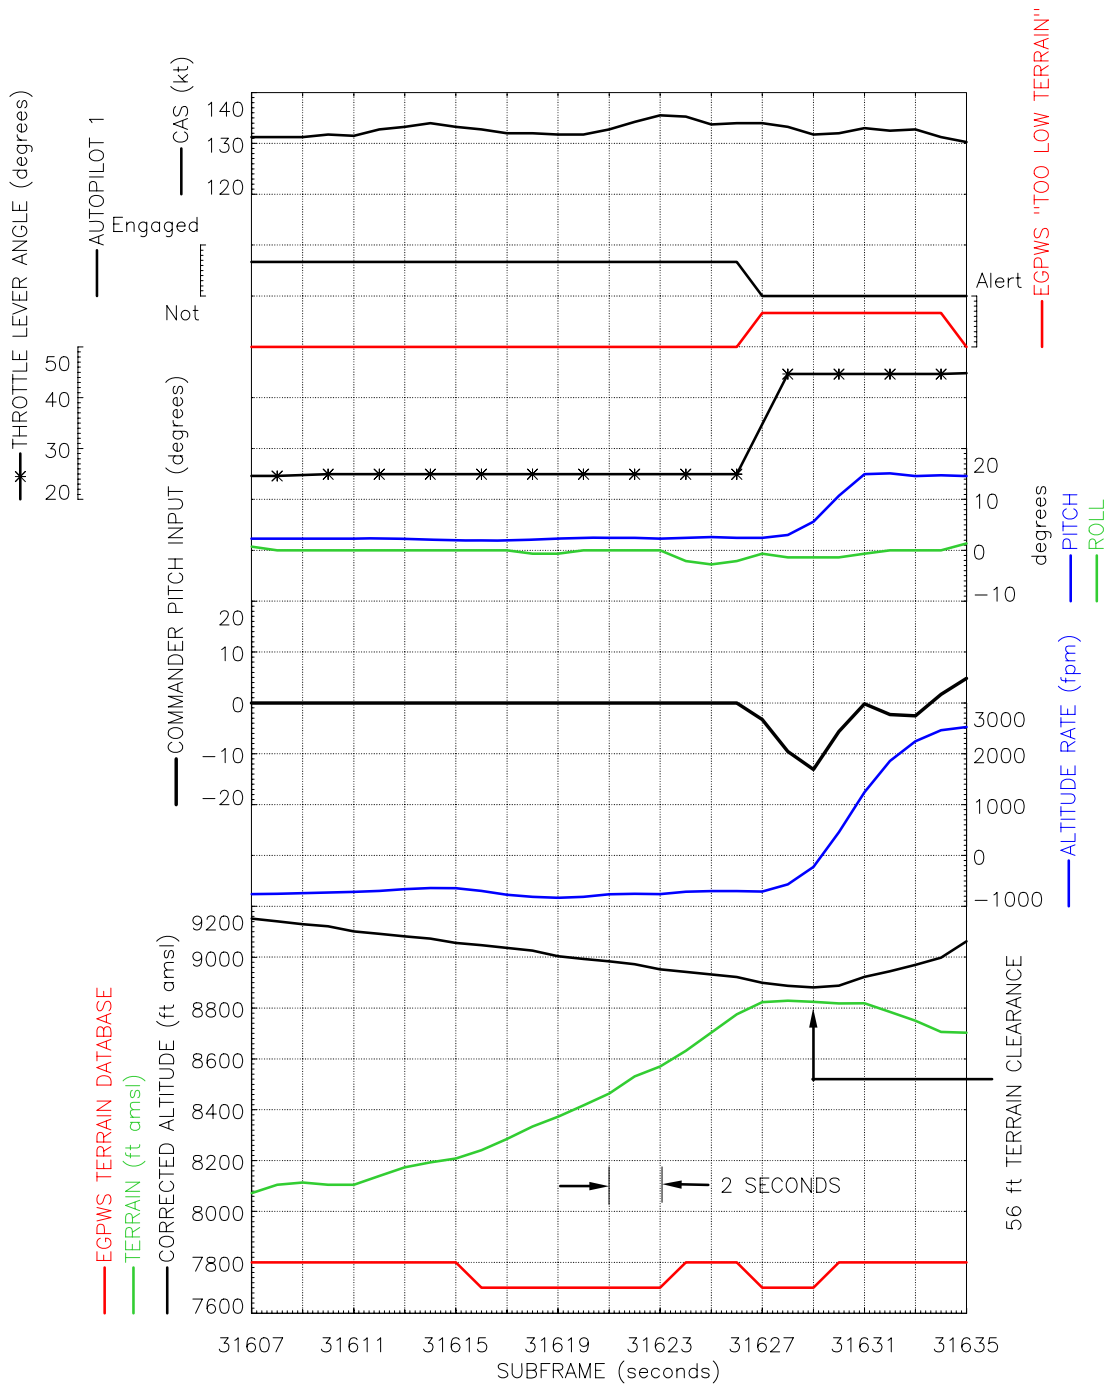
The EGPWS also recorded the expected terrain elevation from its database for the given FMS aircraft position. This is also shown in Figure 15. When the aircraft

was closest to the ground, the difference between the EGPWS database expected terrain elevation and the measured terrain elevation was more than 1,000 ft.

Figure 15
EGPWS alert on the second approach

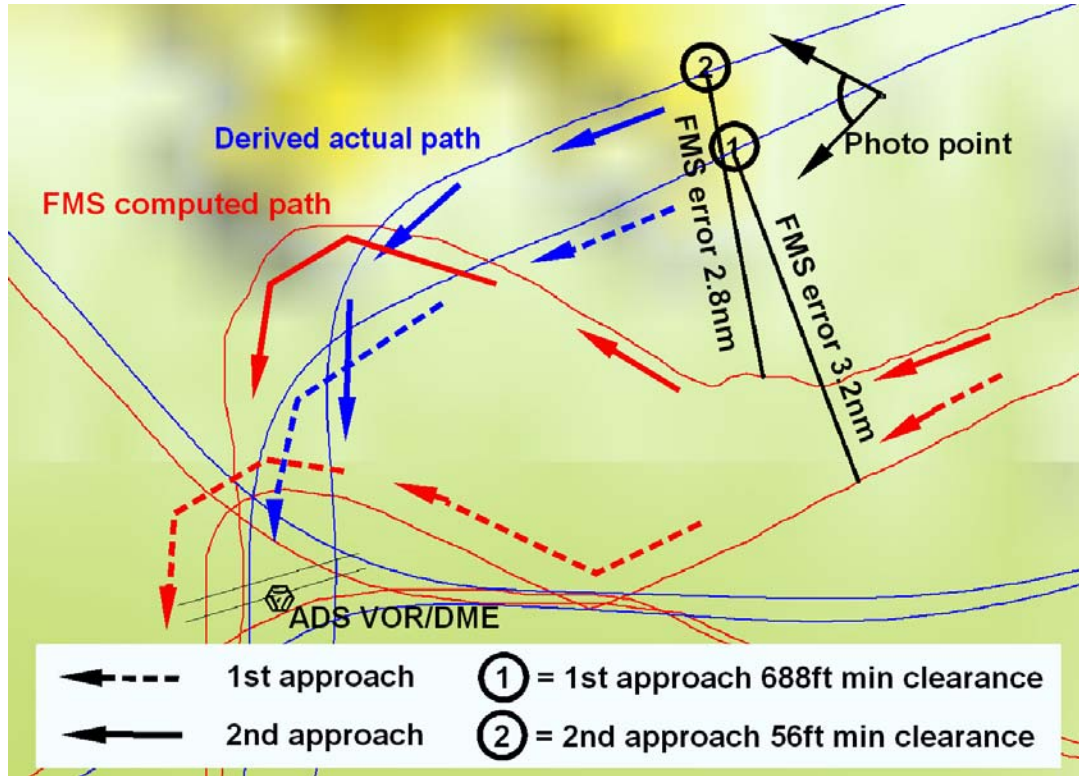
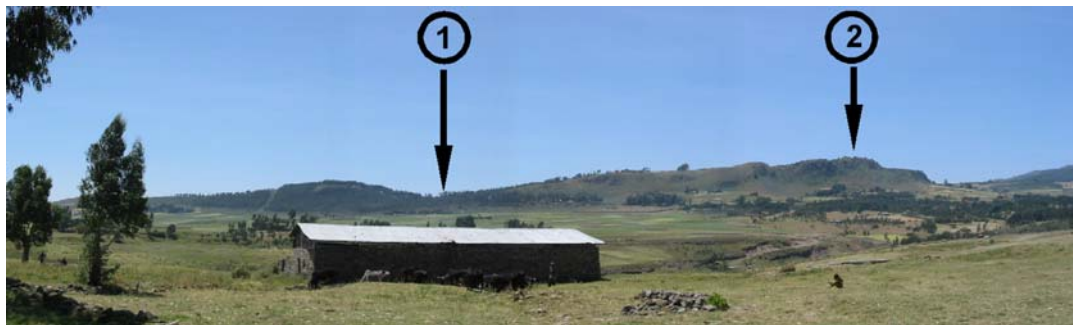
Figure 16

Figure 16a shows a comparison of the sections of both approaches where the terrain clearance was at a minimum. The data shows that the FMS was approximately 3 nm in error on each approach, with the aircraft over much higher terrain than the FMS position would indicate. The picture at Figure 16b shows the physical locations of the points of closest approach to terrain during each approach.

b) Picture showing the points of closest approach to terrain during the 1st and 2nd approaches.

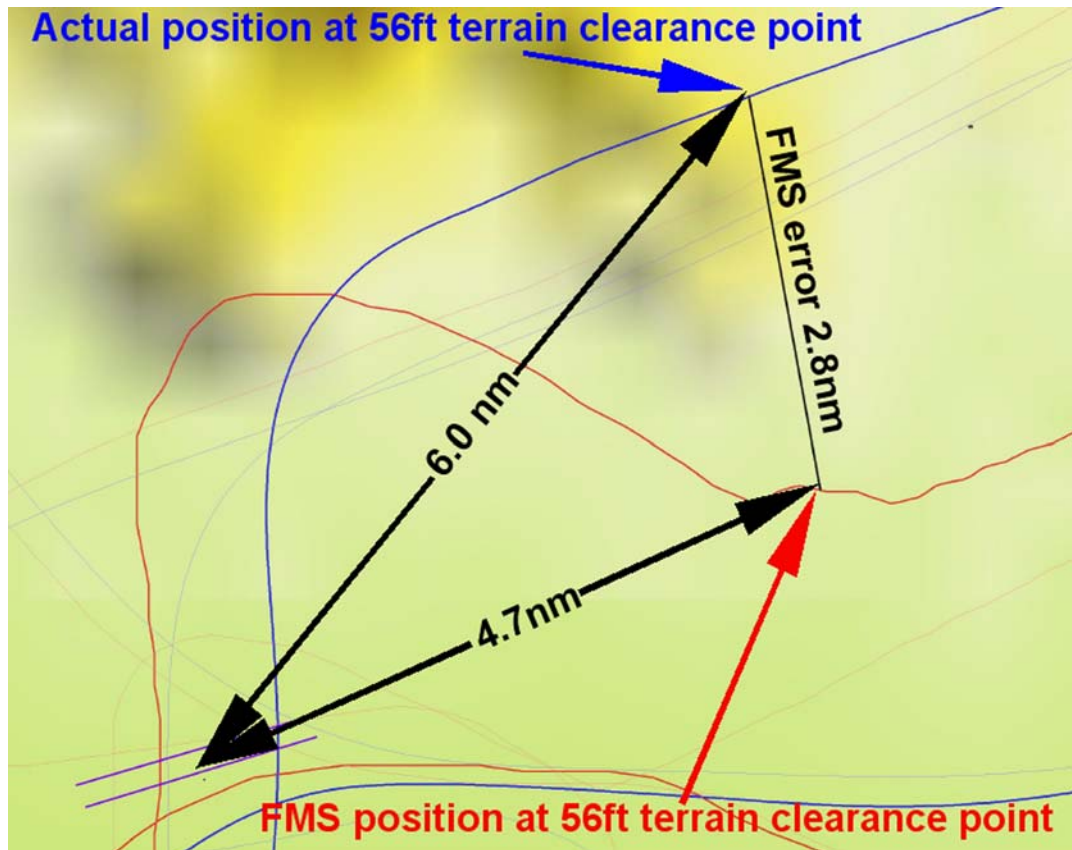
The TCF allowed clearance height is a function of distance to runway, therefore the effect of the FMS error on the TCF function should be reviewed. The effect on TCF distance is shown in Figure 18 below.

Effect of the FMS error on the distance to runway centre calculation of the TCF function, at the point of minimum terrain clearance

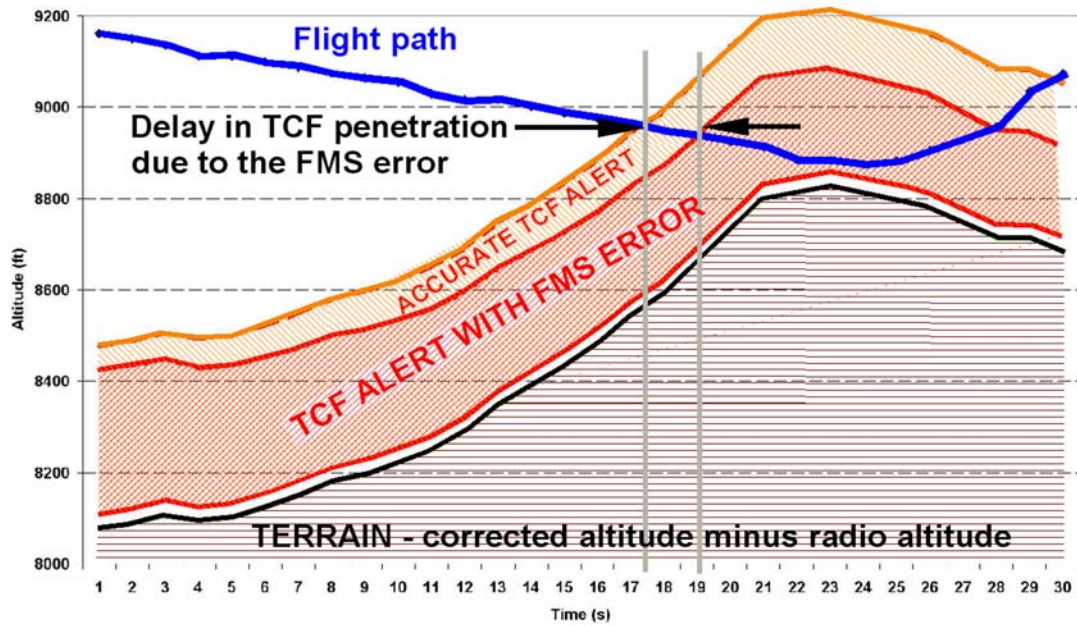
Applying these distances along with a simplistic model of the aircraft's flight path gives a less sensitive TCF alert envelope with the FMC error than if the navigation had been accurate. This is illustrated in Figure 19.

Figure 19
TCF alert envelope with and without the FMS error

The FMS error effectively only delayed the alert by approximately 1.5 seconds. In this case, using the latest, tightest TCF envelopes would not have significantly increased the time to alert.

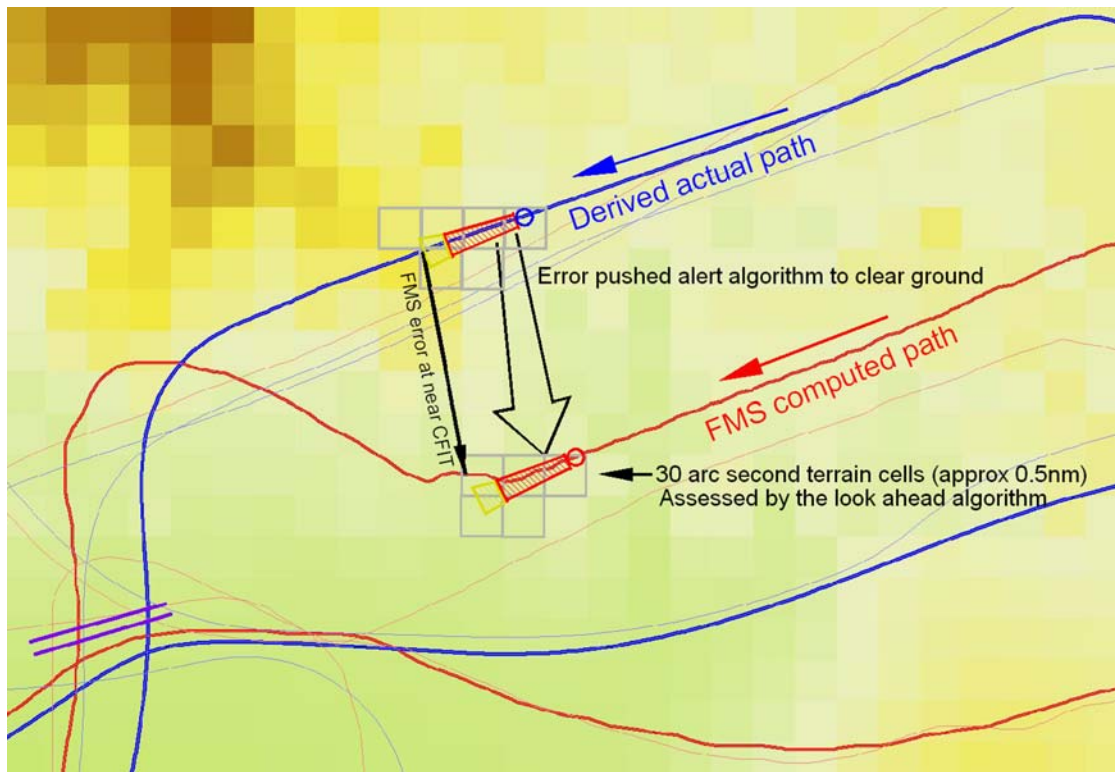
In this case the cross track navigation error was about 2.8nm so the alert algorithm 'passed' by the side of the hazard. Figure 20 illustrates this using terrain data that is not from the EGPWS but is of a resolution that is representative of typical terrain cell sizes used by the EGPWS in terminal areas. The representation of blocks of interest to the look ahead alert algorithms are only an illustration of the nature of the interaction of the terrain data with the algorithms are not definitive indications of actual terrain cells used in the terrain database.

FLTA - Honeywell alert envelopes in relation to the navigation error

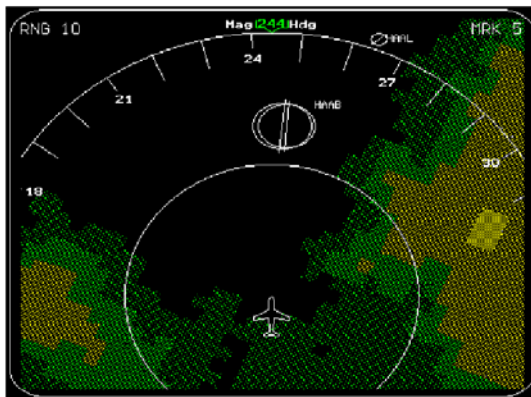
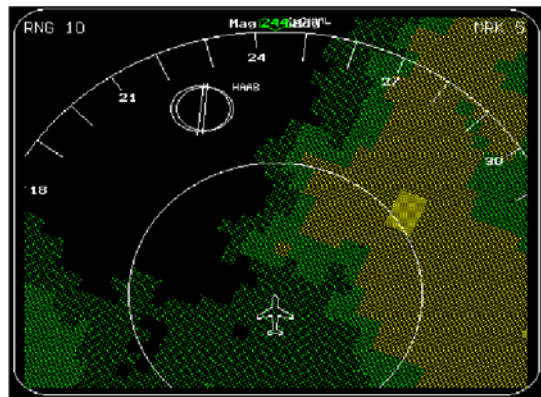
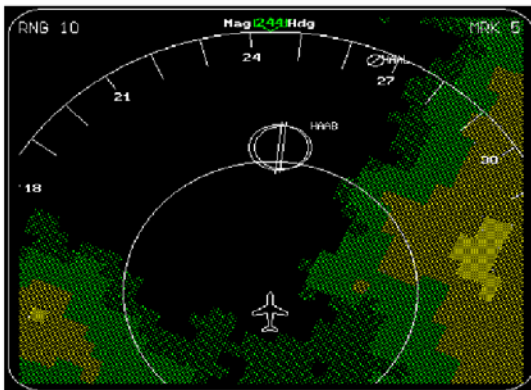
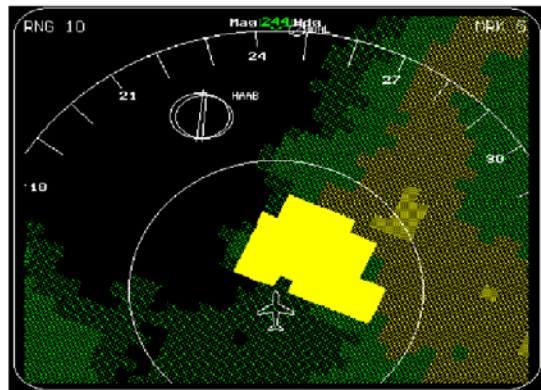
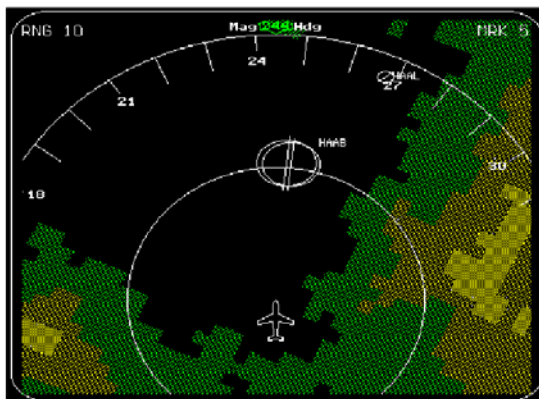
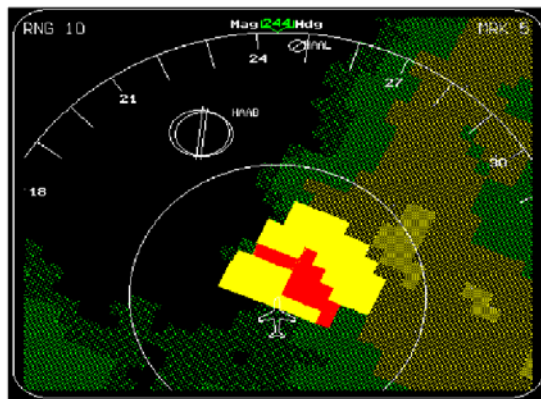
Figure 21

If the terrain display and the navigation display systems had used independent sources of navigation data then the display would have either given correct terrain depiction and incorrect runway depiction or vice versa. Either way, it would have been a possible cue to the crew that things were not right.

With FMS Position Error
Approximately 2.6 NM cross-track error
