----- SYSTEMS GROUP CHAIRMAN'S FACTUAL REPORT -----

Location: Memphis, Indiana  
Date: November 30, 2018  
Time: About 1028 EST  
Aircraft: Cessna Citation 525A  
Serial Number: 525A0449  
Registration: N525EG

### **3 SUMMARY**

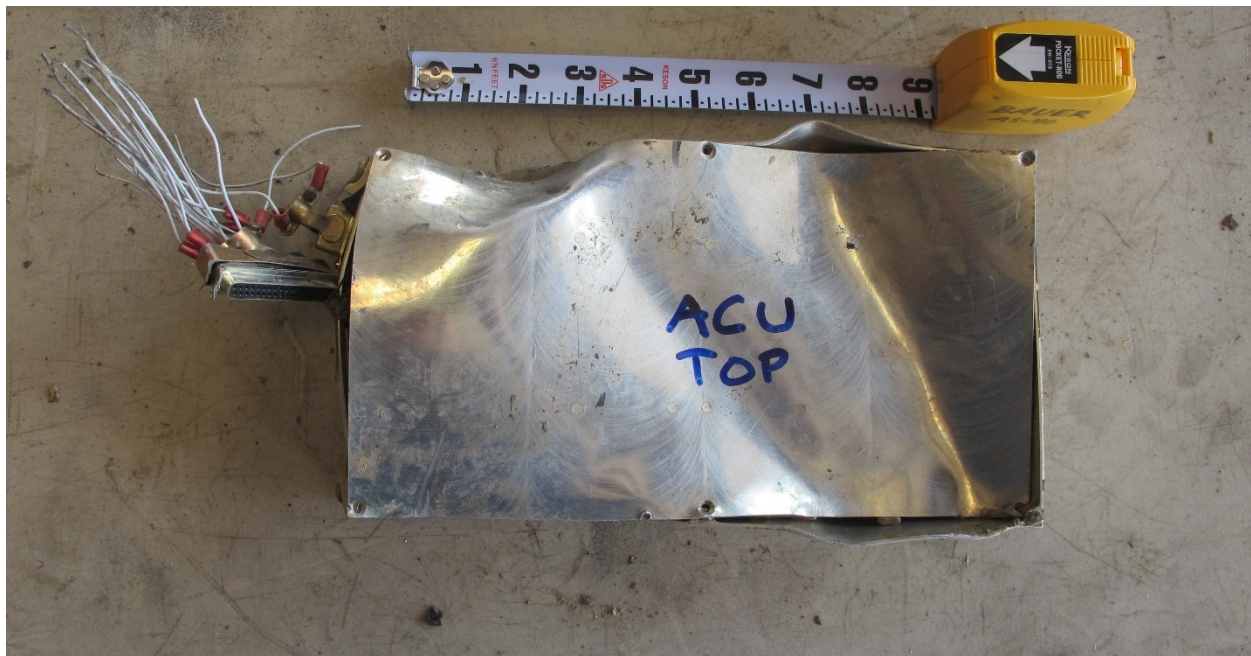
Figure 8 - ATLAS ACU as recovered at storage facility

The unit case showed signs of crushing damage to its exterior consistent with impact, ref Figure 8. On the side of the unit the 9 pin D-sub<sup>6</sup> connector was attached; however, the associated wiring was not present. The 37 pin D-sub connector was partially detached, and wiring was present with the connector. The mating pins were extensively damaged and bent.

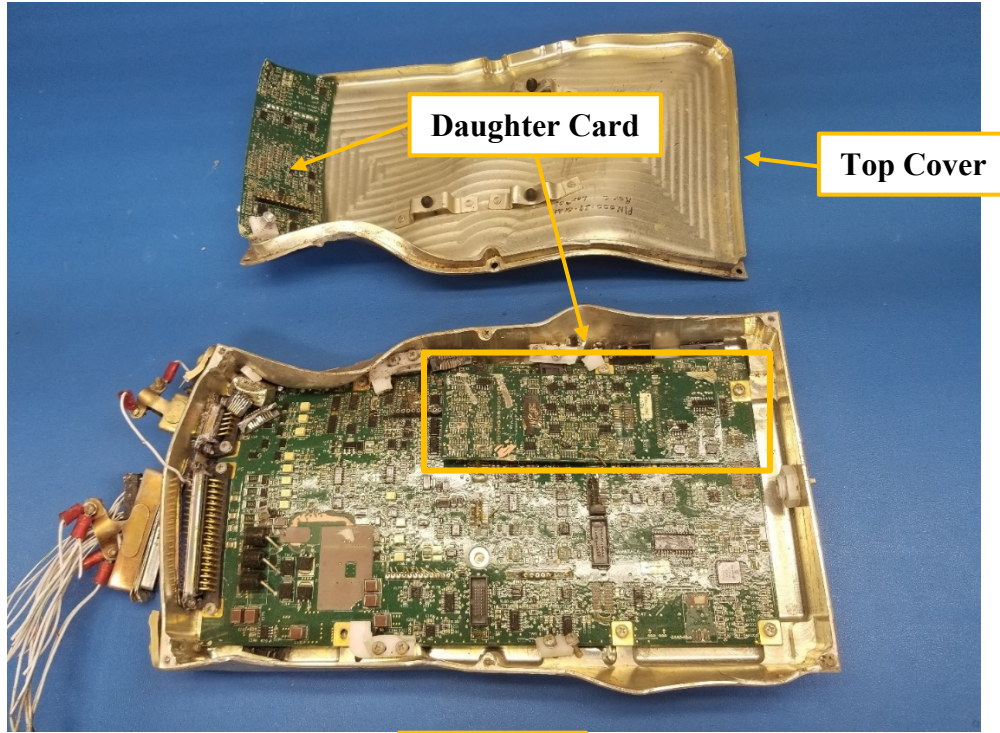
Figure 9 - Acc Main PCB cover removed

The ACU cover screws were not present and light prying pressure was applied to remove the cover. Multiple electrical components were loose in the unit and missing from the main circuit card, ref Figure 9. Two daughter cards, which normally attach to the main circuit card, ref Figure 10, were found loose in the unit, with one embedded in the top cover.

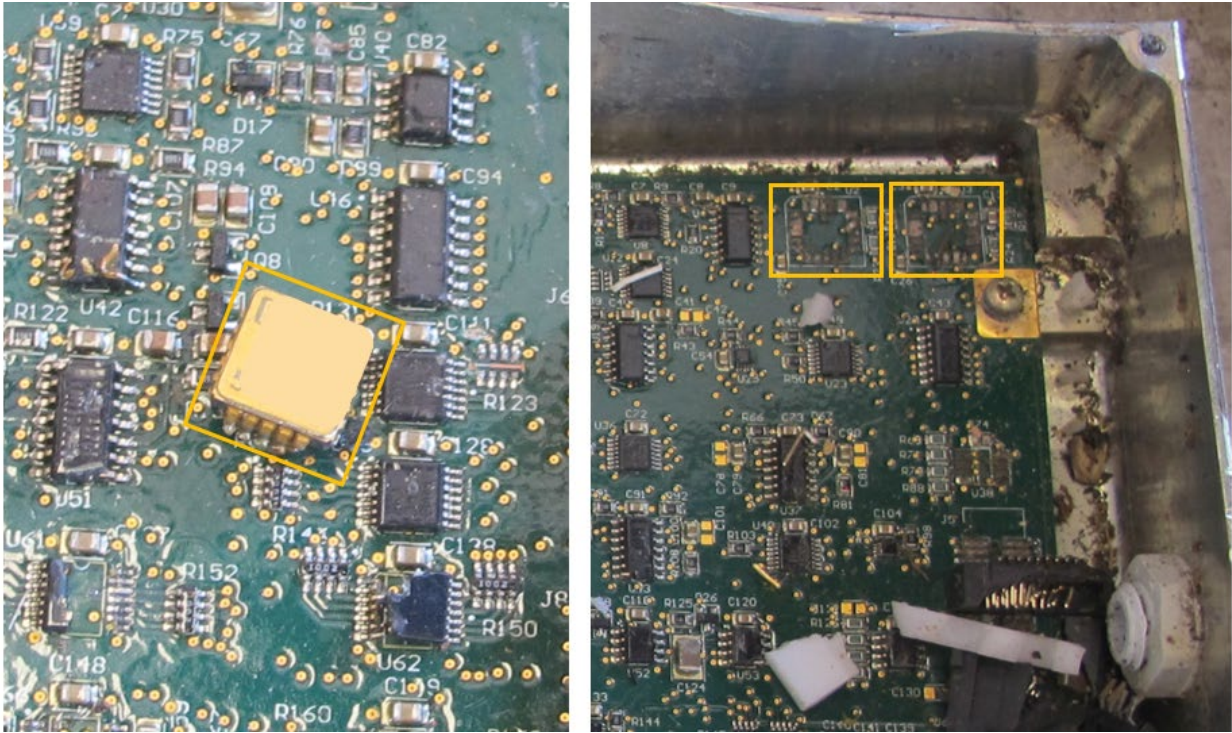
**Figure 11 - Accelerometer and accelerometer mounting positions highlighted as found in accident unit (images cropped and redacted).**

The mounting location for the two accelerometers on the main PCB did not contain either accelerometer, ref Figure 11. One of the accelerometers was identified and found loose in the unit at the initial wreckage recovery. The second accelerometer was located beneath the main PCB during the visual inspection of the unit at the manufacturer.

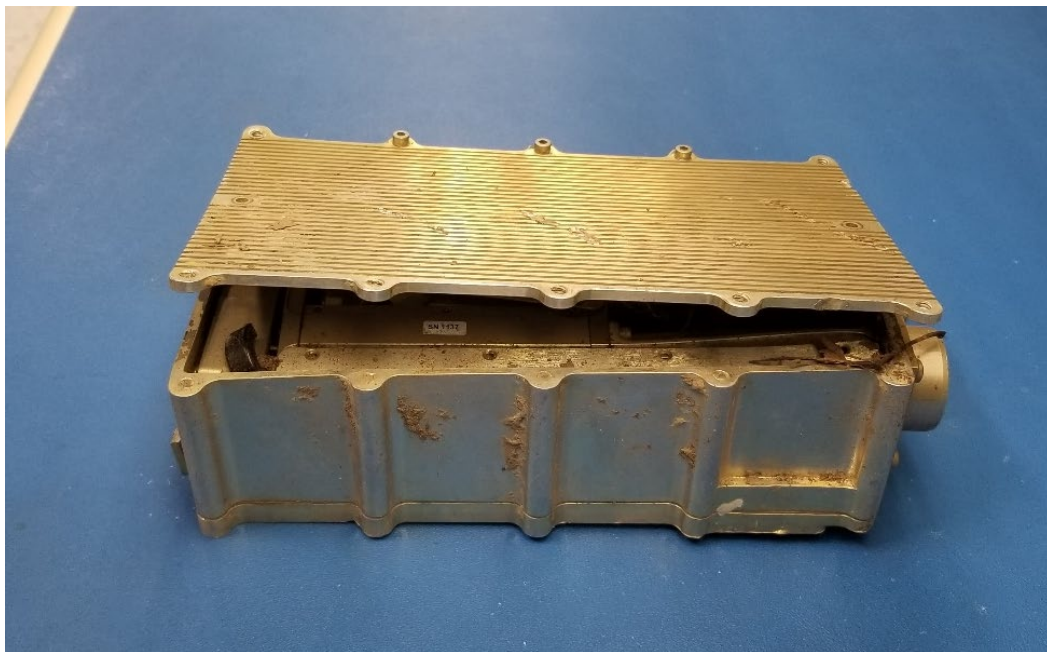
Figure 12 - RH TCU as recovered prior to visual inspection at the manufacturer

The TCU case was deformed and twisted with the upper cover partially separated from the unit consistent with impact damage. The ram tube was fractured at the barrel seal face.<sup>9</sup> The circular electrical connector and grounding wires from the aircraft wiring harness were not present with the unit when it was found.

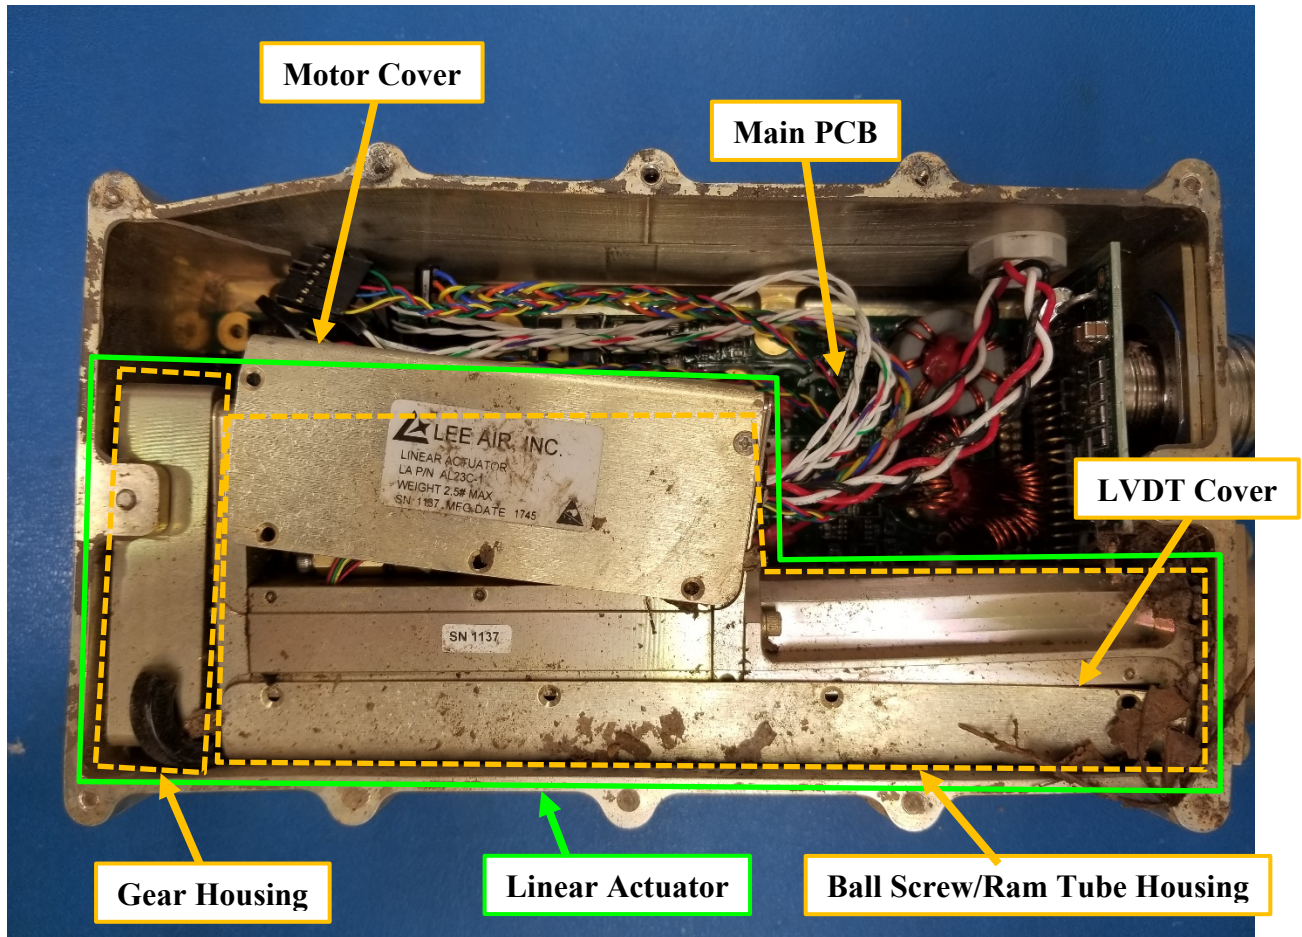
Figure 14 - View of inside of RH TCU

The top cover of the unit was held on by three of the twelve fasteners. The top cover was removed, and unit contained dirt and leaves inside, ref Figure 14. Damage was noted to multiple fasteners for the linear actuator cover and housing. All of the electrical harness connections from the linear actuator to the main PCB were found disconnected.

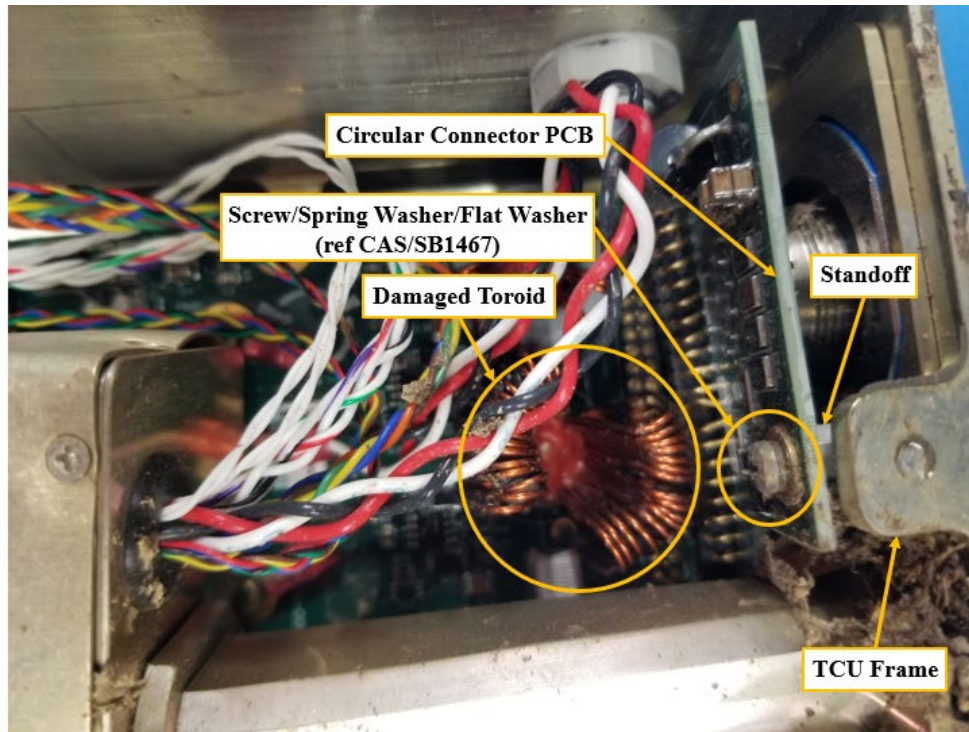
The ground screw, subject of service bulletin CAS/SB1467, was present and secure along with the spring/flat washer combination, ref Figure 15. One of the toroid inductors mounted on the main circuit board was fractured and multiple pieces of the toroid core were recovered within the unit. The linear actuator was removed to allow examination of the main PCB and the actuator. The circular connector PCB was removed and damage/witness marks were noted around the interface of the frame to the standoff and circular connector, ref Figure 16.

Figure 15 - Close-up view of damaged toroid and PCB screw

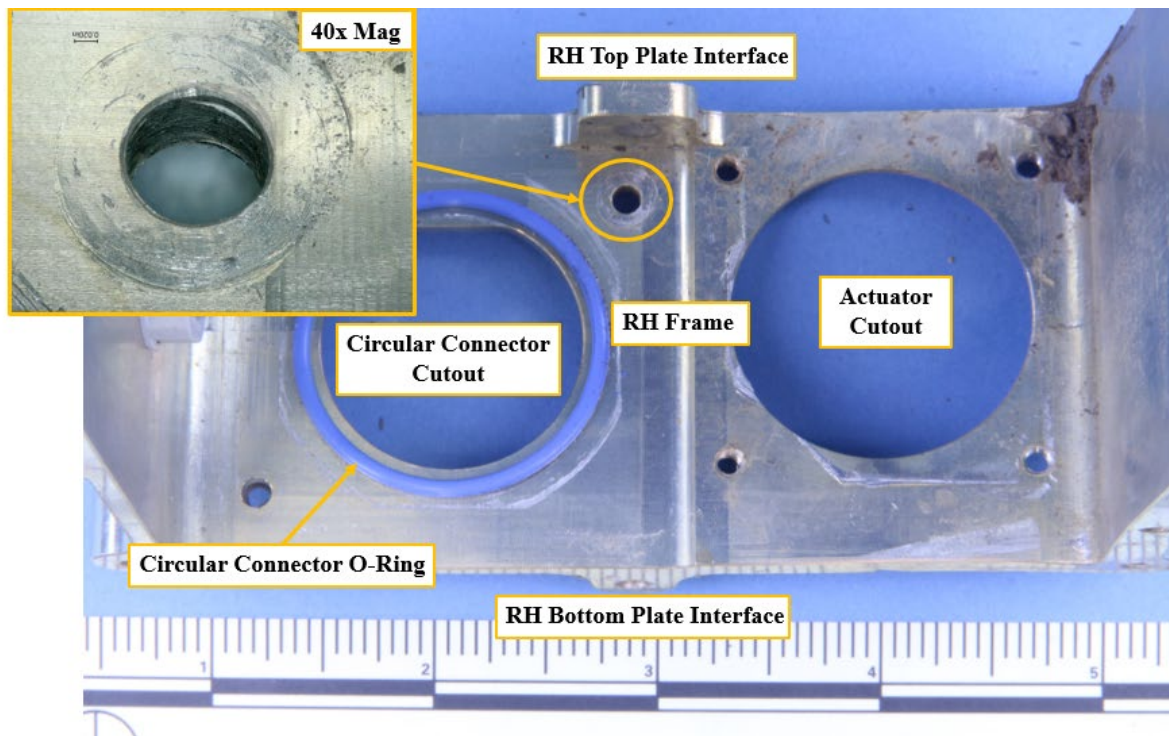
Figure 16 - View of RH frame and close-up of damage around standoff, circular connector and frame interface

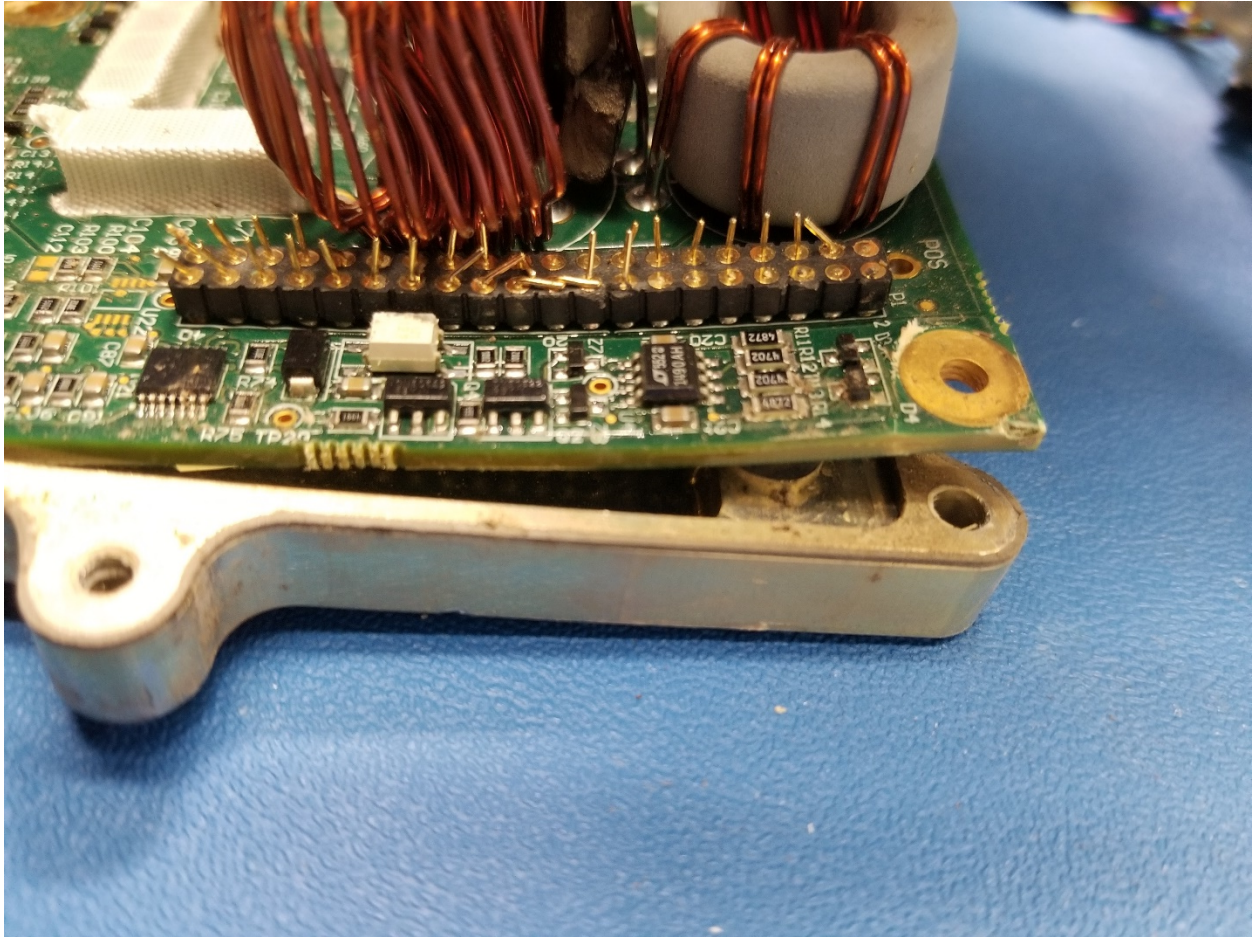
The main control board, which is typically fastened to the bottom cover, was displaced in the unit and all the mounting bolts exhibited tension failures with the bolt heads not present. The main control board was distorted, and some components were damaged on both sides of the board.

Multiple surface mounted components were not attached to the PCB and were not located. Damage to multiple pins on the 40-pin connector was also noted, ref Figure 17.

**Figure 17 - View of main PCB and 40-pin connector**

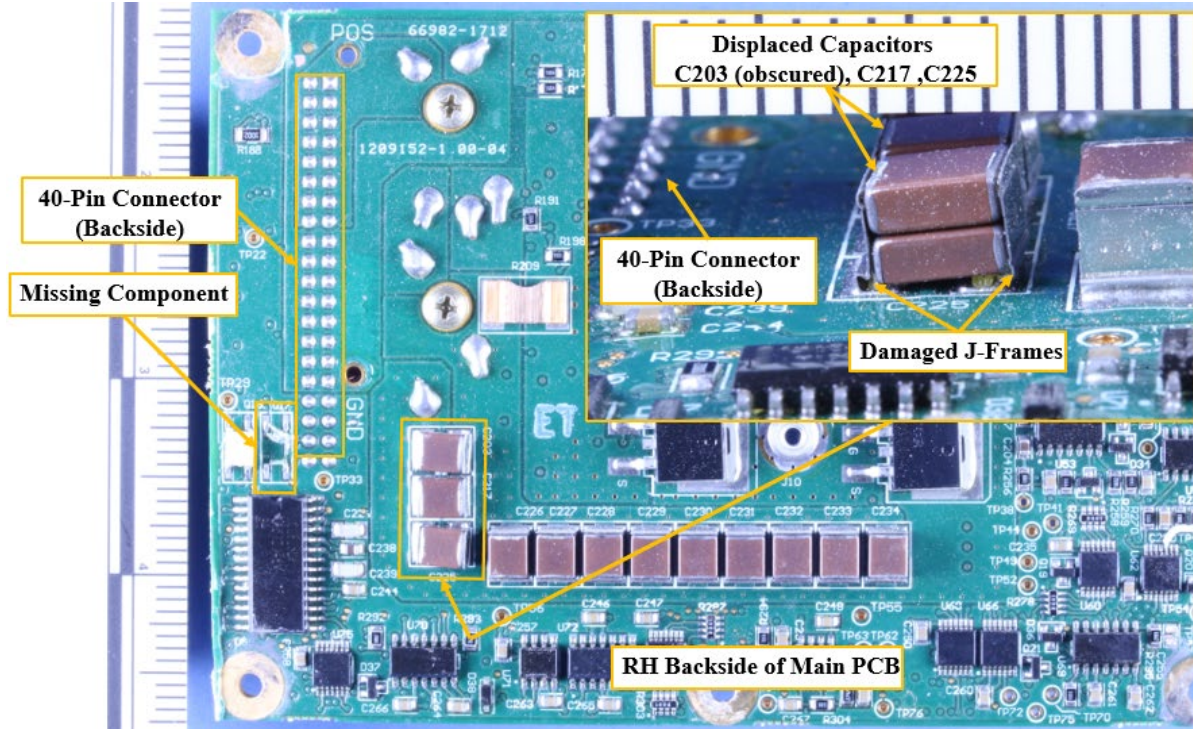
Additional images of the backside of the main PCB and the bottom plate show the extent of damage to the components. Figure 18 highlights damage to the J-frames of three stacked capacitors, exhibiting signs of crushing. Figure 19 contains the bottom plate of the RH TCU and approximations of the locations of the 40-pin connector and stacked capacitors.

Figure 18 - Damage to the backside of the main PCB components in area around the 40-pin connector

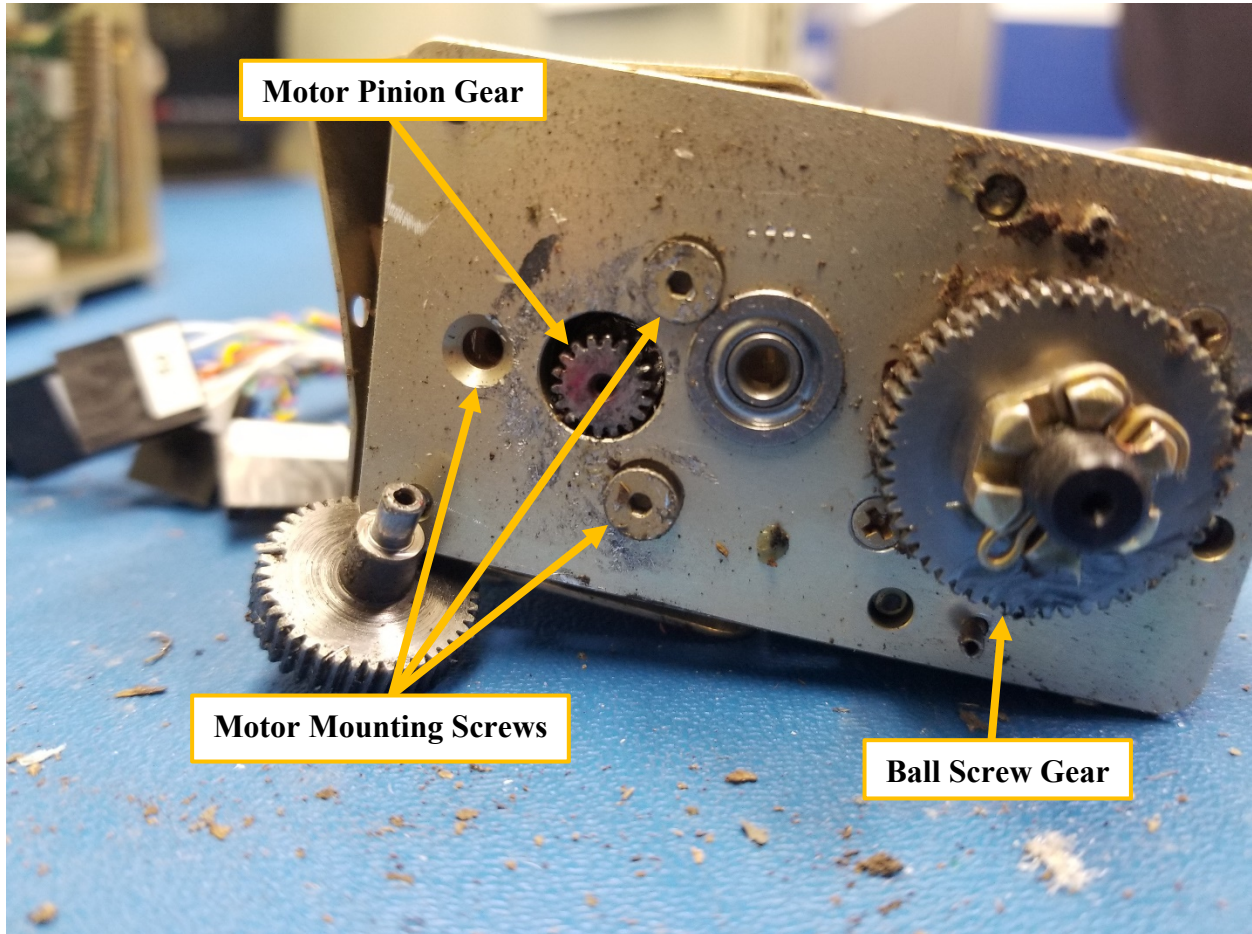
are typically #2-56 flat head machine screw. The gear housing was separated from the motor and ram tube assembly. The gears did not show signs of missing teeth or damage. The screws attaching the gear train to the motor and ram tube exhibited signs of tensile failure consistent with impact damage. All three motor screws were fractured, one mounting screw was not present.

**Figure 20 - View of the motor mounting screws, pinion gear and ball screw gear.**

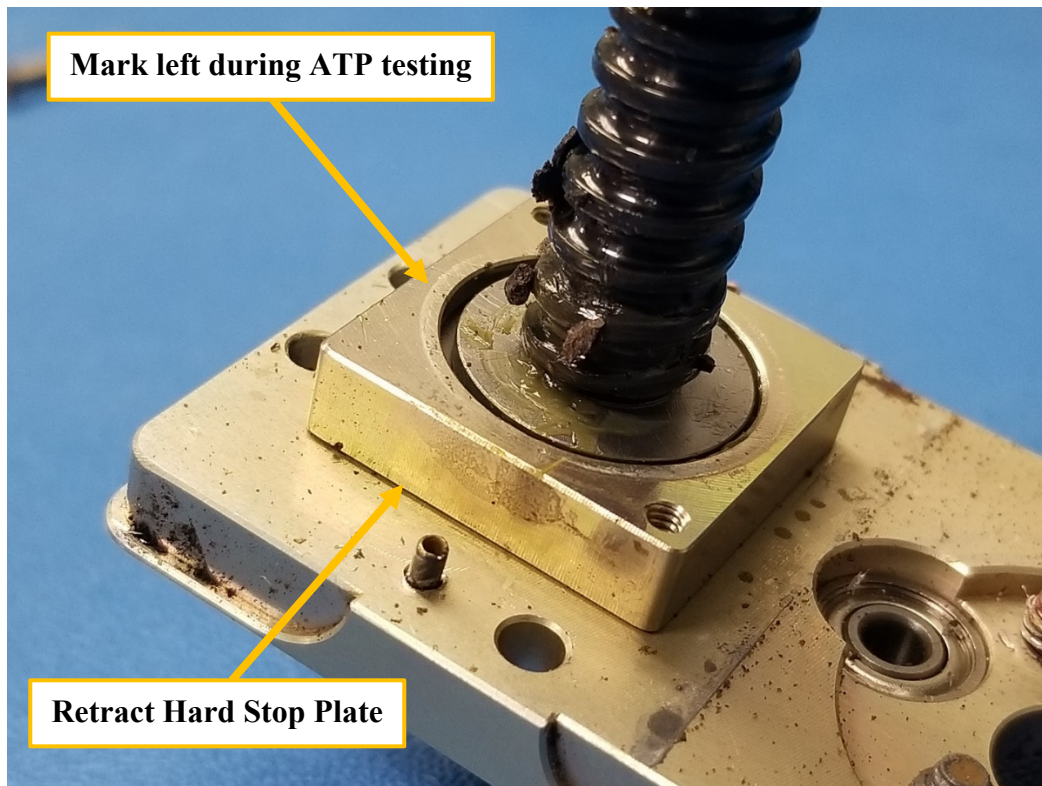
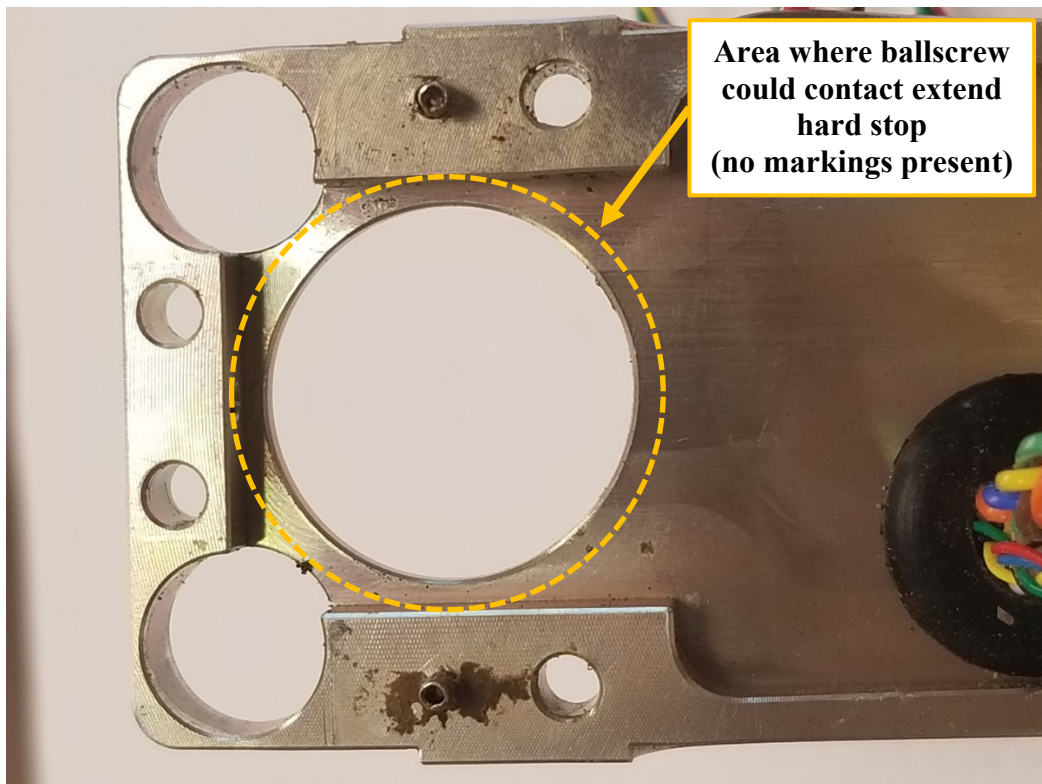
The ball screw was lubricated and free to move by hand with no signs of binding. The ram tube assembly was fractured at the ball screw and the remaining portion of the ram tube, internal to the actuator assembly, was bent.<sup>10</sup> There were no discernable marks on the retract hard stop indicative of a high force impact. There was a slight mark which was consistent with marks occurring during acceptance testing procedure (ATP) testing of the actuator during the back-drive force test, ref Figure 21. There were no discernable marks on the extend hard stop, ref Figure 22.

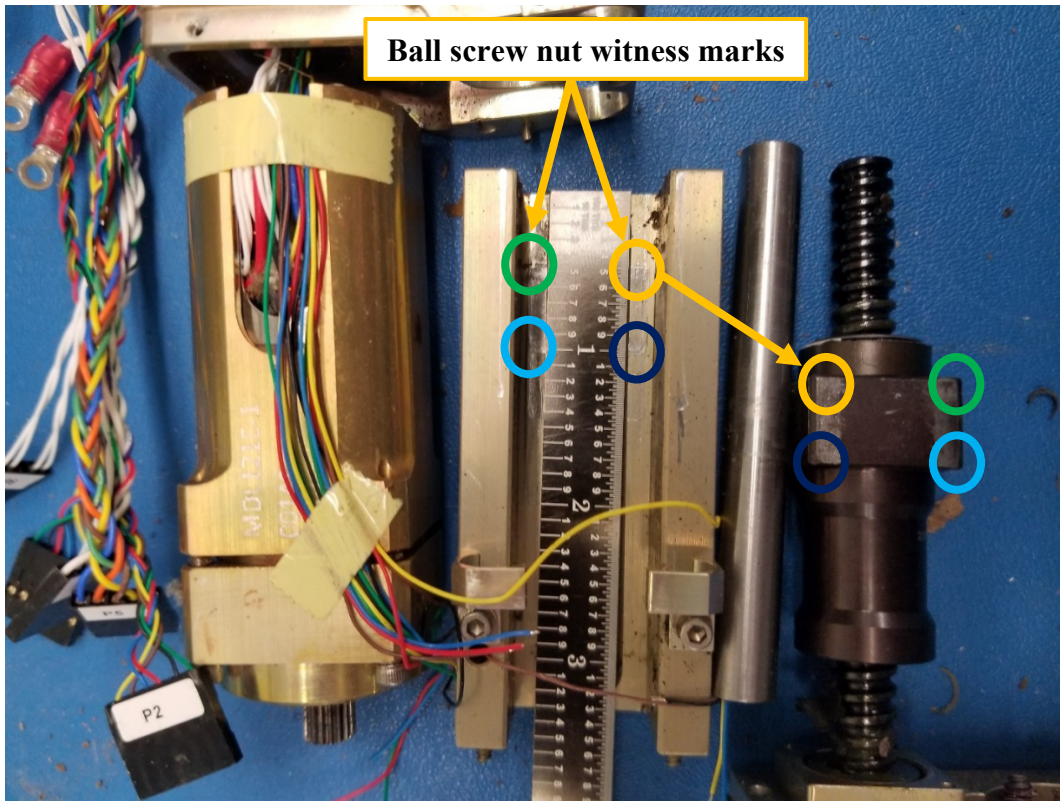
Witness marks were observed on the ram guide housing, ref Figure 23. An additional mark was seen on the bottom ram guide housing which would not normally be in contact with the ball nut, ref Figure 24. The location of the witness marks corresponded to a position of approximately mid-travel of the actuator.

Figure 23 - Ball screw nut witness marks on ram guide housing

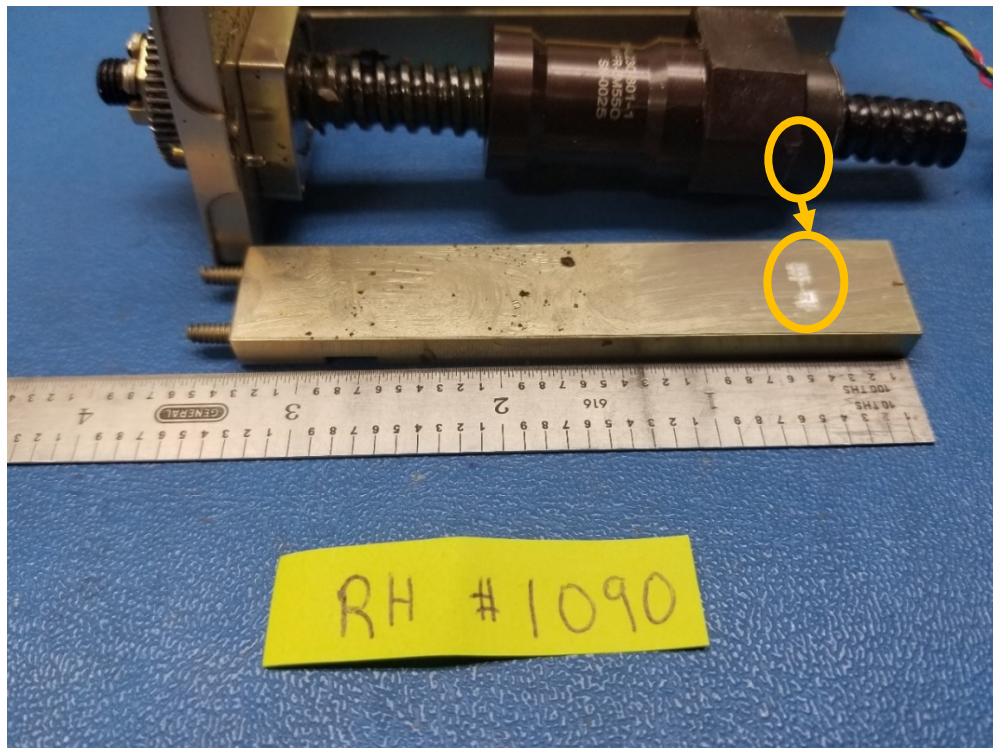
Figure 24 – Bottom ram guide housing with witness mark highlighted

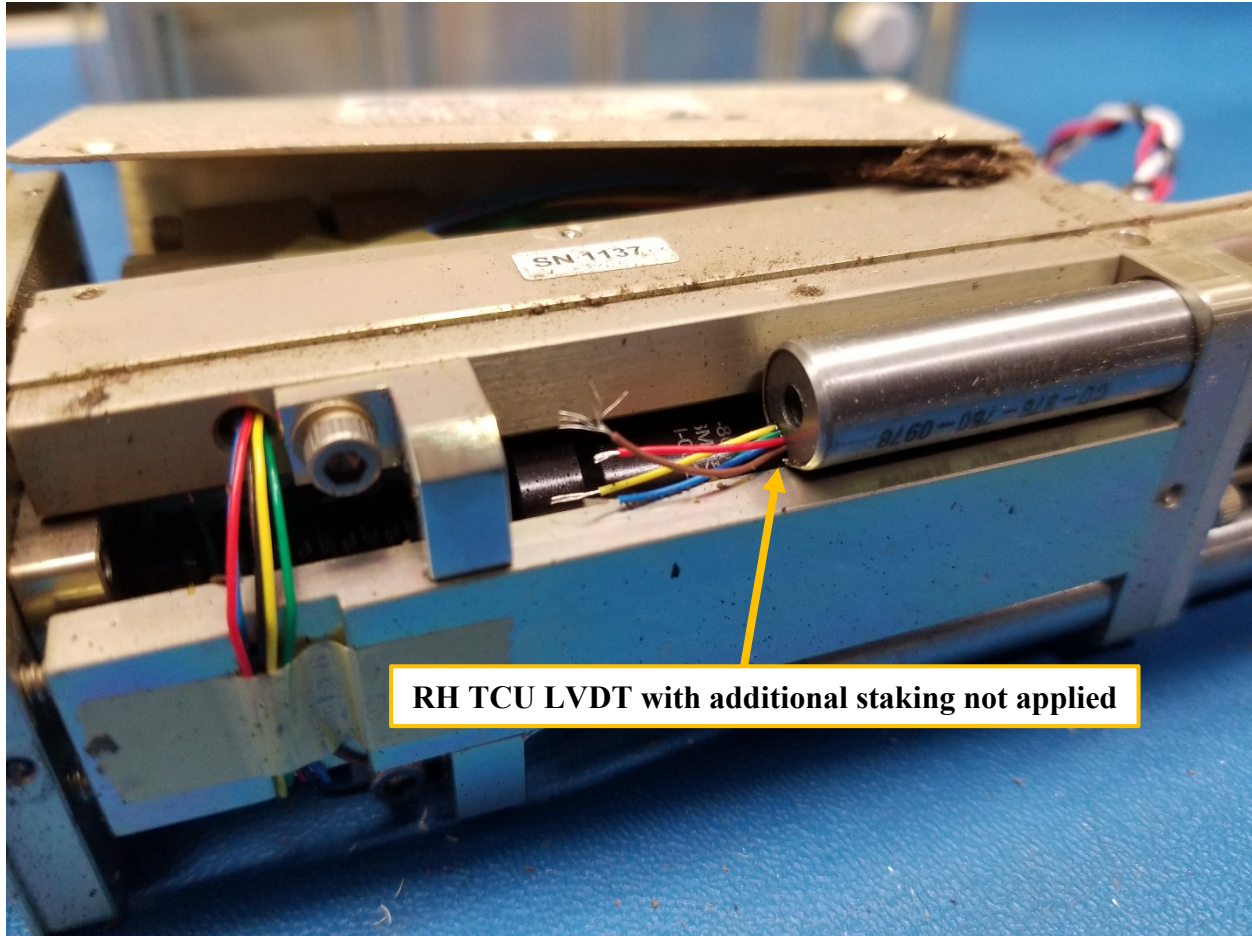
During the production of the units, Tamarack requested that additional staking compound be added to the signal wires, as a general product improvement, to improve stability where they exit the LVDT, ref Figure 25<sup>11</sup>. The additional staking was implemented by the manufacturer in the beginning of 2019 for new production units and previously produced units would have the additional staking applied per SB CAS/SB1480. The LVDTs for the accident unit did not have additional staking where the signal wires exit the unit, ref Figure 26.

Figure 26 - RH TCU LVDT (one side shown) noting the absence of additional staking

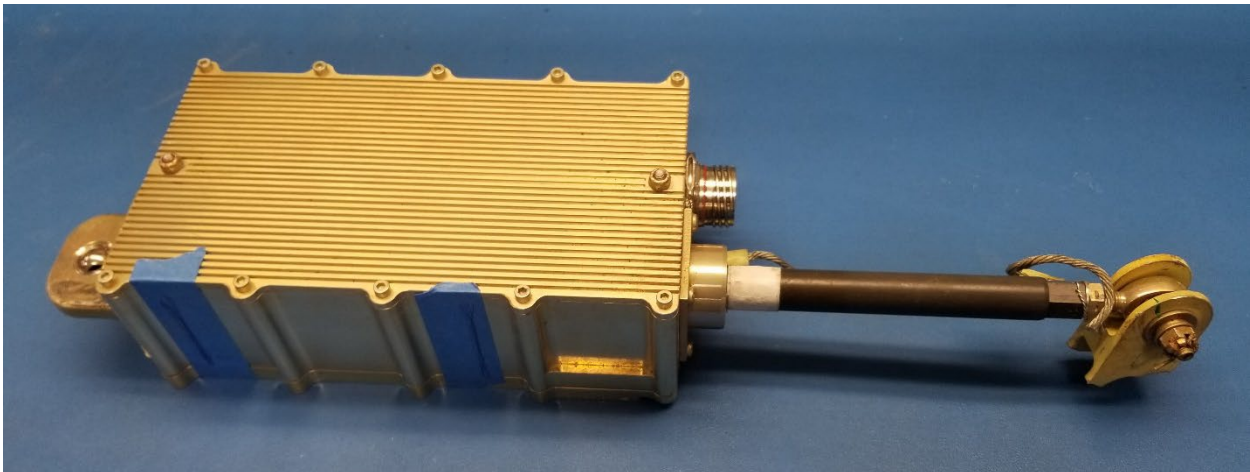
**Figure 29 - LH TCU as recovered prior to visual inspection at the manufacturer**

The TCU case did not exhibit any signs of deformation to the unit's case and the top and bottom cover were secured to the unit. The ram tube was bent and the rod end attaching the remaining section of the walking beam to the ram tube was rotated approximately 90° from nominal, ref Figure 29.

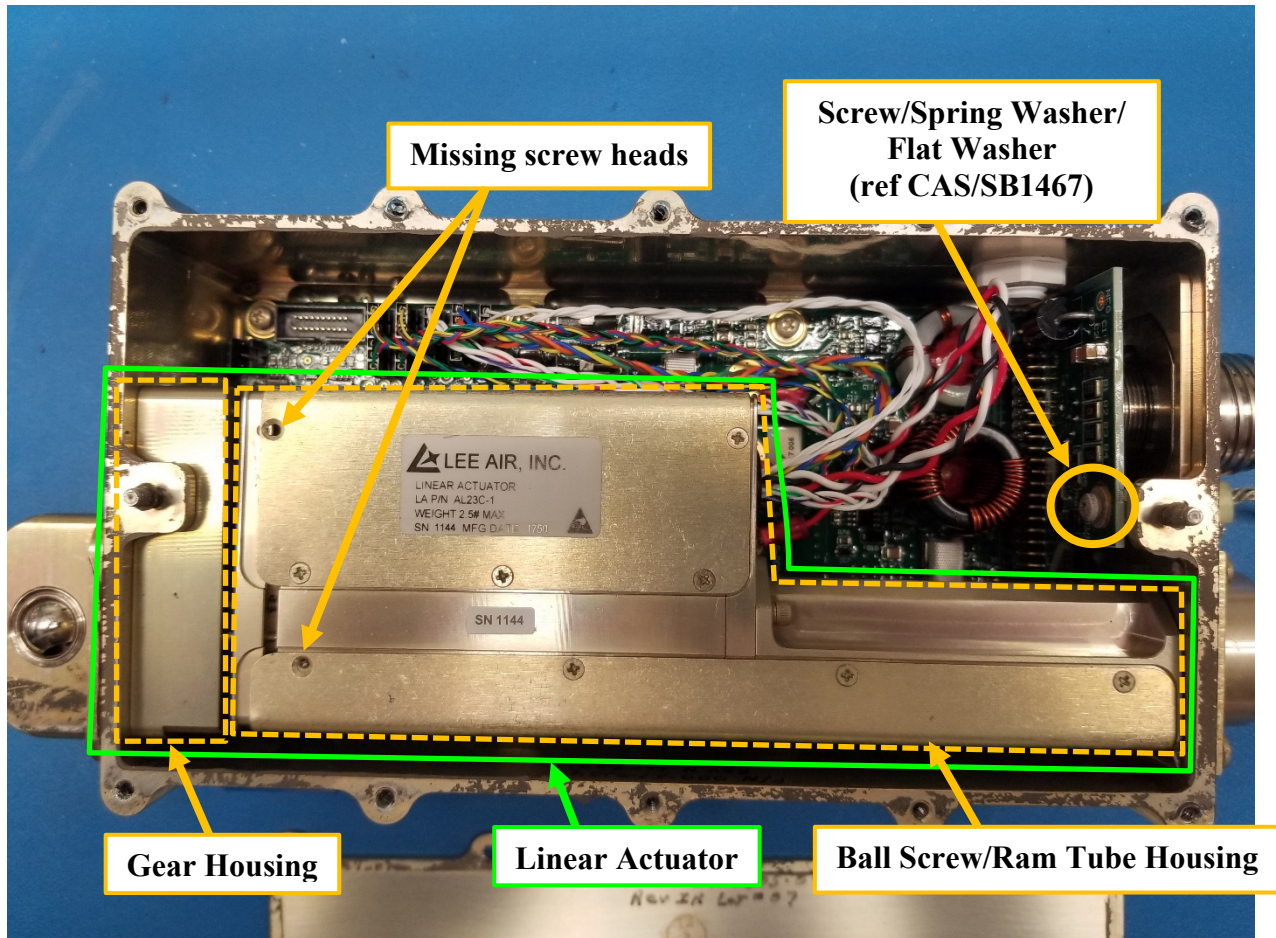
During the CT scan review, it was noted that five screw heads were loose within the unit. After removal of the top cover, a visual inspection was conducted, and the five screw heads were identified as part of the LVDT and motor cover assemblies. The screws are #2-56 flat head machine screws and the screw head damage was consistent with shearing due to deformation to the actuator housing. The five screw heads were removed from the TCU prior to starting the electrical testing.

Figure 30 - LH TCU with top cover removed with two of the missing screws noted (three on aft side of linear actuator)

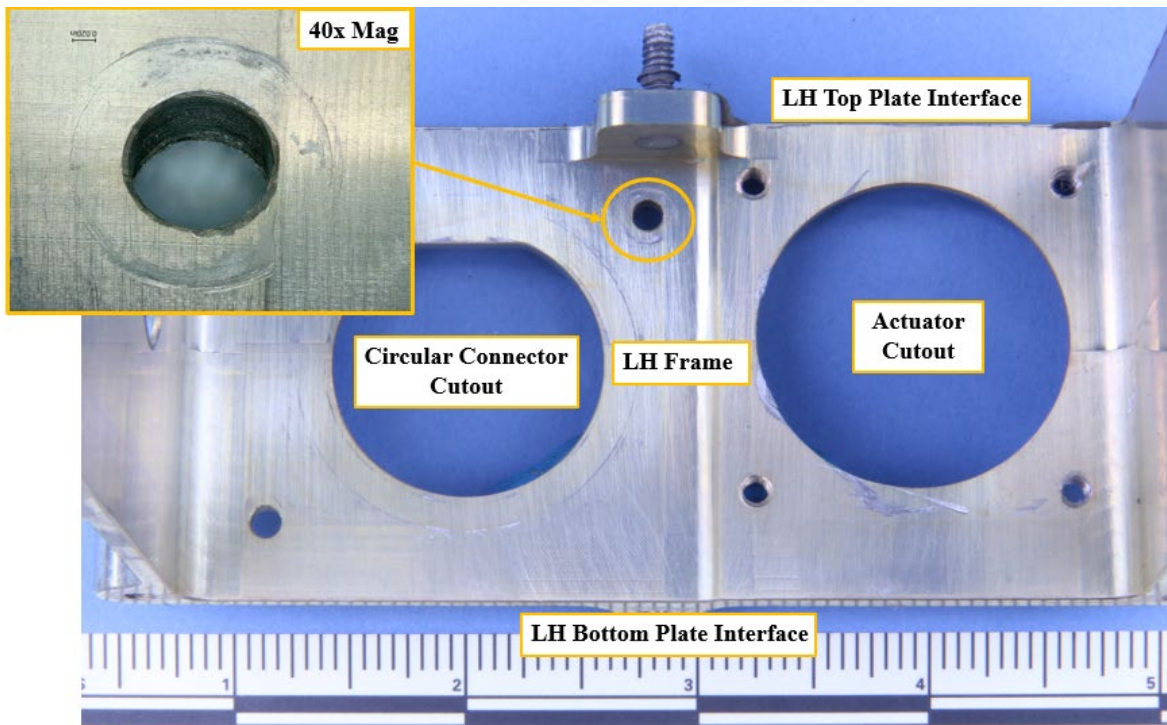
The circular connector PCB was removed and damage/witness marks were noted around the interface of the frame to the standoff and circular connector, ref Figure 31.

**Figure 31 - View of LH frame and close-up of damage around standoff, circular connector and frame interface**

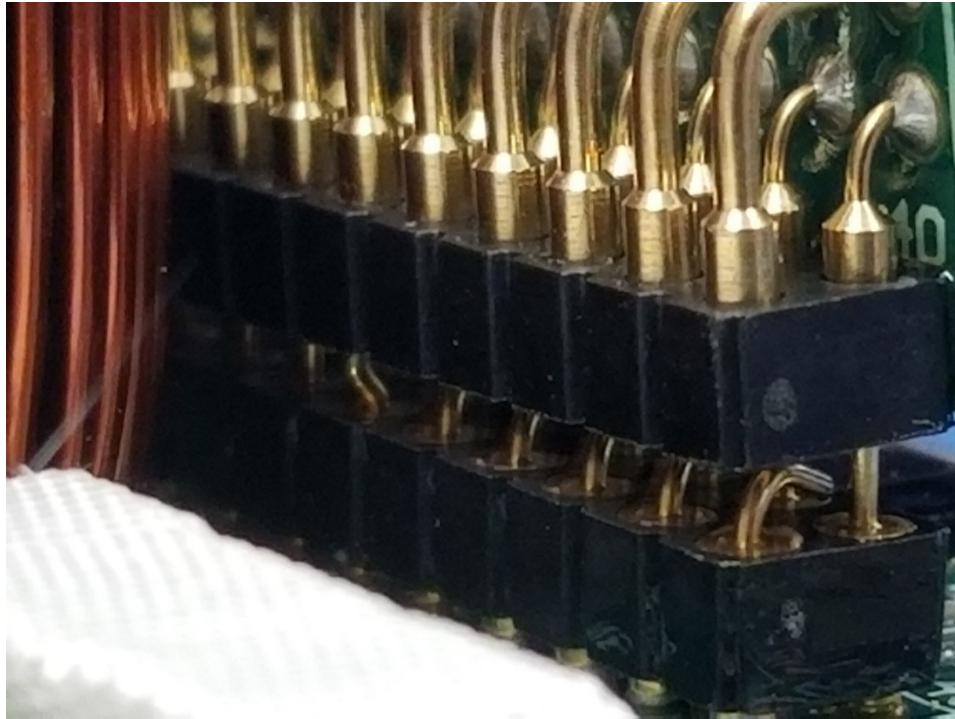
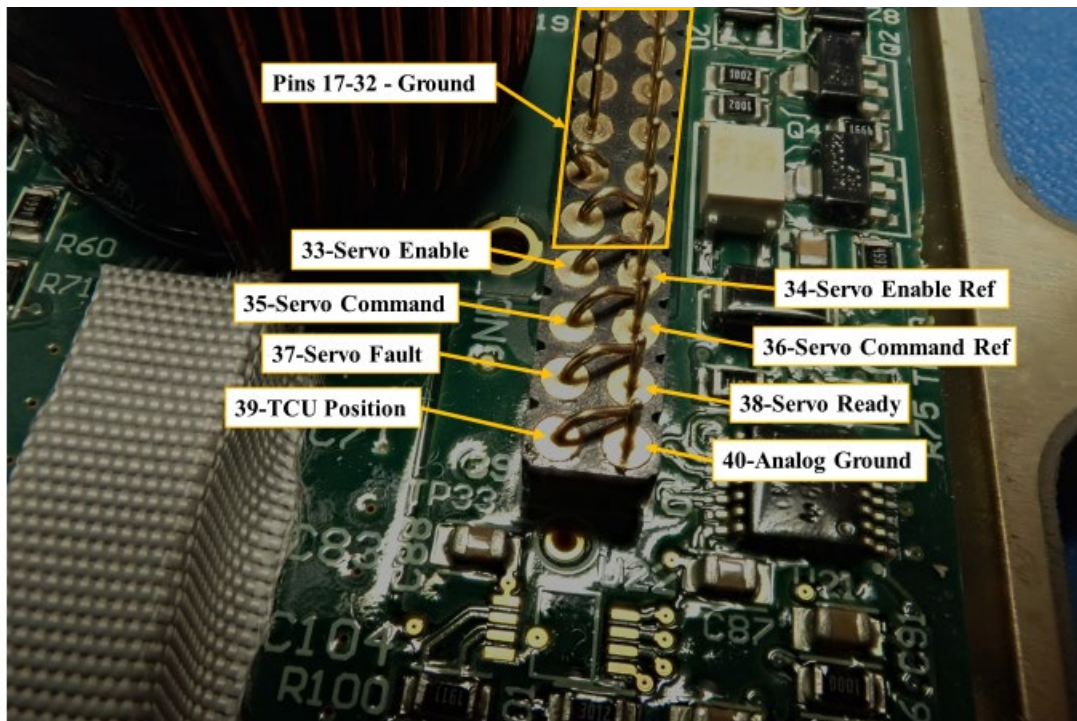
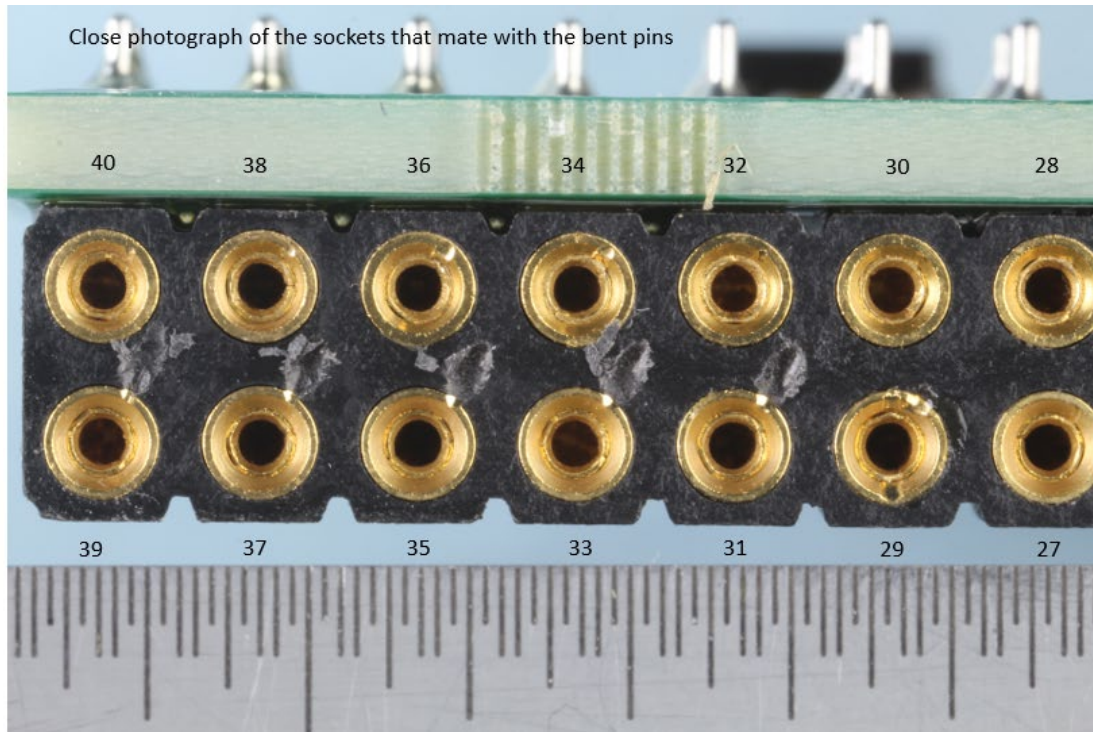
During the CT scan review, it was noted that six pins appeared bent near one end of the 40-pin connector in the unit. A visual inspection was performed to check the condition of the 40-pin connector, prior to the electrical testing. See section 4.4.2.1.3.3 for electrical testing discussion and results. The bent pins were not easily visible with only the top cover removed; however, a larger than normal gap between the two halves of the connector was visible, with the gap at a maximum in the location of the bent pins. After completion of the electrical testing the unit was further disassembled, and the 40-pin connector was separated. Figure 32 shows the 40-pin connector after the center case was removed and prior to the main PCB/circular connector PCB separation. Figure 33 shows the damaged pins and highlights the signals that are carried along the pin. Figure 34 shows the socket interface where the damage from the bent pins is visible.

The manufacturer noted that during the build process for the TCU, the pin/socket connection is mated and de-mated 3 or more times during the build process. The pin/socket connection is visually verified by the technician assembling the unit and subsequently visually inspected during the build process. During the discussions with the manufacturer, they stated that the build process did not match the manufacturing aid document and the document also contained an incorrect statement with regards to the connector PCB attachment to the controller PCB. Additionally, during the rework process for service bulletin CAS/SB1467, a visual inspection of the unit and PCBs is performed. During service bulletin CAS/SB1467, the pin/socket connection is not mated or de-mated per the manufacturer's instructions. As of June 15, 2020, the manufacturer inspected 40 units, representing 18% of the in-service TCU's, and did not find any damage consistent with the bent pins seen on the accident unit.

Figure 32 - View of the 40-pin connector showing damaged pins after center case removed

**Figure 34 - Sockets in the area around the bent pin locations, damage to connector material is visible**
