----- SYSTEMS GROUP CHAIRMAN'S FACTUAL REPORT -----

Location: Memphis, Indiana  
Date: November 30, 2018  
Time: About 1028 EST  
Aircraft: Cessna Citation 525A  
Serial Number: 525A0449  
Registration: N525EG

### **3 SUMMARY**

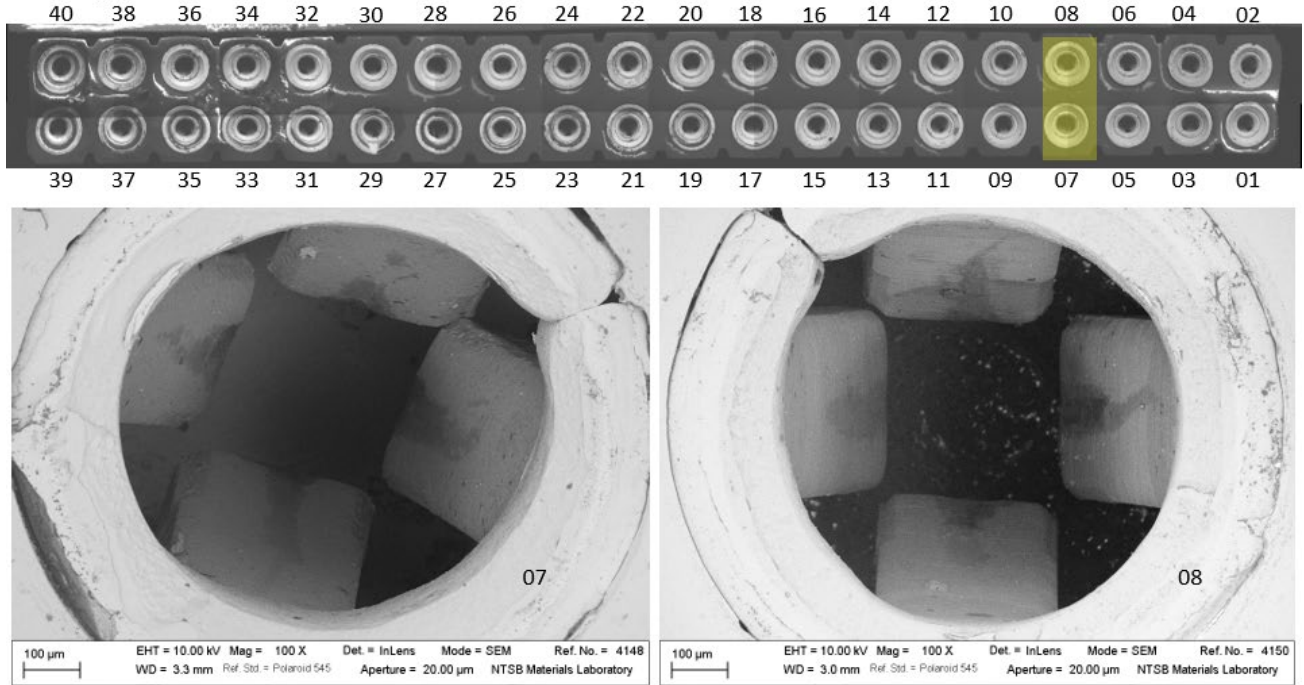
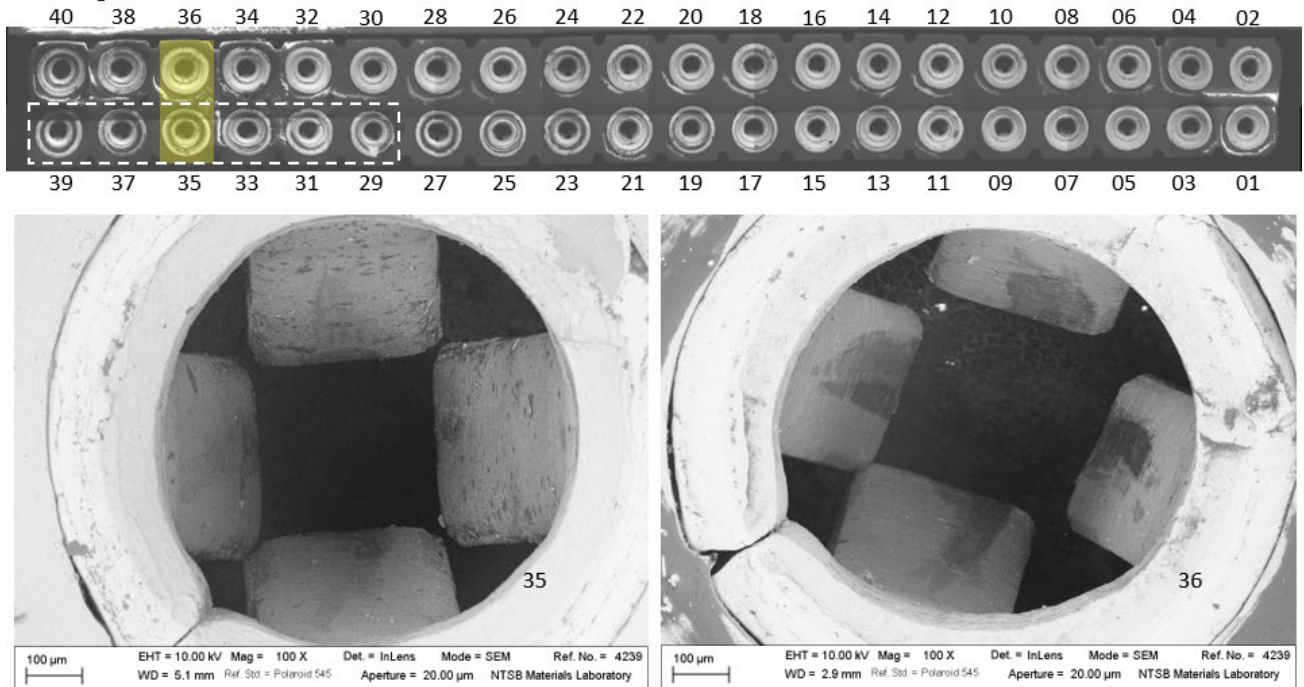
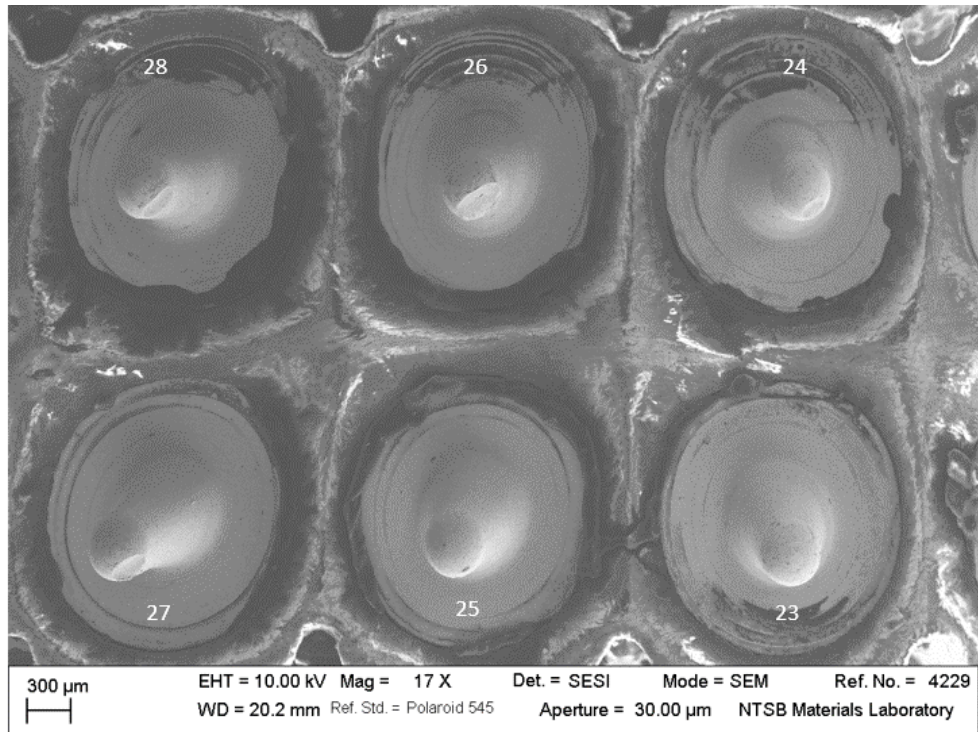
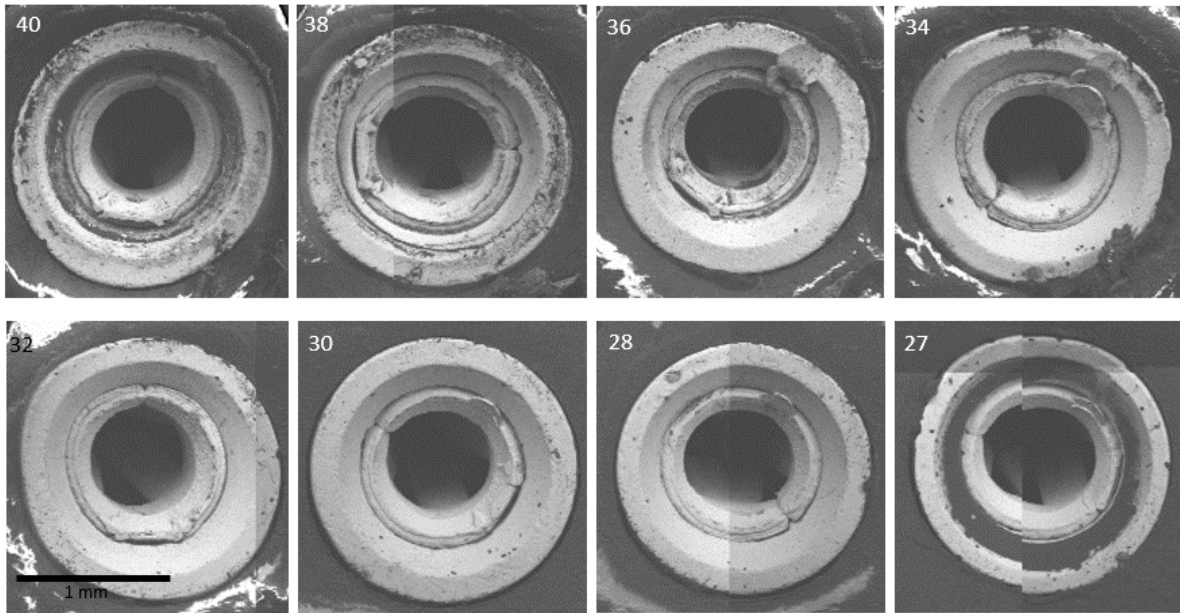
The pins and the sockets of the 40-pin connector were inspected using the NTSB Materials Laboratory high power microscopes and their Scanning Electron Microscope (SEM). The socket and pin layout contains two rows of twenty pins each. Images of the socket contact points were taken for the sockets of multiple socket sets on each row. In Figure 35 and Figure 36, sockets related to pins 07, 08 and 36 which were unbent and socket related to pin 35 which was bent. Additional SEM imagery can be found in Appendix A.

Figure 37 - SEM imagery nick artifacts on pins at approximately 5 o'clock position

Figure 38 - SEM imagery nick artifacts on sockets at approximately 1 o'clock position

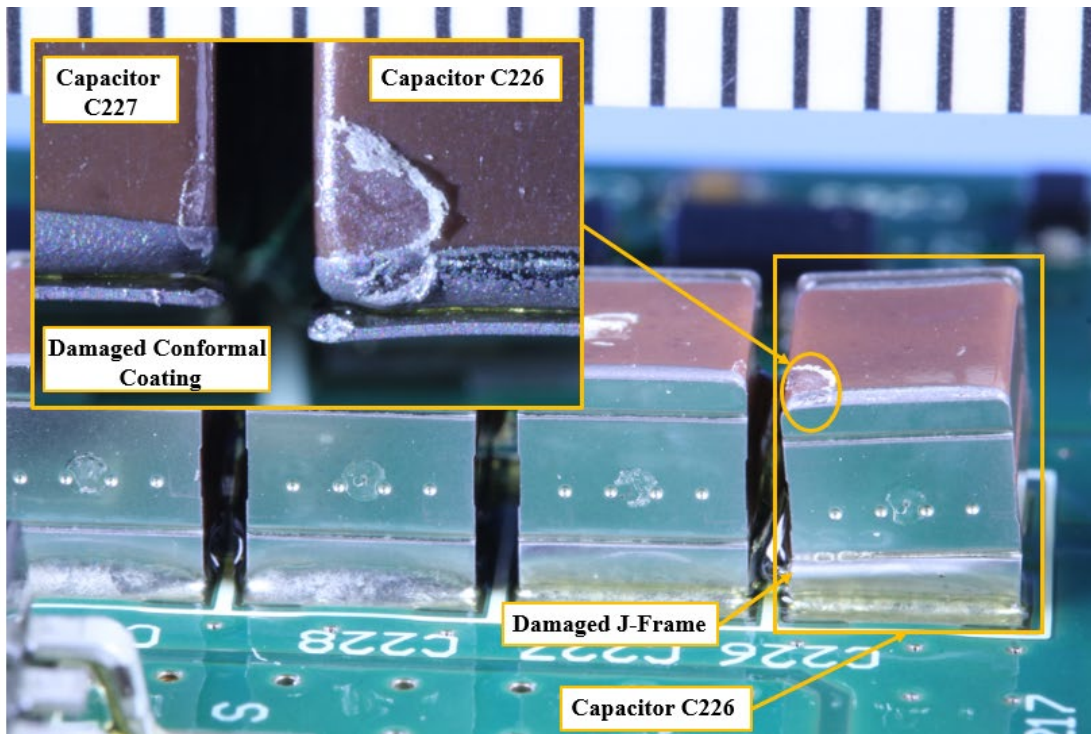
The main PCB was removed from the bottom case to check for any marks or damage. No components appeared to be missing from the backside of the main PCB. There were no marks or patterns consistent with bending or flexure on the PCB. One capacitor, C226, was misaligned with respect to the adjacent capacitors, ref Figure 39. One J-Frame, attached to C226, was fractured across a majority of the width near the base of the J-Frame, but appeared to remain in electrical contact with the capacitors and PCB. An area on the top of capacitors C226 and C227 had noticeable damaged to the conformal coating and the corner of the J-Frame, ref Figure 40. Additionally, the J-Frame exhibited signs of buckling near the PCB attach point.

**Figure 40 - View of the C226 capacitor showing the damage to the conformal coating and J-Frame**

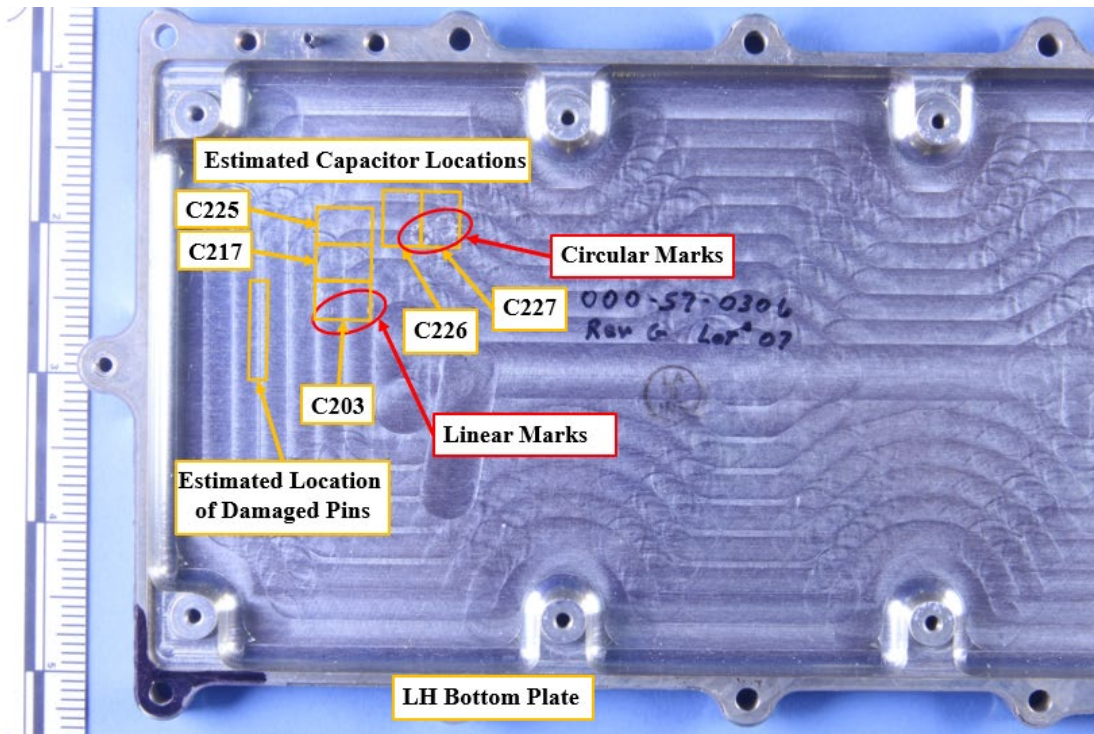
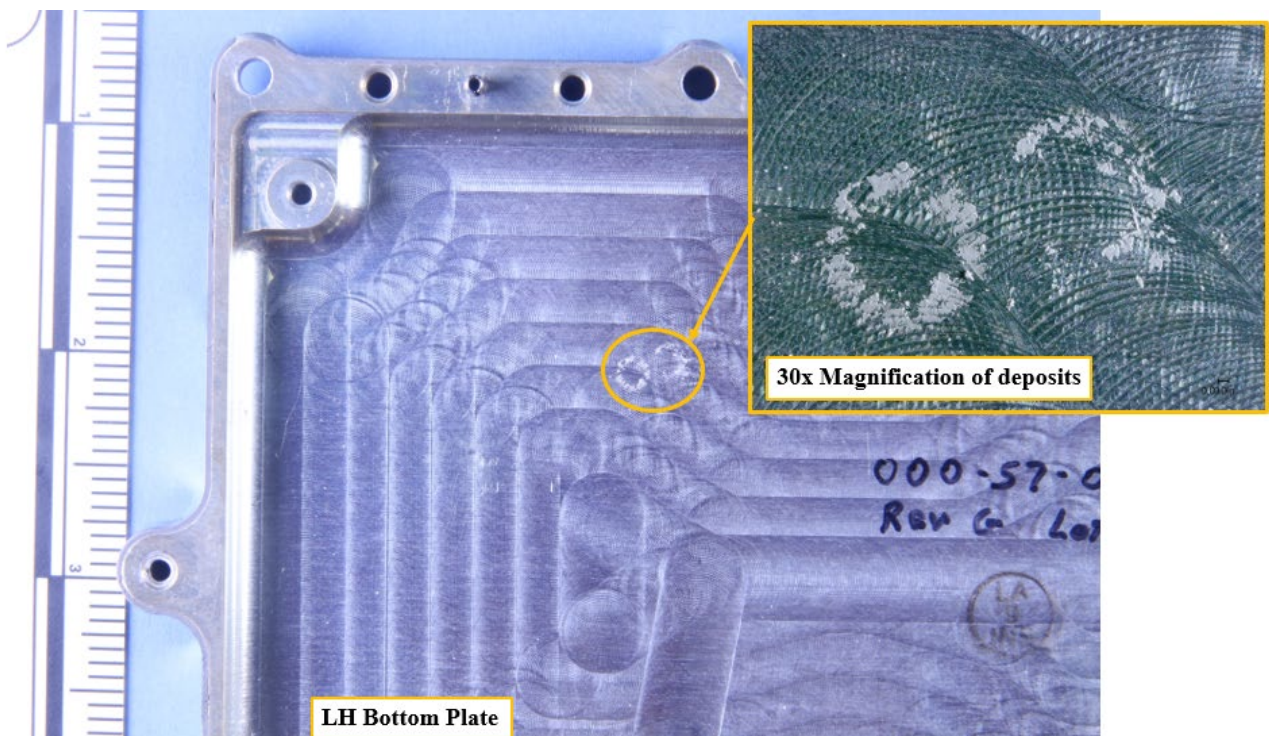
A pair of circular marks/deposits located approximately under C226 and C227 and a pair of witness marks in the area approximately under capacitor C203 were identified on the TCU bottom plate. Figure 41 contains the bottom plate of the LH TCU and approximations of the locations of the 40-pin connector and stacked capacitors. Figure 42 contains an additional view of the circular marks and a microscopic image of the marks/deposits.

Figure 42 – Circular marks and microscopic image of the marks

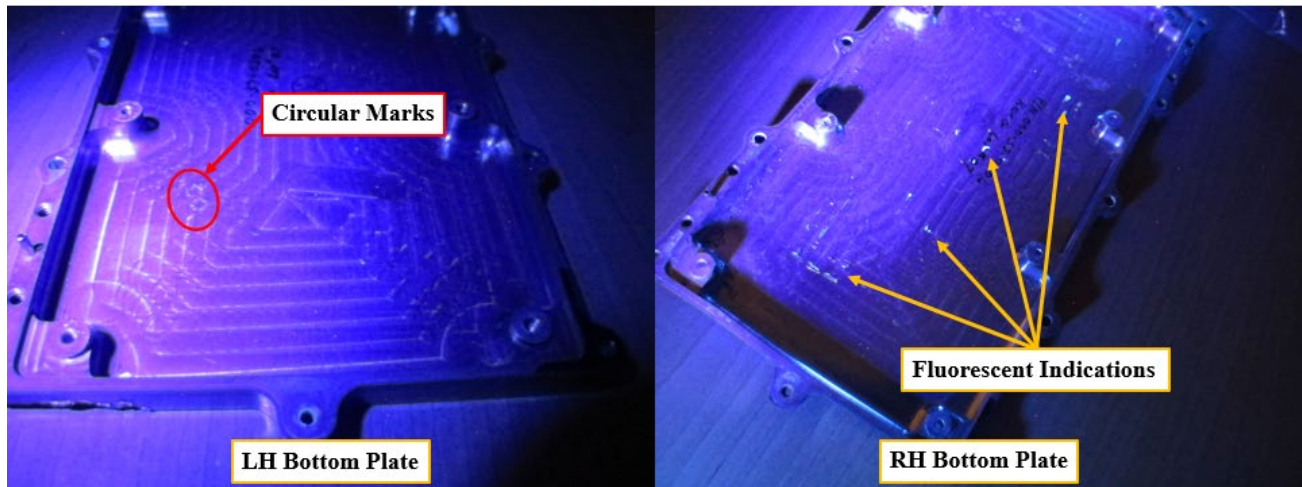
The NTSB performed a visual inspection of both the left and right TCU bottom plates using a UV-A light, commonly referred to as a blacklight. The conformal coating on the PCB contains additives that will glow blue, or fluoresce, when placed under a blacklight<sup>12</sup>. The bottom plates were inspected for evidence of conformal coating transfer from the PCB to the backplate. Figure 43 contains a side by side image of the LH and RH TCU bottom plates taken under UV light. The RH bottom plate had multiple areas of conformal coating transfer that could be seen. The LH TCU bottom plate did not have any evidence of fluorescent indications around the area of the circular marks.

Figure 43 - Images of LH and RH TCU bottom plate UV inspection

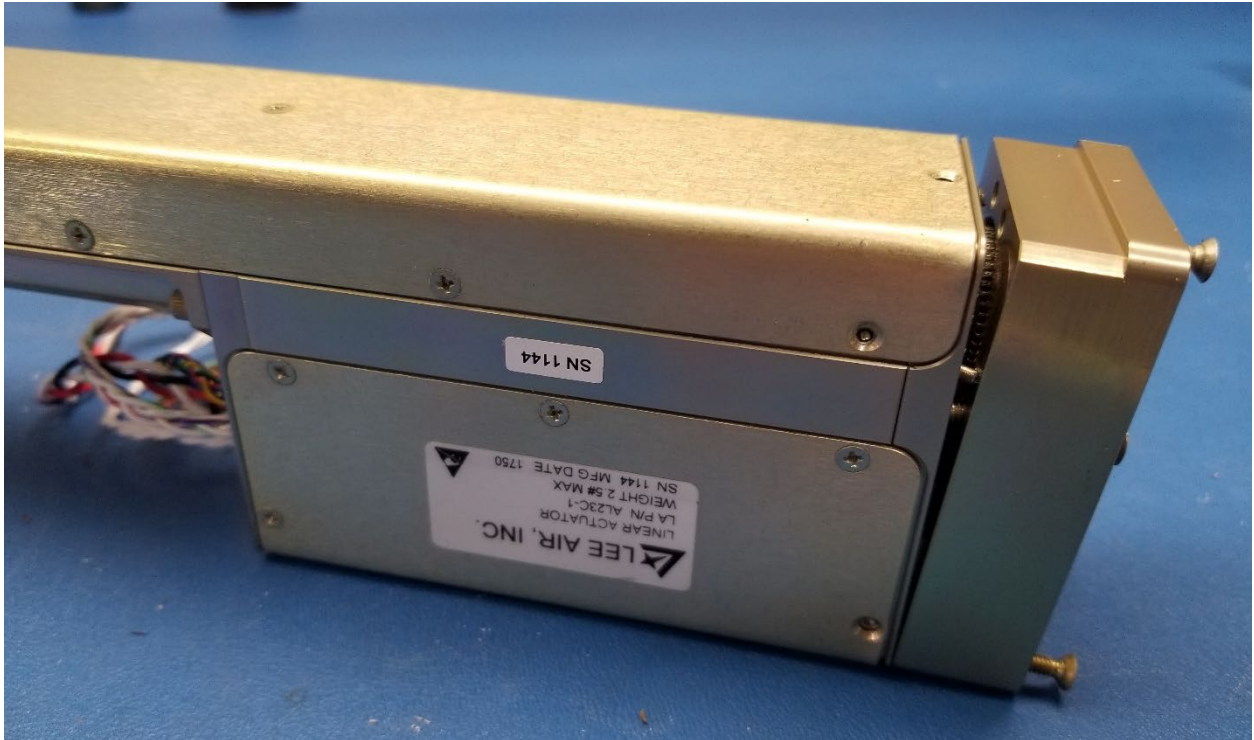
The linear actuator was removed, and the gear housing of the unit was partially separated from the motor and ram tube assembly, ref Figure 44. The gears did not show signs of missing teeth or damage. The screws that hold the gear housing exhibited signs consistent with tensile failure.

**Figure 44 - LH linear actuator and gear housing**

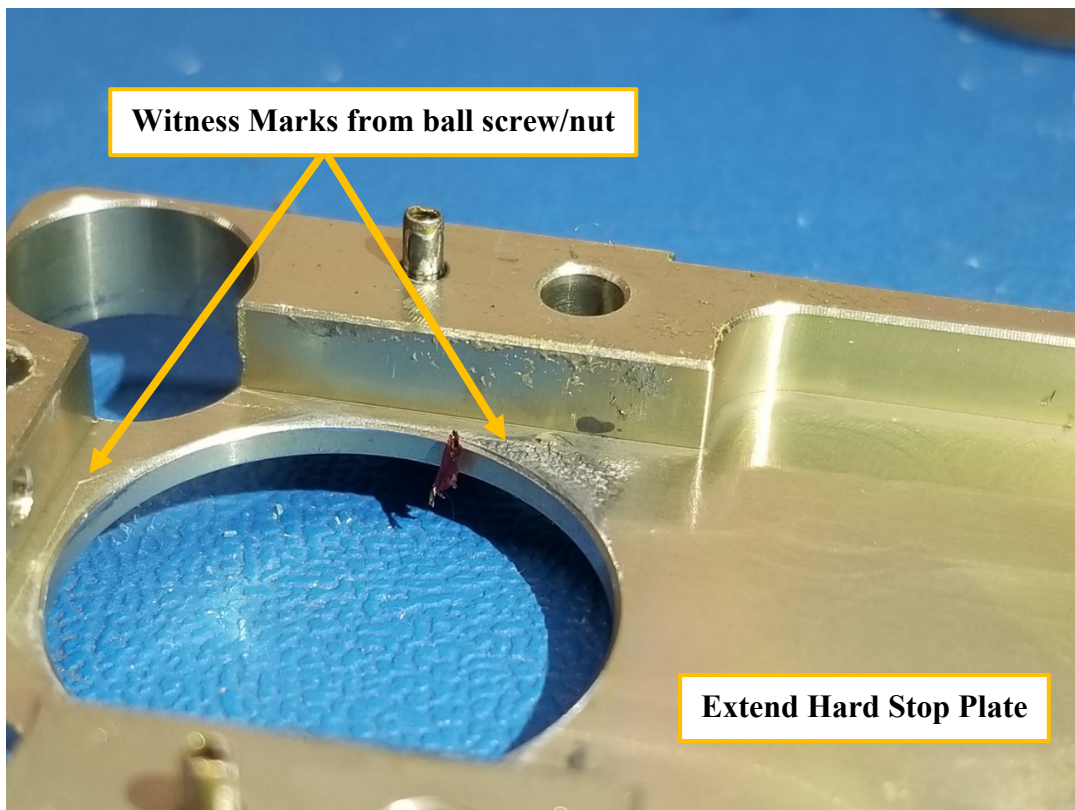
The ram tube was bent and could not be removed using normal disassembly procedures without applying excessive force. There were no visible marks on the retract hard stop to indicate a high-force impact. Minor marks, similar to the RH TCU, consistent with backdrive force tests during ATP were visible, ref Figure 45. There were witness marks on the extend hard stop consistent with a high energy impact, ref Figure 46.

Figure 46 - LH TCU extend hard stop

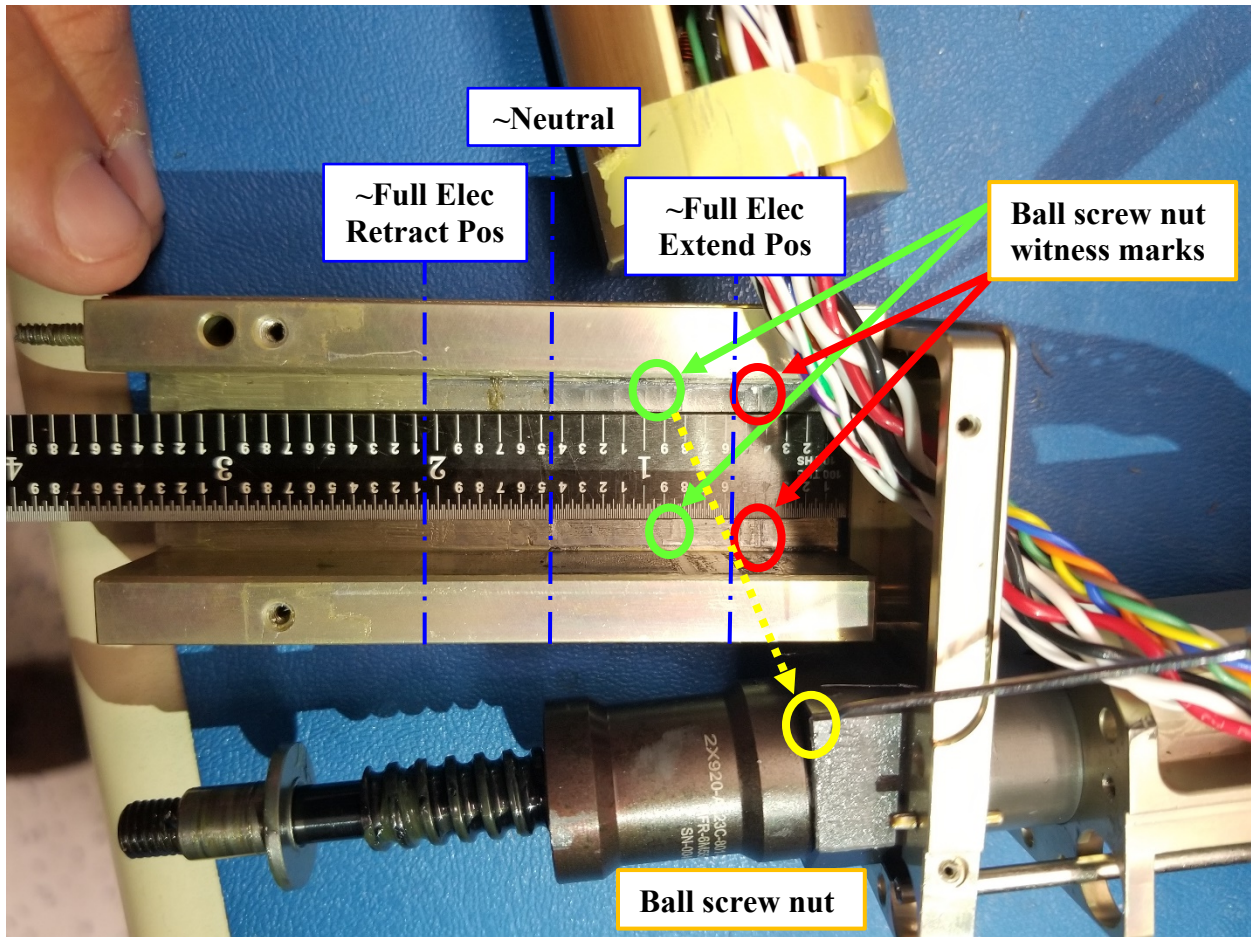
**Figure 47 - Upper ram guide housing with witness marks highlighted and estimated travel positions**

The ball screw nut was lubricated and free to move by hand with no signs of binding. Two sets witness marks were observed on the ram guide housing, ref Figure 47. One set of witness marks (green in picture) correspond to a position of intermediate extension. The location of the other set of witness marks (red in picture) corresponds to a position of full extension of the actuator. Two additional sets of marks were seen on the bottom ram guide housing, which would not normally be in contact with the ball nut, ref Figure 48.

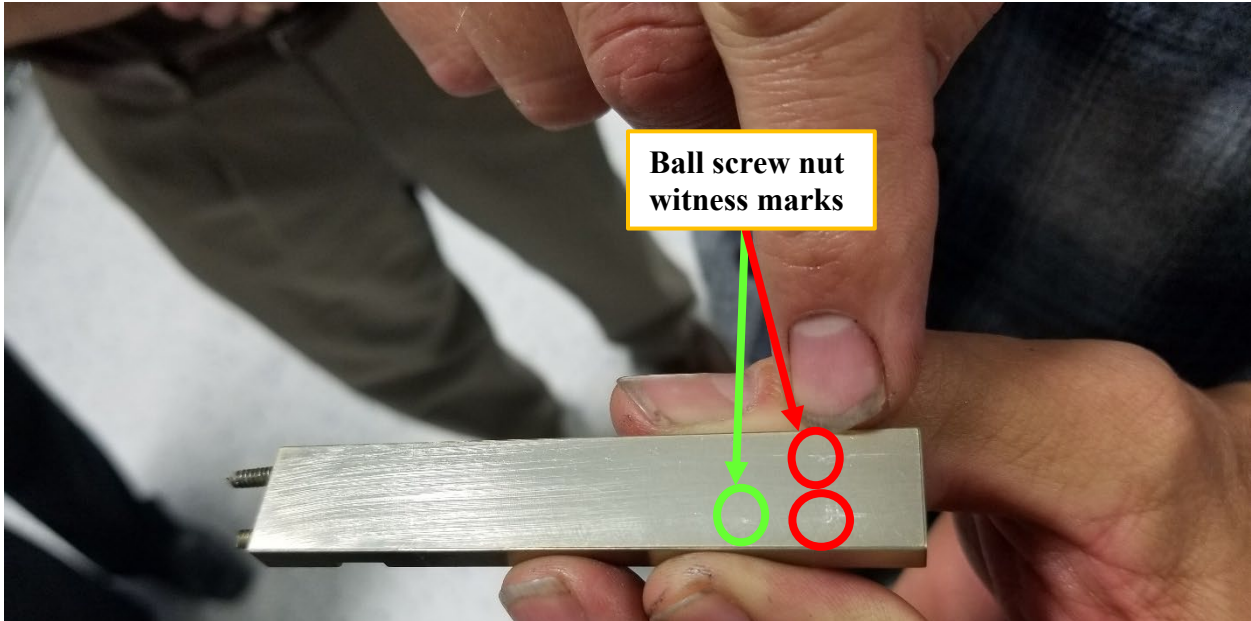
**Figure 48 - Bottom ram guide housing with witness marks highlighted**

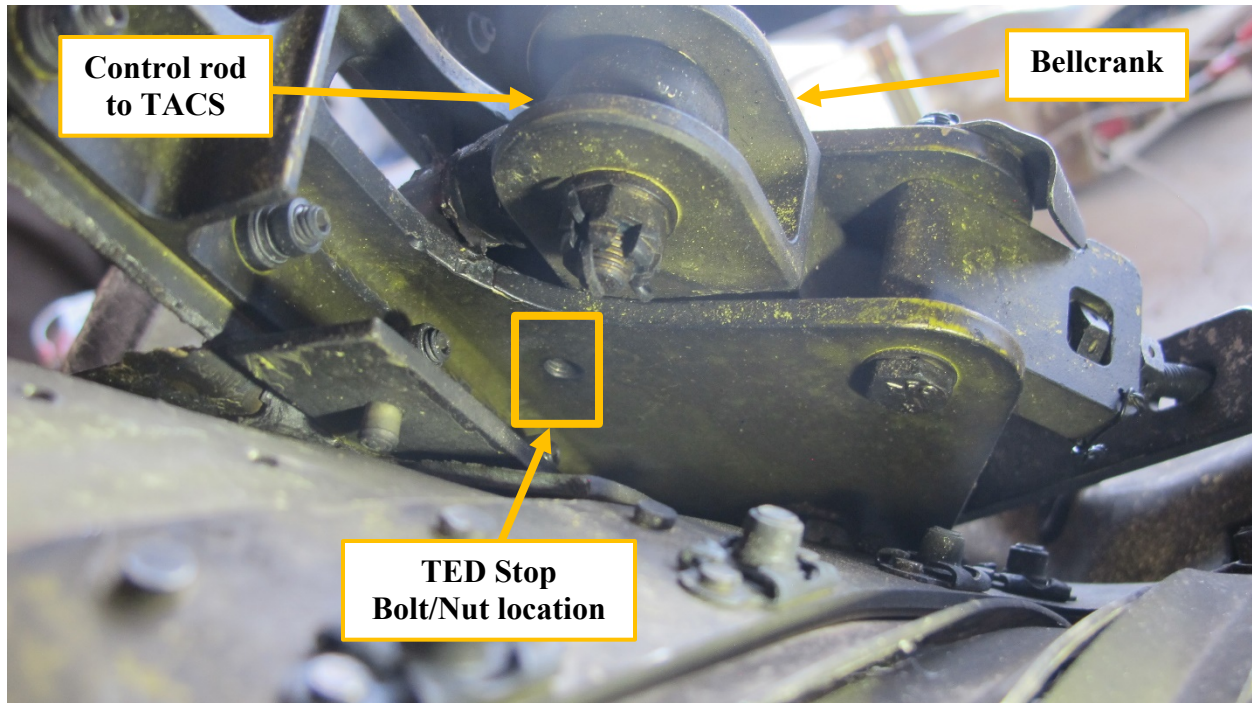
The recovered control linkages exhibited failures consistent with overload. All attachment and securing hardware were present on recovered rod ends. A visual inspection of the trailing edge down mechanical stop revealed that the bolt/stop was deformed and the nut and cotter pin were not present and could not be located, ref Figure 51. The damage to the bolt was consistent with shear loading at the lower attachment fitting. Additional damage consistent with over deflection was noted to the inboard hinge fitting, ref Figure 52.

Figure 51 - RH ATLAS bellcrank and TED stop damage

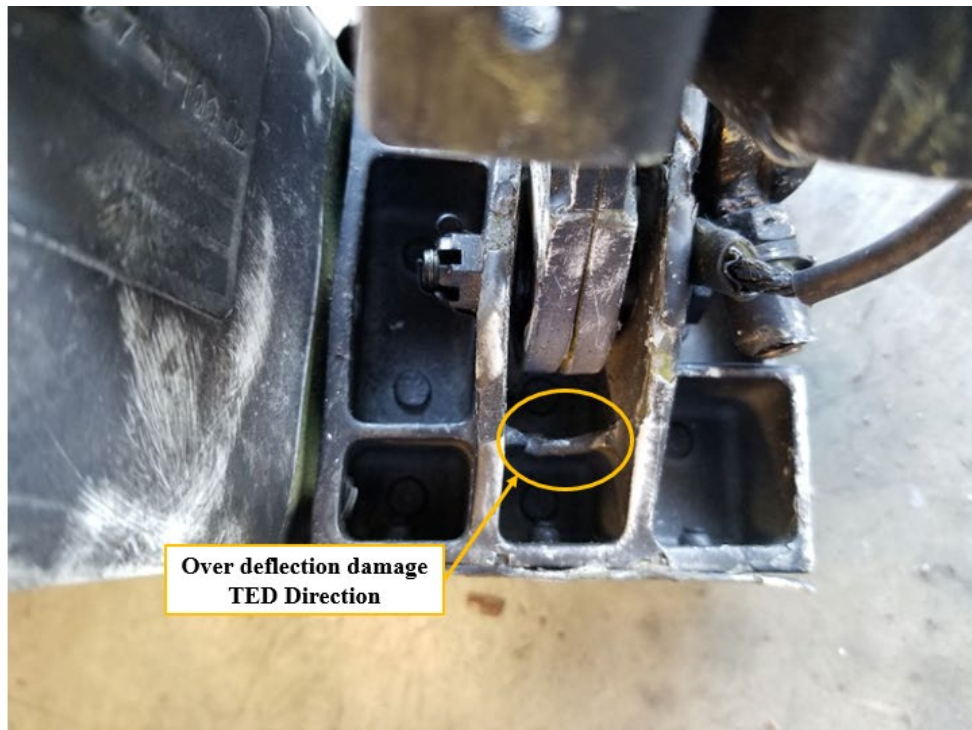
Figure 52 - RH TACS Inboard hinge with signs of over deflection damage highlighted

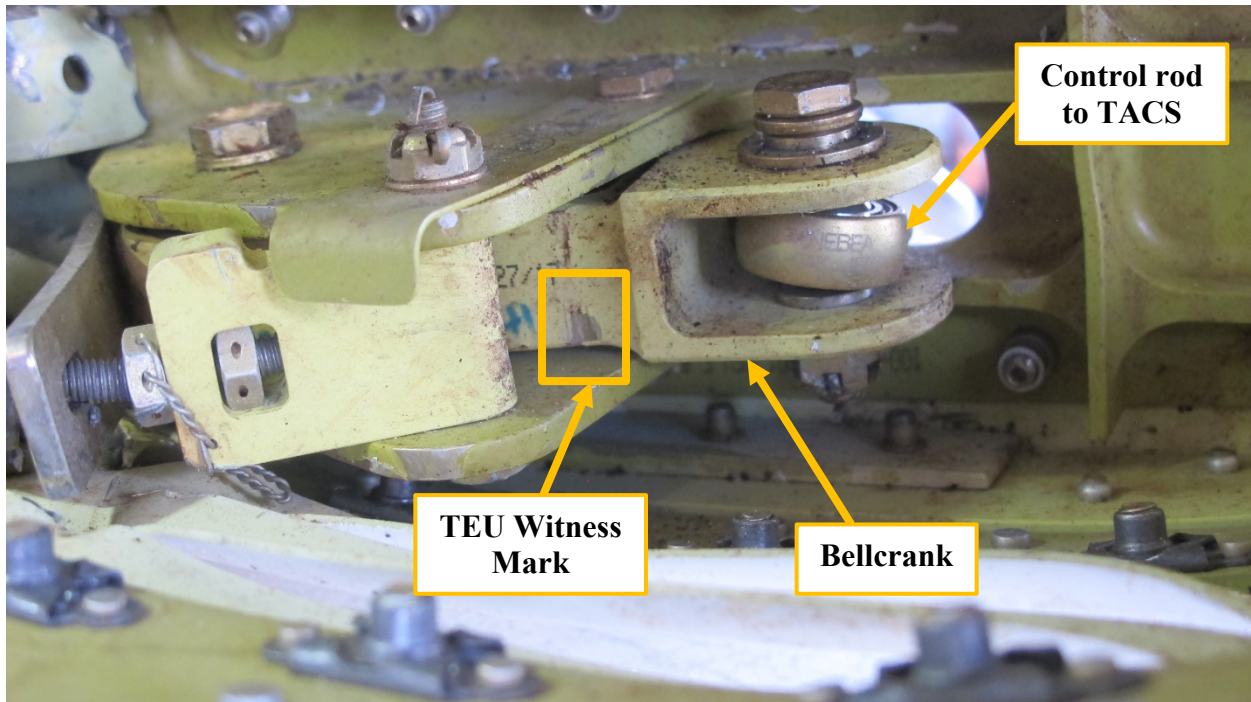
The recovered control linkages exhibited failures consistent with overload. All attachment and securing hardware was present on recovered rod ends. A visual inspection showed a witness mark on the bellcrank, which was consistent with contact with the trailing edge up mechanical stop, ref Figure 54. Additional damage consistent with over deflection was noted to the inboard hinge fitting, ref Figure 55.

Figure 54 - LH ATLAS bellcrank and TEU stop witness mark

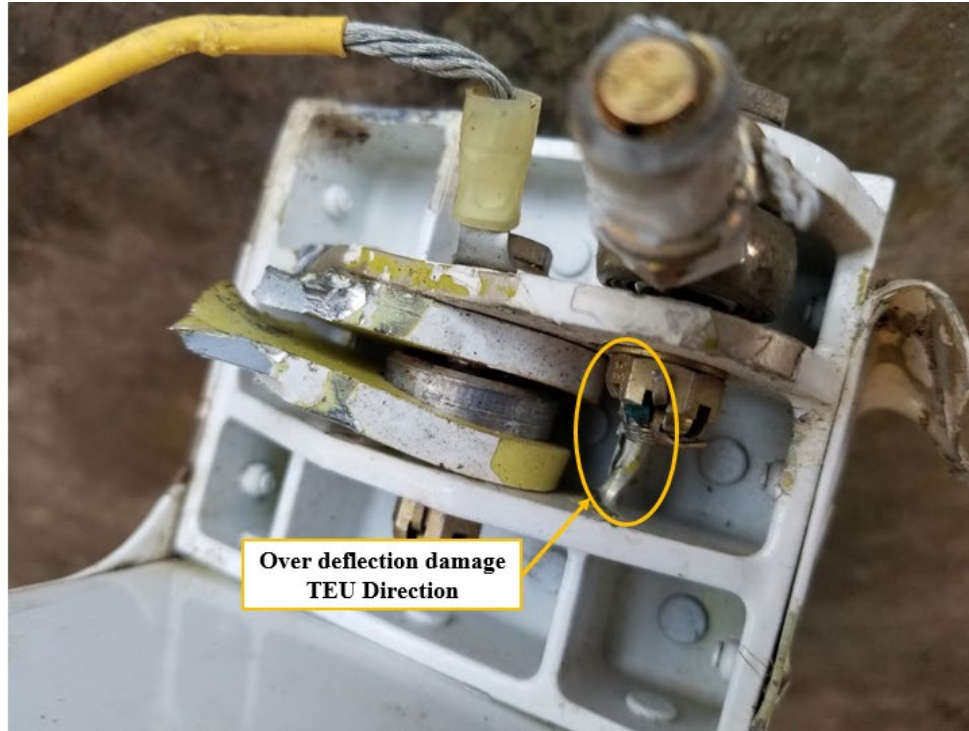
Figure 55 - LH TACS Inboard hinge fitting with signs of over deflection damage highlighted

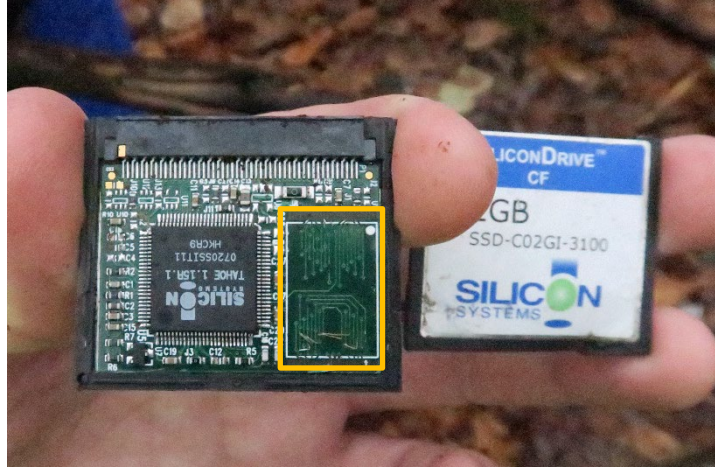
**Figure 58 - AReS CF card with missing memory chip highlighted (photo courtesy of Textron Aviation)**
