Tamarack Aerospace Group Submission to the National Transportation Safety Board

**Collision of Cessna 525A (N525EG) With Terrain Near
Memphis, IN, November 30, 2018**

CEN19FA036

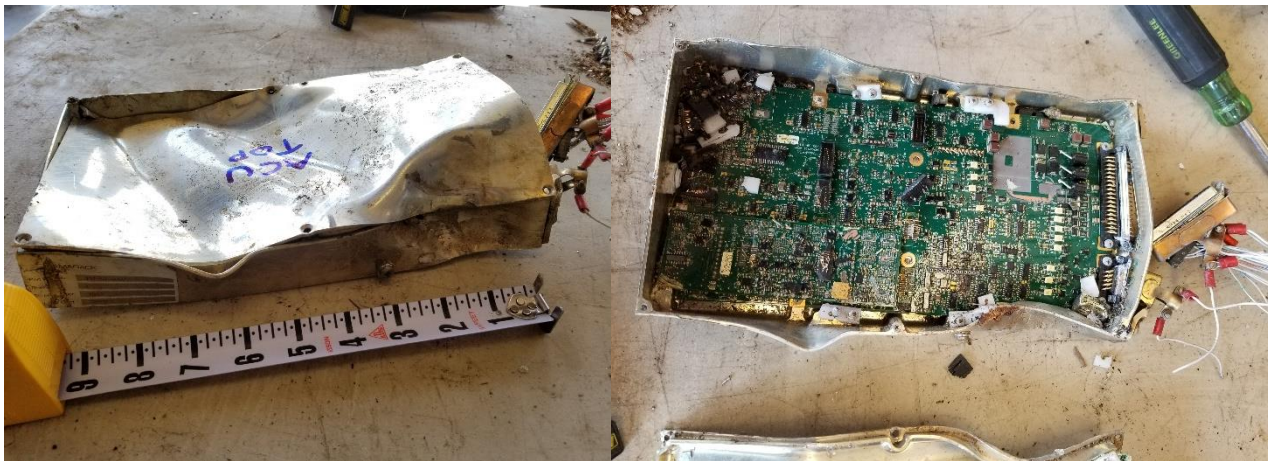
Figure 2-1 ACU as-found condition (external view left, internal view right)

The ACU was found in a severely damaged state, visible in Figure 2-1.

The state of the ACU and the extent of the damage prevented further testing of the unit. The ACU does not have non-volatile memory. The type and extent of the damage is consistent with a severe impact event. The amount of post-impact damage prevents further meaningful investigation into the possibility of in-flight ACU failures. To date, Tamarack has not received any reports of in-flight ACU failures.

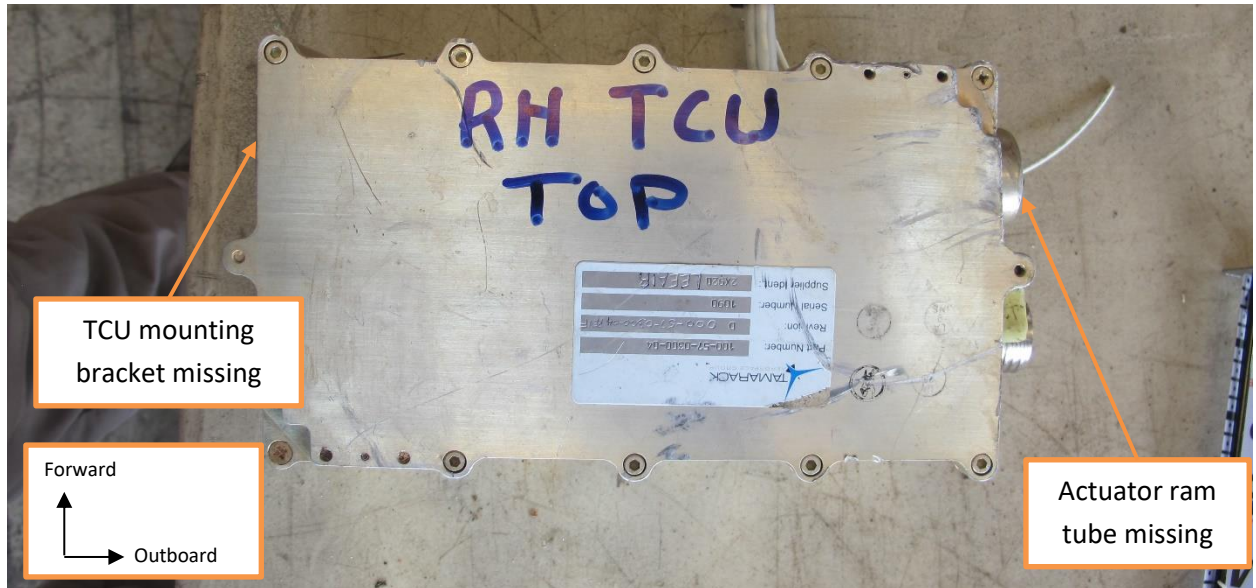
Figure 2-2 RH TCU as-found state (top-down view)

The right hand TCU was found with extensive external and internal damage, similar to the ACU.

A preliminary external examination of the RH TCU found that the actuator ram tube, which ordinarily connects to the TACS deployment linkages via a self-aligning bearing rod end, was broken off from the

actuator. A mounting bracket normally installed on the aft end of the TCU box had been broken off as well. The TCU case was also breached, with leaves and other debris found inside the normally sealed box.

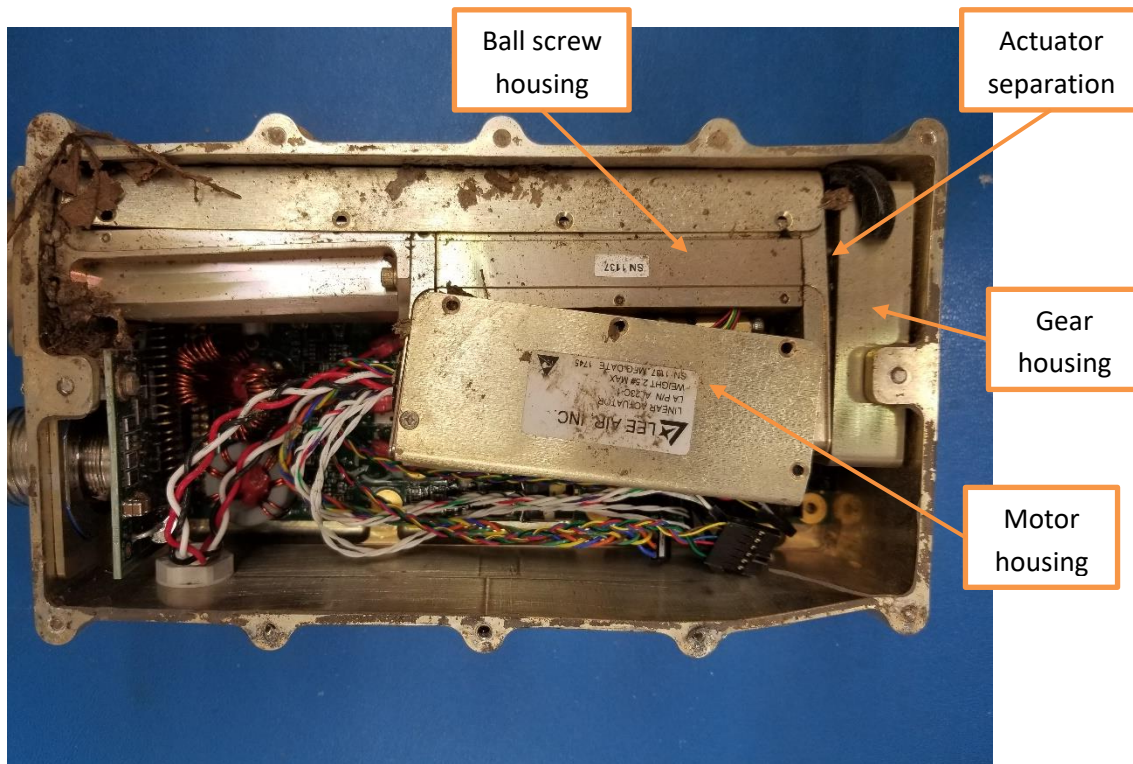
Figure 2-4 RH TCU as-found condition (internal view)

A preliminary internal examination of the RH TCU found that the actuator itself had failed structurally, visible in Figure 2-4 as a separation of the gear housing from the motor and ball screw housings. The gear housing is attached to the motor and ball screw housings by six screws, which were found failed on further inspection. The type of failure was consistent with a tensile overload of the screws. Tamarack notes that the actuator is not capable of developing the static force required to fail these screws in tension, and the separation is thus most likely due to the high energy impact.

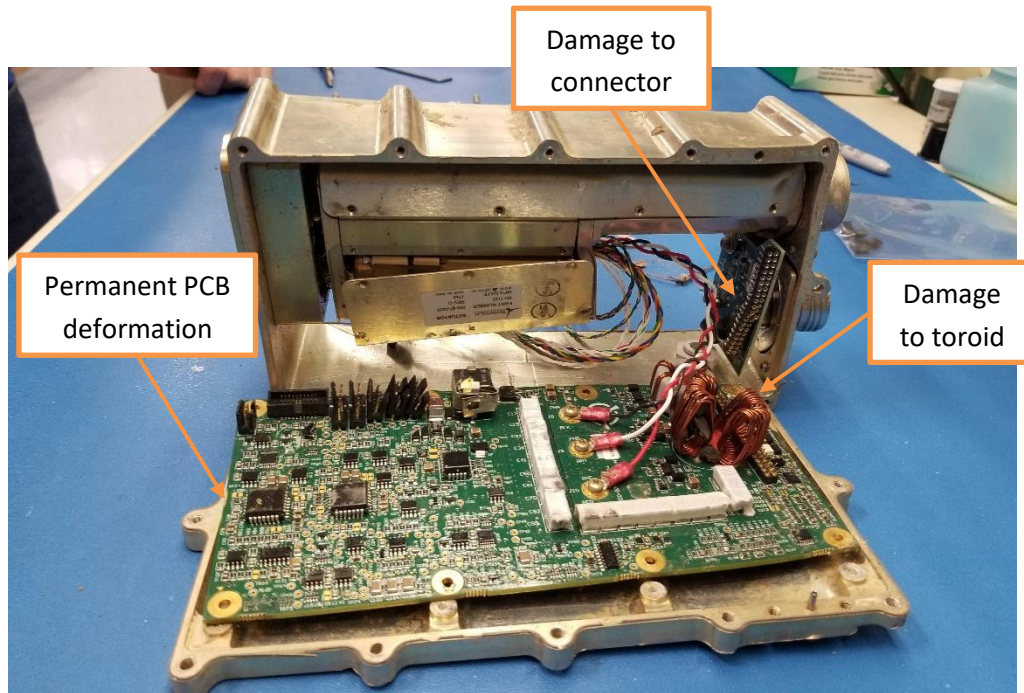
Figure 2-5 RH TCU as-found condition (PCB view)

Extensive damage to the TCU PCB assembly prevented any electrical testing.

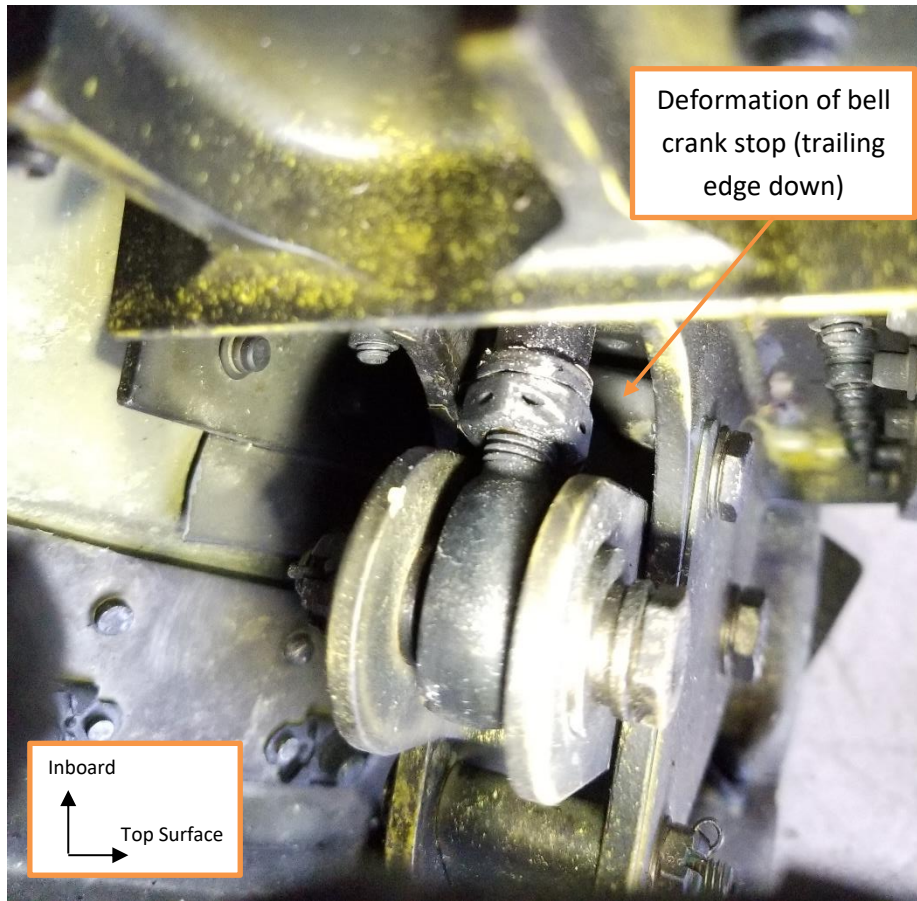
Figure 2-9 RH wing extension bell crank damage

Damage to the right wing extension, specifically the bell crank and the hinge bracket, presents a disparity between the witness marks within the actuator and witness marks on the hinge hardware. The bell crank

The stop corresponding to a trailing edge down deployment is a sleeved AN3-14A bolt installed through the bell crank bracket. The trailing edge down stop was severely deformed the as-found condition of the right wing extension. This does not match the position of the ball nut and the witness marks found within the actuator, which indicate an extended condition (corresponding to a trailing edge up deployment). The deformation of the trailing edge down bell crank stop most likely happened during impact after the actuator ram tube was separated from the TCU, as the actuator is not capable of producing the force required to deform this bolt to the extent it was found.

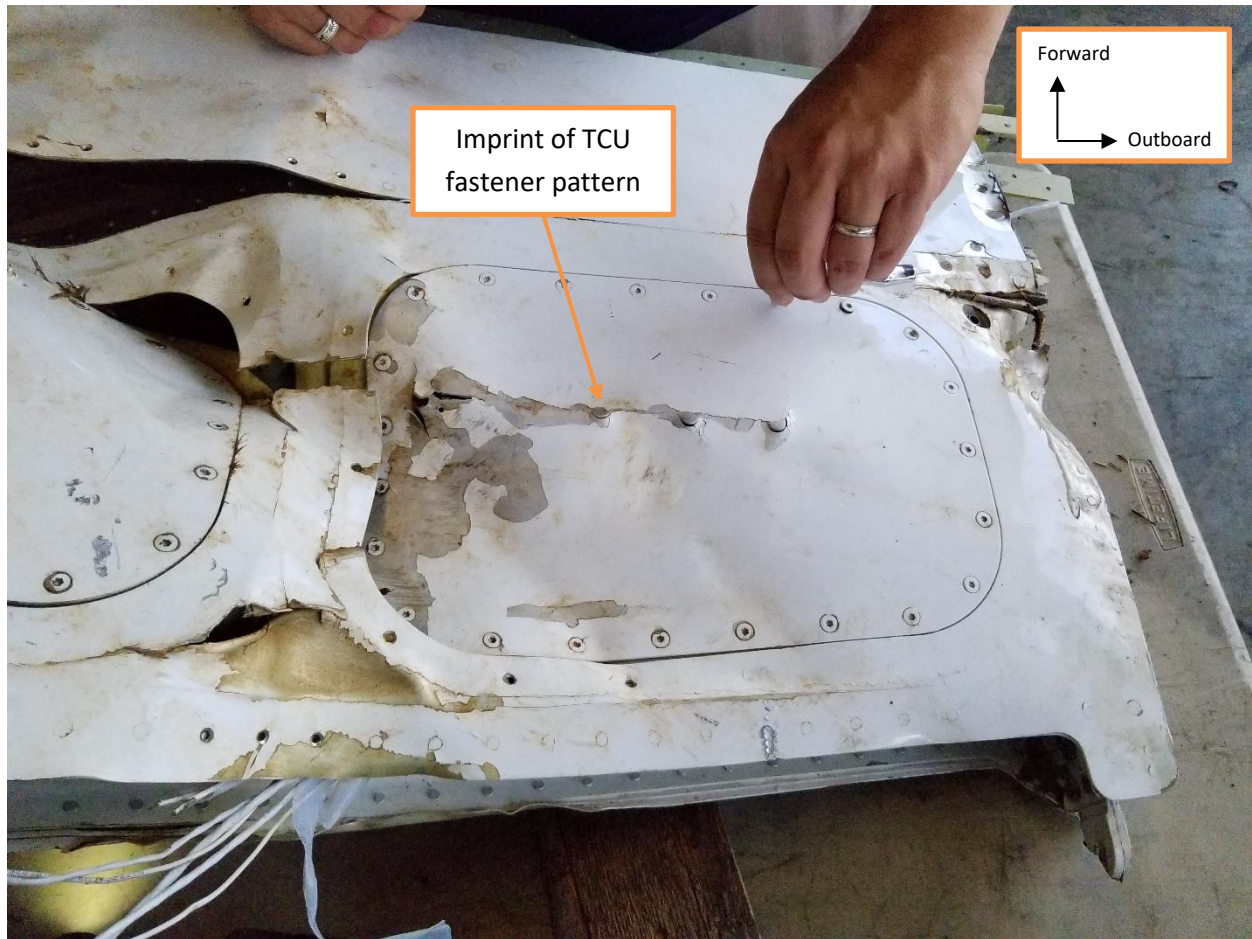
Figure 2-12 LH wing extension (lower surface shown) showing imprint of TCU

The left hand TCU was recovered installed in a mostly intact section of the outboard wing, and the external damage to the unit was less severe than that of the RH TCU, but was still significant. The wing section in which the LH TCU was mounted had sustained significant impact damage, specifically such that the TCU imprinted itself in the access panel below its installed position.

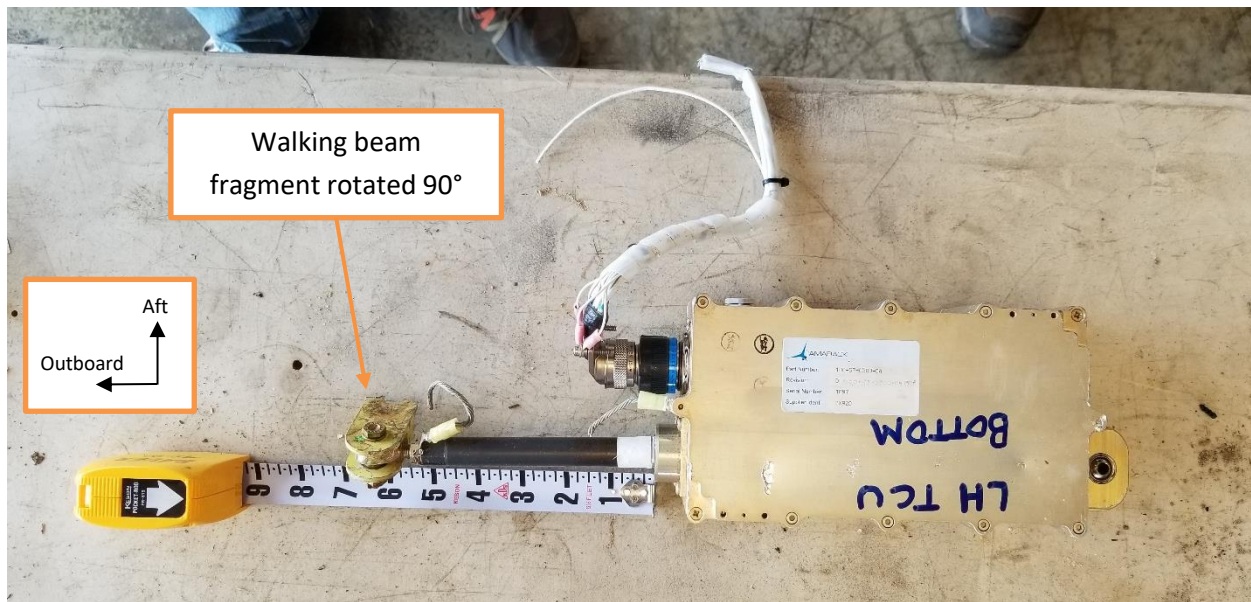
Figure 2-13 LH TCU as-found condition (external view)

The LH TCU case was not breached, as the RH TCU was, and the ram tube was present in the actuator as found. However, the rod end was found rotated 90° from nominal with the safety wire still in place, suggesting the possibility of internal damage to the actuator. This is visible in Figure 2-13.

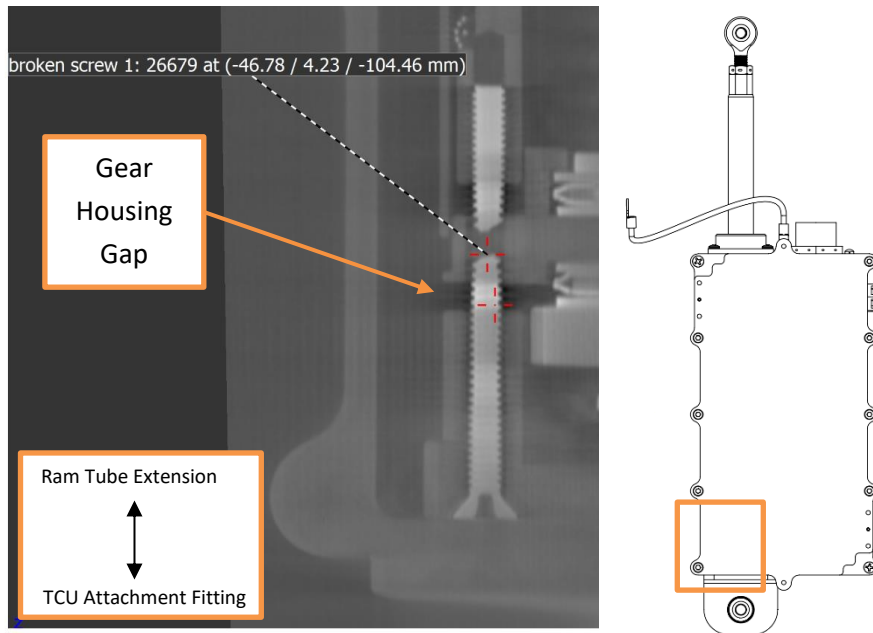
Figure 2-14 LH TCU actuator as-found condition showing broken screws (view from bottom)

CT scanning confirmed this, revealing broken screws between the motor and gear housing, similar to the type of damage found in the actuator of the RH TCU.

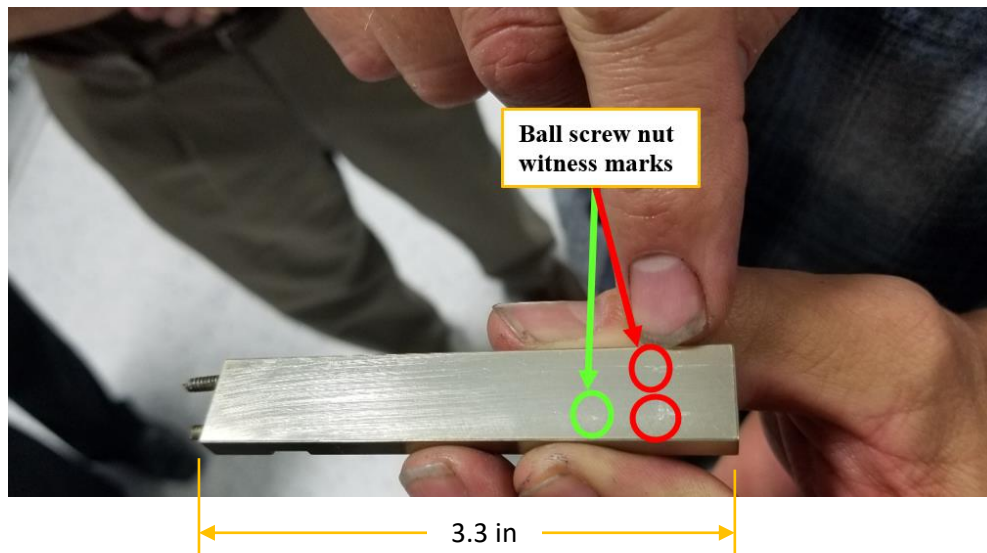
Figure 2-15 LH TCU actuator lower ball nut guide witness marks (excerpt from [3])

Teardown of the actuator also revealed witness marks on the lower ball nut guide similar to those found in the RH TCU actuator. An image of these witness marks is provided below, excerpted from the Systems Group Chairman's Report [3]. Note that the colors only indicate that there are two sets of marks.

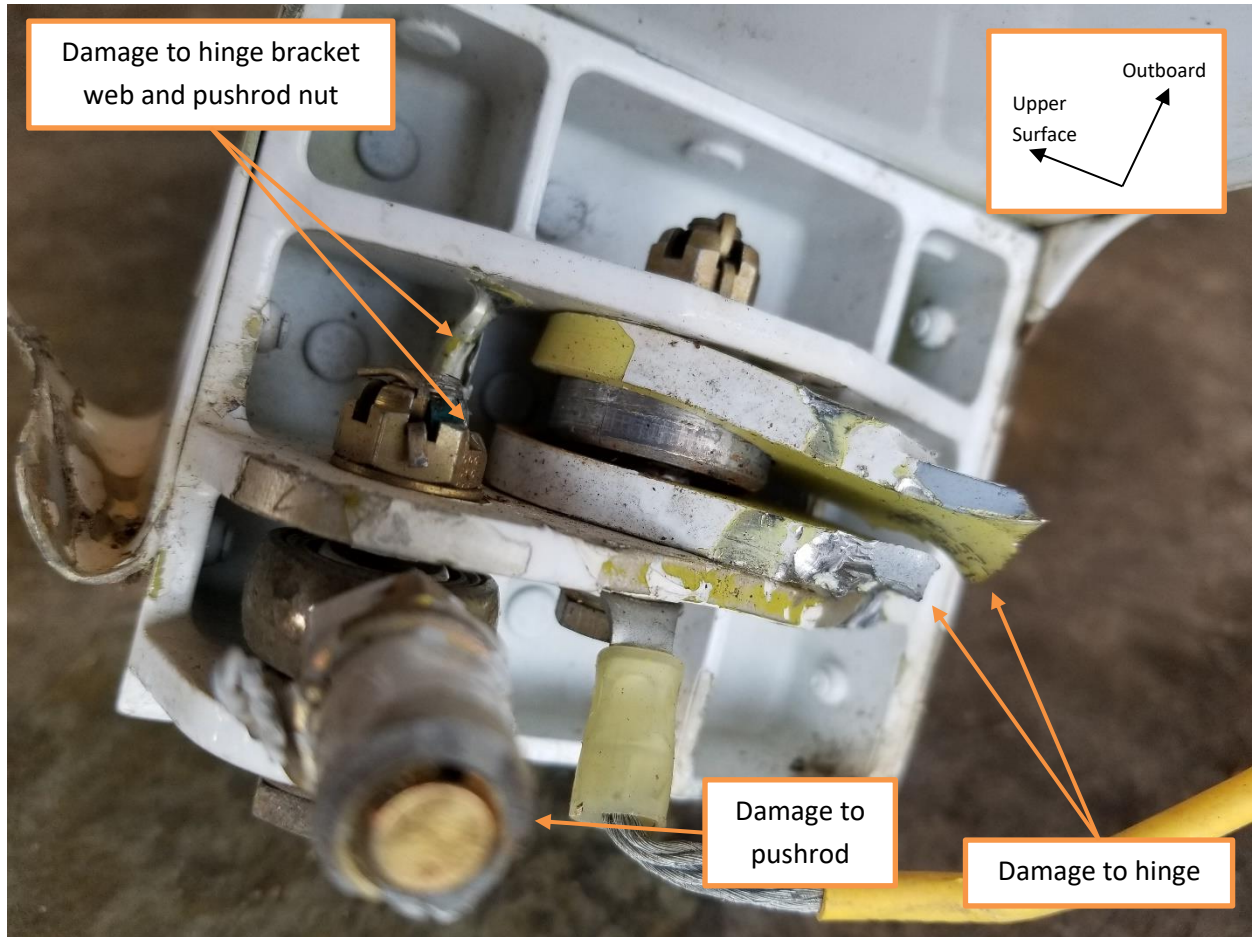
Figure 2-16 LH inboard TACS hinge bracket (view looking aft)

The left hand TACS inboard hinge bracket demonstrated evidence of overdeployment of the surface, trailing edge up. This was in the form of damage to a web in the bracket itself, most likely caused by contact with the TACS hinge itself. See Figure 2-16 for reference. The TACS pushrod rod end was found still

installed on the TACS hinge, but the rod itself was sheared off approximately at the threads of the rod end.

The TACS deployment angle required to cause this type of deformation is approximately 55°, more than twice the maximum angle permitted by either the hard stops internal to the actuator or the stops installed in the bell crank.

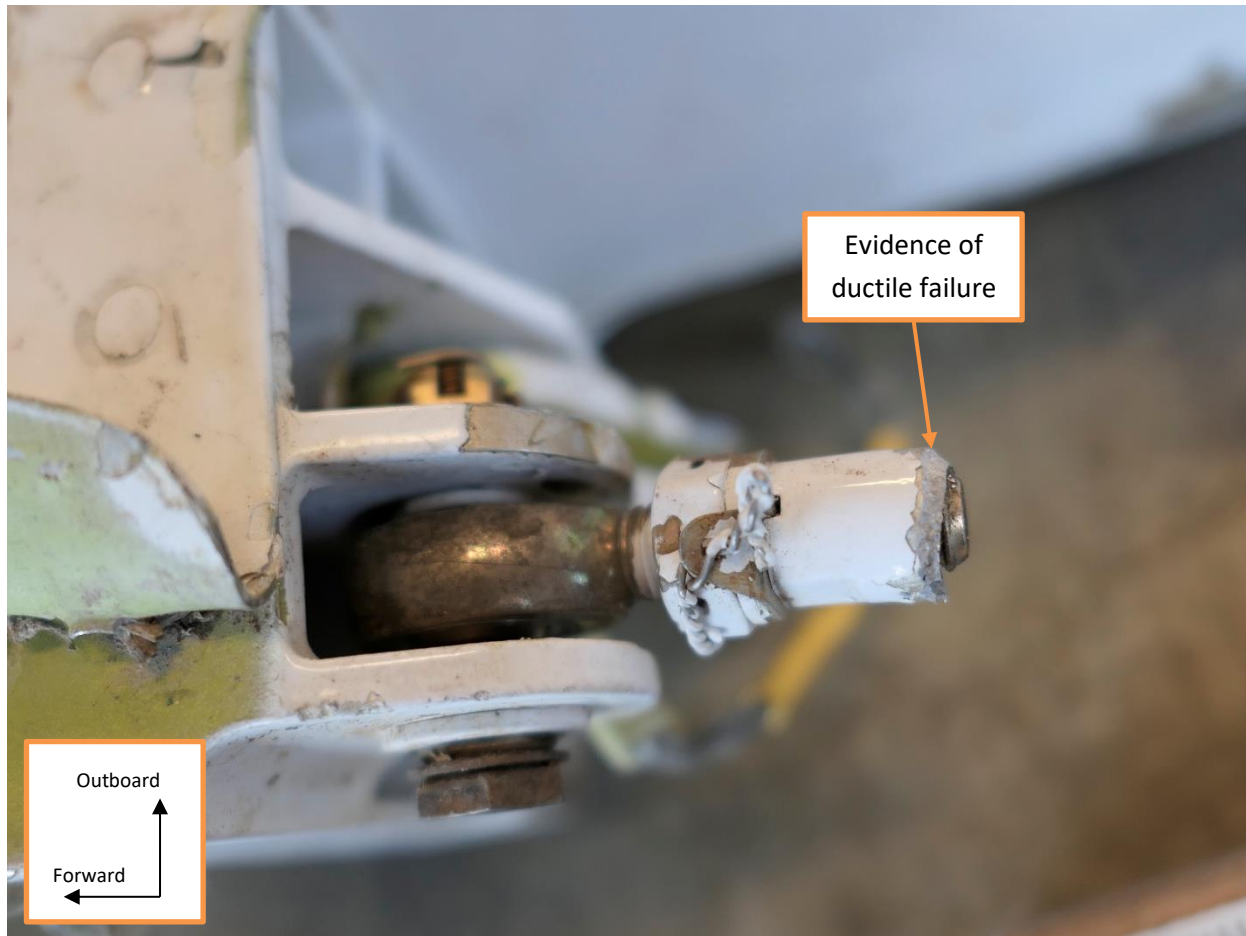
Figure 2-17 LH TACS pushrod failure

The pushrod exhibits the cup-and-cone shape consistent with ductile failure, without evidence of fatigue areas. A slight lateral deformation of the failure area indicates an eccentric tensile load, likely caused as the hinge failed and the TACS separated from the wing extension.

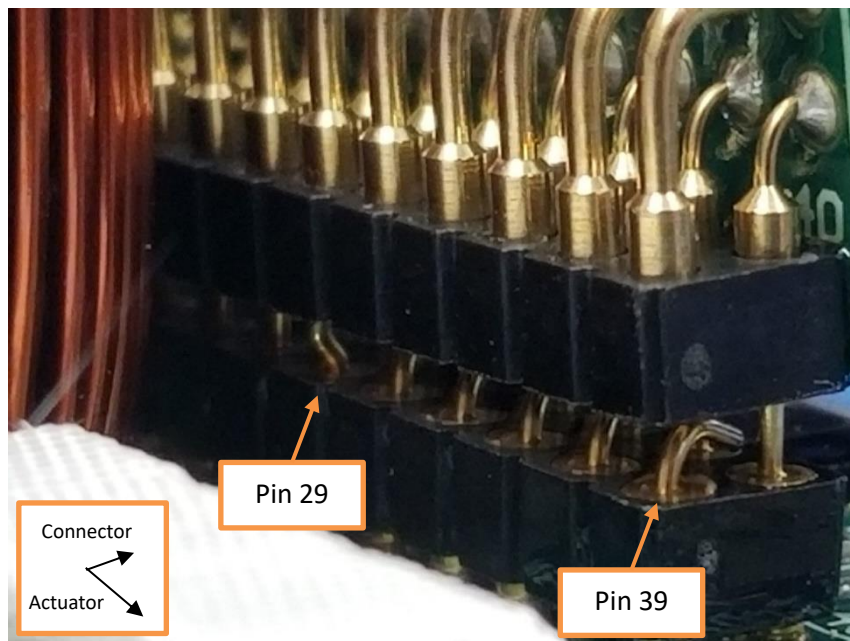
Figure 2-18 LH TCU bent connector pins

An inspection of the LH TCU PCBA found several key indications of damage. Most noticeably, six pins on a 40-pin connector between the main TCU control board and a smaller board providing an external connector interface were found bent and not seated as expected. Pins 29, 31, 33, 35, 37, and 39 were

affected. The bent pins are visible in Figure 2-18, with the start and end range of the affected pins noted in the image.

Initial electrical testing of the LH TCU found that pins 33 and 35 were open. Pin 33 connects to pin A of the external connector, carrying a discrete enable signal from the ACU. Pin 35 connects to pin D of the external connector, carrying the analog actuator command signal.

Tamarack notes that the signals affected by the bent pins (enable and command voltage) are critical to the proper function and powerup of the TCU. This type of extensive damage to those pins, if it had been caused during manufacturing or handling, would most likely have been indicated by faulting or system unavailability on flights prior to the accident flight, especially since the LH TCU was found with fully open circuits on these two signals. Tamarack has no such reports of nuisance failures on this airplane prior to the accident.

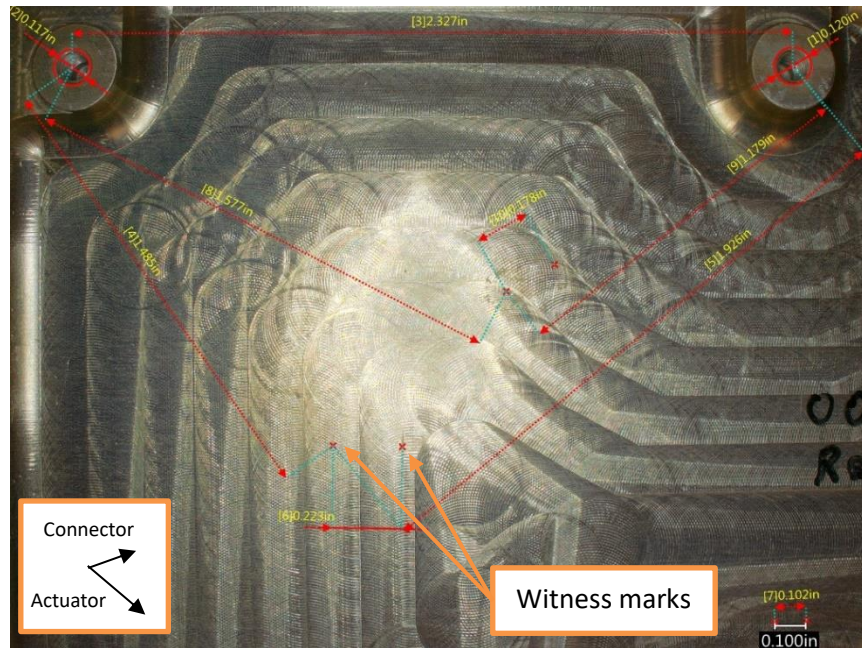
Figure 2-20 Witness marks below PCBA on TCU lower case

There is evidence to suggest that the pins were bent by a substantial flexure of the PCBA during the impact event. The lower surface of the PCBA is populated in part with two rows of capacitors, visible in

Figure 2-19. Witness marks were discovered on the interior of the lower TCU housing, corresponding to the positions of the capacitors installed on the PCBA. These witness marks are visible in Figure 2-20.

It is likely that during the impact, extreme impact forces on the TCU caused the control PCBA to flex downward, contacting the interior face of the TCU housing below the PCBA and causing the witness marks described above. This partially disconnected the 40-pin connector between the control PCBA and the smaller connector PCBA. As the control PCBA returned to normal position, six of the pins failed to re-seat properly and were bent to the positions in which they were found.

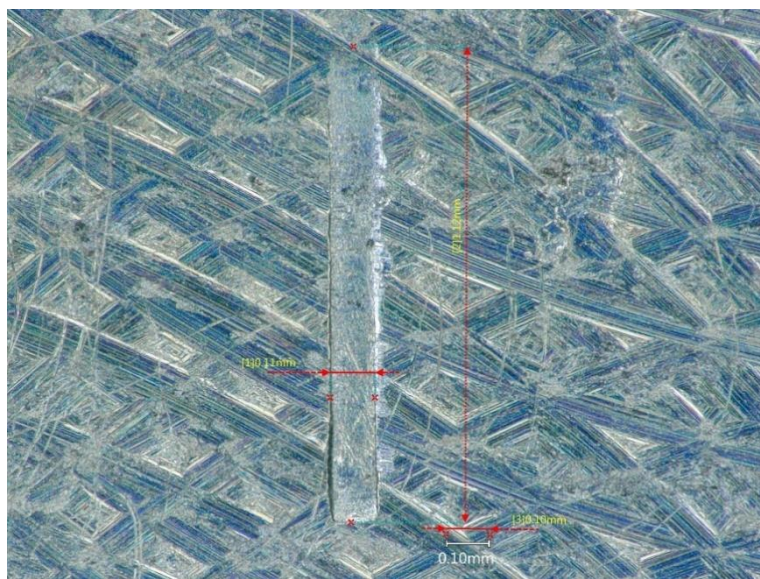
Figure 2-21 Detail view of witness mark on TCU lower case

A detail view of one of the marks in Figure 2-21 shows that it is an impact mark caused by an object with a thin, rectangular cross section. The capacitor bank above the marks in the lower case is populated by capacitors assembled from two smaller capacitors, joined on each end by a small metal plate, which is soldered to the board's solder pads. The plate has a thin, rectangular cross section.

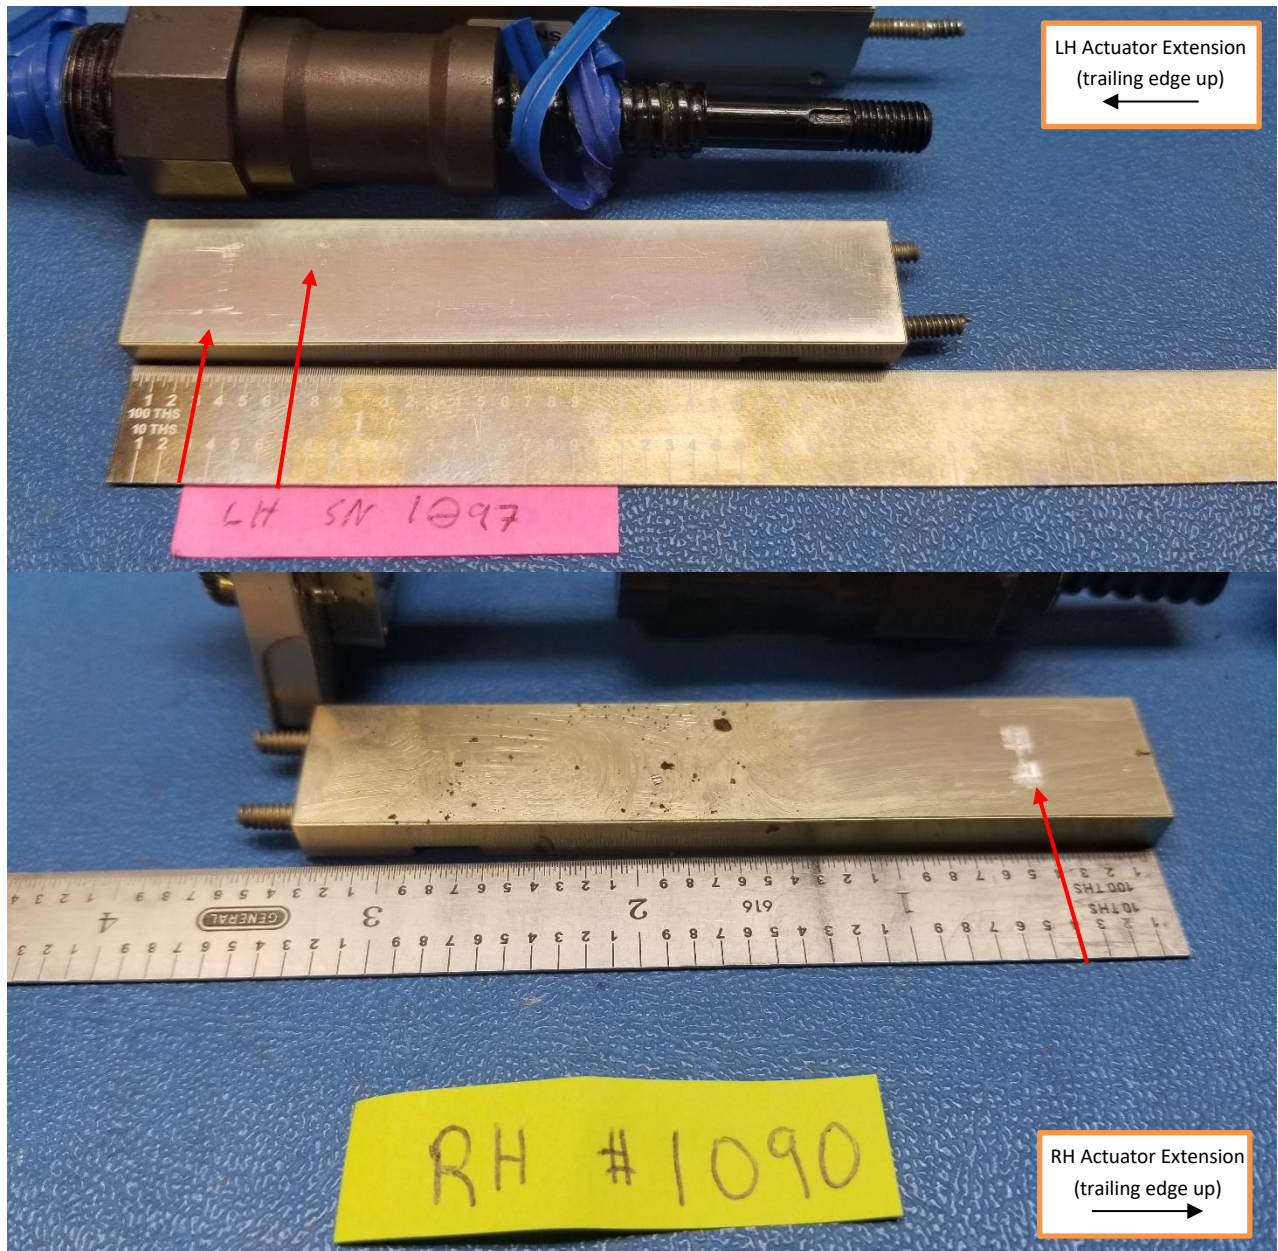
Figure 2-22 LH and RH actuator witness marks comparison

Tamarack concludes that the witness marks left on the upper and lower ram guides in the TCUs were caused by the large impulse force of the impact acting normally to the axis of the ball screw, causing the

ball screw to deflect enough to allow the ball nut to contact the ram guides. Images of the two components are presented below in Figure 2-22 for comparison.

The overall length of the ball screw guide section is 3.35 in. The retraction hard stop extends into the ball nut guide 0.20 in, and the extension hard stop provides an additional 0.15. The distance between hard stops is 3.30 in. The length of the ball screw is approximately 1.8 in. This leaves approximately 1.5 in of ball nut travel. In normal operation, the actuator allows approximately 1.0 in of extension and approximately 0.5 in of retraction.

The witness marks in the actuators are important to understanding the most likely state of the system at the moment of impact. The short time scale of the impact event makes it likely that the witness marks were left by the actuator ball nuts in or near the positions they were in at the time of impact. The LH TCU shows evidence of the ball nut dragging for a short distance along the lower ram guide. This is consistent with evidence that the TACS trailing edge was displaced upward on the left wing, as the scratch marks appear to be moving in the direction of an actuator extension. Note that the presence of scratch marks in the LH TCU suggests that there would be evidence if the ball nut position had changed dramatically during the impact. The length of the markings indicates that the ball nut was positioned consistently with an approximately half-scale extension of the actuator.
