SERIOUS INCIDENT

Aircraft Type and Registration:	Cessna Citation CJ1+, N680KH	
No & Type of Engines:	2 Williams FJ44-1AP turbofan engines	
Year of Manufacture:	2008 (Serial no:525-0680)	
Date & Time (UTC):	13 April 2019 1422 hrs	
Location:	Bournemouth Airport	
Type of Flight:	Private	
Persons on Board:	Crew - 1	Passengers - 3
Injuries:	Crew - None	Passengers - None
Nature of Damage:	None reported	
Commander's Licence:	Airline Transport Pilot's Licence	
Commander's Age:	73 years	
Commander's Flying Experience:	4,400 hours (of which 3,200 were on type) Last 90 days - 17 hours Last 28 days - 13 hours	
Information Source:	AAIB Field investigation

Synopsis

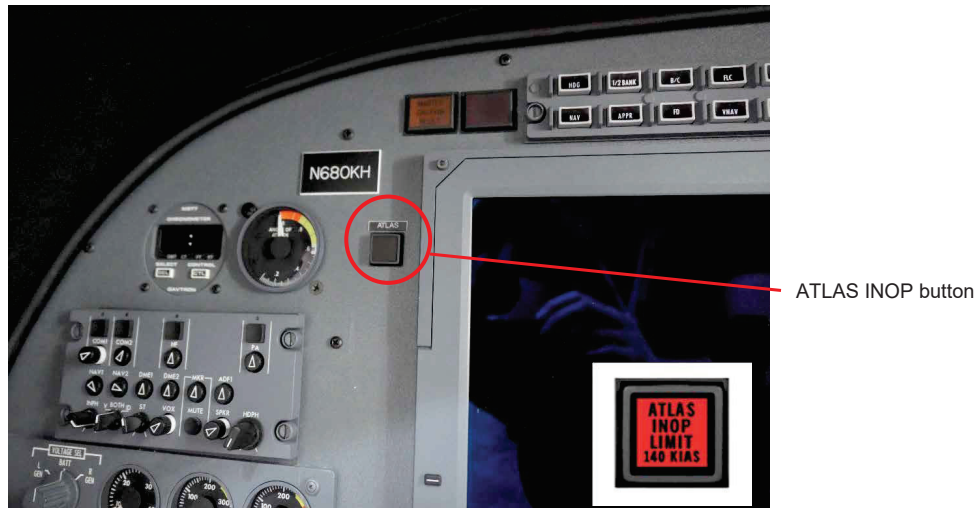
Figure 2

The pilot recalled feeling light vibration, then a button on the left of the instrument panel labelled 'ATLAS' illuminated (Figure 2), displaying the text 'ATLAS INOP LIMIT 140 KIAS' in red. At 1418:39 hrs, when the aircraft was around 6 nm east of the airport, at 3,000 ft amsl and 258 KIAS, the aircraft rolled left with a rate the pilot described as "very quick"⁴. ATC described N680KH turning "sharply... left and descending" (Figure 3)⁵. As it rolled through 45° the autopilot disengaged automatically.

ATLAS INOP button in N680KH, inset representation of button when illuminated

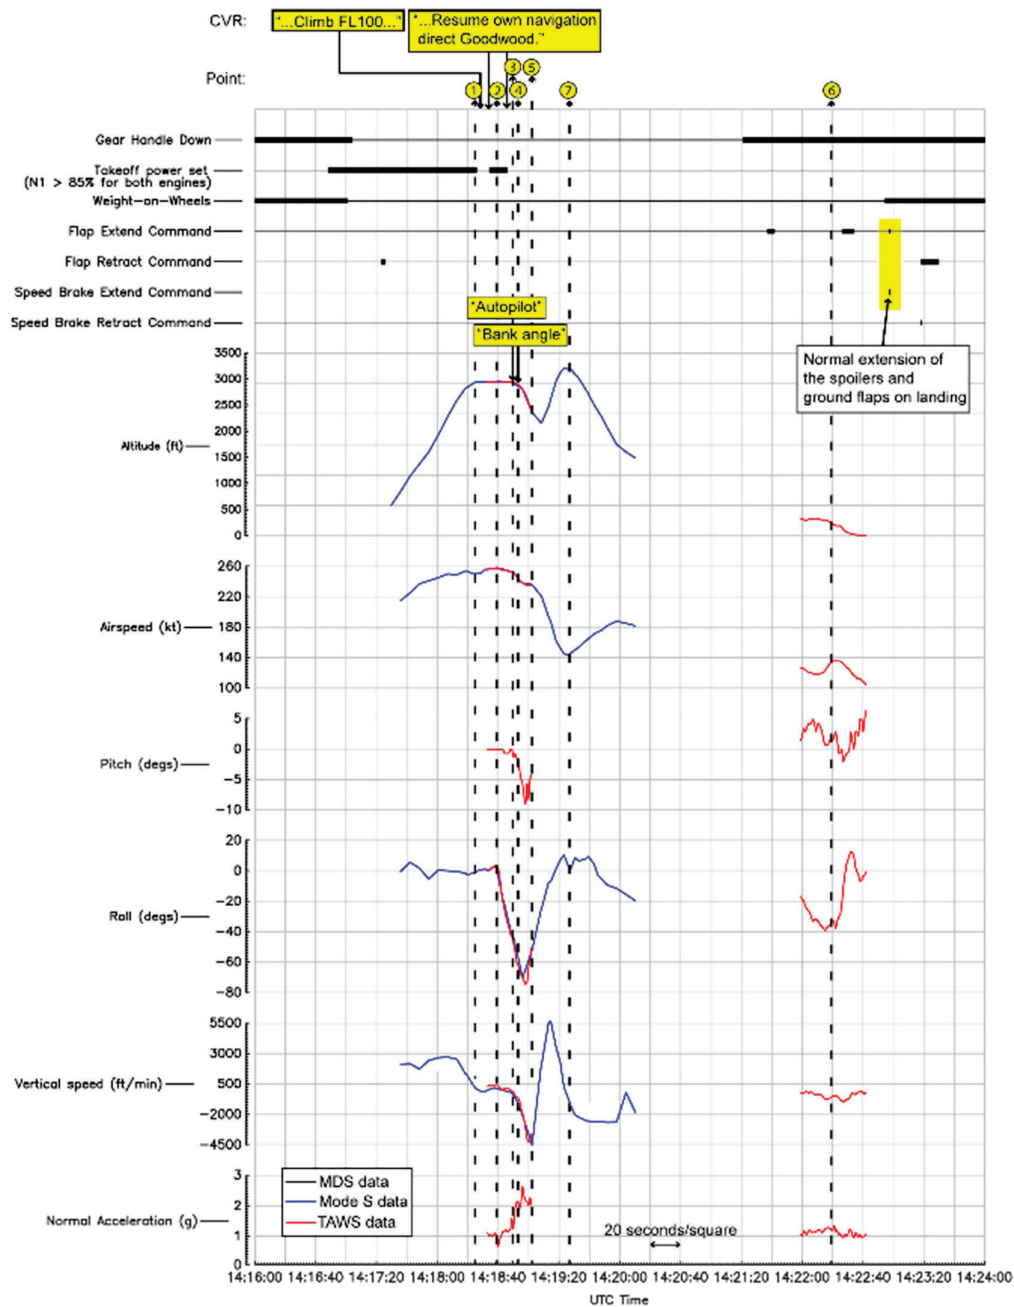
Figure 5

Data for the incident flight showed that after takeoff from Bournemouth the aircraft briefly levelled at approximately 3,000 ft¹³, with a pitch attitude of 0° at between 250 KIAS and 260 KIAS (between Point 1 and 2 on Figure 5). The aircraft then began to roll to the left at approximately 4° per second (Point 2 on Figure 5). Data from the CVR shows the pilot acknowledged an ATC clearance shortly afterwards and recorded data shows the revised climb altitude being selected. Eleven seconds later, the aircraft rolled through approximately 45° . The excessive roll caused the autopilot to disconnect automatically and was accompanied by an aural disconnect warning that was audible on the CVR. At this time the recorded pitch angle markedly decreased to 9° nose down (Point 3 on Figure 5). As bank angle exceeded 60° a bank angle alert¹⁴ was generated (Point 4 on Figure 5) and a sharp increase in normal acceleration was recorded which reached +2.65 g. The bank angle reached a maximum of 75° left wing down, 19 seconds after the onset of the roll (between Point 4 and 5 on Figure 5), although the rate of descent

continued to increase and reached 4,500 ft/min (Point 5 on Figure 5), when the aircraft's airspeed was 235 kt.

Summary plot of recorded information

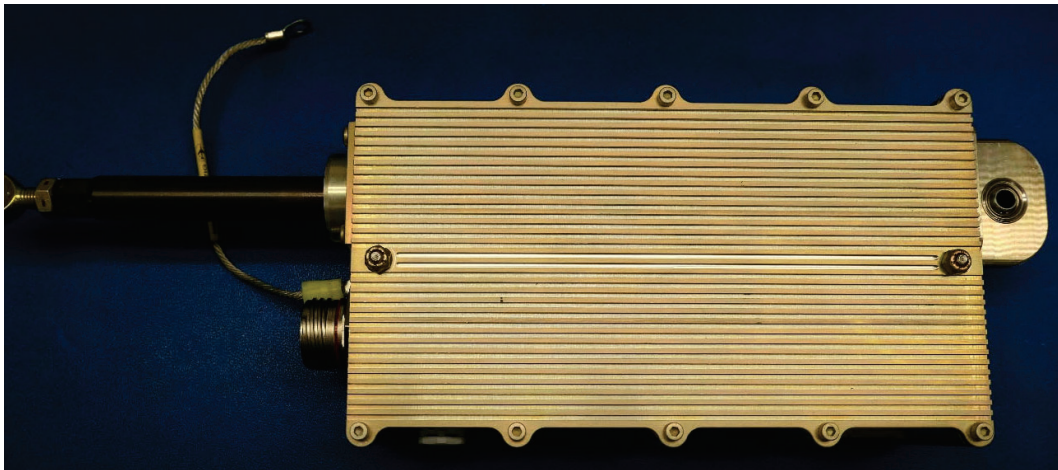
The right TCU (s/n 1014) passed all functional test and was therefore not subjected to any further assessment. Figure 10 shows an image of TCU s/n 1014.

TCU s/n 1014 after initial assessment

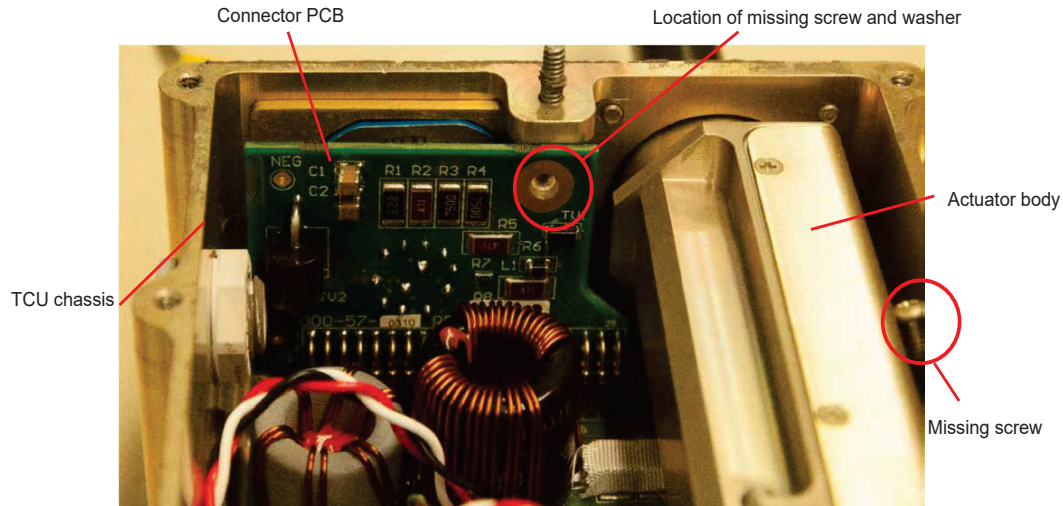
Figure 11

When the unit was shaken, before removing the cover, something rattled inside. Opening the unit revealed that the screw and washer which attached and earthed the electrical connector printed circuit board to the unit's chassis were missing. Both the screw and washer were found within the chassis¹⁶ (Figures 11 and 12).

TCU s/n 1015 showing where the crew should have been, and where it was found.

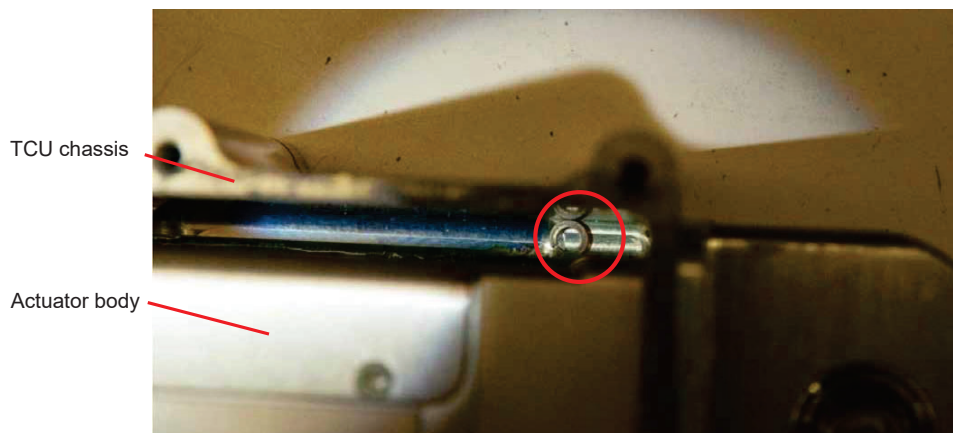
Figure 12

TCU s/n 1015 showing location missing washer was found

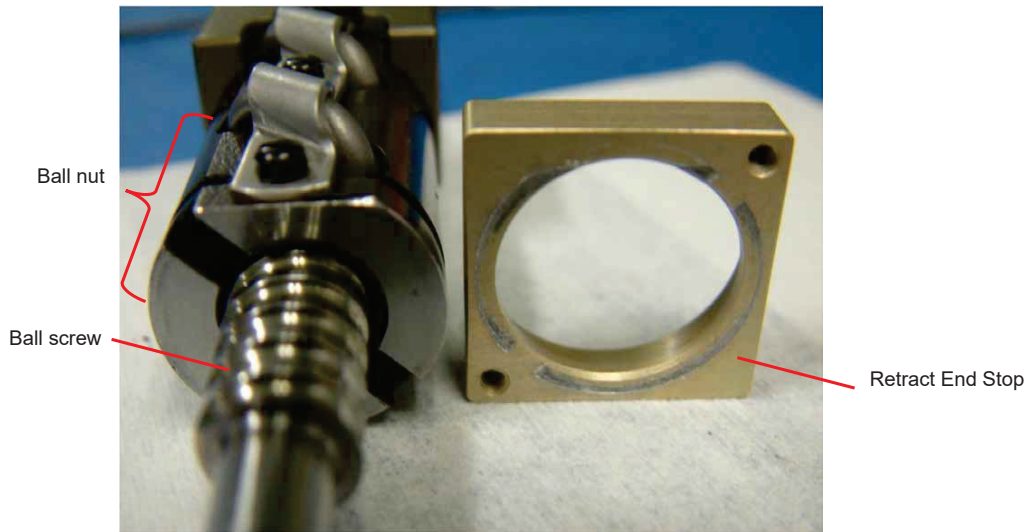
Figure 13

Damage in the actuator retract end stop (Figure 13) and thrust pack carrier was consistent with them being struck by the ball nut that travels with the actuator arm. There was some resistance when the ball nut was separated from the thrust pack carrier, which was determined to be the cause of the actuator being locked in the retract position. The impact marks on the retract end stop, and witness marks on the thrust pack carrier, indicated that the ball screw nut had struck the stop and thrust pack carrier with some force. The impact marks in the stop were 0.012 inch deep. This damage probably occurred during the trouble shooting activity when the aircraft was on the ground.

TCU s/n 1015 impact marking from actuator ball screw against retract end stop (retract end stop turned to show impact mark next to contact point on ball nut)
