# AIRCRAFT ACCIDENT REPORT 1/2020

Report on the accident to  
**Piper PA-46-310P Malibu, N264DB**  
22 nm north-north-west of Guernsey  
on 21 January 2019

Published 13 March 2020

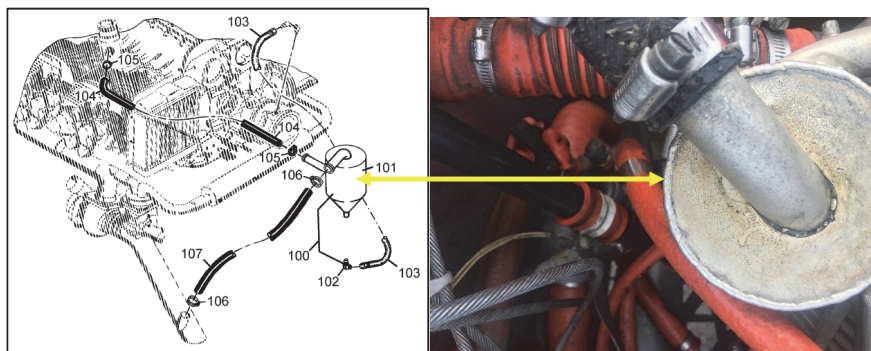
**Figure 10**

Following the engine ground run carried out at Nantes to investigate the bang on the outbound flight, the pilot noticed what he thought might be a small oil leak from the top of the oil accumulator, which he believed had been present for some time. The pilot took photographs, which he sent to the individual who managed the aircraft who then forwarded them to the FAA IA. From one of the photographs, the component was identified by the engine manufacturer as the air / oil separator assembly (Figure 10).

Photograph sent by pilot showing location of oil leak from the air / oil separator (item 101 in the left image)

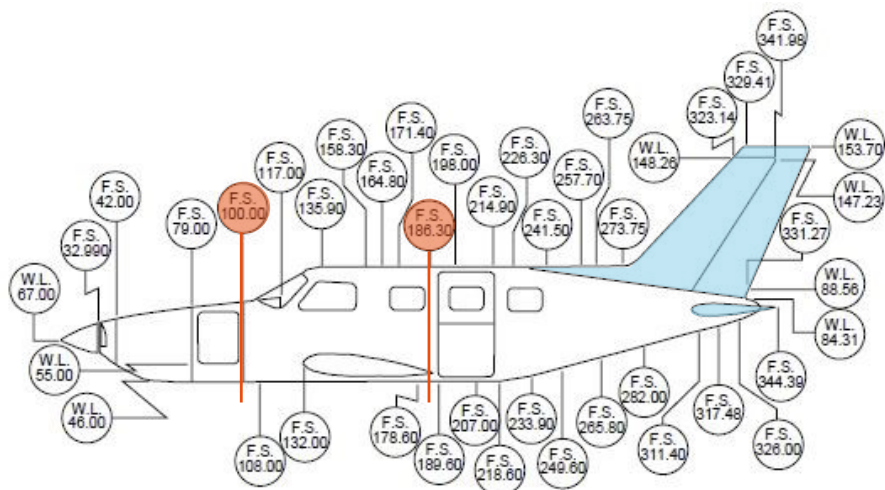
**Figure 13**  
PA-46 fuselage

The central fuselage had broken away from the nose section at Fuselage Station (F.S.)100 and from the tail section at F.S. 186.30 (shown in orange in Figure 13). The roof section of the central fuselage aft of the front seats was missing. There was significant compression damage along the top of the aircraft from the windscreens to the tail cone. There was no evidence of compression damage on the lower surface of the tail section. The fin and horizontal stabiliser assemblies had detached from the tail section at their attachment points (shaded blue).

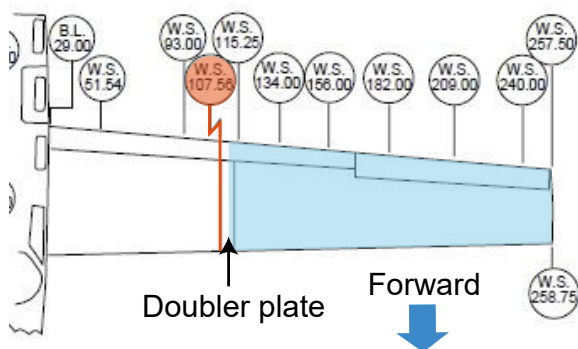
**Figure 14**  
PA-46 left wing

The left wing and flap had failed at Wing Station (W.S.) 107.56 (shown in orange in Figure 14) beneath the skin doubler plate where the inboard section of the wing joins the outer section (shaded blue) at the splice joint. The inboard section of the main wing spar appeared to be undamaged. The failure of the main spar splice joint and the adjacent structure was consistent with the wing failing due to a downward bending force. The top wing surface displayed evidence of a compressive force that had pushed the skins inwards with the edges having been torn away from the fasteners. The remainder of the wing structure and flaps were extensively damaged.

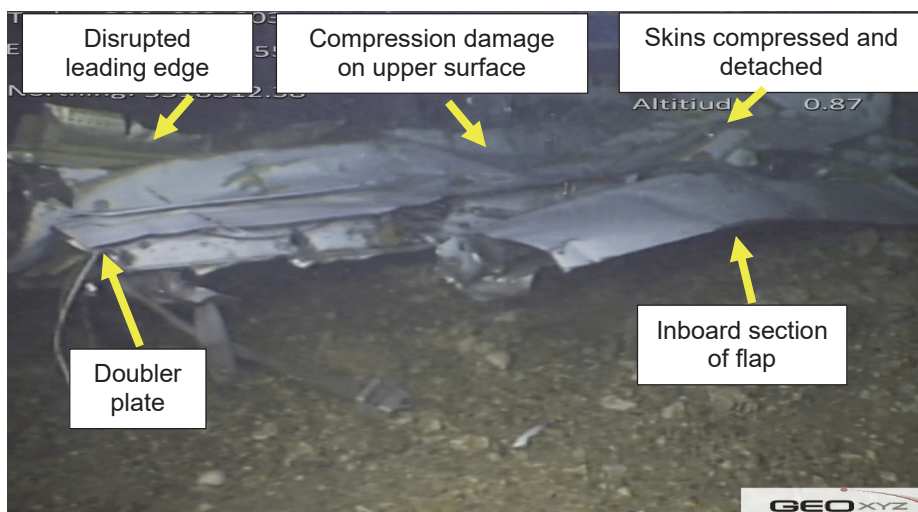
**Figure 15**  
Damage to left wing

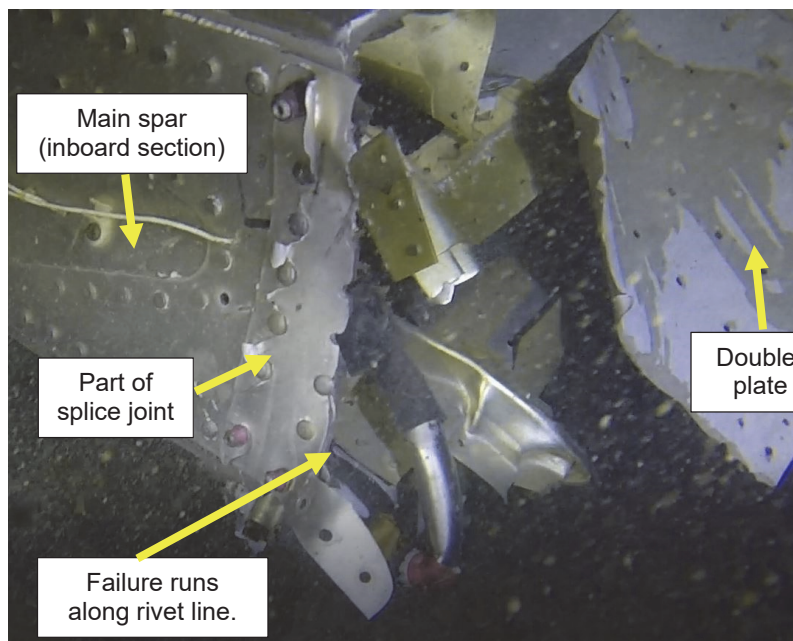
**Figure 16**

Failure of left-wing main spar at the splice joint  
(Image taken from a video provided by Blue Water Recoveries)

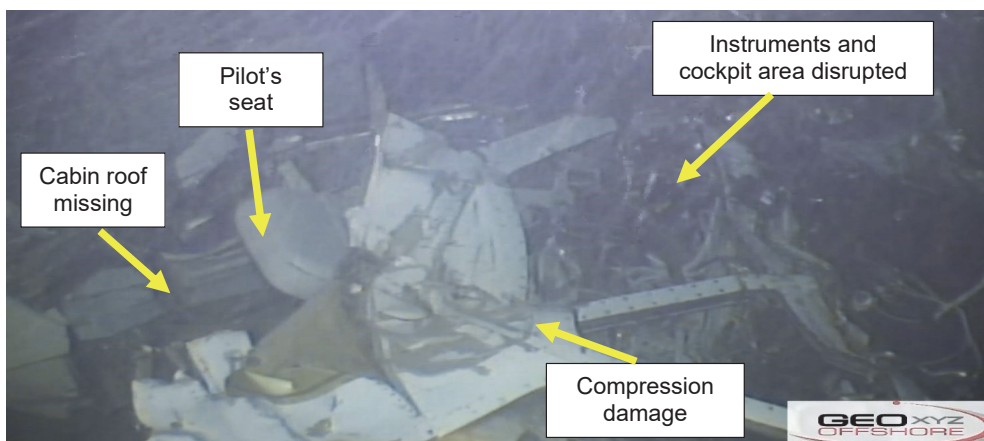
**Figure 17**

Damage to cockpit roof

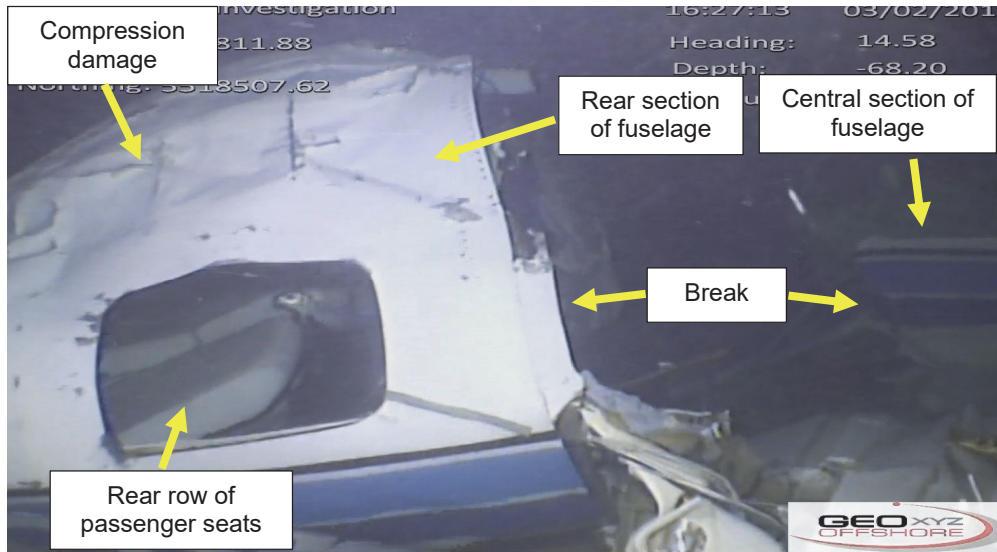
**Figure 18**  
Break in central fuselage

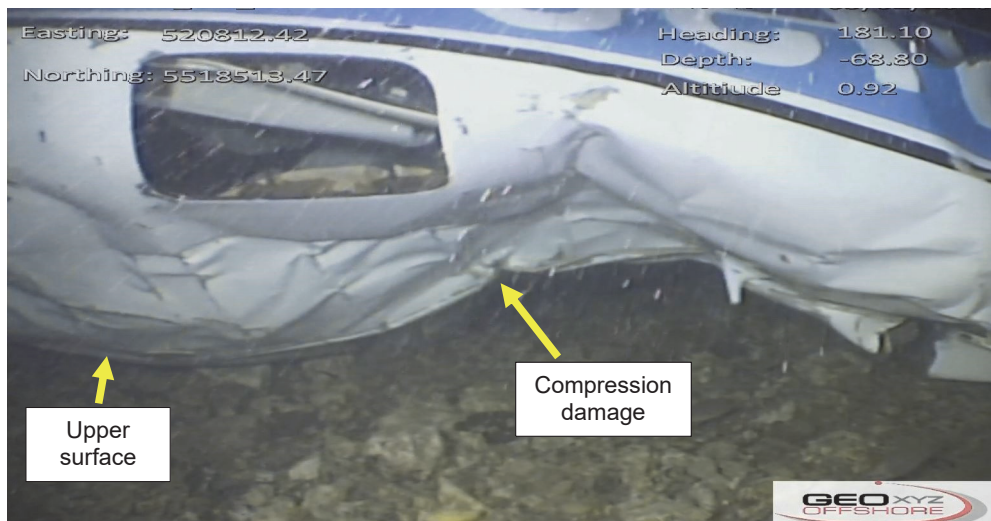
**Figure 19**  
Damage to roof of rear section of the fuselage  
(This section of the fuselage has been rotated by the tidal flow)

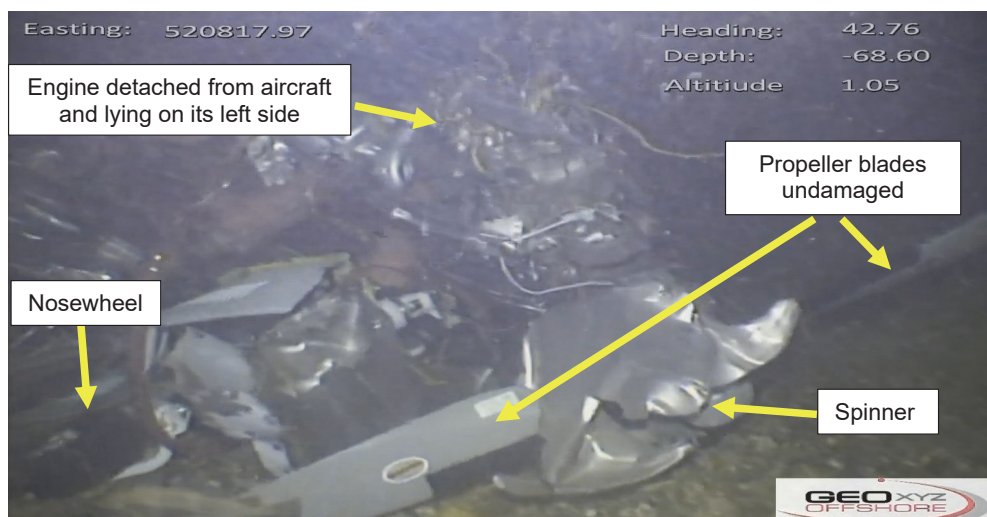
Apart from a slight rearward bend in one of the blades, the propeller blades were undamaged. The engine cowlings had detached and the engine and nosewheel had rotated 90° relative to the front of the cockpit. Several components had detached from the engine. The right tailpipe / heater shroud was still attached to the right turbocharger and video footage of part of the right tailpipe showed no evidence of scoring on the inside. There was no evidence of burnt oil residue on the inside of the exhaust. The induction, heating and ventilation pipes, and the engine baffles had been disrupted. The ignition harness was still connected to the engine.

**Figure 20**  
Propeller and engine

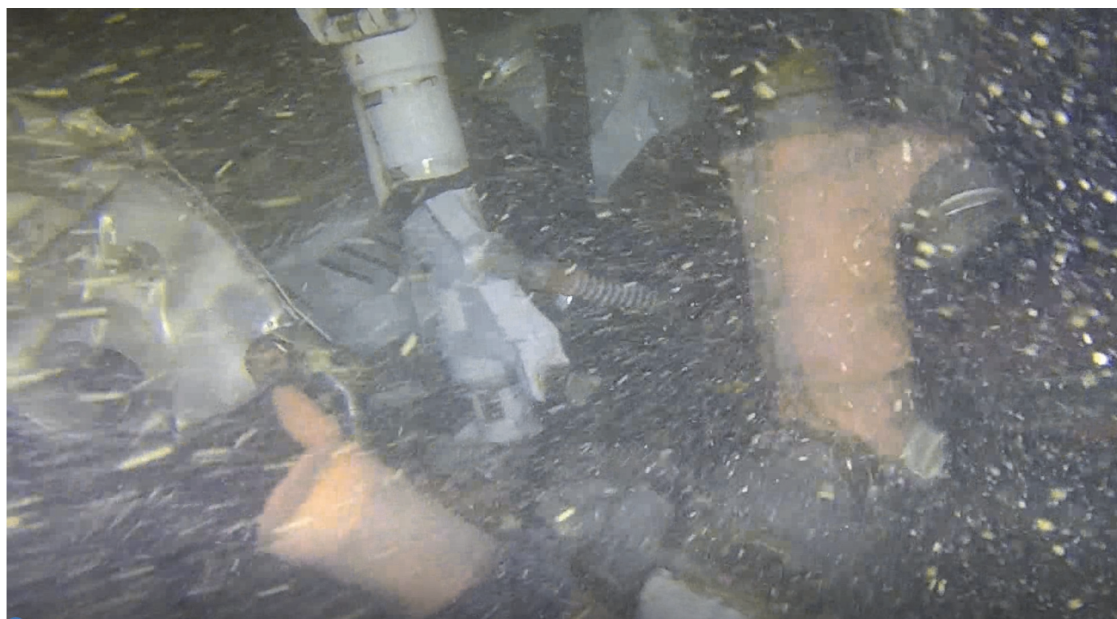
**Figure B-7**

Right tailpipe and heater muff / shroud  
(image taken from video provided by Blue Water Recoveries)

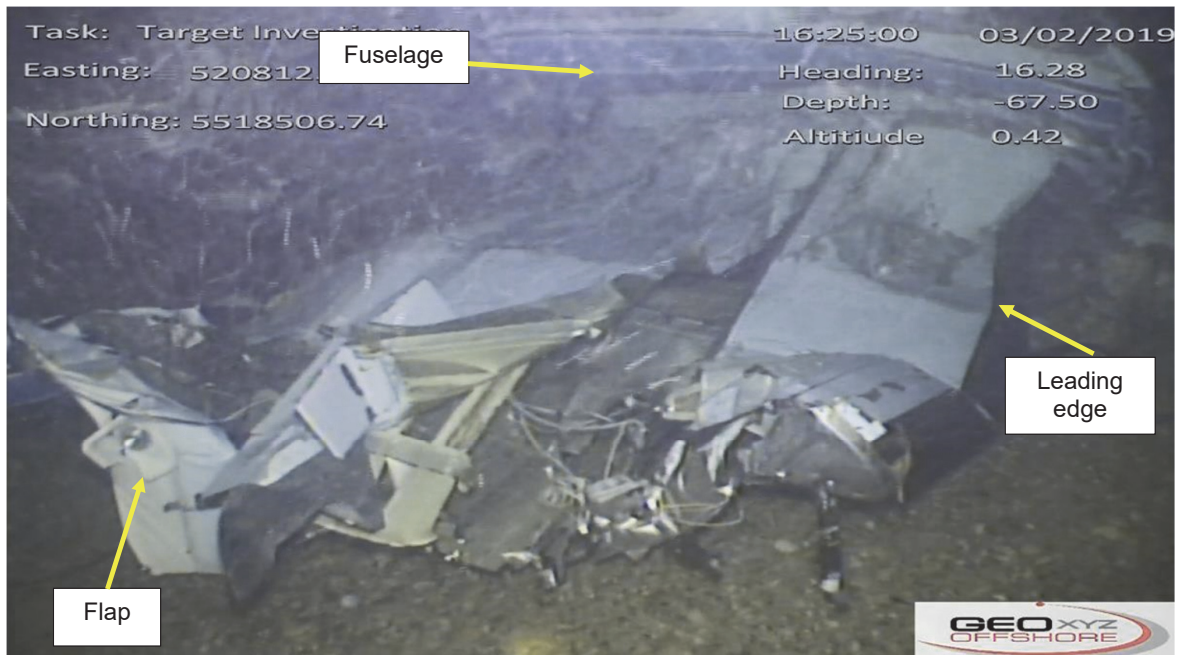
Figure B-8  
Remains of right wing

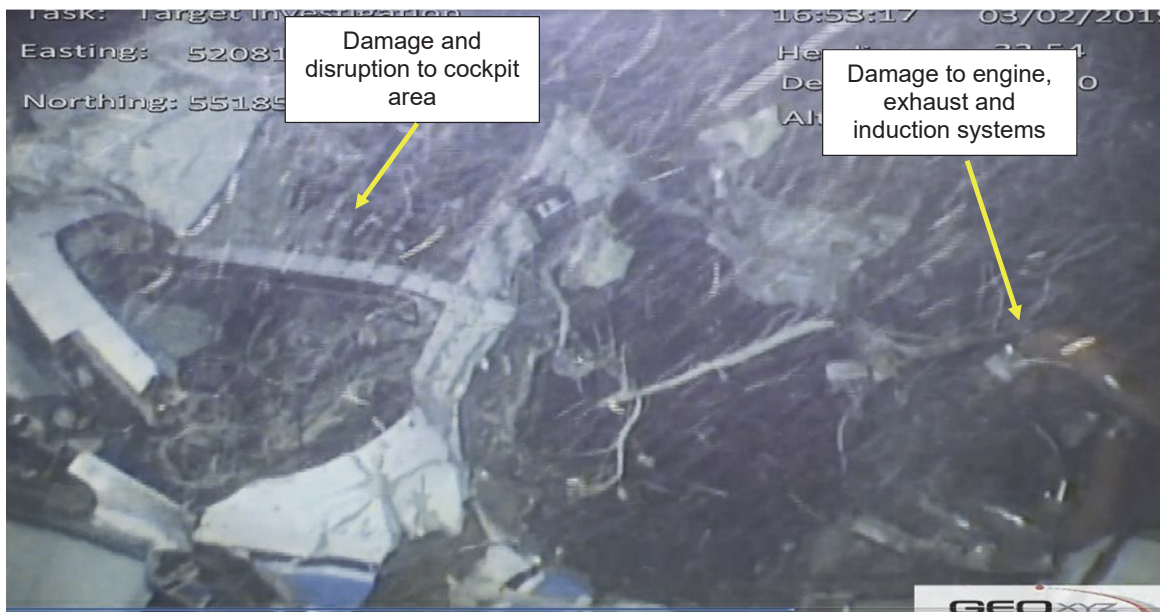
**Figure B-10**  
Disruption to cockpit and engine

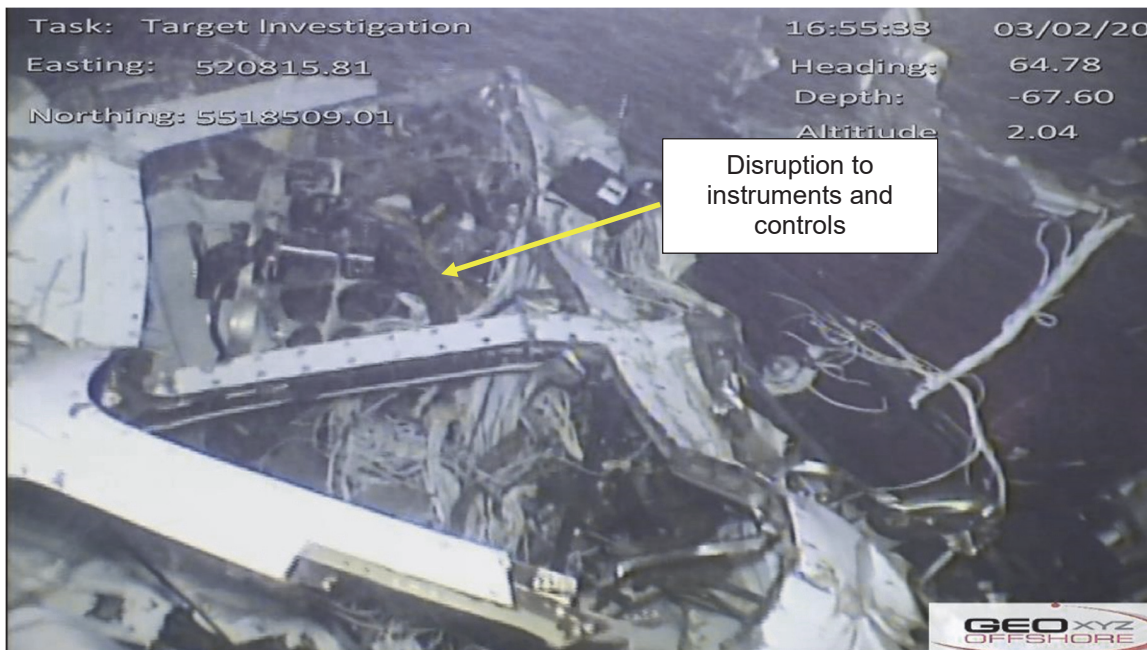
**Figure B-11**  
Damage and disruption to instruments and controls

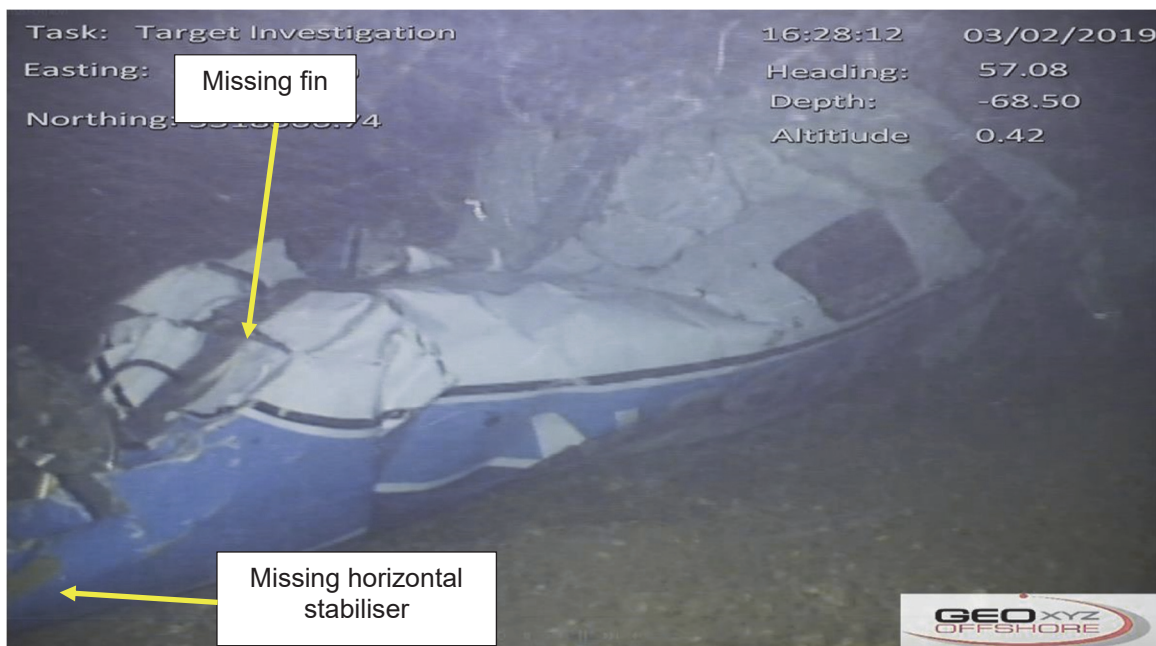
Figure B-12

Missing fin and horizontal stabiliser
