# Air Accident Investigation Sector

- Final Report -

AAIS Case N°: AIFN/0008/2016

## Runway Impact during Attempted Go-Around

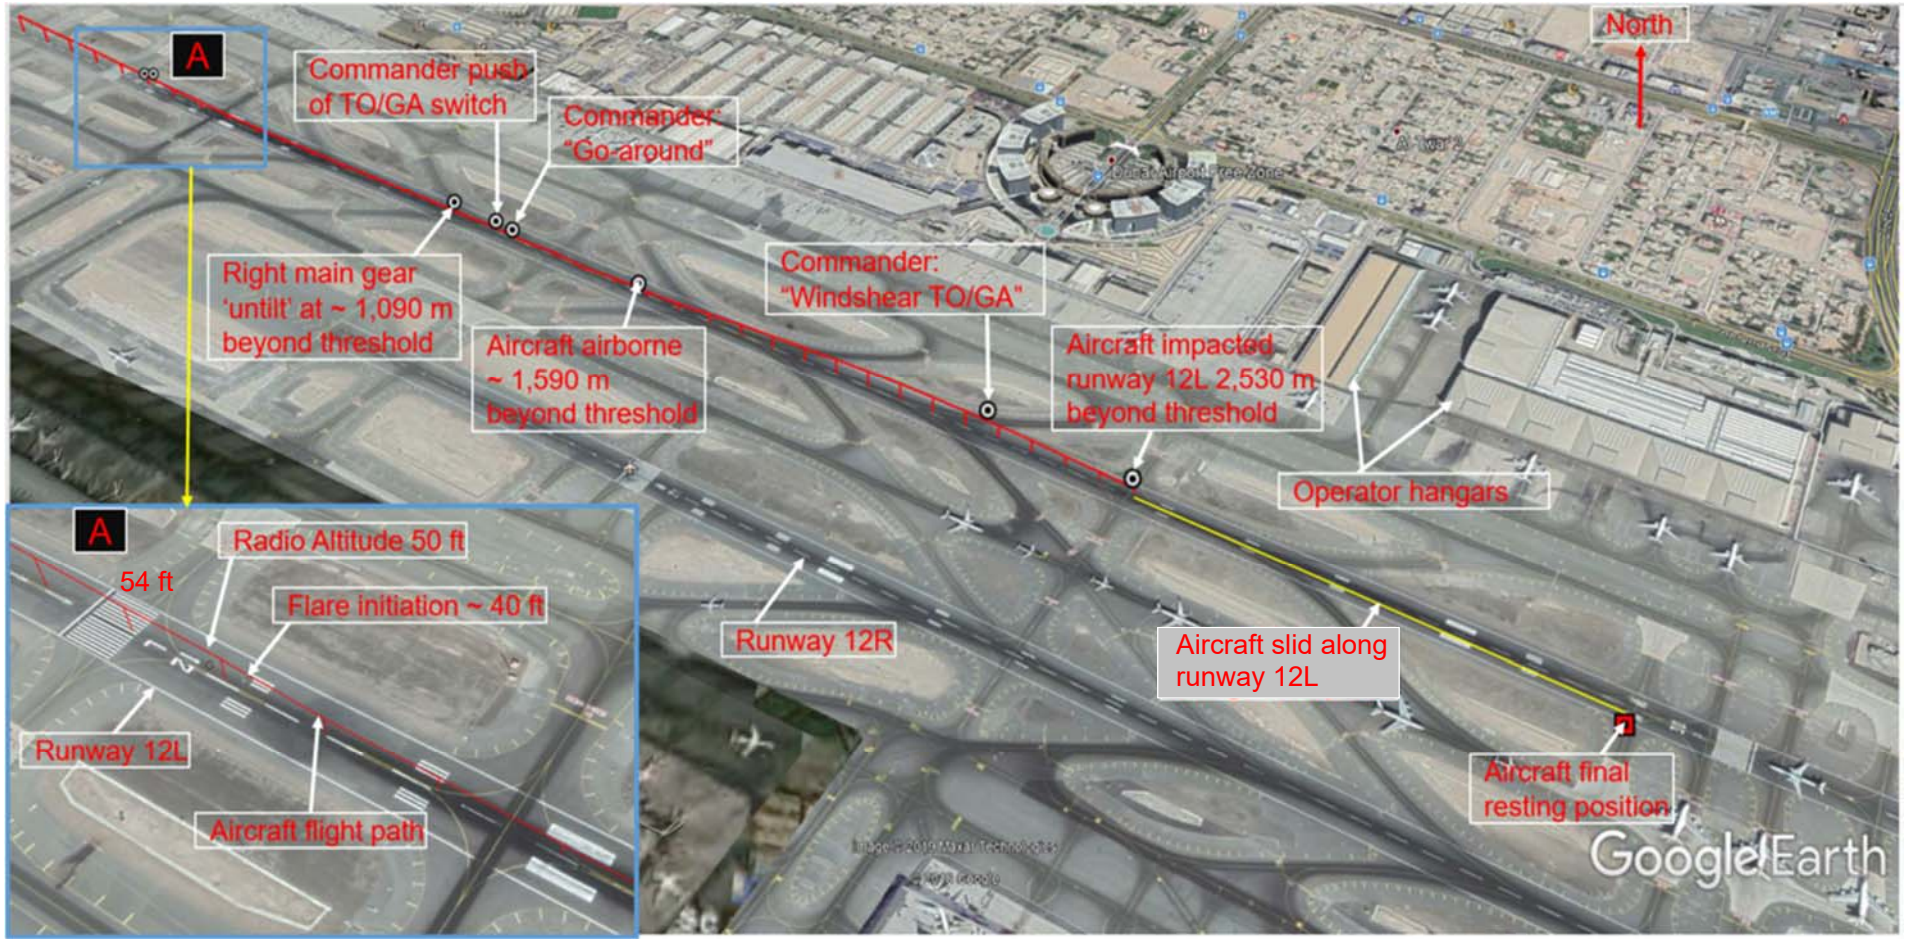
At 0837:16, the Aircraft rolled 3 degrees to the left due to the wind effect and the Commander corrected with right control wheel input of 30 degrees. In response to this input, the resulting right bank of 7.4 degrees caused the right main landing gear to contact the runway approximately 1,090 m beyond the threshold.

The Aircraft sustained substantial structural damage as a result of the impact and its movement along the runway and it was eventually destroyed by fire.

Figure 1. UAE521 flightpath and impact along runway 12L

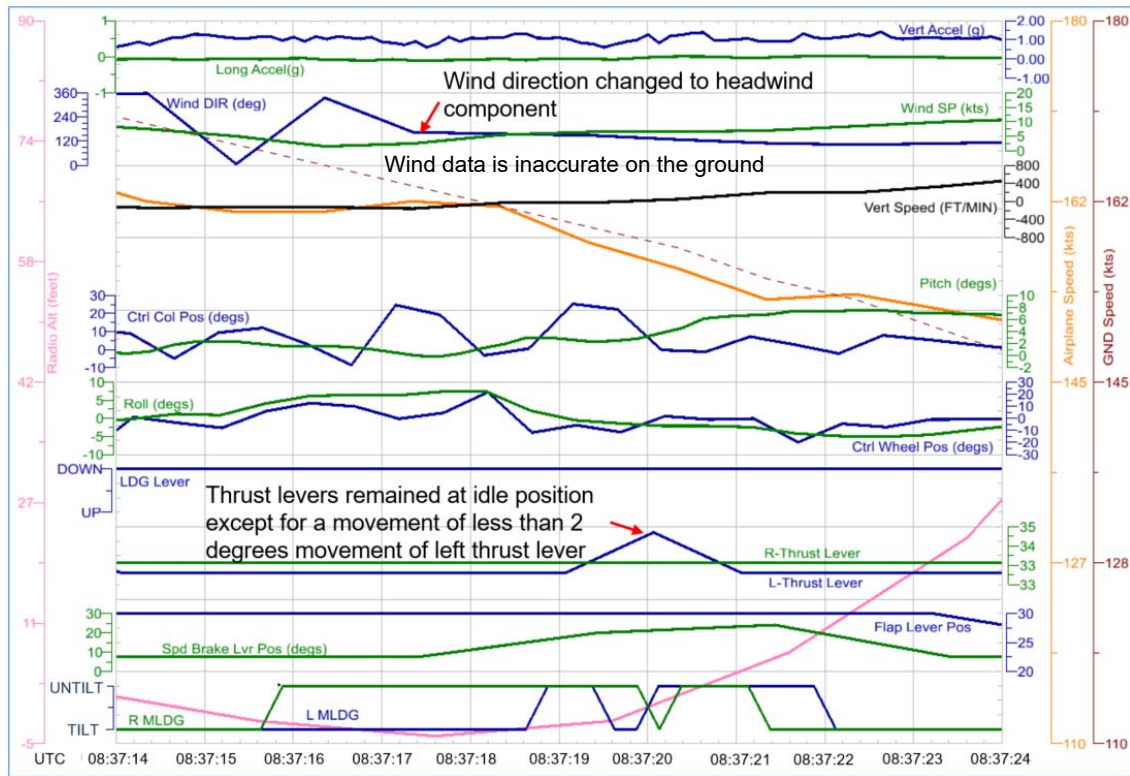
At 0837:18, the FDR indicated the pitch-up angle increasing from 0.8 to 3 degrees. The increase in pitch angle occurred shortly before the Commander called for a go-around, at about 161 kt IAS. The pitch angle oscillated between 3 and 2.3 degrees over the next one second before it continued to increase at a positive rate towards 7.4 degrees, at about 153 kt IAS, with both main landing gear being 'untilt'. The landing gear lever was selected to 'up' at 0837:29 and the Aircraft then continued in 'air' mode with the landing gear being in transit to the up position until impact.

Figure 14. Main landing gear over six seconds of 'tilt' and 'untilt'

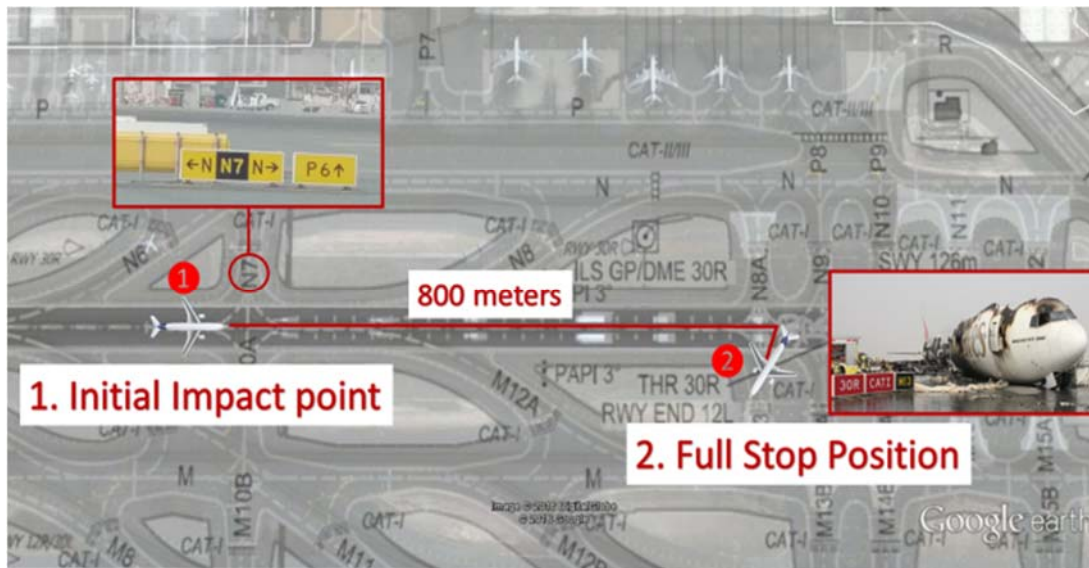
The impact and movement of the Aircraft along the runway caused damage to the runway surface from abeam taxiway November 7 to the final resting point of the Aircraft.

Figure 15. Aircraft Initial impact point and final position

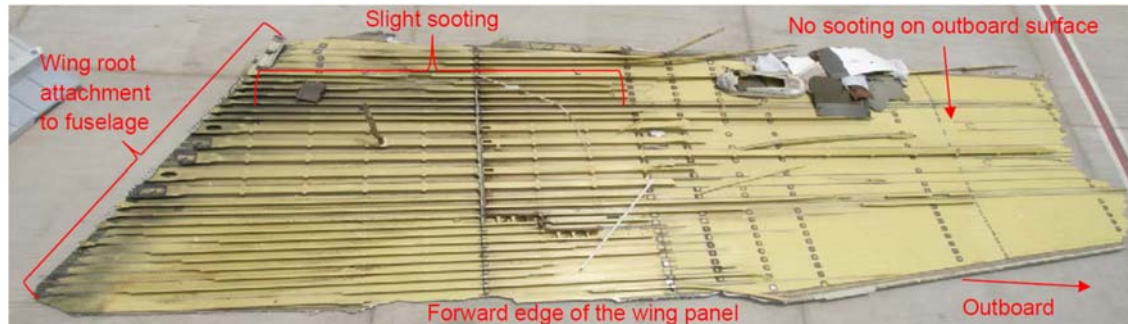
landing gear heating and causing the ignition of the approximately 100 kg of residual fuel in the center wing tank. The explosion caused the right wing upper skin panel of the center wing fuel tank to violently separate (figure 16).

**Figure 16.** Upper skin panel from right wing

The direction of the explosion pressure wave was from the center wing tank towards the right main wing tank. This resulted in a large section of the upper wing skin from the inboard right wing, approximately 15 m in length and the width of the upper wing surface, being separated with such force that it landed behind the right wing on the tarmac approximately 5 m from the wingtip. The wing skin panel separated from wing buttock line station (WB) 123.124 to wing station (WS) 732 (Rib 21). In addition, the explosion also caused the cabin floor over the center tank area to lift which provided a path for fire and smoke to enter into the passenger cabin.

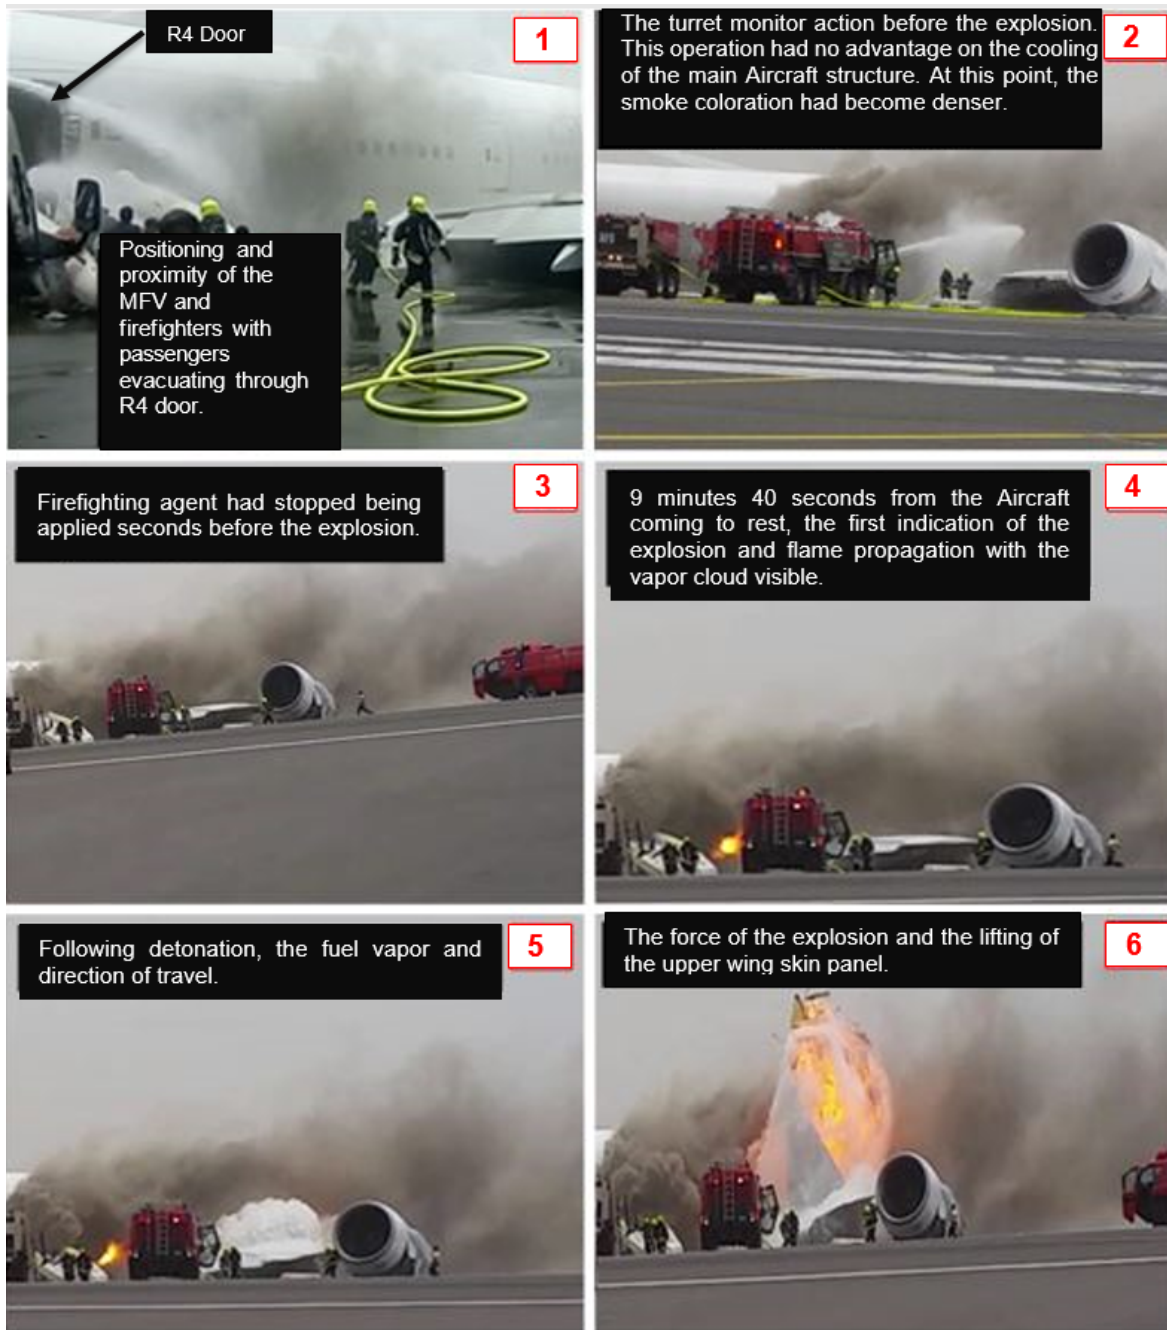
Figure 17 illustrates the sequence of events before and after the explosion.

Figure 17. Center wing fuel tank explosion

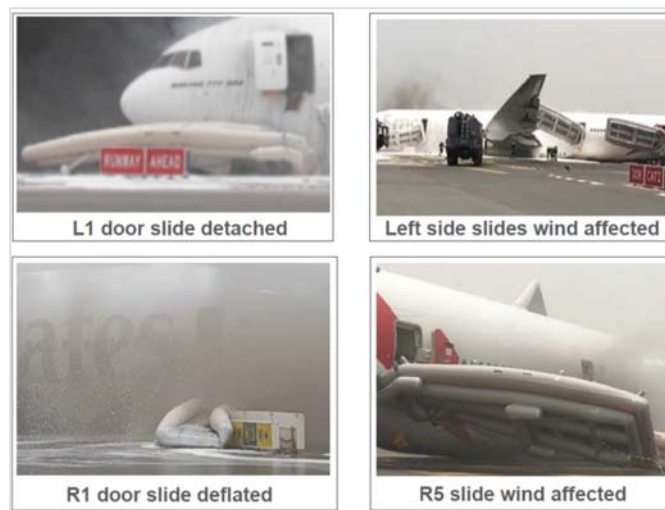
Figure 18. Door escape slides after deployment

Figure 18 illustrates the condition of the some of the door escape slides during the evacuation.

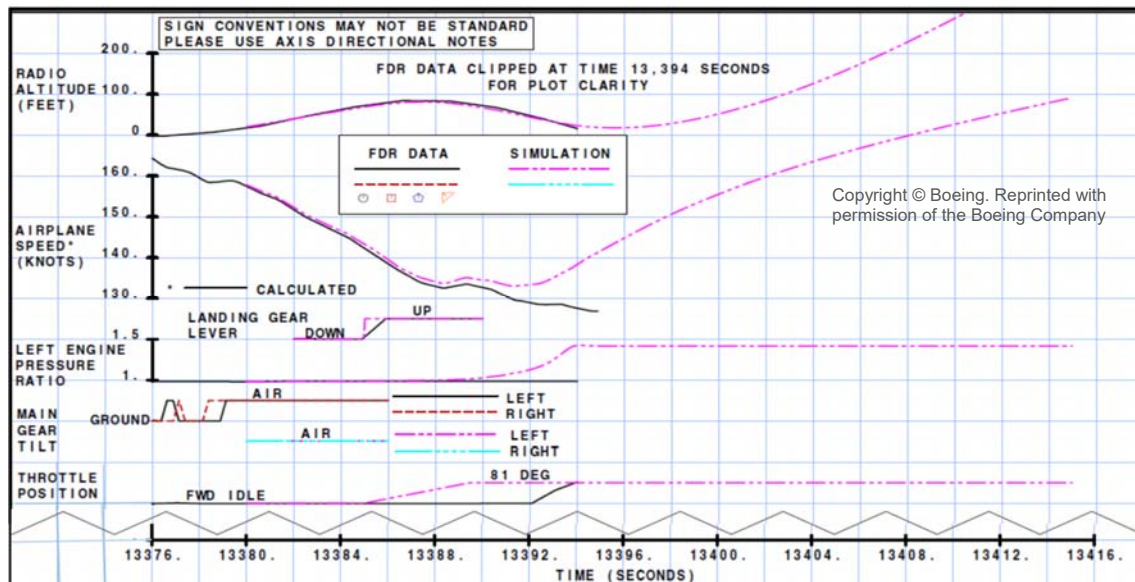
For UAE521, the actual thrust lever increase, which was a manual advancement by the Commander at 13,392 seconds FDR time, was performed fifteen seconds after the Commander called for a ‘go-around’.

**Figure 21. Calculated go-around after TO/GA switch push** [source: Boeing]

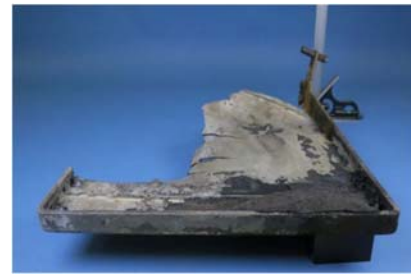
The L1 cabin crew seat parts recovered from the Aircraft were sent to the NTSB materials laboratory in Washington, DC, the United States. The examination found that the left seat pan lever was twisted outwards at the attachment location of the seat pan lever stop and lower back pivot. The left lower back pivot stop bolt (figure 22), attached to this lever, was found bent. The lower back pivot stop bolt hole (figure 23) of the right seat pan lever was found elongated with a plastic deformation of base material.

Figure 22. L1 cabin crew seat pan and left lever distortion [Source: NTSB]

From these findings, the Investigation concluded that the right lower back pivot stop bolt, most likely, fractured due to a force generated by the Aircraft impact. This caused the right seat pan base to be released, and the left lower back pivot stop to be extracted from its position, completely folding the seat base down.

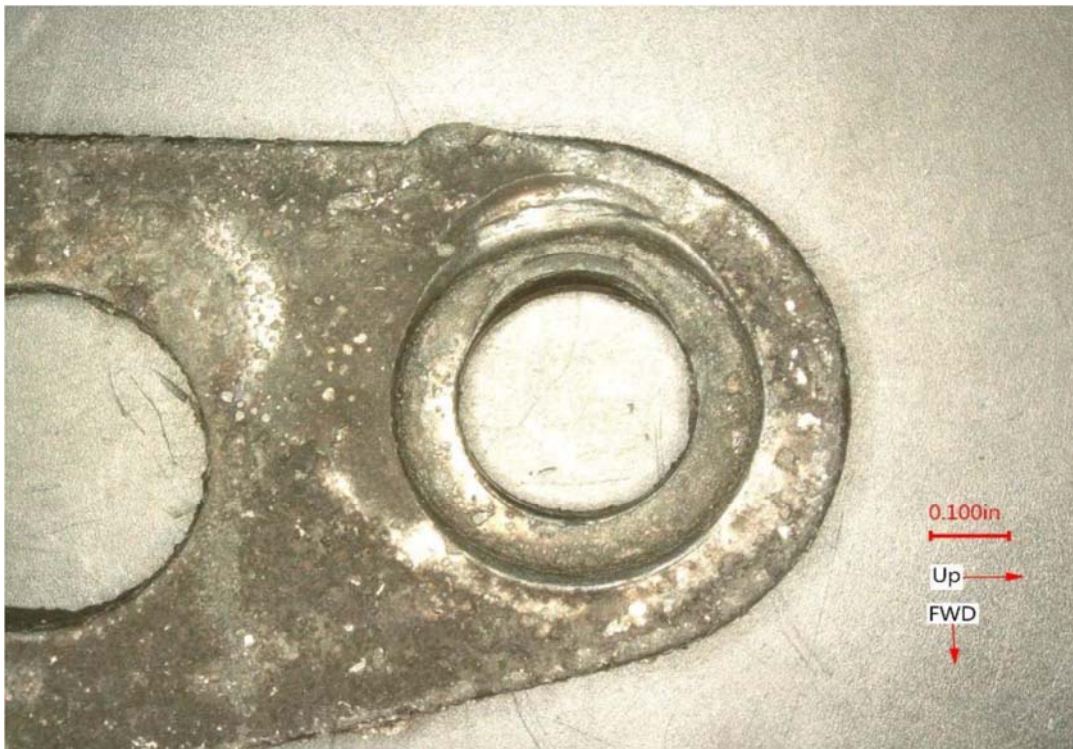
Because the weight of the cabin crewmember was similar to that used for certification conformity test<sup>24</sup>, the impact force most likely exceeded the cabin crew seat design limitations with its certified static 6g downward force, and 14g canted at 30 degrees dynamic downward force.

Figure 23. L1 cabin crew seat pan hole elongated [Source: NTSB]
