PB93-910408
NTSB/AAR-93/07

AIRCRAFT ACCIDENT REPORT

INADVERTENT IN-FLIGHT SLAT DEPLOYMENT
CHINA EASTERN AIRLINES FLIGHT 583
McDONNELL DOUGLAS MD-11, B-2171
950 NAUTICAL MILES SOUTH OF SHEMYA, ALASKA
APRIL 6, 1993

Adopted: October 27, 1993
Notation 6180

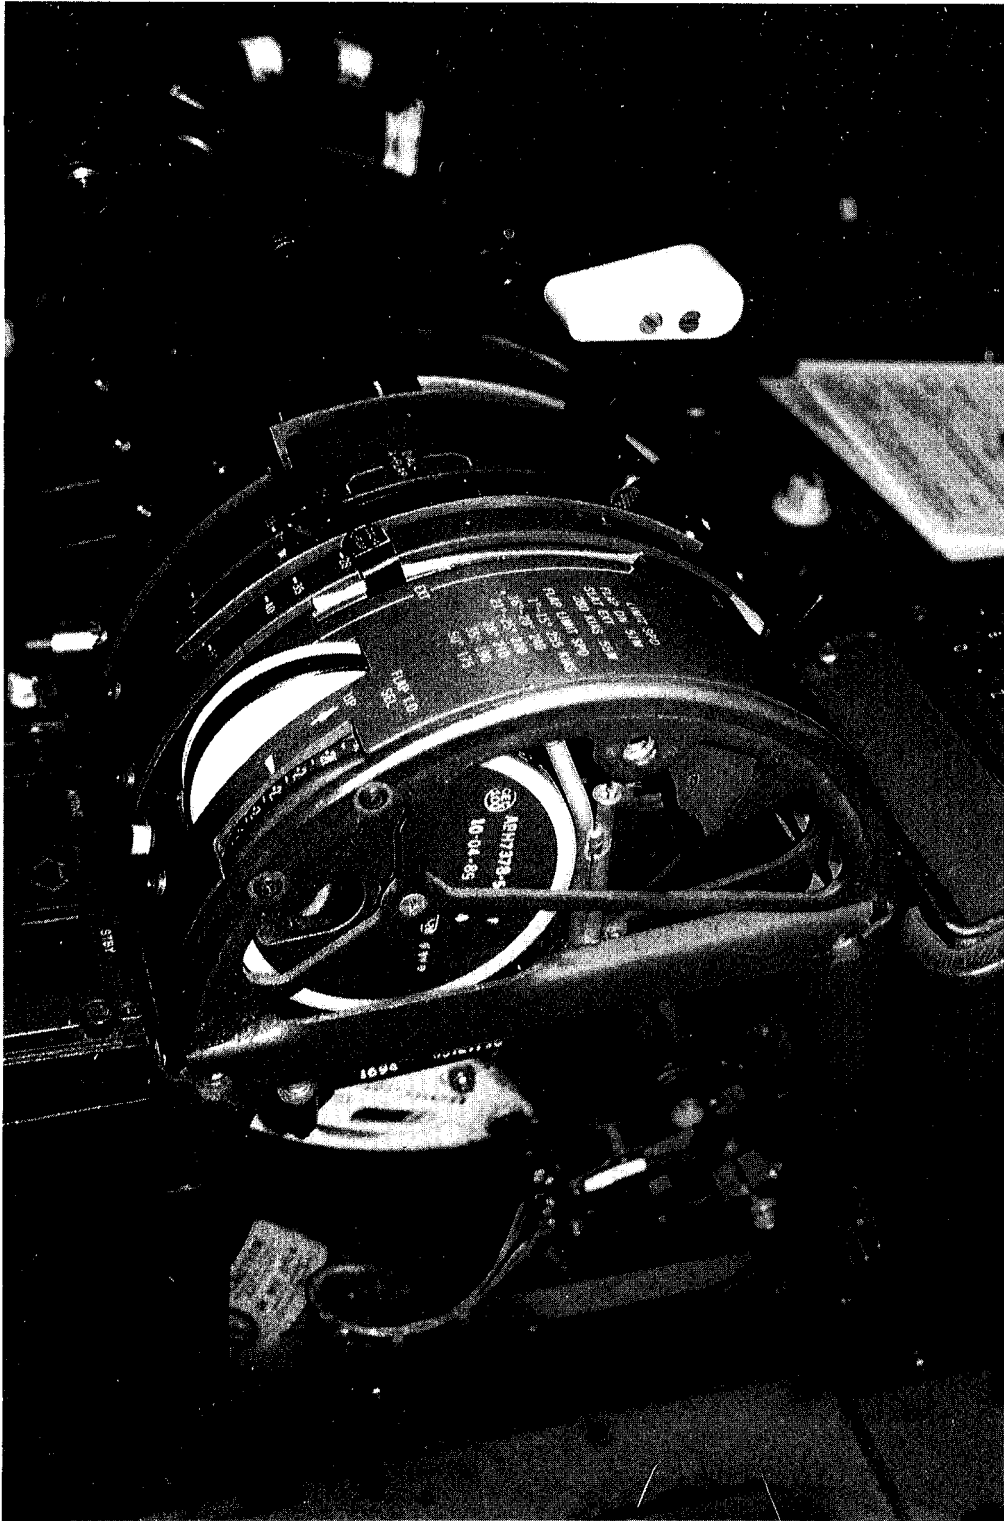
Figure 5.--Closeup view of flap/slat handle in cockpit.

The flap/slat handle was found to operate normally through its range of movement. Examination of the slat stow lever revealed that when the lever was pushed forward (the disconnect position), then released, the lever did not return to its normal position.⁷ The lever was operationally tested several times, and it was determined that it could not be manipulated in such a manner that would cause or permit an uncommanded slat extension.

All slat-related control valves and inter-related systems were examined, functionally tested and found normal. The flap/slat handle module was examined and found to be operational within design limits, with the exception of the slat stow lever. The installation, normal and autoslat extension systems were also found to be correct and capable of normal operations.

The SB recommended that the zero degree detent gate in the flap module be modified with a zero degree detent gate to minimize the possibility of an uncommanded slat extension. The SB was mandated by the issuance of FAA Airworthiness Directive 92-13-03.

DAC recommended the installation of a protective cover over the zero degree detent gate of the flap/slat handle. The modification was prompted by an uncommanded extension of the slats when the pilot on an airplane that had been modified per S/B 27-18, depressed the zero degree detent gate while the flap/slat handle was stowed in the retract detent.

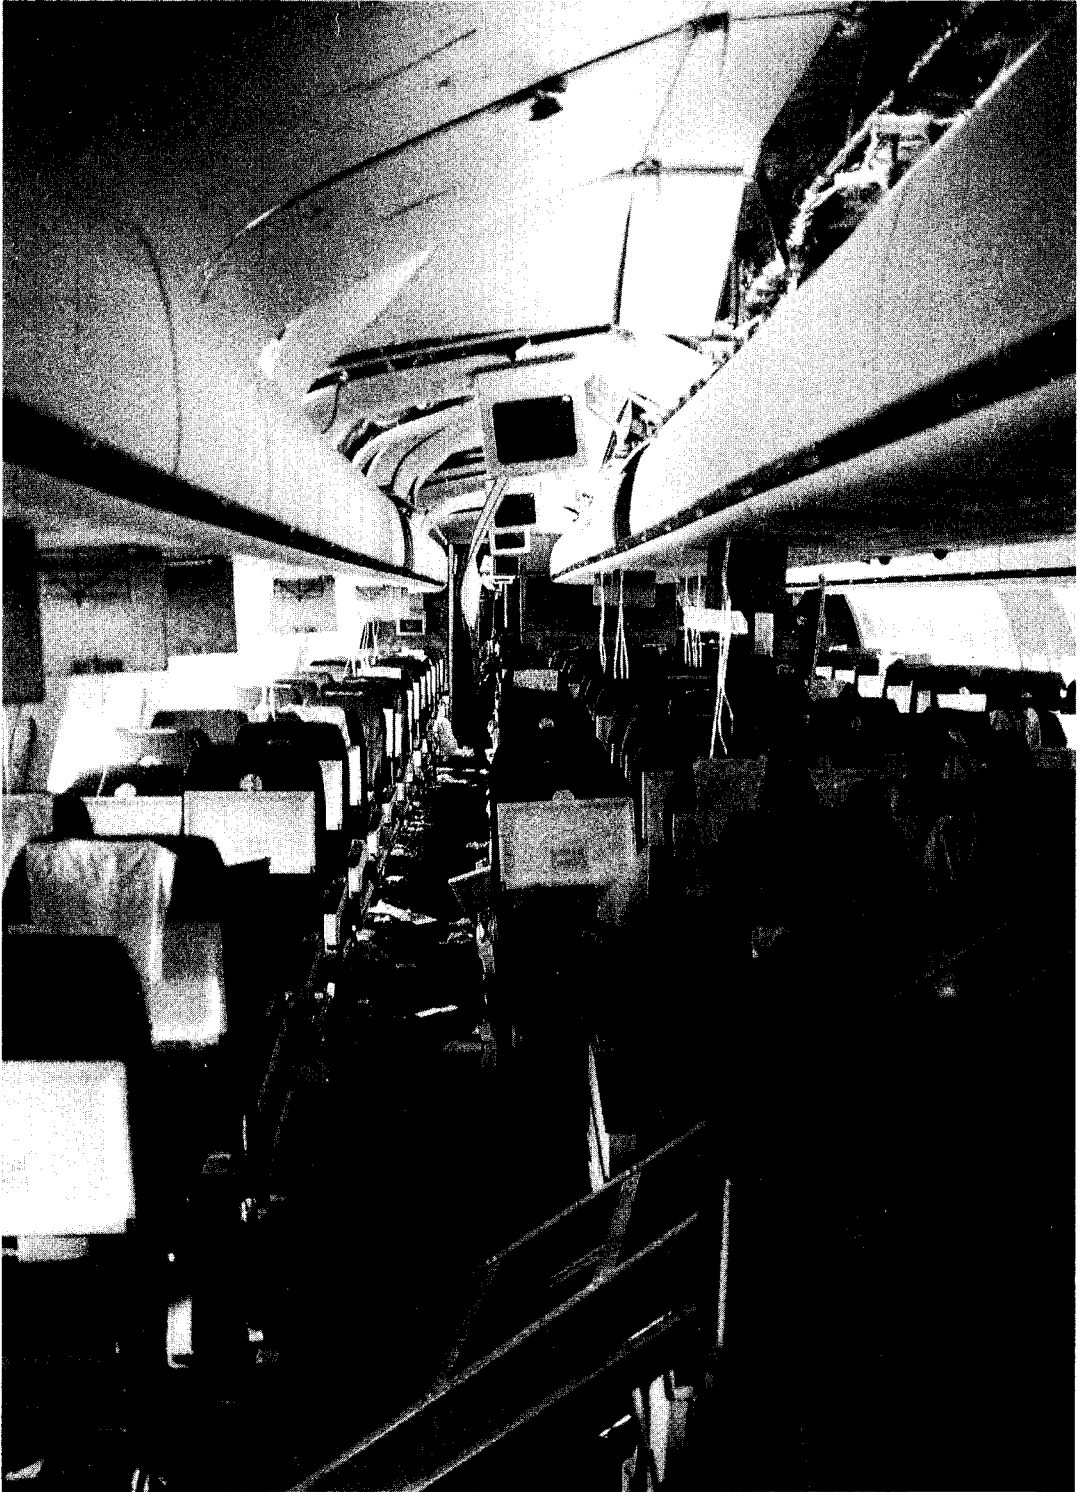
Figure 7.--Passenger cabin interior.

The primary damage occurred to the interior structure and seats in the coach class section. The damage to the passenger seats ranged from slight deformation to distortion and/or complete collapse of the seat arm rests and seat backs. (See figure 7).

Several passenger service units (PSUs) in the coach class section sustained impact damage when they were struck by passengers. The damaged PSUs had been displaced or pushed up into their mounting structure. Twenty oxygen masks, in various parts of this cabin section, were found deployed as a result of damage to the PSUs.

Numerous ceiling panels in the forward coach cabin and all of the ceiling panels in the aft cabin of the coach section were damaged, and some were displaced upward against their support frames. About 80 percent of the ceiling cross beams, which support the ceiling panels in the aft section of the airplane, were found crimped, separated or bent.
