# Aviation Investigation Final Report

<b>Location:</b>	Daytona Beach, Florida	<b>Accident Number:</b>	ERA18FA120
<b>Date &amp; Time:</b>	April 4, 2018, 09:53 Local	<b>Registration:</b>	N106ER
<b>Aircraft:</b>	Piper PA28R	<b>Aircraft Damage:</b>	Destroyed
<b>Defining Event:</b>	Aircraft structural failure	<b>Injuries:</b>	2 Fatal
<b>Flight Conducted Under:</b>	Part 91: General aviation - Instructional

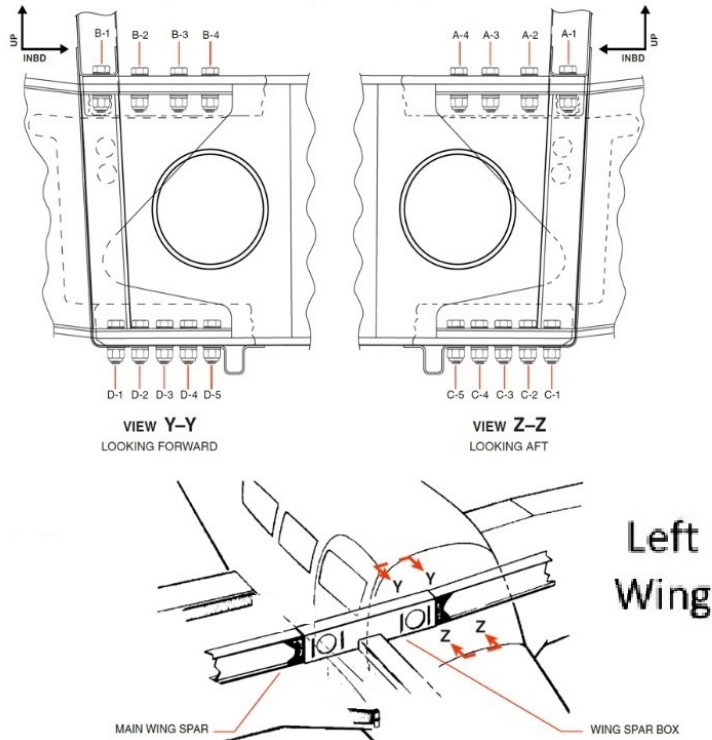
Figure 1. Diagram showing forward and aft side of wing main spars and associated attachment bolt designator map

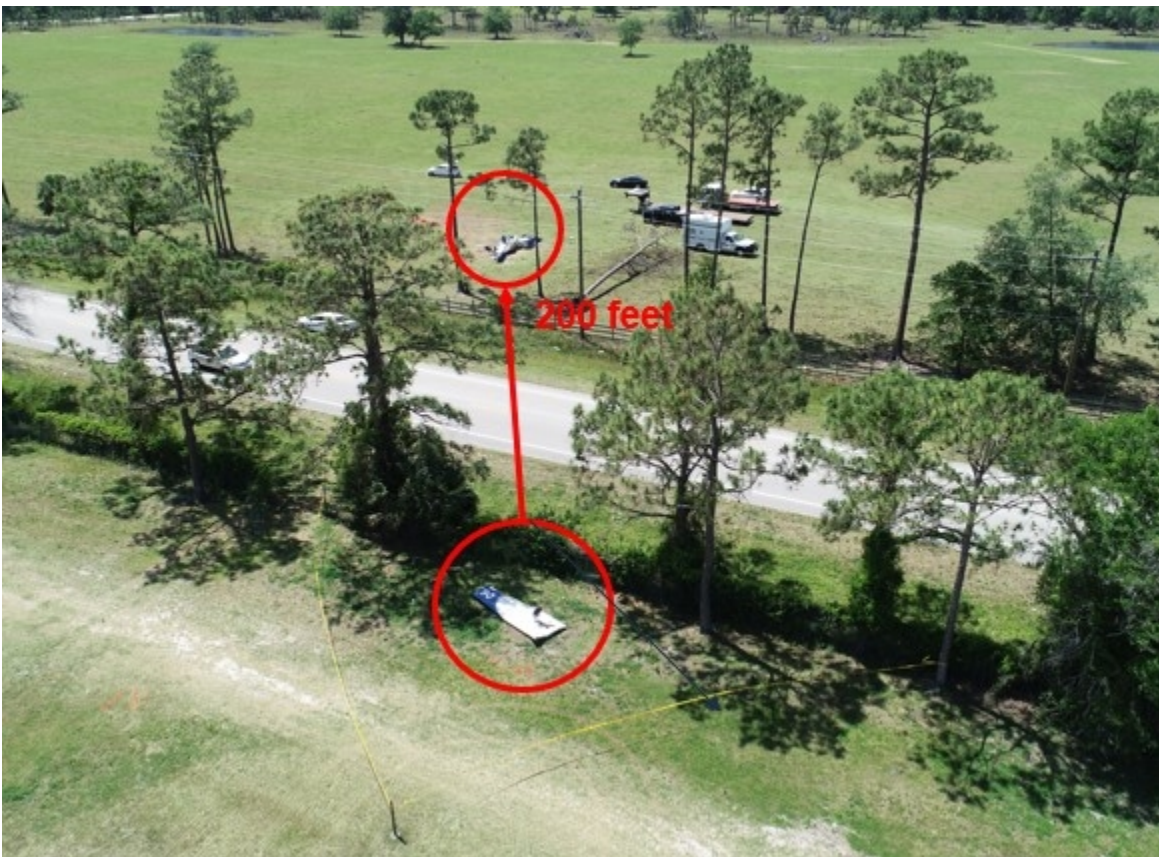
The debris path was about 570 ft long and began about 2 sm southwest of the departure end of runway 25L. The first items discovered along the debris path were a rubber wing root seal and fractured window plexiglass; the left wing was discovered 270 ft farther southwest adjacent to a road and tree line. About 200 ft from the wing on a magnetic heading of about 230°, the main wreckage rested in an adjacent field on the opposite side of the road (see figure 2).

Figure 2. Photograph (looking toward the southwest) showing the separated left wing in foreground and main wreckage in background

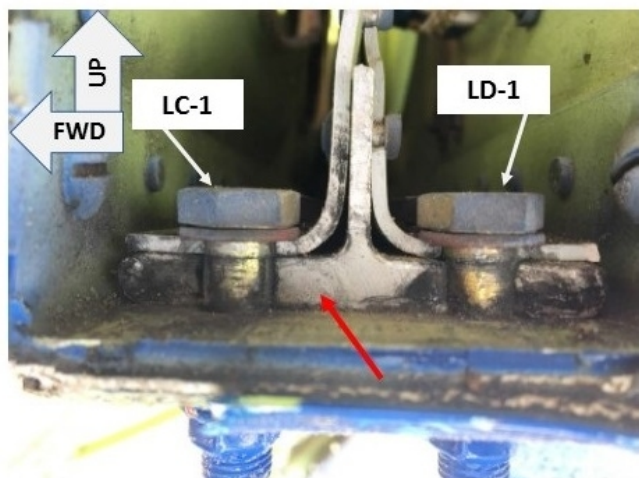
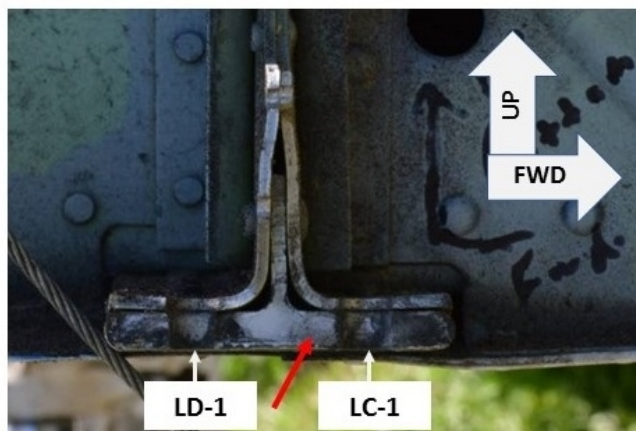
On-scene visual examination of the left-wing main spar found indications of a significant fatigue crack. Further analysis at the NTSB's Materials Laboratory found that more than 90% of the main spar lower cap and portions of the forward and aft spar web doublers exhibited fracture features consistent with metal fatigue (see figure 3). The remainder of the main spar lower cap, spar web doublers, and upper spar cap displayed fracture features consistent with overstress fracture. The fatigue features originated at or near the outboard forward wing main spar attachment bolt holes LC-1 and LD-1.

Figure 3. Left-wing main spar lower cap inboard side of the fracture (left frame) and outboard side of the fracture (right frame) with red arrows highlighting areas visually inspected on scene that showed fatigue regions

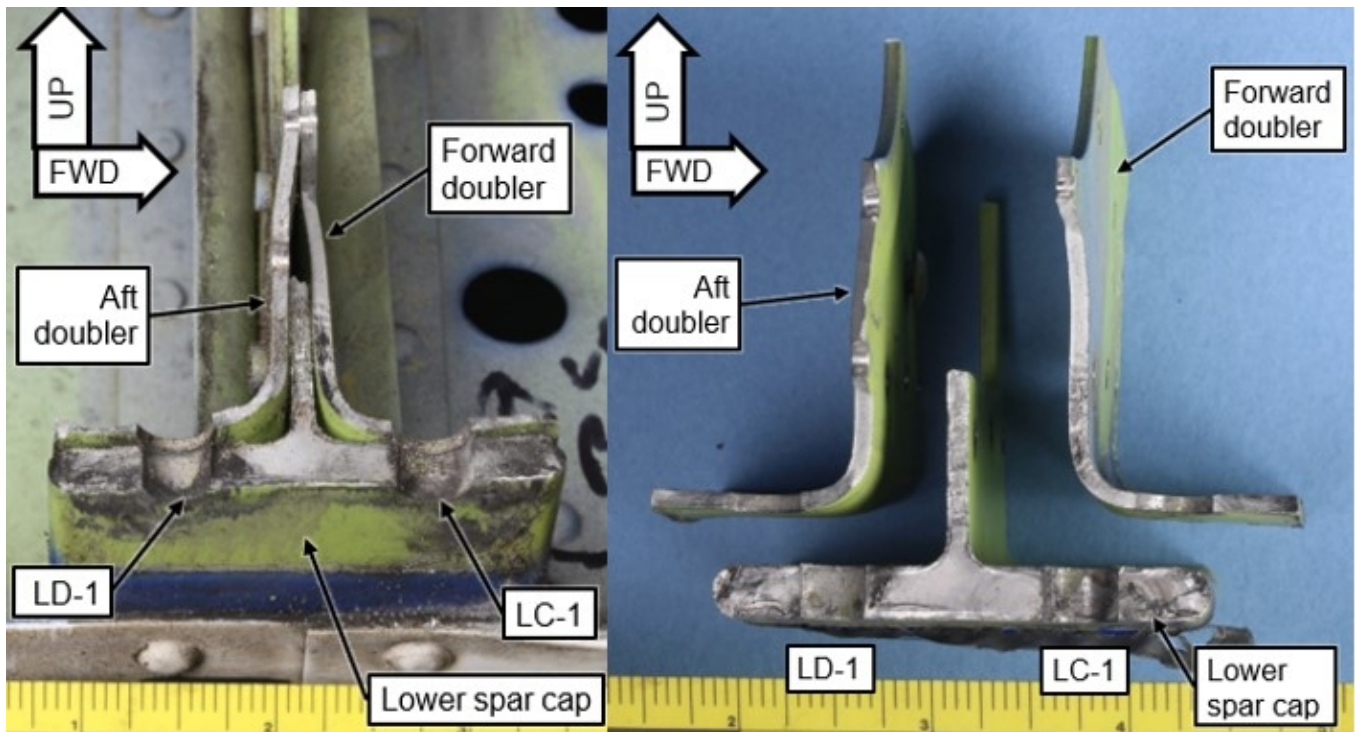
The left-wing main spar lower cap (shown in figure 4) had a fracture that intersected holes for attachment bolts LC-1 and LD-1. Portions of the fracture surface had relatively smooth features in a transverse plane, which is consistent with fatigue fracture. Crack arrest lines were visible on the fracture surfaces of the main spar lower cap and on the forward and aft doublers, also consistent with fatigue fracture. The upper spar cap displayed rough matte gray features consistent with ductile overstress fracture. Deformation associated with the fracture in the upper spar cap was observed, consistent with an upward bending load.

Figure 4. Photographs showing pieces of the accident left-wing main spar lower cap and doublers before (left) and after (right) sectioning and rivet removal to facilitate examination.
