A1. Factual information

A1.12 Information on the wreckage, impact and accident site

A1.12.3 Technical findings on the wreckage

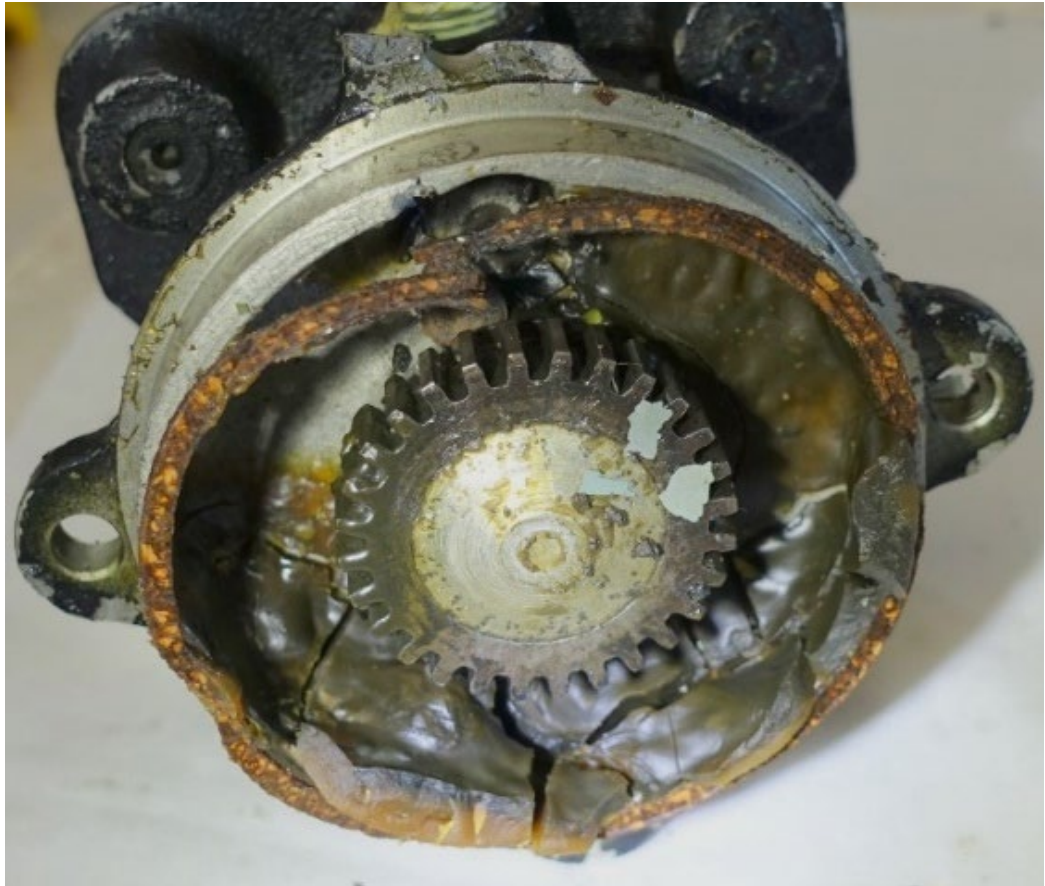
The electric fuel pumps had not been in operation for several years. The fuel therefore did not flow through the pump body but through the bypass. Both pumps were found to have solidified grease in them after dismantling and defective seals due to their age (see figure 32).

Figure 32: Electric fuel pump gear.

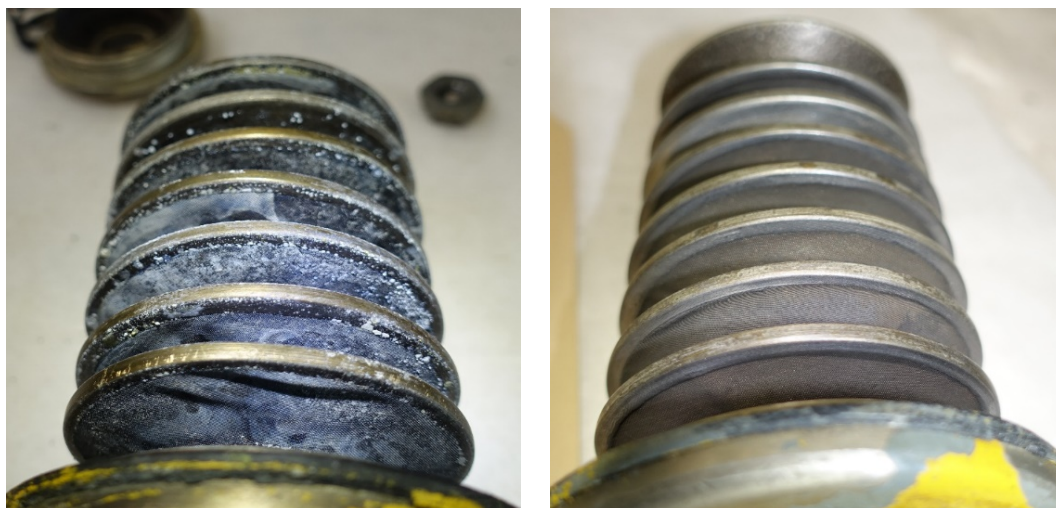
Each outer wing was fitted with a fuel filter. However, following the accident, it was not possible to determine which one they had come from. While one set of filter elements was clean, the other set was found to be heavily contaminated (see figure 33). According to the technical files, these filters were last checked and cleaned on 19 June 2018, some 42 flight hours before the accident. The manufacturer's operating instructions stipulate that the filters must be checked every ten flight hours.

Figure 33: Fuel filter elements.

From the different condition of the two fuel filters and the fact that all tanks were filled with the same fuel, it can be concluded that the contamination did not originate from the fuel. The nature of the contamination in the one fuel filter indicates that deposits from one of the tank systems had led to the contamination.

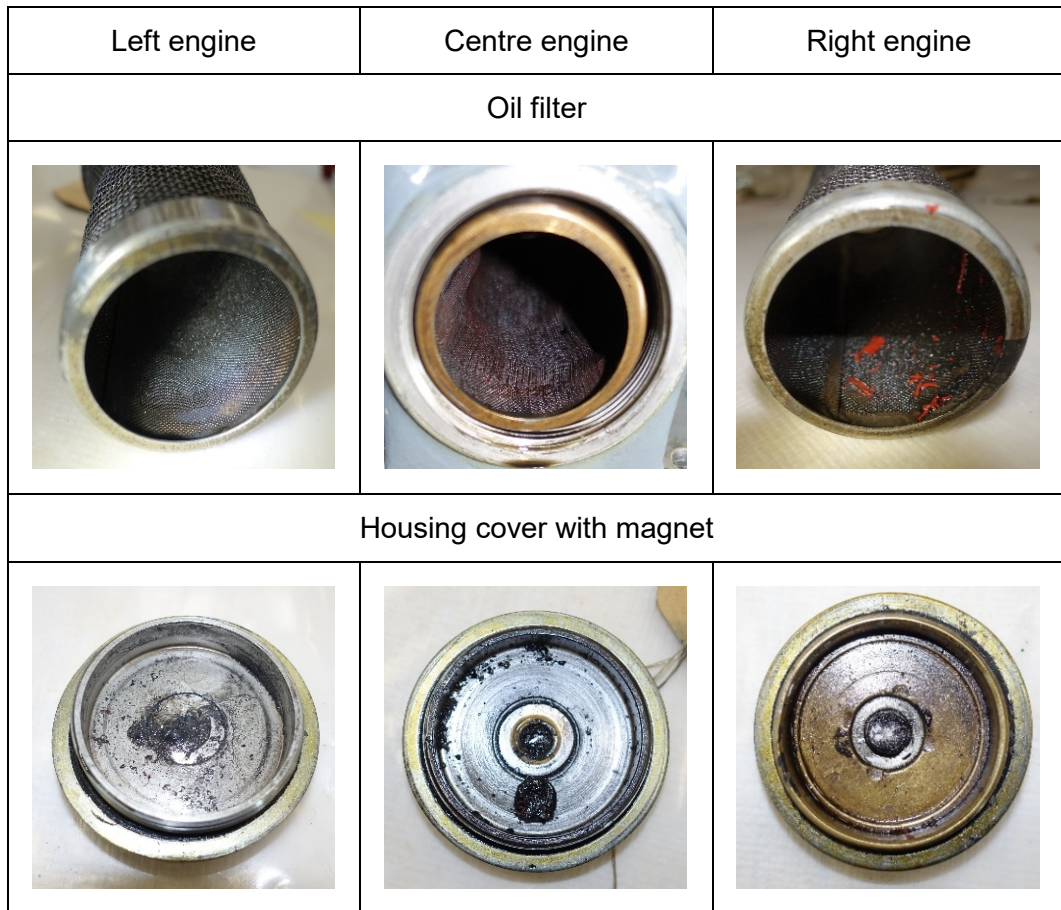
Each engine had an oil filter, which was fitted with a magnet in the housing cover (see figure 34). Loose pieces of red sealing compound were found in the oil filter element of the right engine. Metallic debris was found in all of the oil filters.

Figure 34: Oil filter and housing cover with magnet from all three engines.

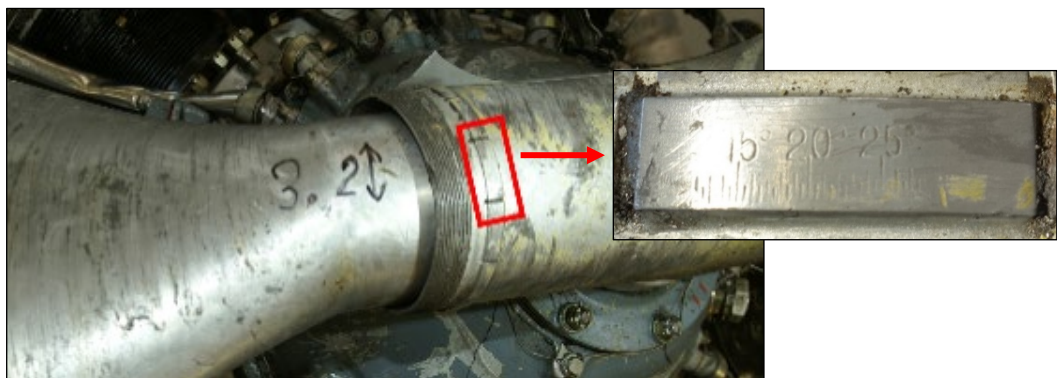
Upon removing the anti-corrosion paint, an adjustment scale became visible on the propeller hubs (see figure 35), which is intended to be used to adjust the pitch of the blades once they are installed on the aircraft. The maintenance team had no knowledge of this scale.

Figure 35: Adjustment scale on a propeller hub.

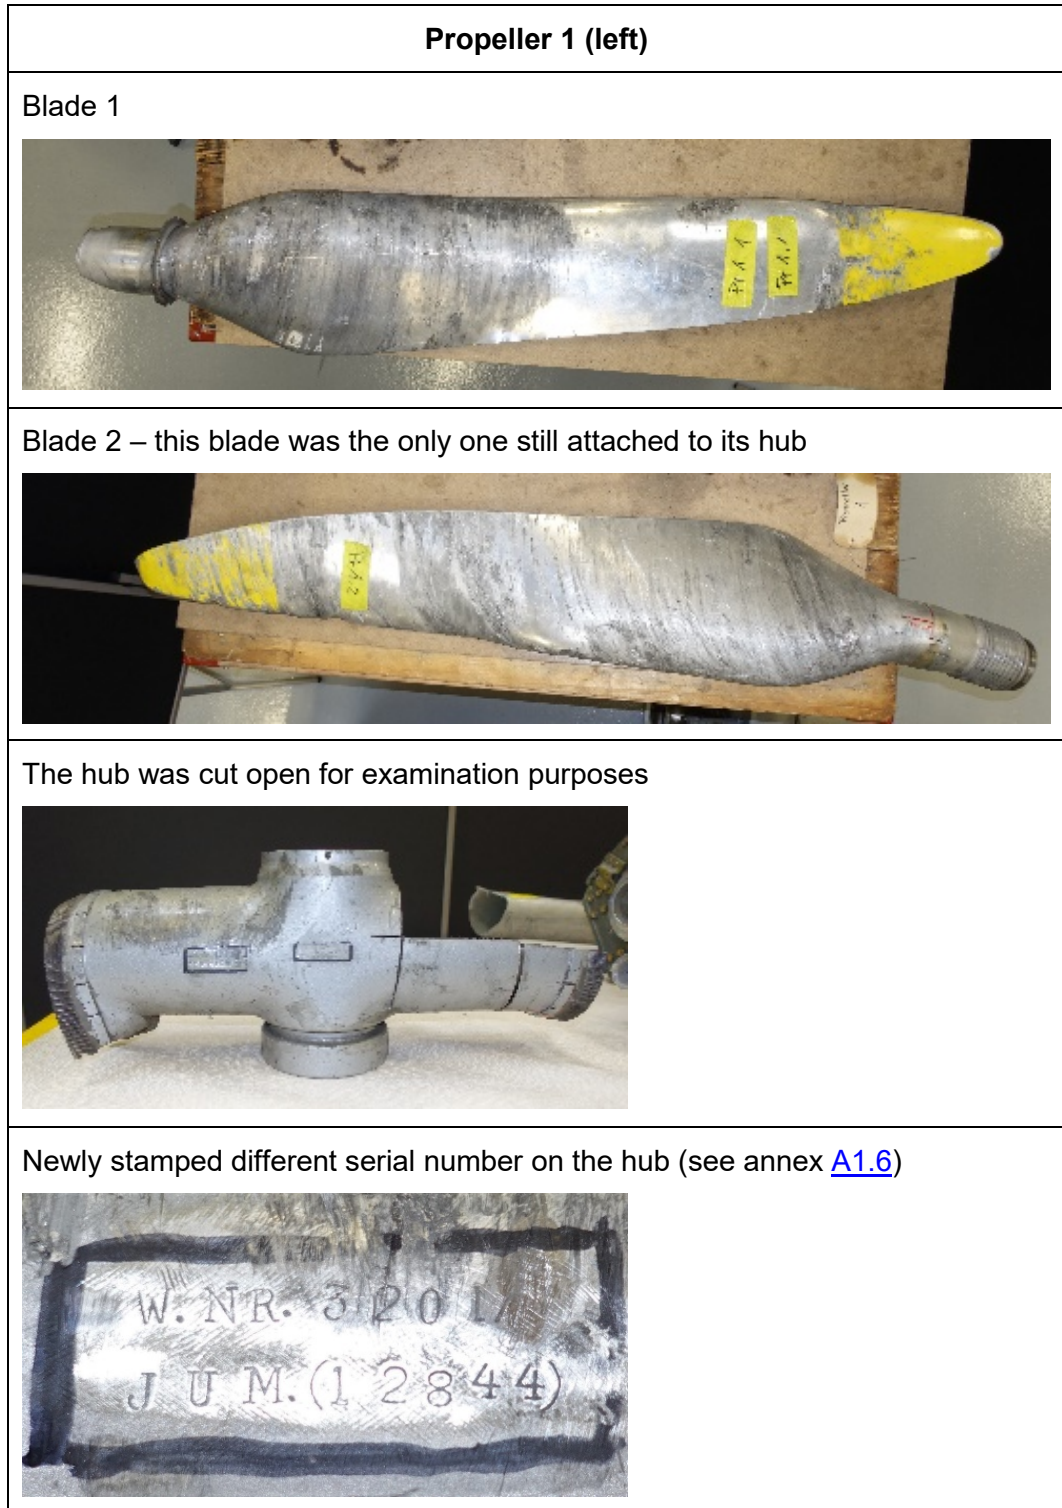
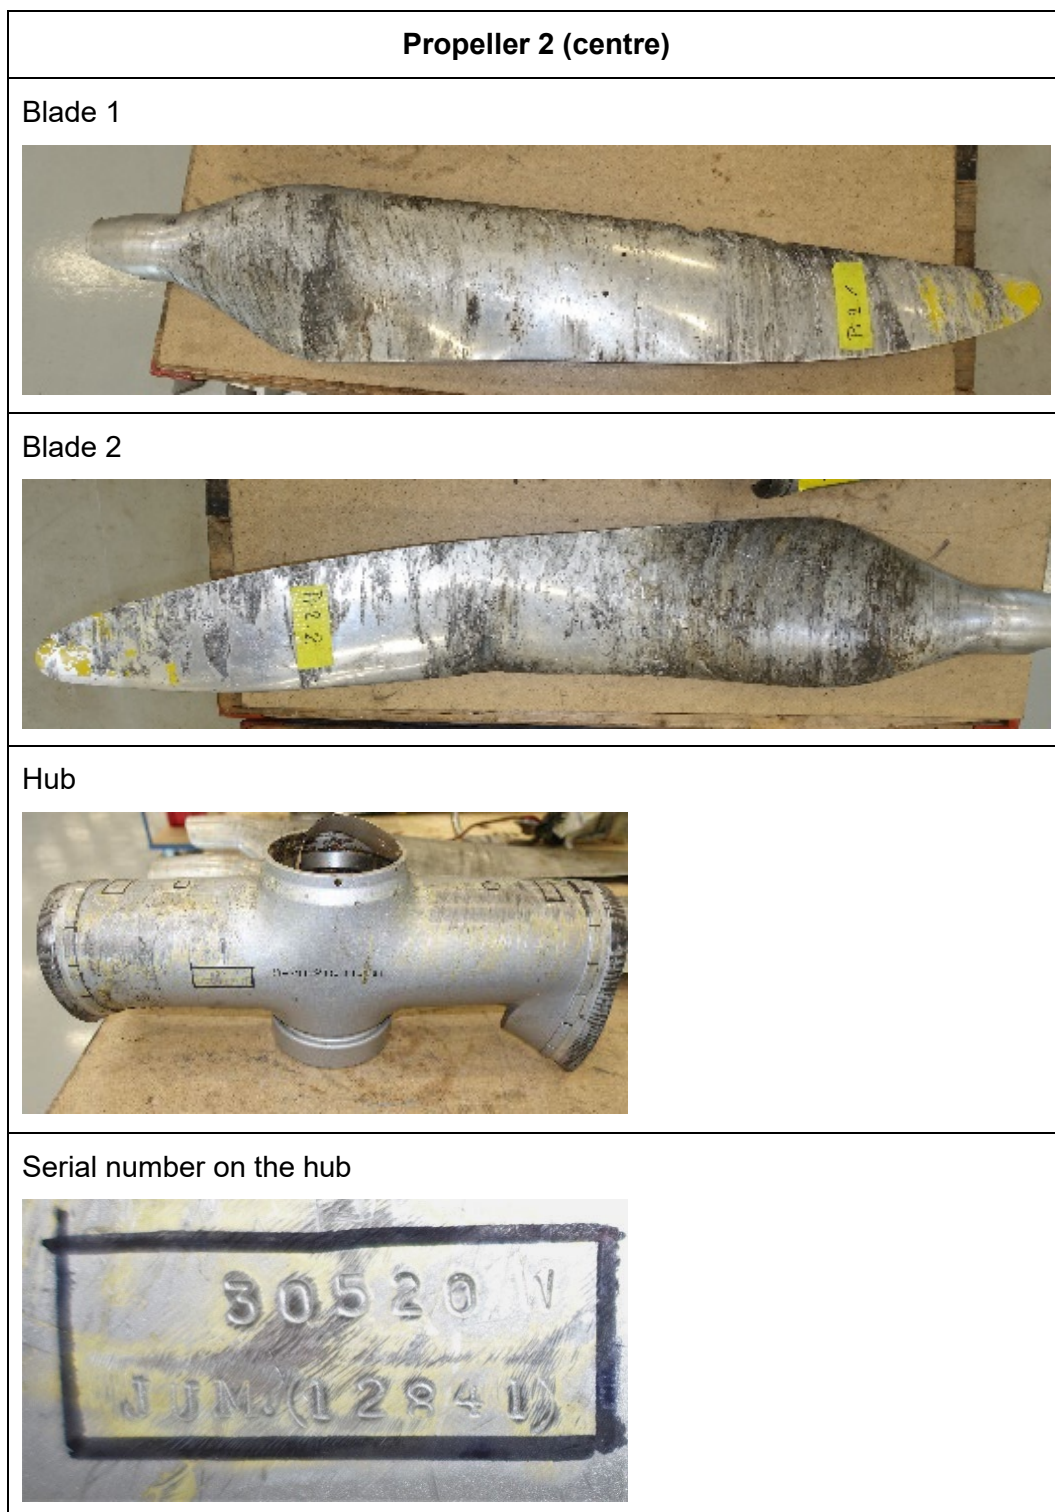
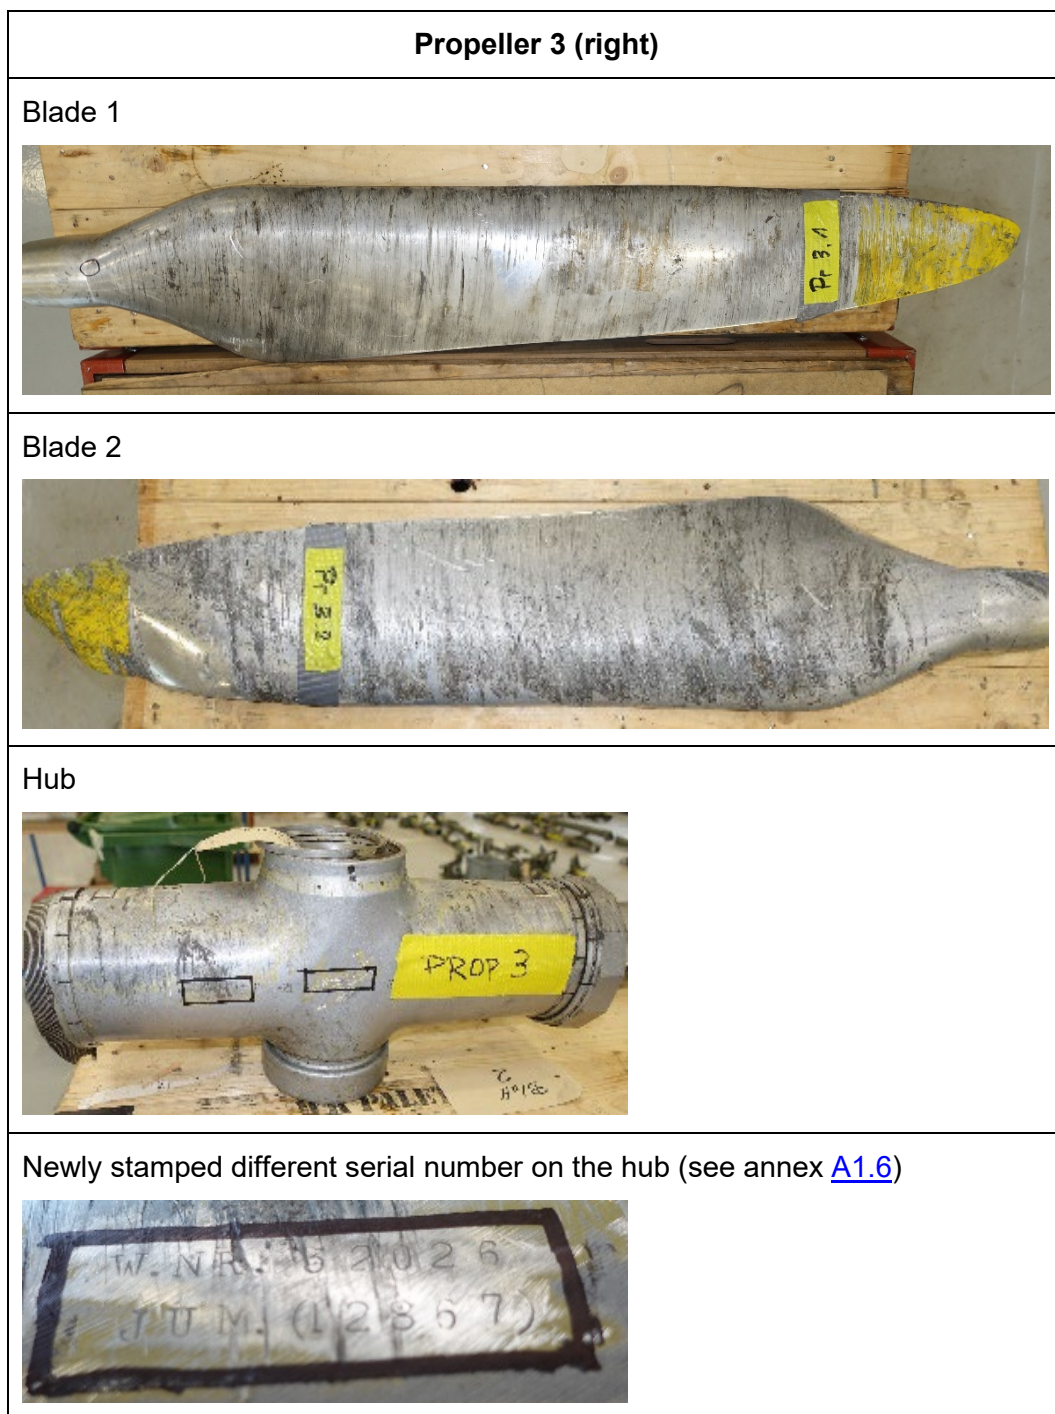
Blade 2 of the left propeller was still attached to the hub. All the other propeller blades had broken off at the root. The propeller blades all exhibit a similar degree of damage. The marks indicate that the three propellers were rotating on impact (see figures 36 to 38).

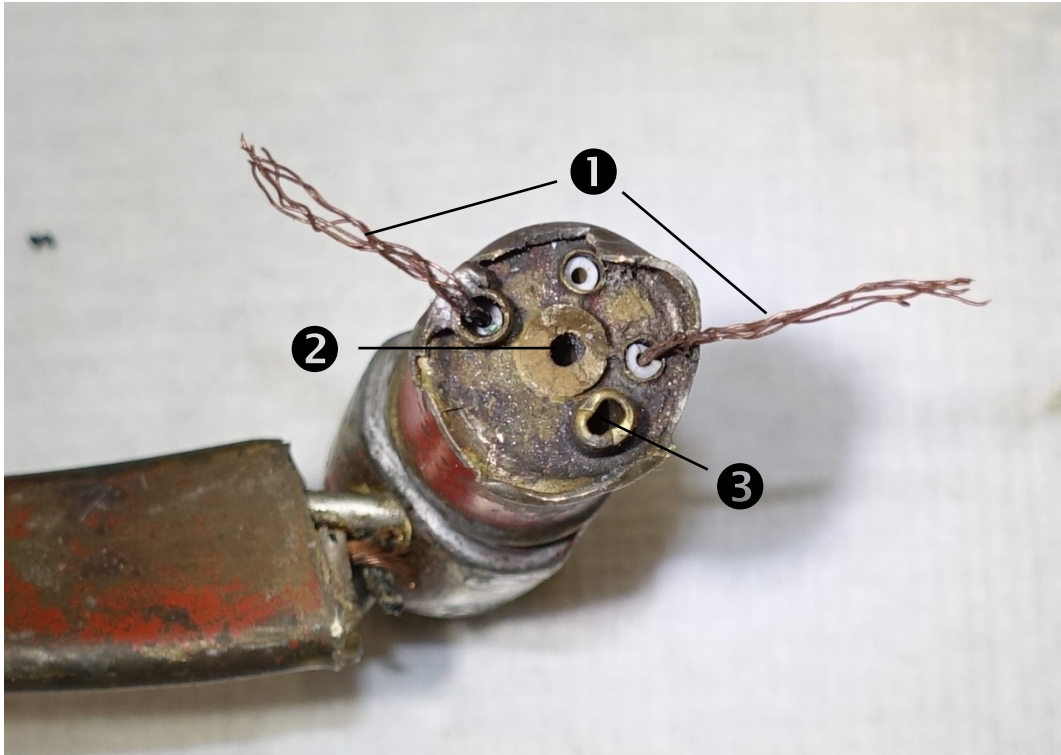
The pitot tube was severely damaged in the accident (see figure 39). Its functionality could no longer be assessed.

Figure 39: Severely damaged pitot tube. (1) Pitot tube heating element wires; (2) borehole for dynamic and static pressure; (3) borehole for static pressure.
