A1. Factual information

A1.16 Tests and research results

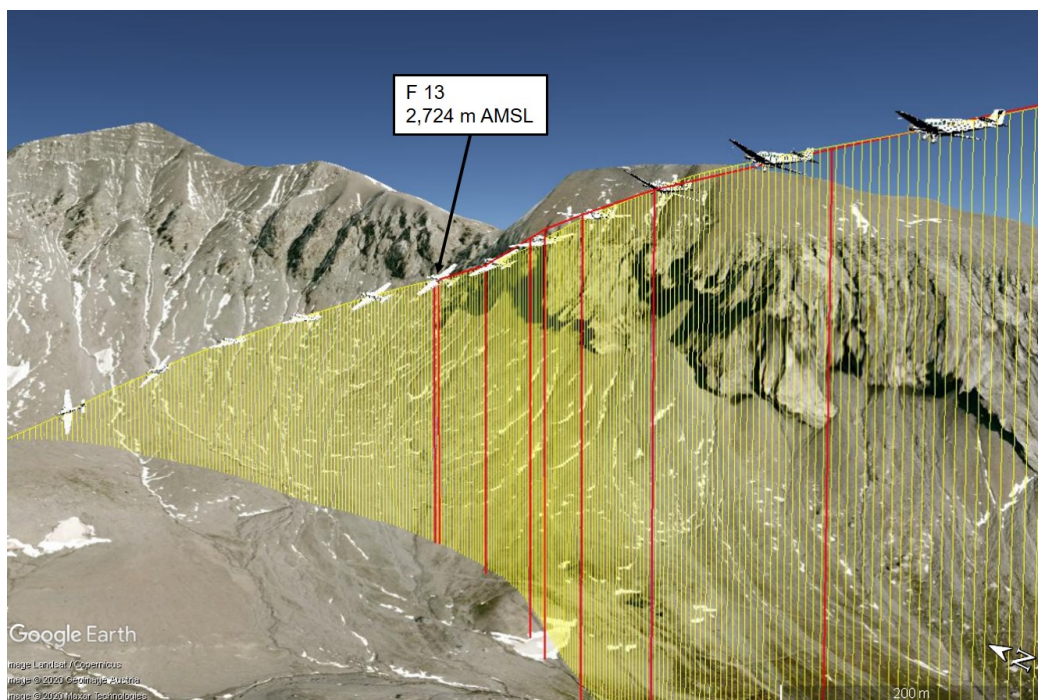
Figure 1: Simulated flight path (yellow) and reconstructed flight path of HB-HOT (red) from 4 August 2018 leading up to the photogrammetrically determined position F13; shown on Google Earth. The enlarged (2:1) three-dimensional models are shown on the basis of simulation results at position F13 and at two-second intervals before and after that point.

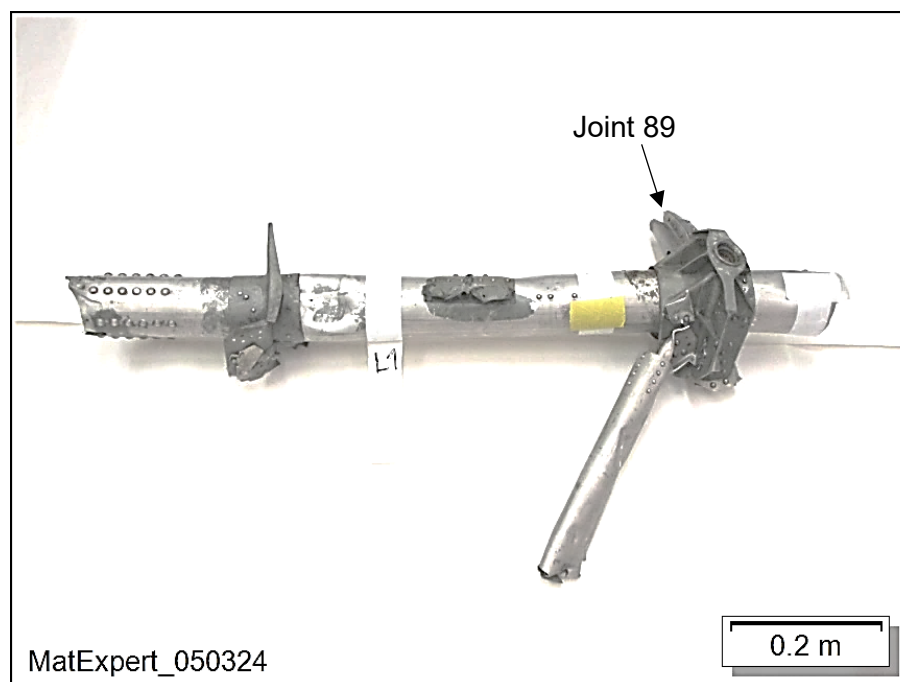
After removing joint 89 (see figure 4), severe corrosion and cracks were found in the contact area between the joint and the spar tube. This would not have been visible without dismantling the joint or the panelling. After cutting open the spar tube, no damage was visible on the inside (see figure 5). This shows that a borescope inspection cannot detect such damage and is therefore unsuitable (see annex [A1.6](#)).

Figure 4: Lower spar section L1 of the left outer wing.

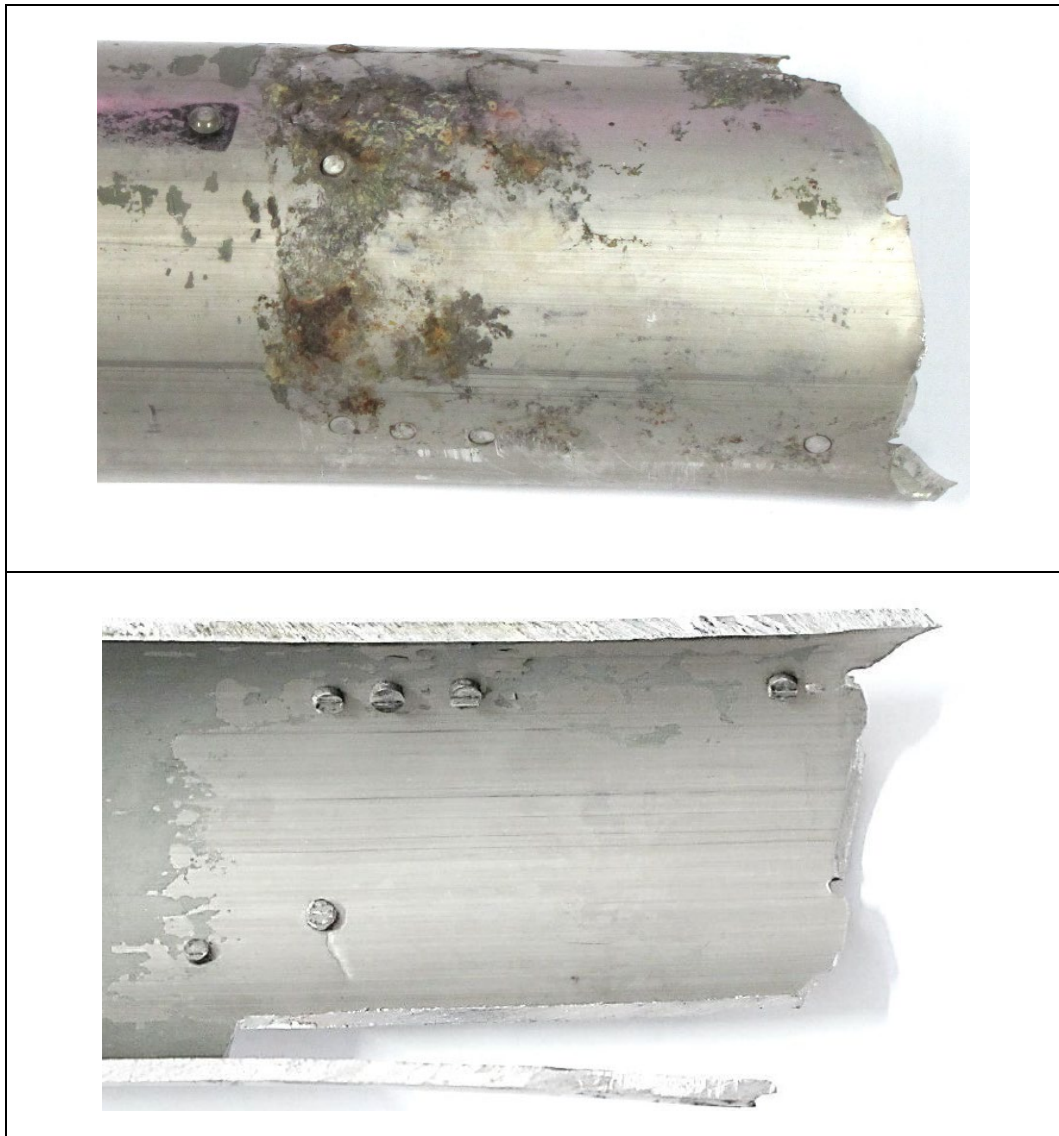
Figure 5: Cut open lower spar section L1 – the outer surface with corrosion and cracks, the inner surface with no signs of corrosion.

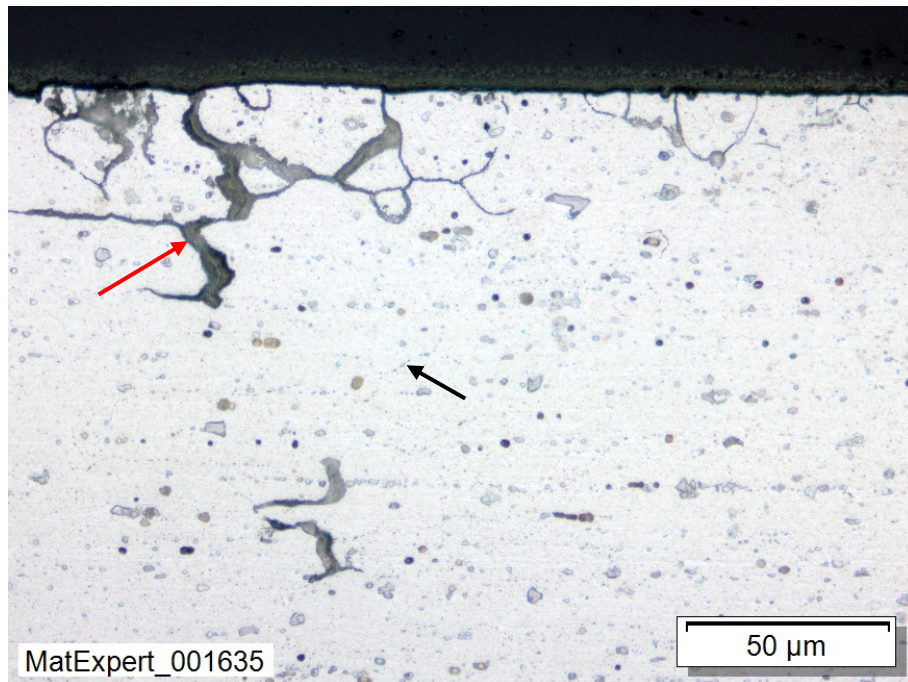
Spar section L1 (see figure 4) exhibited grain boundary precipitations (see figure 6). These precipitates were formed either by artificial ageing after solution heat treatment or by a secondary, longer exposure to a temperature of more than 120 °C. This makes the material in question susceptible to intergranular corrosion. Intergranular corrosion can develop along the detected grain boundary precipitates.

Figure 6: Microsection of spar section L1 – intergranular corrosion attack (red arrow) and grain boundary precipitation (black arrow).

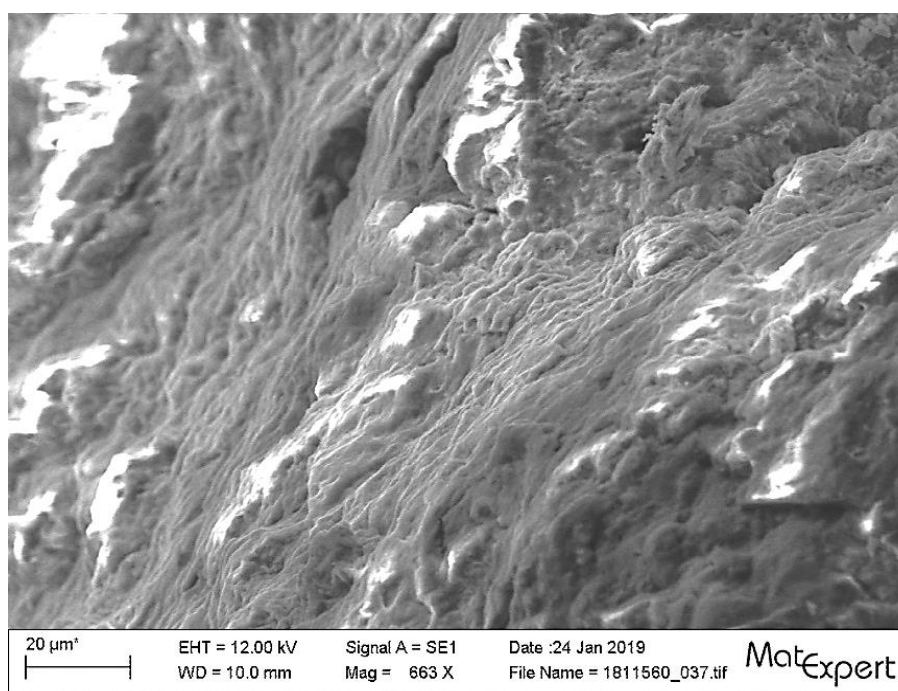
The spar tube below joint 89 was broken (see figure 7). The analysis of this fracture surface using SEM showed a ductile spontaneous fracture and a fatigue fracture with typical striations (see figure 8). The fatigue fracture accounted for approximately 10 % of the total fracture surface. Extensive corrosion damage and further cracks were uncovered in the contact area between joint 89 and the spar tube. This corrosion was intergranular corrosion resulting in a loss of wall thickness (see figures 9 and 10). One of the cracks was exposed and fractographically analysed (see figure 11). This crack was an intergranular fracture with striations, i.e. a fatigue crack (see figures 12 and 13).

Figure 8: Fatigue fracture with typical striations.

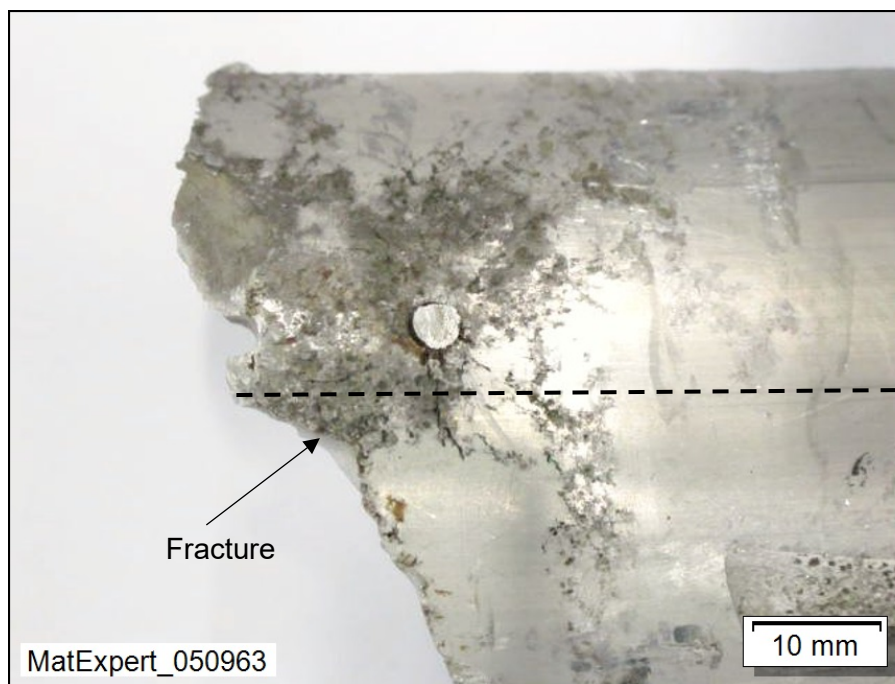
Figure 9: Point of corrosion with broken rivet. The black, dashed line indicates the position of the microsection.

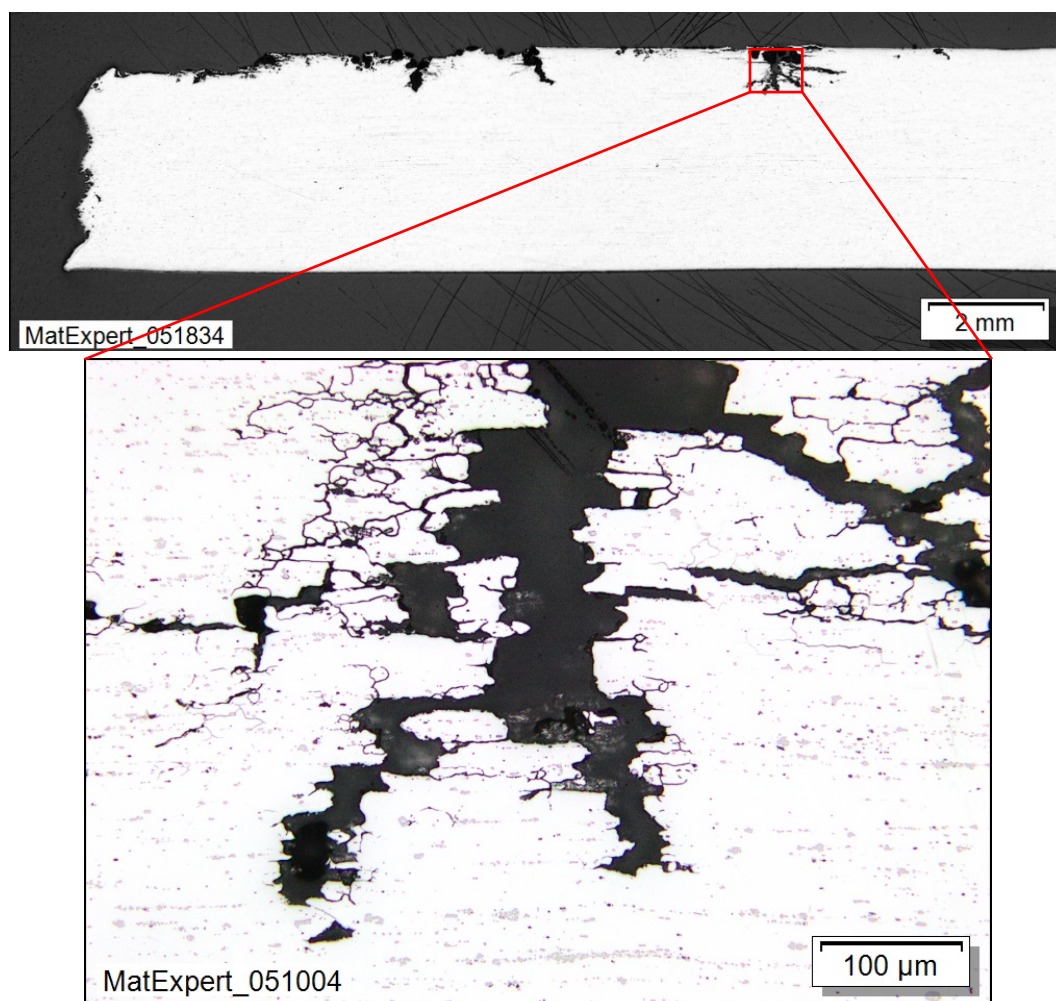
Figure 10: Wall thickness loss due to corrosion and intergranular corrosion.

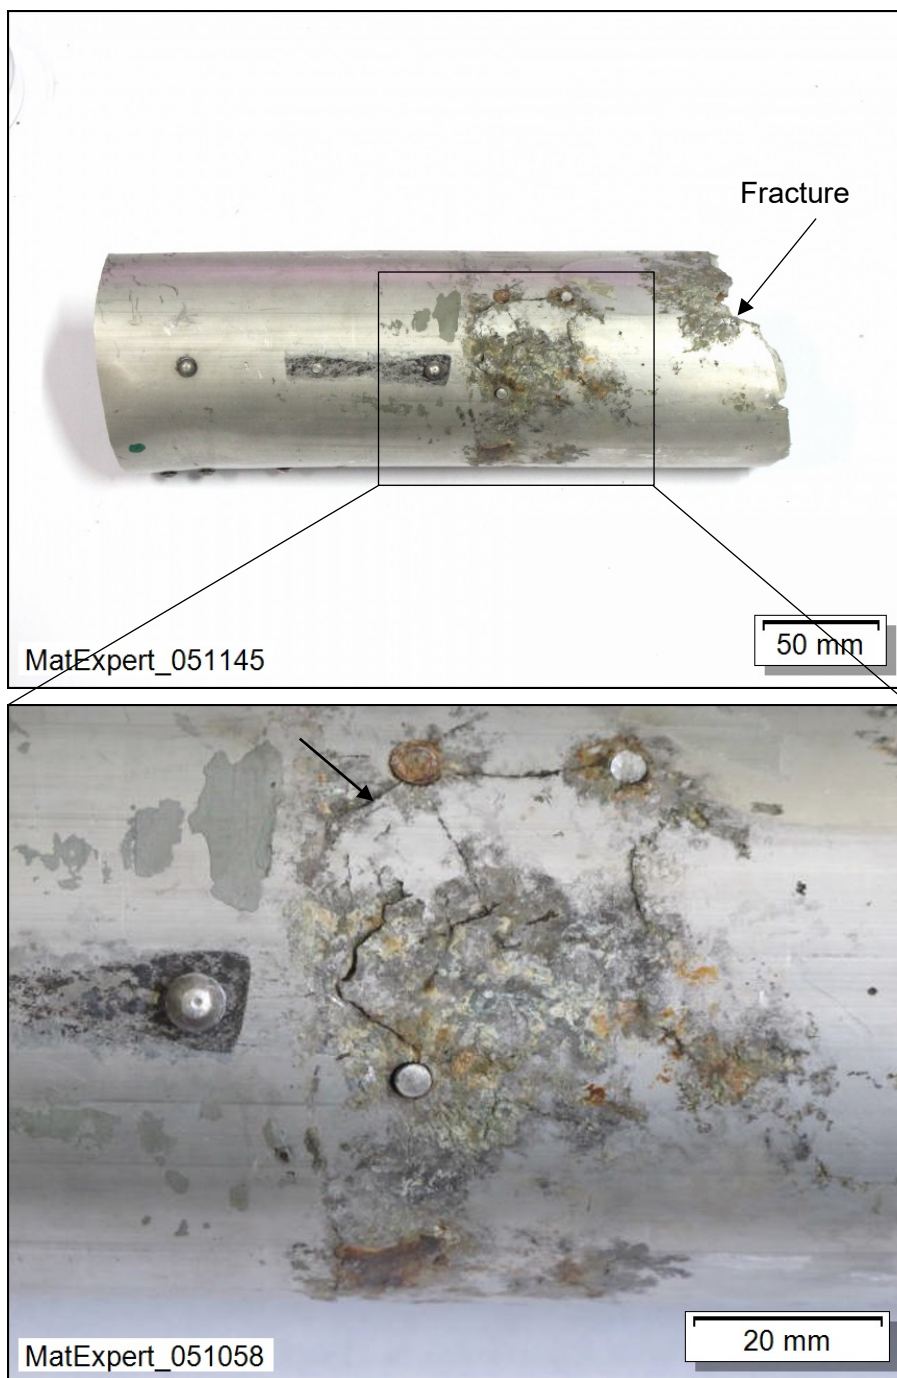
Figure 11: Exposed crack (arrow) under joint 89 on the lower spar section L1.

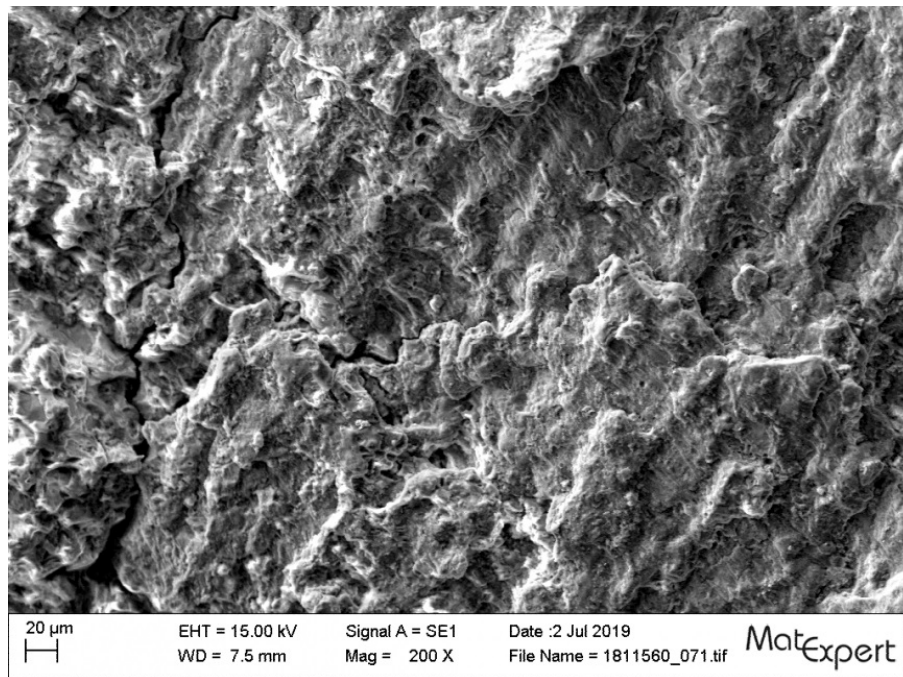
Figure 12: Close-up – crack surface in the exposed crack with fatigue fracture and intergranular cracks.

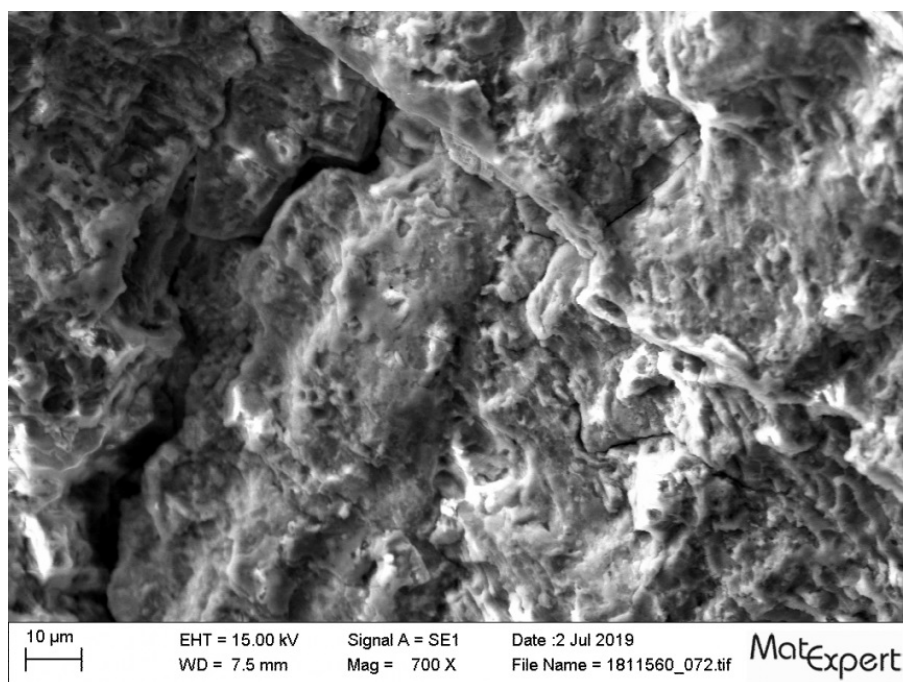
Figure 13: Magnified version of figure 12.

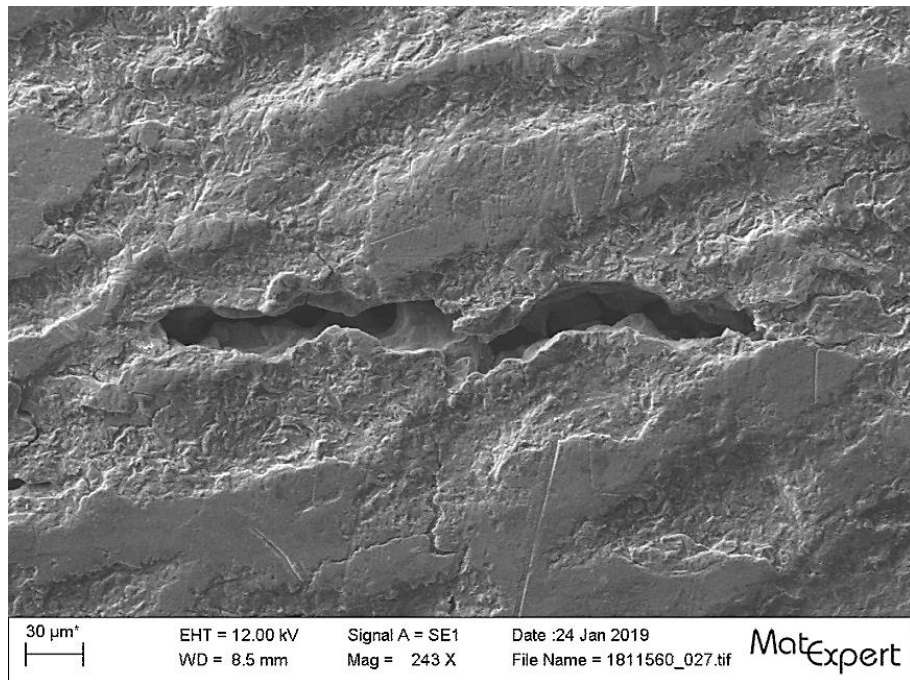
Figure 15: Impact wear on lower spar L1 (close-up of number (1) in figure 14).

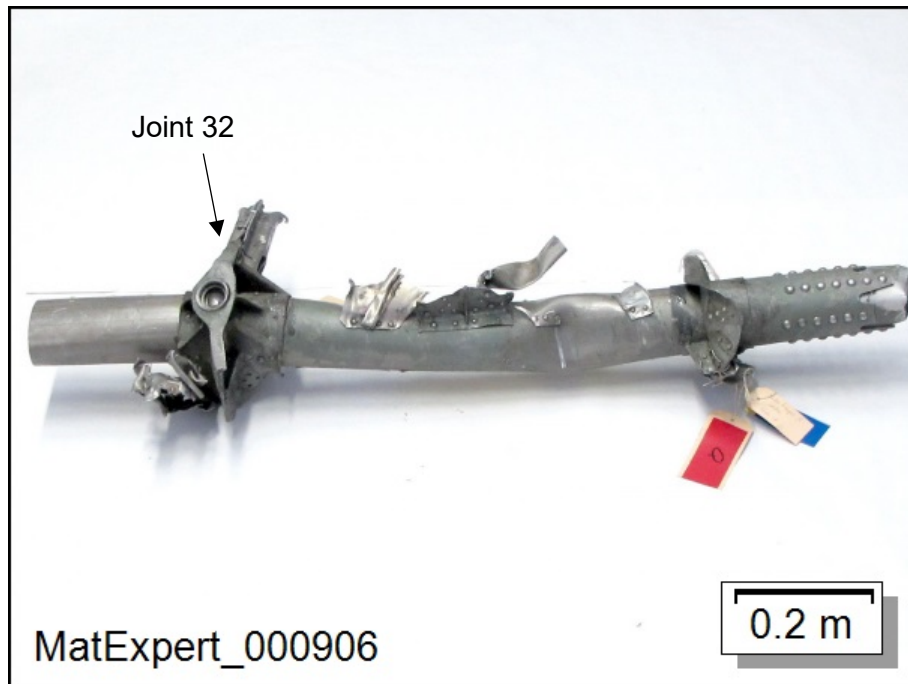
The lower spar section 1Ru (see figure 18), cut from spar I near the right engine, exhibits pitting (see figure 19). This is the typical type of corrosion for a naturally aged structure. This type of corrosion also leads, among other things, to a localised loss of wall thickness. Wear caused by the panelling is also present on this spar section.

Figure 18: Lower spar section 1Ru.

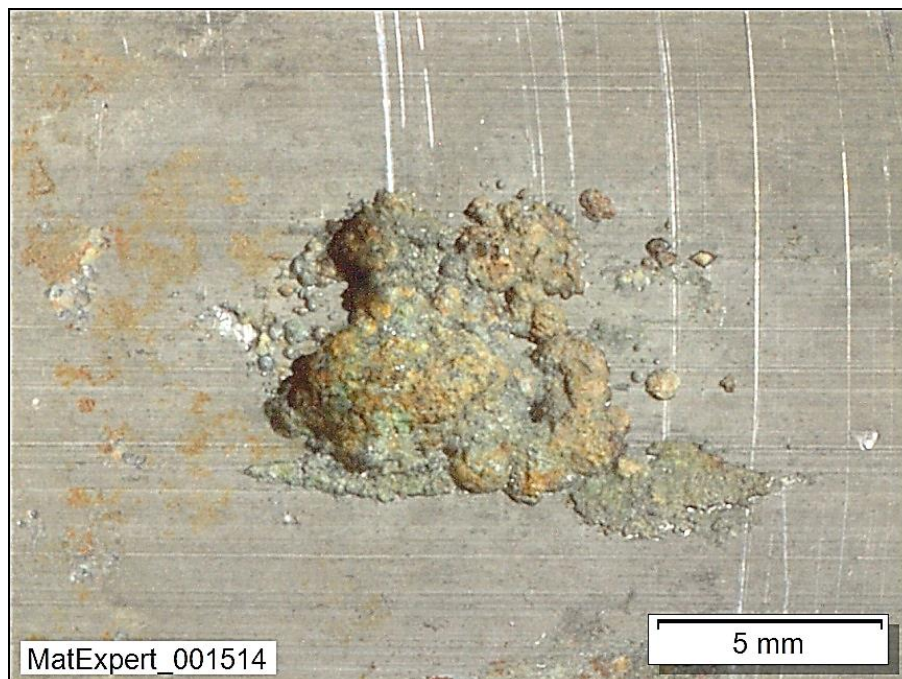
Figure 19: Close-up – pitting on the lower spar section 1Ru.

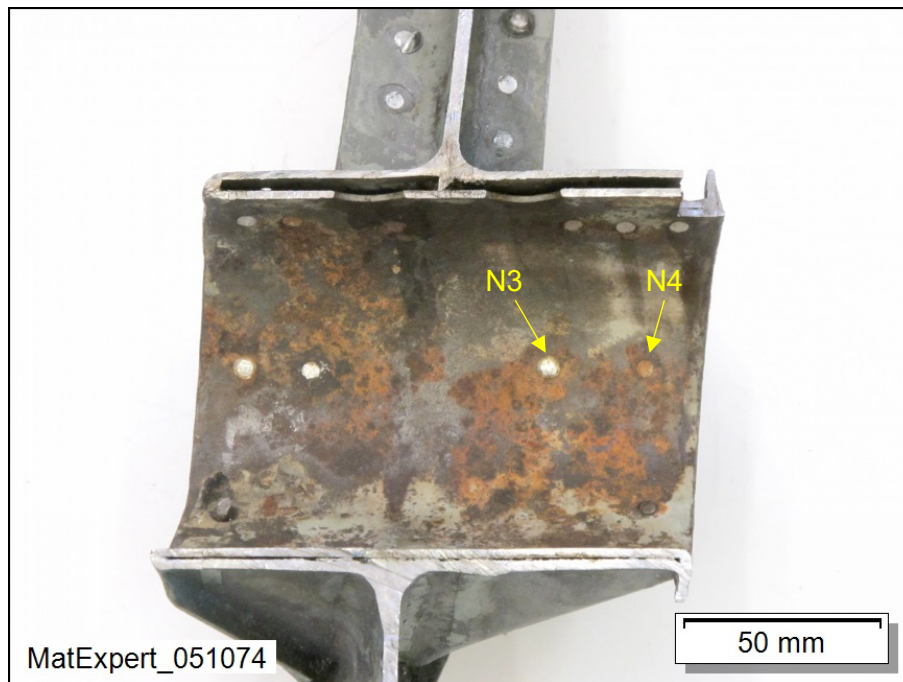
The inner tubing of the analysed joint exhibited corrosion with surface corrosion around the rivets (see figure 20).

Figure 20: Cut open joint 89 with rivets N3 and N4.

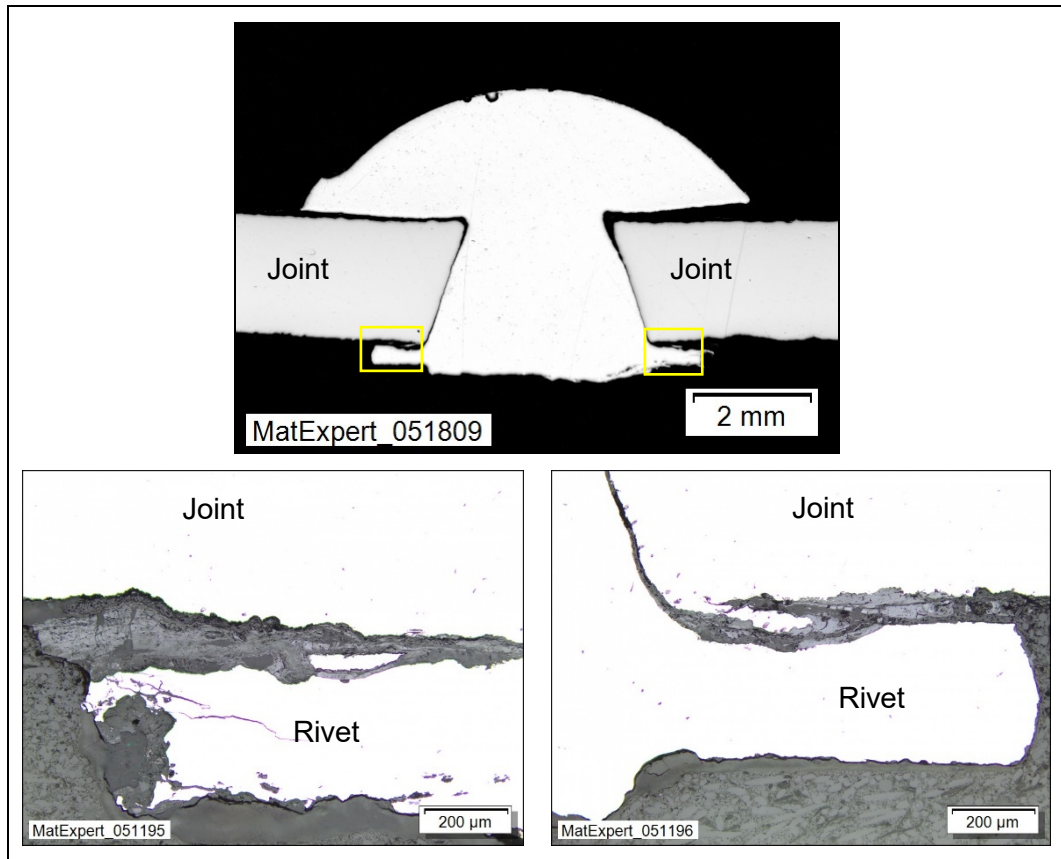
Pitting and surface corrosion can be identified in the contact area between the rivets and both the joint and spar tube (see figure 22).

Figure 22: Cross section of rivet N3 – pitting and surface corrosion of sheet steel and aluminium rivets.

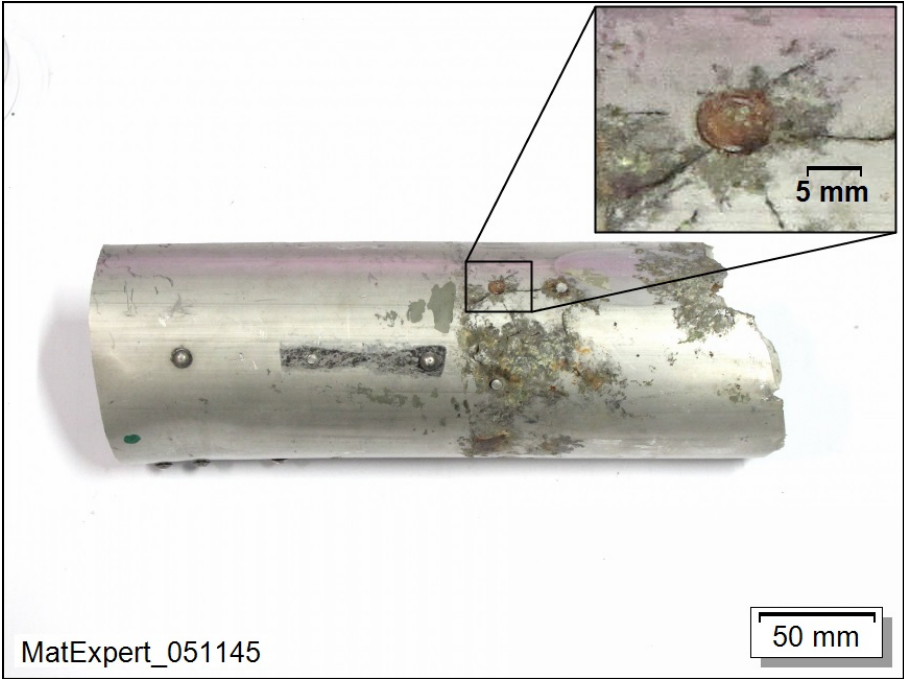
Figure 23: Spar section L1, after removing joint 89, with rivet N5.

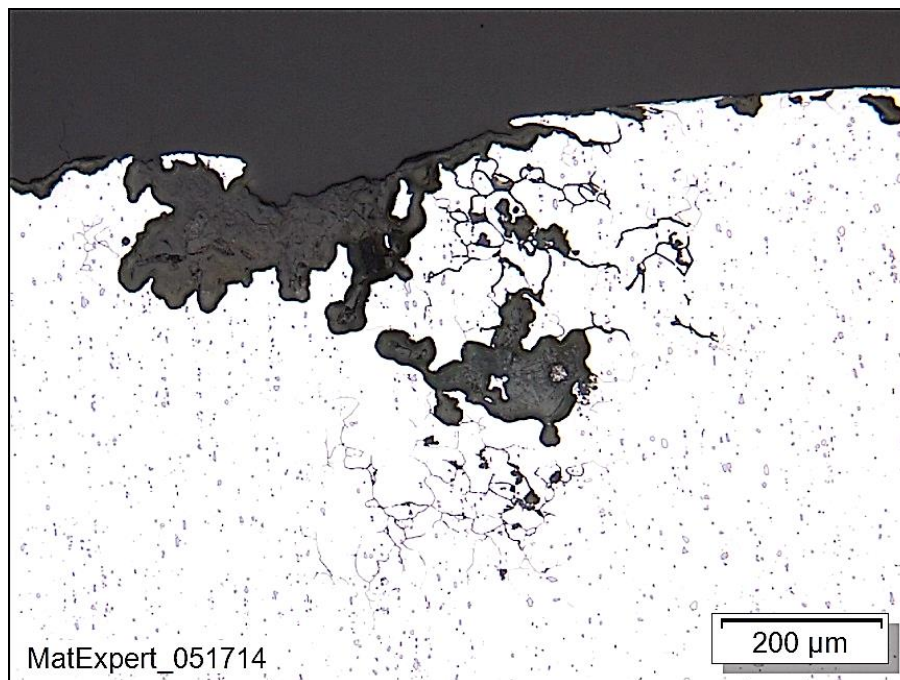
Figure 26: Close-up – intergranular corrosion on rivet N5.

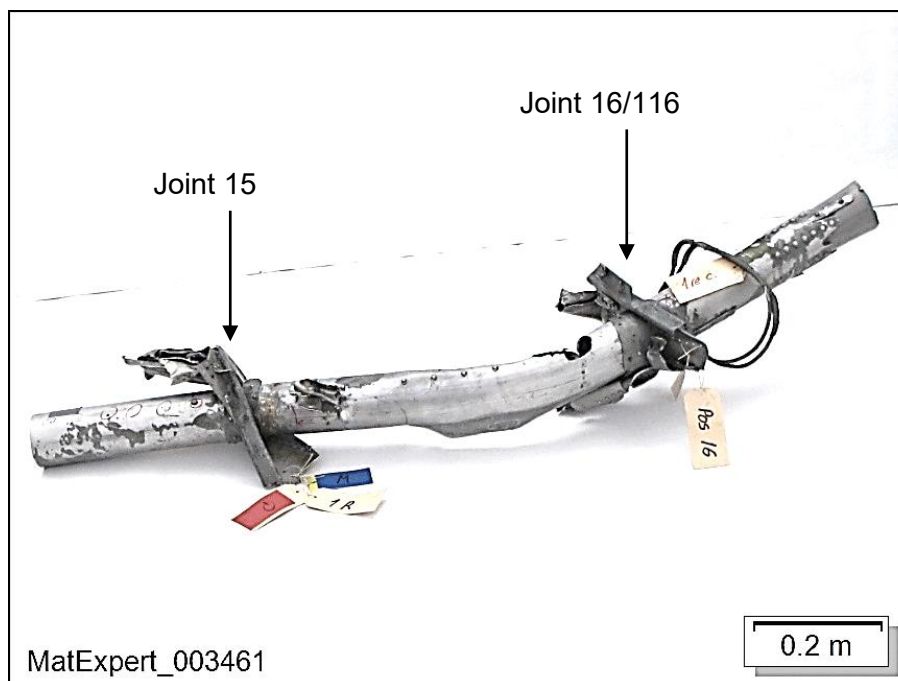
Examination of spar section A (see figure 27) shows a similar condition for the joints as those on spar section L1. In the contact areas between the joints and the spar tube, severe corrosion and cracks, old rivet fractures, impact wear, erosion and cavitation were also found on the surface of the aluminium spar tube (see figures 28 to 32).

Figure 27: Spar section A.

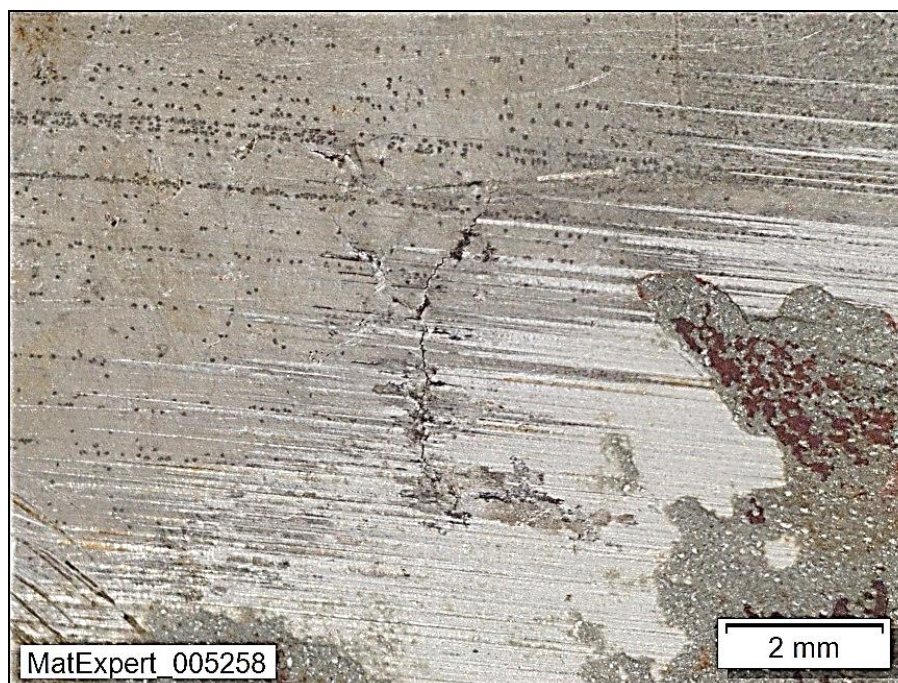
Figure 28: Area around joint 15 – brittle cracking, partially intergranular.

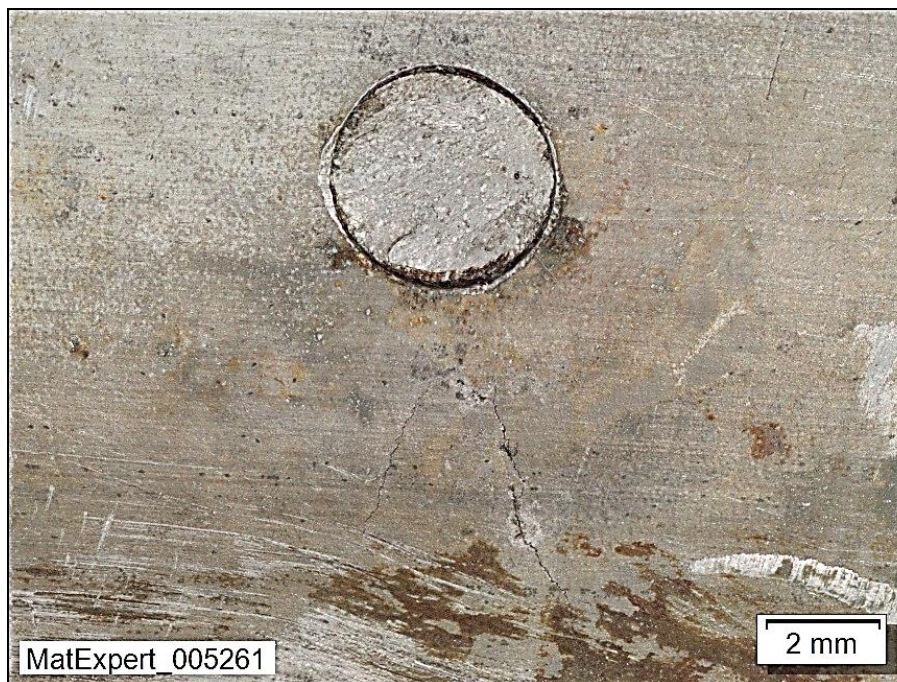
Figure 29: Area around joint 15 – brittle cracking, partially intergranular.

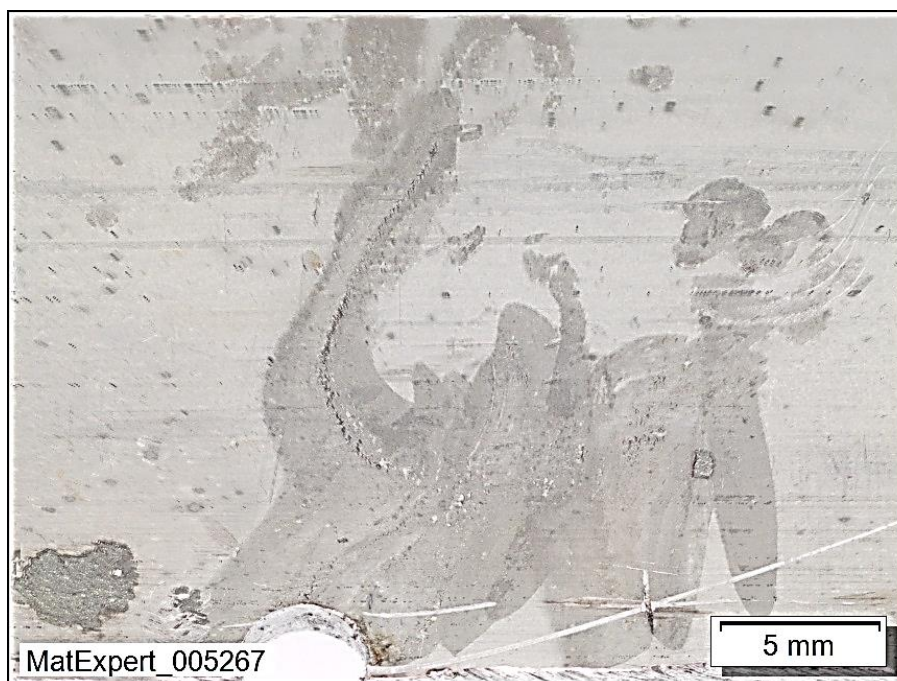
Figure 30: Area around joint 15 – crack-like surface condition.

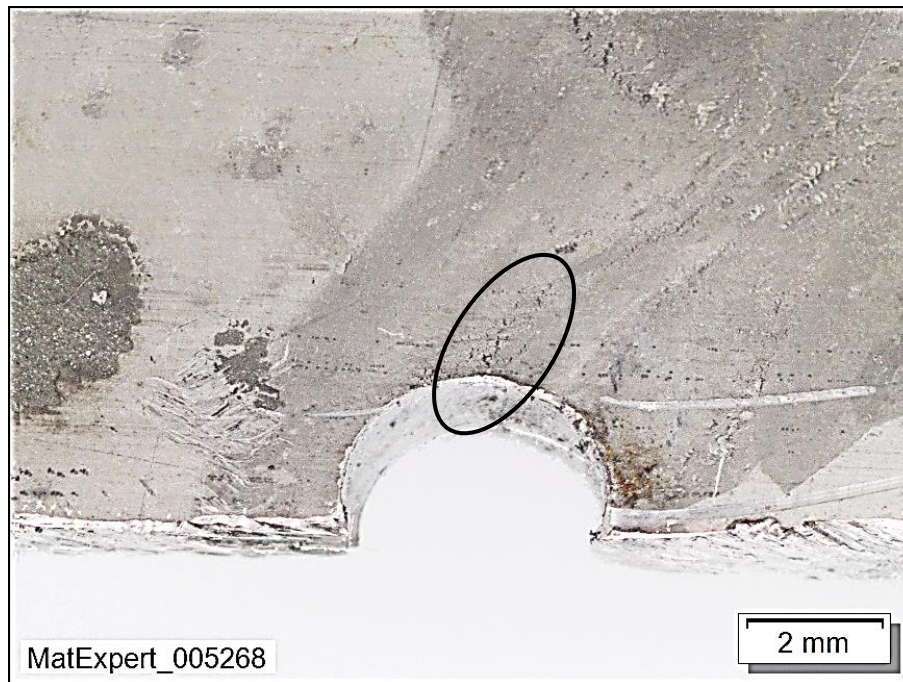
Figure 31: Close-up of figure 30 – start of a crack at the rivet hole (circled).

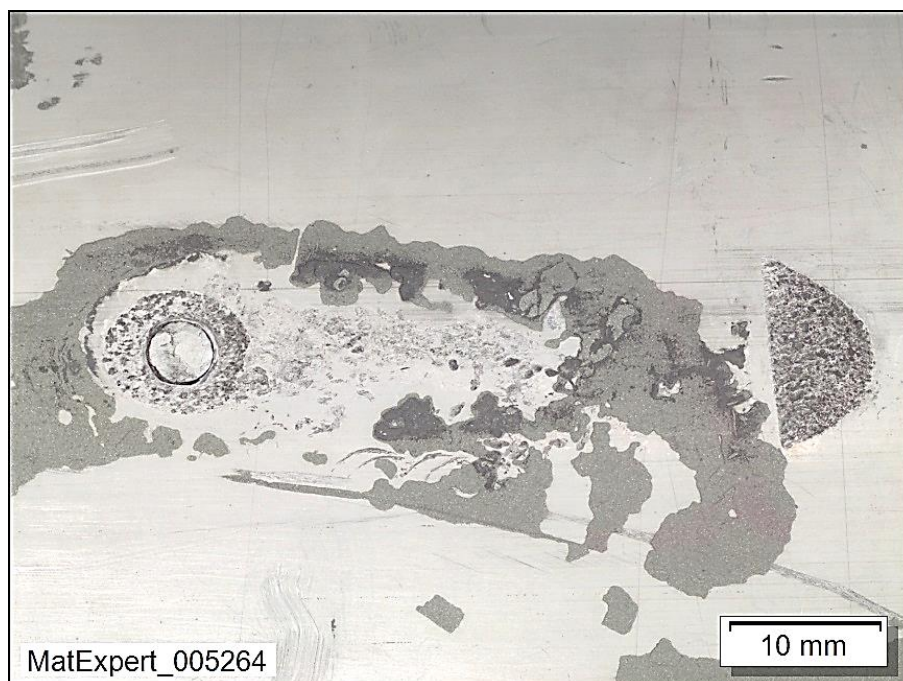
Figure 32: Area around joint 16/116 – pre-existing broken rivet and impact wear, erosion and cavitation on the spar tube.

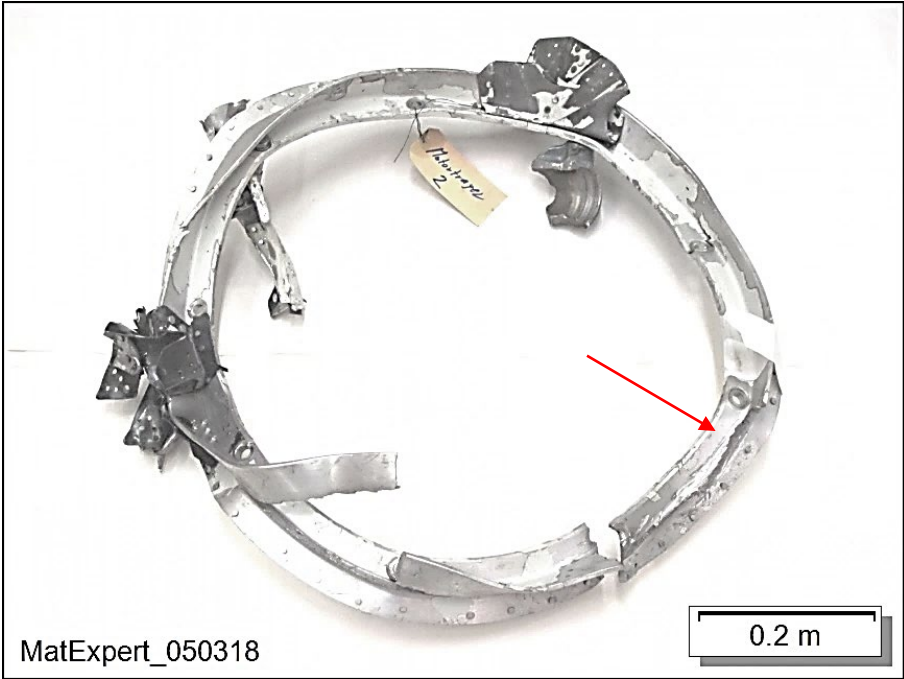
A fracture surface from the centre engine mount (see figure 33) was microfractographically analysed using SEM (see figure 34). The fracture was identified as a brittle, spontaneous fracture exhibiting a mixed fracture pattern of honeycomb, quasi-cleavage and intergranular fractures across a wide area (see figure 35). The intermetallic phases are clearly visible in the fracture pattern and are partially surrounded by roundish cavities. The localised 'terracing', which is a defect, is striking (see figure 36). On the fracture surface, a localised fatigue fracture-like formation can be seen (see figure 37).

Figure 33: Severely deformed and broken centre engine mount. A part of the fracture surface on the engine mount (red arrow) was analysed.

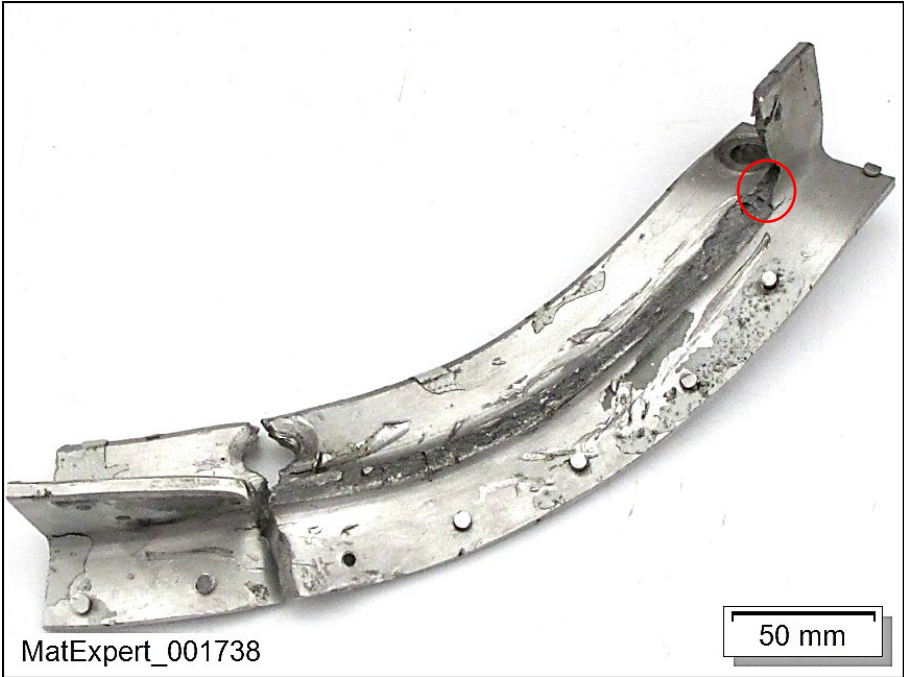
Figure 34: Location of the analysed fracture surface (red circle).

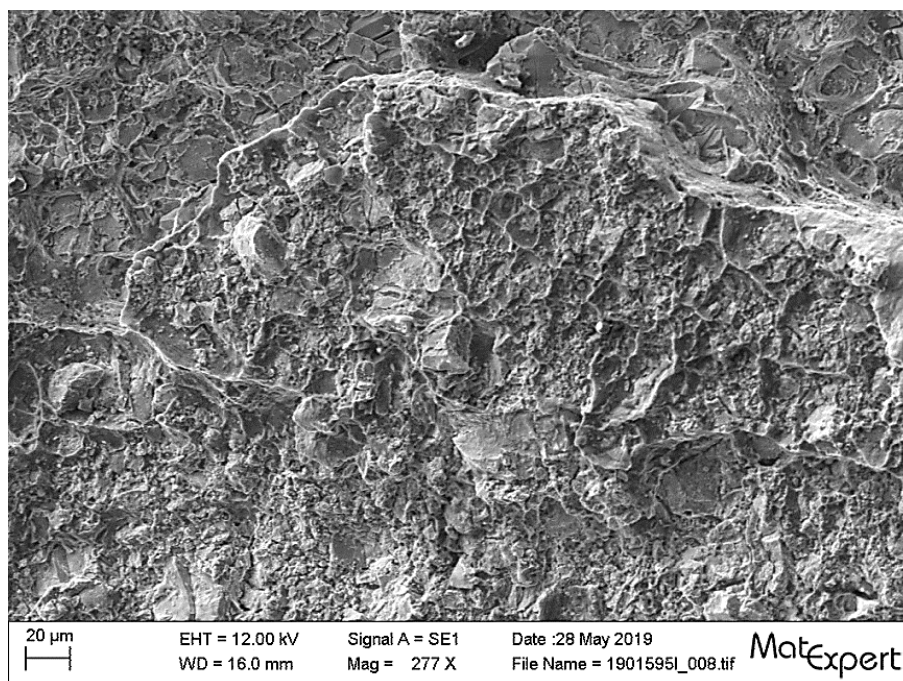
Figure 35: Mixed fracture featuring honeycomb and quasi-cleavage fractures.

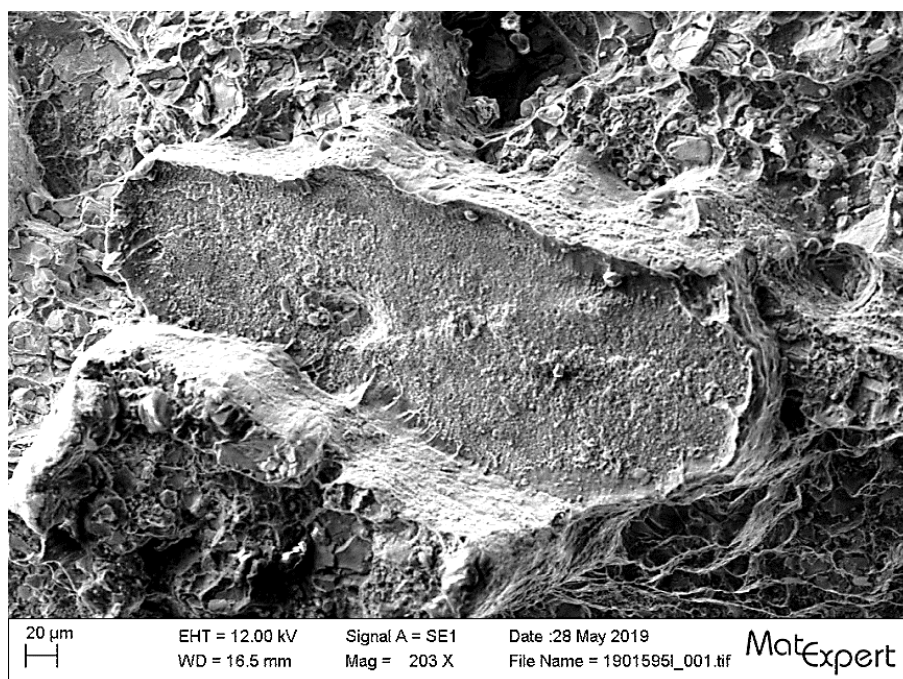
Figure 36: Defect in the form of a terrace, with oxide skin.

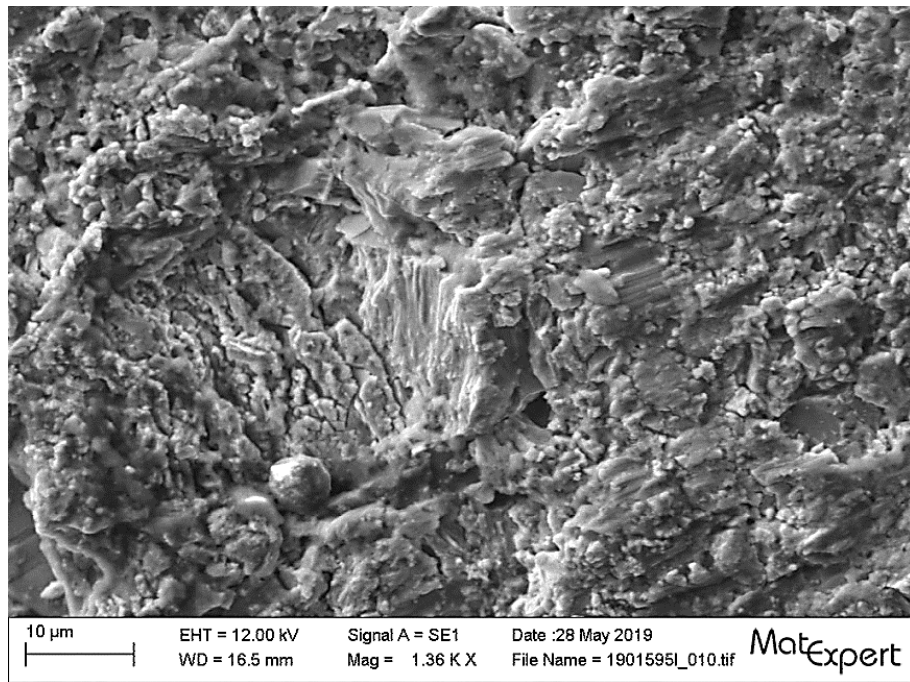
Figure 37: Fine, fatigue crack-like secondary cracks.

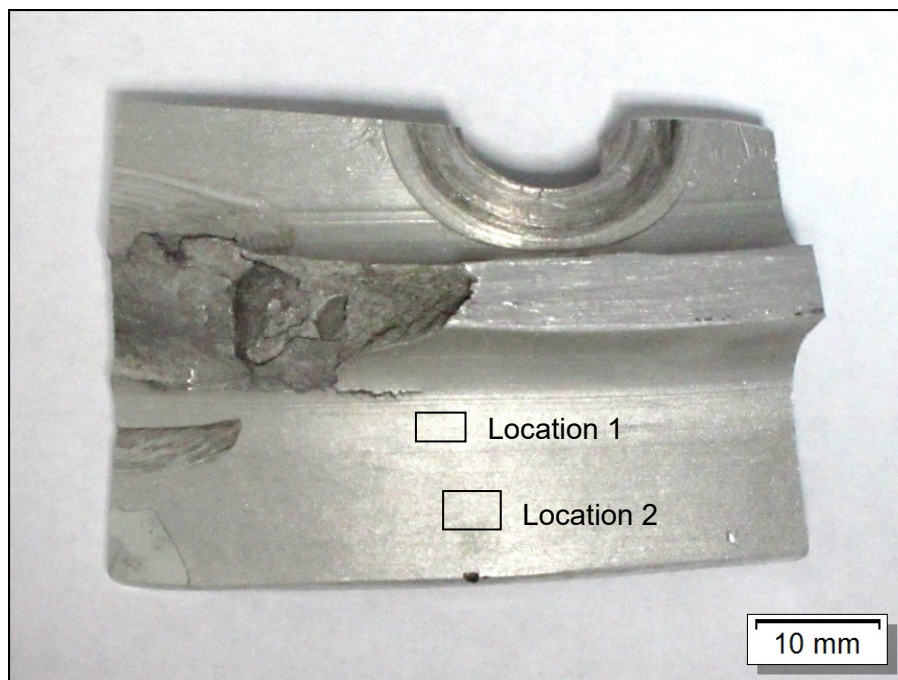
The centre engine mount is assumed to have been shot-peened. In addition, many small cracks can be seen on the surface (see figures 38 to 42). It is not possible to determine when these cracks were formed. The crack depth was not measured.

Figure 38: Segment of the centre engine mount – locations of the examined surfaces.

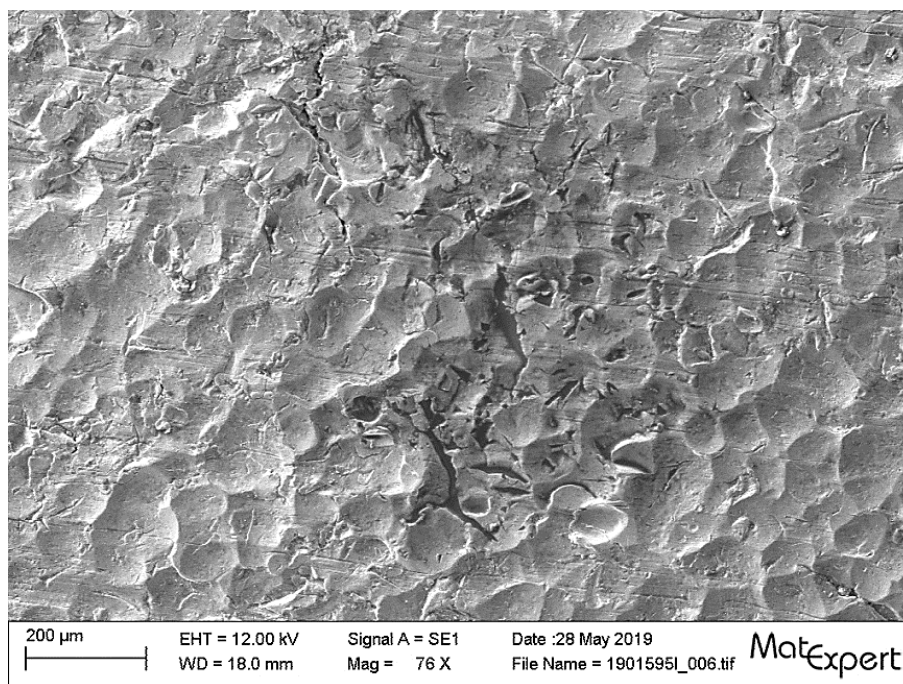
Figure 39: Close-up of location 1 – shot-peened surface with cracks.

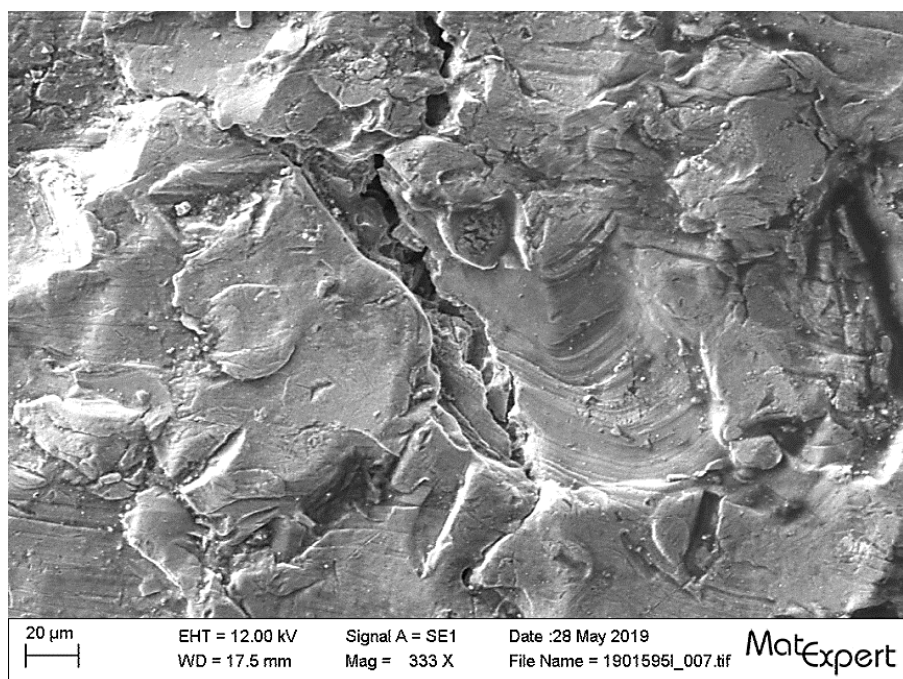
Figure 40: Magnified version of figure 39.
