A1. Factual information

A1.16 Tests and research results

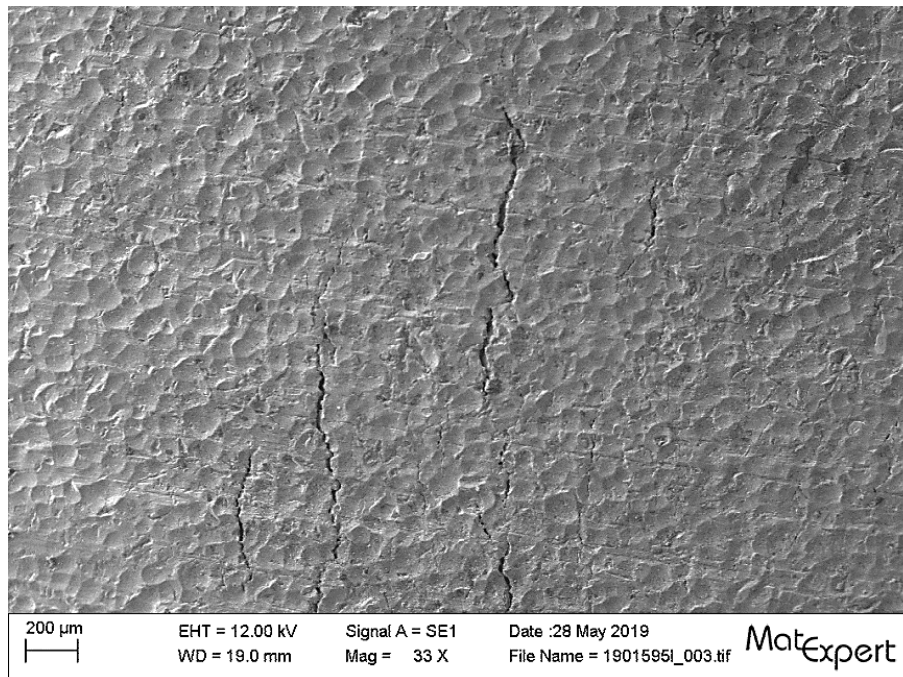
Figure 41: Centre engine mount, location 2 – shot-peened surface with cracks.

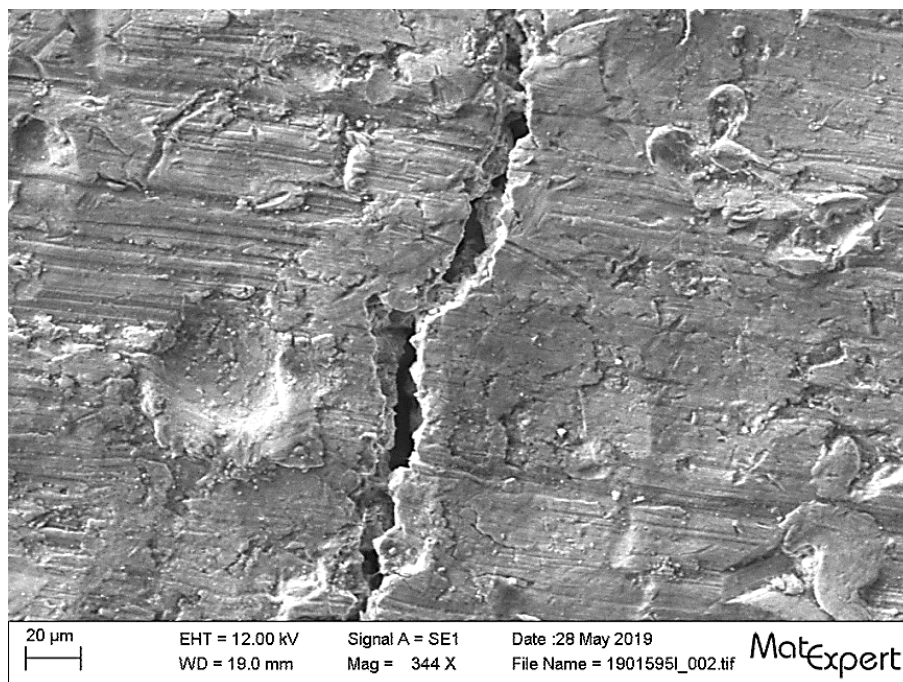
Figure 42: Magnified version of figure 41.

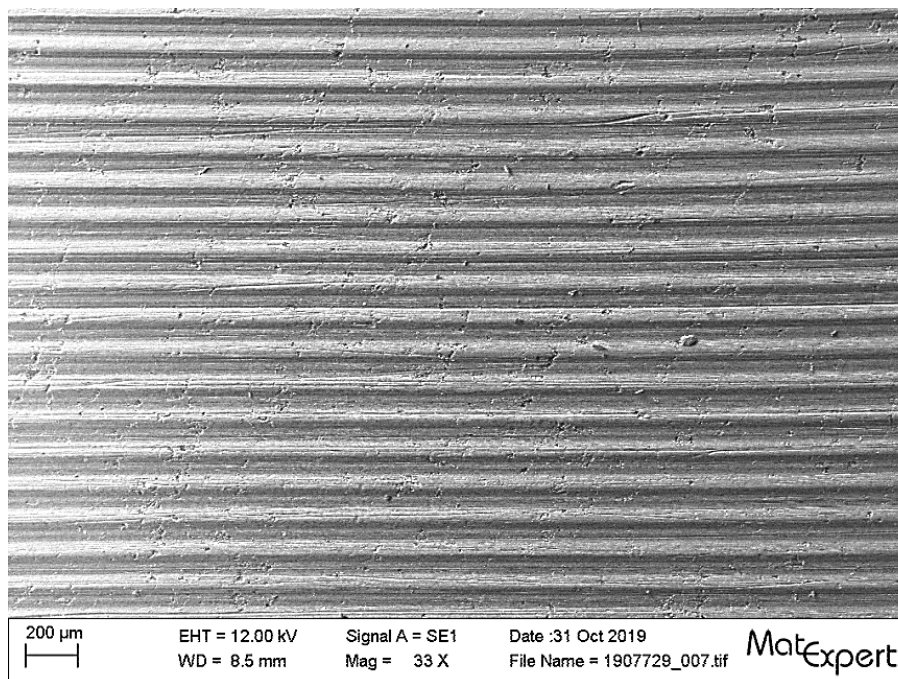
The distinct marks found on the surface of the right engine mount indicate that it was machined (see figure 43). No signs of shot peening and no surface cracks were found.

Figure 43: Right engine mount – existing, distinct machining marks (from turned surface).

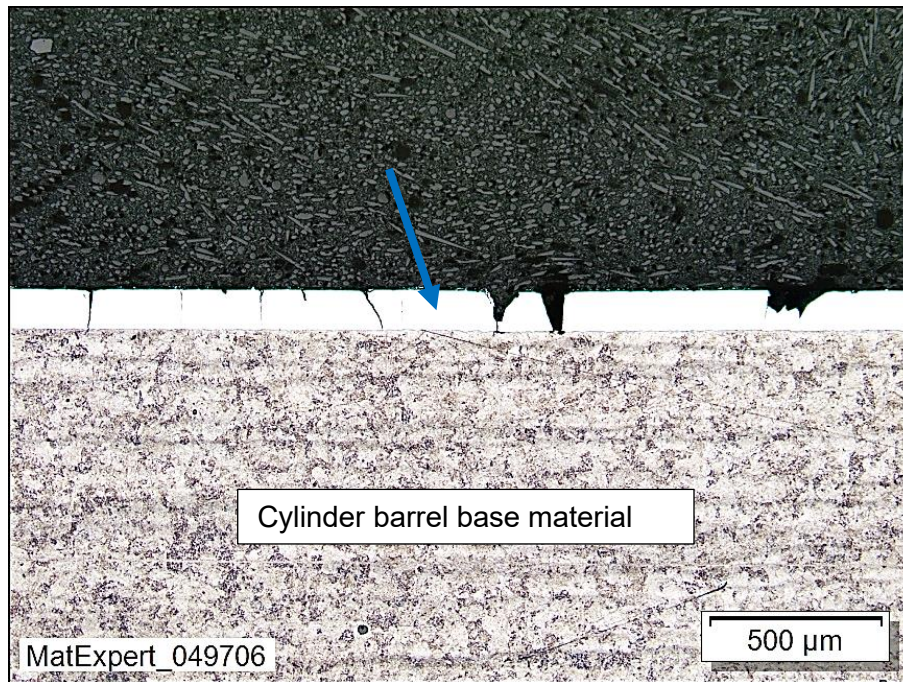
The examined cylinder from the left engine as well as that from the centre engine has been hard-chrome plated (see figure 44). The thickness of this plated surface is 0.121 and 0.123 mm respectively. It features peeling and has cracks covering the surface like a net, which can be seen with the naked eye. The cracks detected are typical for these kinds of coating and are a result of the process used. The chrome plating is extremely hard, the measured value HV0.3 is between 775 and 820.

Figure 44: Microsection of the cylinder wall (left engine, cylinder 5) including hard-chrome plating (blue arrow), network of cracks and peeling.

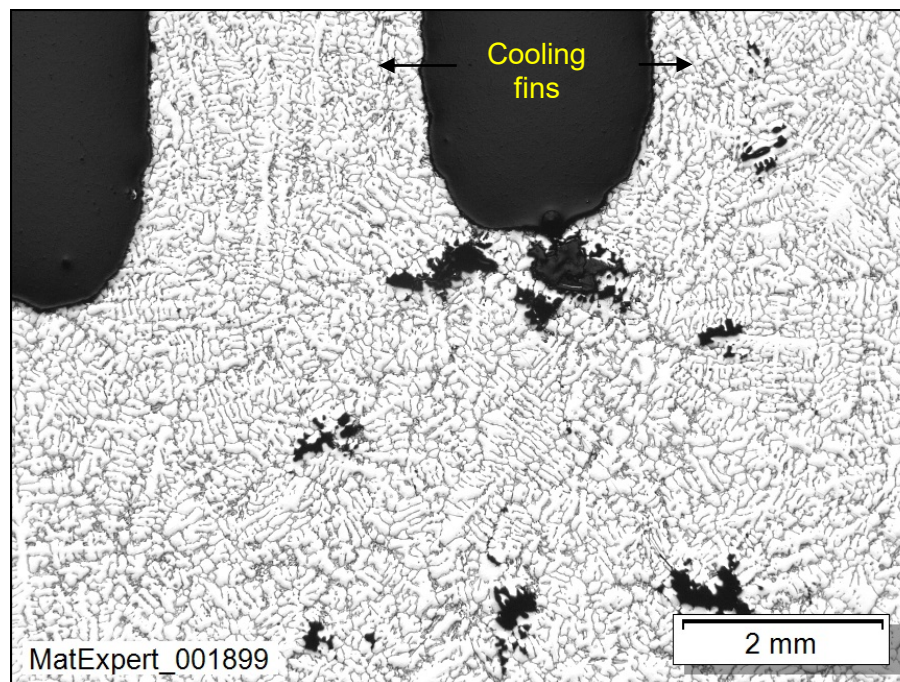
The material used for the cylinder head complies with the specifications of the engine manufacturer. Casting defects in the form of shrinkage cavities are evident (see figure 48). The microstructure can be judged as typical for the alloy in question, but is more consistent with a brittle state.

Figure 48: Microsection of the cylinder head's structure with solidification holes (left engine, cylinder 5).

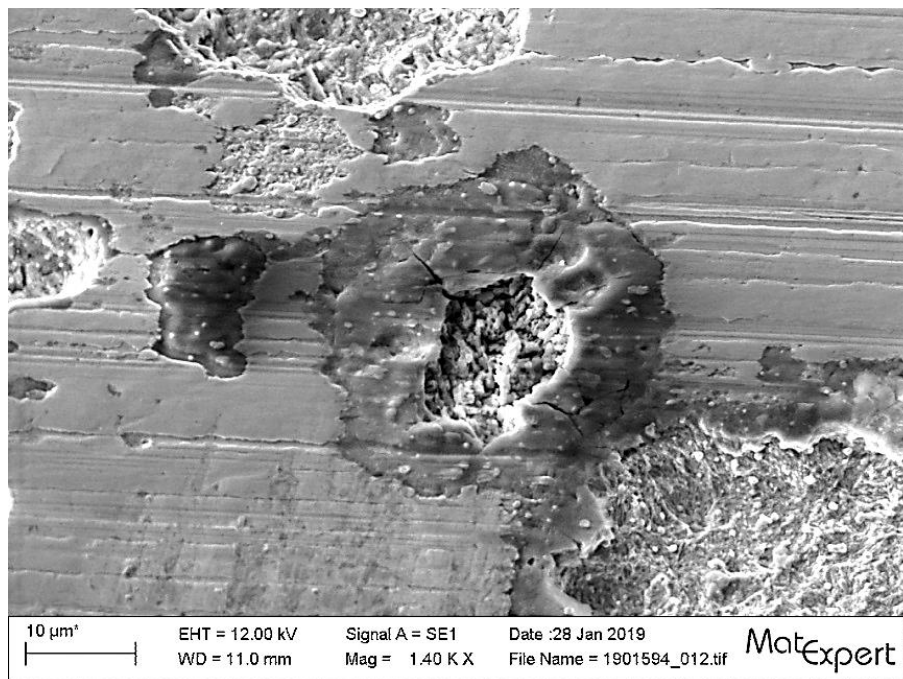
Figure 49: Ball bearing from the right engine, inner-race bearing track – material chipping and corrosive damage.

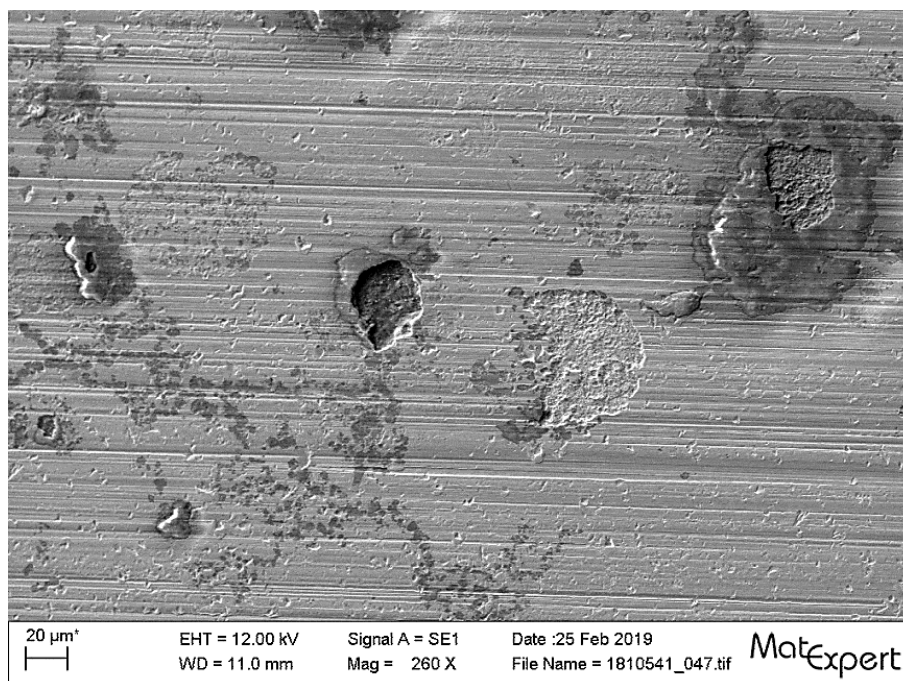
Figure 50: Ball bearing from the left engine, inner-race bearing track – material chipping, corrosion and minor pitting.

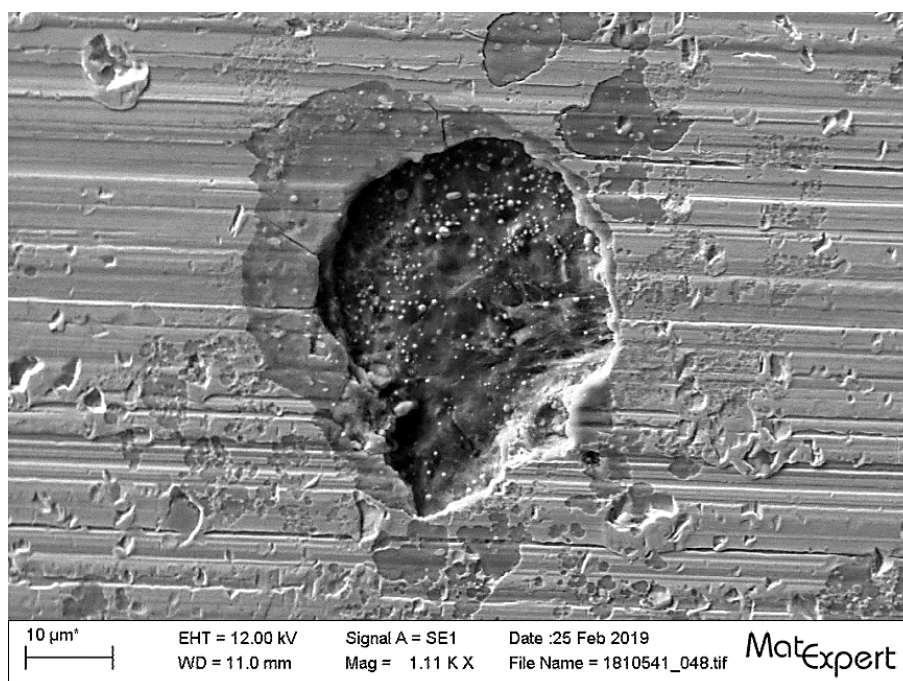
Figure 51: Close-up of figure 50.

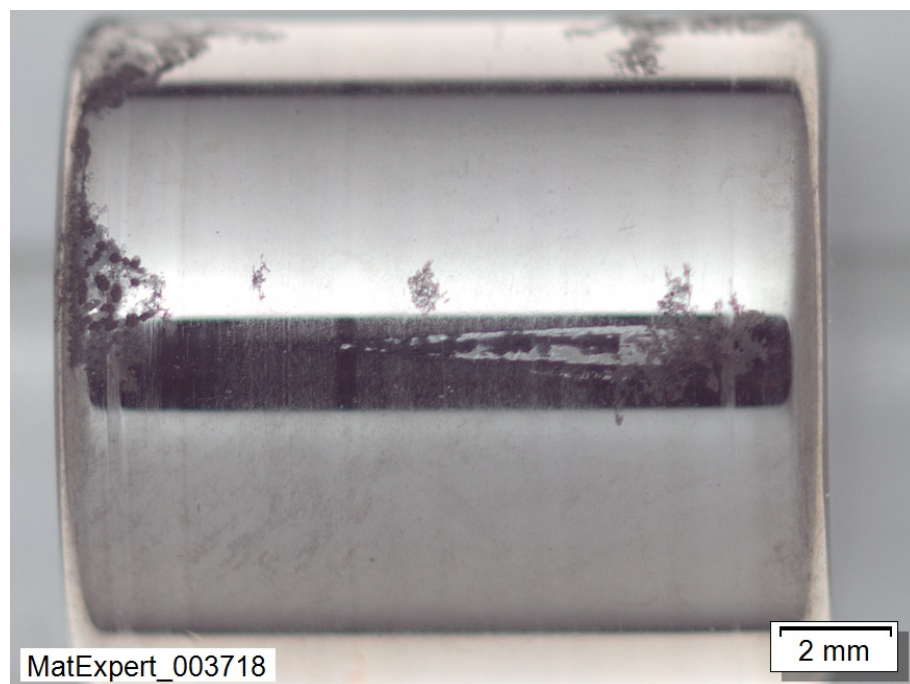
Figure 54: Bearing no. 3 – cylindrical roller with wear.

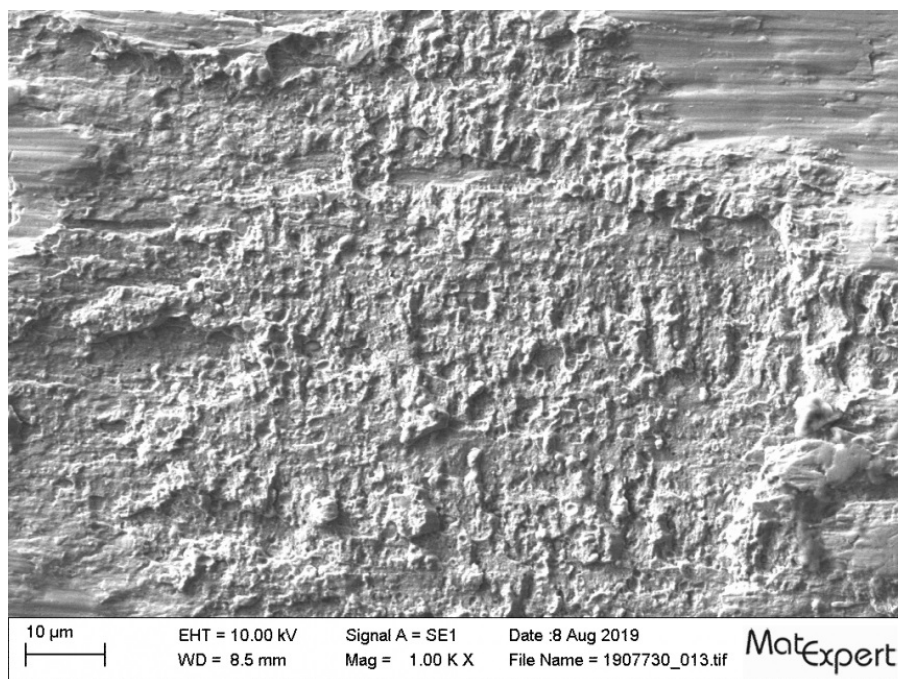
Figure 55: Close-up of the worn area – material chipping and cavitation.

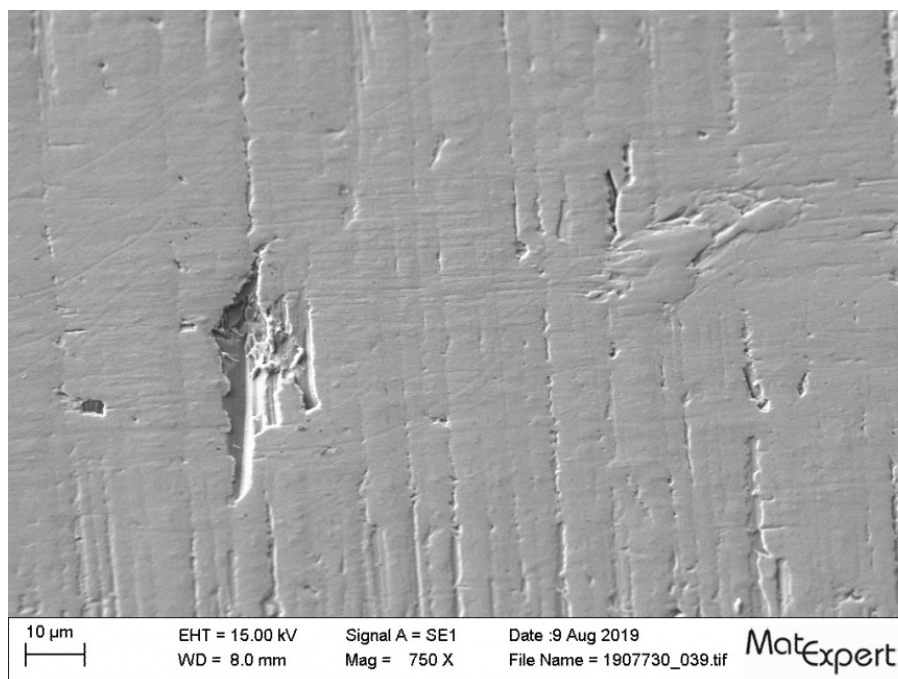
Figure 57: Bearing no. 3, outer-race bearing track – smoothed stop point and material build-up.

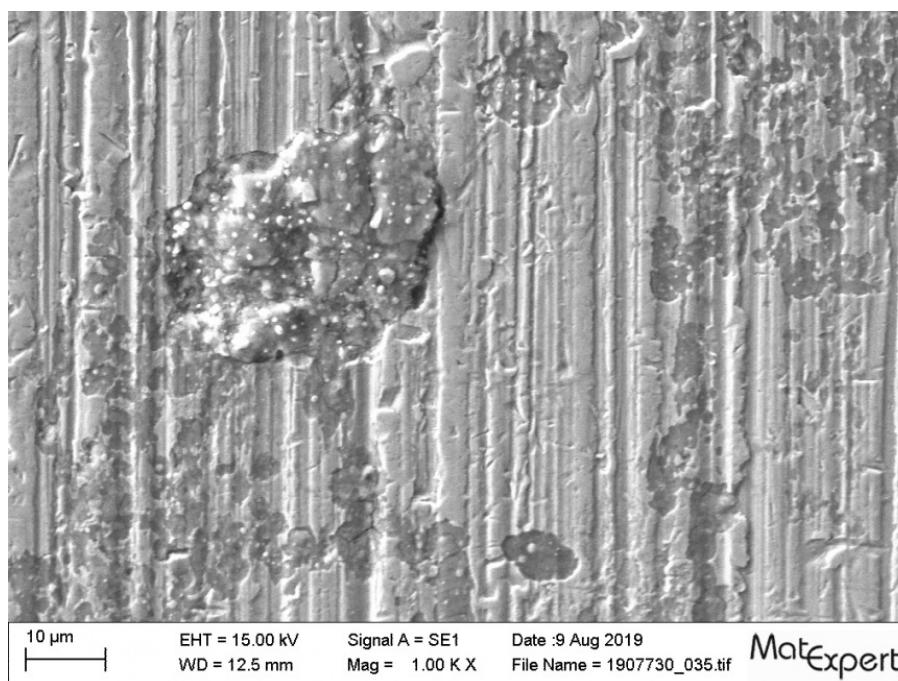
Figure 58: Bearing no. 3, outer-race bearing track – flat-rolled corrosion and abrasive wear.

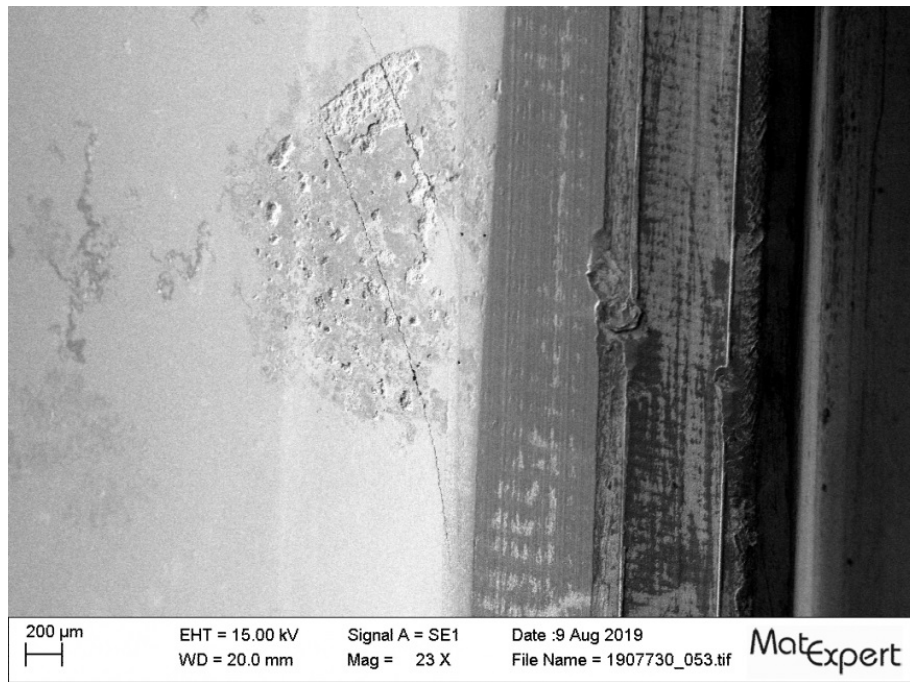
Figure 59: Bearing no. 4, outer-race bearing track – damage due to material chipping and cracks.

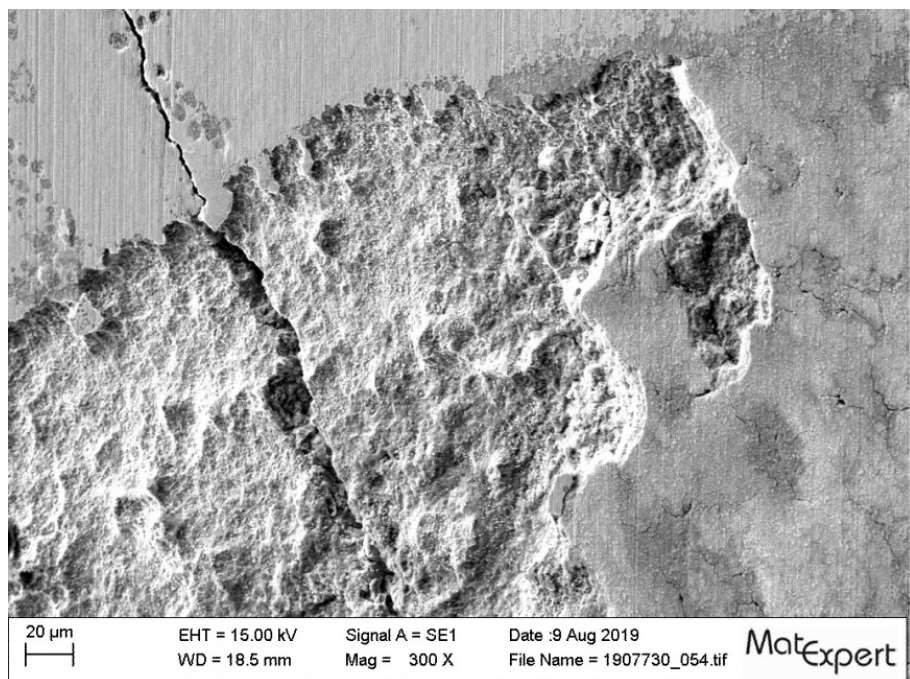
Figure 60: Close-up of figure 59.

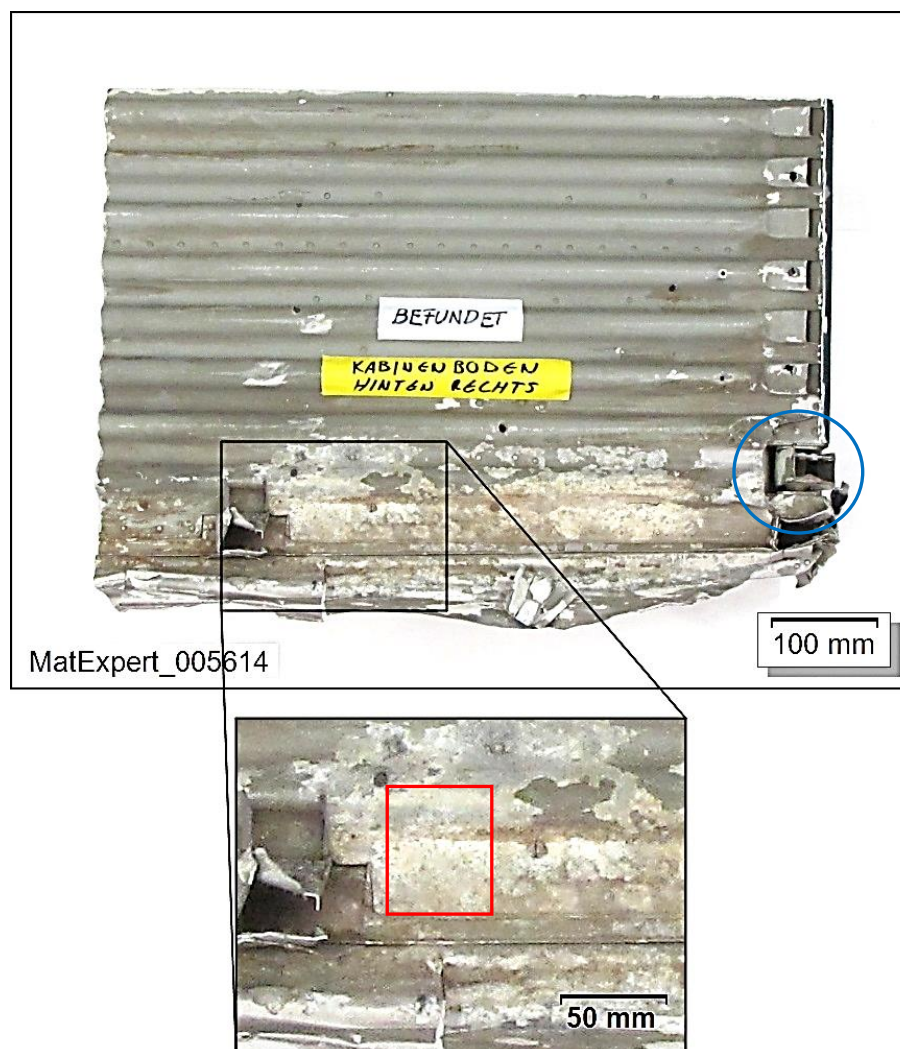
The sheet metal of the cabin floor near the aft hinge of the cargo door exhibited cracks, pronounced intergranular corrosion and pitting. In parts, the sheet was affected all the way through (see figures 62 to 64).

Figure 62: Corroded cabin floor from the aft right area (label text reads cabin floor, aft right). Samples were taken from the zone marked in red for the subsequent microsections. The blue circle marks the cargo door's aft hinge.

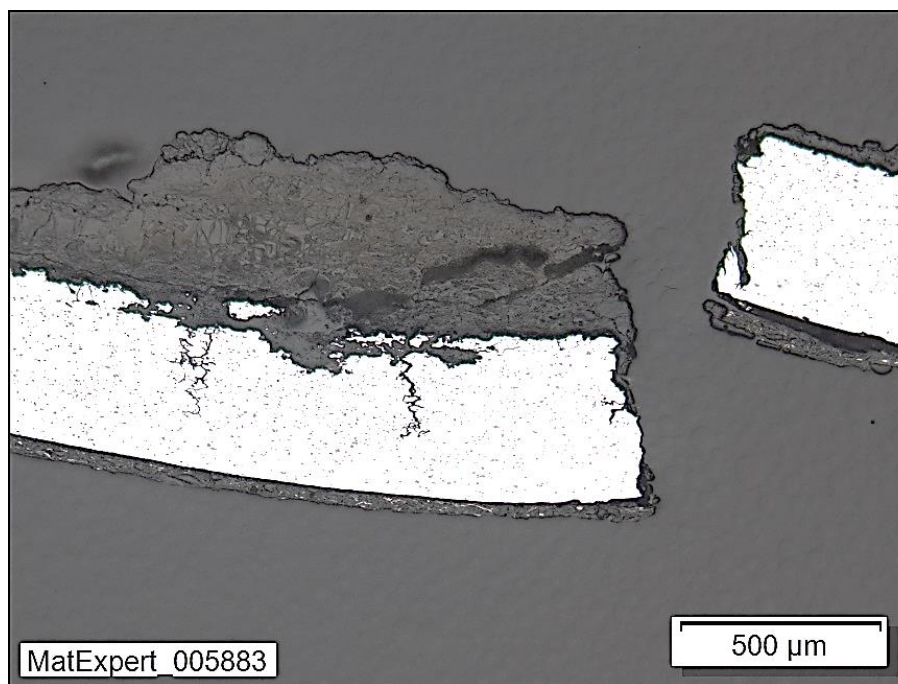
Figure 63: Microsection of the corroded sheet. Cracks with intergranular corrosion.

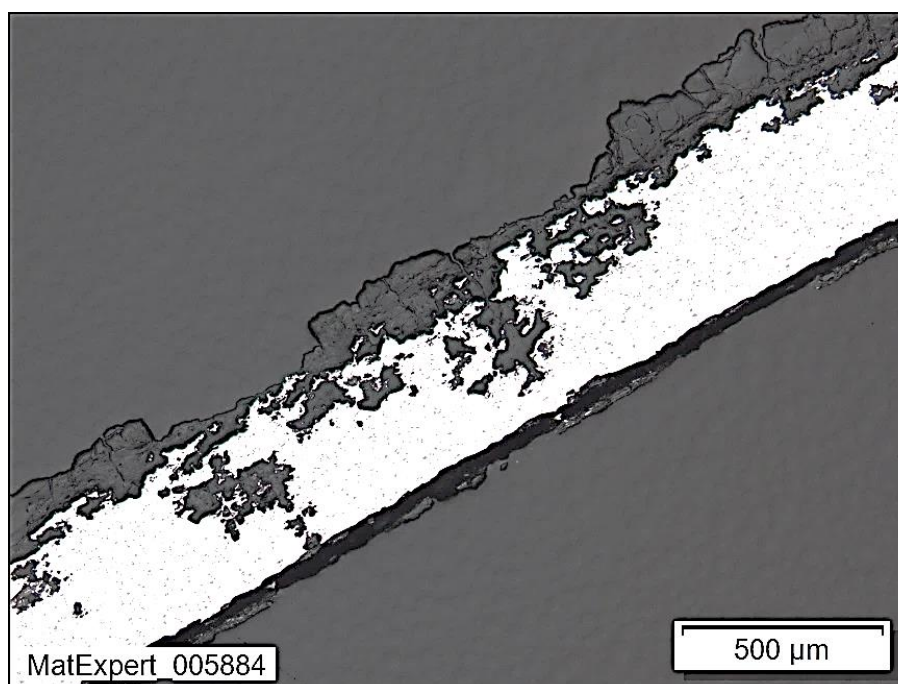
Figure 64: Microsection of the corroded zone; intergranular corrosion and pitting.

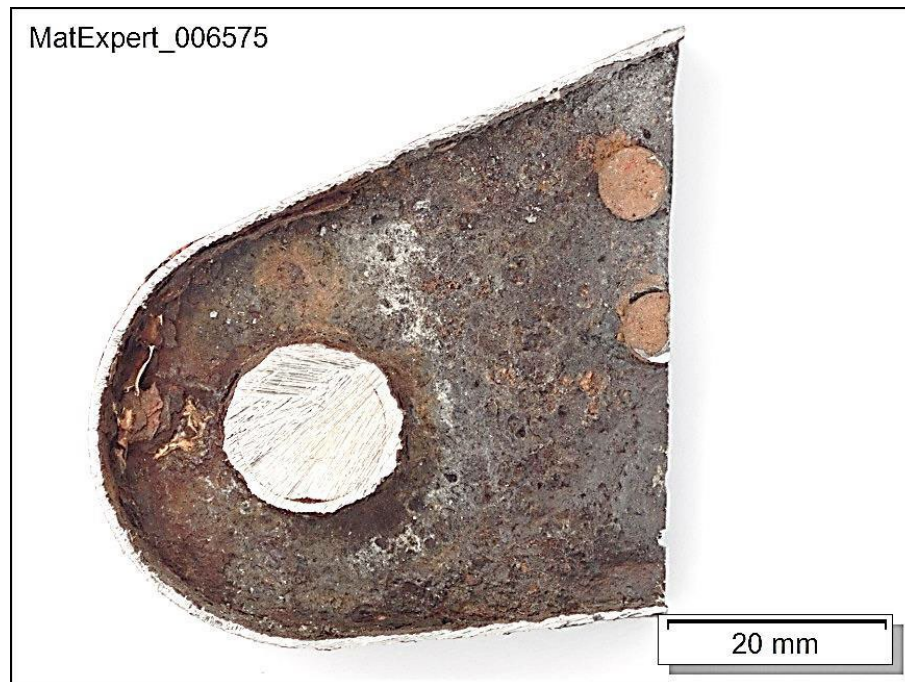
The hinge of the cargo door made of steel was severely corroded. Some of this corrosion was very advanced (see figure 65).

Figure 65: Severely corroded inner side of the cargo door hinge.

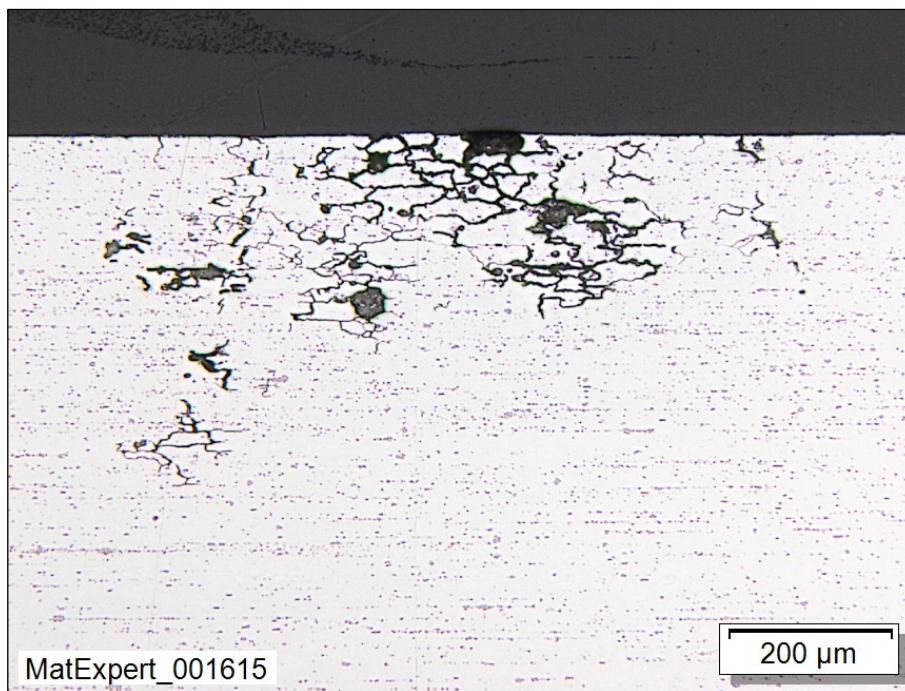
Intergranular corrosion was found in lower spar section L1 (see figure 66), while on section 1Ru, pitting, as is common for this material, was found (see figures 67 and 68). The former only occurs when the material does not conform with the specifications and is the result of artificial ageing or thermal stress and grain boundary precipitation.

Figure 66: Microsection of lower spar L1 with intergranular corrosion.

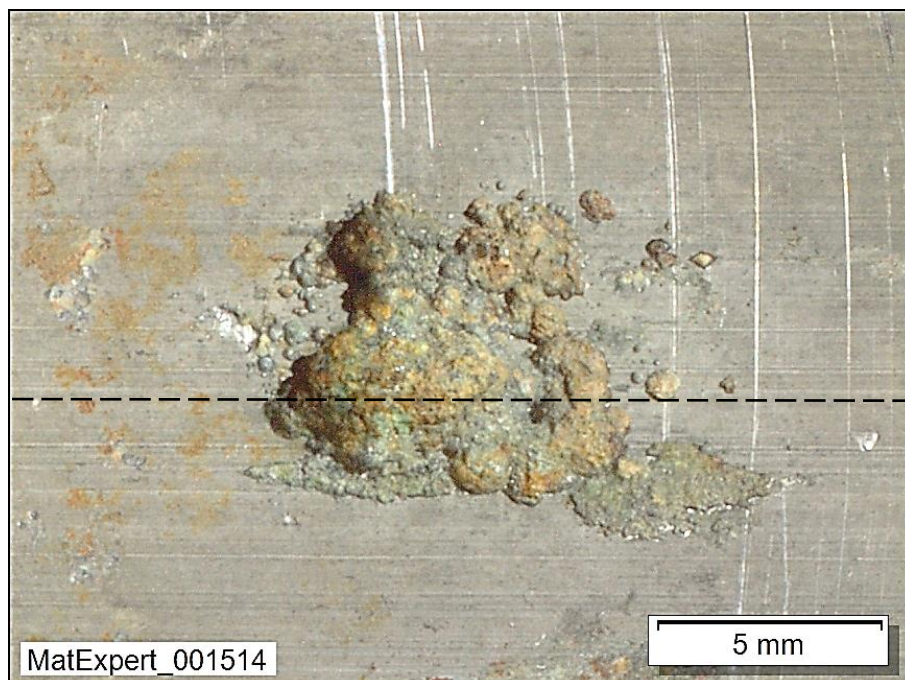
Figure 67: Pitting on spar section 1Ru (line of cross section, see figure 68).

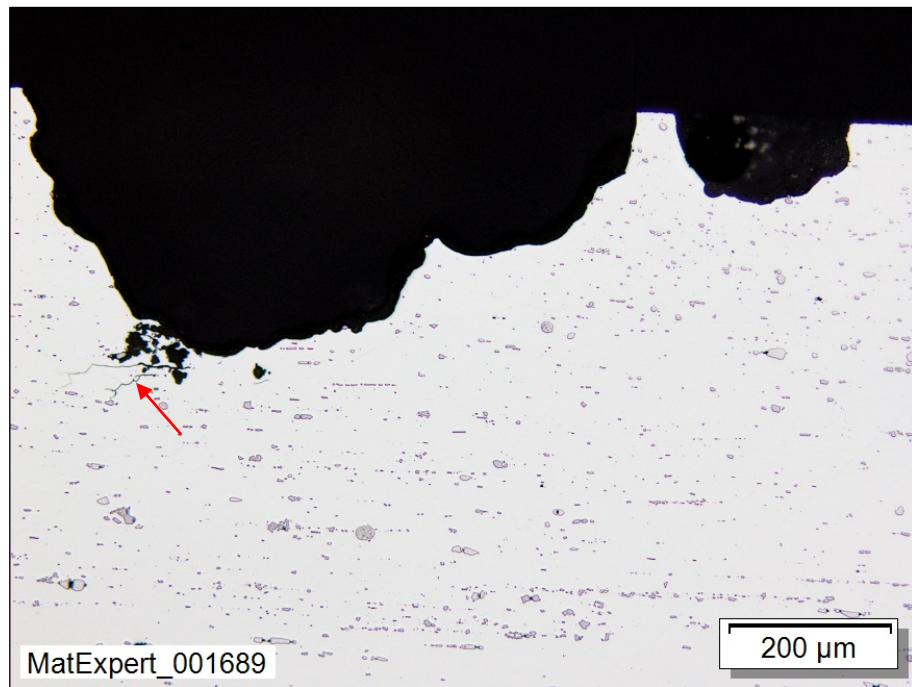
Figure 68: Microsection along the line as indicated in figure 67 with severe pitting and individual stress cracks (arrow).

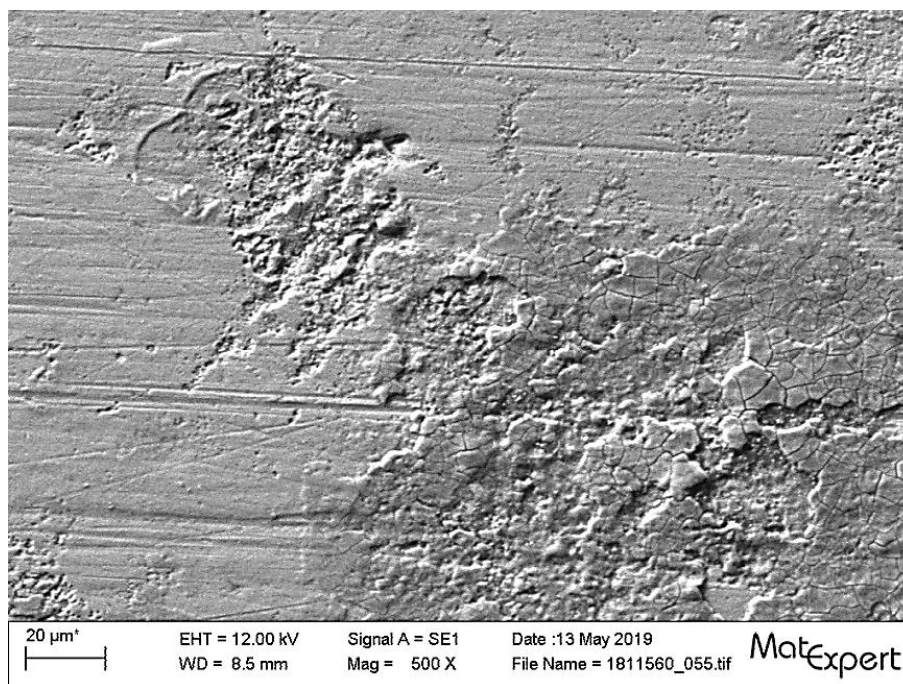
Figure 69: Outer surface with corrosion and corrosive damage.

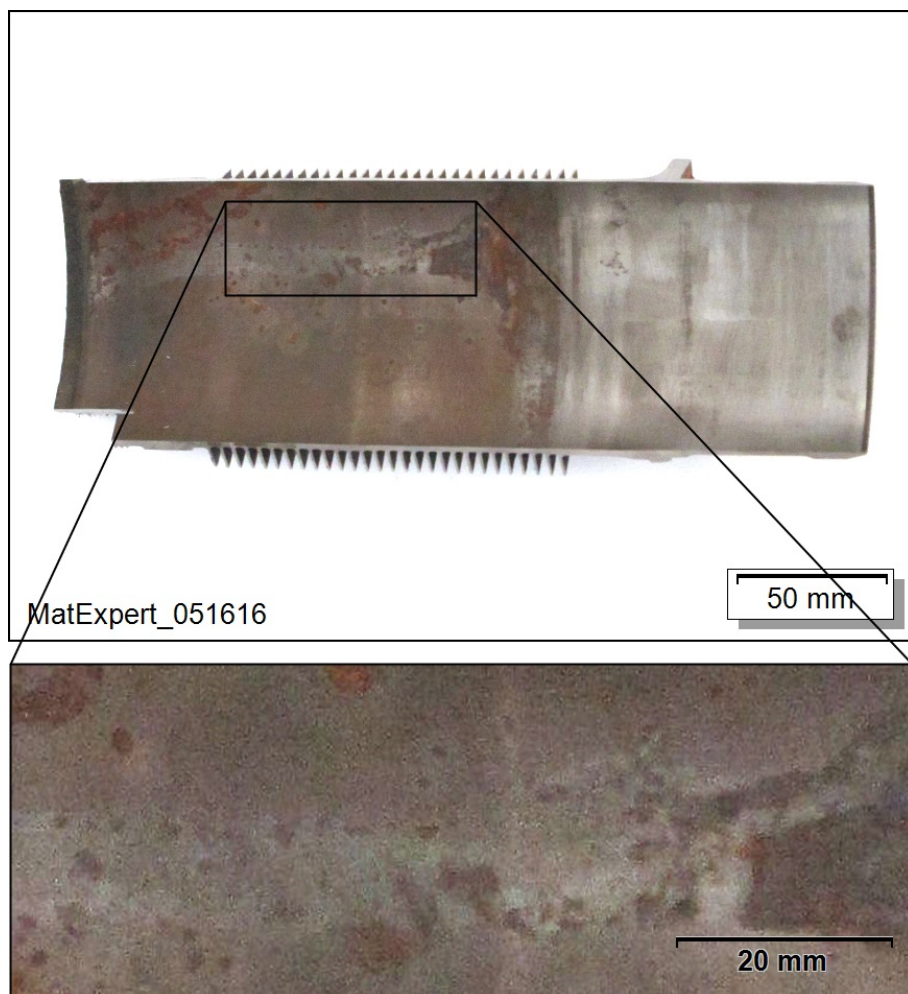
This corrosion was identified as rust, which explains the red discolouration of the bore. The cause of the bond coat's detachment from the cylinder barrel (see figure 72) is indication of pre-existing corrosion damage.

Figure 71: Right engine, bore of cylinder 1 – rusty surface.

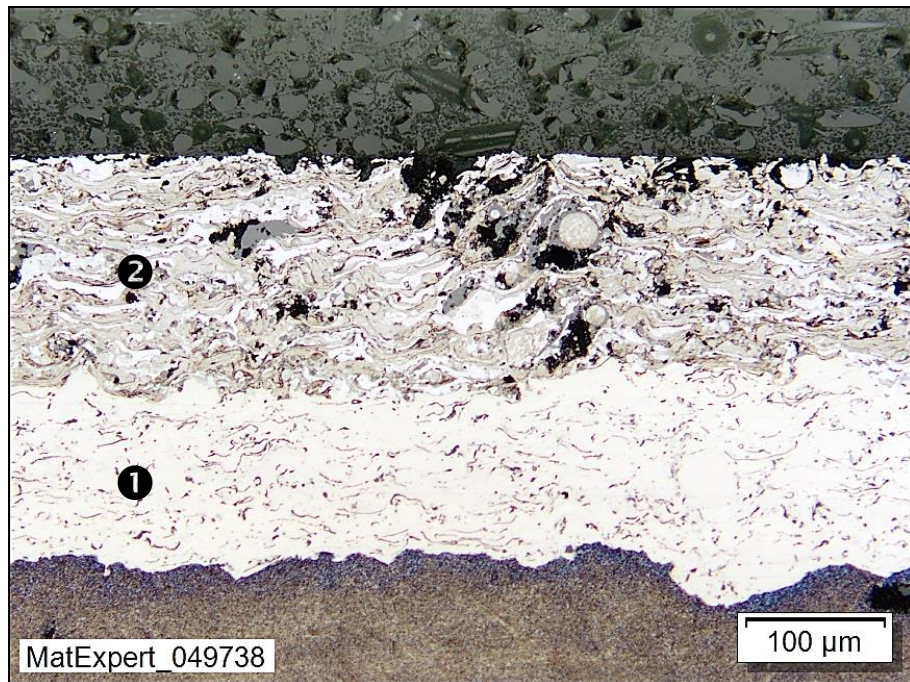
Figure 72: Close-up of the bore of cylinder 1 with two-layer thermal spray coating. Number (1) is the bond coat. Number (2) is the top coat, which is partially open-pored.

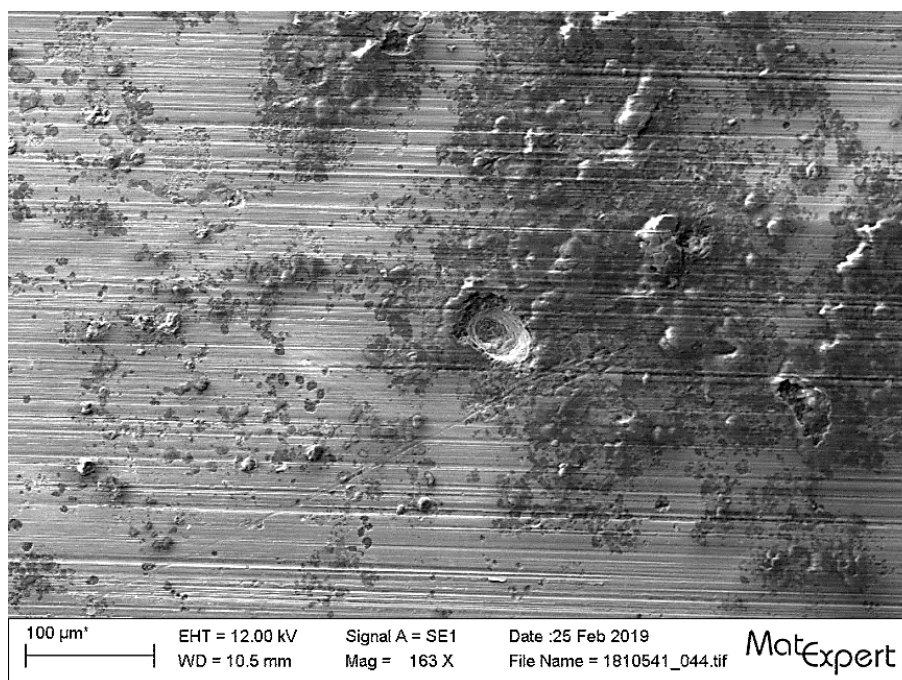
Figure 73: Ball bearing from the left engine, inner-race bearing track – corrosion.

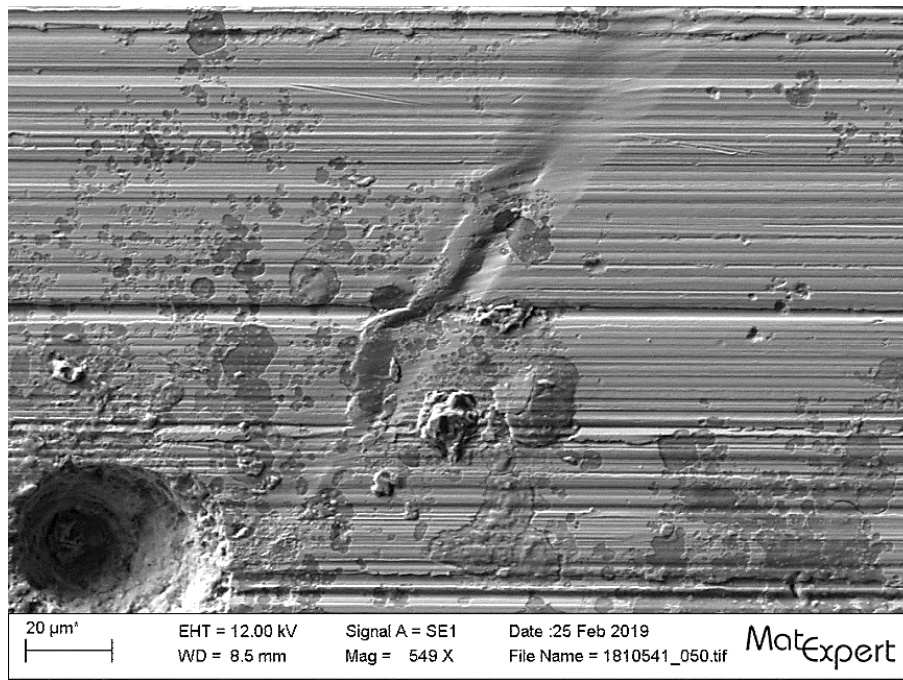
Figure 74: Ball bearing from the left engine, inner-race bearing track – pitting and indentation.

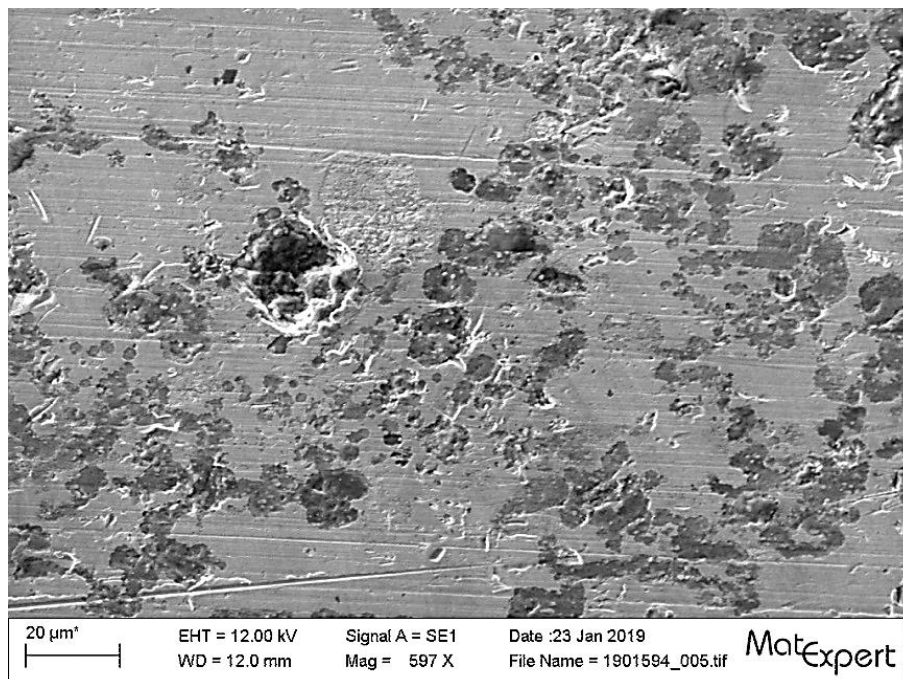
Figure 75: Ball bearing from the centre engine, inner-race bearing track – corrosion.

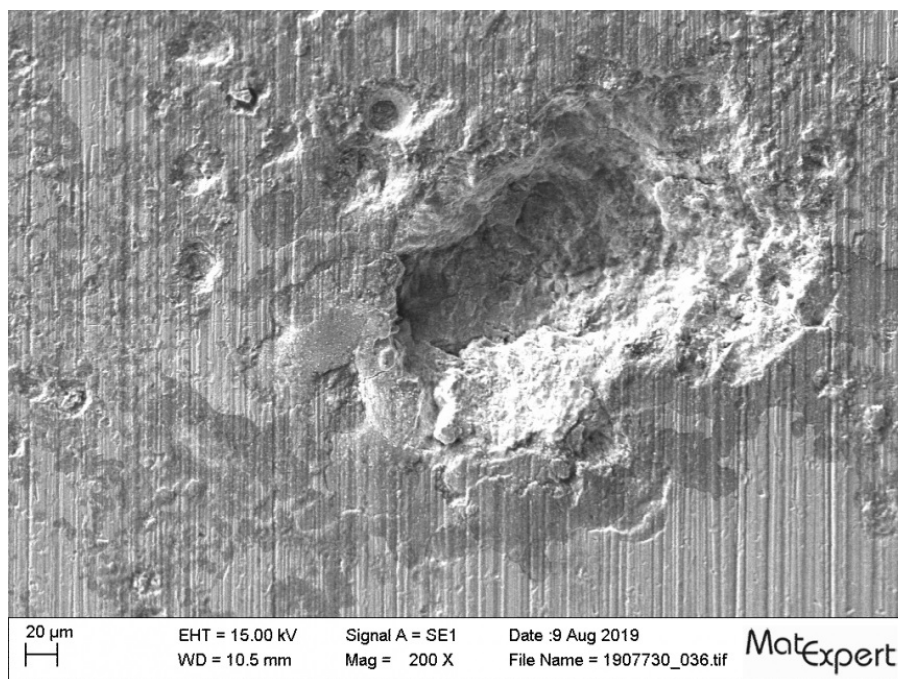
Figure 76: Bearing no. 3, outer-race bearing track – pitting.

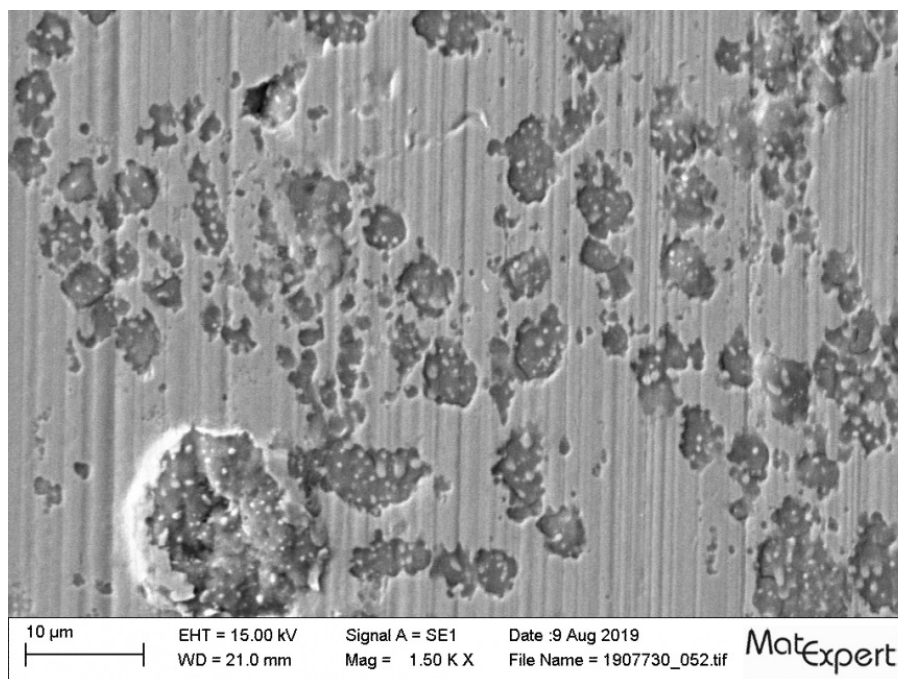
Figure 78: Close-up of figure 77.

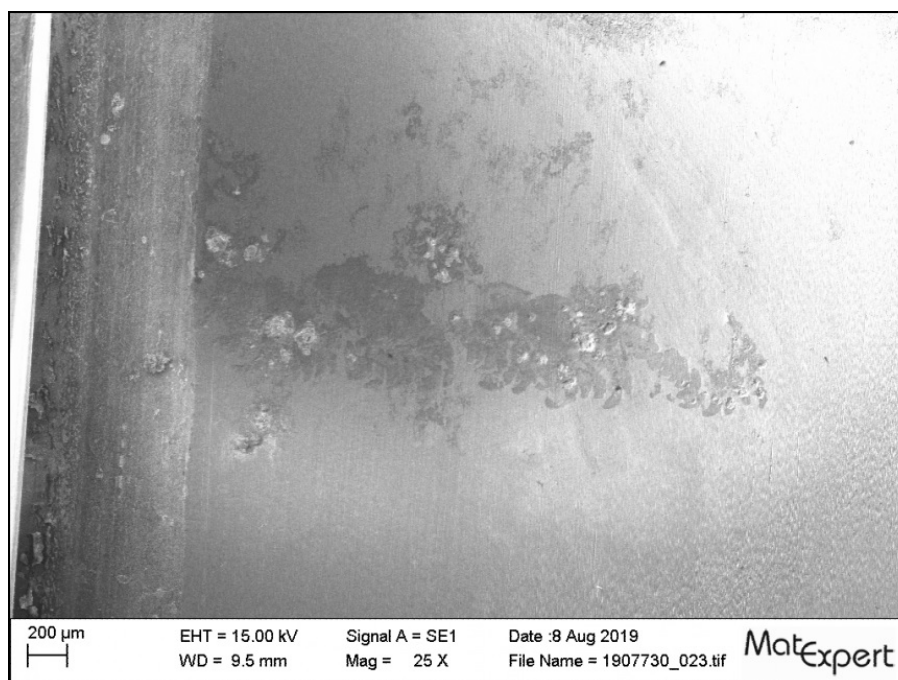
Figure 79: Bearing no. 3, inner-race bearing track – pitting and filiform corrosion.

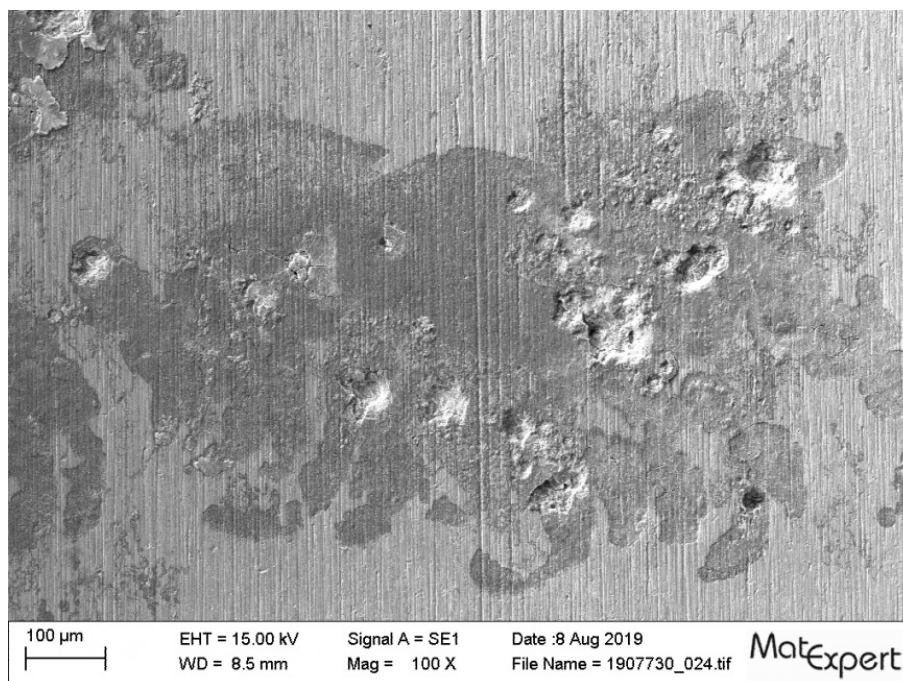
Figure 80: Close-up of figure 79.

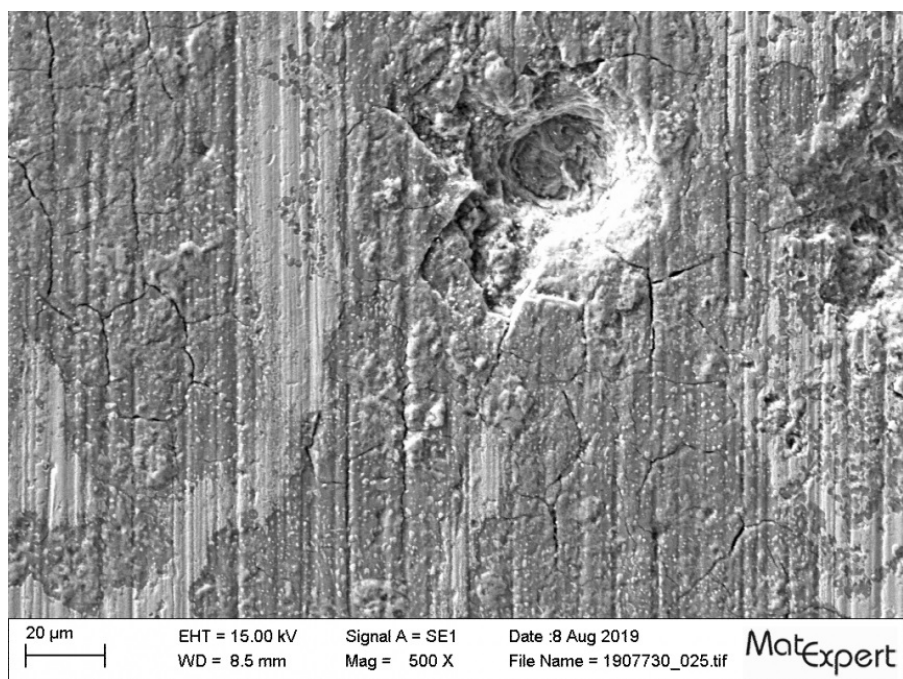
Figure 81: Close-up of figure 80 – stress cracks in the corrosion.

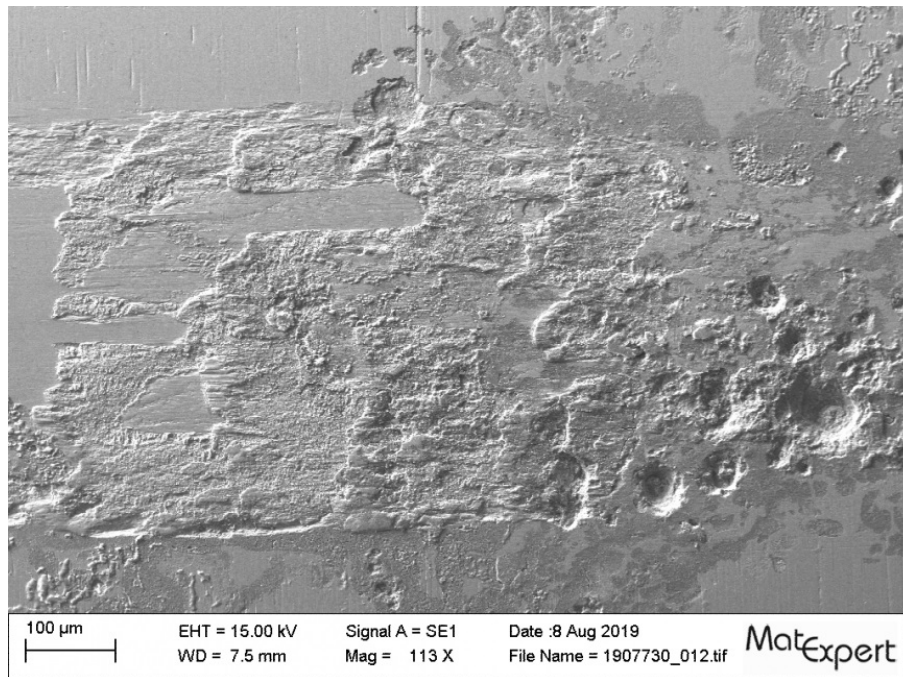
Figure 82: Bearing no. 3, cylindrical roller – pitting and corrosion.

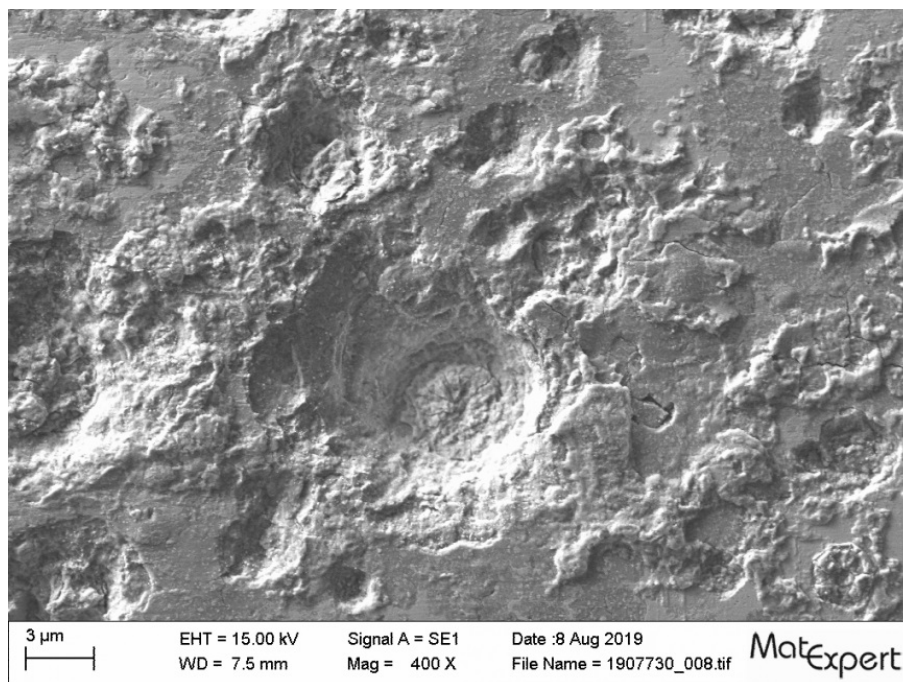
Figure 83: Close-up of figure 82.
