A1. Factual information

A1.16 Tests and research results

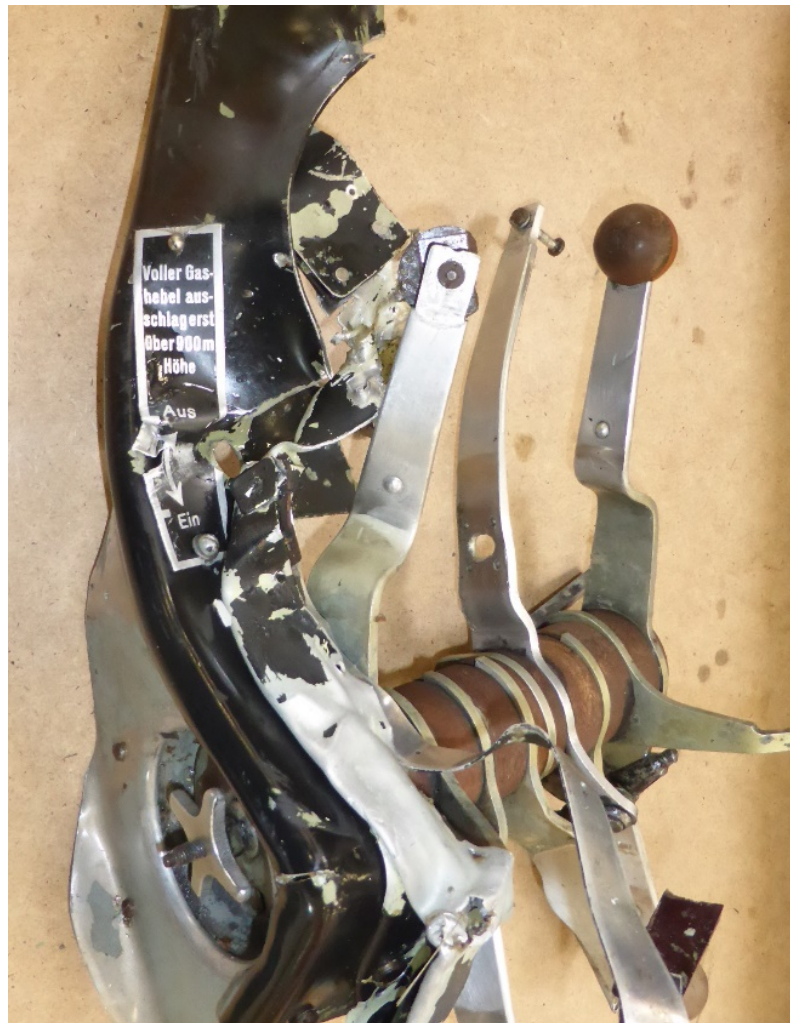
The control panel for main and high-altitude throttle regulation was severely damaged. The main throttle levers were deformed (see figure 86).

Figure 86: Deformed main throttle levers.

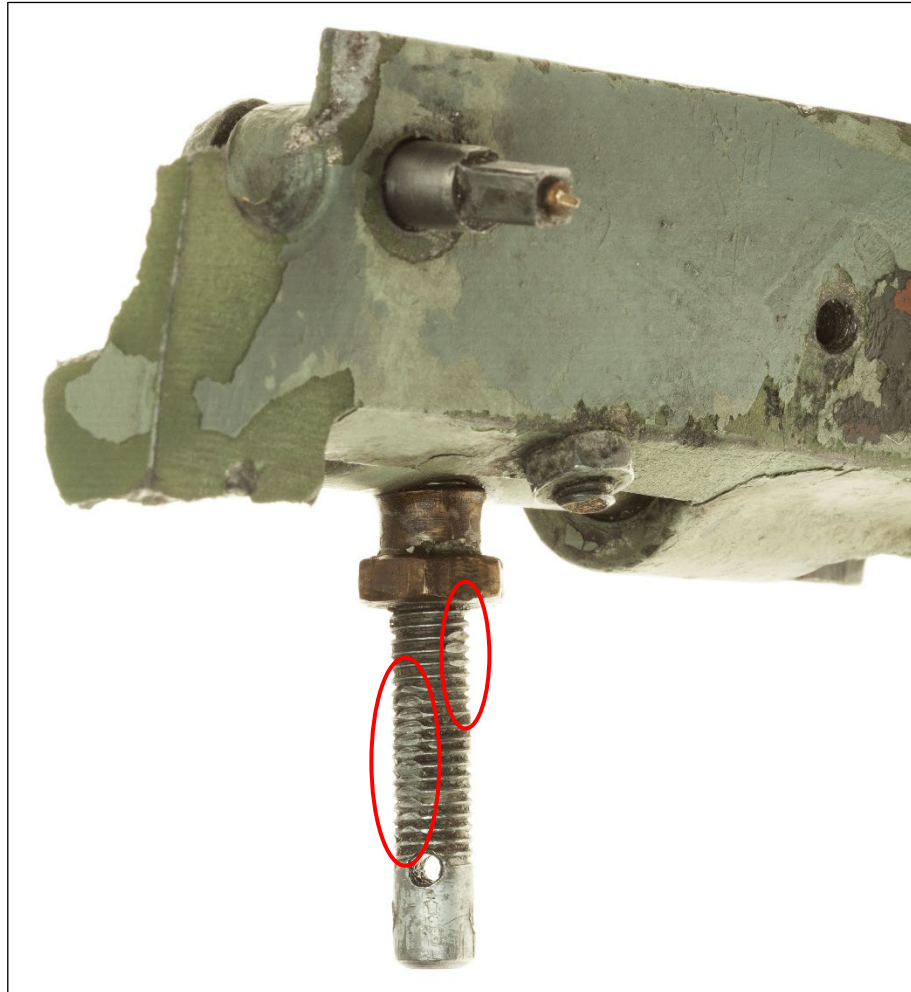
Figure 90: Limiting stop bolt for the left engine with damaged thread.

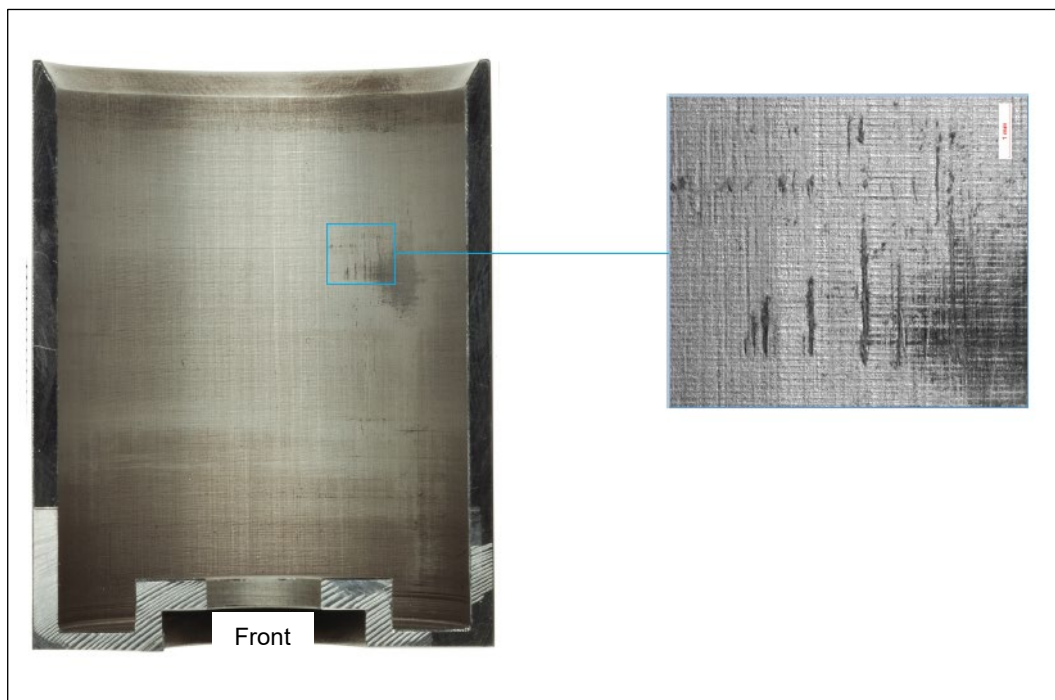
Figure 93: Abrasions in the pump cylinder from the carburettor for the left engine.
