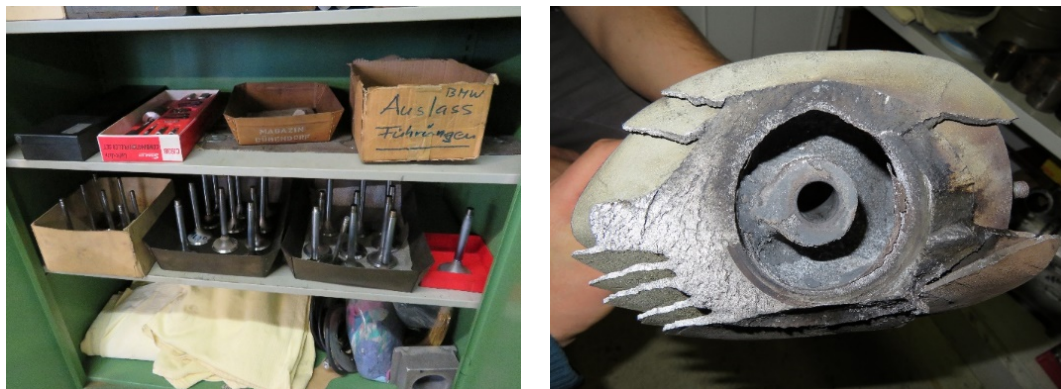
The STSB also discovered after the accident that, at Ju-Air, the components stored in the hangar were neither marked with a tag nor with a release certificate for identification. Furthermore, the spare parts warehouse did not have identification papers for all components. In Naef Flugmotoren AG's engine workshop, there were engine components which were also unidentifiable (see figure 2).

Figure 2: Unidentifiable engine components stored in a cabinet.
