**A1. Factual information**

**A1.19 Useful or effective investigation techniques**

A1.19.1 Use of data memories from mobile phones and cameras

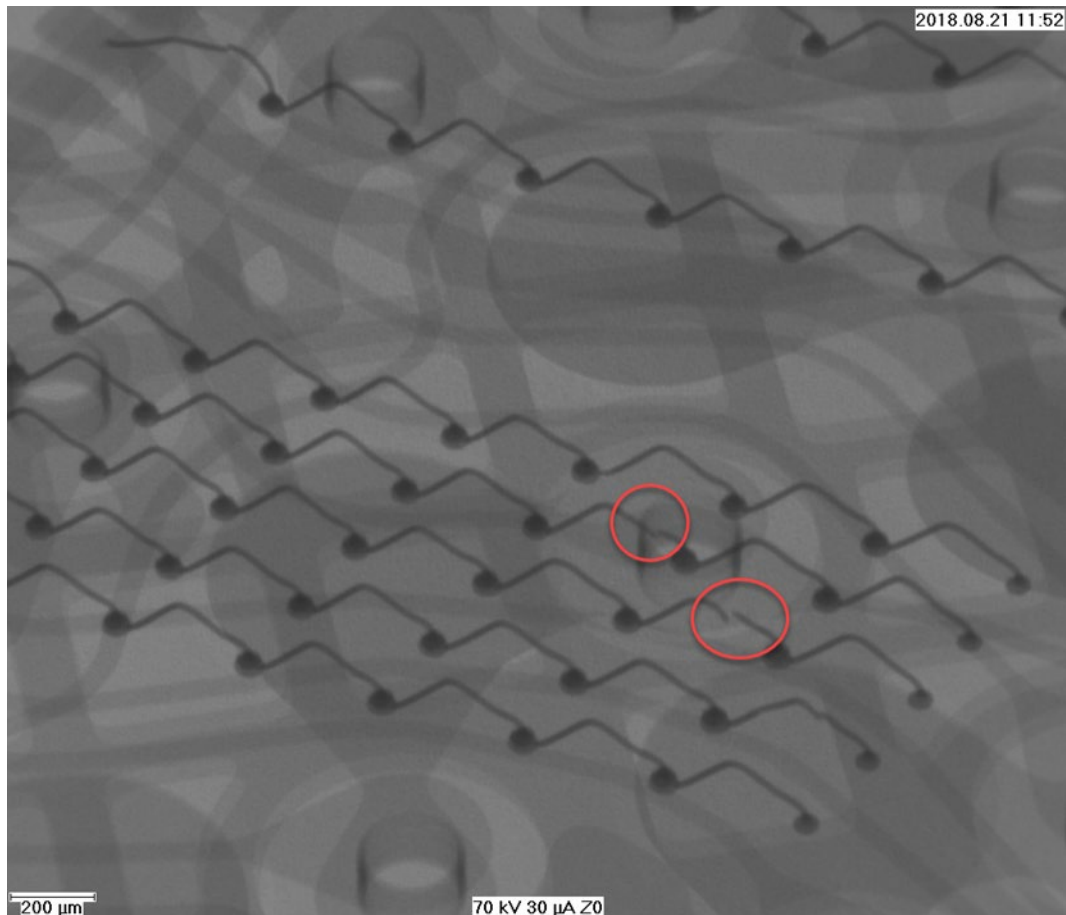
SD cards that could not be repaired using IT forensics were also analysed using a CT device. Their internal circuitry and the silicon blocks in the data storage units were assessed for damage (see figure 2).

**Figure 2:** Heavily magnified CT scan of an SD card. Damage to the circuitry within is circled in red. Source: BEA.

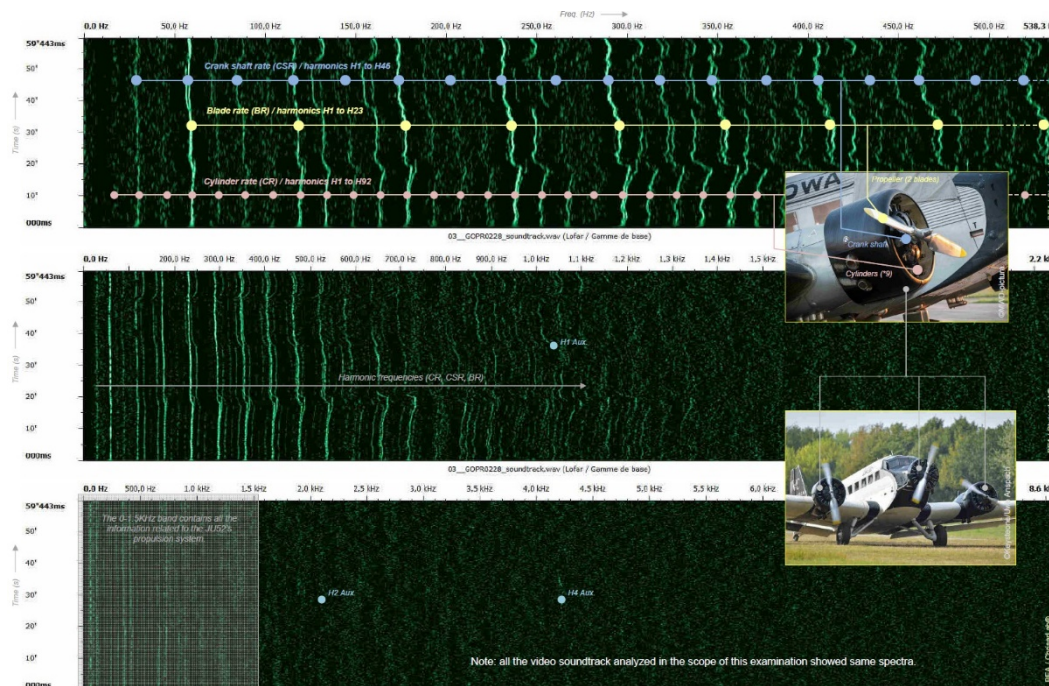
**Figure 3:** Example of a sonogram for a video recording from the cockpit of HB-HOT. The identified components CSR (blue), CR (pale red) and BR (yellow) are labelled. The images of the aircraft show the components. Here, the y-axis describes the time and the three x-axes describe the frequencies in three different amplifications. The harmonic frequencies of the main signal caused by interferences are also visible. Source: BEA.

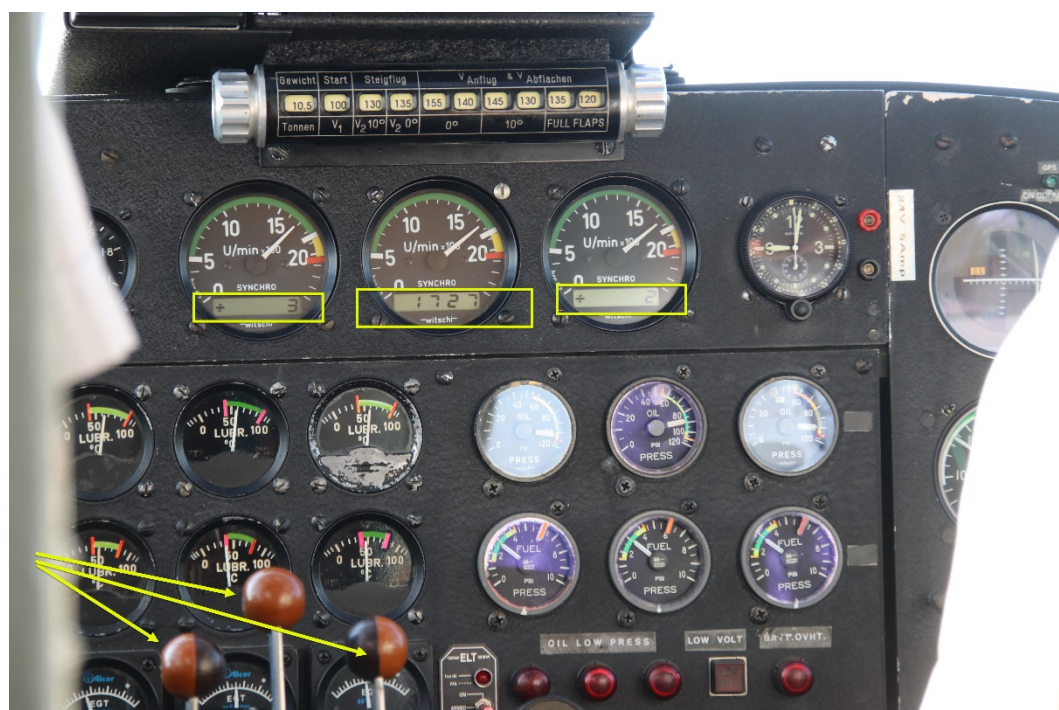
In the cockpit, the engine speed (rpm) is displayed on three tachometers featuring analogue and digital gauges. The digital gauge in the middle shows the speed of the centre engine. The digital gauges for the left and right engines each show the difference in speed for the respective engine in relation to the centre engine. In figure 4, the digital gauge for the centre engine shows a speed of 1,727 rpm. The left engine tachometer displays a value of + 3 (1,730 rpm); the right engine tachometer displays a value of + 2 (1,729 rpm).

**Figure 4:** Tachometers with digital displays, marked by yellow rectangles. The yellow arrows point to the three throttle levers that must be operated to set the respective rpm.

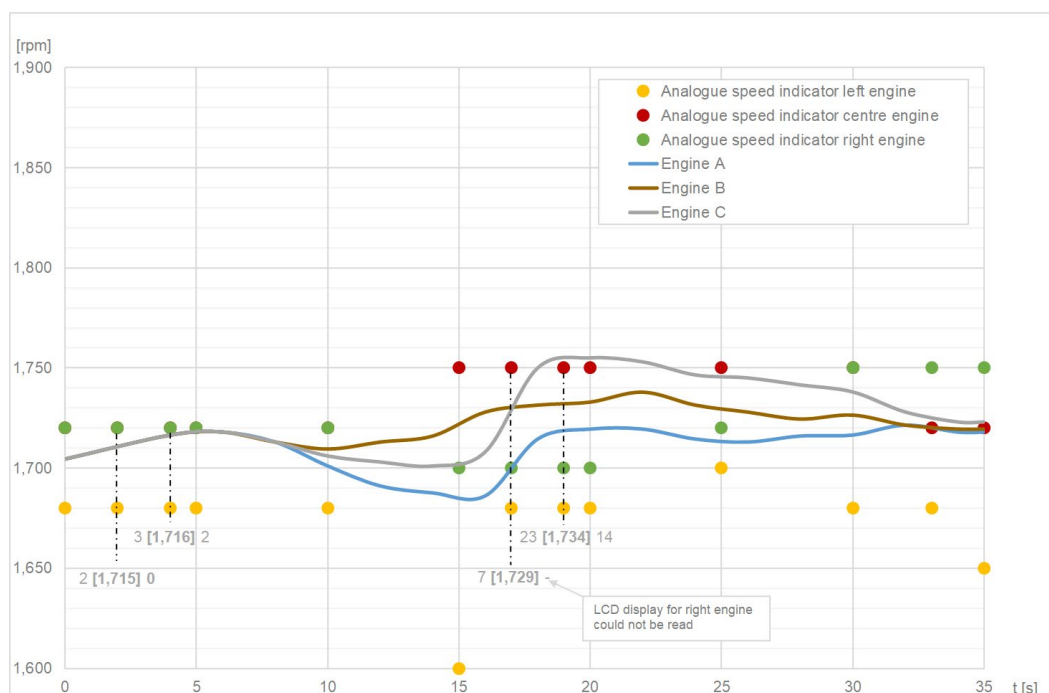
**Figure 5:** Graph of the engine speeds from HB-HOT over the course of the video footage recorded whilst flying past Mount Rigi on 3 August 2018.

In the first phase of the fly-by, the engine speeds were between 1,700 and 1,720 rpm. After 15 seconds, the speeds of engines A and C were increased by 20 to 30 rpm, now ranging between 1,720 and 1,750 rpm. The speed of engine A never exceeded 1,720 rpm.

The graph reveals that there are considerable discrepancies between the speeds determined from sonogram analysis and those read from the still images displayed in analogue form on the gauges. At 20 seconds, for example, the speed from the sonogram ranges between 1,720 and 1,750 rpm, whilst the values read from the analogue gauges range from 1,680 to 1,750 rpm.

At the 2-, 4-, 17- and 19-second marks in the video footage, it was also possible to read the three digital tachometers from the respective still images. This established that the four readings corresponded rather accurately to the respective sonogram analysis speeds.
