Final Report No. 2370

by the Swiss Transportation Safety Investigation Board STSB

on the accident involving
the Junkers Ju 52/3m g4e
commercial aircraft, HB-HOT,

on 4 August 2018

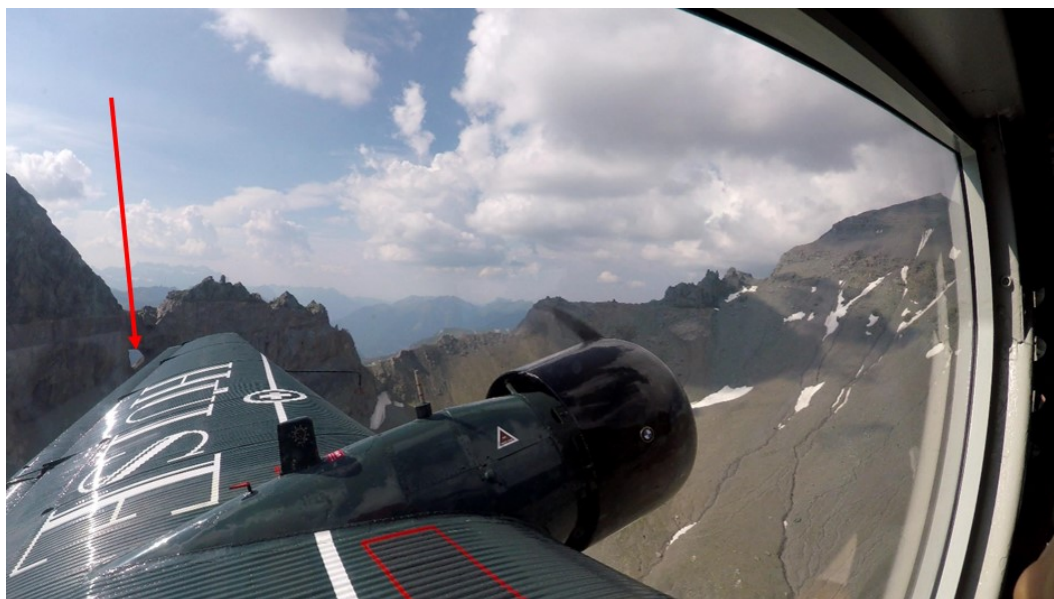
Figure 3: Still image from a video at point F10, recorded from the cabin of HB-HOT looking towards the Martinsloch (red arrow). The pitch attitude was 11.0 degrees, the left bank attitude 4.8 degrees and the altitude 2,749 m AMSL. The difference between the flight path angle and the pitch angle was 20.6 degrees.

During roughly the next 4 seconds, the aircraft descended by 25 m and the already negative flight path angle became even more negative, which is clearly apparent when comparing figures 3 and 4 as well as in figure 5.

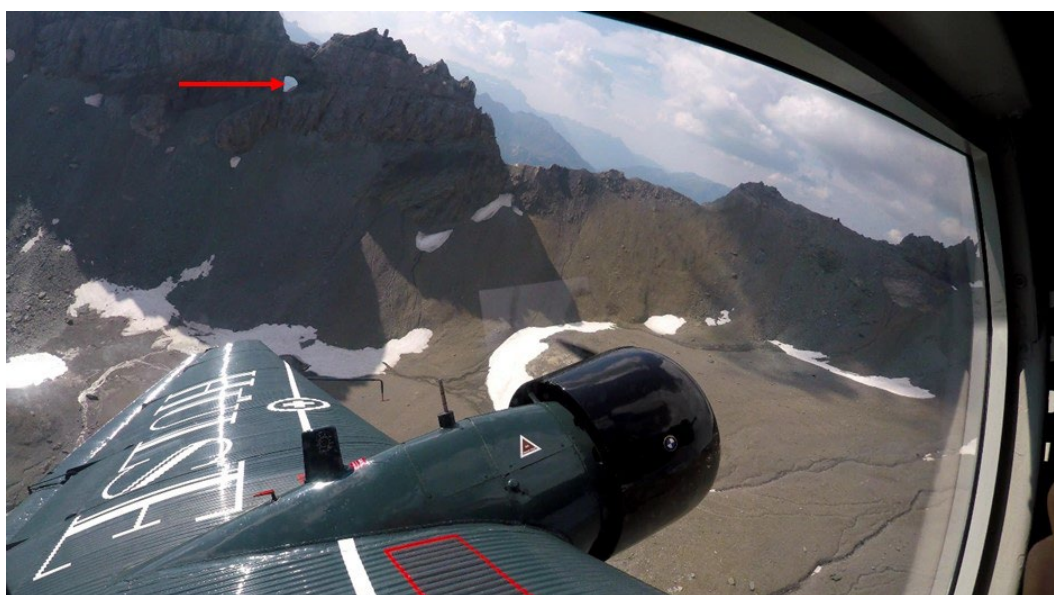
Figure 4: Still image from a video at point F13, recorded from the cabin of HB-HOT looking towards the Martinsloch (red arrow), 4.3 seconds after the image shown in figure 3 was taken. The pitch attitude was 12.1 degrees, the left bank attitude 32.7 degrees and the altitude 2,724 m AMSL.

After point F13, the roll to the left increased steadily and did not decrease even when a significant aileron deflection to the right was made. The ailerons were then brought into a neutral position and temporarily deflected into a position for a left turn.

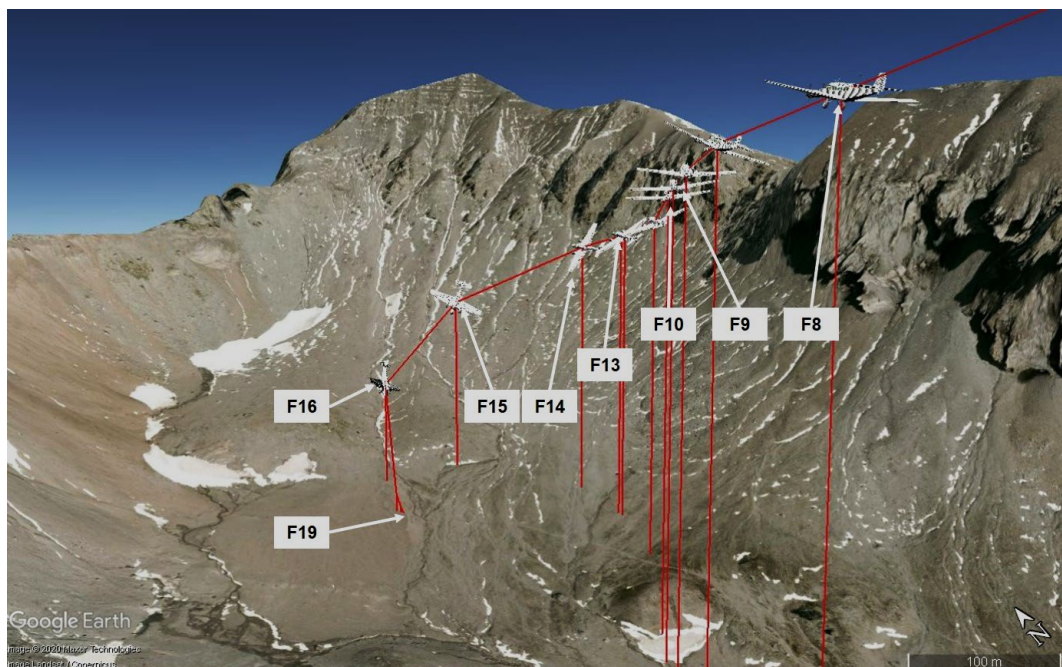
At the same time, the pitch attitude began to decrease and the flight path ran increasingly steeper downwards whilst the left bank attitude constantly increased (see figure 6).

Figure 6: Photogrammetrically reconstructed flight path of HB-HOT on 4 August 2018 (red) between point F8 and the site of the accident (F19), with Piz Segnas in the background; shown on Google Earth. The aircraft has been enlarged by a factor of 2.5 to make it easier to see.

During this last flight phase, the aircraft experienced low-frequency vibrations. Ultimately, when the aircraft was 108 m above ground (point F16, see figures 6

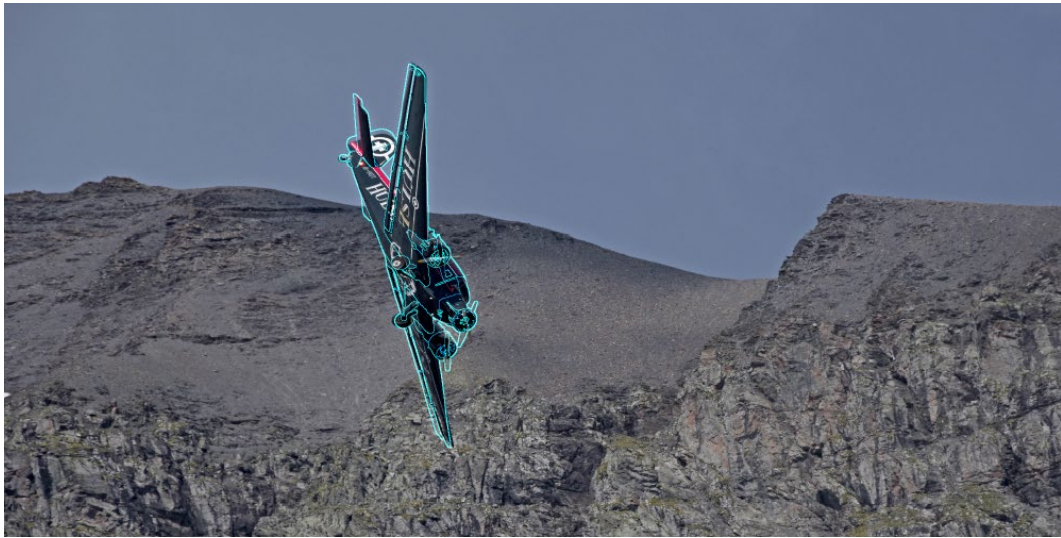
and 7), its longitudinal axis was pointing downwards by 68 degrees from horizontal. By this time, the elevator had deflected upwards by approximately 13 degrees and the rudder was pointing 2 degrees to the right.

Figure 7: Image showing HB-HOT at point F16, including a superimposed three-dimensional model of an identical Ju 53/3m g4e (light blue) for the purpose of determining attitudes, wing deflection and deflections of the control surfaces. The direction of view is north-eastwards, the southern spur of Piz Segnas is visible in the background.

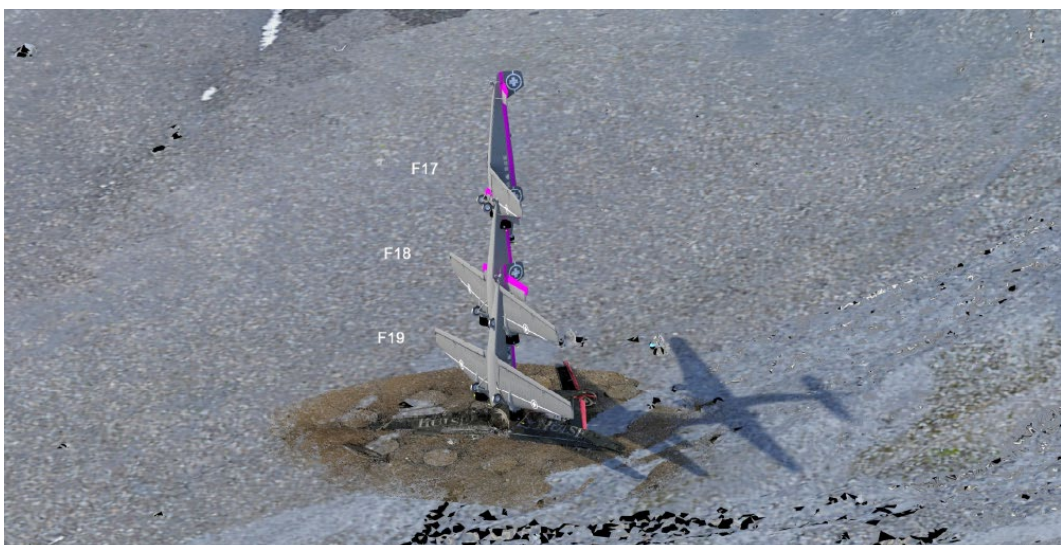
The roll to the left accelerated significantly during this phase. Shortly after 16:57, the aircraft hit the ground in a vertical flight attitude with an almost vertical flight path and at a speed of approximately 200 km/h (see figure 8).

Figure 8: Reconstructed spatial positions and flight attitudes of HB-HOT before impact at points F17, F18 and F19. The three-dimensional model of an identical Ju 52/3m g4e is shown in the reconstructed 3D terrain model with a direction of view to the north. The final position of the wreckage and debris were left vague for a better overview.

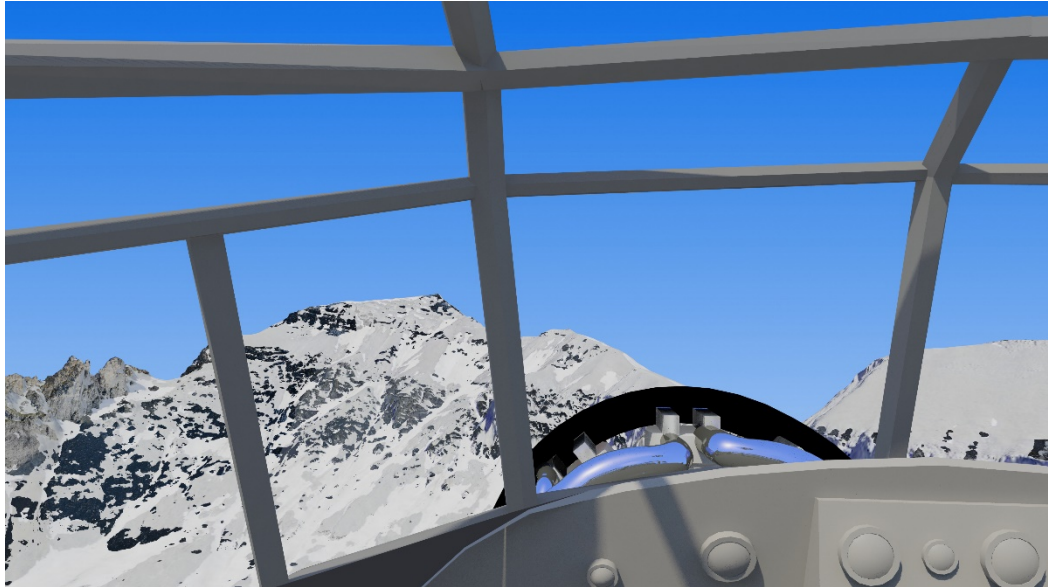
It is conceivable that due to their preoccupation with the engines and the view from the cockpit, which made it difficult to easily recognise the descent, the flight crew's increase in pitch attitude was made subconsciously in order to compensate for this (see figure 21). Furthermore, the fact that the centre of gravity was beyond the rear limit facilitated the process and made the aircraft more unstable around its pitch axis, which represents a factor that directly contributed to the accident.

Figure 21: Reconstructed view from the position of the commander of HB-HOT at point F9. Piz Segnas can be seen in the line of sight. Shown using a simplified model of the aircraft and the three-dimensional terrain model. The absence of visible reference points made it difficult to detect the descent caused by the downdraught.

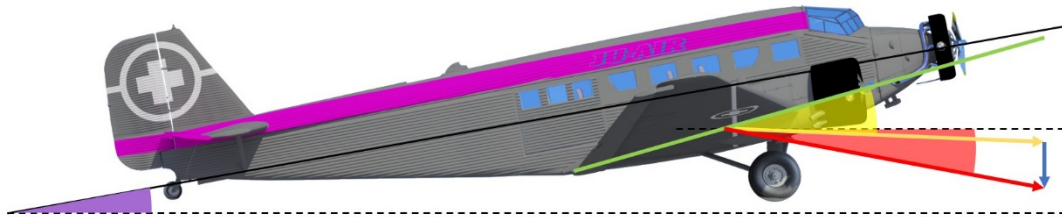
From an aerodynamic point of view, the stall can be explained as follows: HB-HOT had been caused to enter a descent by an area of downdraught. The descent in the downdraught, which was partially compensated by increasing the pitch attitude, led to a flight attitude close to the maximum angle of attack. Given this flight attitude, the additional increase in the angle of attack caused when flying into an updraught was sufficient to lead the airflow to at least partially stall. This development would not have been expected had the downdraught continued or eased slowly. The air currents observed in the basin indicate that the aircraft was moving from an area of downdraught into an area of updraught. A change in the vertical component of the wind's vector from a downdraught with a speed of 2 to 5 m/s to an updraught with a speed of 0 to 3 m/s was sufficient to exceed the critical angle of attack (see figures 22 and 23). As both the measurements and the airflow calculation have shown, even larger shear values were easily possible. Correspondingly turbulent conditions in the mountains are not unusual and become a risk when flying close to the terrain.

Figure 22: Stationary flight in an area of downdraught. Black line: longitudinal axis of the aircraft; Black dashed line: horizontal plane; Green line: chord line; Yellow vector: movement for the aircraft in relation to the area of downdraught; Blue vector: downdraught vector; Red vector: flight path (i.e. the resulting vector of movement for the aircraft in space); Purple angle: pitch angle (angle between the horizontal plane and the aircraft's longitudinal axis); Red angle: flight path angle (angle between the horizontal plane and the flight path); Yellow angle: angle of attack (angle between the direction of airflow, which is the inverse of the vector of movement for the aircraft in relation to the area of downdraught, and the chord line).

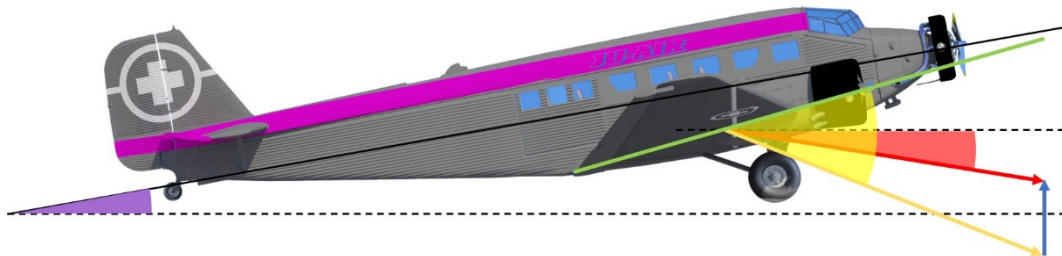
Figure 23: Entry into an area of updraught from an area of downdraught. The flight path vector (red) momentarily remains the same because of the inertia of the aircraft; Blue vector: updraught; Yellow vector: vector of movement for the aircraft in relation to the area of updraught. The angle of attack (yellow) increases considerably. Black line: longitudinal axis of the aircraft; Black dashed line: horizontal plane; Green line: chord line; Purple angle: pitch angle (angle between the horizontal plane and the aircraft's longitudinal axis); Red angle: flight path angle (angle between the horizontal plane and the flight path); Yellow angle: angle of attack (angle between the direction of airflow, which is the inverse of the vector of movement for the aircraft in relation to the area of updraught, and the chord line).

It is therefore also one of the fundamental principles of flying in mountainous areas that the airspeed, and thus the energy of the aircraft, must be increased during turbulent conditions and when in closer proximity to the terrain, so that wind shear does not cause a stall, even if it would usually only do so for a short time. It must be ensured that the aircraft is not overloaded by gusts or deflection of the control surfaces, so that the calculated manoeuvring speed lends itself to be the optimum speed. HB-HOT had a true airspeed of approximately 180 km/h during this phase (when it encountered wind shear) which was roughly 55 km/h or 44 % above the stall speed in the prevailing conditions. This level of speed reserve is too small for the turbulence that is common in the mountains.
