F I N A L R E P O R T

concerning the accident
which occurred on June 26th 1988
at Mulhouse-Habsheim (68)
to the Airbus A 320, registered F-GFKC

November 29th 1989

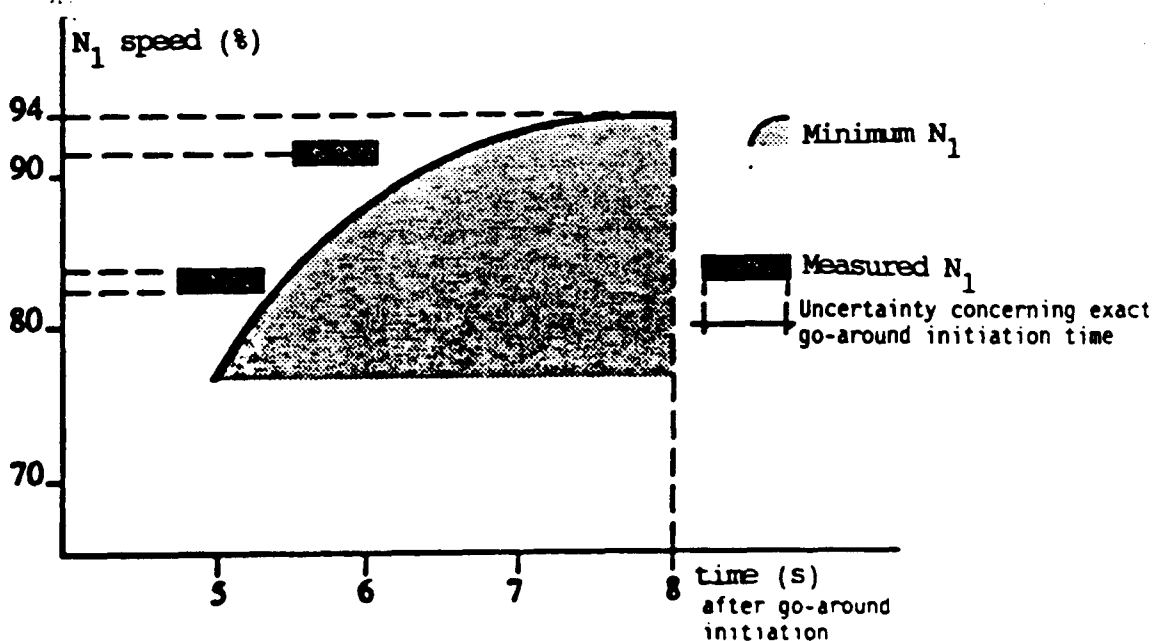
The speeds measured by external means are 91 % 0.6s after having reached 83 %.

Under these conditions, the curve below compares these recorded speeds to the minimum speeds required to meet the certification requirements. We can conclude that the engine acceleration was in compliance with these requirements.

It was thus verified that the engine acceleration defect sometimes reported in certain low altitude flight cases on the A 320 did not occur during the flight on June 26th. Also, the conditions required for this to occur were not present (speed much lower than 250kt).

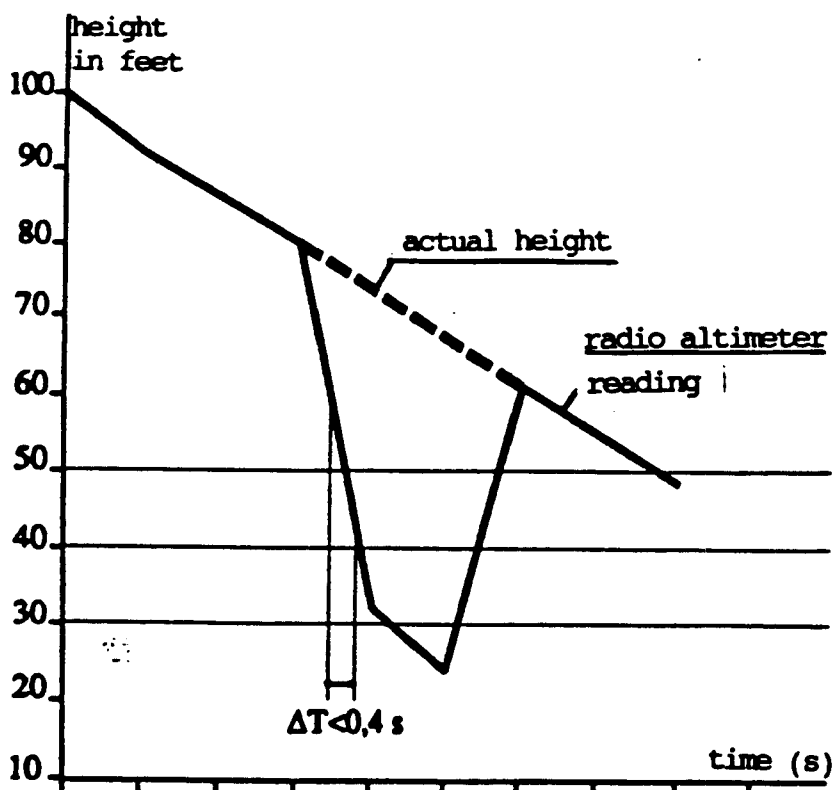
In case of the flight made on June 26th, when the actual height of the aircraft was decreasing continuously from 100 to 50 feet between 12h 45mn 15s and 12h 45mn 23s, there was a discontinuity in the radio altimeter information between 12h 45mn 18s and 12h 45mn 19s. The evolution of these readings was in compliance with the curve below :

This discontinuity comes from flight over a clump of trees located shortly before the runway. The 50 feet announcement, triggered by passing through a height of 52 feet, was inhibited as the 40 feet announcement was triggered, by passing through a height of 42 feet, less than 0.4 sec. after the 50 feet announcement had been triggered.

The 40 feet announcement was therefore made without the 50 feet announcement having been made and before the 30 feet announcement was triggered. This 30 feet announcement was inhibited as at the time when it should have been announced, the radio altimeter altitude was increasing.

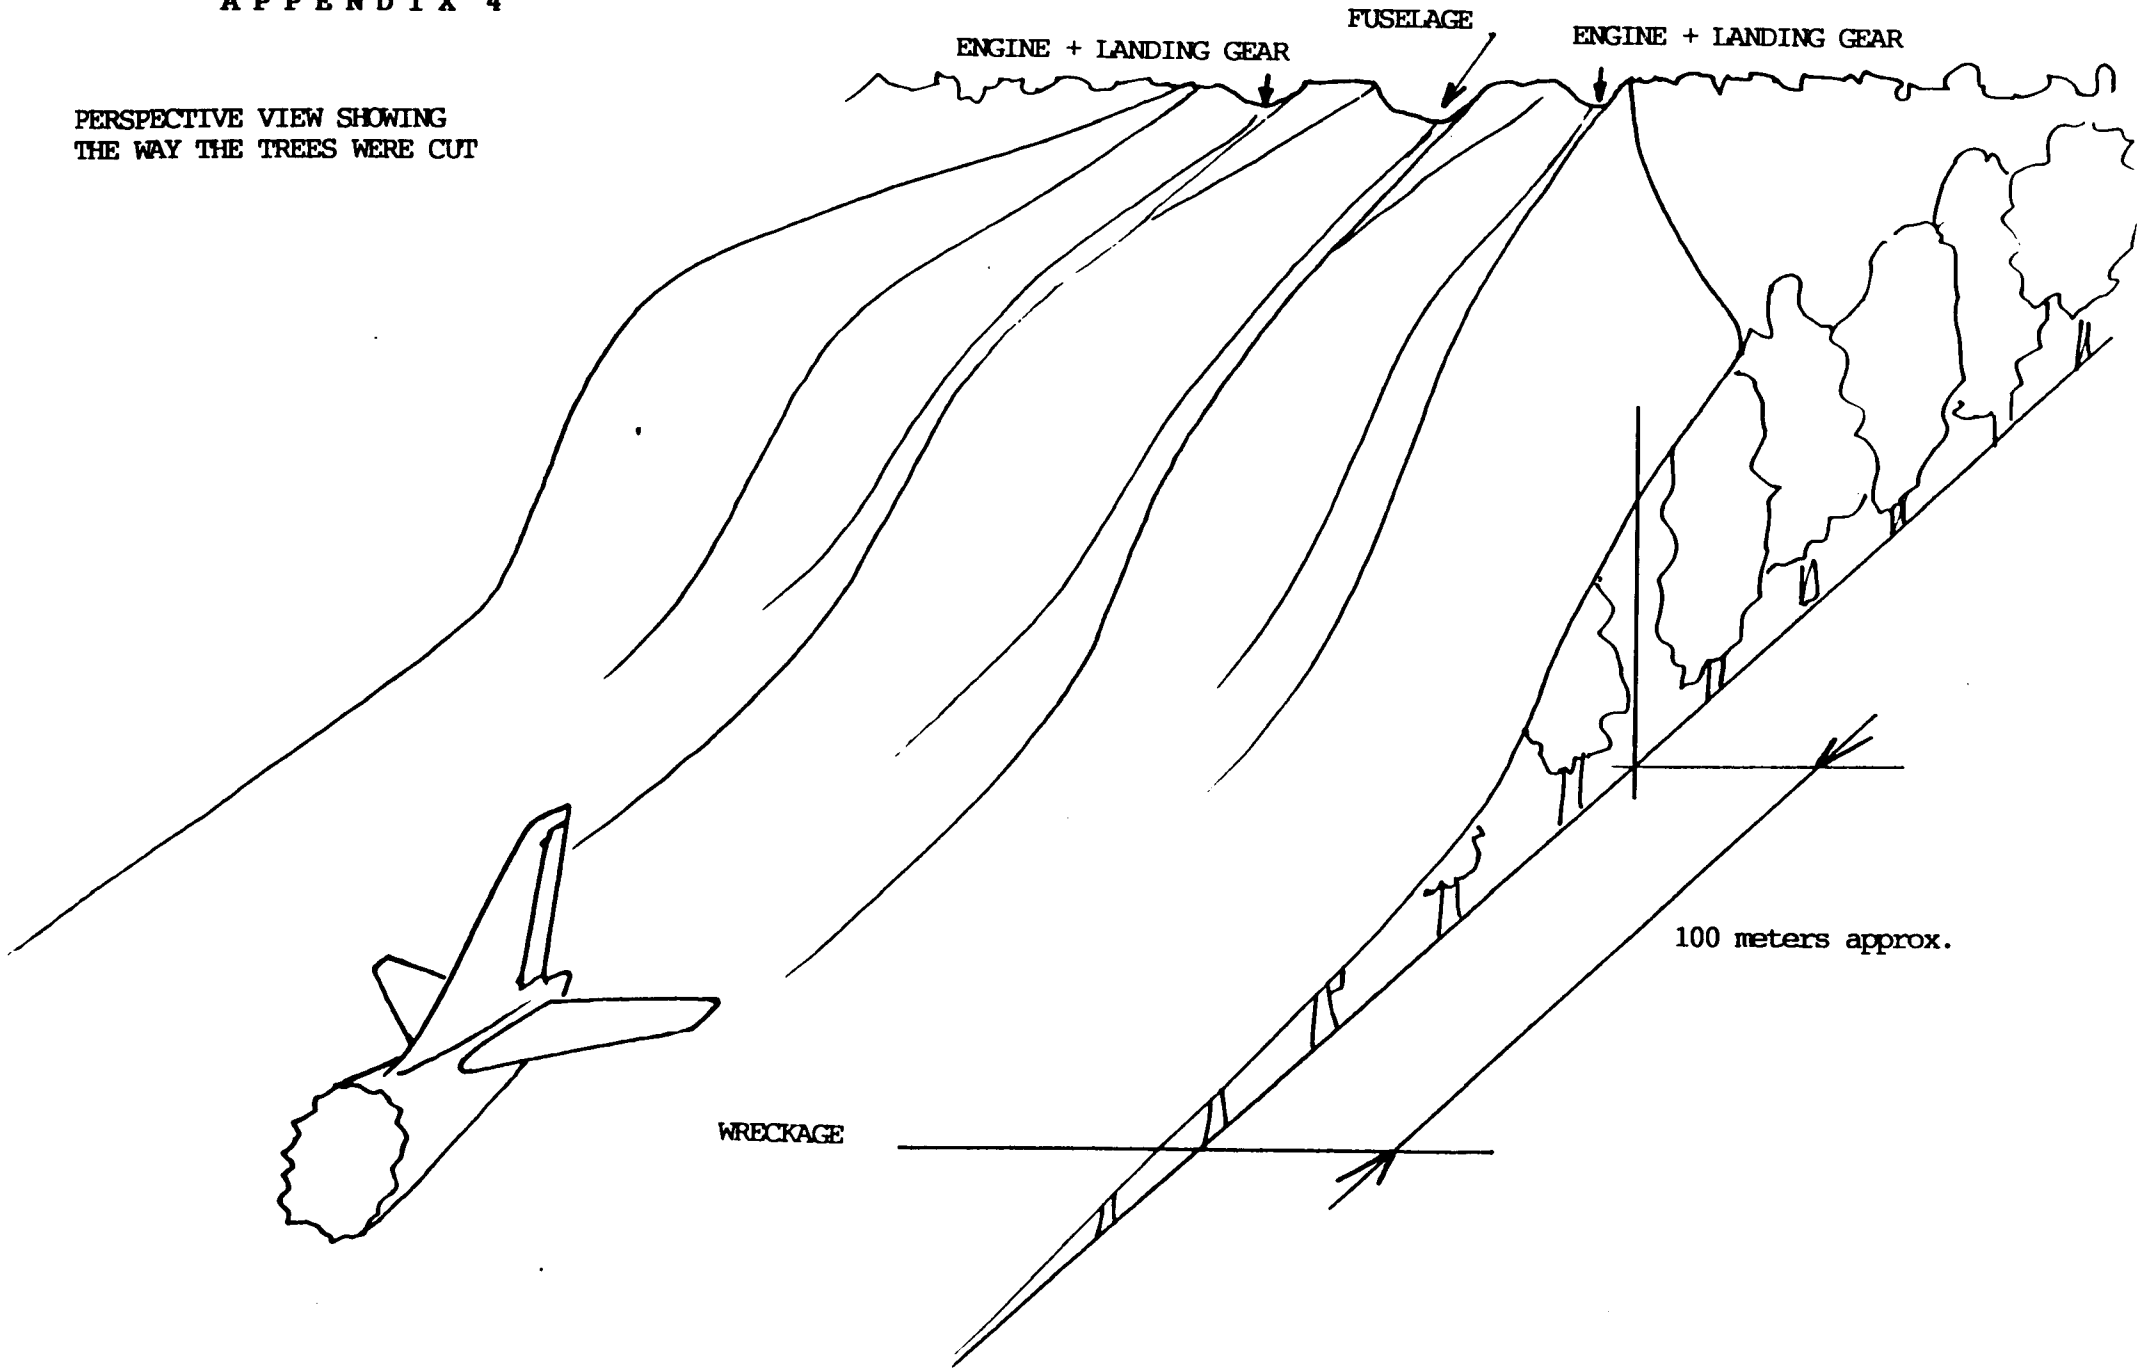
PERSPECTIVE VIEW SHOWING
THE WAY THE TREES WERE CUT

The evacuation of the various elements of the wreckage (especially for the investigation) required that these trees be felled. The heights of fracture were measured and plotted on a dimensioned drawing. This enabled an accurate path of the entry of the aircraft into the trees to be plotted.

Trees cut by the aircraft
