# AIRCRAFT INCIDENT REPORT

**Report by the Spanish Air Accidents and Incidents Investigation Commission (CIAIAC) into the incident to Boeing 747, TF-ATH at Madrid Airport, Spain on 14 September 2002**

**M-07302/AIG-26**

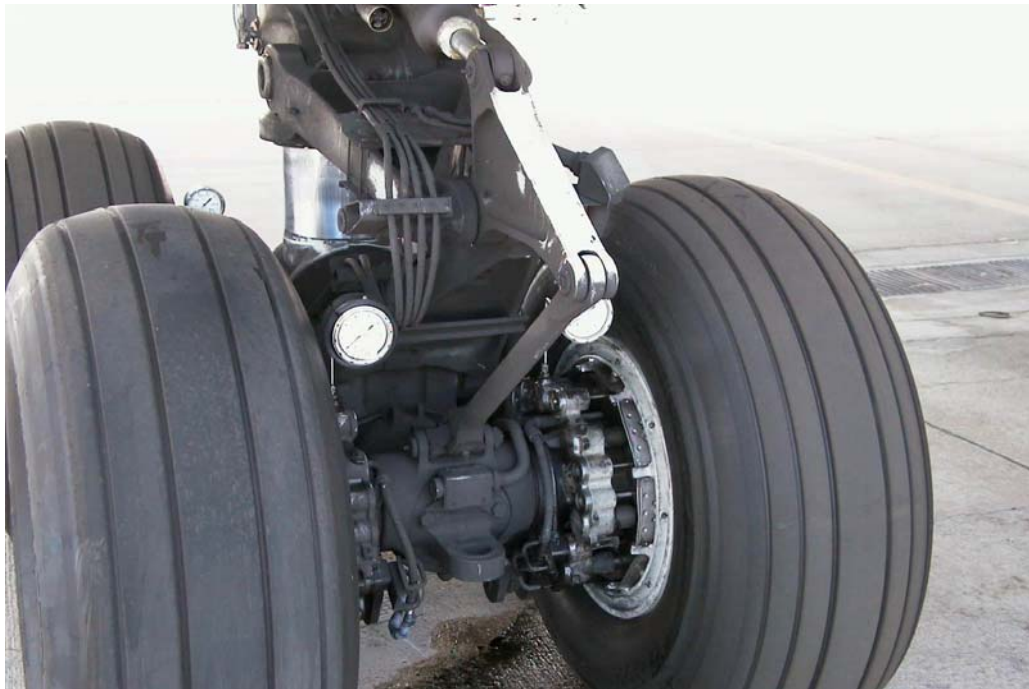
*Gauges installed on the brakes of TF-ATH*

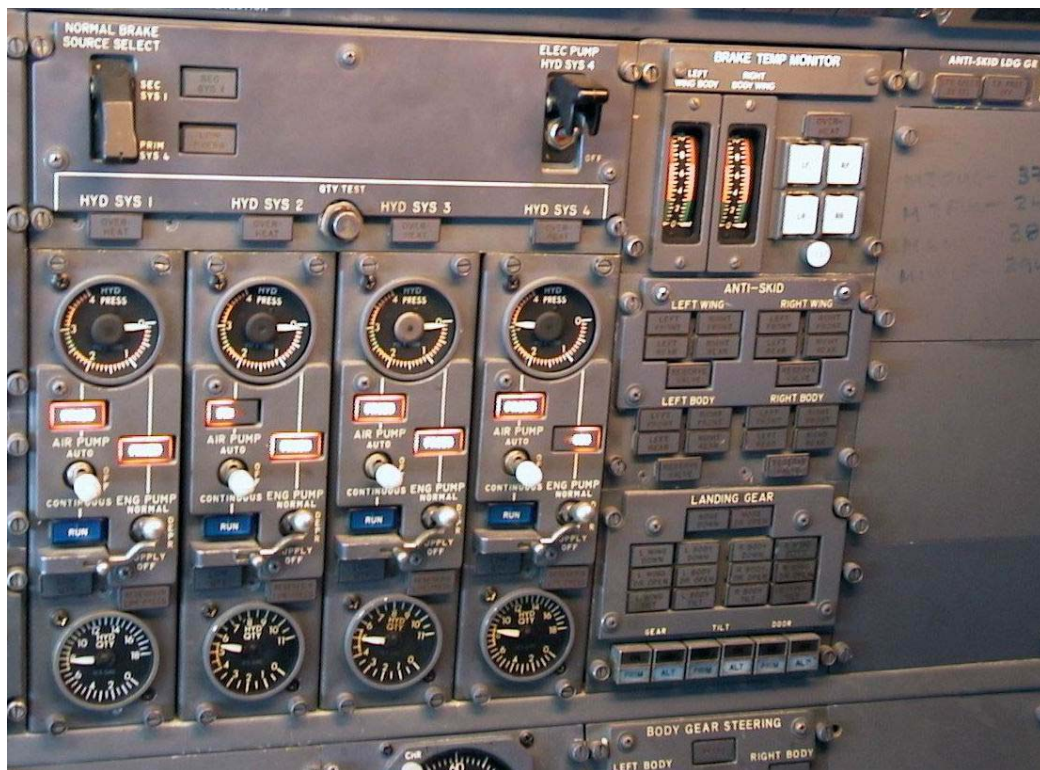
*CM-3 Panel. ACP switch (labeled "ELEC PUMP HYD SYS 4", cover lifted) noted. Pressure gauge of Hyd. System No. 4 shows 3100 PSI.*

Additionally, it was noted that the electrical pump (ACP) was immediately and automatically disconnected at the very first crank of engine four.

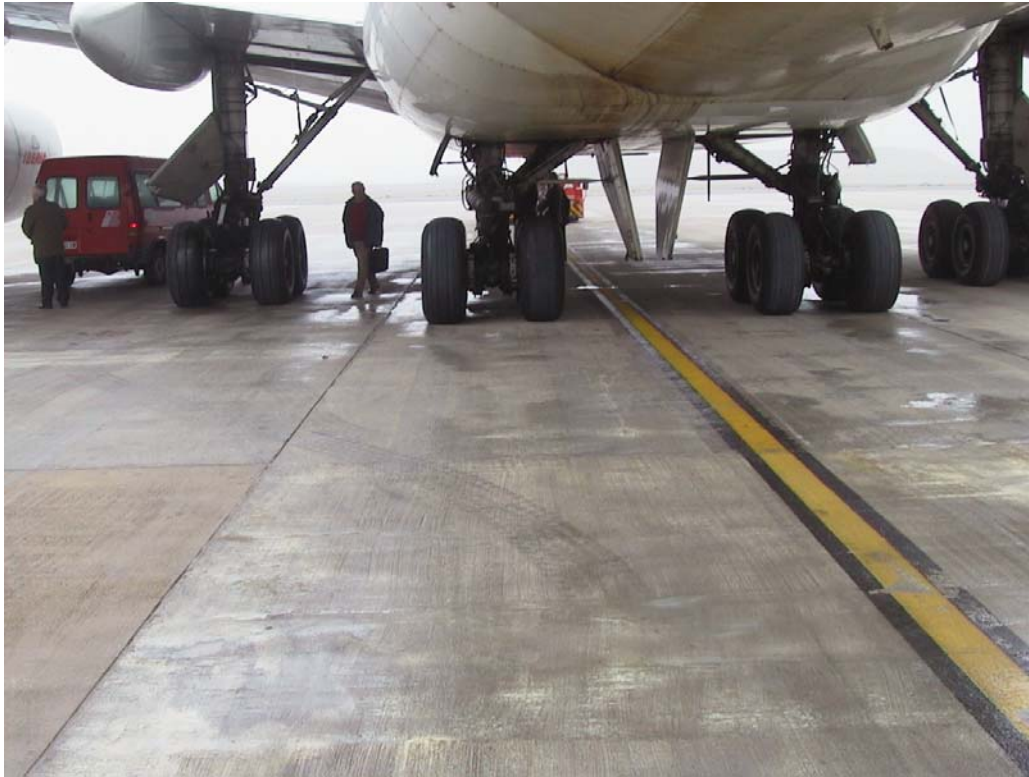
*Ground marks during the taxi tests (continuous and lightly marked)*

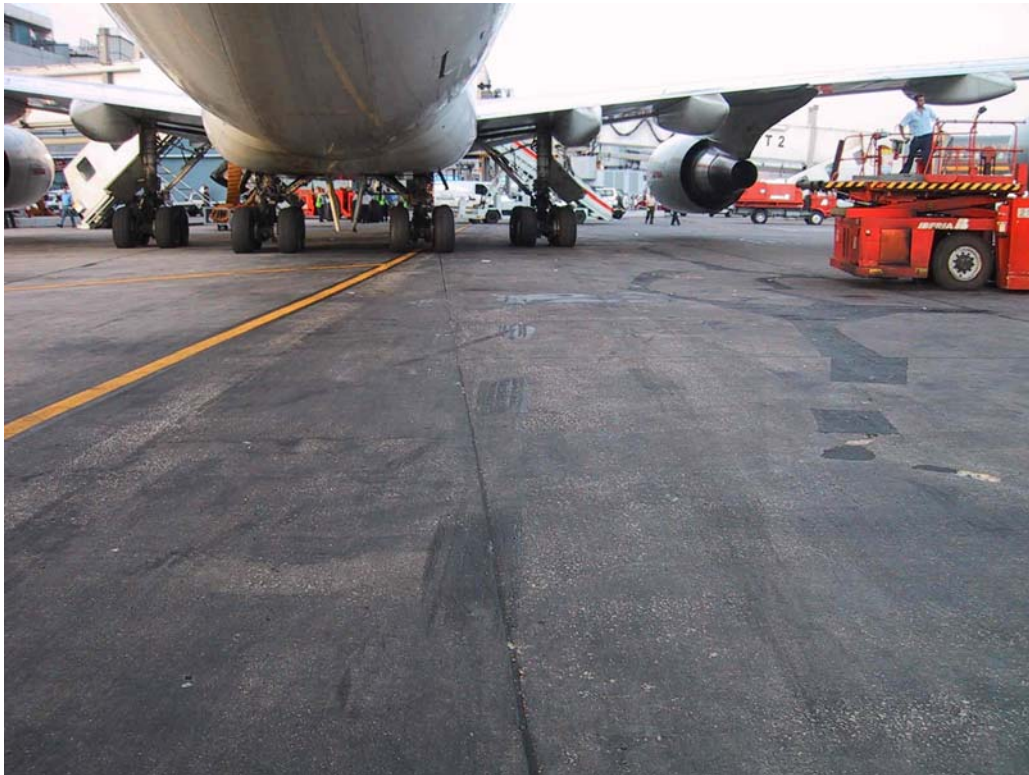
Several tire marks were clearly noted on the ground. The marks clearly led to the wheels of the RH wing landing gear. Additionally, the marks, that extended for a length of around 10 m, had an intermittent nature regularly spaced that was more noticeable for the inboard wheels of the RH wing landing gear. The marks of the outboard wheels were more continuous. The marks were arranged in a more or less straight line that showed an angle with the yellow guidance line similar to the final angle that the fuselage had with that line, indicating that the turn against the finger had taken place previously.

*Ground marks the day of the incident (intermittent and strongly marked)*

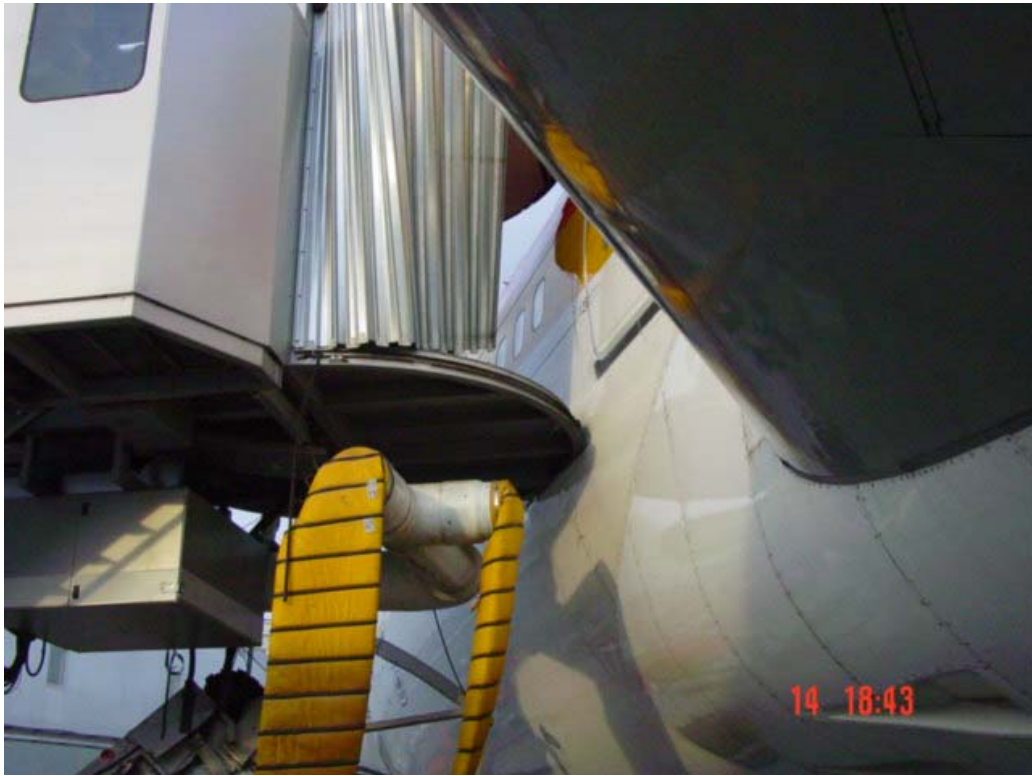
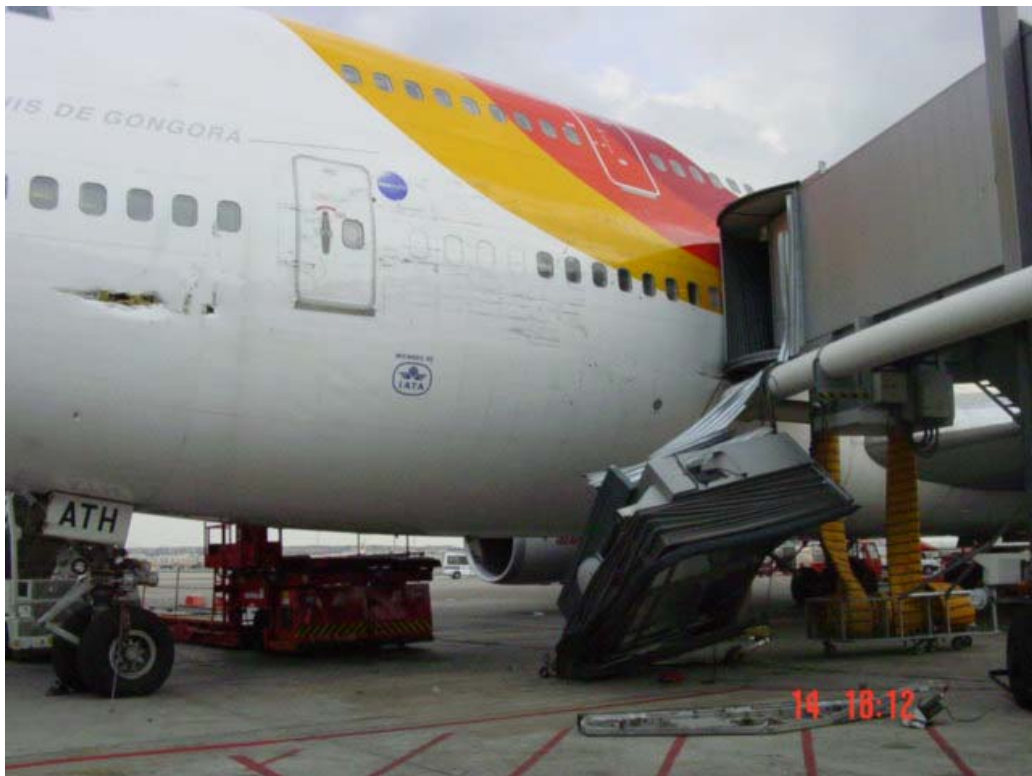
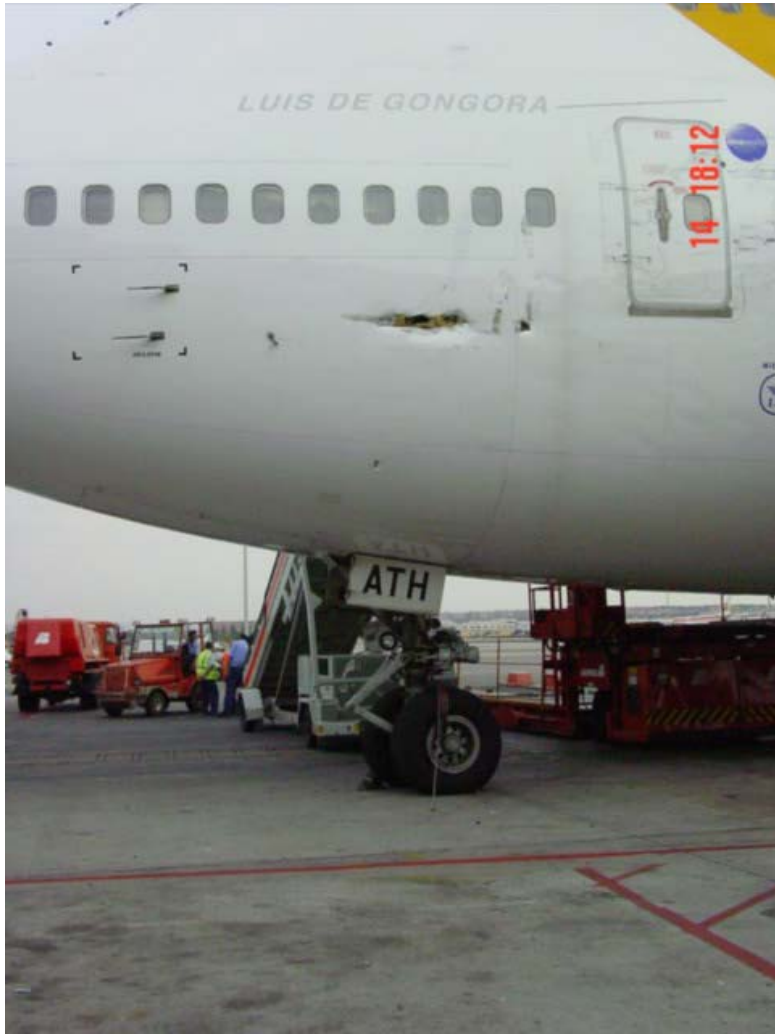
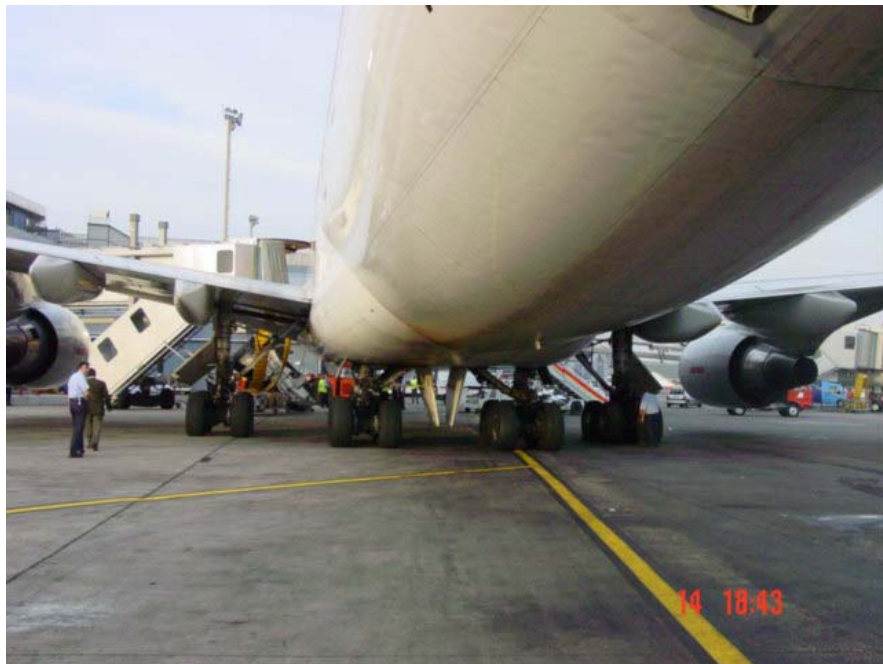
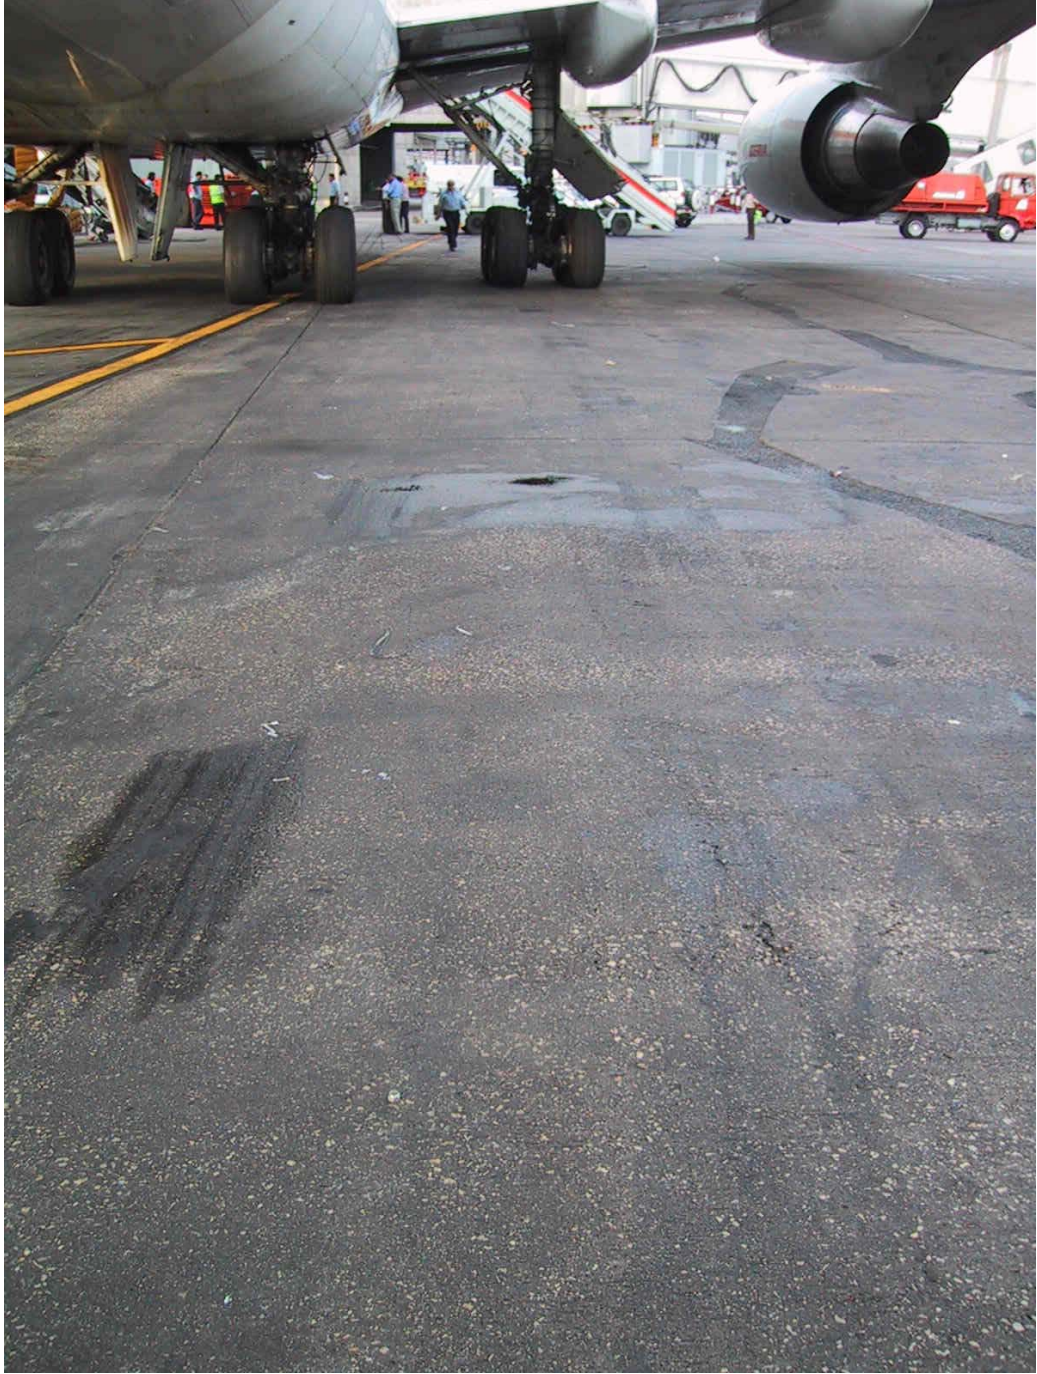
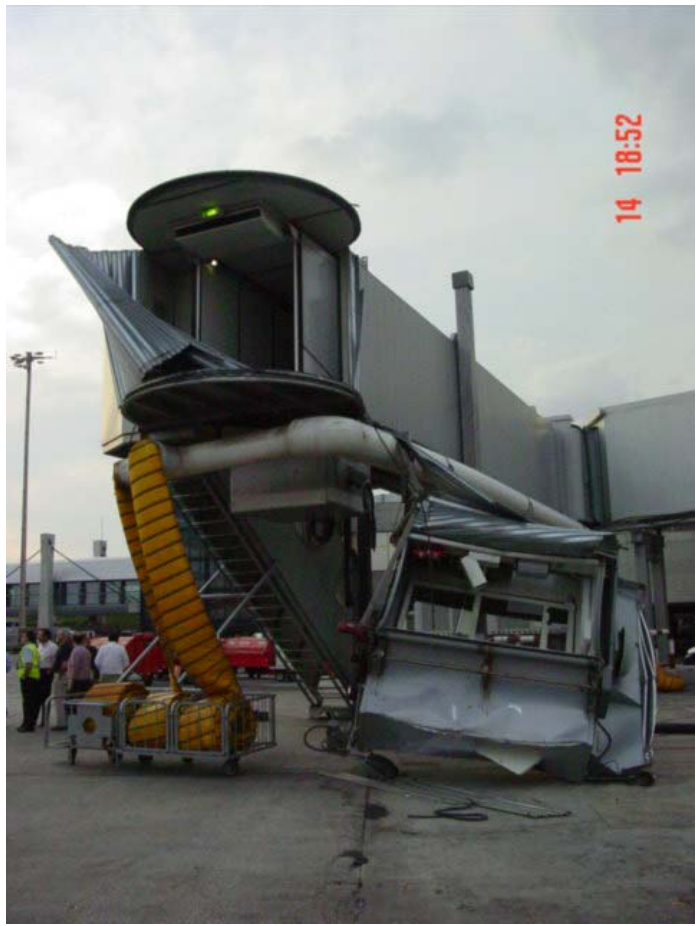
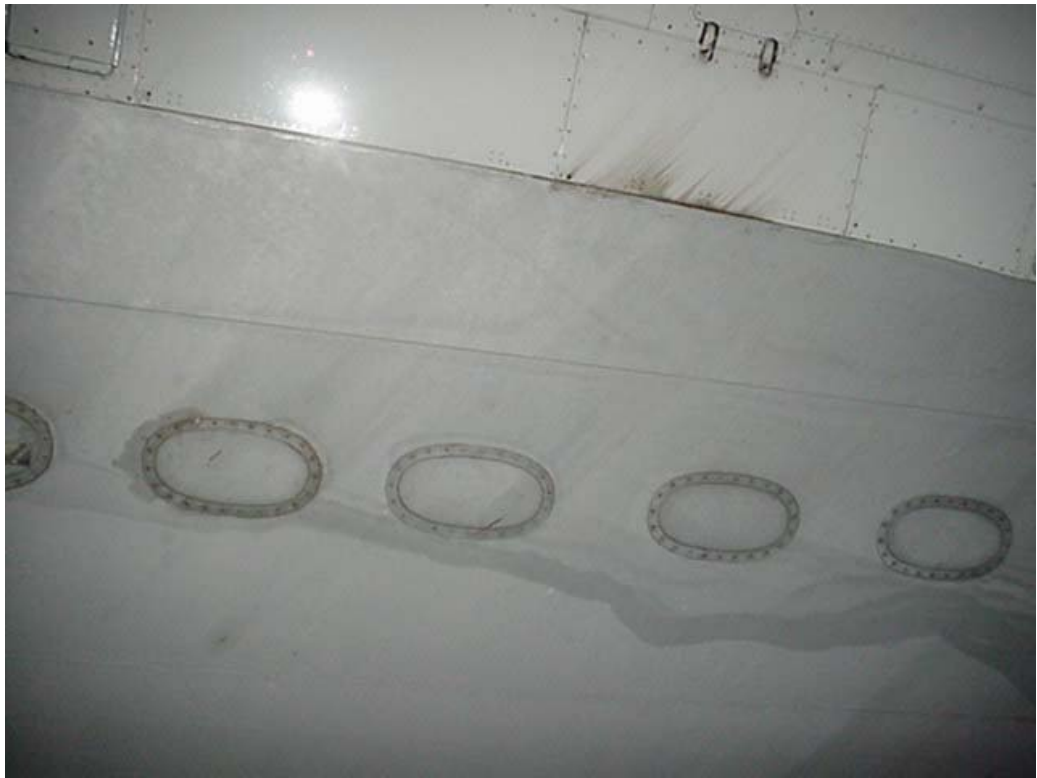
## **PHOTOGRAPHS**

The aircraft suffered major damage on the left forward part of its fuselage. There were four major punctures of the fuselage skin, with damage to the several fuselage frames. There was a puncture of around 60 inches between Station 350 and Station 410, at the height of stringer 27A, and tears and punctures between doors 1L and 2L. Photos of the damage are presented in Annex A.

In Appendix A, some photos of the damage to the aircraft and the finger are included. A drawing of the final position of the aircraft is presented in Appendix B.
