**INCIDENT**

<b>Aircraft Type and Registration:</b>	Boeing 737-500, SP-LKA	
<b>No &amp; Type of Engines:</b>	2 CFM 56-3C1 turbofan engines	
<b>Year of Manufacture:</b>	1992	
<b>Date &amp; Time (UTC):</b>	4 June 2007 at 1007 hrs	
<b>Location:</b>	On departure from London Heathrow Airport	
<b>Type of Flight:</b>	Commercial Air Transport (Passenger)	
<b>Persons on Board:</b>	Crew - 6	Passengers - 89
<b>Injuries:</b>	Crew - None	Passengers - None
<b>Nature of Damage:</b>	None	
<b>Commander's Licence:</b>	Airline Transport Pilot's Licence	
<b>Commander's Age:</b>	55 years	
<b>Commander's Flying Experience:</b>	15,000 hours (of which 9,000 were on type) Last 90 days - 270 hours Last 28 days - 65 hours	
<b>Information Source:</b>	AAIB Field Investigation

**Synopsis**

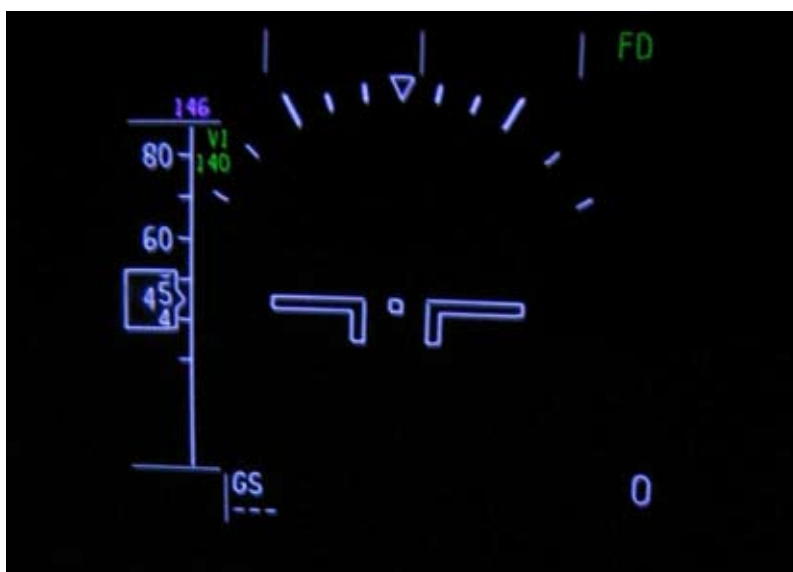
The aircraft was given clearance to line up and was taxied onto the runway. The departure clearance was for a BPK5J Standard Instrument Departure (SID). The co-pilot was the handling pilot. Immediately after takeoff, at 1009 hrs, the pilots noticed that there was almost no information on their EHSIs and EADIs; they described the displays as ‘blank’, Figure 1.

**Figure 1**  
Representation of ‘blank’ EADI

When the IRSs are in ALIGN mode (IRSs data being NCD), the EFIS displays will show very limited information, Figure 1. For approximately two minutes before LOT 282 took off, the pilots' displays were probably in this condition. As the pilots were busy watching for other traffic and lining the aircraft up on the runway, it is possible neither one looked at the displays during this period. As the aircraft accelerated along the runway, it is likely that the commander's attention would have been focussed on his ASI. It was probably only when the aircraft rotated on takeoff that the co-pilot would have looked down or seen that no attitude or navigational information was available.

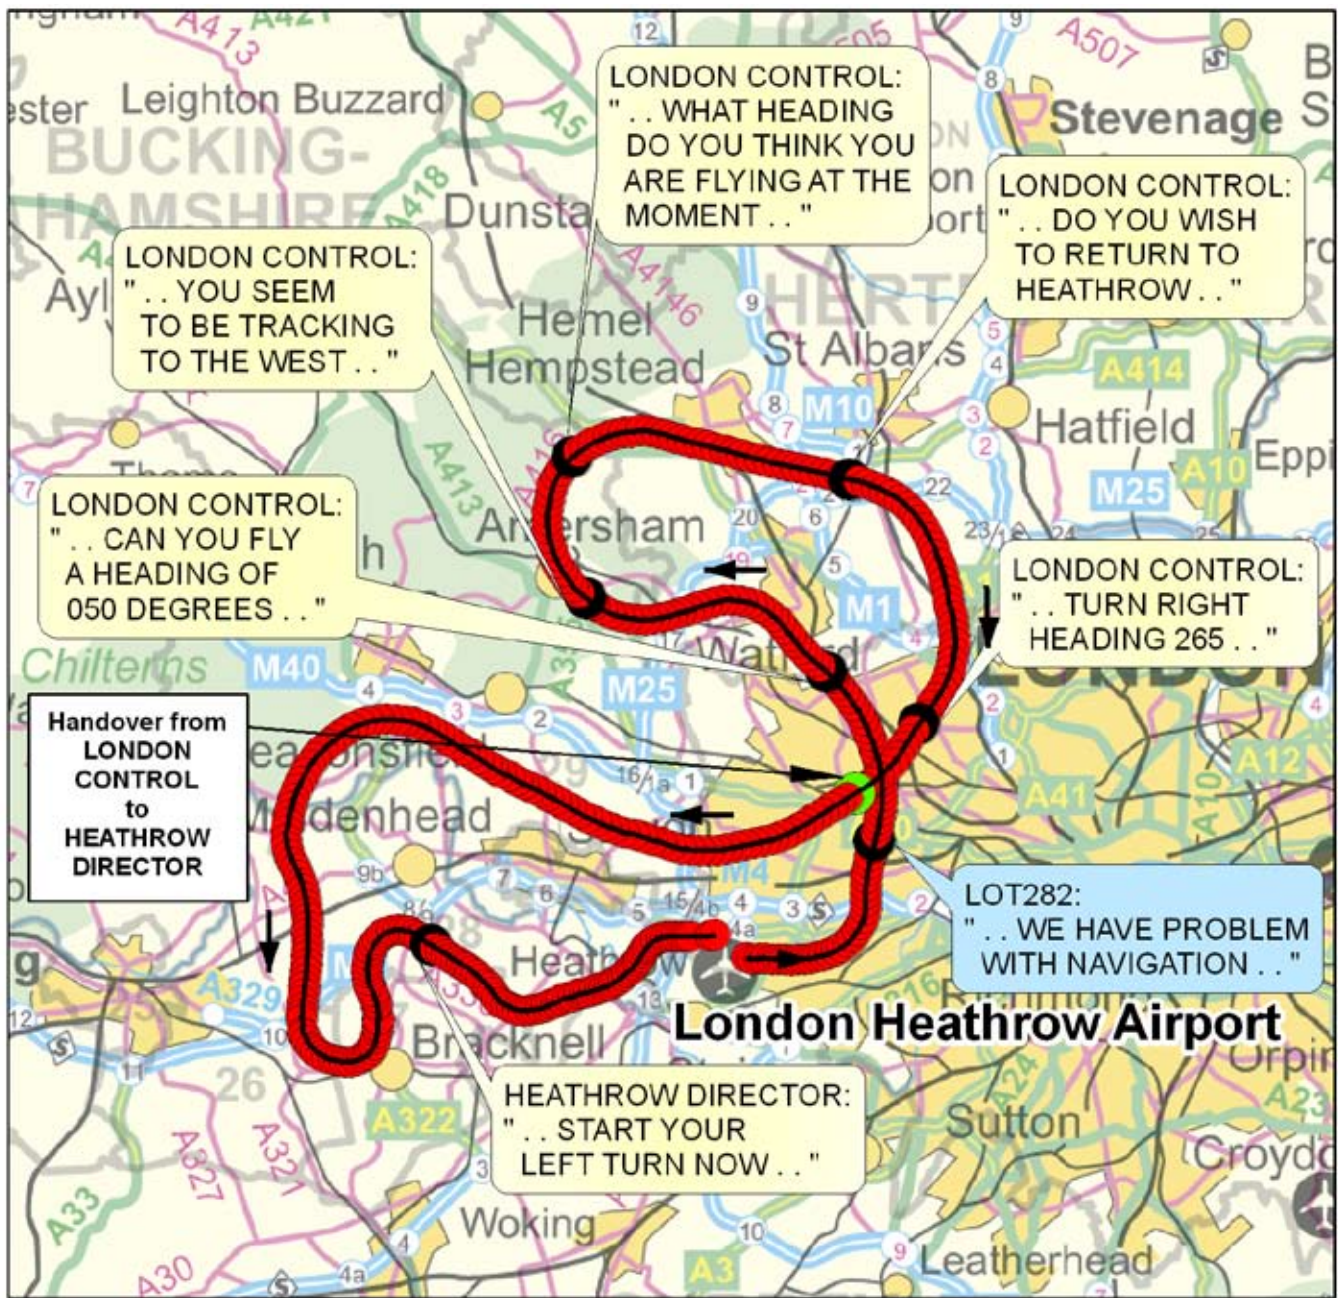
Figure 3 is a view of the aircraft's radar track, overlaid with some relevant communications.

**Figure 3**  
Radar track of LOT 282

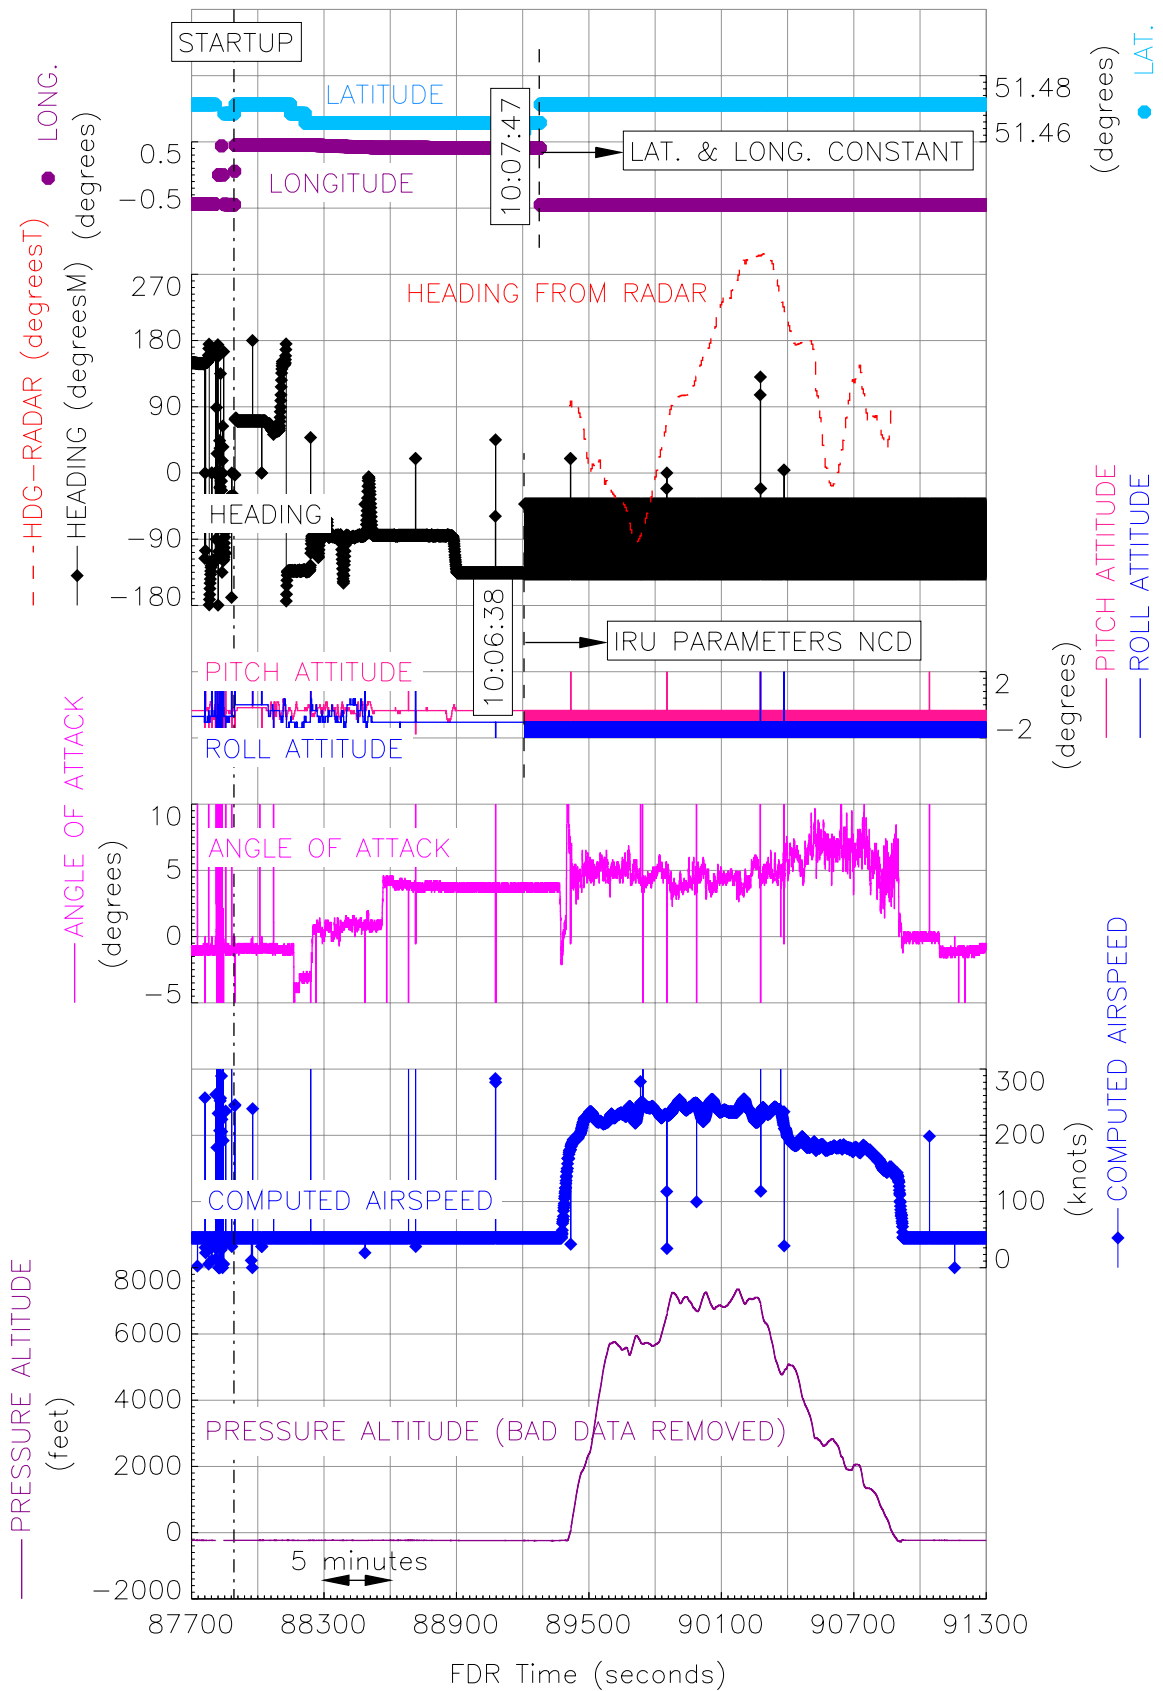
Figure 5

A time history of salient parameters from the FDR for the incident flight is shown at Figure 5, starting three minutes before the shutdown at the end of the previous flight. Of note is the following:

- the difference in recorded longitude between the shutdown at 08:40:13 hrs and start-up for the incident flight at 09:44:41 hrs
- the loss of IRU sourced data at 10:06:38 hrs, while the aircraft was in the hold area for Runway 09R
- a step change in the FMS aircraft position at 10:07:47 hrs, which remained constant for the rest of the flight

A time history of salient parameters from the FDR

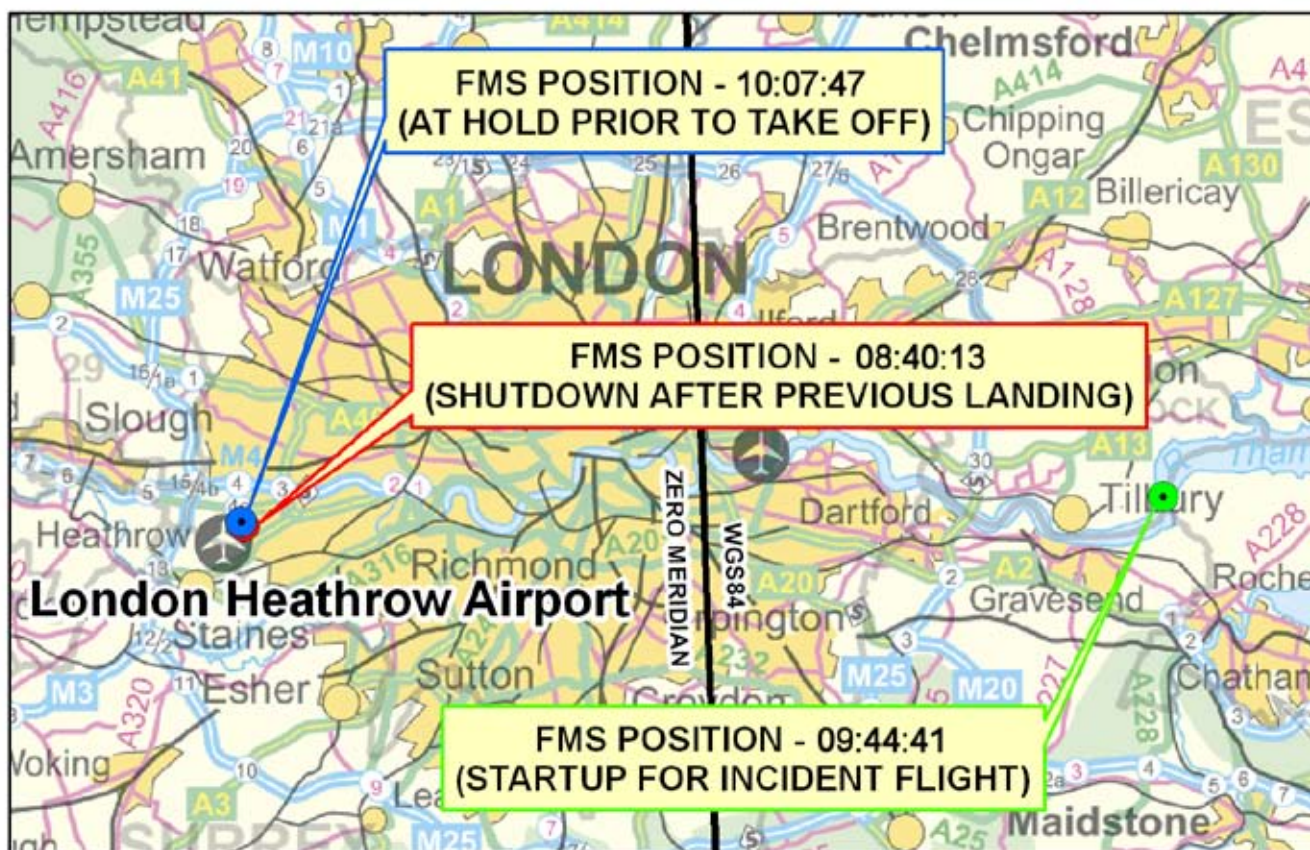
Figure 6

FMS positions at Heathrow

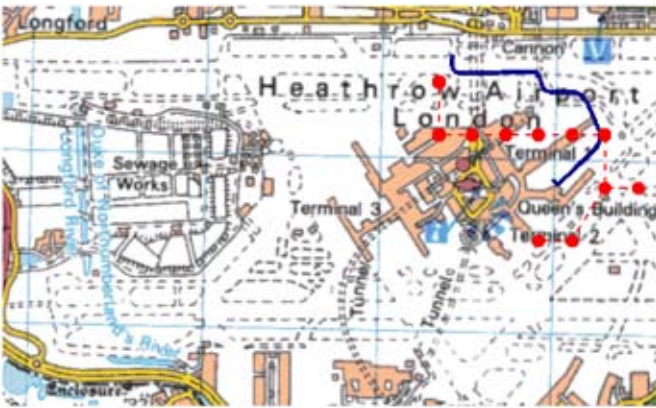
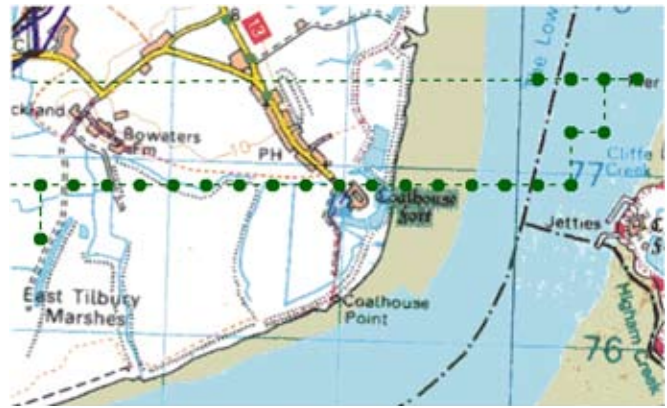
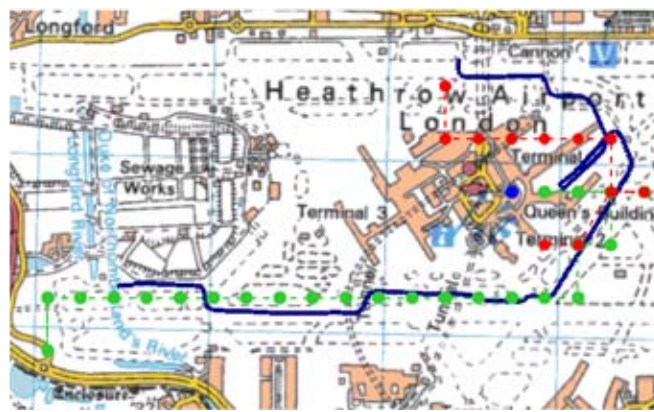
plotted, as the aircraft moves another 305 m or 190 m in latitude and longitude respectively, from the last recorded position. This is seen in Figure 7a, which shows the aircraft's ground track (in red) as it taxied to the stand after the landing from the previous flight. Figure 7a also shows a plot of the ground track derived from groundspeed and heading. The difference between the two illustrates the FMS position error at the end of the flight<sup>2</sup>.

Figure 7b shows the FMS position track (in green) for the incident flight as the aircraft taxied from the stand to the holding point for runway 09R. Figure 7c shows these same positions plotted after being transposed in longitude

(ie correcting for the east/west difference at startup) together with a plot of the ground track derived from groundspeed and heading (blue). A single point (blue) in Figure 7c (adjacent to the terminal) represents the updated FMS position when the aircraft was at the holding area.

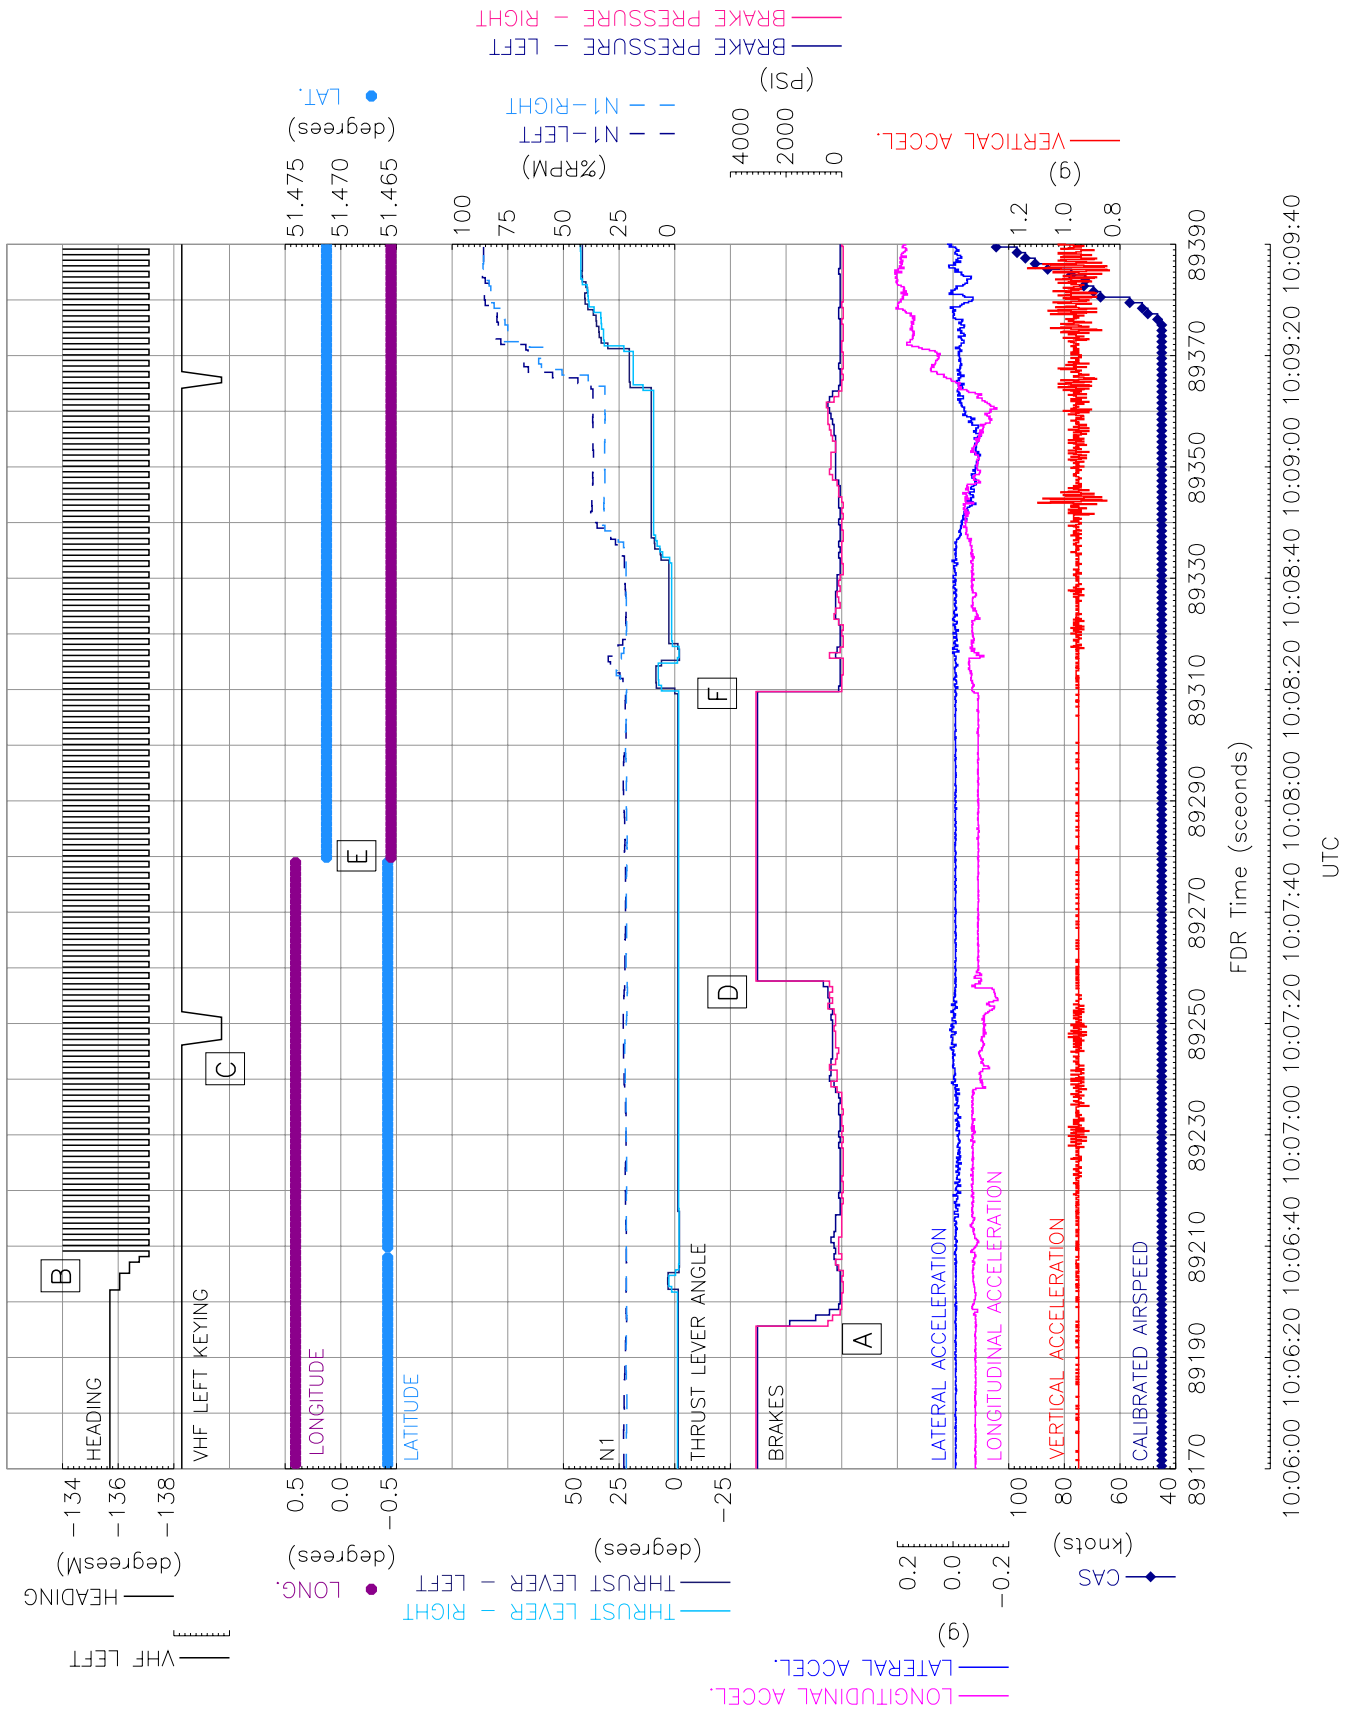
Figure 8 shows some FDR parameters in detail, starting with the aircraft at the hold. At 10:06:25 hrs **[A]**, the brakes were released and the aircraft moved slowly forward, turning to the left though 224°M before the heading and other IRU sourced parameters became NCD **[B]**. At 10:07:20 hrs, the commander **[C]** transmits a reply to ATC just before reapplying the brakes and stopping at hold NB11 **[D]**. While waiting at this point, the aircraft's position is updated in the FMS **[E]**. This position remains fixed as the brakes are released 30 seconds later **[F]** and the aircraft lines up and takes off from Runway 09R.

**Figure 8**  
Selected FDR parameters
