# **Final Report of the Aircraft Accident Investigation Bureau**

to the Piper PA31-350 Navajo Chieftain Panther II aircraft, HB-LTC

on 26 May 2000

### Final Report No. 1767

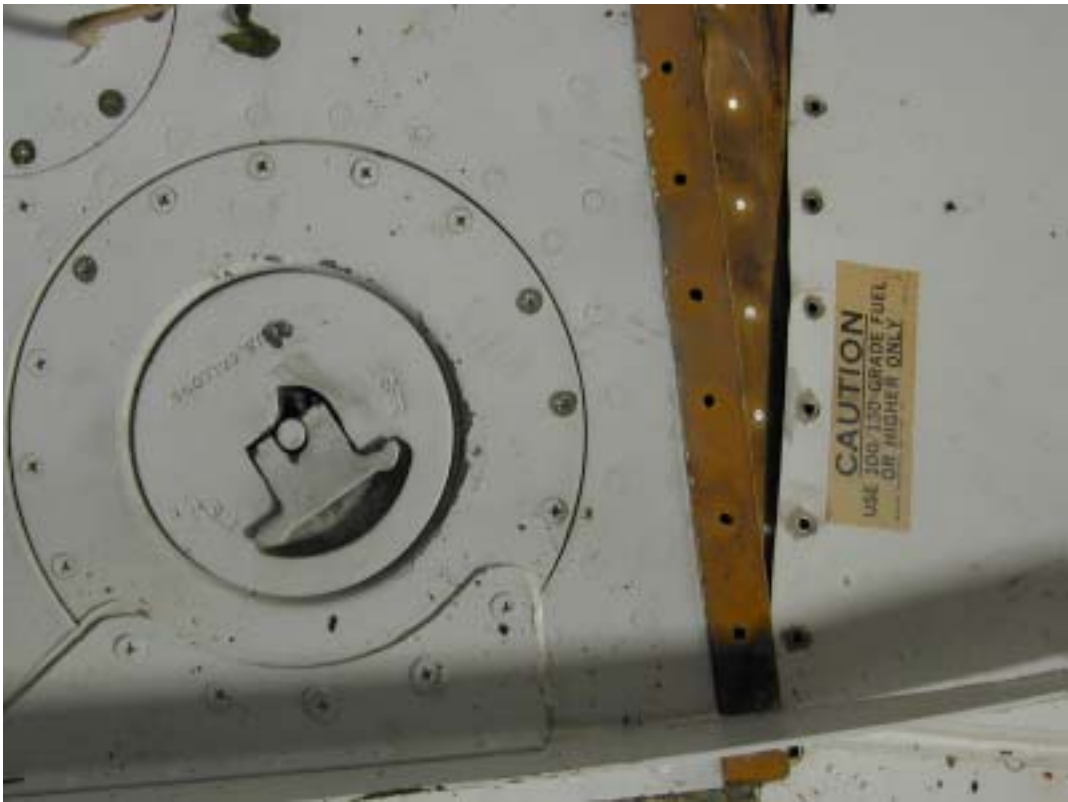
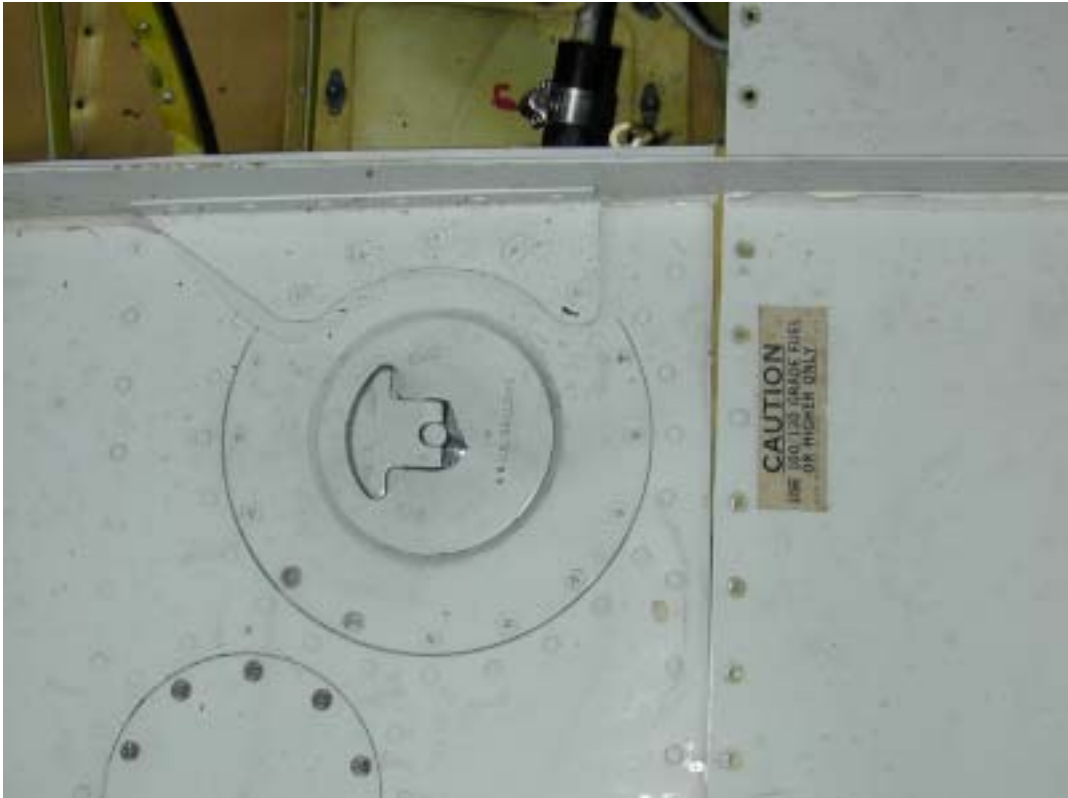
Appendix 2

Refuelling attendant A later reported that he had not noticed markings which described the types of fuel permitted for this aircraft, either on the wing or on the tank seals.

Fuel grade rating placards forward of the tank openings of the main inboard cells of HB-LTC.

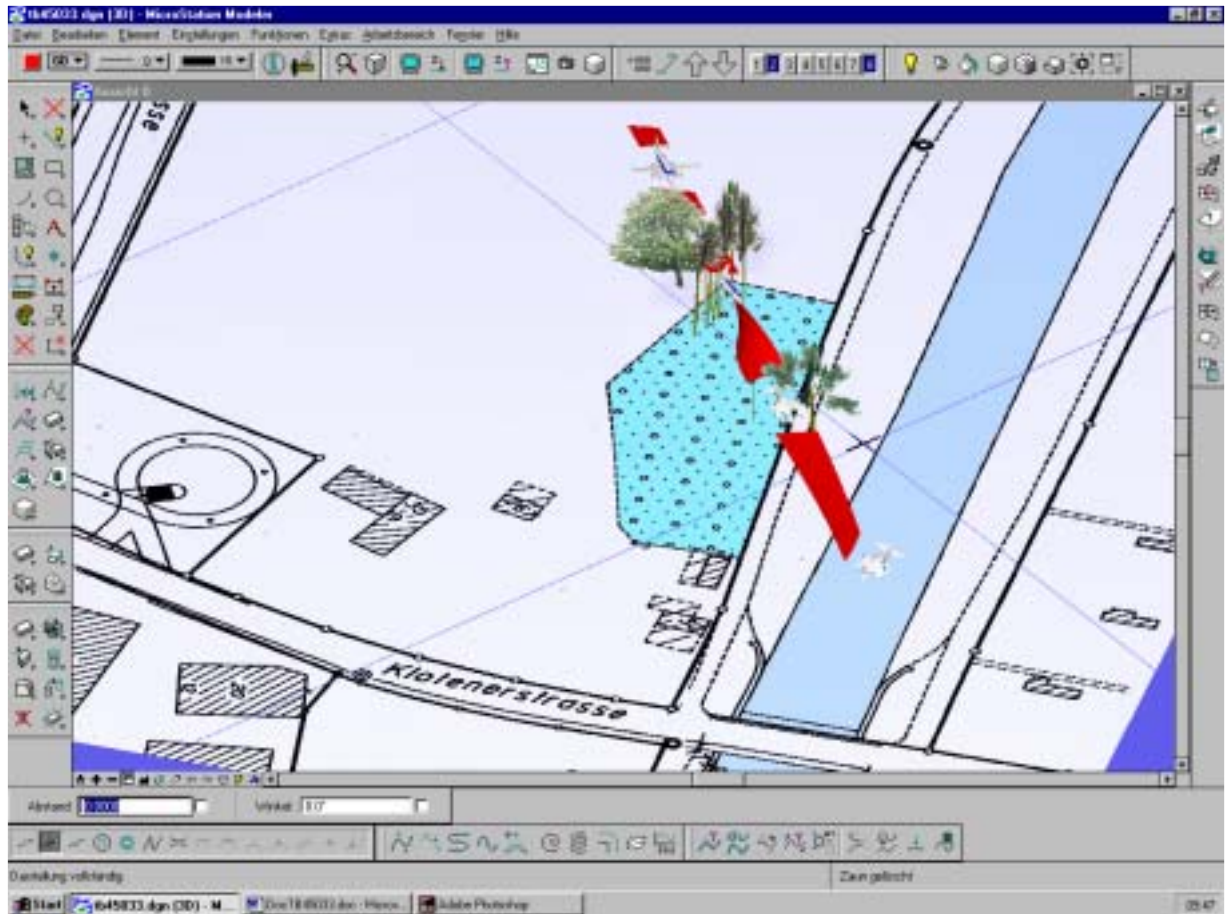
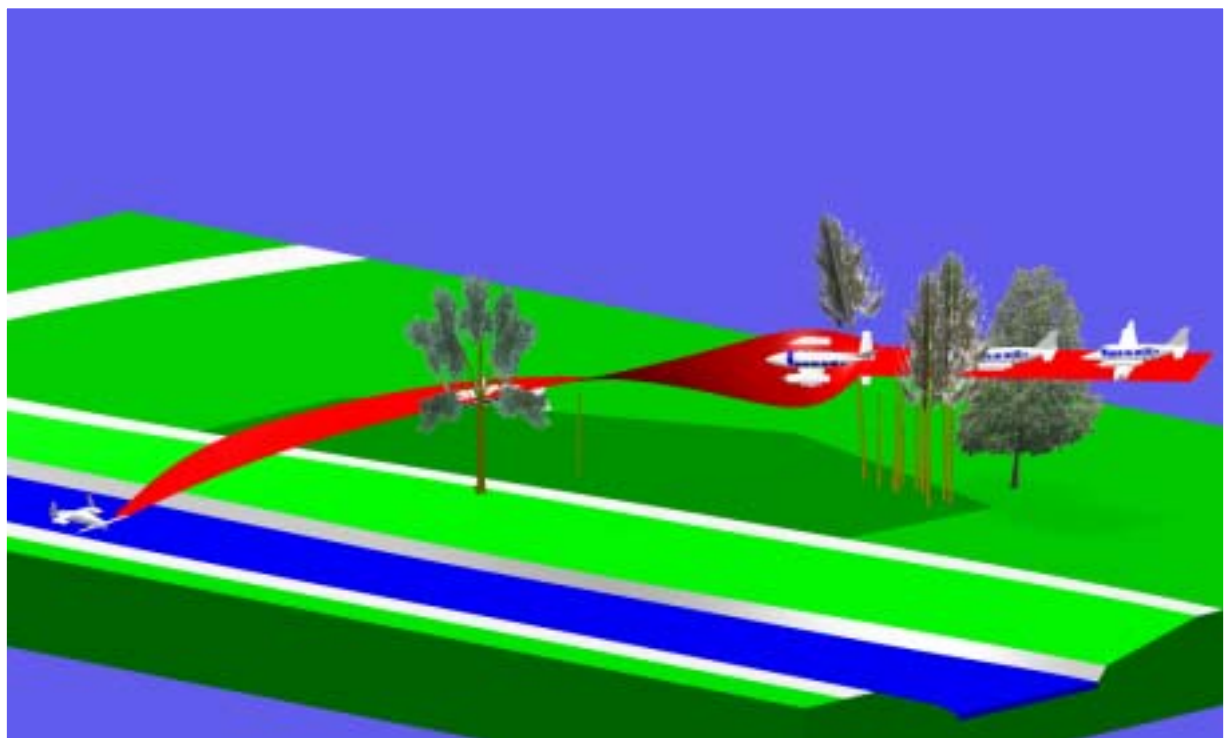
## Appendix 3

Shortly after the take-off roll, however, this must have been the case: the engines were now being supplied with a mixture of JET A-1 and AVGAS 100LL, which was hardly combustible in view of the mixture ratio. On the basis of the progress of the flight observed by witnesses, it must be concluded that the engines continued to provide reduced power for a few seconds. This fact may have induced the pilot not to initiate an emergency landing on the remaining section of the runway or in the direction of the runway to the west of the aerodrome perimeter. Instead, he first prepared to turn right and then began a 180° left turn, very probably with the intention of landing on runway 10.

During this turn both engines failed completely, or rather the power they were still providing was no longer sufficient to maintain level continuation of the turn, at which point the pilot was no longer able to avoid collision with the obstacles in his path. The bank attitude of the aircraft at this time was 12° - 13° to the left. This low bank angle indicates that control had not been lost (a stall) before the aircraft flew into the trees.

Reconstruction of the last flight phase of HB-LTC.

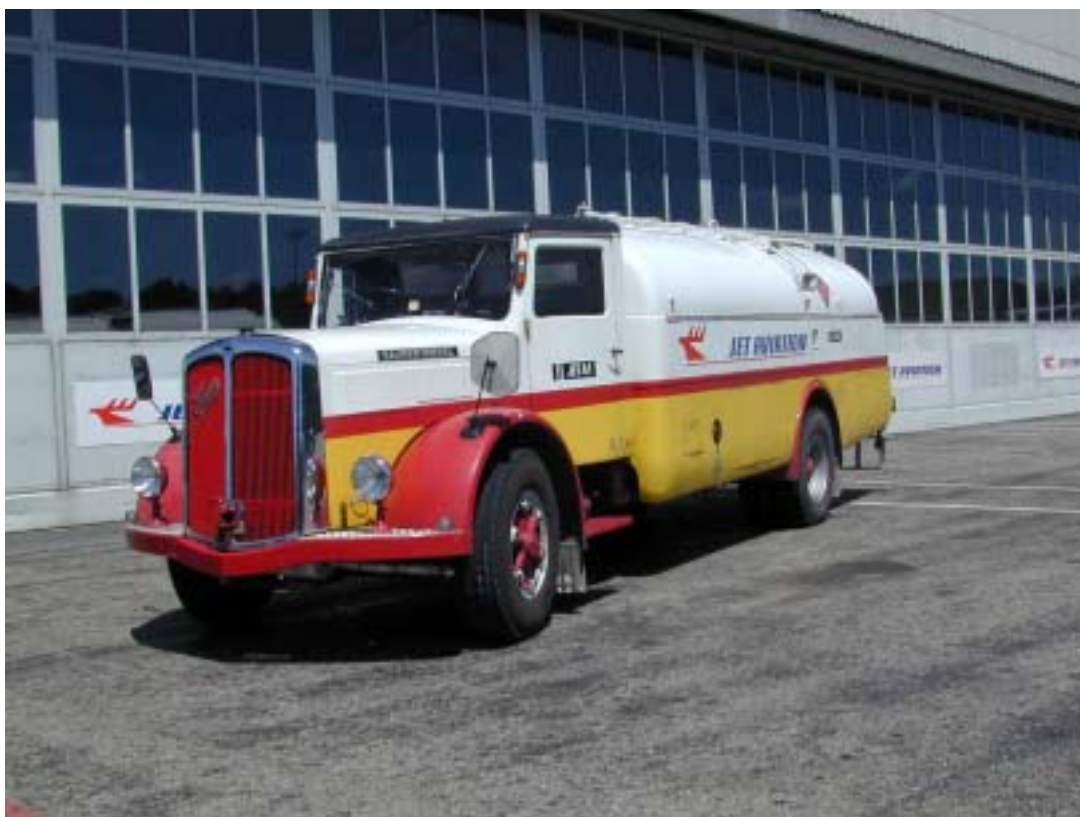
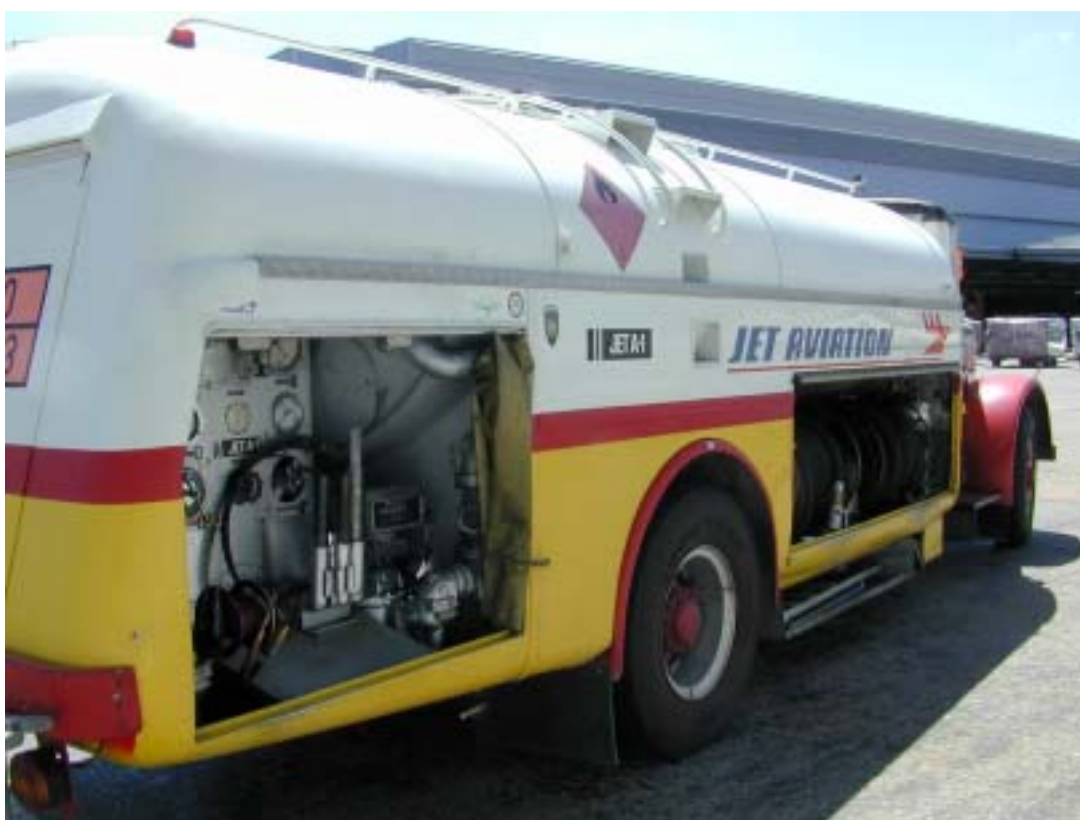
Appendix 4

Tanker vehicle FL 7 for JET A-1 kerosene.

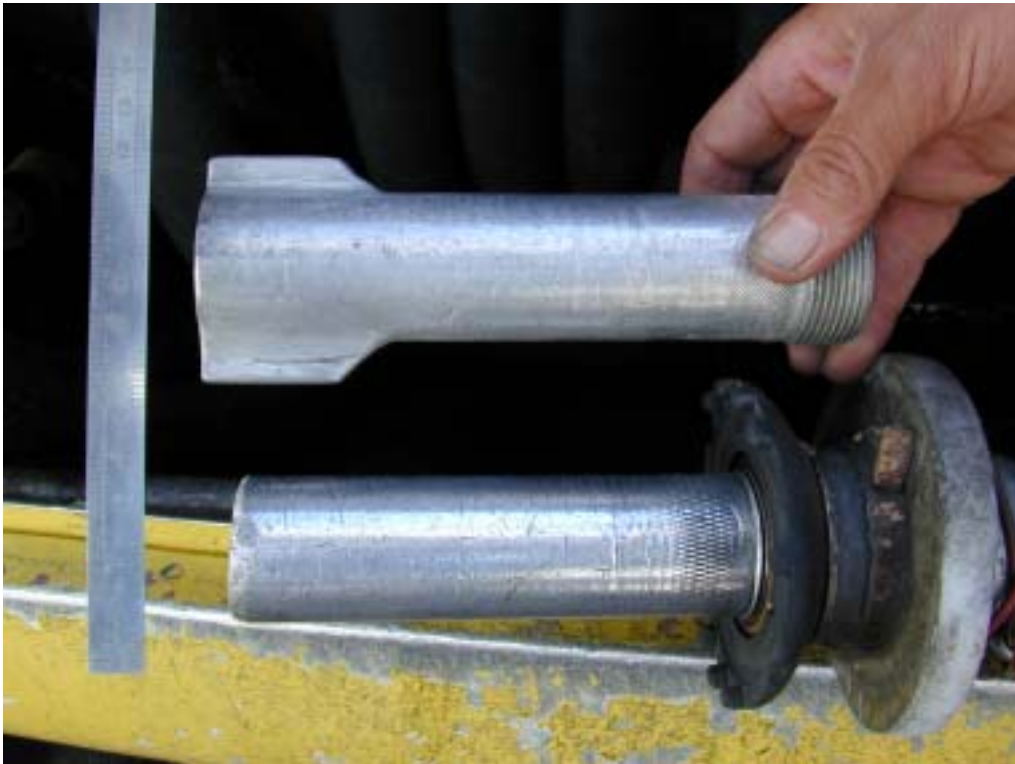
## Appendix 5

- The delivery nozzle on the filler gun was of an outside diameter which allowed the aircraft involved in the accident to be refuelled.
- The level of training and knowledge of the refuelling personnel concerned was inadequate.
- The Federal Office for Civil Aviation never inspected the refuelling operation before the accident.
- Until the time of the accident, the Federal Office for Civil Aviation had issued no regulations on the training of refuelling personnel, the size of delivery nozzles and tank openings on aircraft or on the identification of filler guns and tank openings.

Delivery nozzle of tanker vehicle FL 7 (bottom) in comparison with the modified delivery nozzle obtained from the refuelling company with enlarged outer diameter (top).

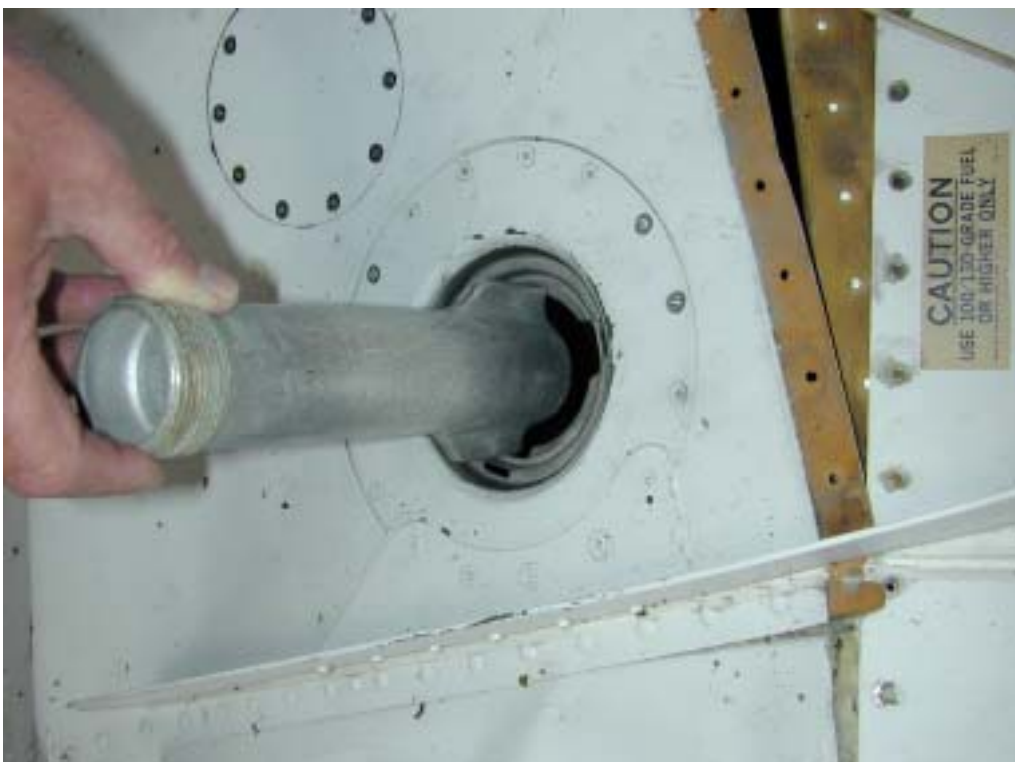
purpose of the modification was to reduce the original tank openings with a diameter of 76 mm (3 inches) and therefore make it impossible to incorrectly refuel with kerosene. This conversion was based on service bulletin (SB) 797A, published by the aircraft manufacturer, Piper Aircraft Corporation, on 2 April 1985. On 1 September 1987 the aircraft manufacturer replaced SB 797A with SB 797B, which now described the modification as mandatory. On 2 November 1987, the FAA issued airworthiness directive (AD) FAA AD 87-21-01, which prescribed implementation of SB 797B within a period of one year. Consequently, the FOCA brought AD HB-231 into force on 16 December 1987; it contained the same modification.

The delivery nozzle with enlarged outer diameter cannot be inserted into the tank openings of HB-LTC as these were modified to smaller diameters using metal plates.
