National Transportation Safety Board

Human Factors in the Accident Involving Gulfstream Aerospace Corporation G-IV, N121JM Bedford, Massachusetts May 31, 2014

William Bramble, Ph.D.
NTSB Office of Aviation Safety

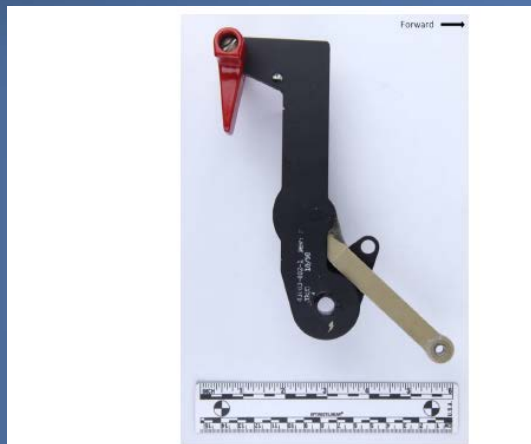
Figure 4a. Photograph of an exemplar gust lock handle in the ON position.

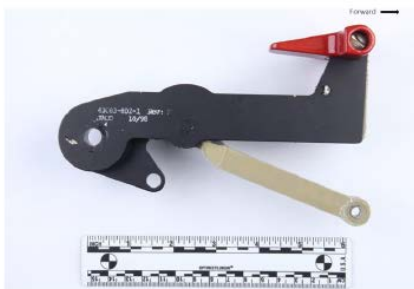
Figure 4b. Photograph of an exemplar gust lock handle in the OFF position.

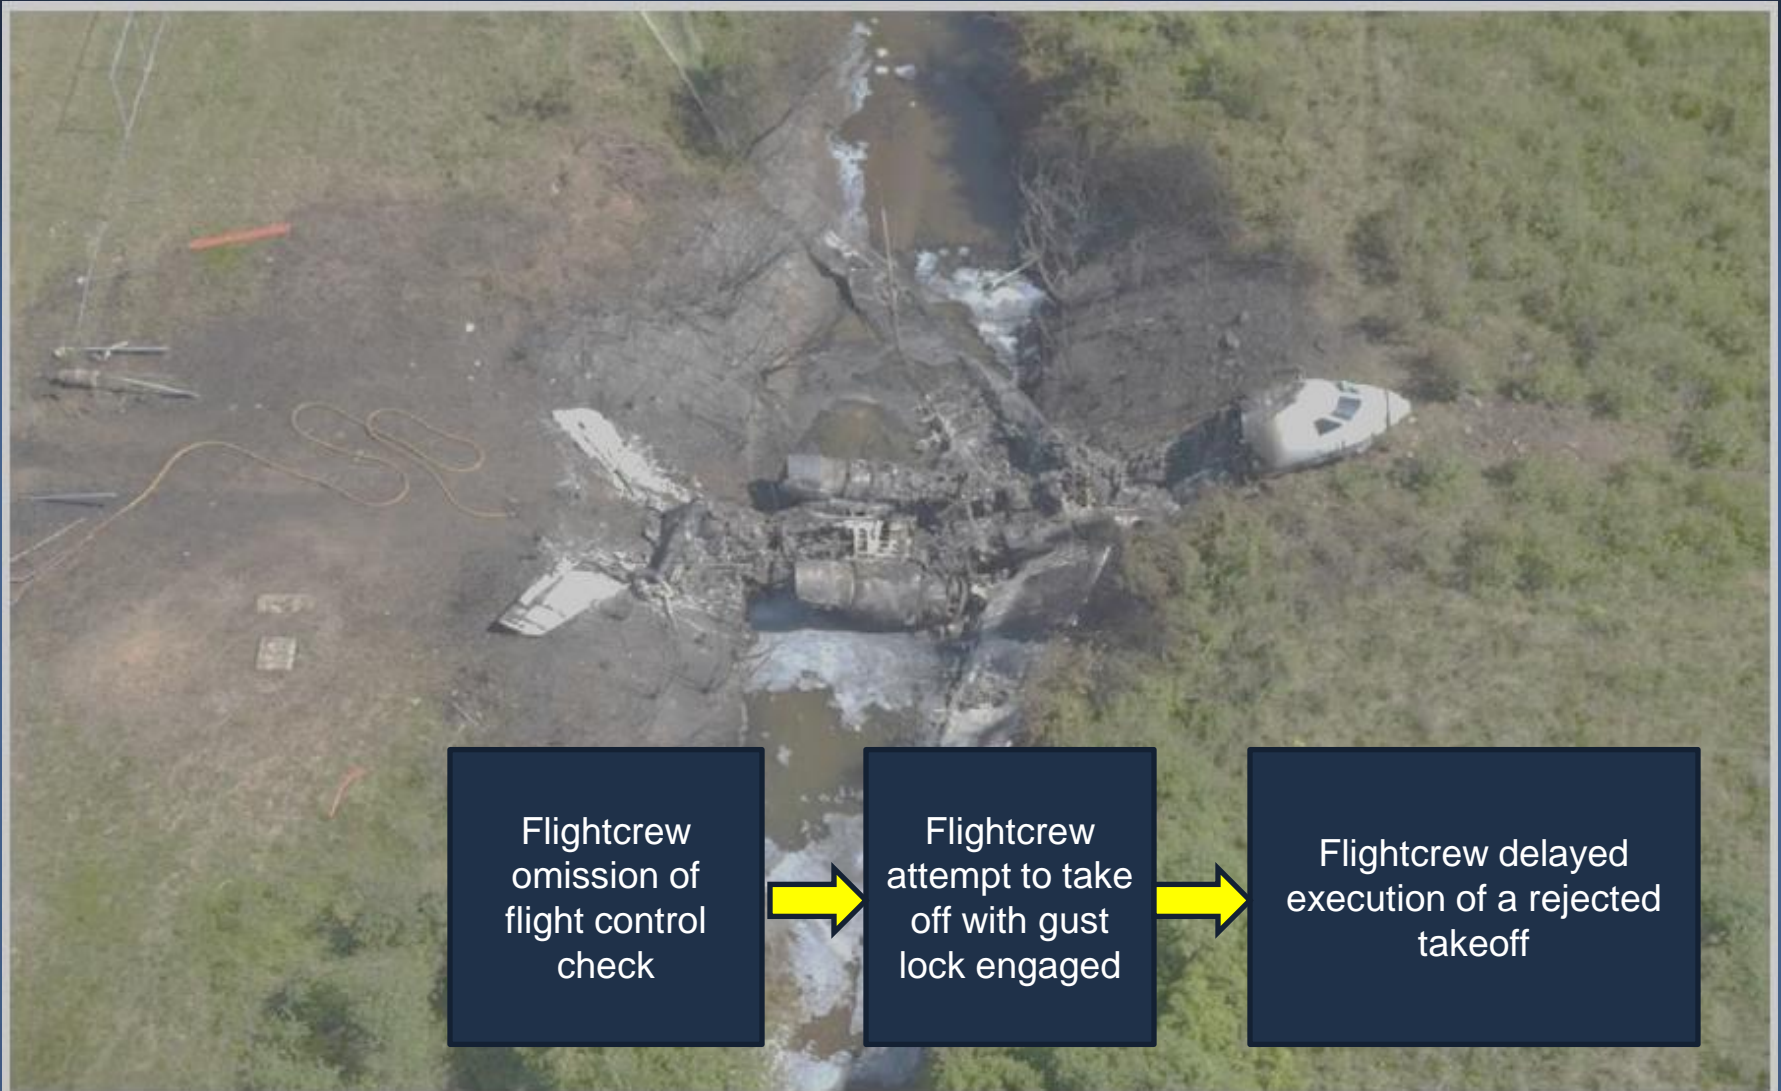
Flightcrew Errors

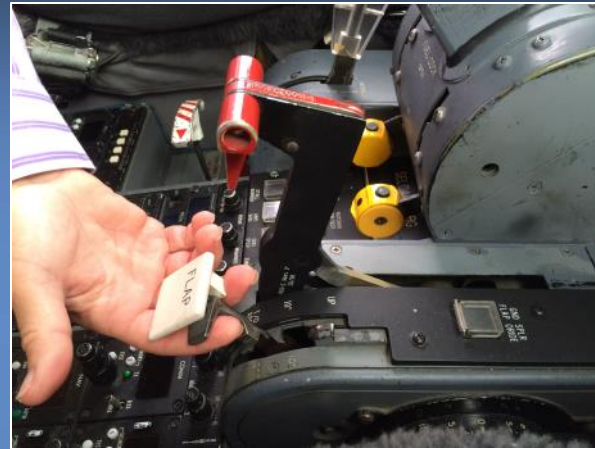
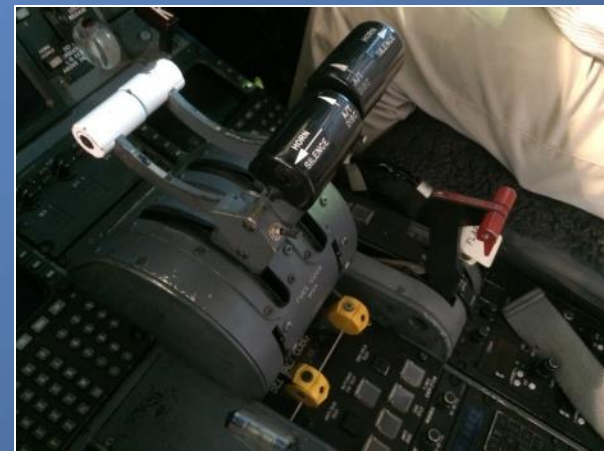
- Crew set flaps for takeoff
- Crew taxied to the runway
- Crew did not notice the position of the gust lock

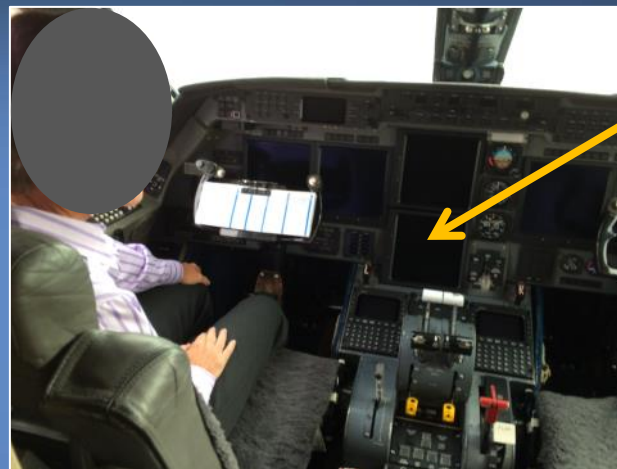
EICAS
Message
Display

- “RUDDER LIMIT” advisory message appeared on the EICAS, brief discussion
- PIC advanced the throttle levers and encountered a restriction
- PIC engaged the autothrottle and expressed puzzlement about restriction

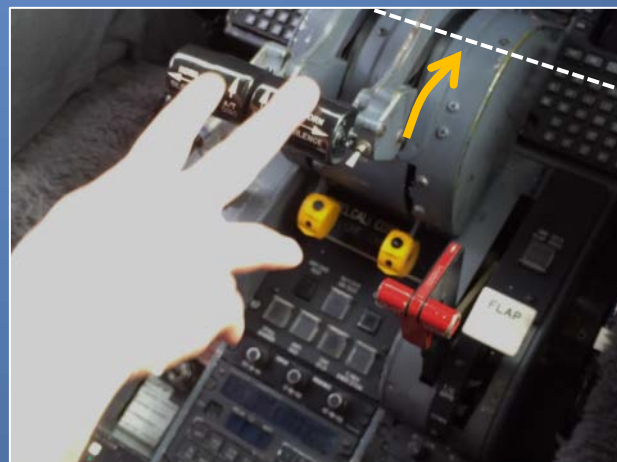
Throttle
Lever
Restriction

- Certification required “unmistakable warning at the start of takeoff” if gust lock was engaged
- Interlock mechanism was intended to limit throttle lever angle to 6° , but it actually permitted 22° of movement
- The levers reached 27° after autothrottle servos broke the gust lock pin

- NTSB examined several other G-IV airplanes and found the same issue
- The throttle interlock was not performing its intended function
- FAA certification records indicated that the design was reviewed using engineering drawings with no functional test

- Require the gust lock system to be retrofitted on all G-IV airplanes
- Develop guidance on the appropriate use of engineering drawings during aircraft certification
