REPORT OF THE BOARD OF INQUIRY
INTO THE ACCIDENT TO TUPOLEV
134A-3 AIRCRAFT C9-CAA ON 19TH
OCTOBER 1986

REPORT OF THE BOARD OF INQUIRY INTO THE ACCIDENT TO
TUPOLEV 134A-3 AIRCRAFT C9-CAA ON 19TH OCTOBER 1986
AT MBUZINI, IN THE DISTRICT OF KOMATIPOORT, IN THE
REPUBLIC OF SOUTH AFRICA, IN WHICH PRESIDENT SAMORA
MACHEL OF THE PEOPLE'S REPUBLIC OF MOZAMBIQUE AND 33
OTHERS LOST THEIR LIVES

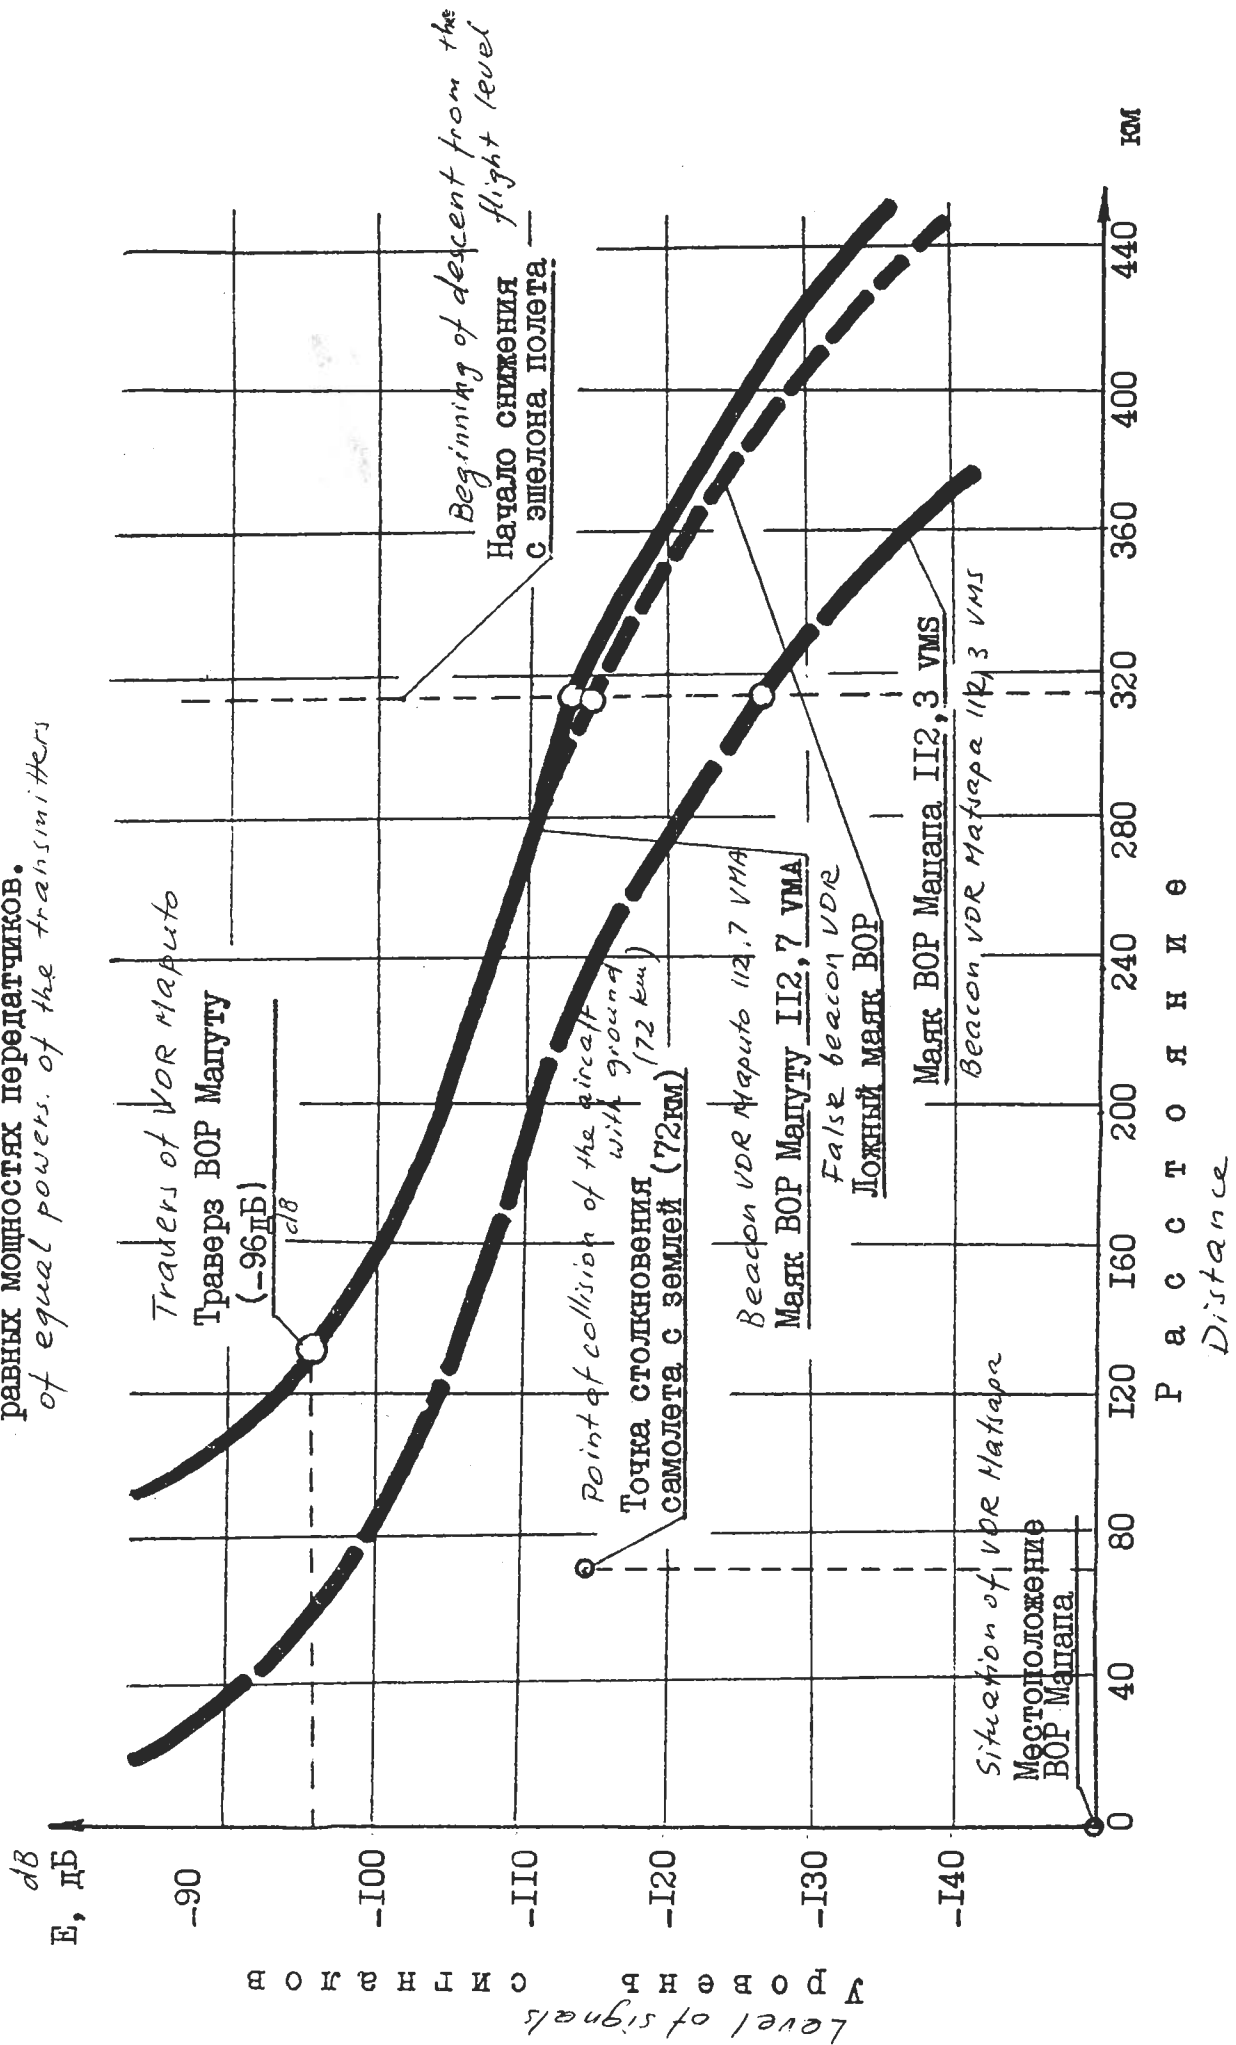
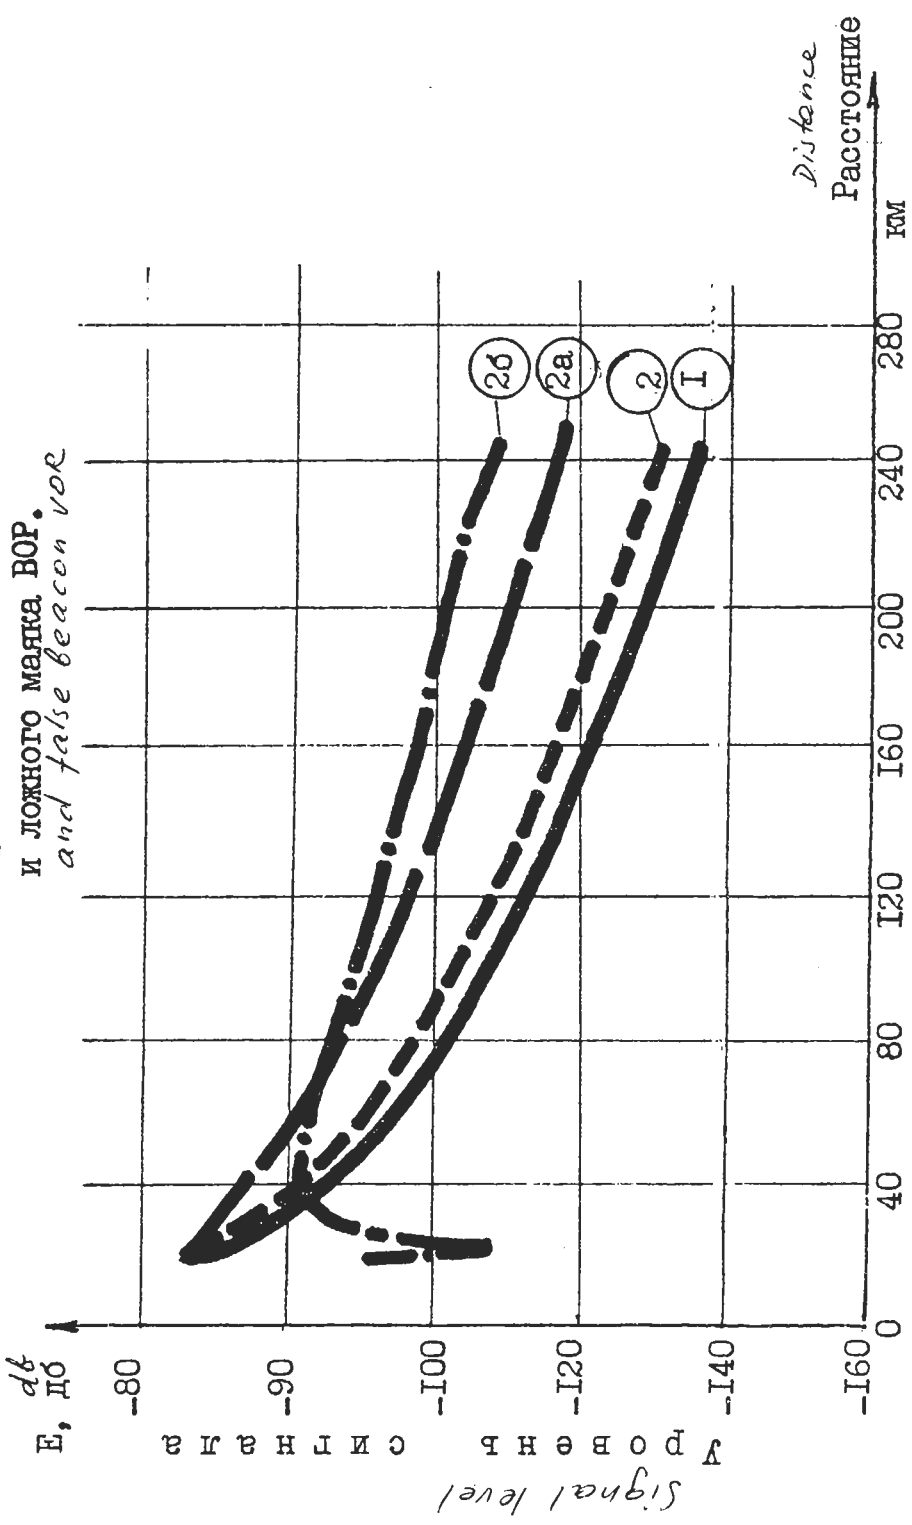
Fig. 7. Signal levels in the place from the beacon VOR Маруты

- 1 — сигнал маяка ВОР Маруты 112,7 УМА Signal of the beacon VOR Маруты 112,7 UMA
- 2 — сигнал ложного маяка ВОР с высотой антенны 7м Signal of the false beacon VOR from the high aerial of 7m
- 2a — сигнал ложного маяка ВОР с высотой антенны 15м Signal of the false beacon VOR from the high aerial of 15 m.
- 2б — сигнал ложного маяка ВОР с высотой антенны 20м Signal of the false beacon VOR from the high aerial of 20m

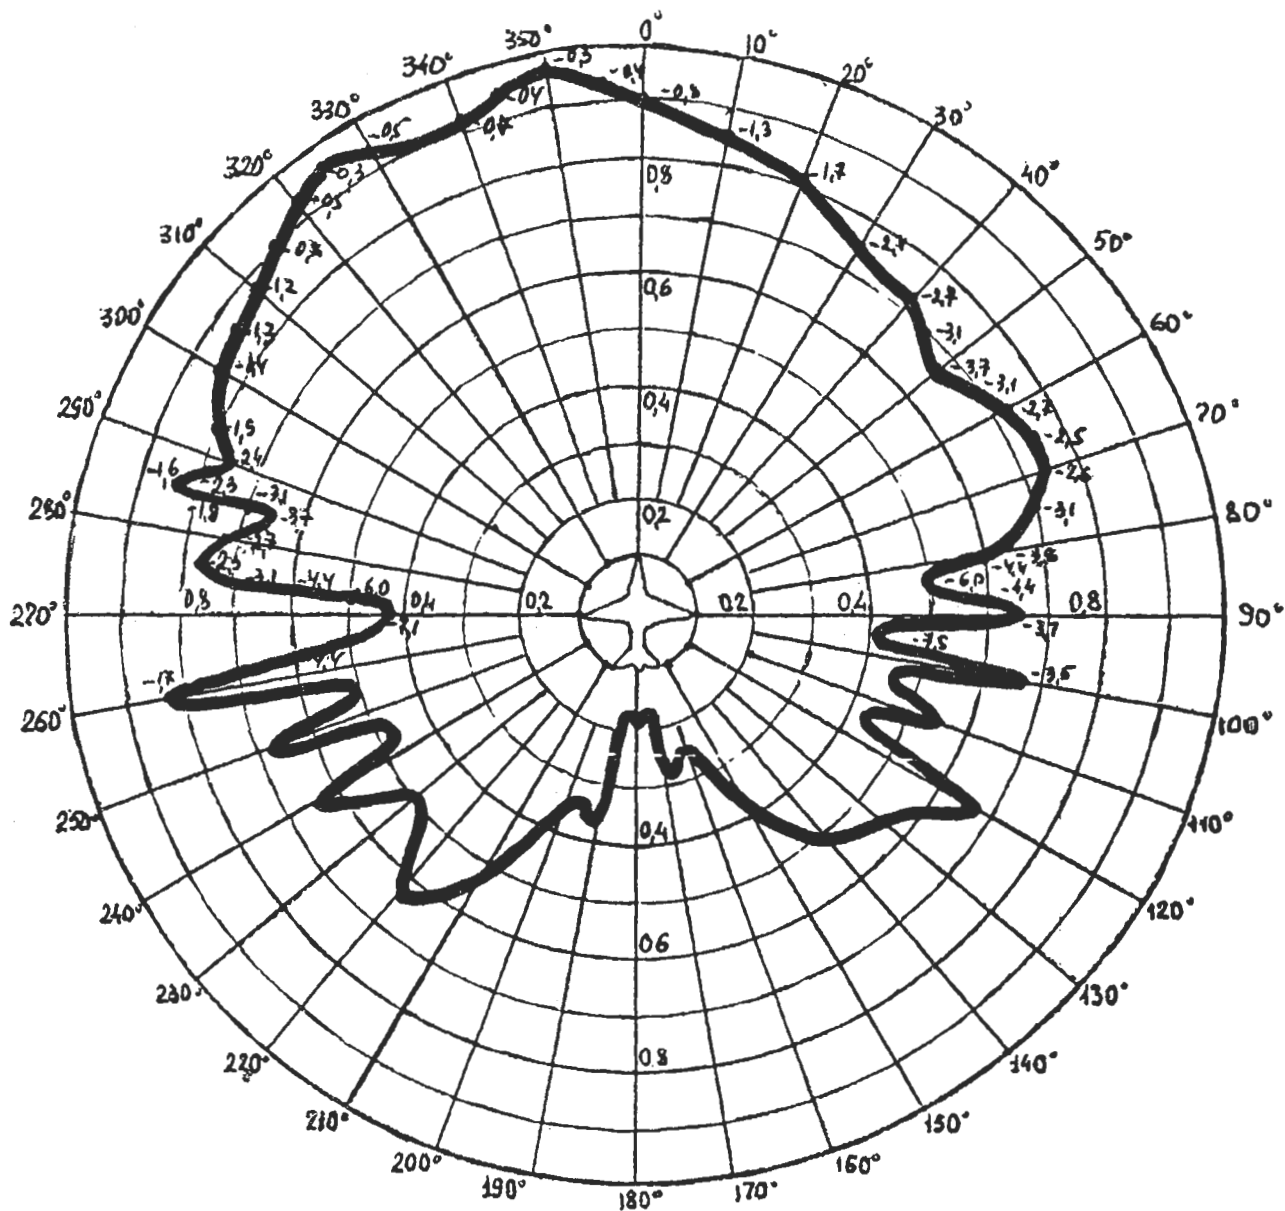
Рис. 8. Диаграмма направленности курсовой антенны самолета.
 Fig-8. Diagram of directional pattern of the aerial

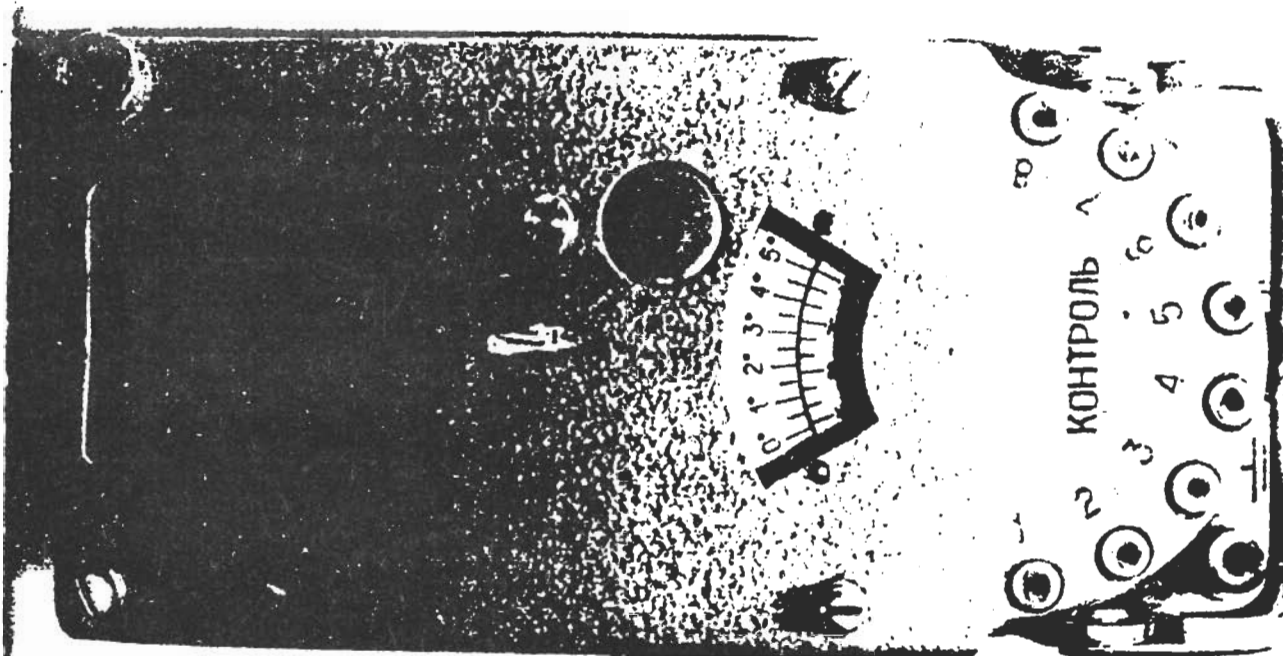
Phot. 16. The scale with the vernier of servo system mechanism on the UN-2P block №188783 intended for the control of working-out the azimuth on the radio beacon

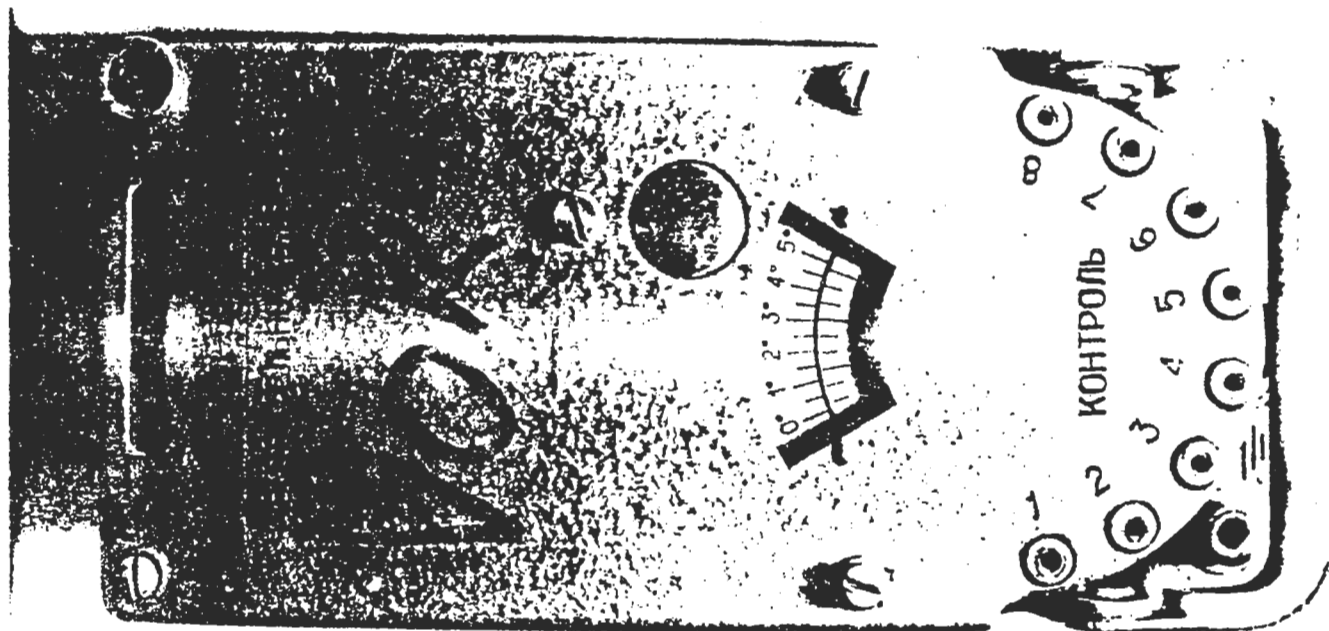
Phot. 17. The scale with the vernier of servo system mechanism on the UN-2P block №188789 intended for the control of working-out the azimuth on the radio beacon

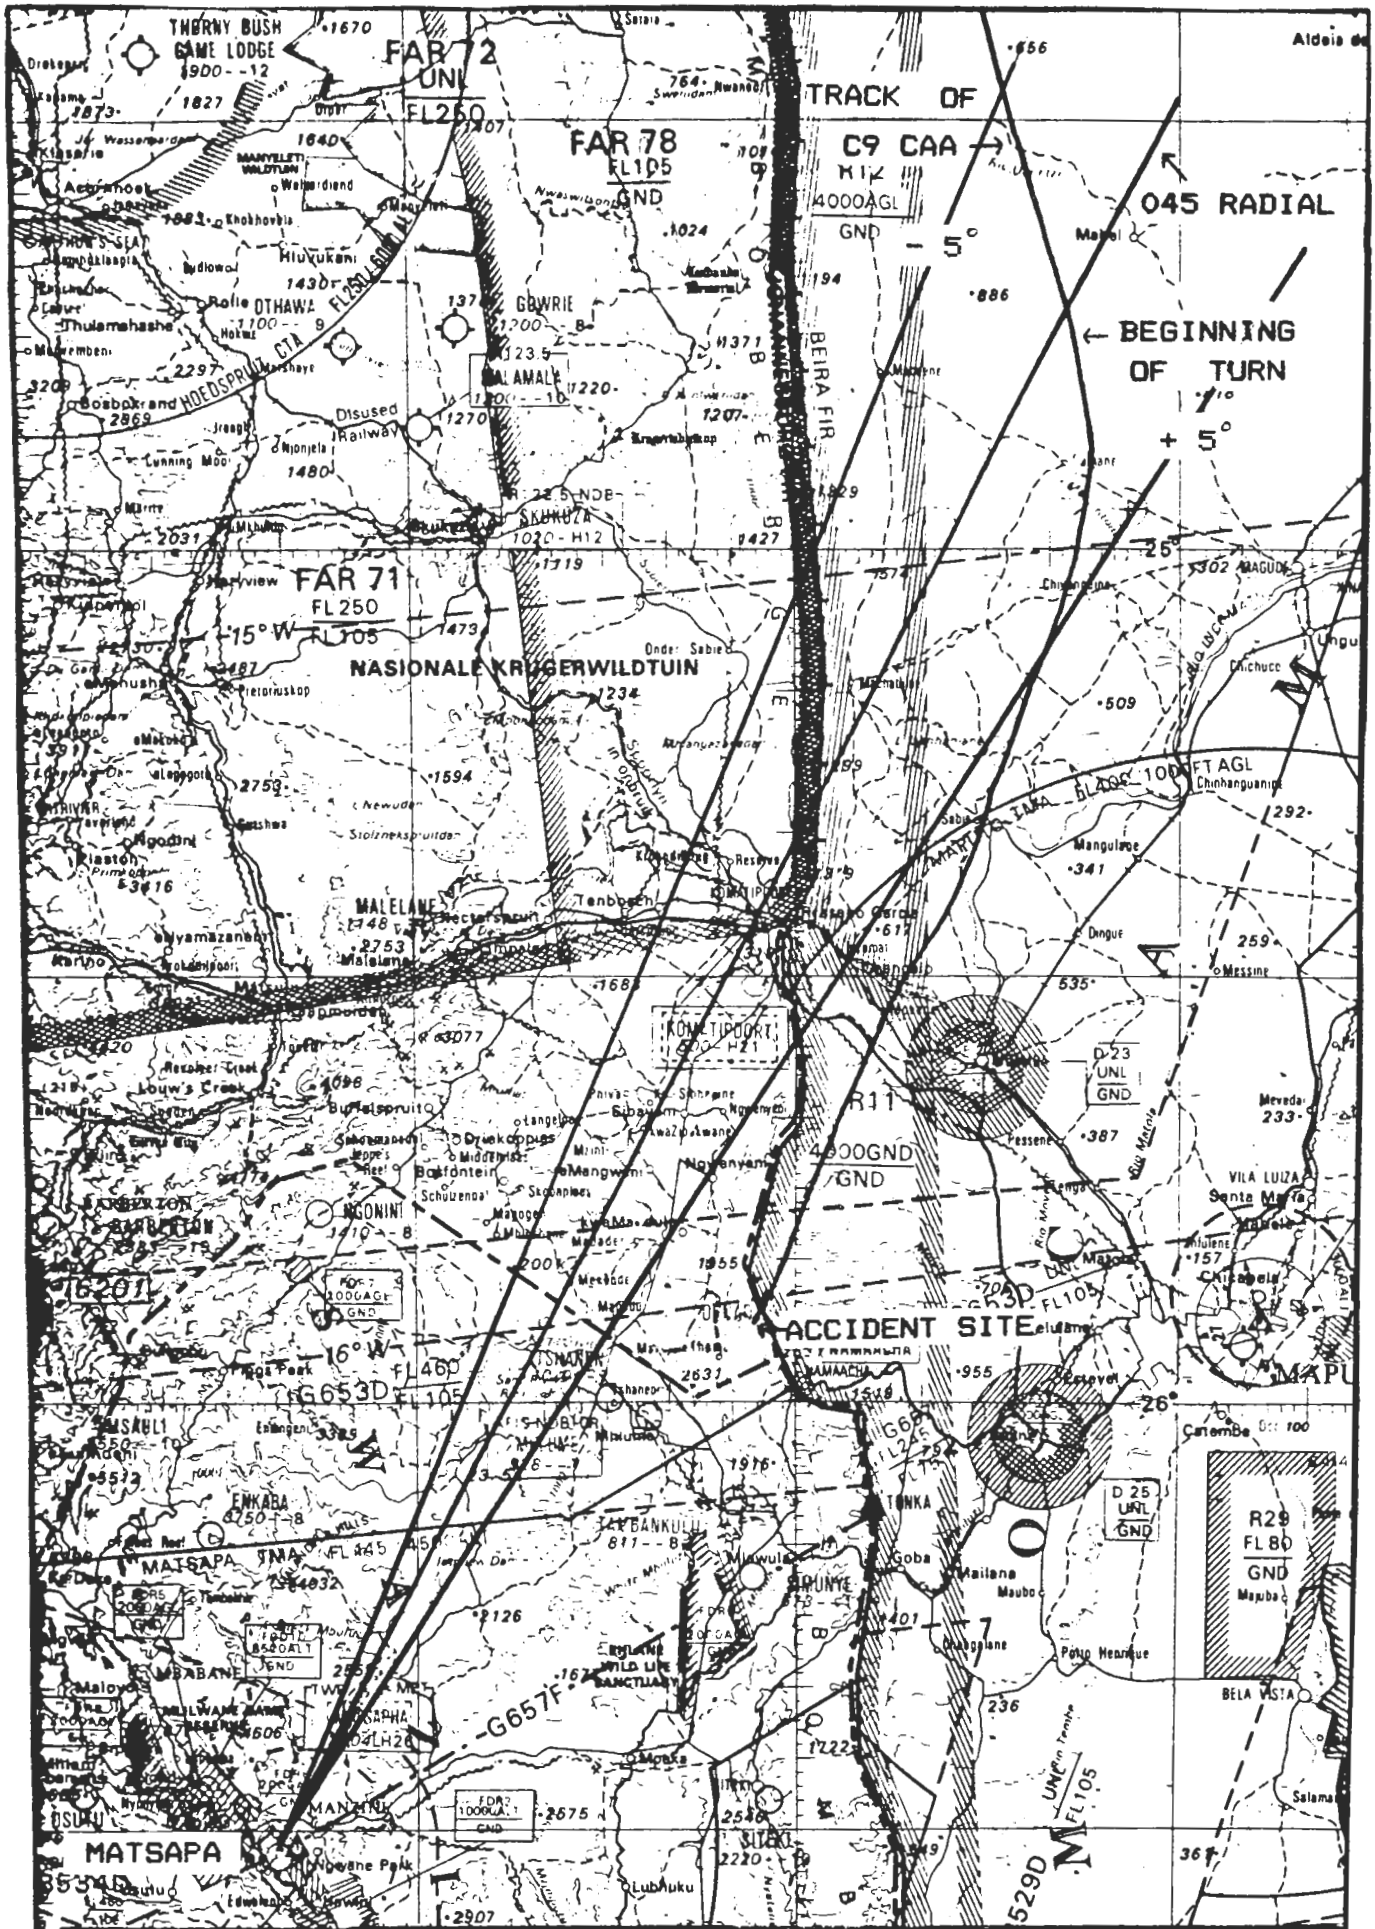
TURN AND TRACK RELATION OF C9 CAA TO MATSAPA 045 RADIAL

ICAO ANNEX 10 VOL I ATTACHMENT C TO PART I PARA 3.7.3.5
 5° TOLERANCE ALLOWED FOR.
