Celebrating TAWS ‘Saves’: But lessons still to be learnt.

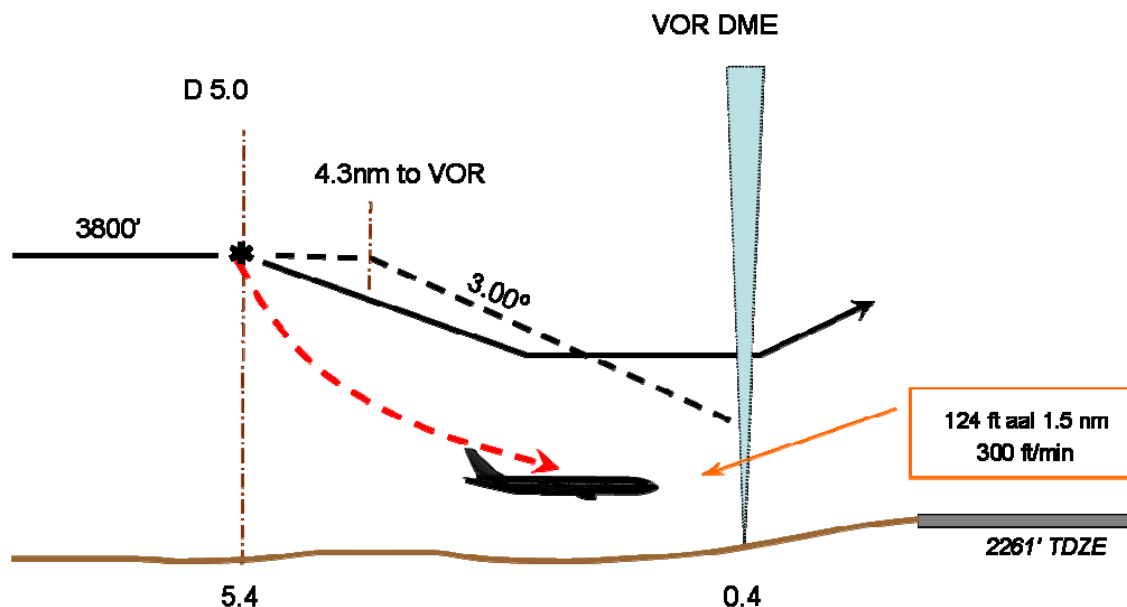
Figure 3. Vertical profile

The aircraft was making a visual approach to a major airport in a remote geographic area. The crew had a VOR DME approach procedure chart for reference. Figure 3 shows the vertical profile; the Final Approach Fix (FAF) was at 5nm DME (5.4nm from the threshold).

After the FAF the aircraft flew below the expected flight path. A TERRAIN PULL UP warning was given at 250ft agl (125 ft above airport level) at 1.5nm, the aircraft recovered from the 300 ft/min descent for an uneventful landing.

Black hole conditions induce a visual illusion of the aircraft being high on the approach, which usually results in the aircraft being flown below the optimum glidepath and in the extreme, landing short of the runway.

1. Black hole conditions are a pre-existing threat which can be identified, avoided, or at least the effects mitigated by the crew prior to an approach. Threat information can be gained from the chart (approach briefing) and from an airport briefing guide (operator survey / audit). When a black hole threat is identified then additional awareness and monitoring defences must be implemented.

2. Without cross monitoring or intervention alerting the pilot-flying to any flight path deviation, a threat condition can quickly become a significant safety hazard. In black hole conditions there is no point in the pilot-monitoring using the same visual references as the pilot-flying as both could suffer from the same illusion. An altitude / range table or an electronically defined VNAV flight path would provide the basis of independent monitoring, altitude checks should be made every 300ft (1nm).

3. The runway should always be shown on the EFIS map display. If fitted, the vertical profile display must be monitored during final approach.
4. In this incident, if the pilot flew below the optimum glidepath due to a visual illusion; there was inappropriate or no cross monitoring. The safety resources were either unavailable or not used, but primarily the crew’s mental picture of the where the aircraft was in relationship to the runway deteriorated to a hazardous low level. TAWS saved the aircraft from the combination of threats, error provoking situation, and false perception encountered during this approach.

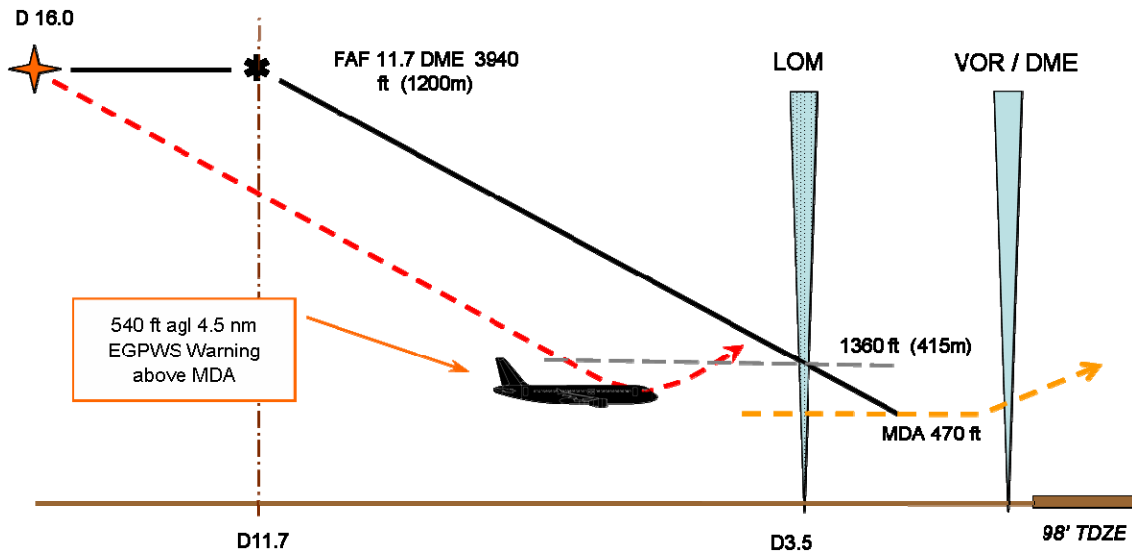
Figure 4. Vertical profile

The crew planned to fly the VOR/DME procedure. However, the aircraft commenced descent approximately 4nm before the FAF; a TERRAIN PULL UP warning was given at 540ft at 4.5 nm from the runway. This altitude is above the minimum descent altitude (MDA). The 460 ft/min descent was reversed and the aircraft climbed away safely. The approach procedure and vertical flight profile is shown in Figure 4. An extract of the approach plan view is at Figure 5.

- Altitude / range not monitored during the descent although a table was provided.
- Descending below the NDB / marker check altitude before over-flying the beacon.
- Airport / runway not programmed as a TO waypoint on the FMS EFIS Map
- Airport / runway not displayed or observed on the EFIS Map - a 12nm final from FAF (11.7 DME), possible inappropriate use of 10nm EFIS Map scale.
- Mistook the EFIS Map ADF symbol for the airport and used an open descent mode or 'green arc' descent towards the ADF symbol instead of the runway.

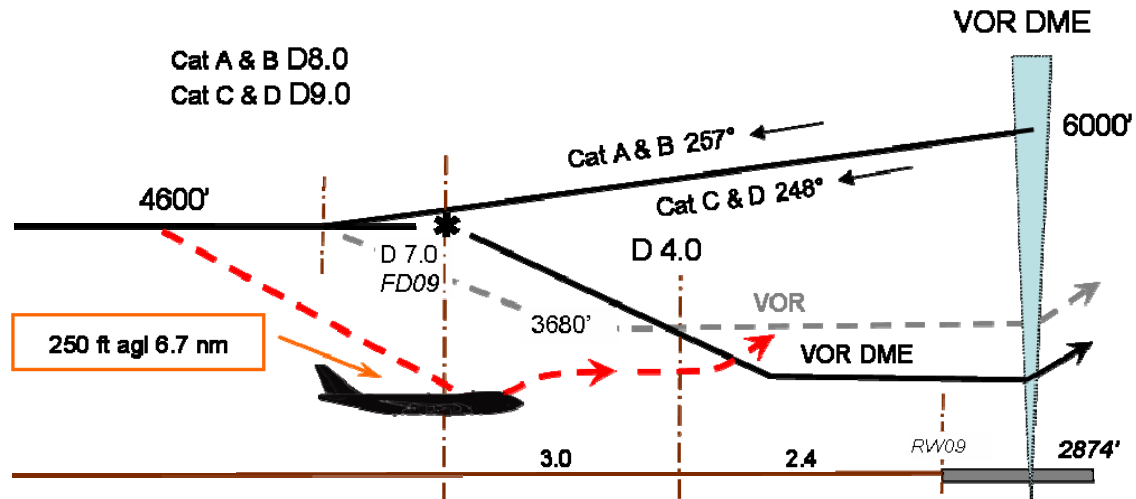
Figure 6. Vertical profile and erroneous flight path

The aircraft descended 2nm early on a 3 degree flight path. A TERRAIN PULL UP warning was given at 250 ft agl (6.7nm), the aircraft climbed slightly to maintain the MDA. After 1.5 nm of level flight a TOO LOW TERRAIN alert was given, after a short period the aircraft commenced a climb.

The most probable scenario was that the descent was commenced at 9 DME; there were several contributing factors:

- The crew deliberately descended early – duck under, dive and drive procedure.
- The crew suffered from the black hole illusion (the conditions existed).
- The approach was programmed in the FMS. The track might have been automatically constructed from the database, or it required the crew to enter a 9 DME waypoint (089/9) on the runway centreline. This would be necessary to give a continuous turn from the 9 mile outbound leg turn point, back on to the centreline. Subsequently the crew mistook the 089/9 way point as the FAF descent point (Figure 7).
- After receiving an EGPWS warning the crew thought that they were visual with the (distant) runway, they climbed to MDA and continued the approach, after 1.5nm a further EGPWS warning was given and after a further delay a climb was commenced.
- The runway position was either not displayed or not referred to on the EFIS map.

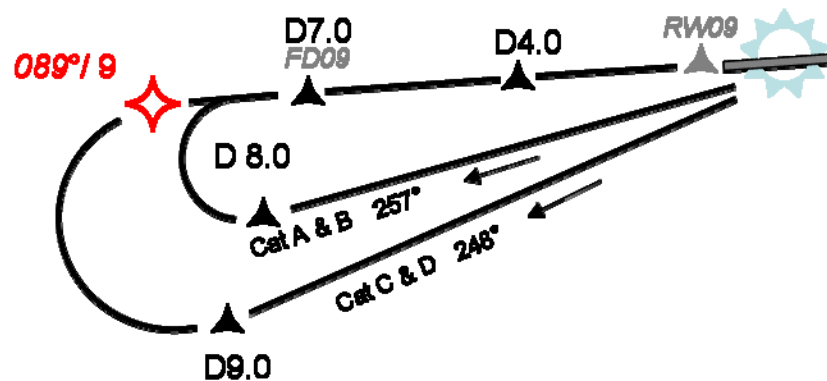
Figure 7. FMS / crew generated waypoint; erroneous descent point.

- The crew did not monitor altitude / range although a table was provided.
- The crew did not pull up and climb to a safe altitude after the first EGPWS warning.
- The aircraft was flying level at MDA just after the FAF (1500ft lower than required).
- Both crewmembers lost awareness of the progress of the approach; this may have included failing to scan the radio altimeter (> 500ft before the FAF on a NPA).

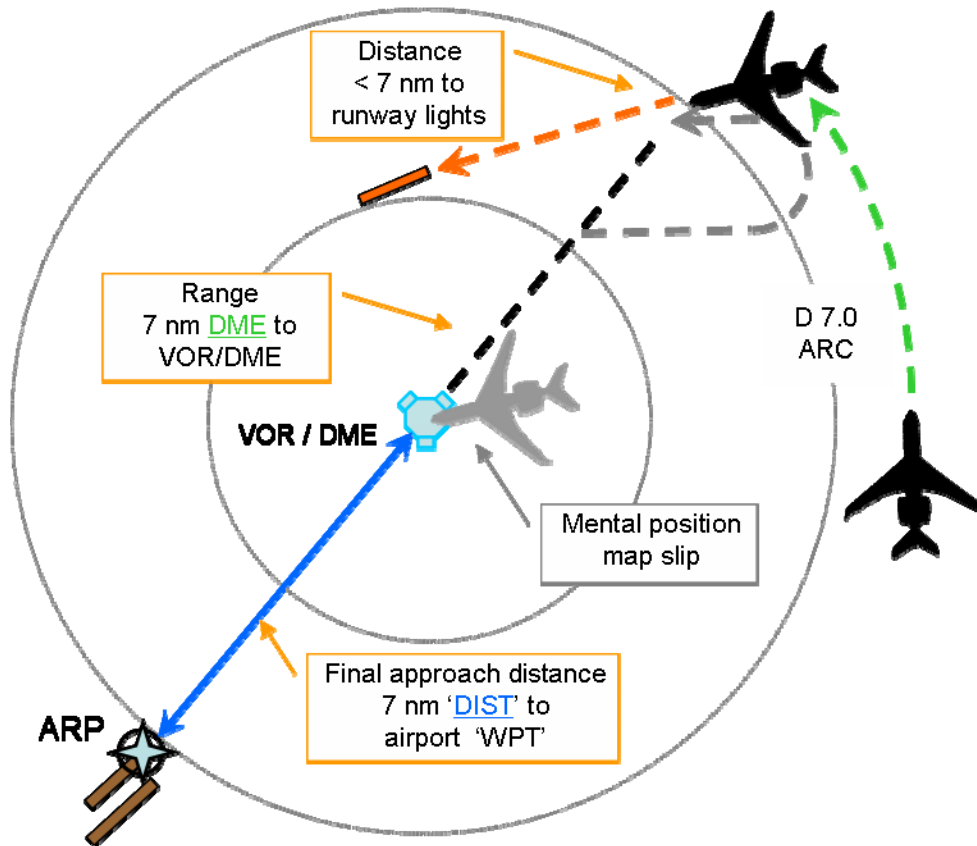
Figure 8 DME Arc procedure, wrong airport.

Turning on to the runway centreline after a DME ARC procedure, the crew became visual with the runway and commenced descent. A TERRAIN alert was given. The crew realised that they were approaching the wrong airport. The alert was given because the mistaken runway was not in the TAWS airport database due to its restricted length. The TAWS database is configurable for runway length according to the operator's requirements. The approximate flight path is shown in Figure 8.

1. Beware of habit and complacency, ‘we have always done it this way’ and expecting to see something.
2. Mental resources and ability for careful thought are reduced with tiredness, fatigue, or stress; in these circumstances humans are susceptible to errors of mind (mental map) slip, situation awareness, timing, and failure to monitor. Pilots must refocus their attention on lateral and vertical position before starting an approach.
3. Conscious effort must be made to avoid distraction or fixation on the nearest or brightest lights; visual approaches should always be cross checked with navigation aids.

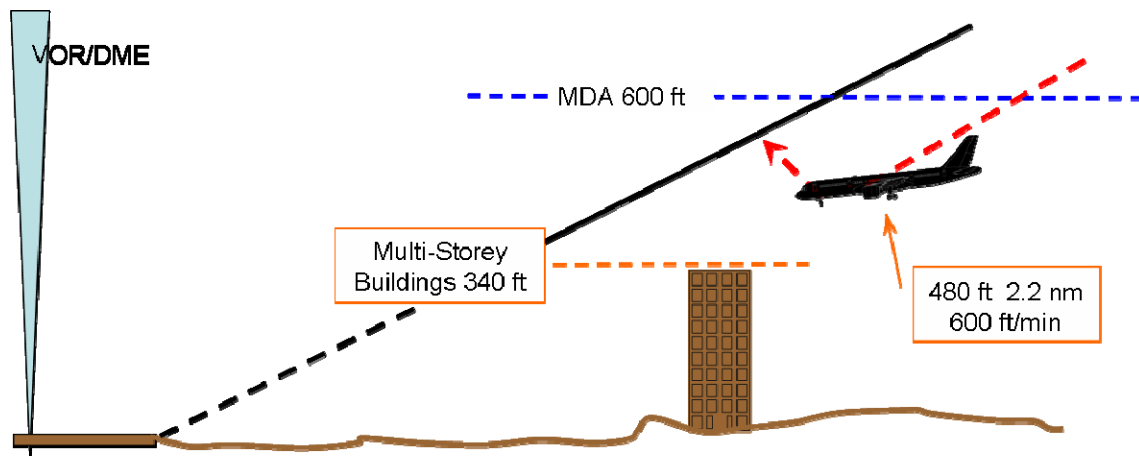
Figure 9. Night IFR. Obstacle warning.

The procedure descent should commence from the FAF; this was defined either by DME or a VOR cross radial; if the VOR was used, then a higher MDA is used to account for any position error. The DME origin was offset 0.8nm beyond the runway threshold.

There was only one check altitude in the procedure; beyond that the crew were dependant on the protection given by a go around at MDA or by establishing visual contact with the runway environment. The approach chart depicted a 'dive and drive' or 'stepped down' procedure that detracted from the recommended constant angle approach path that would have provided a stabilised approach. There was no altitude / range table. The final part of the approach is shown in Figure 9.

There was no indication that the crew had or used an altitude / range table. Thus any error in commencing an early descent was not identified during the approach; additional flight path errors could occur due a higher rate of descent than required.

The reason for the aircraft's low approach was not established. However, this error enabled the crew to make ground contact at an earlier point than the conditions would have normally allowed.

At the time of the warning the aircraft was below MDA; the crew, believing that they had seen the approach lights were continuing the approach partly visual, in foggy conditions.

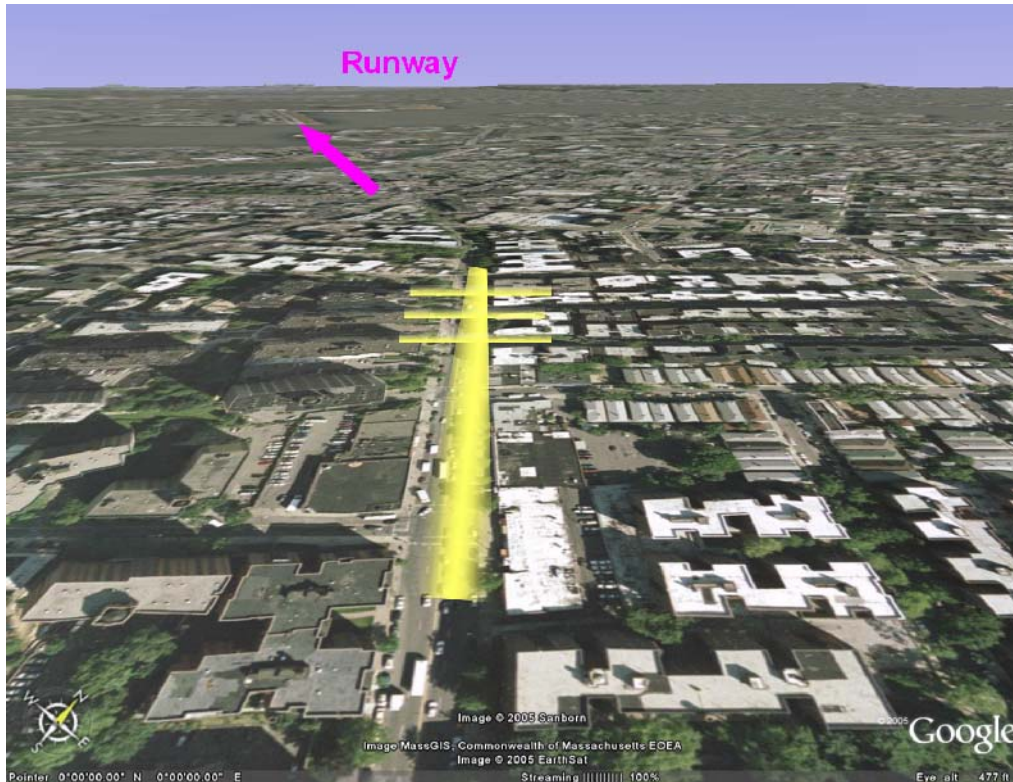
It was concluded that the crew mistook the regular pattern of street lights for the approach lights; there were alignments both longitudinally (centreline), laterally (cross bars), and patterns resembling PAPI.

Figure 10. Street lighting pattern at 2nm (runway upper left). © Google Earth

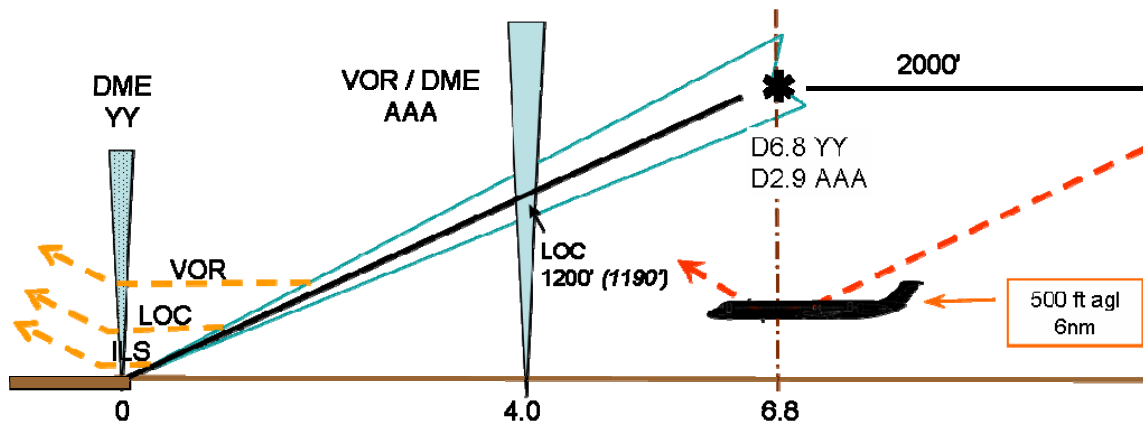
Figure 11. Combined ILS, LOC (GS out) and VOR DME Procedures.

ranges could have given them a higher mental priority than for the VOR ranges; it is most likely that a pilot would have read the top line before reading the lower lines. Therefore more mental effort and concentration is required to remember which procedure is being flown and for searching down the chart for VOR data.

The most likely scenario was that the descent was commenced at 6.8 nm from the VOR instead of 2.9 nm. The crew had retuned the DME from the ILS to the VOR, but failed to move their mental position by 4 nm with respect to the DME. This lapse, together with chart weaknesses, inclined them to use the LOC (GS out) altitude / range table for monitoring instead of the VOR DME table. The approach appeared safe and correct.

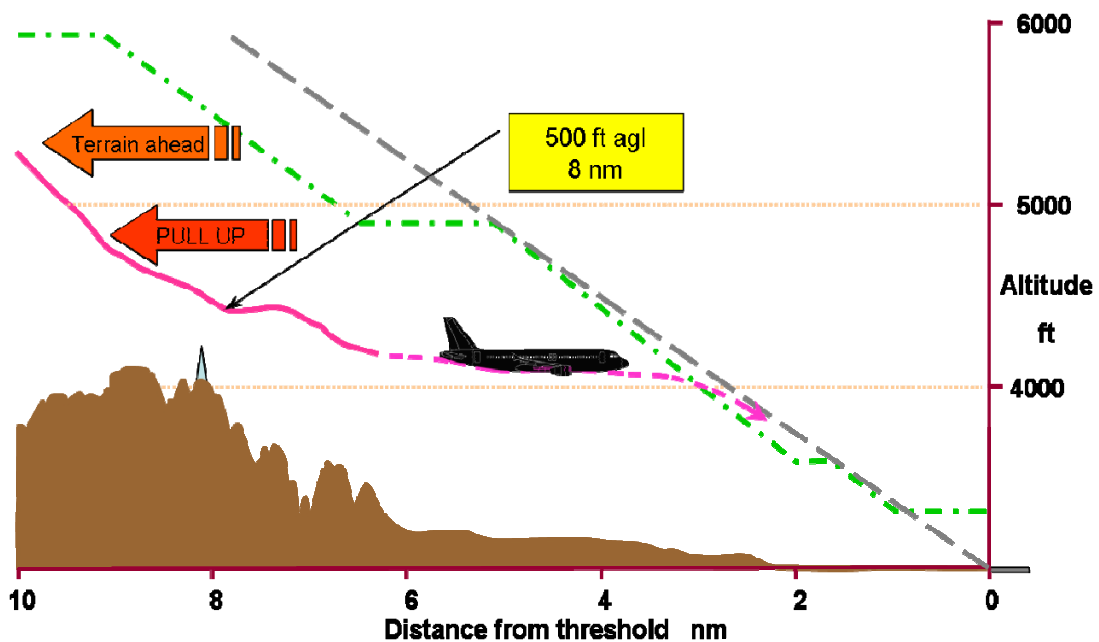
As the aircraft descended below 5300ft, still 10nm from the threshold, a TAWS Terrain Ahead alert was given; the flight path was towards terrain 1500ft below. The descent was continued; at 4600ft a Terrain Pull Up warning was given. The crew stated that they flew level, and after visually verifying safe terrain clearance continued the approach. Further TAWS warnings, including 'To Low Gear' were given until the aircraft approached the visual glide path. The EGPWS memory data indicated that the aircraft had not flown level as the crew believed and that it had followed a flight path well below that which the crew had perceived. The minimum ground clearance was 500ft as confirmed by the gear warning; in addition, the aircraft had over-flown a mast of elevation 4180ft with less than 300ft clearance. The profile of the flight path is shown in Fig 12 below.

- Mis-set altimeter. The altitude deviation was between 1000ft and 1500ft. A mis-set altimeter was a possible scenario, but this was unlikely to have been the main problem although it could have contributed to the crew's initial perception of a safe flight path.
- A range error which resulted in an early descent approximately 5nm before the required approach path. The DME/TACAN is within 0.5nm of the runway threshold, which other than misreading would not account for the discrepancy. There are no other DMEs in the locality which could be mis-identified.
- The crew suffered a visual illusion which encouraged an early descent and then progressively contributed to a low approach path. The conditions for a black hole illusion were present and the flight path had the characteristic bow shape. It is concluded that this scenario is the most likely one that the crew encountered.

- A black hole illusion can be experienced during any night approach; it is a significant hazard to safe flight.
- The illusion can affect both pilots simultaneously. In these circumstances the external scene does not provide a reliable means of judging the start of a descent or for confirming terrain clearance after a TAWS warning.

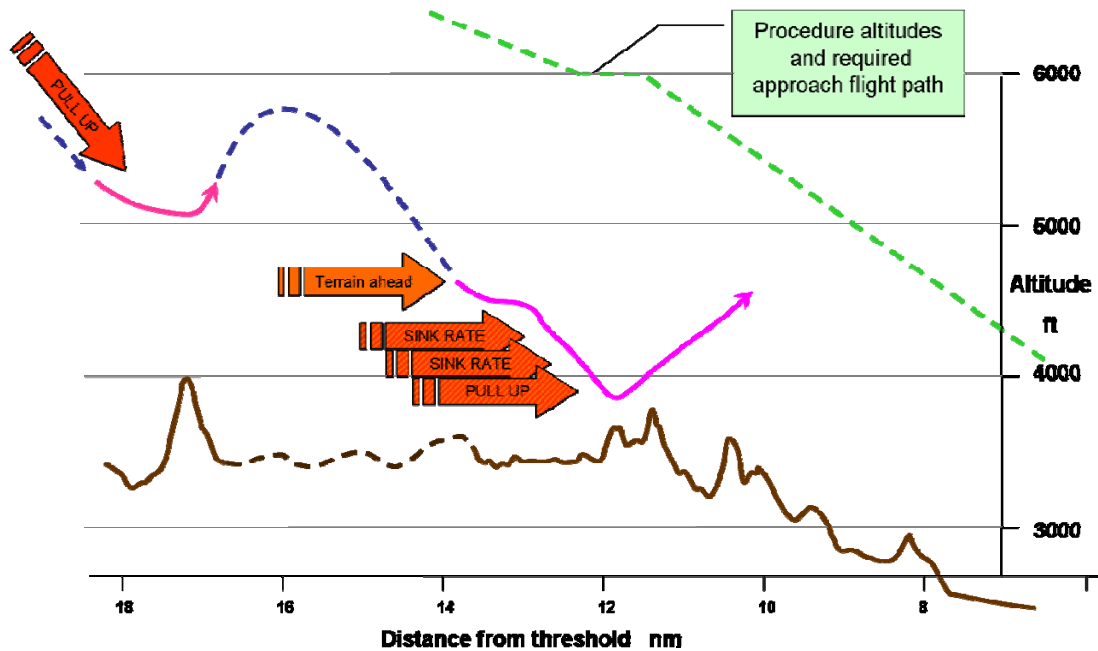
Figure 13 - Two encounters, EGPWS and GPWS

As the aircraft descended below 5000ft (approximately 2800ft above threshold altitude) with a vertical speed of 1100 ft/min, a TAWS Terrain Pull Up warning was given. It was reported that at the EFIS terrain ‘popup’ display on the ND map turned ‘completely red’. The crew stopped descent and climbed, but as the terrain display reverted to less threatening colours, the crew apparently did not establish any reason for the warning or if the aircraft was at a safe altitude. It is probable that the crew assumed that the flight conditions were now safe and that the warning was a ‘nuisance’ or spurious alert. The minimum safe altitude (sector safe altitude) was 8400ft; the aircraft was still 2000ft below that altitude.

The descent was recommenced. As the aircraft turned on to the final approach course, descending through 4400ft with a vertical speed of 1300ft/min and increasing to 2100ft/min, a Terrain Ahead warning was given. The crew inhibited the EGPWS enhanced terrain warning function by selecting TERR OFF and continued the approach. Ground clearance at this point was 1000ft reducing to 700ft. In this aircraft installation, as in most fitted with EGPWS, if the enhanced terrain warning functions are inhibited the original GPWS modes 1 - 7 remain active. Therefore shortly after selecting TERR OFF a repeated ‘Sink Rate’ Alert (Mode 1) was given. The profile view of the sequence of events is shown in Figure 13.

The descent was continued, with a ground clearance of 420ft (Radio Altitude) and at a vertical speed of 2000ft/min, a continuous ‘Sink-Rate’ ‘Pull Up’ Warning (Mode2) was given. The crew complied with this warning approximately 30 sec after the start of the second series of alerts. During the pull up the aircraft cleared terrain by 160ft, which previously was above the aircraft’s descending flight path.

7. Never switch TAWS off believing that it has given a nuisance warning. System failures are now less likely than crew error. Instead of considering '*switch TAWS off*' crews must change their behaviour to '*switch "safety thinking" on*' and establish the reasons for the warning.

8. Procedures for TAWS warning 'Pull Up' should not include conditional items such as 'if visual', 'if sure of position'. These statements do not protect crew from the effects of powerful and compelling visual illusions or mis-set altimeters.

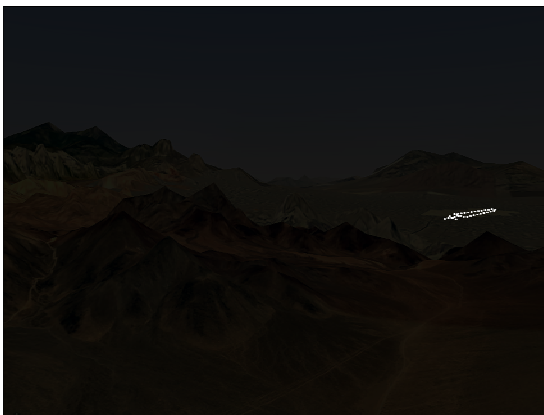
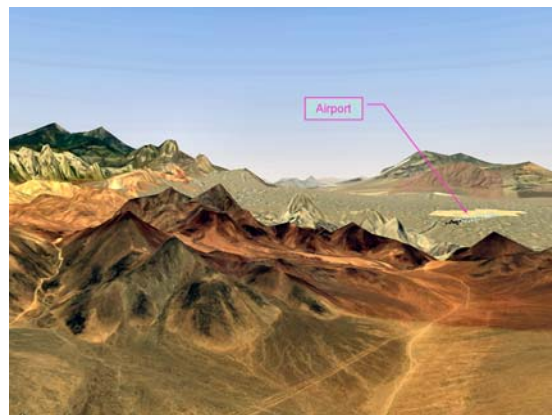
- The crew established and maintained visual contact with the airport, but both pilots experienced a ‘black hole’ illusion (see incidents 1 and 7). All of the conditions for this illusion existed, and perhaps more so due to the relative position of the runway before turning onto final approach. Figures 14 and 15 show a graphic representation of the scene at the time of the first warning.

Fig 14 Night scene - apparent safety.

Fig 15 - reality.

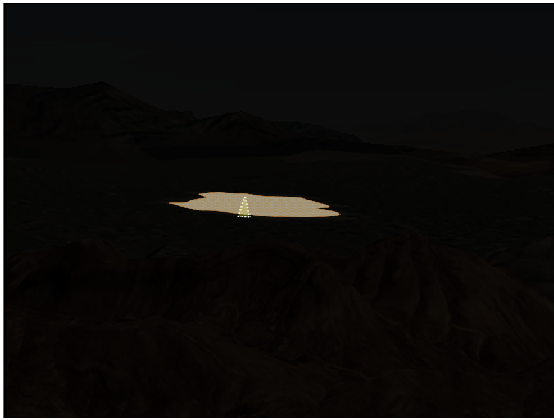
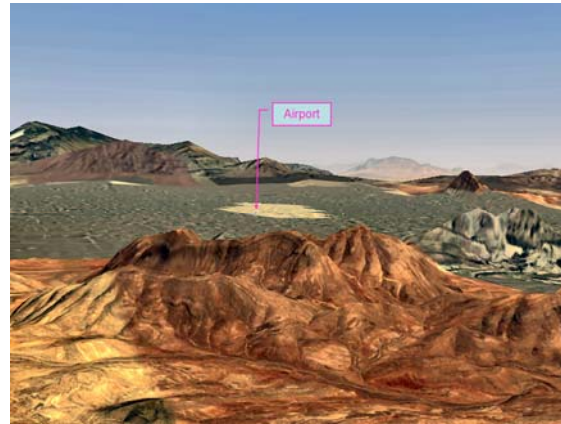
- It is unlikely that the crew had mistaken the distance to the airport as the aircraft track approximated the DME arc, however ATC may have issued an early ‘visual’ approach clearance which was misunderstood as a clearance for further descent to 4300ft, (which is only safe within 9.3nm). The crew either commenced an early descent on this clearance without crosschecking the aircraft location or they used the visual scene for guidance and underestimated the range. This perception also existed during the final approach. Figures 16 and 17 show a graphic representation of the scene at the time of the second warning where the crew were flying a steep descent

to regain a flight path that they perceived as correct, but they were in fact nearly 2000ft below the required glide path.

Fig 16 final approach – black hole.

Fig 17 reality
