Islamic Republic Of Iran
Civil Aviation Organization
Aircraft Accident Investigation Board

Final Report

Aircraft Model: Bombardier CL604 Challenger

Registration: TC-TRB

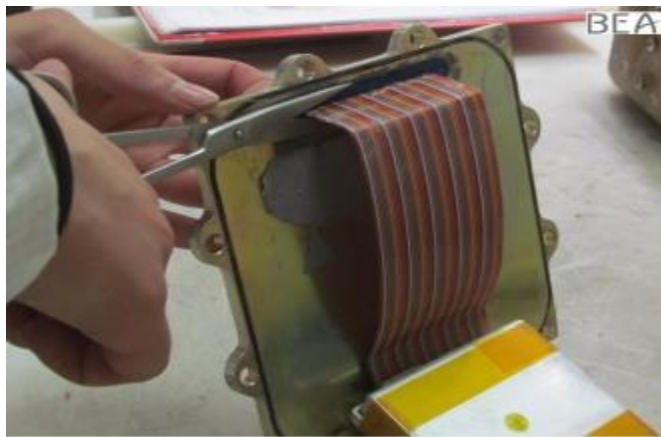
The FDR FCSSU was visually checked. The connector of the memory board was damaged.

The FCSSU was opened, the metallic casing of the memory board was extracted and the ribbon cable was cut close to the cover of the FCSSU.
