Aircraft Accident Investigation Board

Preliminary Report

Aircraft Model: Bombardier CL604 Challenger

Registration: TC-TRB

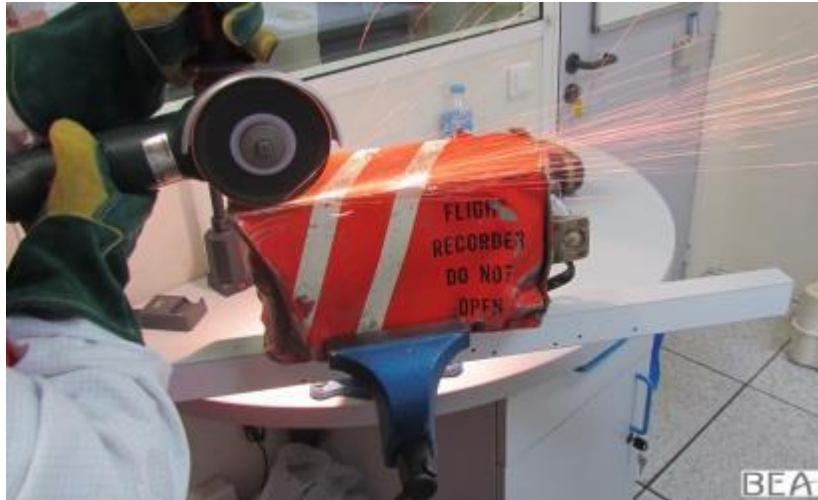
The CVR opening operations took place in BEA facilities. A visual Assessment of the CVR was performed. The recorder was damaged. The ULB still attached to the chassis.

Due to the recorder's damage, the chassis was cut with electrical grinder to have a clear access to the main processor PWA.

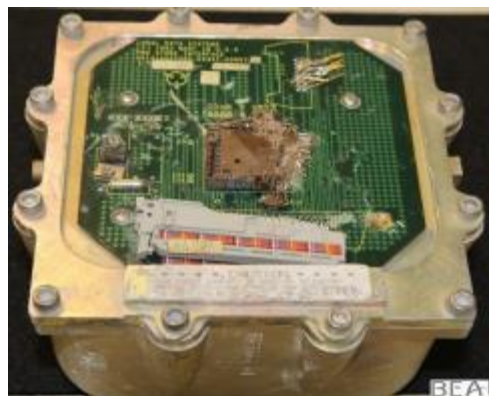
The FDR FCSSU was visually checked. The connector of the memory board was damaged.

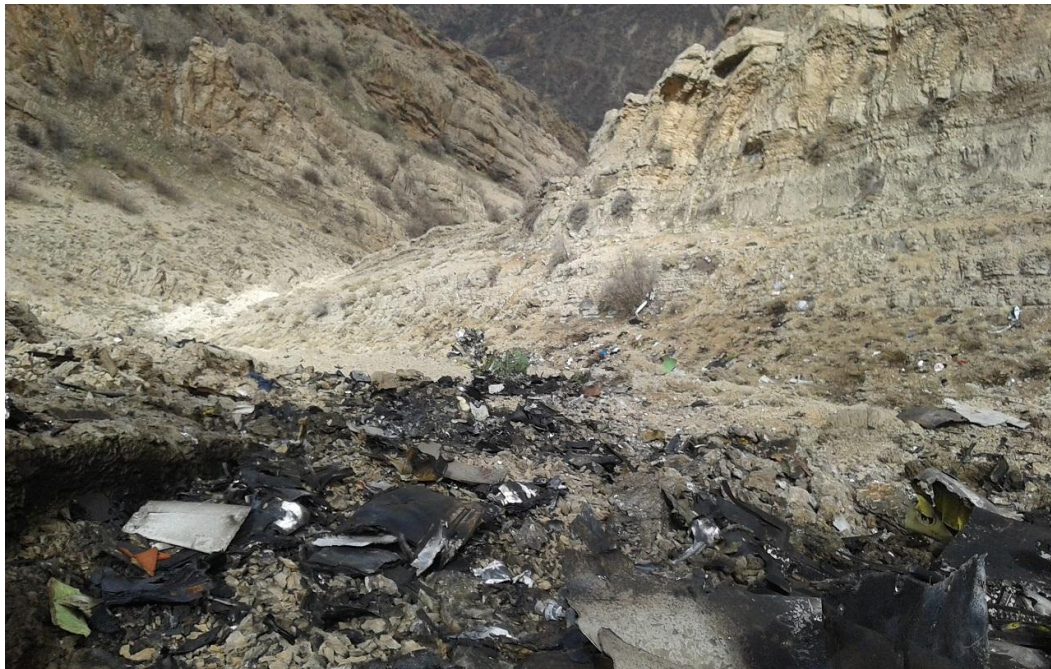
Impact point and the wreckage of the aircraft

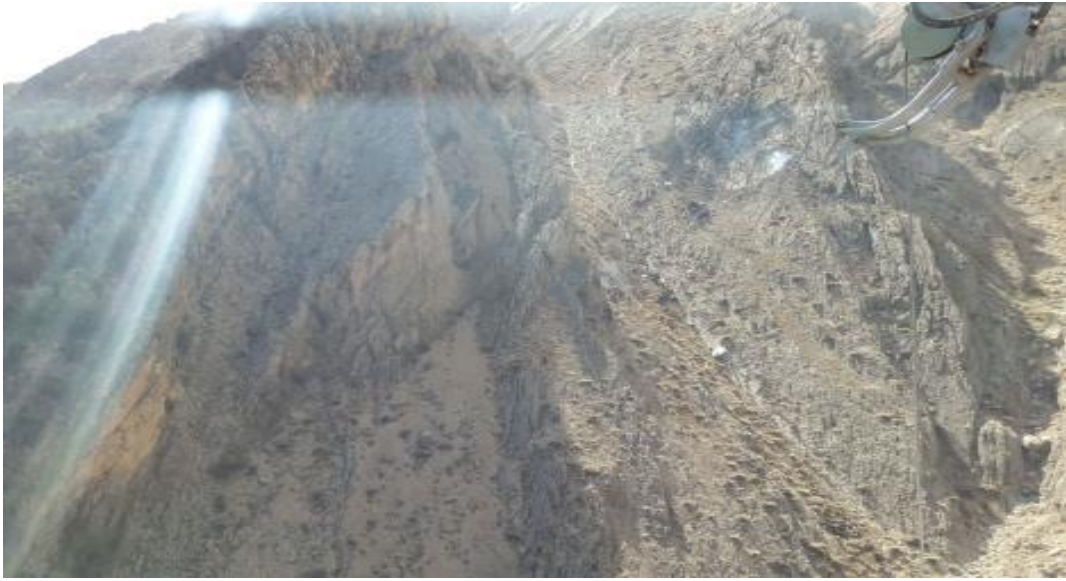
Impact point of the aircraft

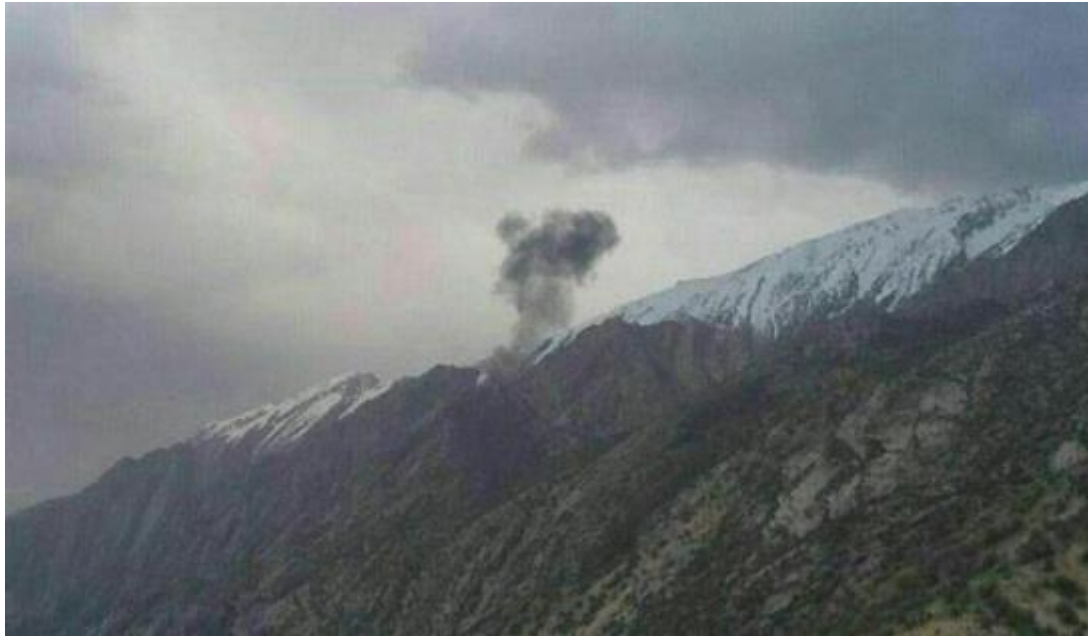
The first picture from crash site
