**McDonnell-Douglas DC-8-61, C-GMXQ, accident at
King Abdulaziz International Airport, Jeddah, Saudi Arabia, on 11 July 1991.
Report released by the Presidency of Civil Aviation, Kingdom of Saudi Arabia.**

SYNOPSIS

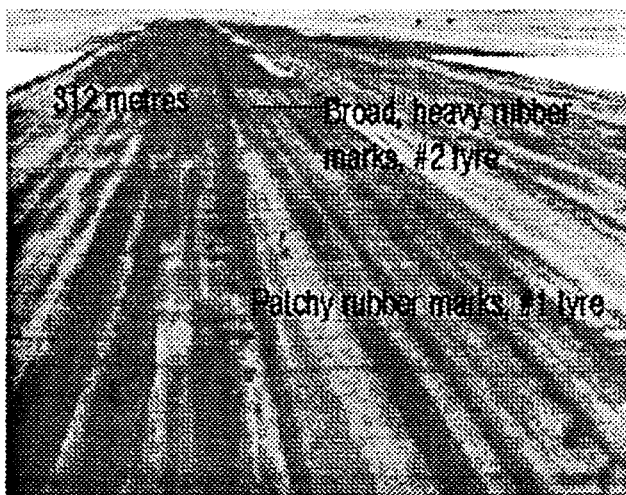
160 metres from the threshold, #1 tyre began to deposit “patchy” rubber marks on the runway. By 185 metres (from the threshold) #1 tyre was depositing dense, broad patchy rubber marks. At a distance of 290 metres from the threshold, #1 tyre had ceased depositing tread marks and the #1 wheel rim began to contact the runway surface. At the same time, #2 tyre began to deposit dense broad patchy rubber marks on the runway. To allow for the turning radius of the aircraft while lining up on the centre line, the measured distances along the runway should be reduced by 30 to 60 metres to tie in with the aircraft take-off roll.

To allow for the turning radius of the aircraft while lining up on the centre line, the measured distances along the runway should be reduced by 30 to 60 metres to tie in with the aircraft take-off roll.

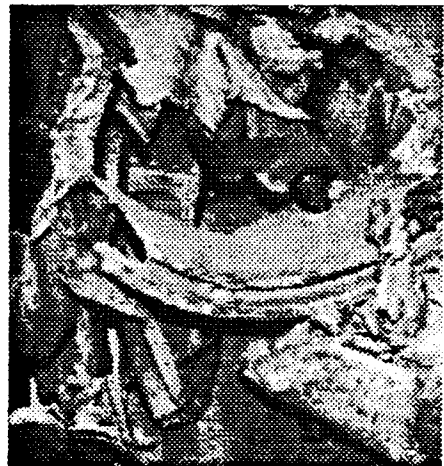
Rim Piece

Most of the wing flaps had been involved in the ground fire. A number of sections were extensively burned with major portions missing. The left inboard flap was found to have a piece of a main landing gear wheel assembly lodged in its damaged leading edge. The location of the damage was directly aft of the left main landing gear when extended and the piece was identified as being part of the rim of #1 wheel.

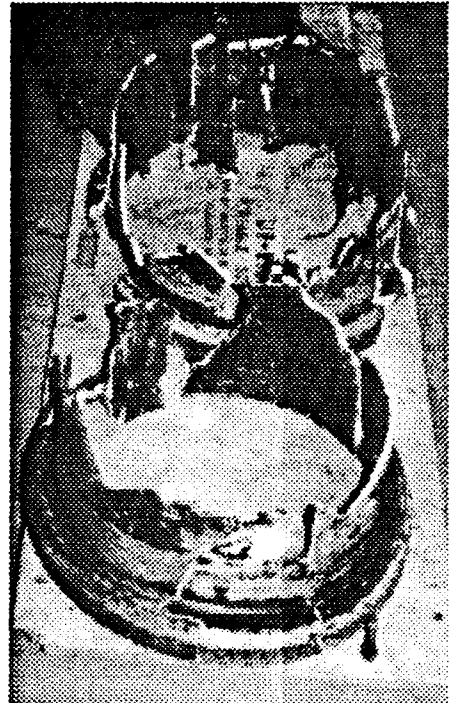
#1 Wheel Pieces

The central hub and spoke section was recovered from the accident site, as was a portion of rim section which was found lodged in the leading edge of the inboard left wing flap panel. Reconstruction of recovered parts accounted for almost all of the wheel assembly; two small rim sections three and a half and four inches of the outer circumference were missing. The edges of fractures on adjacent parts were clean and sharp. The outer diameters of both rims were roughened in an even pattern over the full circumference.

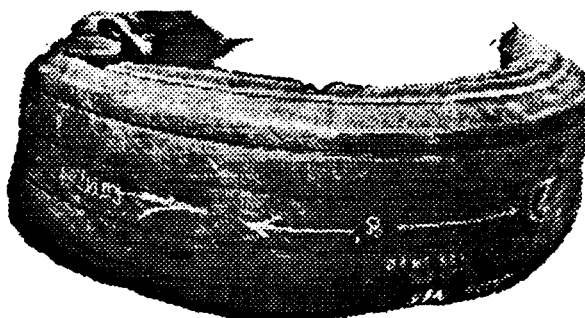
Part of #2 Tyre Carcass

The bead sections of this tyre were recovered from the main crash site. Both were ground down in a pattern which matched that of wheel #2. The bead pieces were burned and charred but remained intact. The carcass of this tyre was broken into one large piece and a number of small pieces. Enough pieces of tread surface were recovered from the runway (when matched) to

complete the full (tread) circumference. There was still a significant amount of missing tyre. The large number of small fragments that could not be directly matched to either the #1 or #2 tyre would not have accounted for all the missing material.

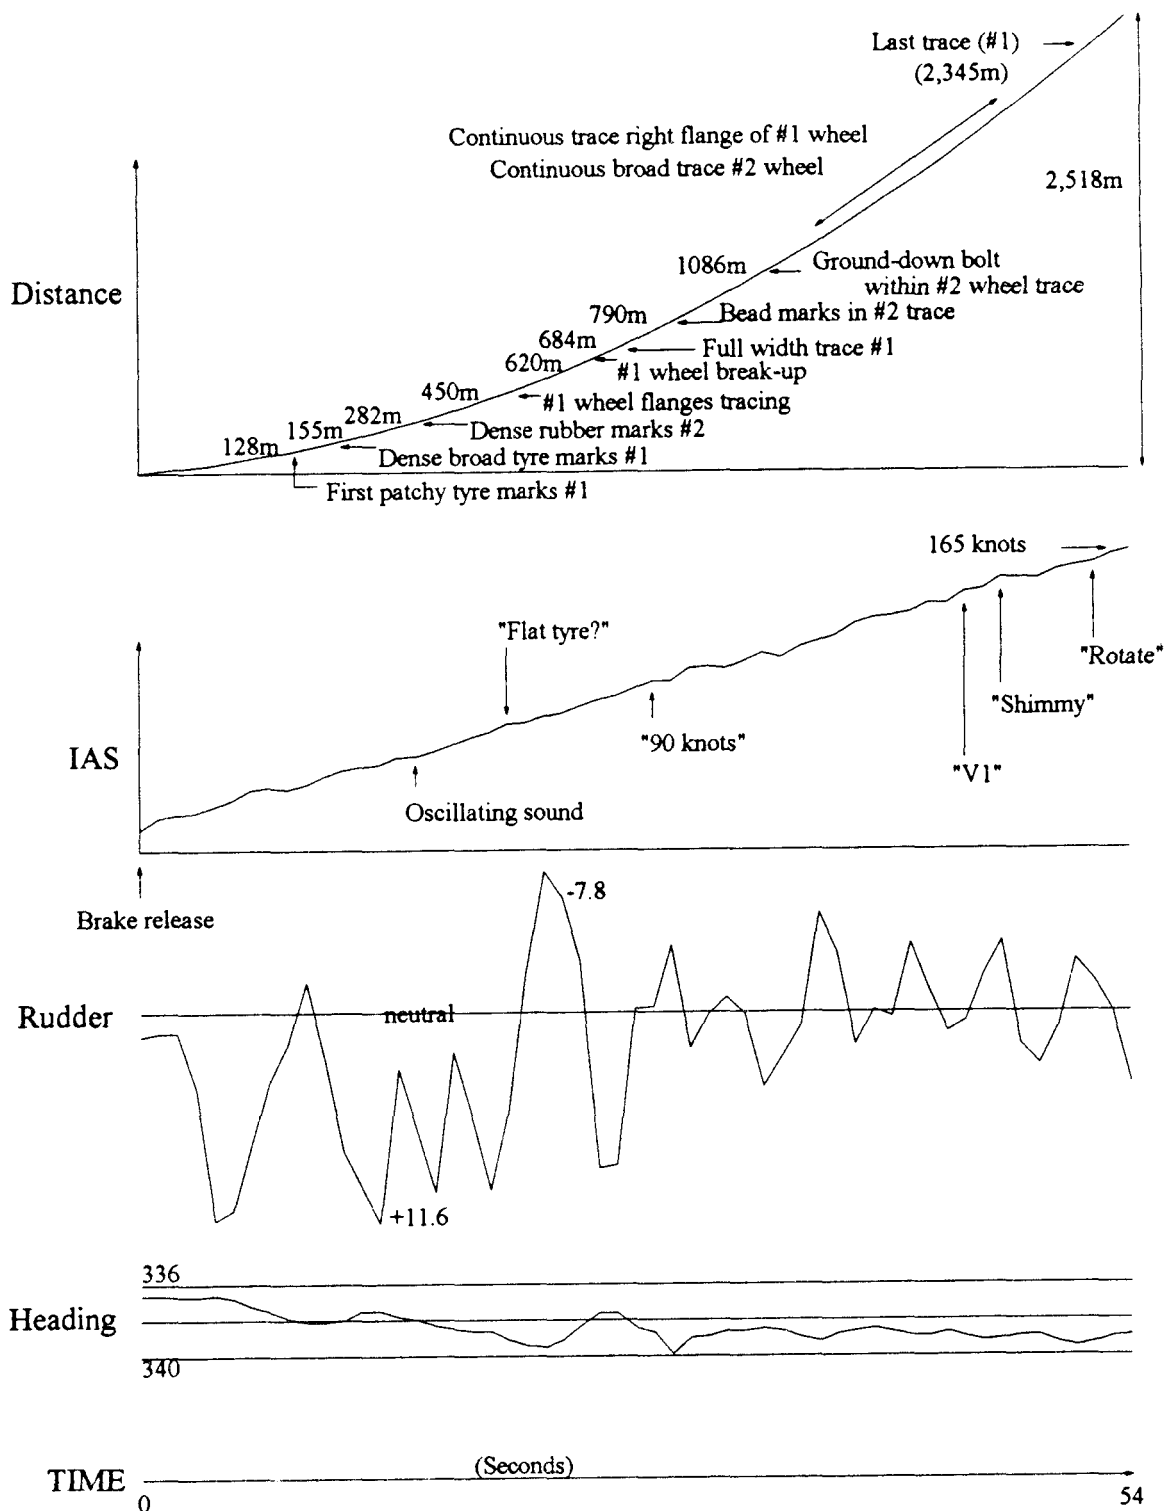
Take-off Features.

- The distance plot includes annotations derived from the runway survey (See 1.12.1) with the measured distances from the runway threshold reduced by an arbitrary 30 metres.
- The IAS stagnation points, recorded in the table and plotted, may be significant; they may be data recording errors. The annotations on the IAS plot are abbreviated extracts from the CVR.
- The rudder plot shows control activity and may indicate the directional effect of the tyre and wheel failures.
- The heading plot is fairly consistent with the traces and marks noted during the survey of the runway.
