AIRCRAFT ACCIDENT REPORT

OVERSEAS NATIONAL AIRWAYS, INC
DOUGLAS DC-10-30, N11032F

JOHN F. KENNEDY INTERNATIONAL
AIRPORT

1. No. NTSB-AAR-76-19		2. Government Accession No.		3. Recipient's Catalog No.	
4. Title and Subtitle Aircraft Accident Report -- Overseas National Airways, Inc., Douglas DC-10-30, N1032F, John F. Kennedy International Airport, Jamaica, New York, November 12, 1975		5. Report Date December 16, 1976		6. Performing Organization Code

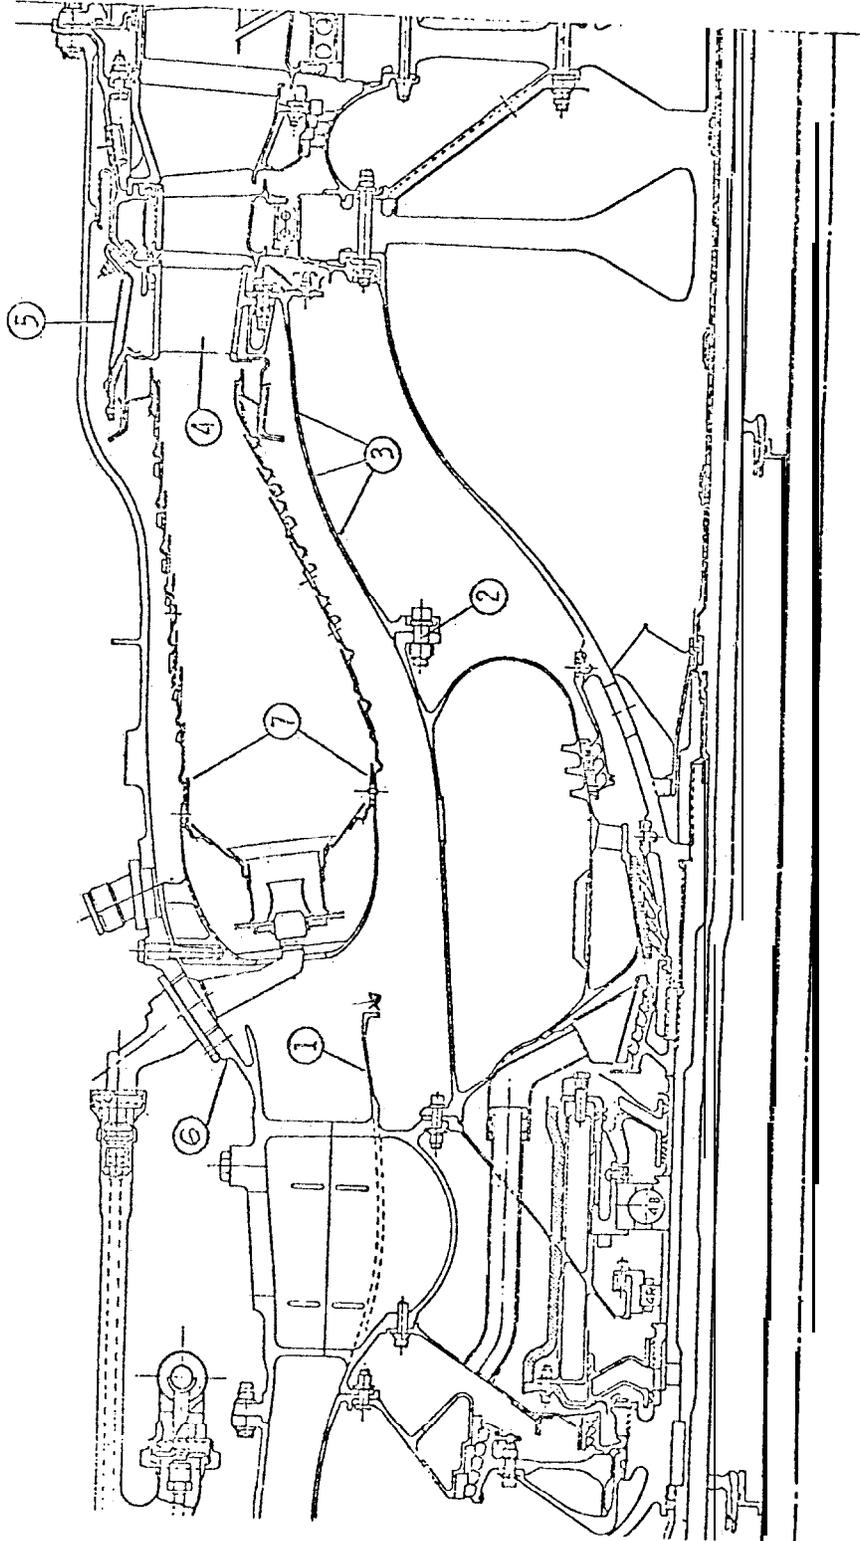
DEFORMATION LOCATION

Calculations were made to determine the pressures required to cause the internal deformations found in the No. 3 engine. The calculations were made using the material properties for steady-state loading at the material's operating temperature. The results were expressed in terms of the differential pressure across the section. These pressures would have to be applied as a high-rate impulse. (See Appendix E.)

7. Combustor Liner
Inward and aft buckling of shell
Normal differential pressure is 15 PSI
Pressure required for buckling is 192 PSI differential pressure
