One-Two-Go Airlines Flight OG269, HS-OMG September 16, 2007, Phuket, Thailand

A. INTRODUCTION:

This paper relates to the September 16, 2007, accident of One-Two-Go Airlines flight OG269, Thailand registration HS-OMG, a Boeing-McDonnell Douglas MD-82 that crashed during an attempted go-around at the Phuket International Airport (HKT), Phuket, Thailand. The flight departed the Don Muang Airport (DMG), Bangkok, Thailand on a regularly scheduled passenger flight destined for (HKT). There were 123 passengers and 7 crewmembers on the flight, of which 89 persons were fatally injured. Among the fatalities were both pilots and 3 of the 5 cabin crewmembers.

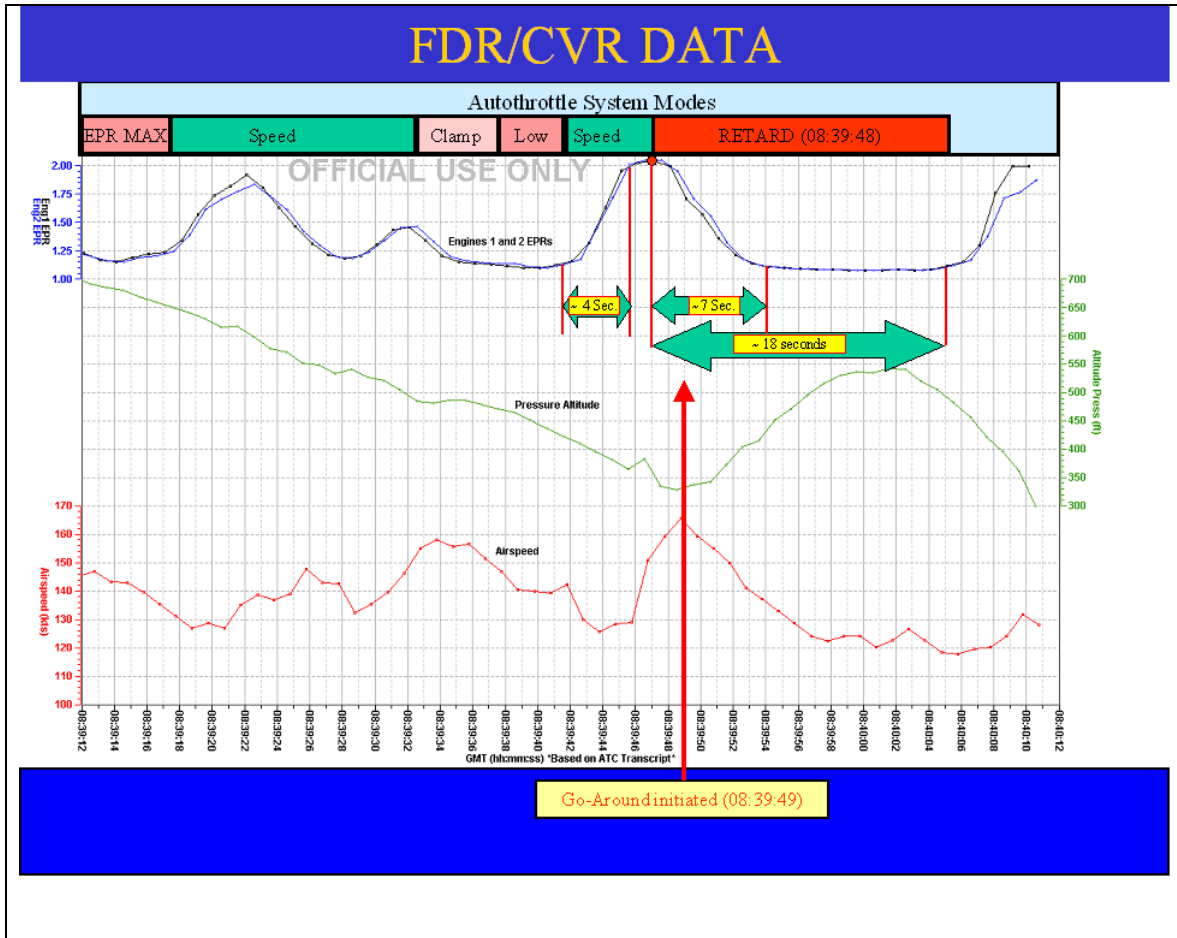
Figure 1 Autothrottle System Modes

At about 08:39:47, with the aircraft in the SPD mode, at about 50 feet (RA), airplane HS-OMG experienced an automatic reduction of all engine thrust from about 2.0 EPR to about 1.1 EPR because the retard (RETD) mode function of the autothrottle system automatically activated. Both engine's EPR remained at about 1.1 for approximately 13 seconds allowing the airspeed to drop below 120 kts. According to Boeing, the RETD mode is automatically activated as a function of radio altitude and landing flap configuration when the autothrottle is not in the EPR G/A mode. With the approach slat/flap logic applied to the autothrottle system, the flaps positioned to at least 20 degrees and the radio altitude less than or equal to 50 feet, the retard mode of operation is automatically established. The FDR data indicates the RETD mode activated when the flaps were positioned at 40 degrees and the aircraft descended below the 50-foot autothrottle retard altitude. Once activated, the FMA displays "RETD" and both throttles are driven to the aft stop at a rate dependant on the radio altitude. The autothrottle retard mode is independent of the autopilot or flight director-operating mode.

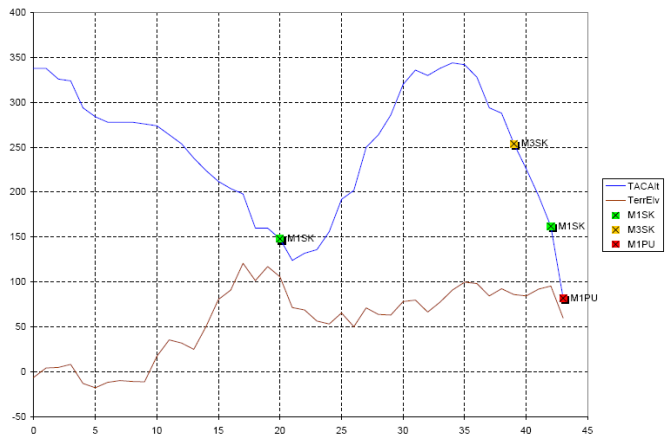
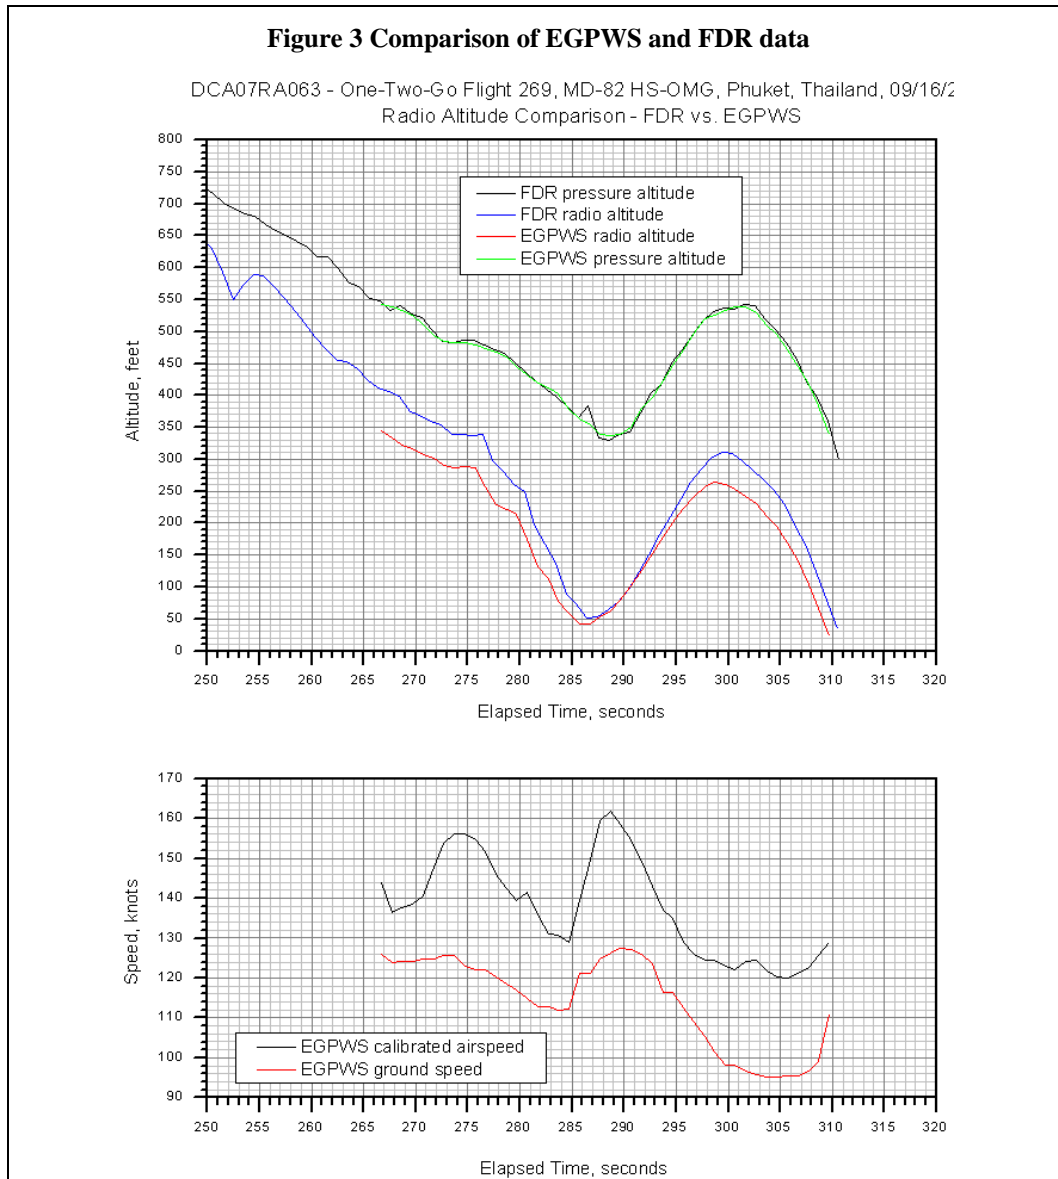
Figure 2 EGPWS Alerts

¹¹ As mentioned previously, an accurate conversion for radio altitude data recorded on the FDR could not be determined. The FDR radio altitude presented in Figure 3 is based on one of the conversions that was evaluated and is included to show the trend of the data compared to the radio altitude recorded on the EGPWS.

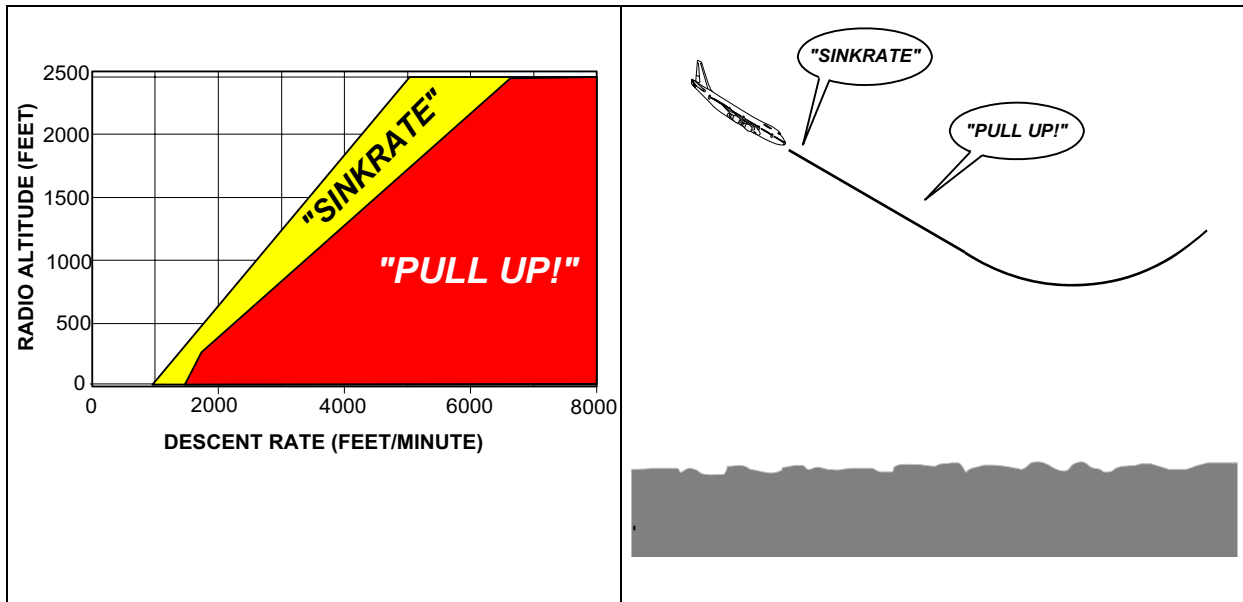
MODE 1 - EXCESSIVE DESCENT RATE

Mode 1 provides alerts when the aircraft has excessive descent rate close to the terrain (see figure 2).

If the aircraft penetrates the outer alert boundary, the voice aural "Sinkrate" is generated, and alert discrettes are output by the computer for driving visual annunciators. If the aircraft penetrates the inner alert boundary, the voice aural "Pull Up!" is generated and visual alert discrettes are also output. The alert boundaries are defined in terms of aircraft vertical speed (barometric vertical speed supplemented by inertial vertical speed when available) and radio altitude.

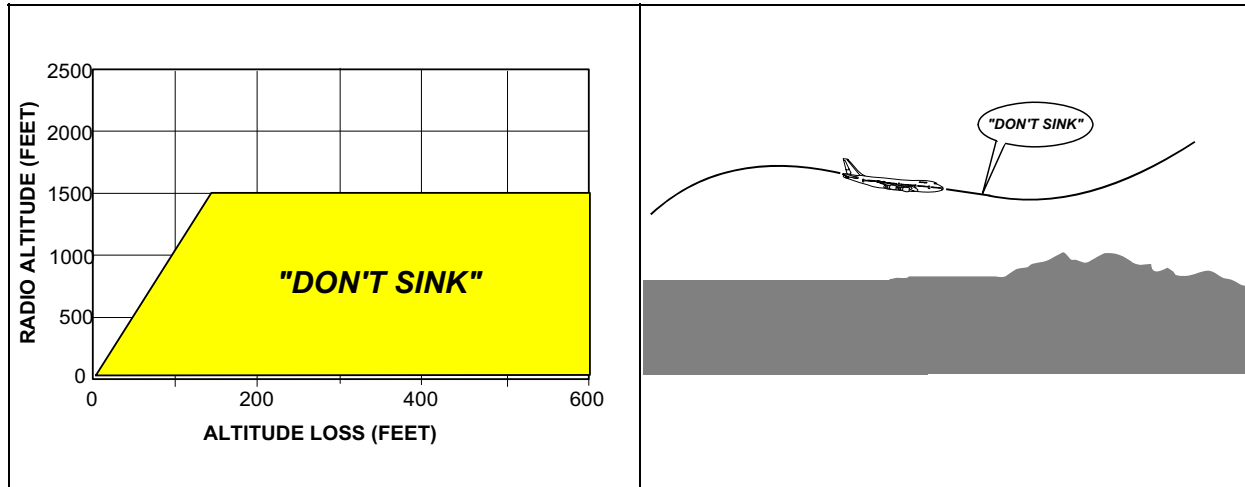
FIGURE 1 MODE 3 - ALTITUDE LOSS AFTER TAKEOFF

Mode 3 provides alerts when the aircraft loses a significant amount of altitude immediately after takeoff or during a missed approach, as shown in Figure 1

The altitude loss variable is based on the altitude (MSL) value from the time of the beginning of the inadvertent descent. The amount of altitude loss, which is permitted before an alert is given, is a function of the height of the aircraft above the terrain, as shown in Figure 1. Mode 3 is enabled after takeoff or go around when landing gear or flaps are not in landing configuration, and stays enabled until the EGPWS computer detects that the aircraft has gained sufficient altitude that it is no longer in the takeoff phase of flight.

If the aircraft penetrates the mode 3 boundary, the voice aural *“Don’t Sink”* is generated, and alert discrettes are provided for activation of visual annunciators. The visual annunciators remain active until a positive rate of climb is re-established.

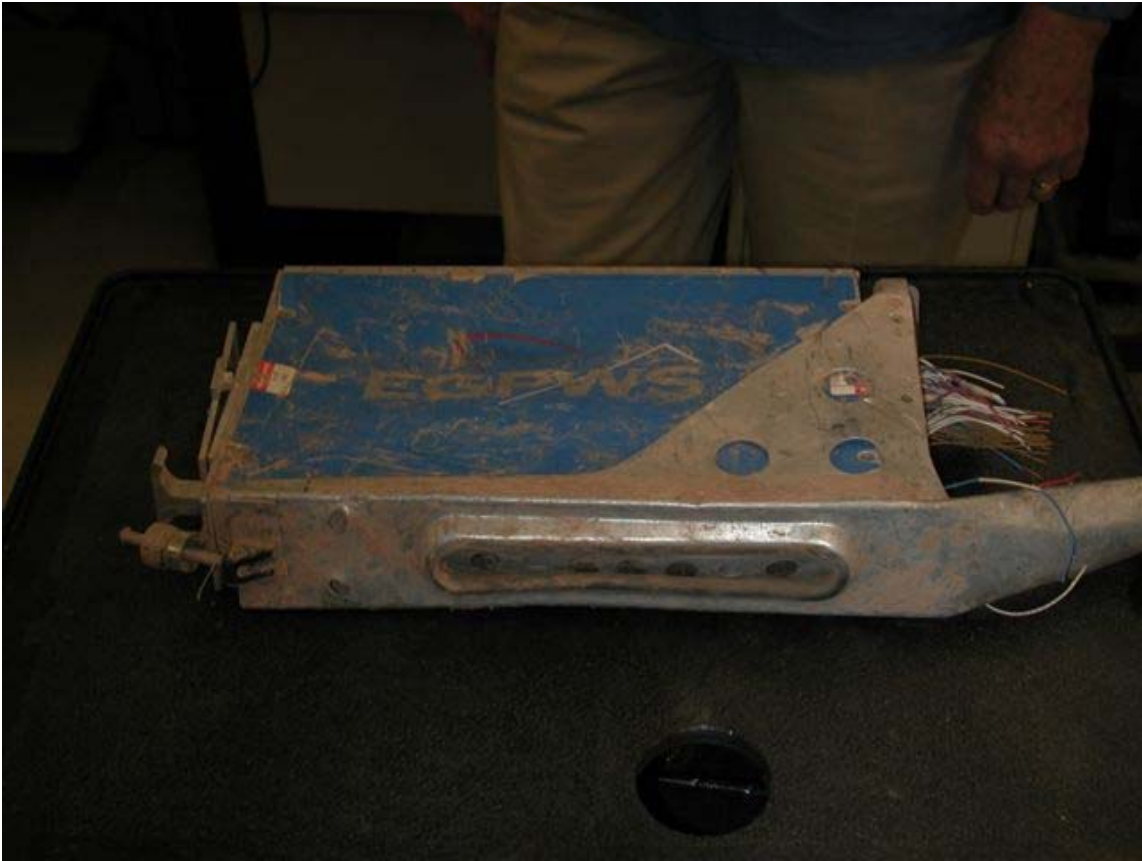
PHOTO 1

The EGPWS unit as received had been severely damaged in the accident. Honeywell removed the appropriate memory chip and reinstalled this onto an exemplar card. The flight history data from the chip was then downloaded and analyzed.

Unit as received at Honeywell Redmond facility

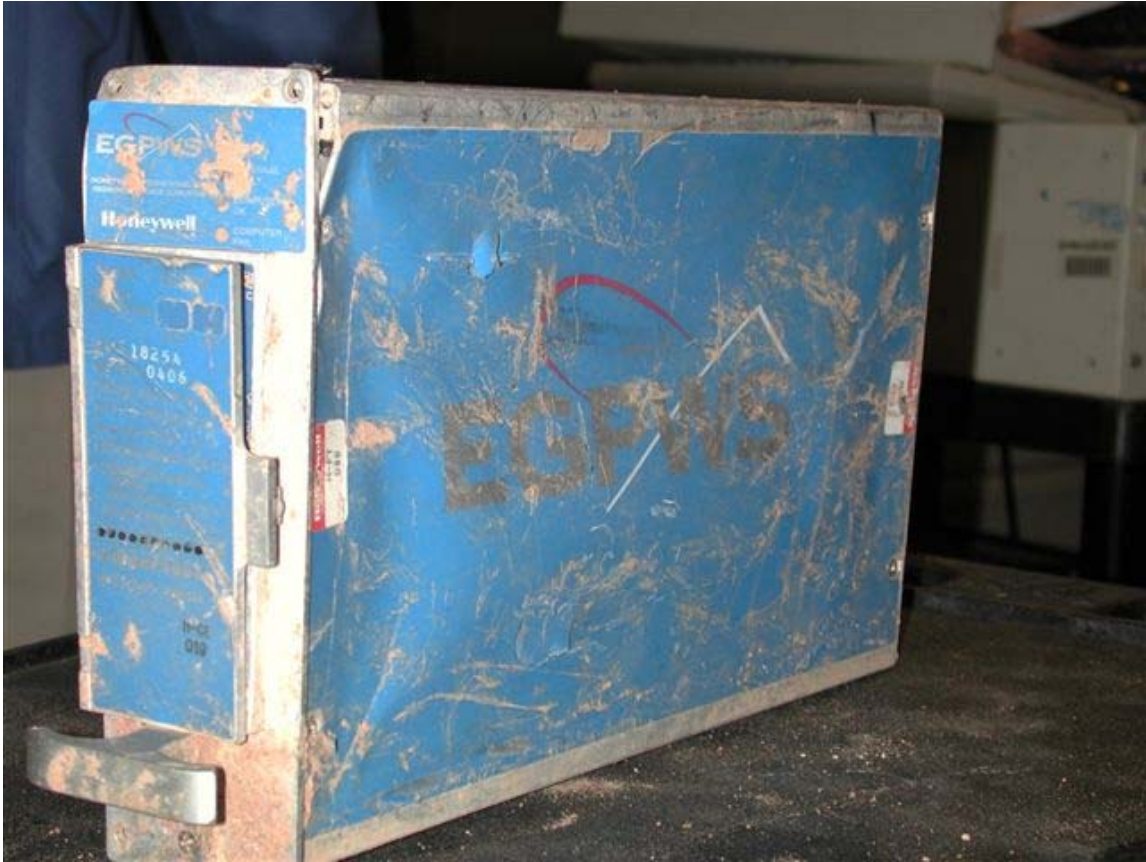
PHOTO 2

Unit removed from aircraft rack

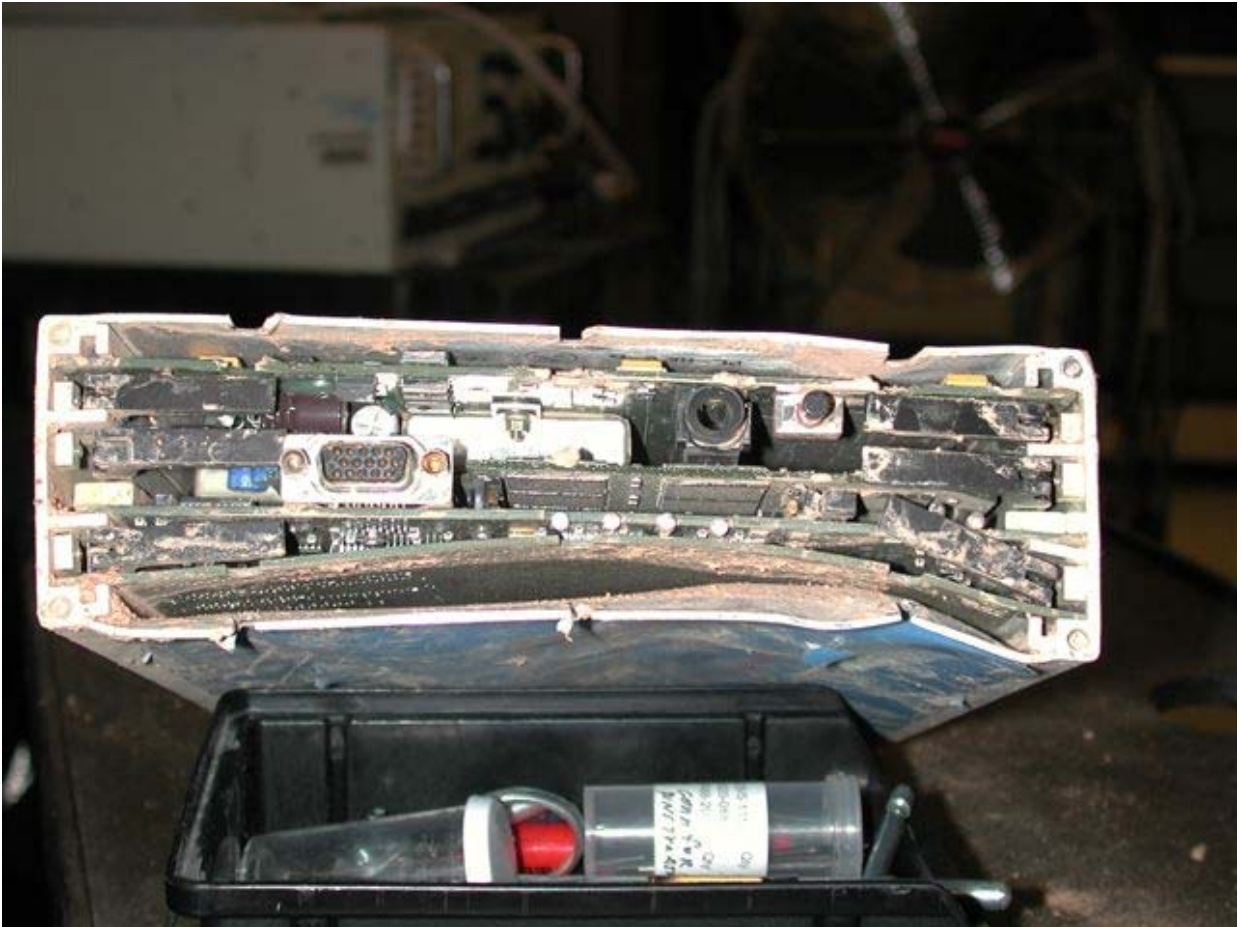
PHOTO 4

Unit with front end cap removed

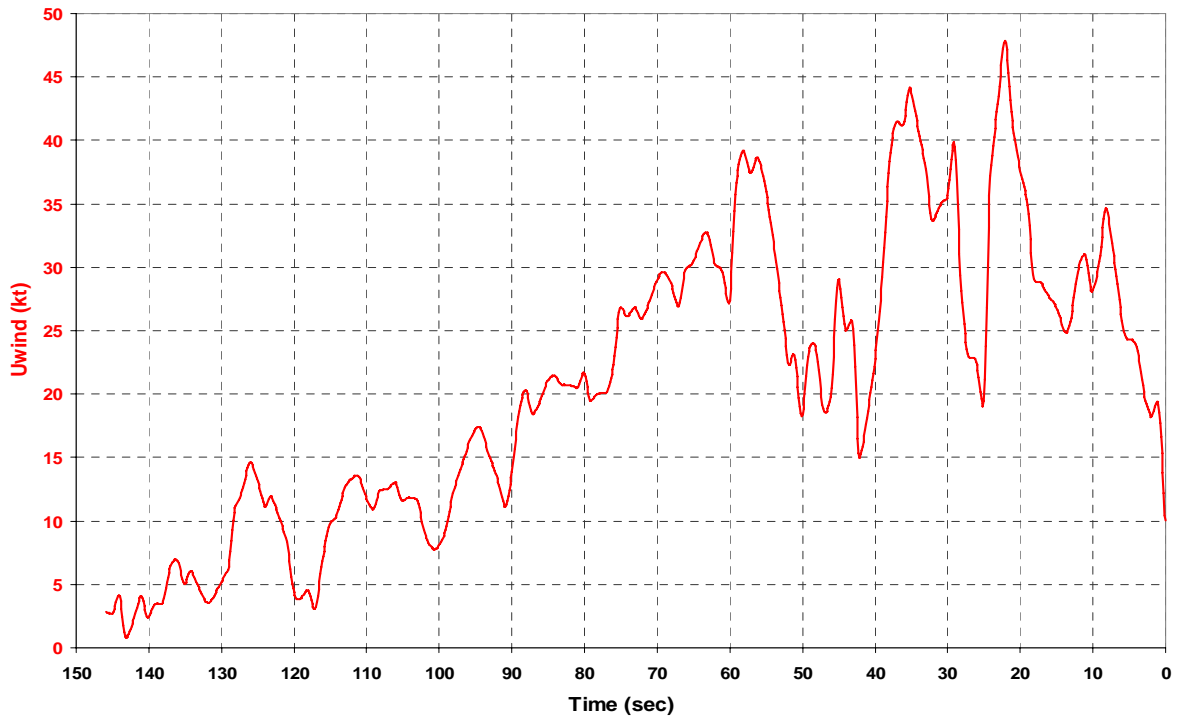
Figure 2. Horizontal Wind

Towards the end of the approach, the headwind component (Figure 2) decreases, and the negative shear value eventually reaches a magnitude sufficient to cause the system to issue a warning alert (Figure 5).

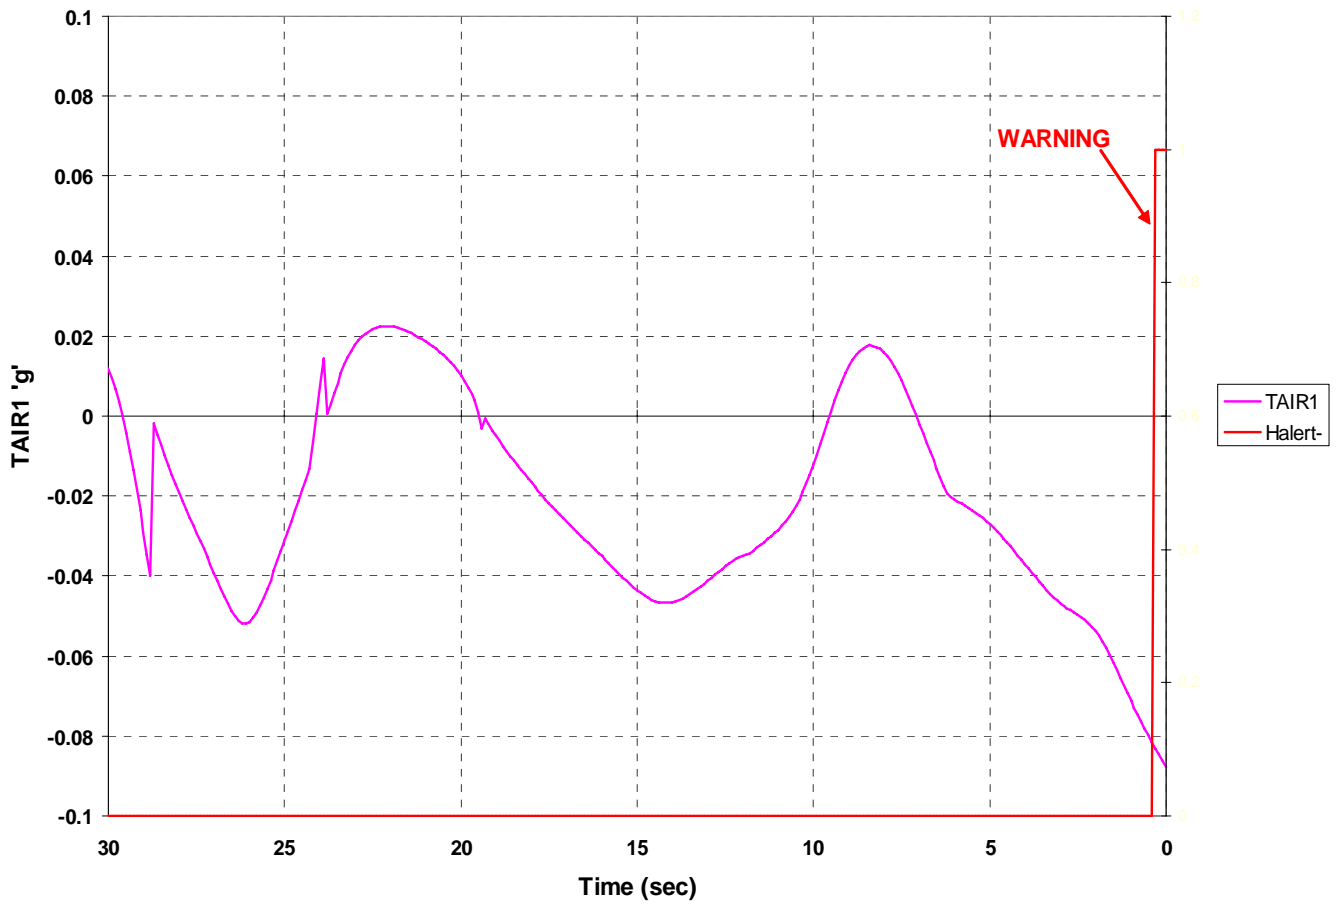
Figure 5. Simulation Time Histories of Windshear Algorithm Variables TAIR1 & Horizontal Negative Shear Warning (Expanded Time Scale)

The variables within the legacy Honeywell algorithm which are most responsive to horizontal shear are the variables TAIR1, TWIND1 and the 'wind vector rotation' variable TVIV. Plots of these variables against time from the simulation are shown in Figure 4. It is the variable TAIR1 which finally exceeds the threshold and causes an alert, as shown in Figure 5.

From the simulation data and accident data, the preliminary conclusion is that the legacy windshear detection system performed its function as intended, and that the performance was compatible with the requirements of FAA TSO-C117.
