Aircraft Accident Report
Beechcraft Super King Air 200, Z3 - BAB
Mostar, Bosnia and Herzegovina
February 26, 2004

Aircraft Accident Investigation
Commission

Edition: 1.0
Edition Date: 27. April 2004.
Reference Number: 01-293.8-292-116/ 04
Registered as: BHDCA/AND/INV/A1

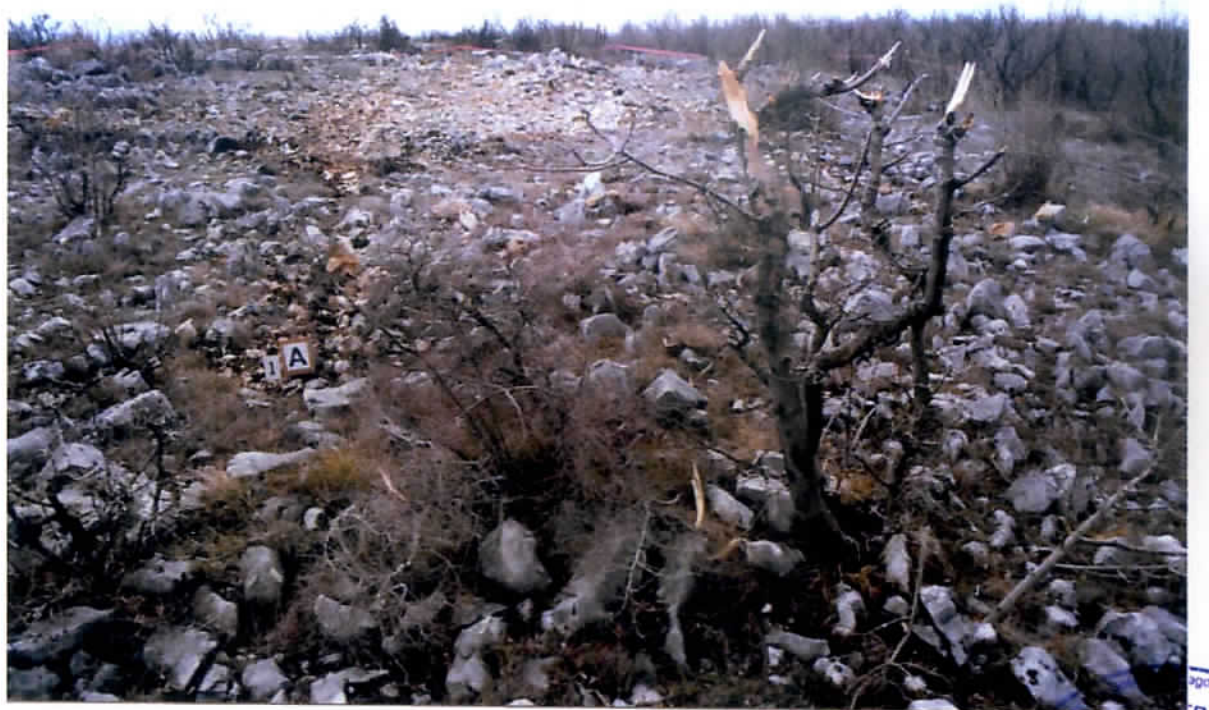
Picture 5.2: Initial impact with the ground (Mark A)

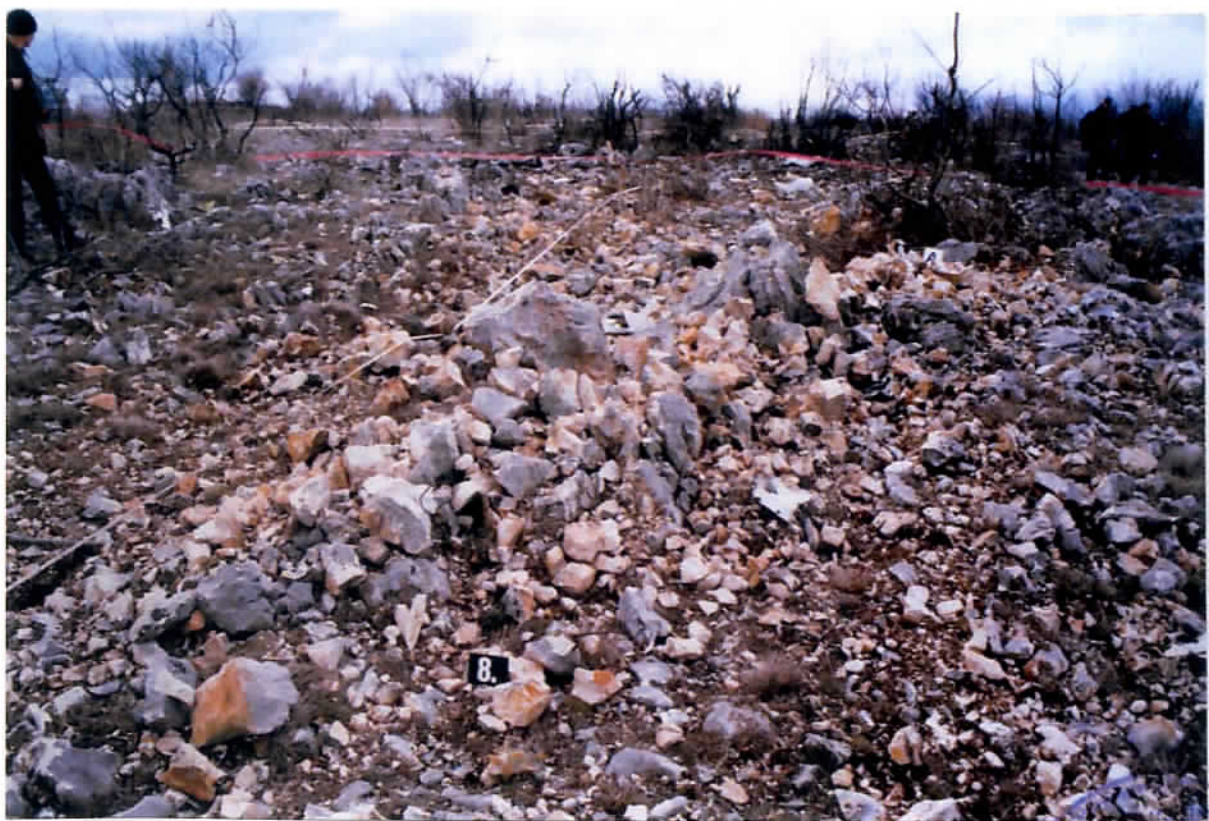
Part of the air conditioning system found at distance of 29 m, cockpit carpet with the rudder pedal found at 71 m and many minor parts show that during the collision to the above mentioned stone heap, aircraft sustained significant damage. During this collision structural damages of the landing gear, propeller blades and engine housings were made. As a result of the heavy damage of the nose part, cockpit was damaged as well, which is indicated by certain parts of crewmembers' clothes found before the resting place of the wreckage.

Picture 5.3: Pile of rocks along the impact path (Mark B)

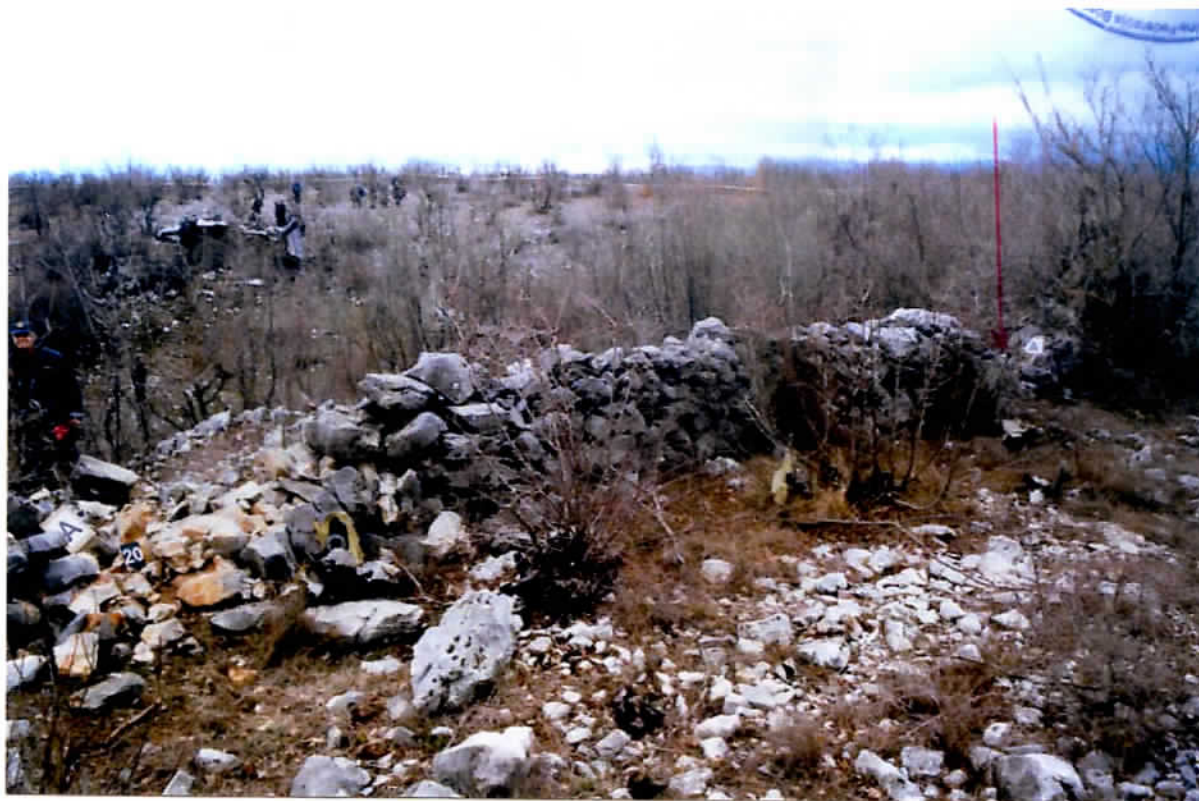
Picture 5.4: Stone wall (Mark C)

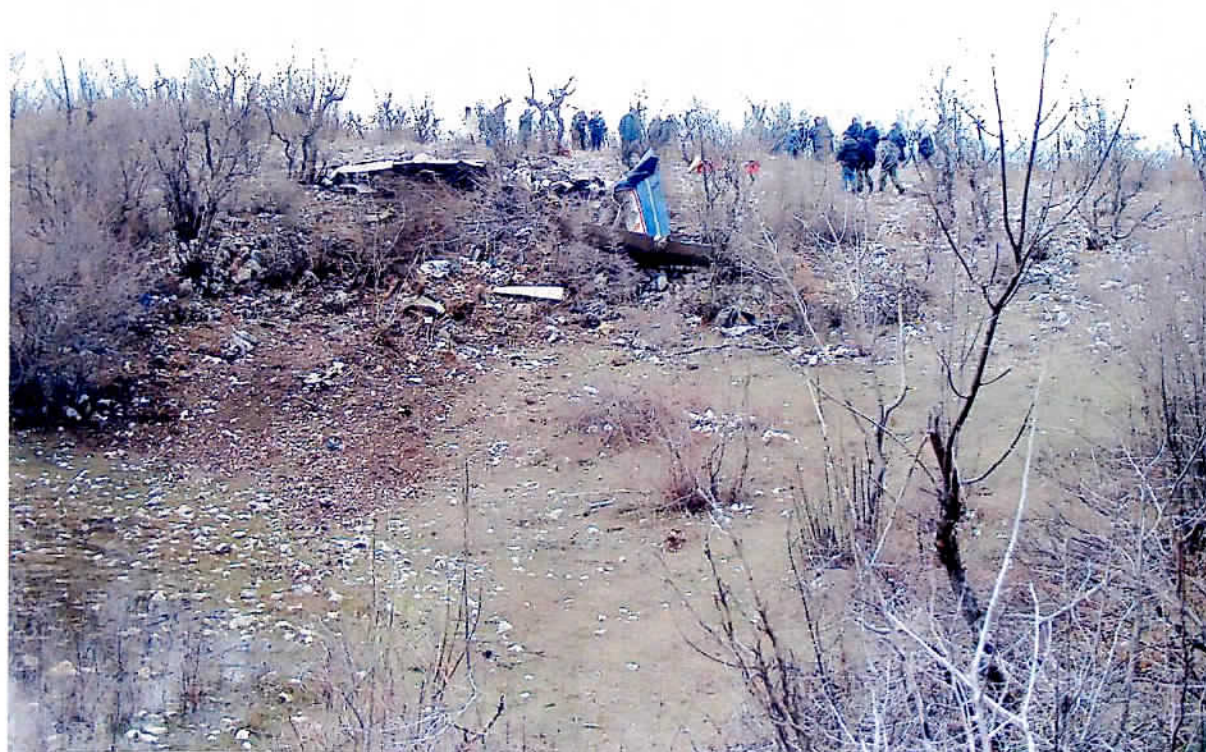
Picture 5.5: Resting place of the wreckage (Mark D)

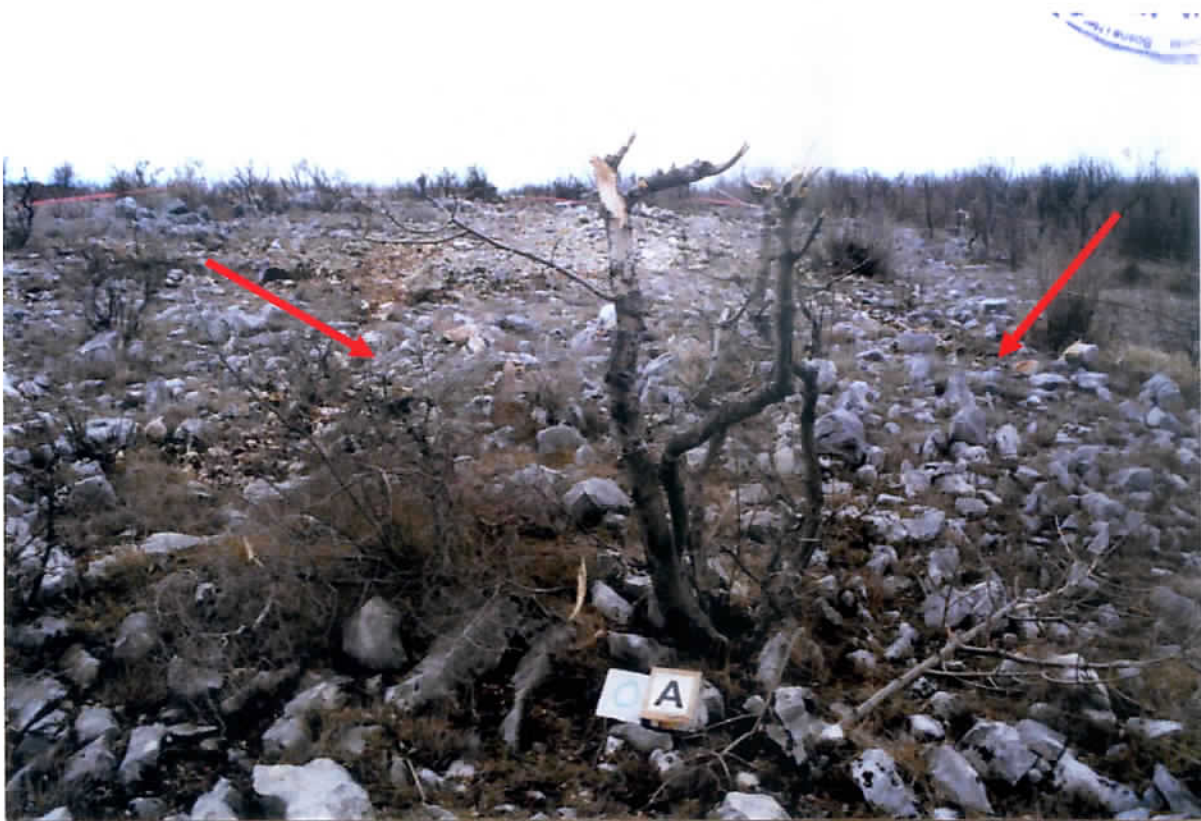
Picture 8.2: Initial collision with the tree and traces along the impact path

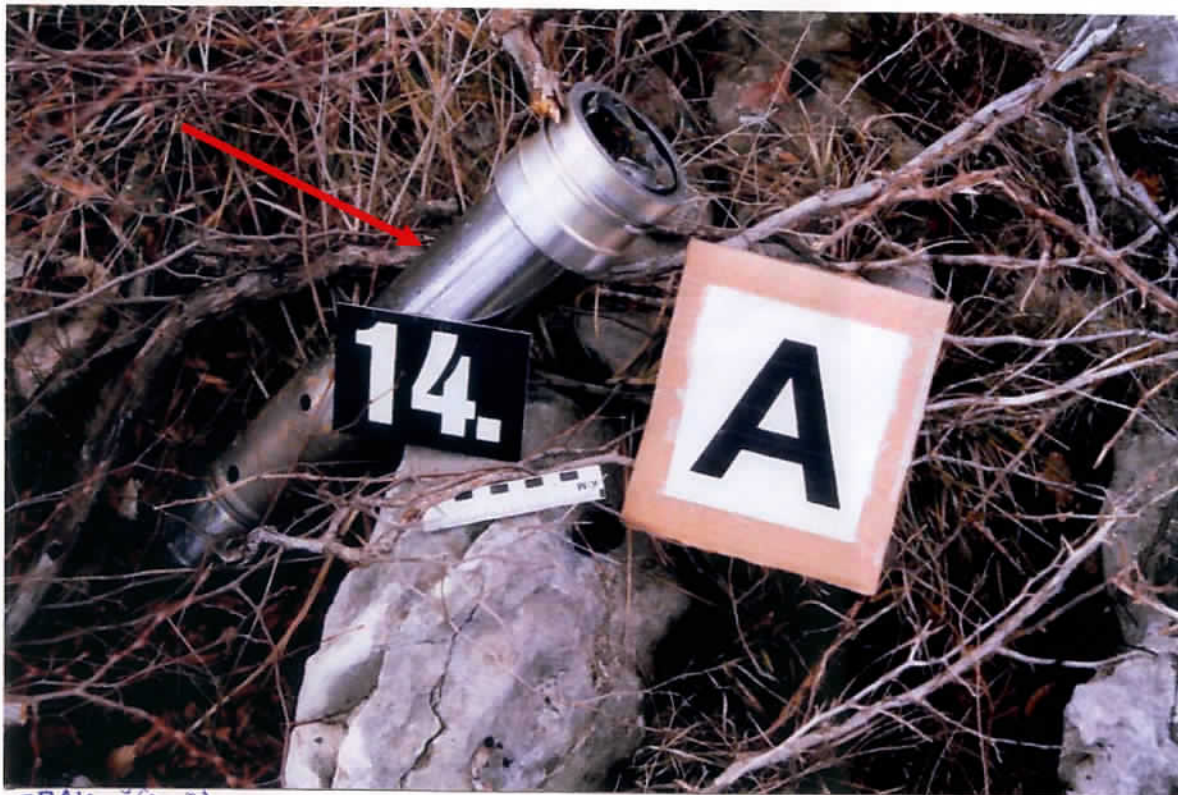
By examining breakages of the landing gear, engines and propellers, it can be concluded that fractures were caused by force encountering obstacles. Damage to propeller blades and bends on their ends show that damage and deformations were caused while propeller blades were run into blockages.

Picture 8.3: Landing gear shock absorber

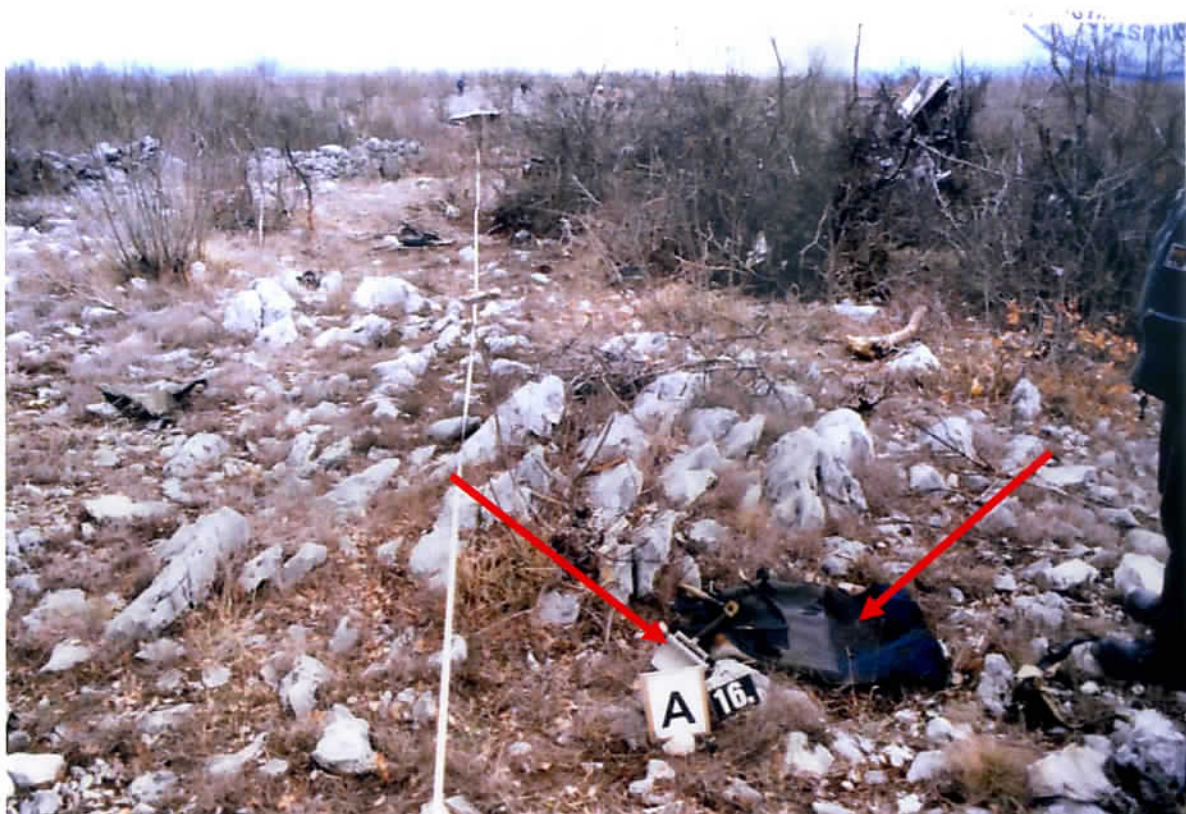
Picture 8.4: Cockpit carpet and rudder pedal

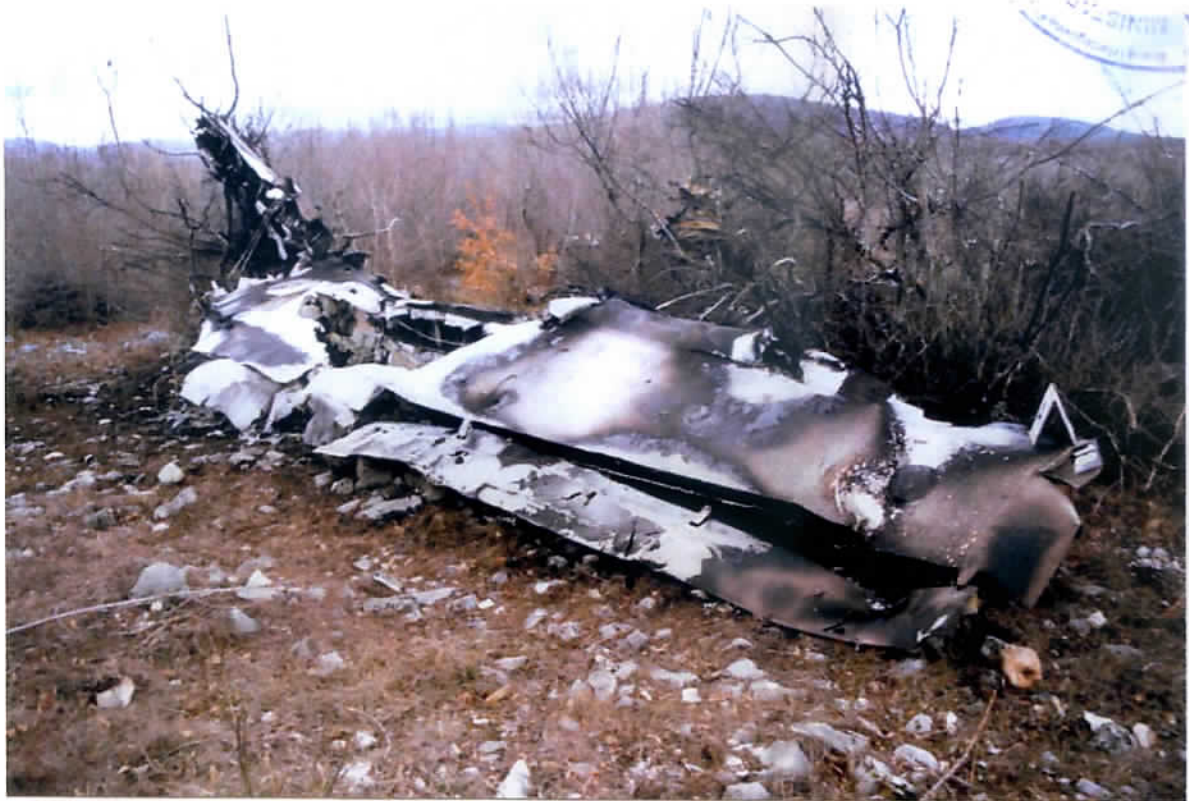
After separating from the aircraft the right wing stopped at distance of approximately 83 m to the right from the axis of the impact path, inverted for 180° and started burning. Location where the right engine collided with the ground is at distance of 9 m from the right wing, and during further uncontrolled movement, went through the wall at distance of 16 m from the axis of the impact path and stopped at 1.5 m from the wall. The right propeller with reduction gear box was found on distance approximately 4 m ahead of the engine.

Fire on the right wing after the fracture and separation from the aircraft, and fire on remaining part of the aircraft, after it hit a side of a stone craterlike formation, started because of fuel leakage from wing tanks as a consequence of major damage of the wings. Both fires developed high temperature, which can be concluded from melted aluminium alloy parts and other materials with lower melting points than aluminium alloy. Fire on the aircraft, after its stoppage, spread all over and consumed out left wing and entire body, except the aft part with tail surfaces. Tail surfaces were found in upside down position, leaned to the rest of the body and horizontal stabilisator.

Picture 8.6: Right wing inverted by 180°

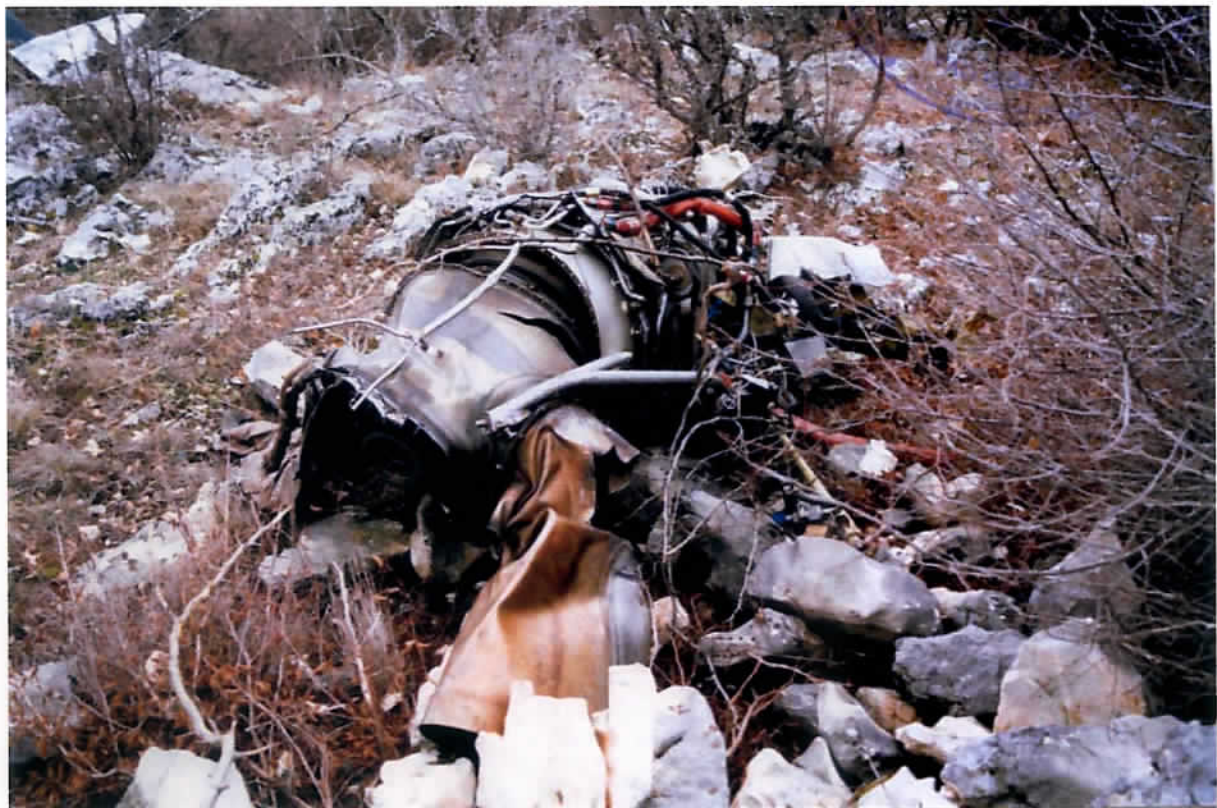
Picture 8.7: Right engine

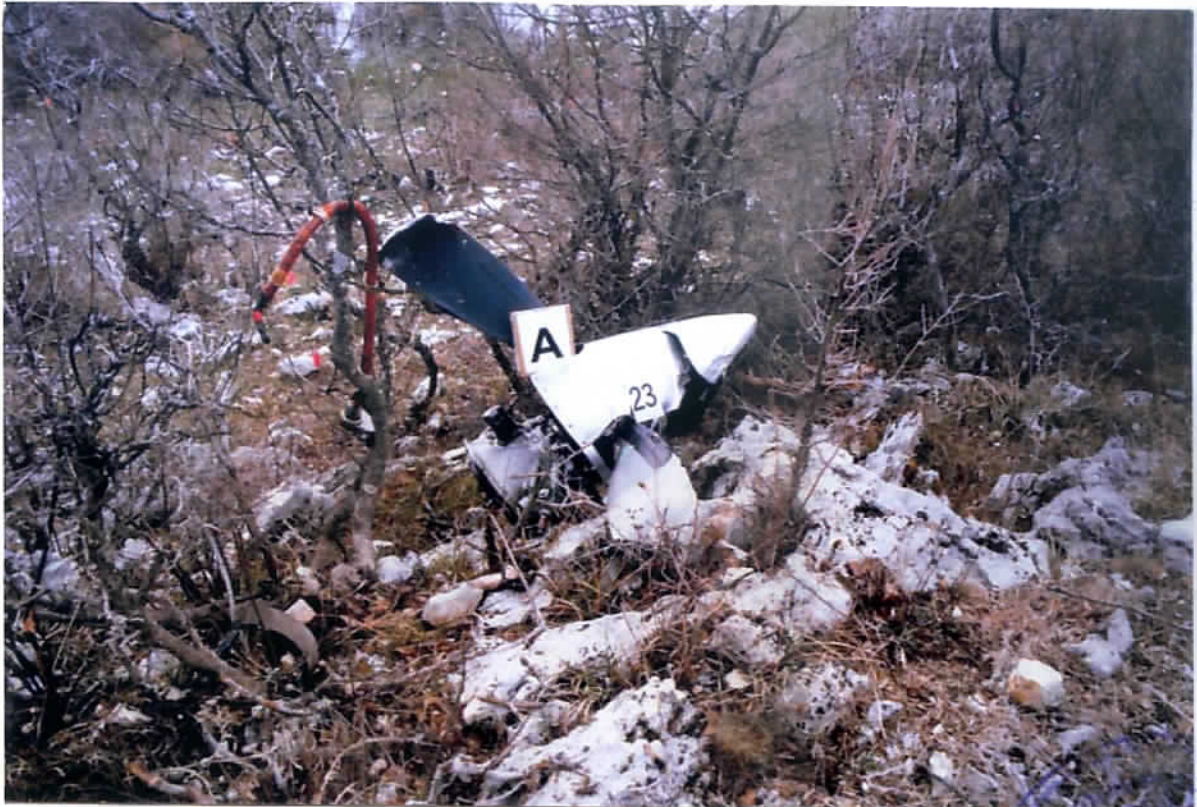
Picture 8.8: Right propeller and associated reduction gear box

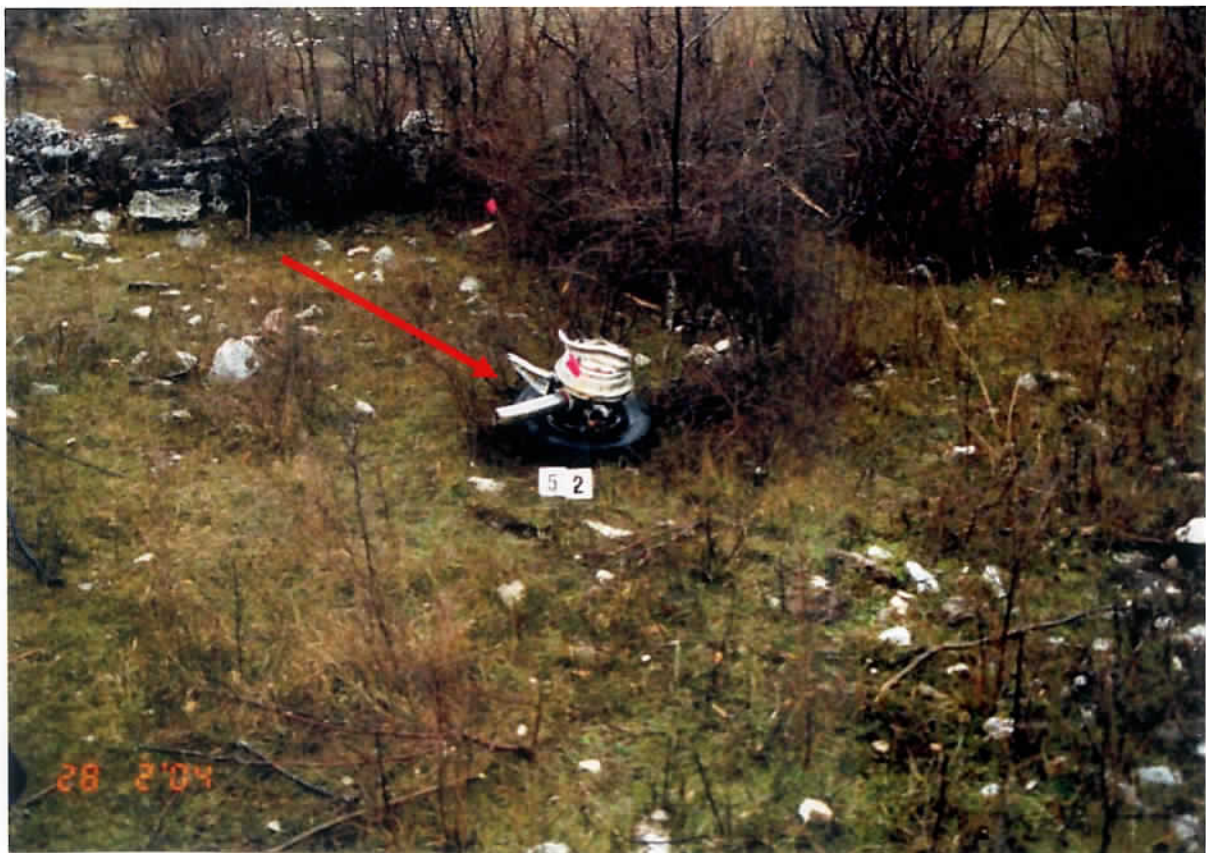
Picture 8.9: Right landing gear wheel hub

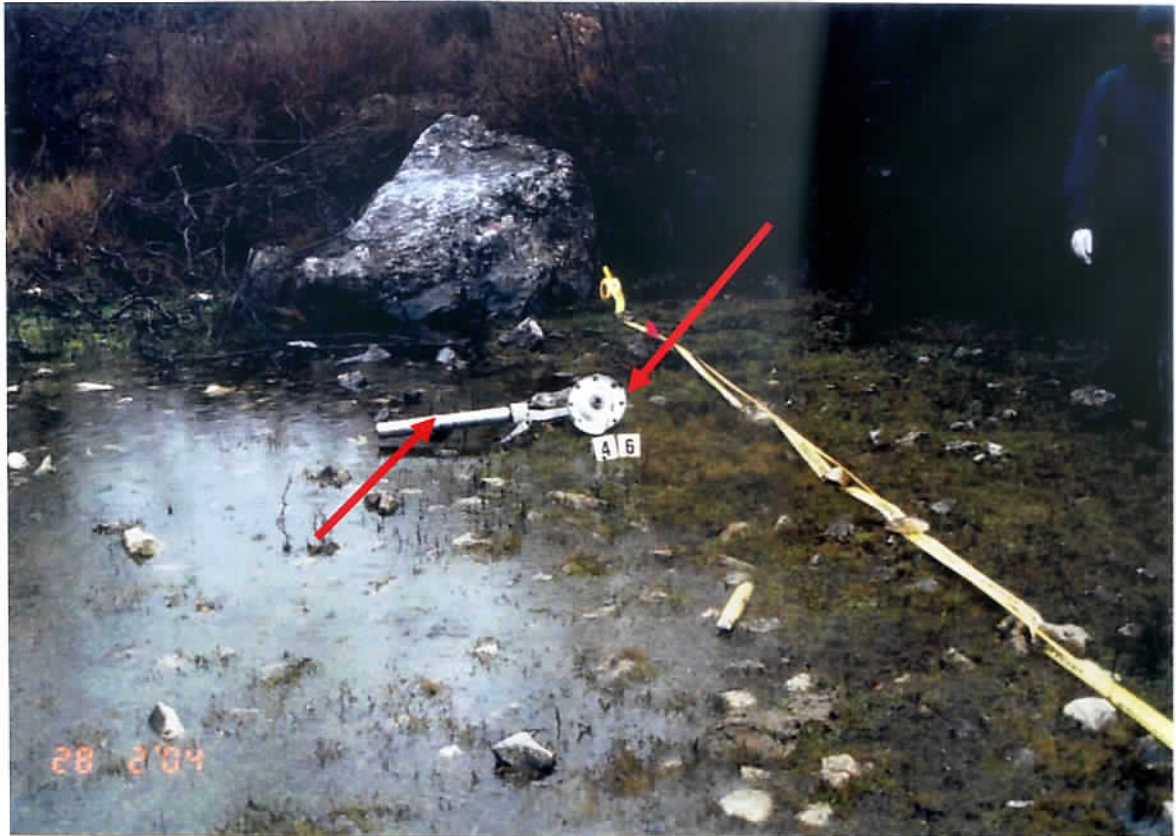
Picture 8.10: Landing gear shock absorber and wheel hub

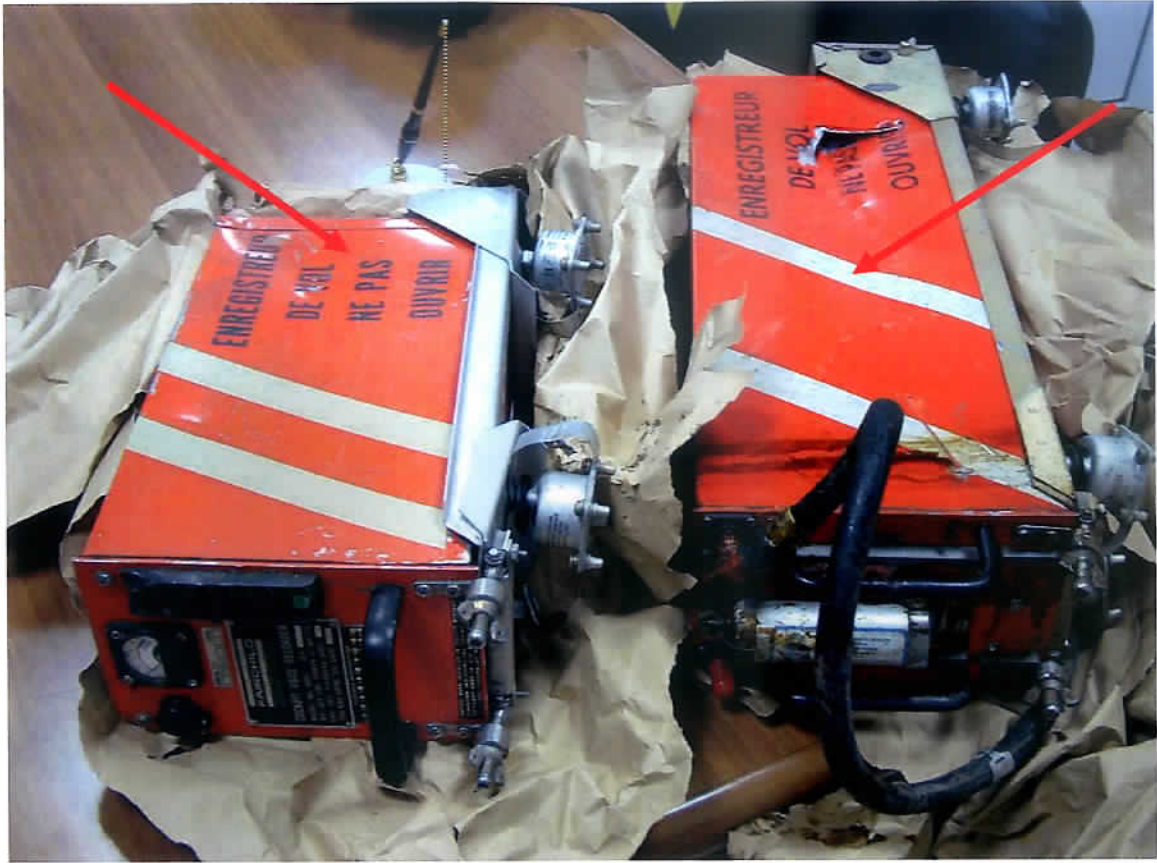
FDR and CVR found on the accident site did not sustain major mechanical or thermal damage during the hit or fire on the aircraft (**Appendix 8, picture 8.14**). They were sent to authorised service *RUAG Aerospace Services GmbH* (Germany) on 03rd March 2004, for readout.

Picture 8.14: FDR and CVR

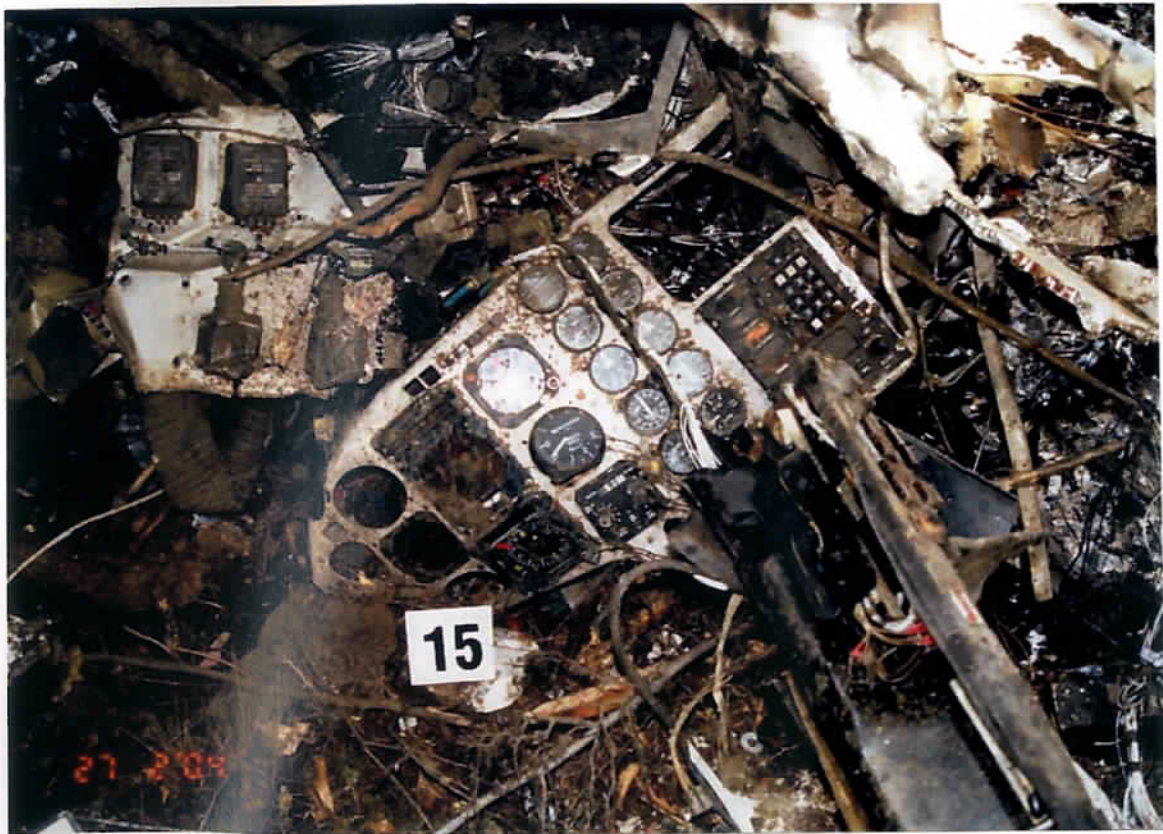
In fire captain's instrument panel was partially damaged, while co-pilots instrument panel was heavily damaged, where only altimeter stayed on place. Other instruments dropped out from their housings in the instrument panel. Panels in cockpit with command switches, fuses and signal lights were significantly damaged or burnt out. Instrument readouts after the aircraft accident (Appendix 8) are as follows:

Picture 8.15: Instrument panel and equipment at the resting place

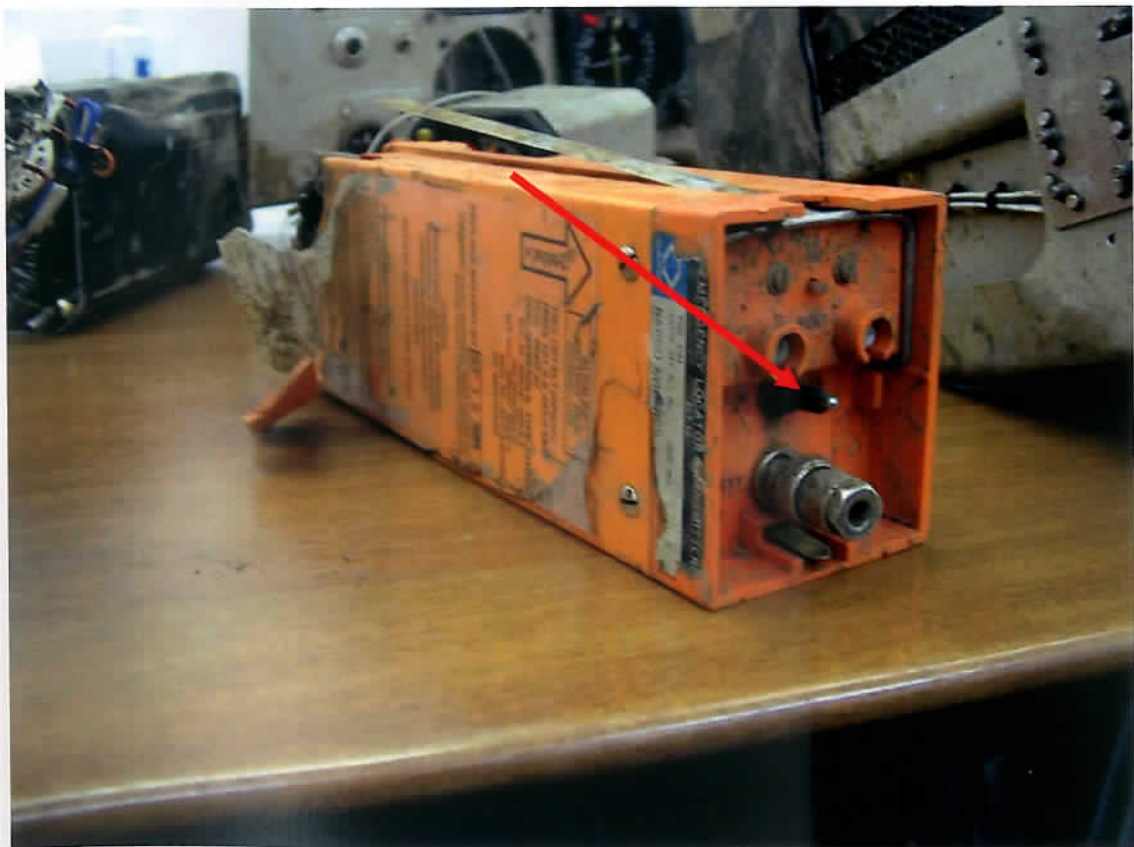
ELT was found on the site of the accident, type ELT 10, S/N 77273, in good condition (Appendix 8, picture 23). COSPAS-SARSAT in Bari did not register ELT signals after the accident. No signal was received neither by any aircraft flying in the ELT coverage area on the day of the accident, nor by any aircraft landed to Mostar airport. However, during SAR on the following day, SFOR helicopter, type UH-60, Raven-81, received weak ELT signals at 0810 hrs, and the site of the accident was found at 0824 hrs. After a while, ELT signals were also received by the crew of UH-1 VF BiH Airforce helicopter.

During the inspection and test of ELT it was determined that the switch was in ARM position, that the antenna cable of the external fixed antenna was ripped out from its connector, and that the flexible antenna was broken. According to the label on the housing, the batteries had expiry date of 15th September 2004. Opening the housing, containing 9 serial connected batteries, it was determined that joint of a connection between two batteries was disconnected because of the weak welding (**Appendix 8, picture 8.24**). Measuring the voltage of batteries separately, each battery had voltage of at least 1.45V. By overbridging the broken connection the batteries had output voltage of 13.5V. During the testing with serially connected batteries, ELT emitted signals when switch was in position "ON" but not in the position "ARM".

Picture 8.23: ELT and switches position

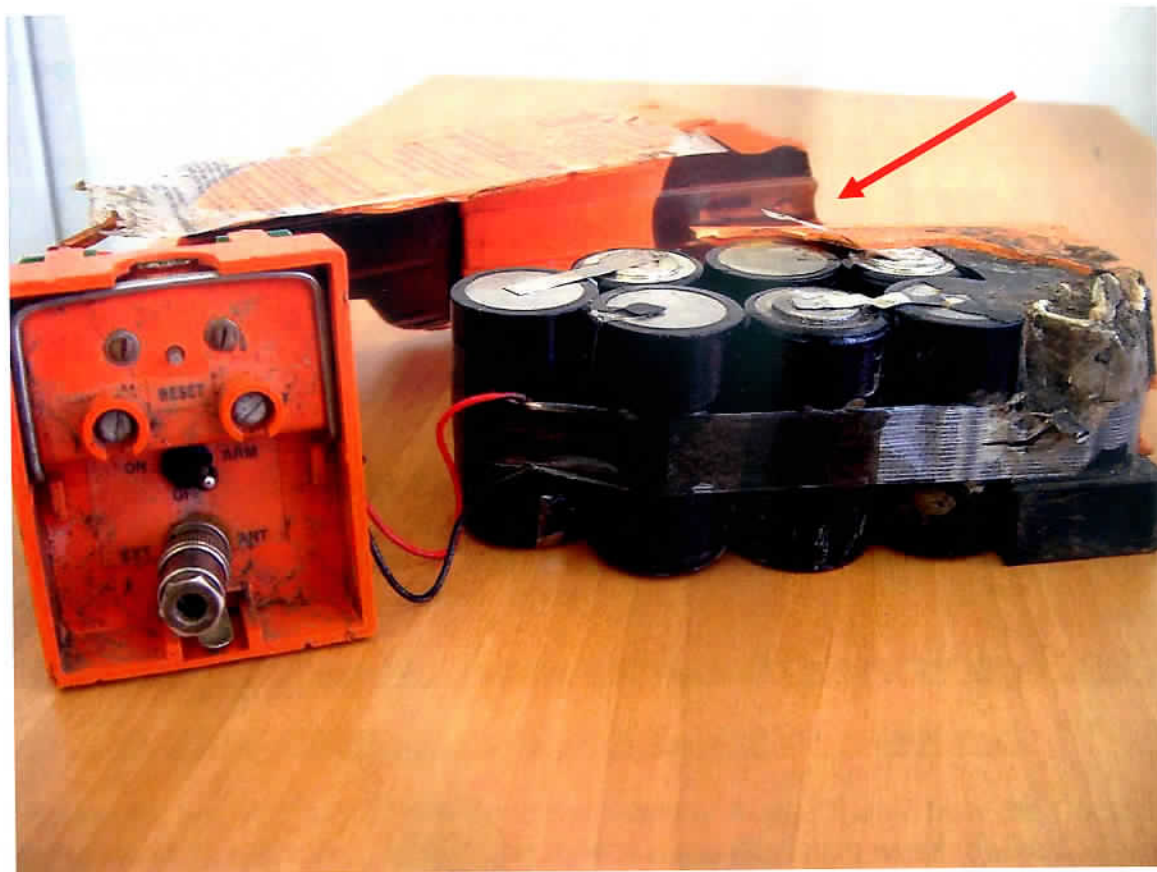
Picture 8.24: ELT batteries loose connection
