This document is an English translation of the Final Report on the fatal accident involving the Falcon 50EX aircraft registered F-GLSA that occurred on October 20, 2014 at Vnukovo Airport, Moscow.

INTERSTATE AVIATION COMMITTEE

FINAL REPORT

Type of occurrence	Fatal accident
Type of aircraft	Airplane, Falcon 50EX
Registration	F-GLSA
Owner	Unijet Airline
Operator	Unijet Airline
Place of occurrence	Russia, Moscow (Vnukovo) Airdrome , coordinates: N 55°35'29,66", E 37°15'41,12"
Date and time	20.10.2014, 19:58 UTC (23:58 local time), night time

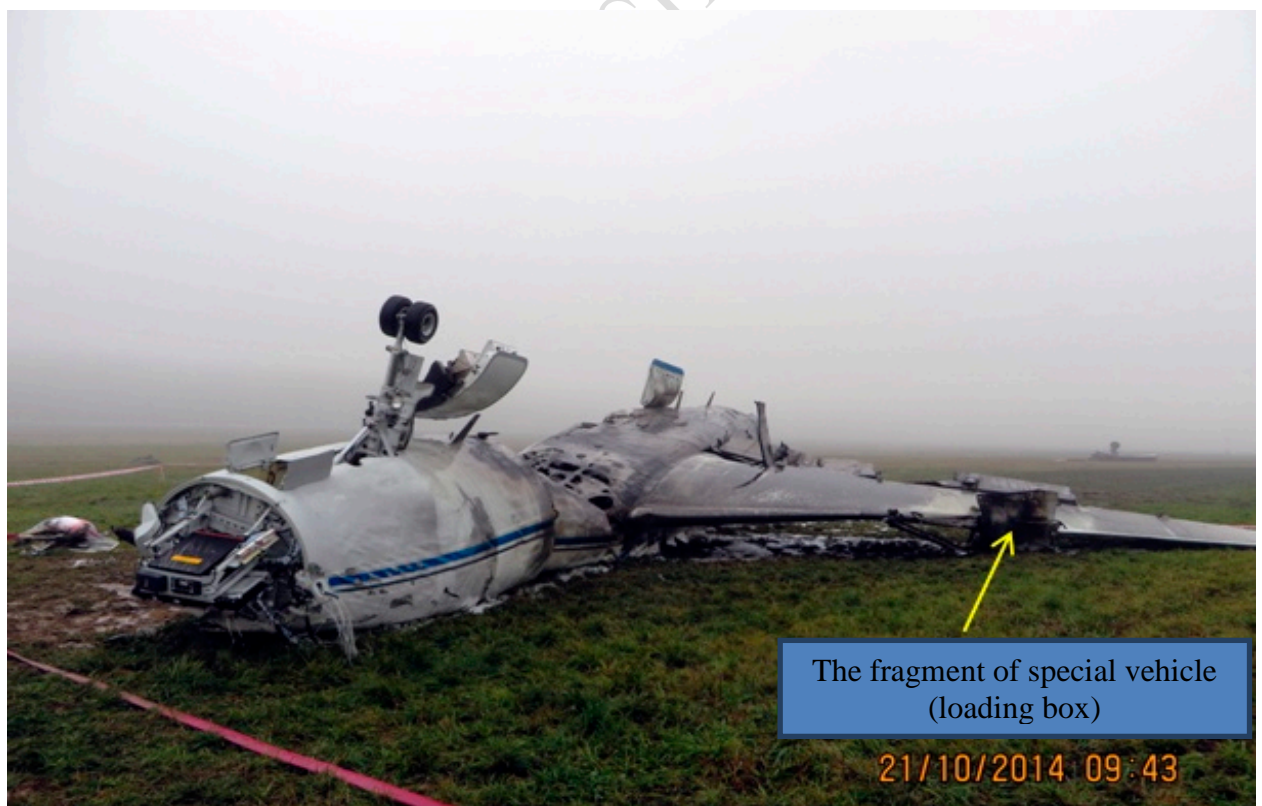
Figure 1. Falcon 50EX F-GLSA airplane at the accident site

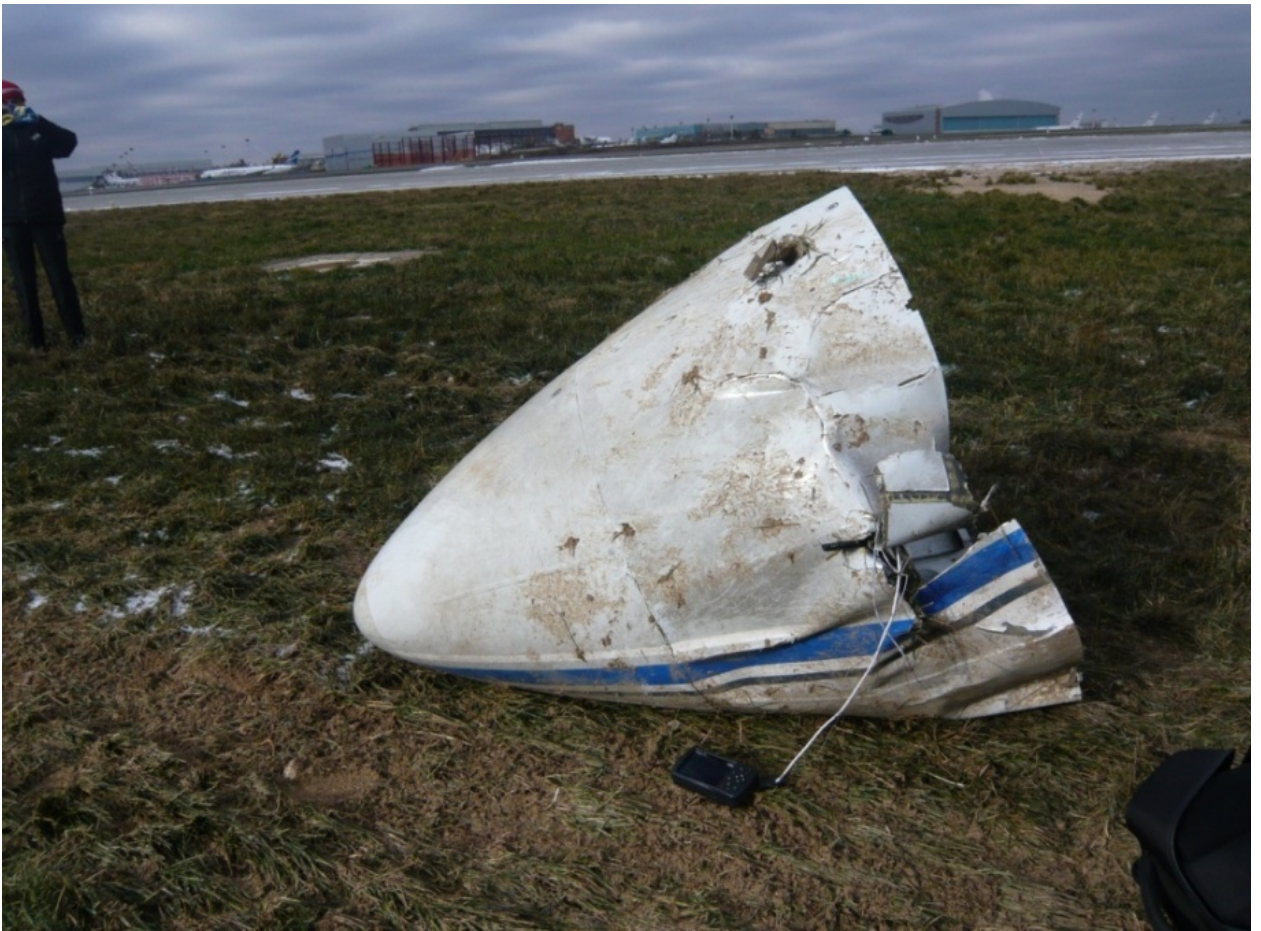
Figure 32. Radome.

Inverted (Figure 32), deformed in the lower part, skin and rib fractured on the right side. A part of the rib at the attachment of the radome turning mechanism was missing. All radar units were secured as per design and had no external damage. All visible socket connectors were connected to the respective units.

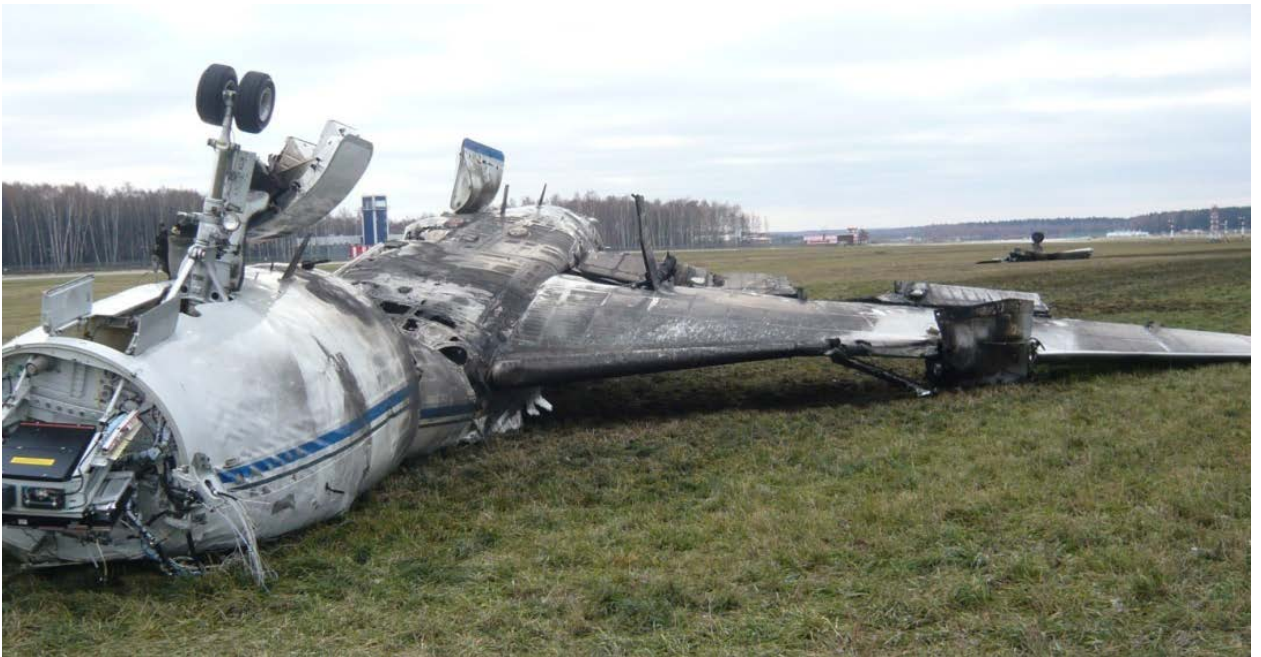
Figure 33. Fuselage and right wing

Fuselage and right wing with a fragment of right main landing gear was found inverted (Figure 33) and broken into two parts along the rib behind the door. The rivets were torn up on ground impact. A geometric fracture in the middle part of the fuselage had appeared due to the skin being burnt out and ribs and stringers being damaged by high temperature during the fire. The high temperature impact at that place was confirmed by round flattened solidified drops of melted metal up to 15 mm in diameter. The right wing tip was touching the ground. The junctions of central wing to the left wing were destroyed.

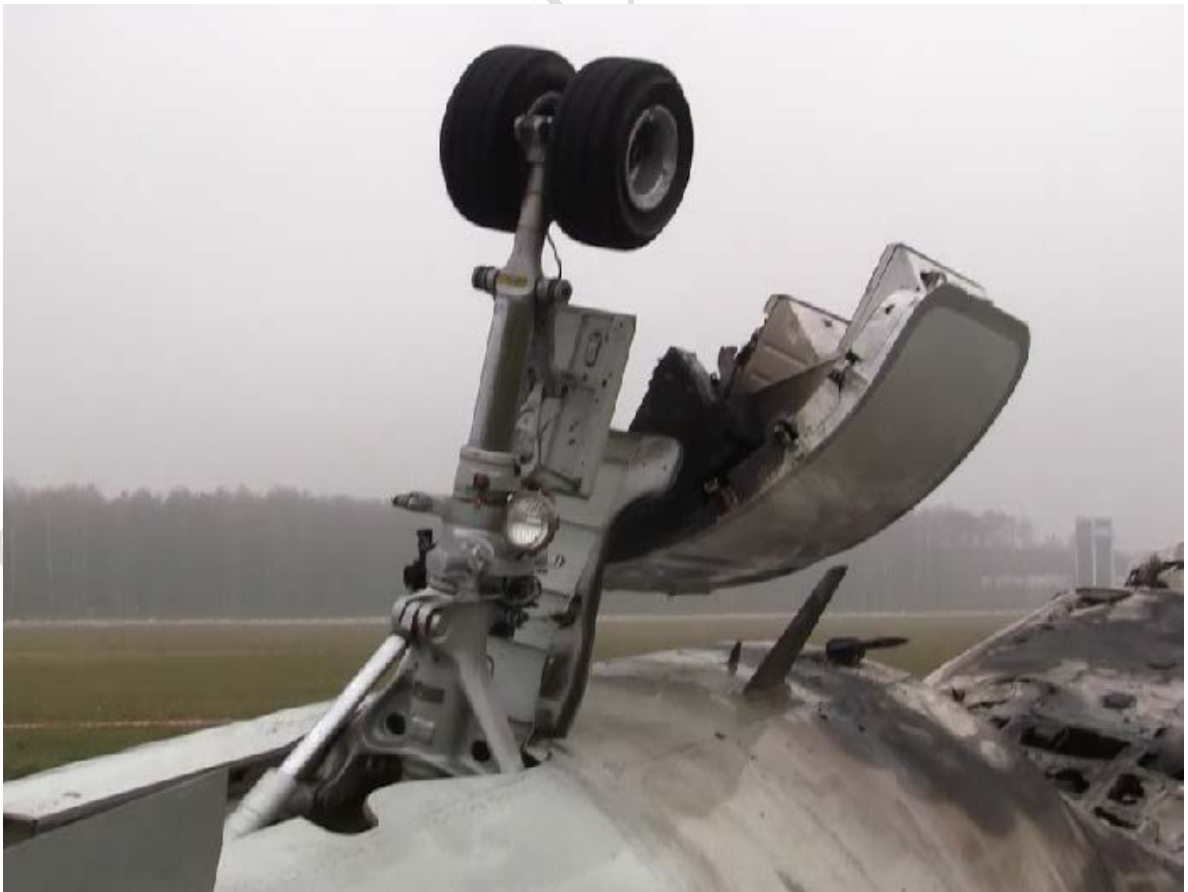
Figure 34. Nose landing gear

The nose landing gear was extended, showing no mechanical damage or fire traces (Figure 34).

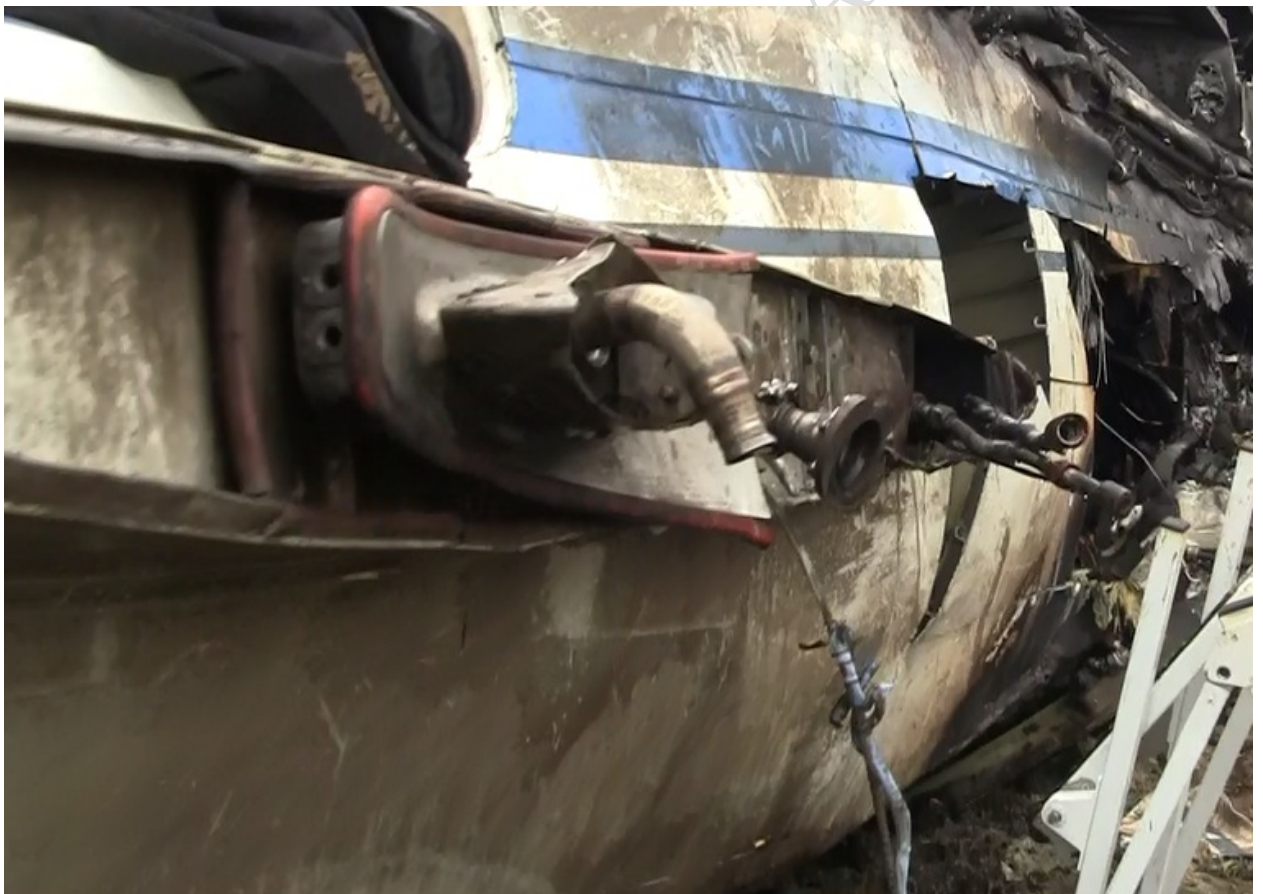
Figure 35. Engine № 1 Fitting

The fittings of Engine № 1 and Engine № 3 were damaged, wirings and ducts torn out (Figure 35 and Figure 36).

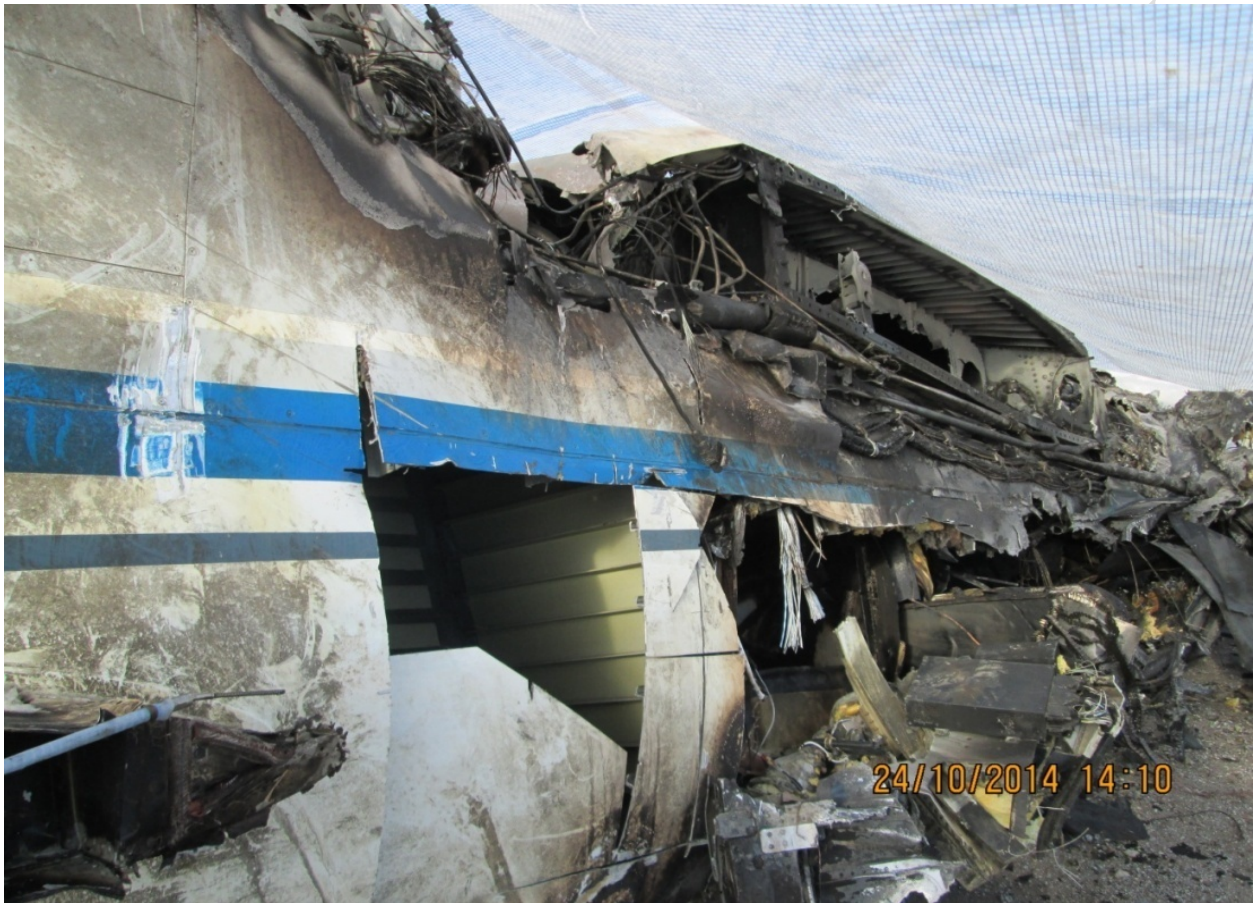
Figure 38. Fuselage and LH wing attachment

The center wing had traces of fire and deformation, lower panels burnt out (Figure 38). The LH wing to center wing attachment was destroyed along the wing rib, the center wing fuel tank was torn open, fuel missing.

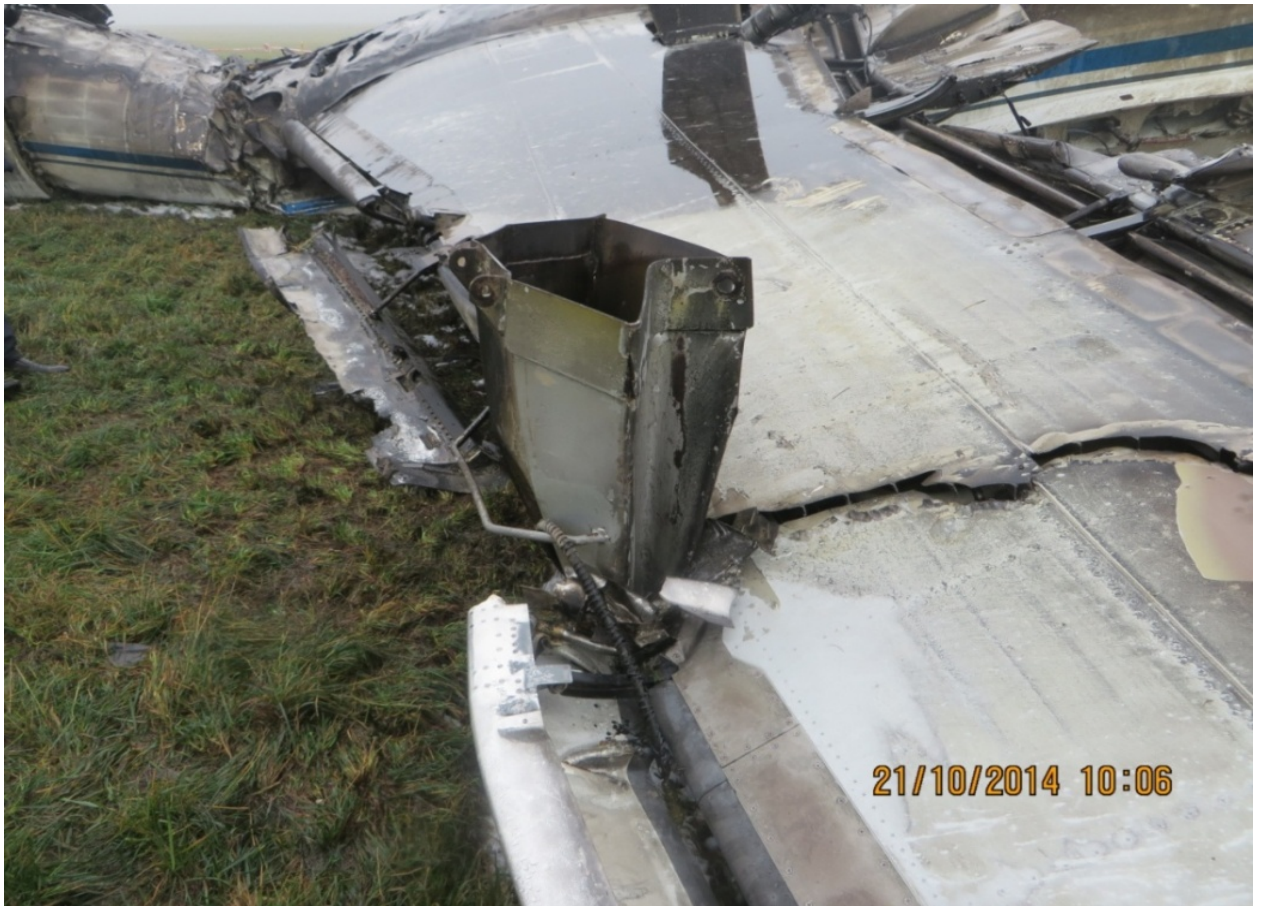
The RH wing showed damage, skin deformation and fire traces. There was a hollow metal foreign fragment in the form of a flattened squared tube (a snowplow fragment) pressed in between the outer and inner slat sections (Figure 39). The metal fragment was wedged perpendicular in the center between the right and left leading edge slat of the right hand wing. The lower part of the RH wing had a through zig-zag crack extending from the forward spar to the aft spar.

Figure 39. RH wing with a snowplow fragment

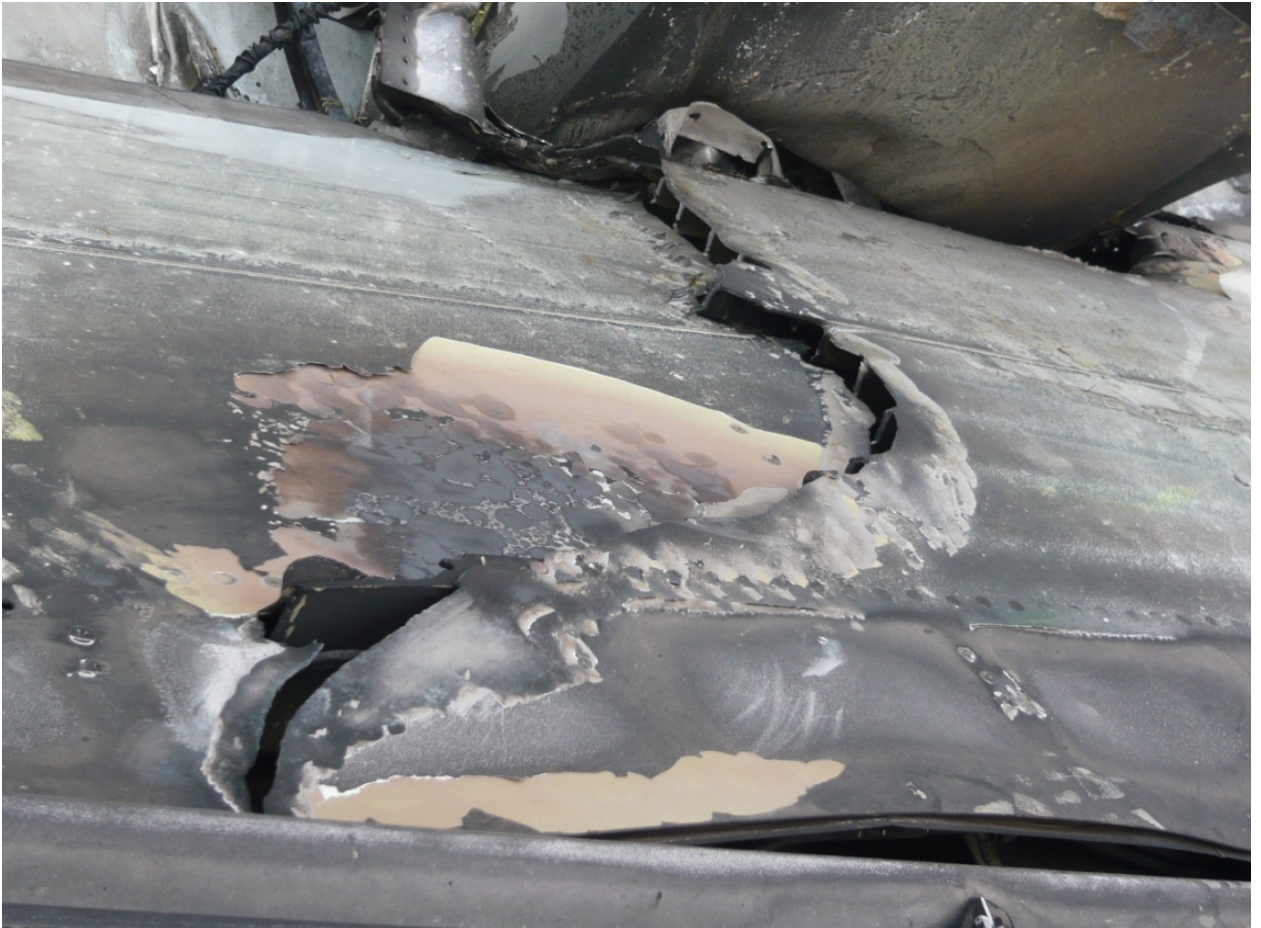
Figure 44. RH fuel tank

The RH fuel tank was torn open, having a lateral zig-zag crack (Figure 44). The fuel leaked out completely after the wing hit the snowplow.

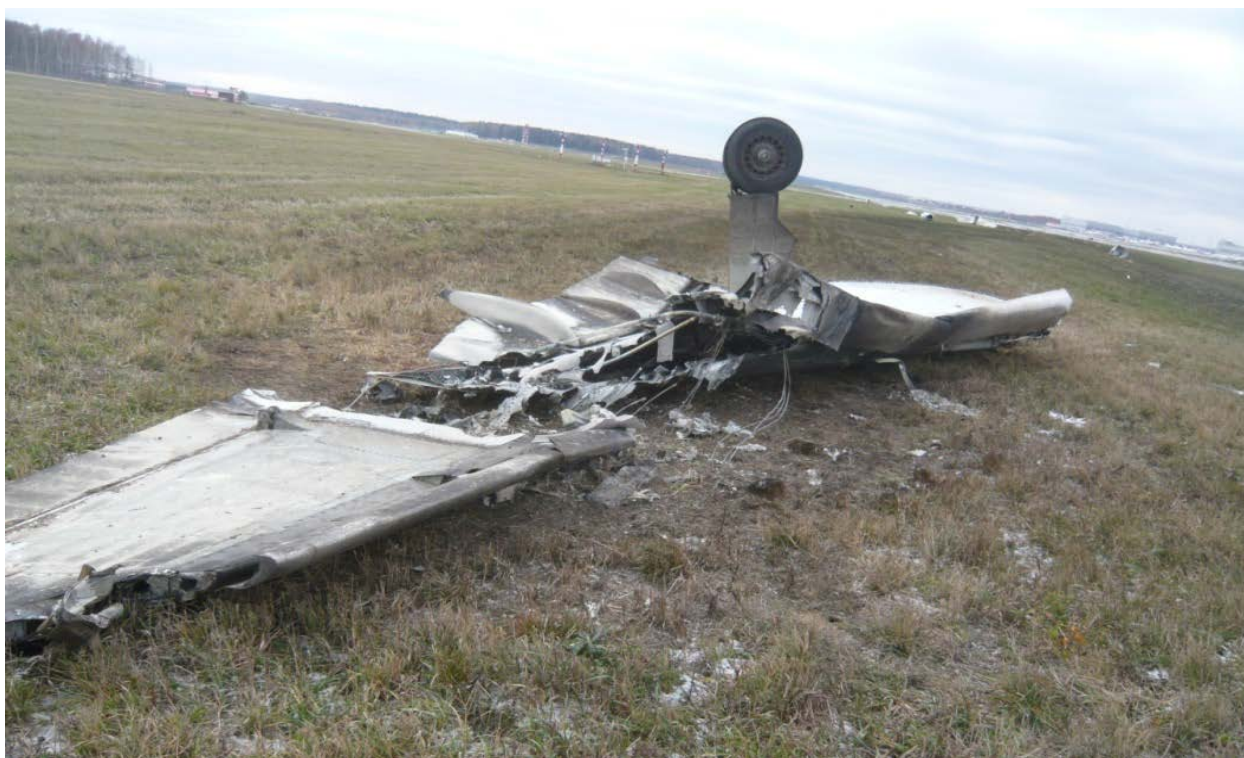
Figure 45. LH fuel tank

The LH fuel tank was torn open, 50% of the tank structure (from the LH landing gear to the LH aileron) was destroyed by the fire (Figure 45). The fuel leaked out completely after the LH wing was detached from the center wing.

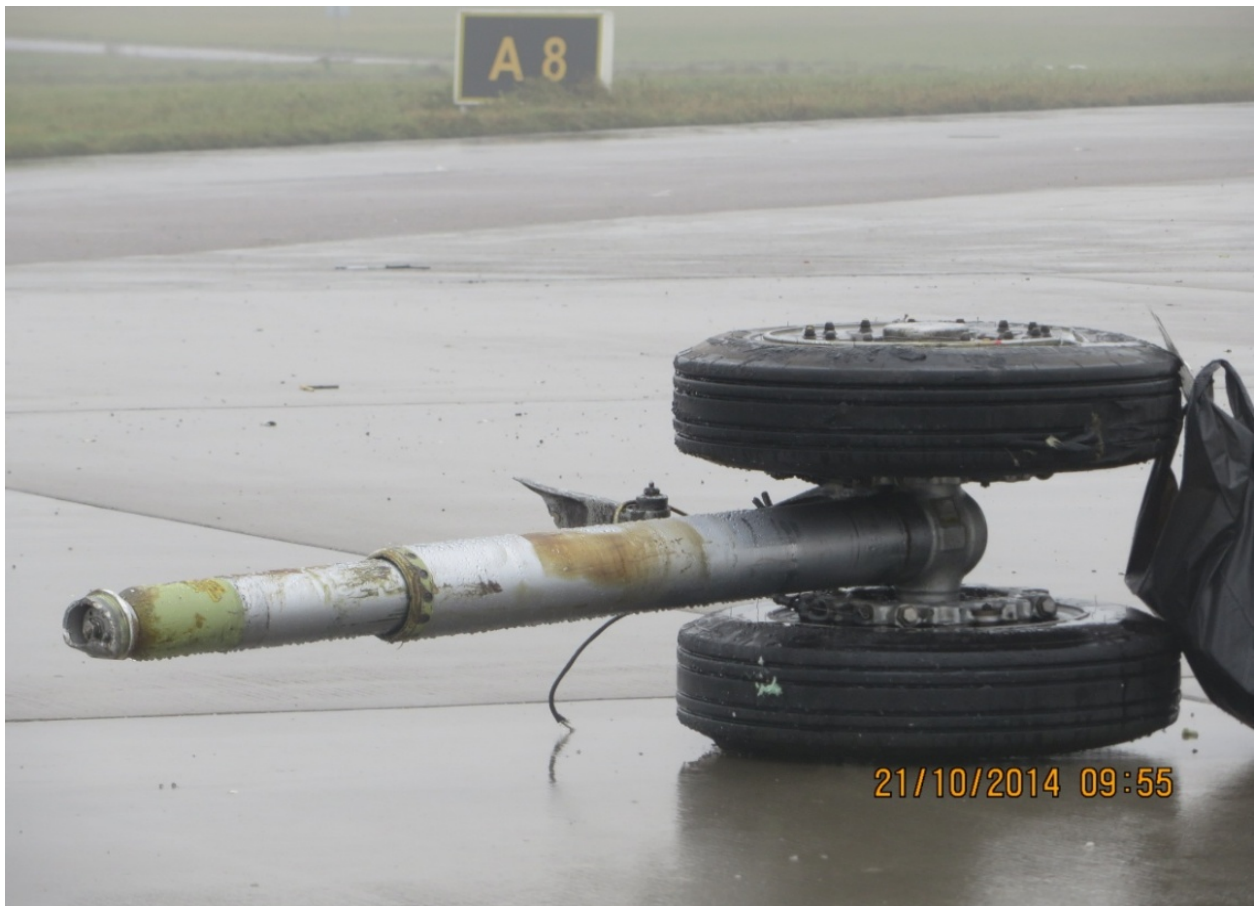
Figure 46. RH main landing gear

The wheel tire had lateral tear, a crack induced by the hit on the wheel disk rim collar, the upper link of the hinge was destroyed. A fragment of the RH main landing gear with the strut cylinder and cross brace was bent backwards (comparing to the flight direction).

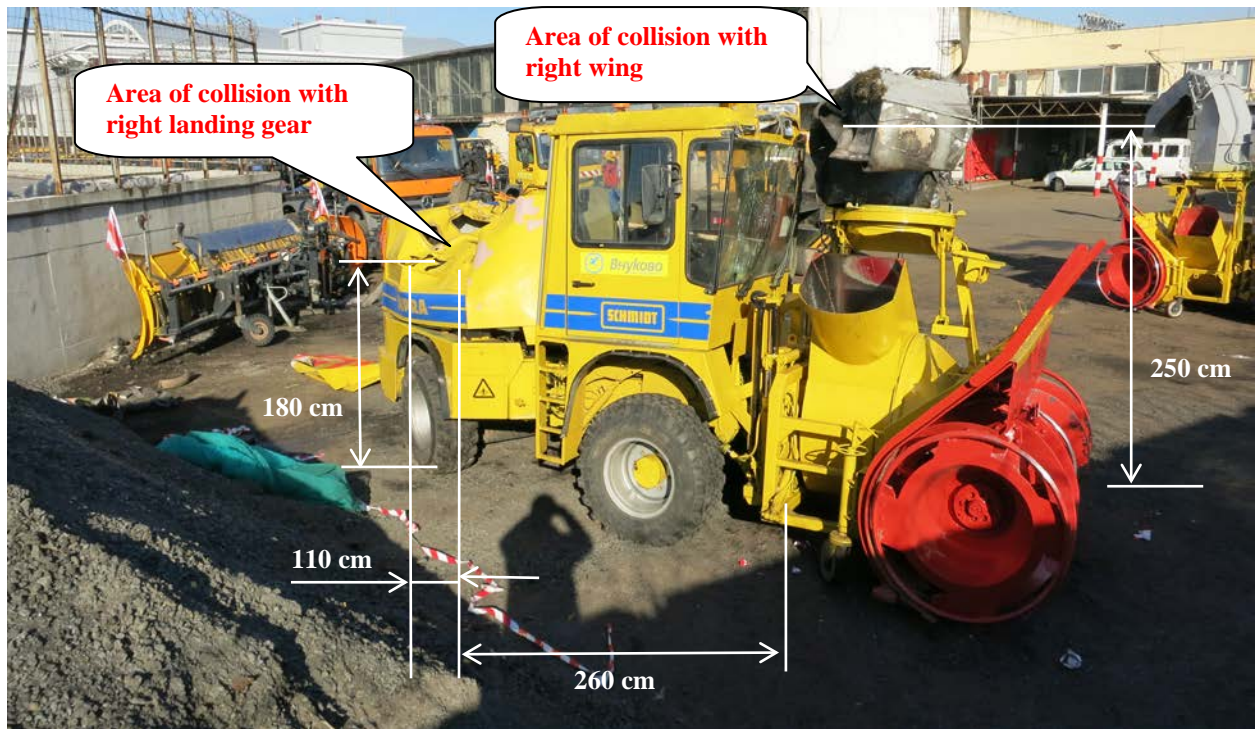
- the roof strobe light glass was missing;
 - the engine cowling strobe light was missing;
 - the left reverse movement light's casing was damaged;
- the engine cowling contained a dent on the RH side left by the airplane landing gear tire.

Figure 46a. Snowplow after the accident (the damaged snow evacuation nozzle was placed at its location as per design)
