## PART 1.4 – ANALYSIS AND FINDINGS

1.4.5 The accident involving Hawk aircraft XX177 was a complex event. Whilst a failure in the ejection sequence led to the Pilot sustaining fatal injuries, the Panel has determined that **the accident event was the initiation of ejection**. The analysis and findings are grouped under the following headings:

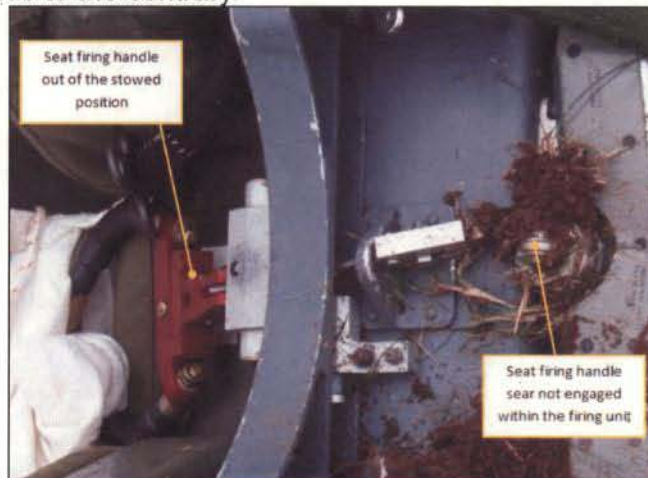
1.4.2.5. **Initial Examination.** Following the accident an initial examination of the ejection seat was conducted and the XX177 SFH was found un-stowed from the housing and the sear was not engaged within the firing unit (Figure 9). Examination of the seat firing unit cartridge showed that it had fired and there was a firing pin indentation on the percussion cap. There was damage to the sear and the SFH which were consistent with a single impact following ejection. All of this evidence was consistent with an ejection initiated via the SFH and the Panel found no evidence to the contrary.

Figure 9 – XX177 SFH out of housing and sear not engaged.

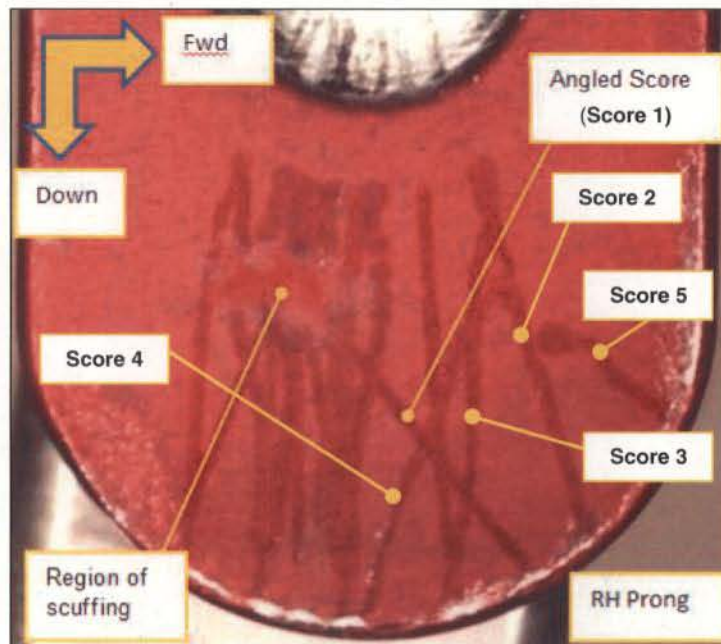
Markings on the sides of the SFH appeared unique in two ways: a substantial 'scuffing' mark on the right hand side of the SFH body sub-assembly and an 'angled' score (score 1) passing over the scuffing area (see Figure 10). A similar 'angled' score mark was found on the opposite (left hand) face of the body sub-assembly (see Figure 11). There was no scuffing evident on the left hand side of the body sub-assembly.

Figure 10 – Right hand side of XX177 SFH.

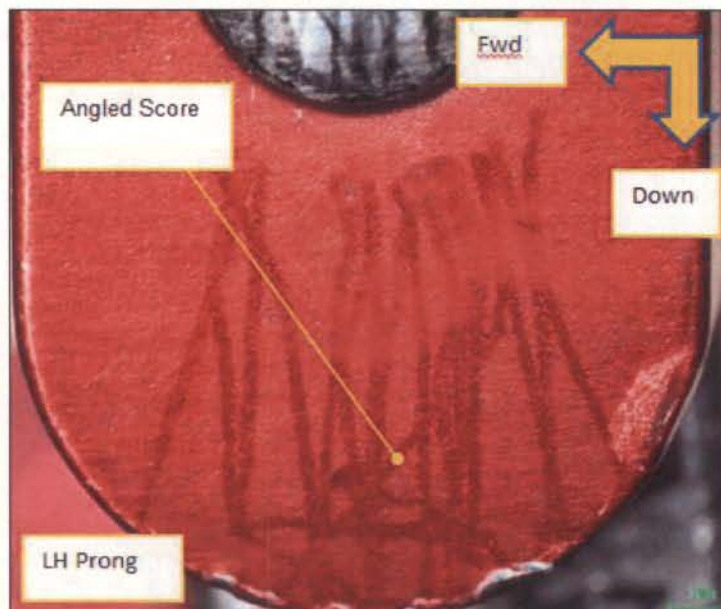
Figure 11 – Left hand side of XX177 SFH.

The scuffing and angular score mark 1 had over-laid all of the vertical scores with the exception of two: one where the angular score did not intersect (score 2); and the other where it was not clear whether the angular score had passed over or under the vertical score at the intersection of score 1 and score 3. It could be established that score 2 and score 3 had been

created after the accident when a 'pull-off'<sup>4</sup> test had been conducted at MB. Score 2 was most likely to have been created when inserting the SFH prior to the pull-off check and score 3 (which overlaid score 2) was caused by the pull-off check itself. Furthermore score 4 was found to be under score 1 and score 3. The angular scoring was therefore likely to have been the penultimate event that had occurred in this region of the SFH. There was one other angular score evident on the SFH (score 5): the score was not straight and was shorter than all of the other scores; it originated at a lower location compared to the majority that could be traced below the body sub-assembly connecting link rivet. A similar score mark was evident on the left hand side. The location and length of the scoring on both sides suggested that this was as a result of fitment rather than operation.

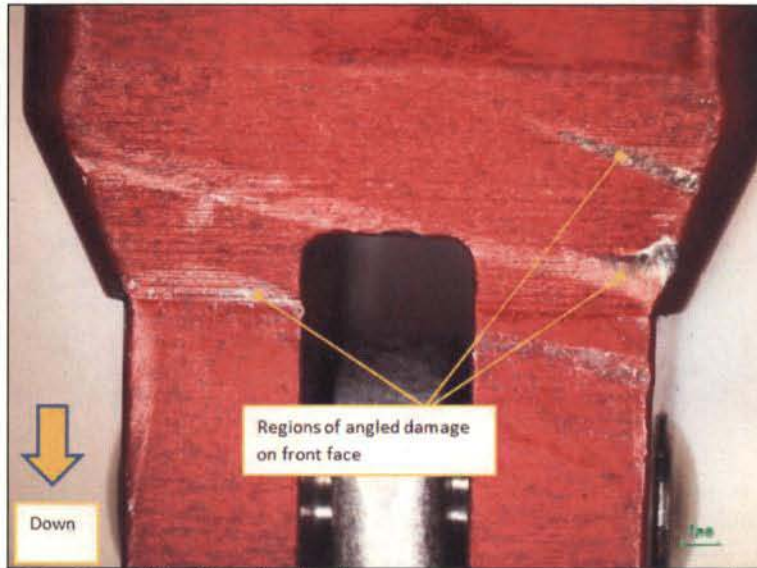
The SFH body sub-assembly also exhibited three unique transverse angular markings on the front face (see Figure 12), and a compression mark on the lower rear face of each prong (see Figure 13). These marks were not considered to be as a result of ground impact damage.

Figure 12 – Seat Firing Handle showing transverse angular markings on front face

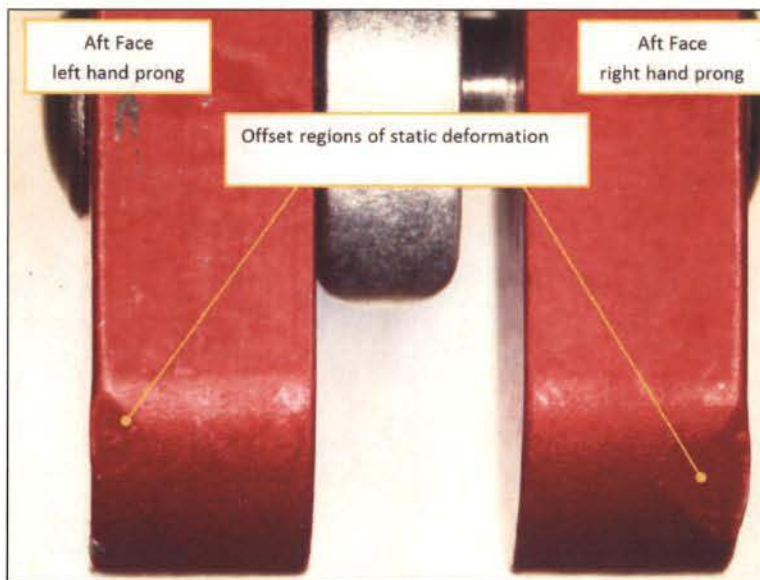
Figure 13 – Deformation to aft face of XX177 SFH prongs.

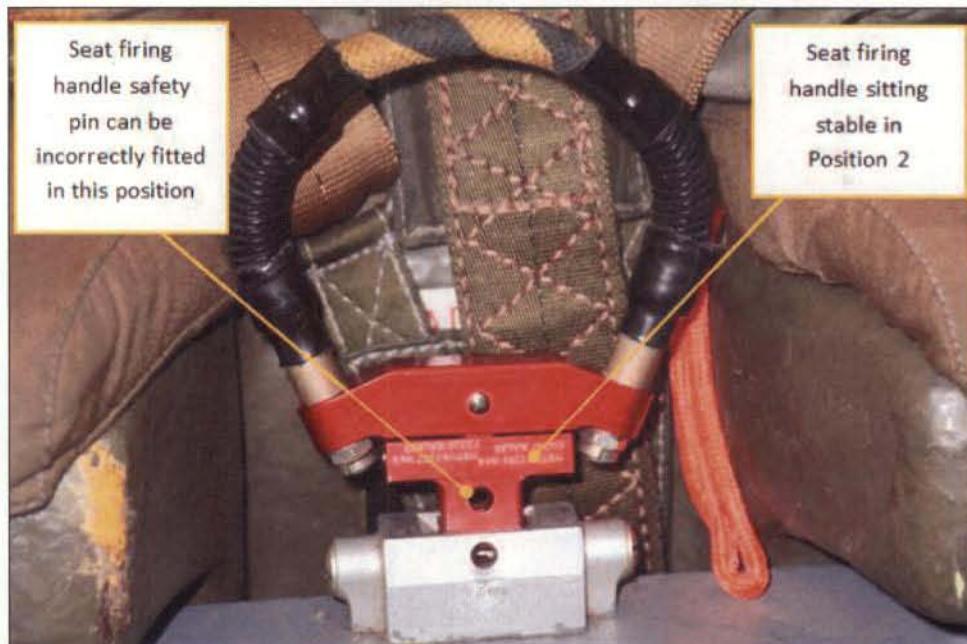
Figure 15 – Position 2.

- b. **Position 2.** Out of the stowed position with the housing plungers resting above the connecting link attachment rivet (see Figure 15).

Position 2 was found to be a relatively stable condition, whereby the SFH could be moved in a variety of ways and would remain in that position unless pulled vertically upwards to initiate ejection or pushed downwards to re-stow the handle. Position 3 was found to be less stable, whereby movements could displace it in one of two ways: by returning the SFH to Position 2 or overcoming seat firing unit spring pressure to withdraw the seat and initiate ejection. It was also found that in Position 3, movement of the SFH in a forward direction, away from the pilot, could initiate ejection; this was not possible from Position 2. The majority of operators and engineers would have had no reason to recognise the specific unsafe positions referenced in this report (Positions 2 and 3). However, they were aware that the only position they should expect to find the SFH in was with the handle fully housed (safety pin inserted in to the handle and housing, or removed for flight). Any other condition, if discovered, would be assessed as being unsafe. Moreover, the ability to initiate ejection by anything other than a vertical pull, was unknown. The Panel concluded that had the information regarding Position 2 and 3 been more widely known, including the possibility of initiating ejection through a forward movement, different procedures and training could have been introduced which may have made the discovery of the SFH in an unsafe condition more likely and was therefore **a contributory factor**.

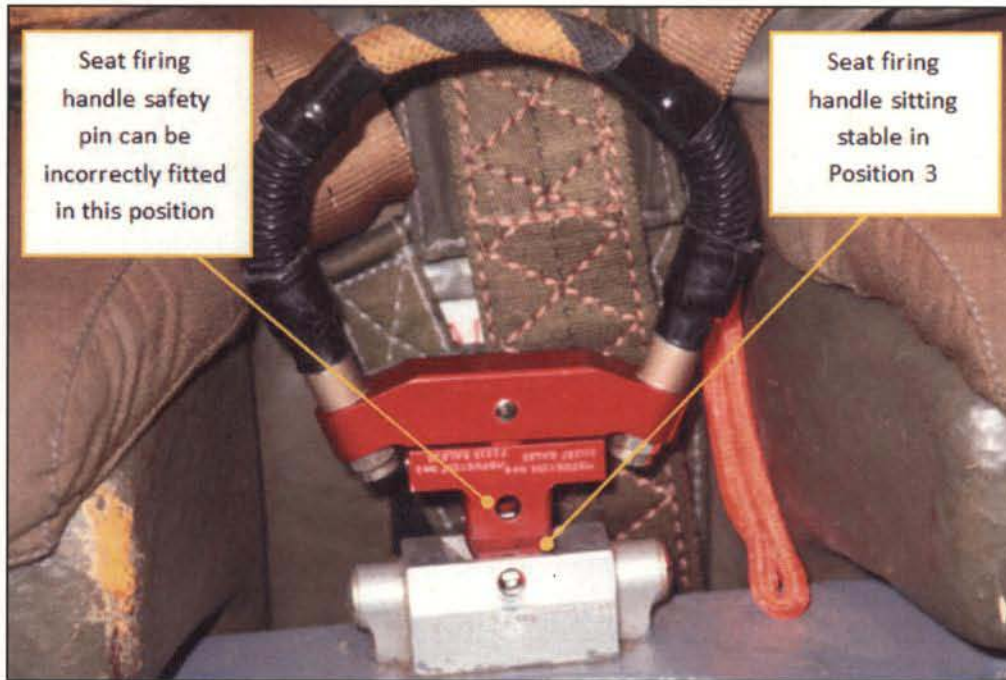
Figure 16 – Position 3.

- c. **Position 3.** Out of stowed position with the housing plungers resting below the connecting link attachment rivet (see Figure 16).

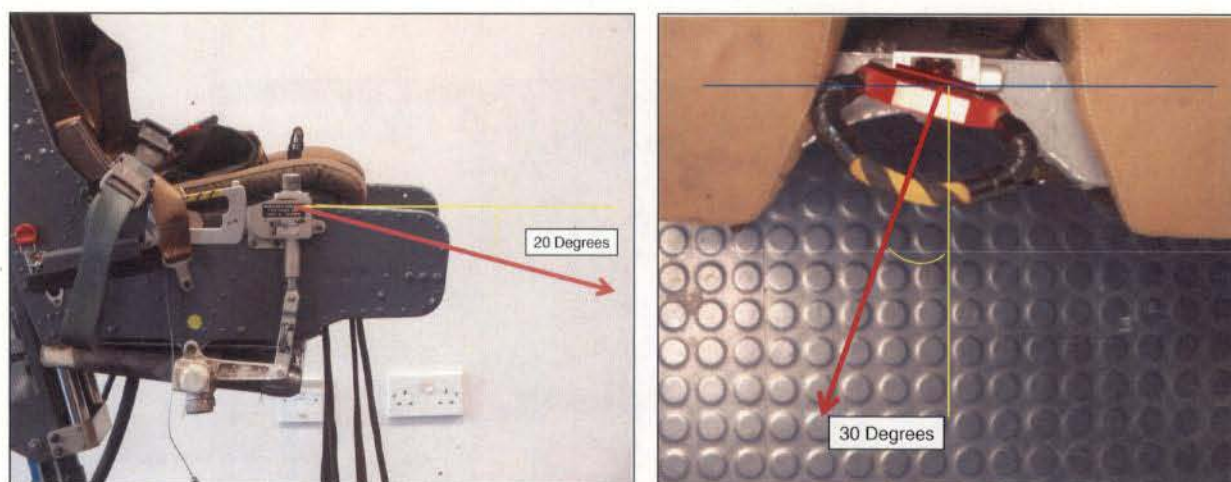
Figure 17 – Direction of SFH movement that initiated ejection.

1.4.2.9. **Ejection Initiation Cause.** The Panel concluded that **the cause** of the accident was an inadvertent ejection following the application of a force to the SFH in Position 3; 20 degrees down from the horizontal plane and 30 degrees right from SFH housing centre line.

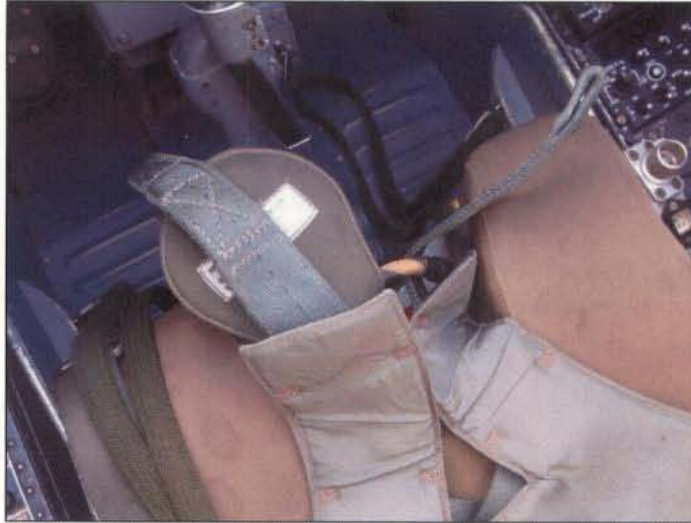
1.4.2.12. **Incorrect Routing of Crotch Straps.** It is normal for ground-crew to leave the ejection seat straps folded on the seat to tidy the cockpit in preparation for the next flight. Prior to entering the cockpit pilots often move the straps away from this position to ease their entry into the cockpit prior to strapping in. Figure 20 shows how a harness crotch strap could fall through the SFH and potentially go unmissed. It was established that during strapping-in misrouting either one of the seat harness crotch straps through the SFH could cause it to be moved from the Position 1 to Positions 2 and 3 (see Figure 21), but this was only possible once the SFH safety pin was removed. The movement of the SFH was found to be relatively easy to achieve through routine cockpit activity by the pilot, such as the leg movement required to apply full rudder during a 'full and free' control check. Moreover, testing demonstrated that detection of this SFH movement through feel was extremely difficult and therefore unlikely if not anticipated. Although it was found to be possible to initiate ejection while strapped to the SFH in this manner it was difficult to achieve and required abnormal and significant movement

Figure 20 – Straps moved off seat obscuring SFH prior to crew cockpit entry with the RH crotch strap miss-routed through the SFH.

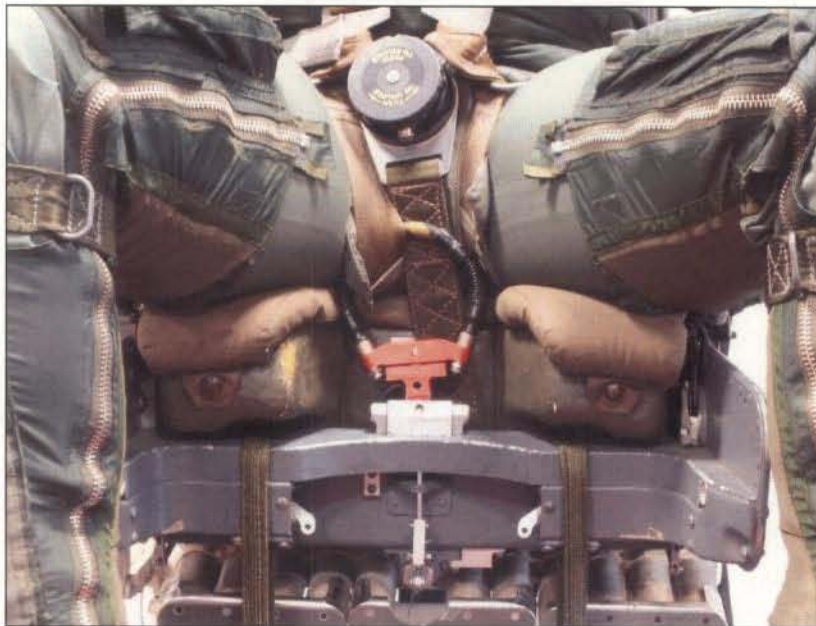
by the pilot. Additionally, the initiation of ejection with the crotch strap misrouted through the SFH was only achievable via a vertical movement upwards of the SFH. It was not possible to initiate ejection in a manner consistent with the XX177 forensic evidence while the crotch strap remained incorrectly routed through the SFH.

Figure 21 – Incorrect routing of RH crotch strap through SFH.

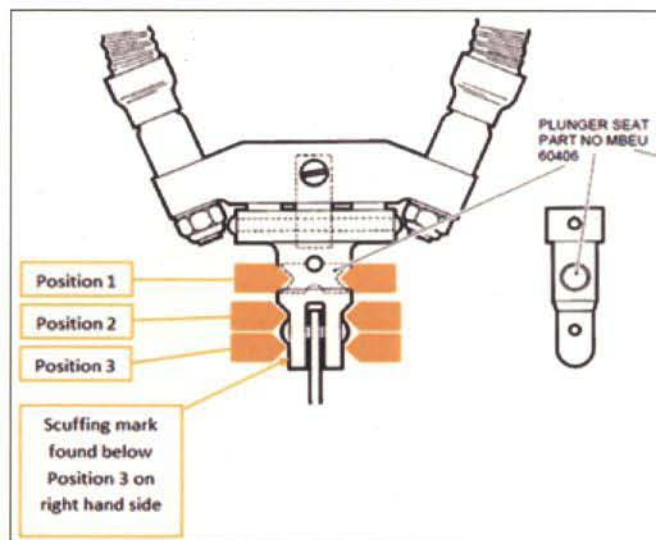
1.4.2.13. **Replication of 'Scuffing'.** The patch of 'scuffing' was only found on the right hand side of the SFH, at a location beyond Position 3 (see Figure 22). This position was not found to be naturally stable and indicated that it must have been held for a period of time by some other means other than the SFH assembly. It was observed that by misrouting the right hand crotch strap (Figure 21) and performing leg and buttock movement, which the Panel considered to be consistent with normal pilot activity, it was possible to raise and hold the SFH at a location beyond Position 3, but without releasing the seat. In this configuration it was possible to cause scuffing on the right hand side of the SFH in the same region as that found on XX177. No other configuration was found to cause scuffing in this manner.

Figure 22 – SFH scuffing at position 3.

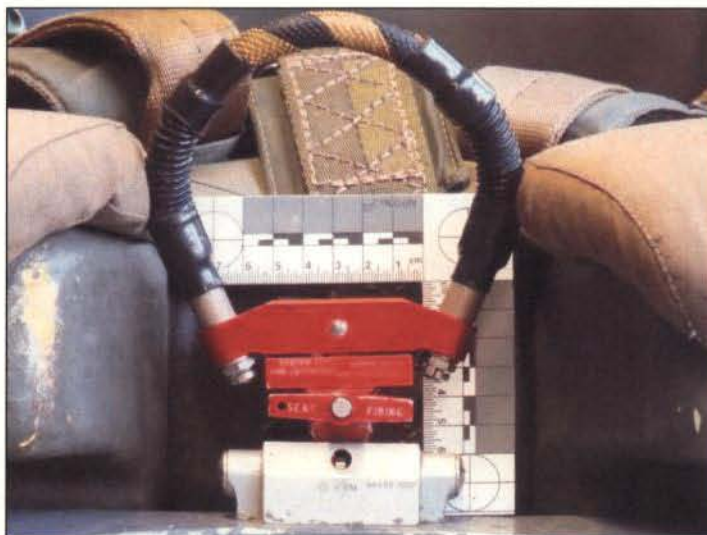
1.4.2.15. **Incorrect Fitment of the SFH Safety Pin.** During the testing at 1710 NAS and during MITL testing the Panel observed that with the SFH in the raised Position 2 or 3 it was possible to fit the SFH safety pin through the handle only (see Figure 23). In this configuration the ejection seat was not safe and the SFH could be operated. However, particularly when viewed from above, the SFH could appear to be in a safe condition, giving a false sense of safety. That it was possible to insert the pin into the handle in this way was not widely known and this was compounded by maintenance and operator publications which referred to checking that “the pin was inserted into the SFH” as a confirmation of safety. The Panel concluded that the ability to incorrectly insert the safety pin through the SFH alone, leaving the seat in an unsafe condition, was a **contributory factor** in this accident

Figure 23 – SFH safety pin fitted whilst SFH remains in an unsafe condition.

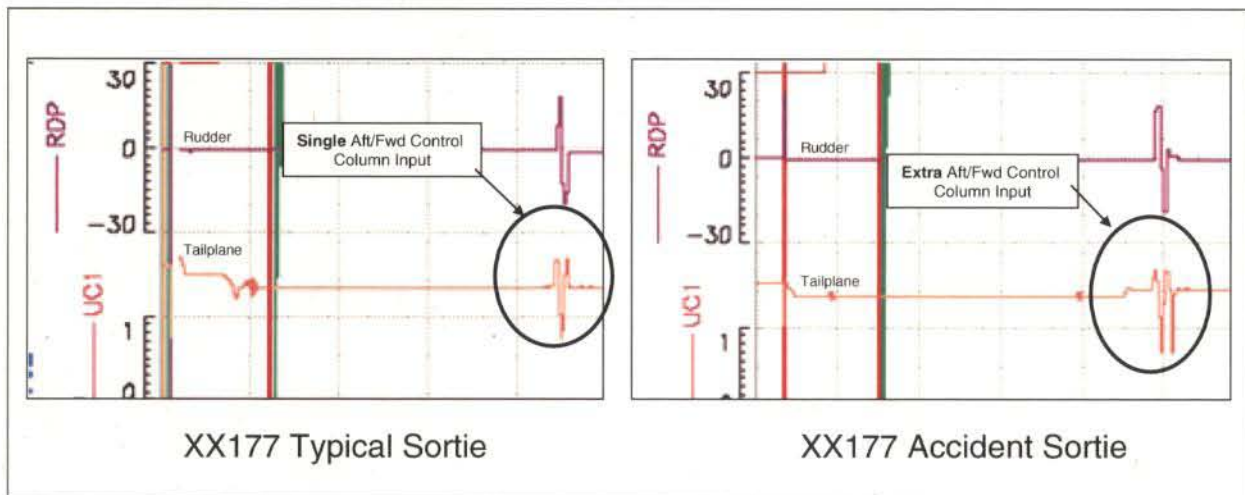
experienced during 'full and free' checks. As the accident Pilot was the last pilot to fly XX177 on 4 Nov 11 only the three other pilots could be interviewed; none recalled experiencing a 'control restriction'. All of the traces, including the four from 4 Nov 11, showed similar control inputs and timings during the 'full and free' control check. These were compared to the accident sortie and showed similar control inputs to all of the other sorties with one exception: during the accident sortie, on completion of the 'full and free' checks, a rapid aft movement of the control column followed by a reset to the central position was carried out by the Pilot. On no other ADR trace examined was this apparent, see Figure 24. It is common practice that if a 'control restriction' is felt during a 'full and free' control check, a pilot will revisit the area of restriction as confirmation and to aid diagnosis. It is therefore the Panel's view that on the day of the accident the Pilot experienced a 'control restriction' during his 'full and free' checks, which caused him to carry out the additional control input. Examination of the ADR traces and witness statements indicate that no similar 'control restriction' (indicative in this case of an SFH in an unsafe condition and correct strap routing) had been experienced on any of the previous four sorties. Following dislodgement of the SFH into an unsafe condition through incorrect strap routing, it is the Panel's view that had it not been detected by some other means, the next pilot to fly the aircraft would have felt a similar 'control restriction' during 'full and free' checks. Evidence suggests that no such control restriction was detected on any of the previous four sorties; therefore the Panel concluded that **the XX177 SFH was most likely moved into an unsafe condition on the final sortie on 4 Nov 11.**

Figure 24 – XX177 Accident sortie extra control input.

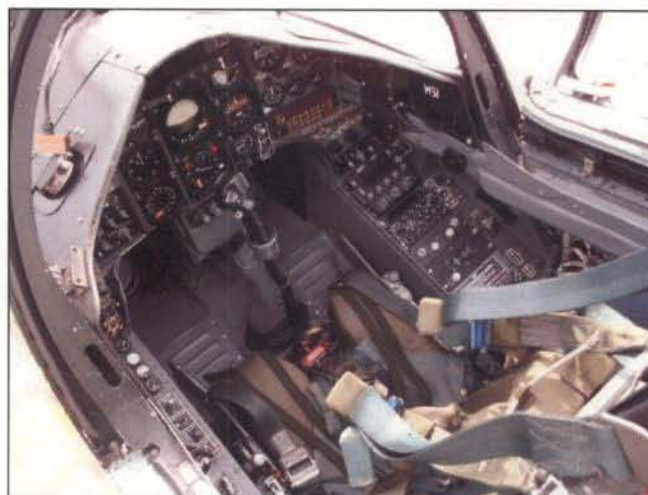
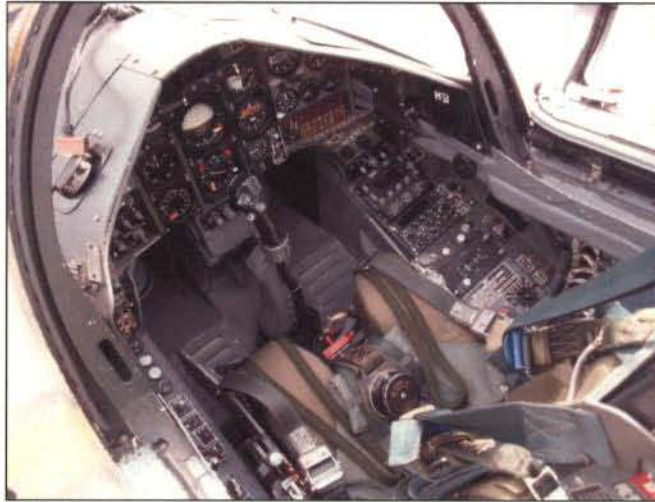
c. **Seat Height.** The ejection seat is able to be motored up and down, allowing the pilot to select the optimum height for flight. The Panel noted that it was harder to gain a front aspect view of the SFH when the seat was motored down (see Figure 26 and 27). Of note, at the point of initiation the XX177 ejection seat was towards the lower limit of travel. Although it is part of the Hawk AF servicing schedule to operate the ejection seat to the upper limit, it is likely that the XX177 ejection seat had not been moved since the previous sortie on 04 Nov 11. The probable reason for this omission is discussed at Section 1.4.5.23a.

Figure 26 – SFH viewed from above; seat motored to the lower limit.

Figure 27 – SFH viewed from above; seat motored to the upper limit.

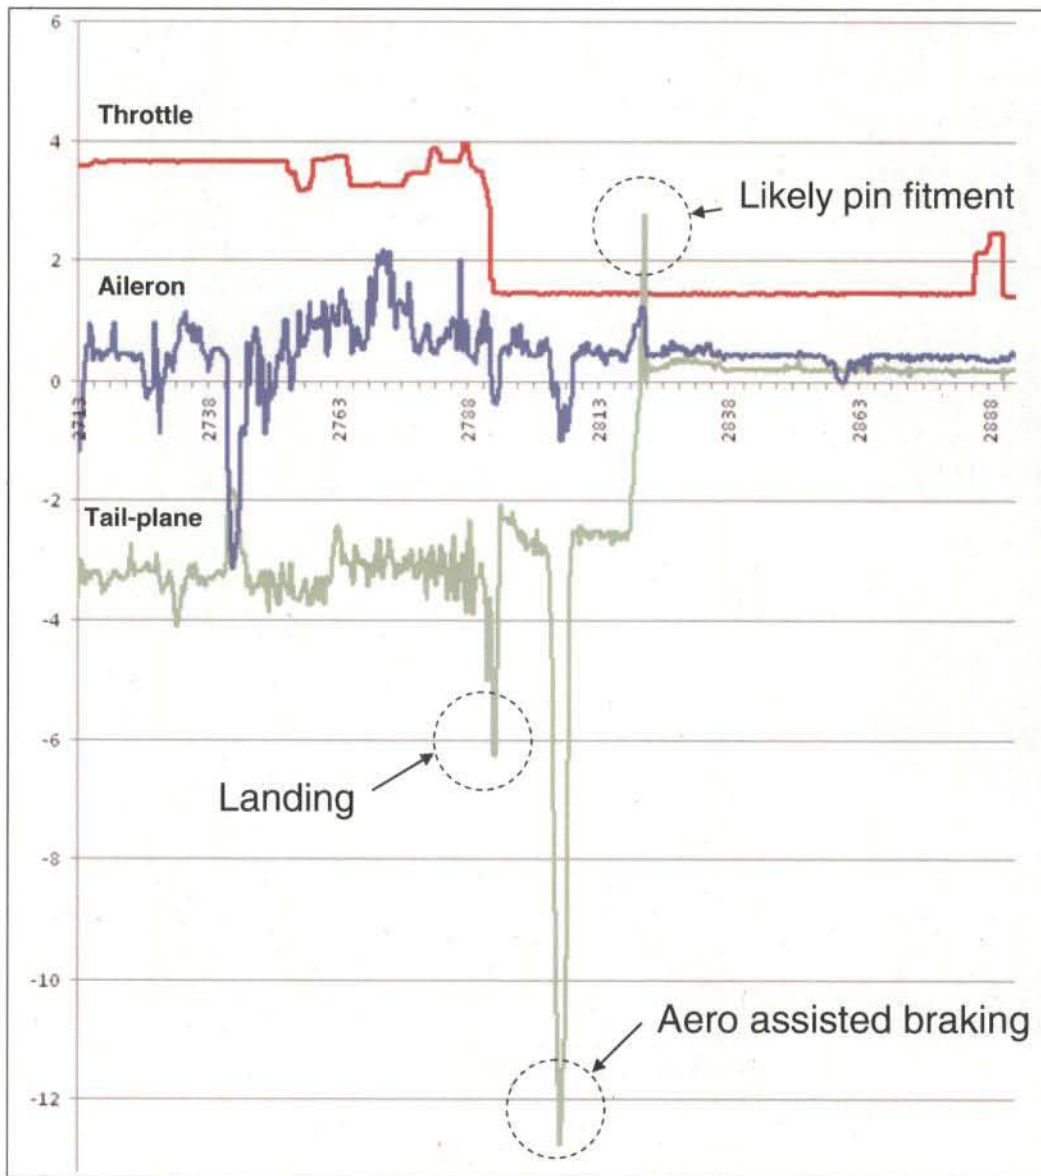
1.4.2.22. **Safety Pin Insertion into SFH.** Witness evidence from other RAFAT pilots indicated that some pilots regularly inserted the SFH safety pin by feel without visual reference. Witness evidence indicates that once the final aircraft in the formation “knows that he is not going to be flying through or over shooting” he calls “clear cross”; this is an indication to the Formation that that they can start to taxi clear of the runway in close formation and that they can make their ejection seats safe. The last sortie prior to the accident was a five aircraft formation practice. The final landing was in number sequence with the accident Pilot, Red 5, piloting XX177 (see Figure 28). In order to make the ejection seat ‘safe’ following the final landing, the safety pin is usually inserted into the SFH and housing as part of the after landing checks. During MITL testing the ‘test’ pilot was tasked with inserting the SFH safety pin by feel alone whilst maintaining ‘eyes out’ of the cockpit to simulate a requirement for visual activity outside of the cockpit. This test was executed with the SFH in Position 2 and 3 and was carried out before the ‘test’ pilot was aware of the existence of Position 2 or 3. On each occasion the safety pin was inserted into the SFH only, leaving the ‘test’ pilot unaware that the ejection seat remained ‘live’. It is normal to move the control column forward to gain access to the SFH for safety pin insertion. The ADR trace from XX177 (4 Nov 11 final sortie) was analysed and showed a forward control column input, consistent with this movement, at 50 knots airspeed (see Figure 29). Although the time of safety pin insertion into the SFH cannot be definitively established, it is the view of the Panel that the safety pin was most likely inserted into the ‘unsafe’ SFH on roll-out from landing. Due to the speed of XX177 and subsequent rate of closure to the aircraft ahead, it is likely that the Pilot inserted the SFH safety pin by feel whilst maintaining eyes out of the cockpit. The Panel concluded that the practice of inserting the SFH safety pin without visual reference is likely to have decreased the probability of discovering the SFH in an unsafe condition or incorrect strap routing and was **a contributory factor** in the accident.

Figure 29 – XX177 accident sortie ADR trace showing point of likely pin fitment.
