**COMMITTEE FOR THE RE-INVESTIGATION
OF THE SMOLENSK AIR CRASH**

TECHNICAL REPORT

**Facts regarding the crash of the TU-154M No. 101,
(Fight PLF101), that took place in Smolensk, Russia on the 10th of April 2010**

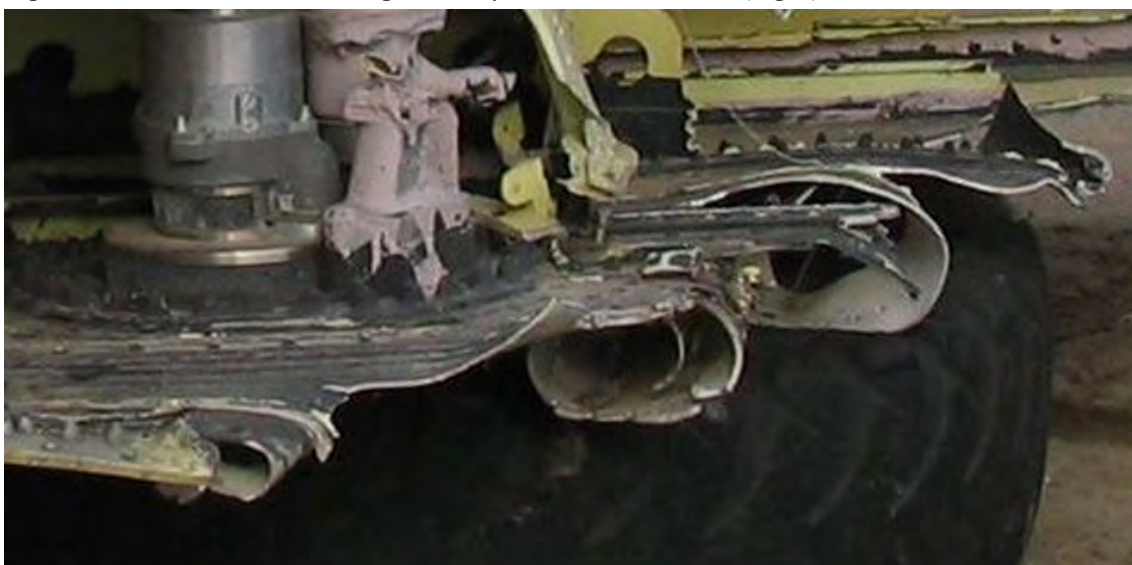
The wing tip shows a number of curls up to 450° seen as significant signs of explosion. In addition a long number of characteristic signs of explosion can be seen (Fig.2).

Fig. 2. Side view of the broken section of the left wing tip of TU-154M no.101 showing significant explosive signatures (curled edges of up to 450°).

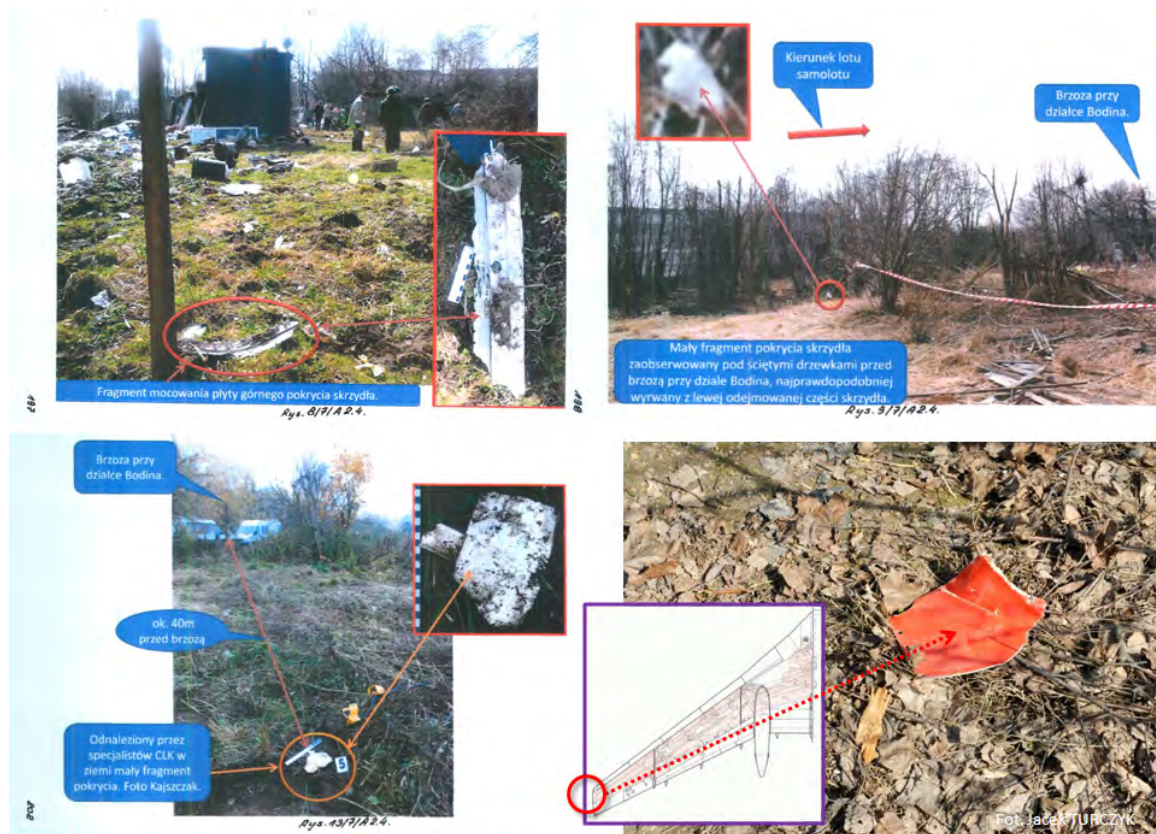
Many pieces of the left wing, in the vicinity of the Bodin birch (bb), were found before the tree in an area of 41 meters north and 17 meters south in the direction perpendicular do the flight direction, and 43 meters to the east of the tree (Fig. nr.3)

Fig. 3. Debris of the detachable part of the left wing identified by the Committee and experts of the Prosecutor's Office of the Republic of Poland.

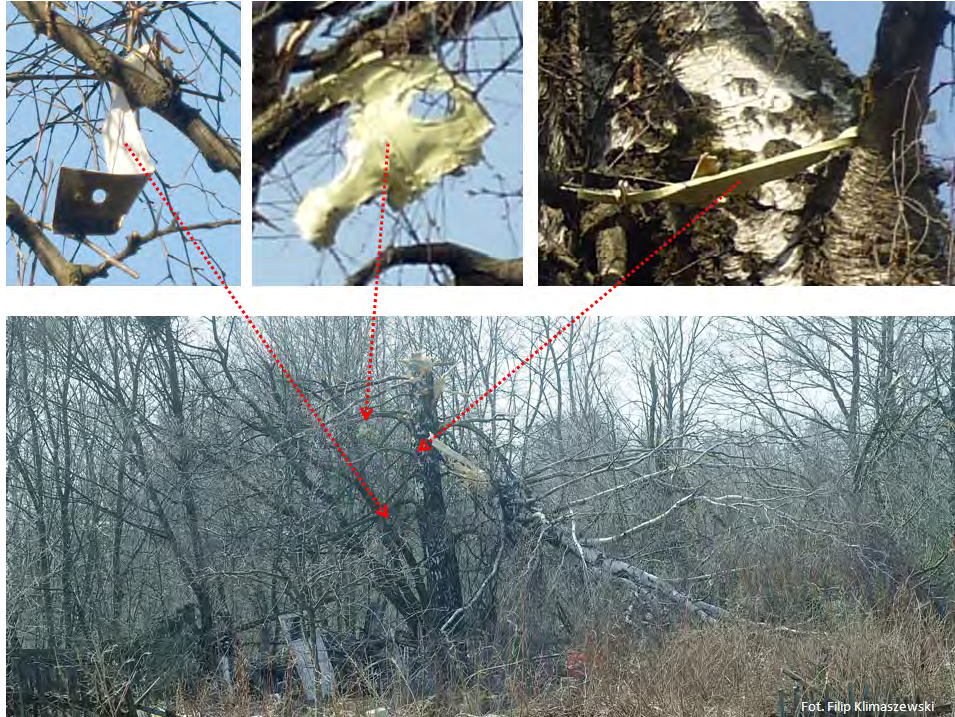
Three pieces of the detachable part of the left wing were hanging on the branches of the so called Bodin birch (Fig.4).

Fig. 4. Identified pieces of the detachable left wing part hanging on April 10, 2010 on the branches of (Bodin) birch tree claimed to have cut the wing (noted "bb").

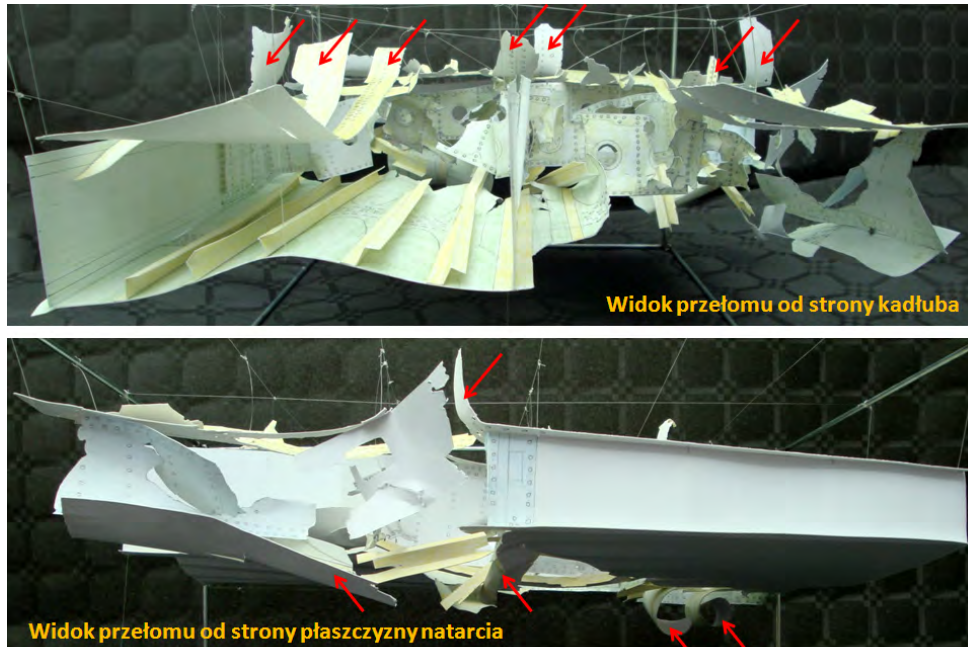
In the area of damaged pieces bent in the opposite direction than the flight direction the presence of buckling and bandings due to an impact against the terrain obstacle was stated. Elements of the skin of the left wing, which according to the MAK and Miller reports were supposed to have contact with the bb tree are torn off and bent outwards; upper side bent upwards, bottom side bent downwards. (Fig. 7).

Fig. 7. Place of separation of the left wing tip. Places in the outer and bottom skin have been marked with red arrows, which have been bent outwards.

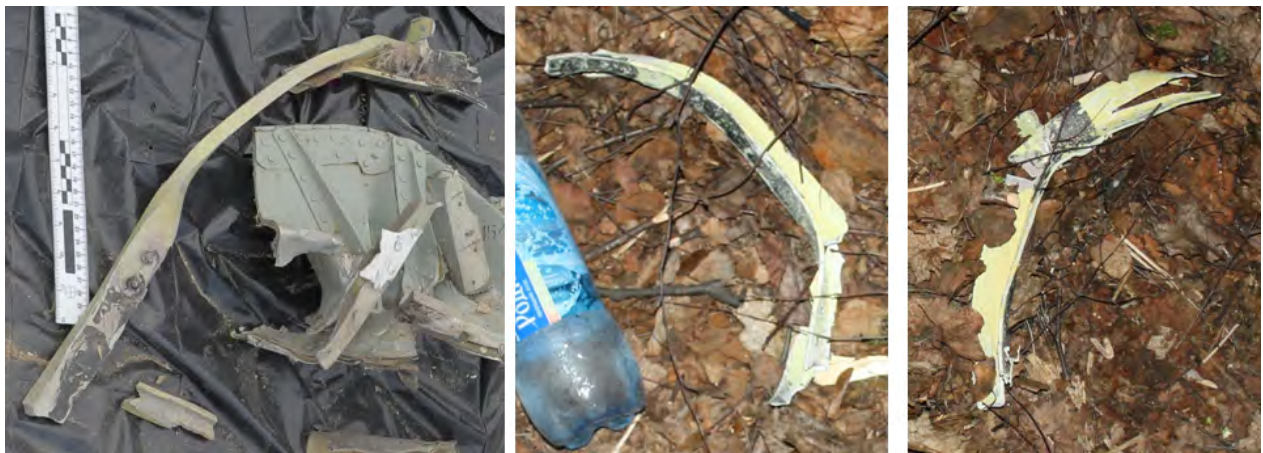
Fig.8. Pieces of stringers of the left wing curled outwards

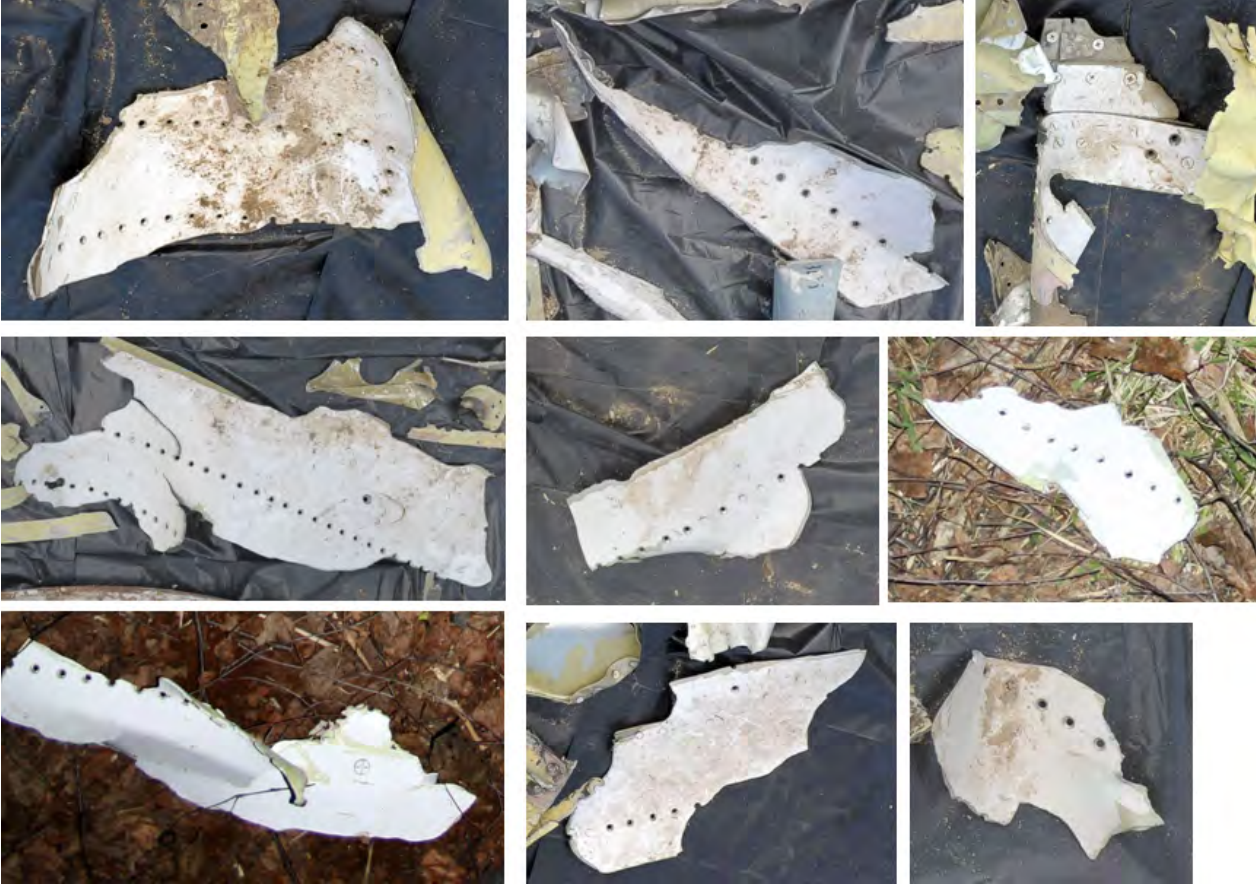
Elements of the plating of the removable part of the left wing, which according to MAK and Miller reports were supposed to have contact with (bb), are ripped out and bent outside the structure; on the surface upwards (Fig. 9), on the bottom surface downwards (Fig. 10).

Fig. 9. Pieces from the top skin curled outwards.

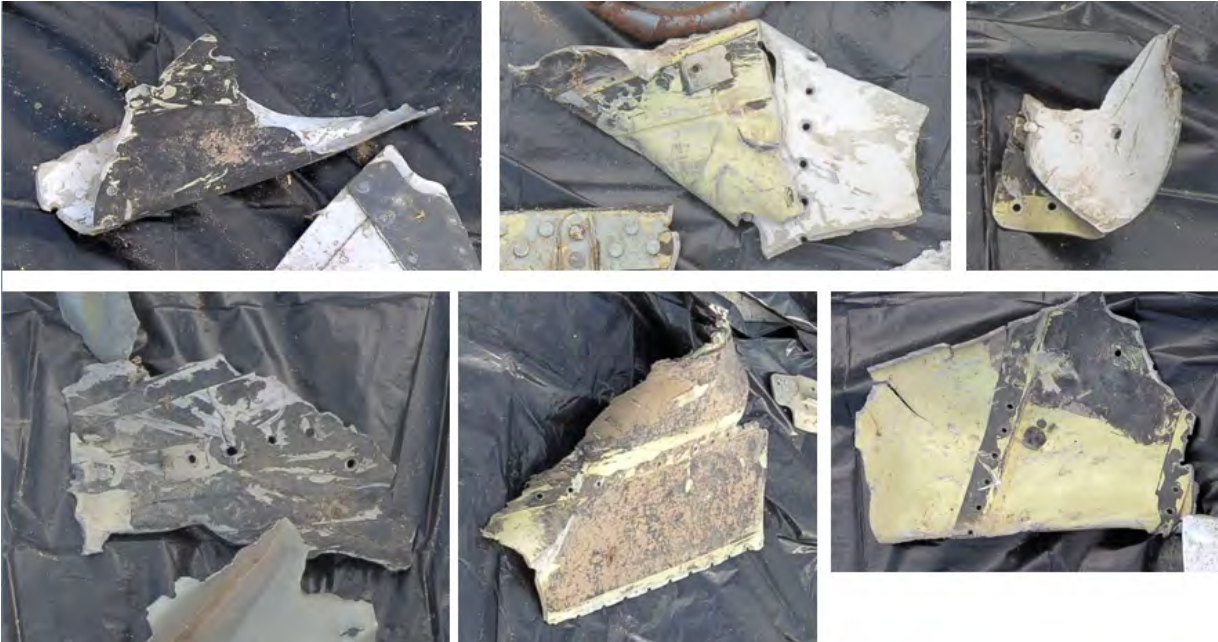
Fig. 10. Fragments of the bottom skin curled outside the structure.

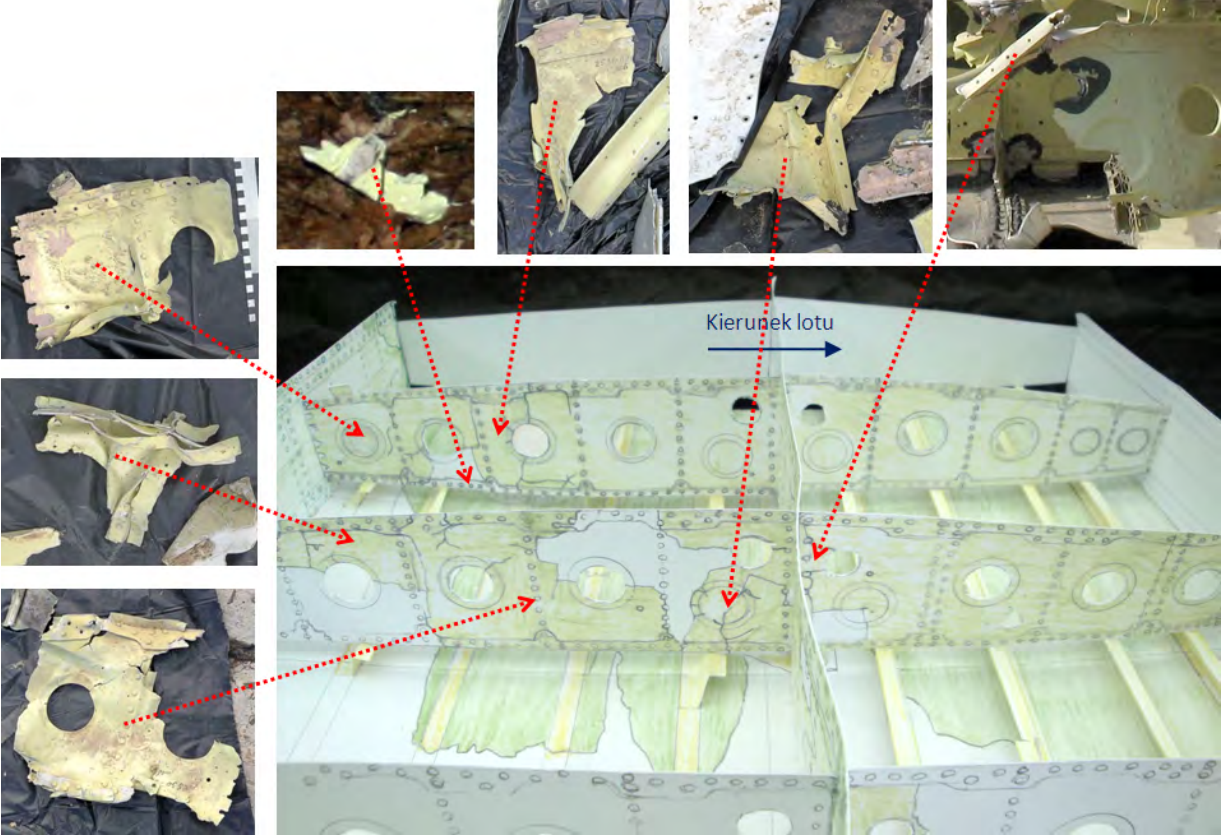
Some pieces of the left wing rib, which according to the MAK and Miller reports were supposed to have contact with the bb tree, are torn off the construction (Fig. 11)

Fig. 11. Condition of the ribs of the left wing according to the reconstruction made by the Committee.

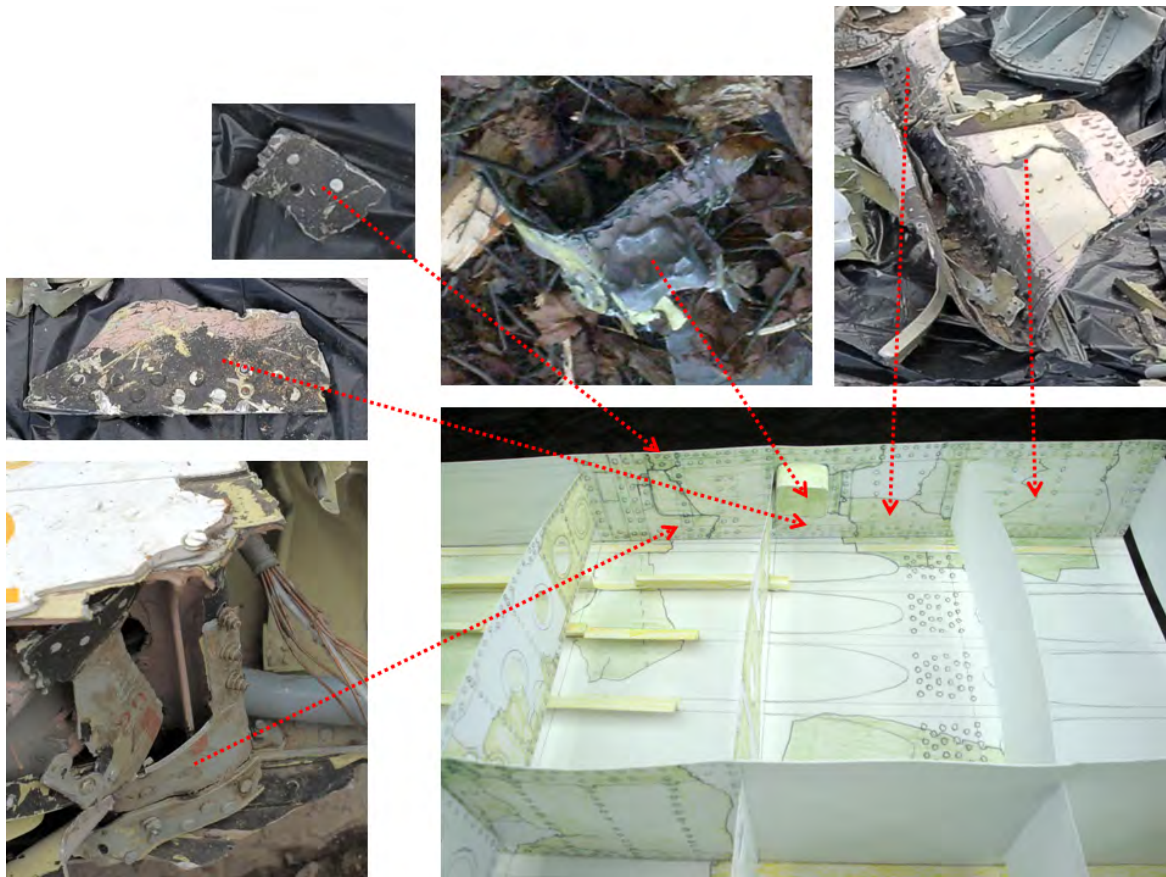
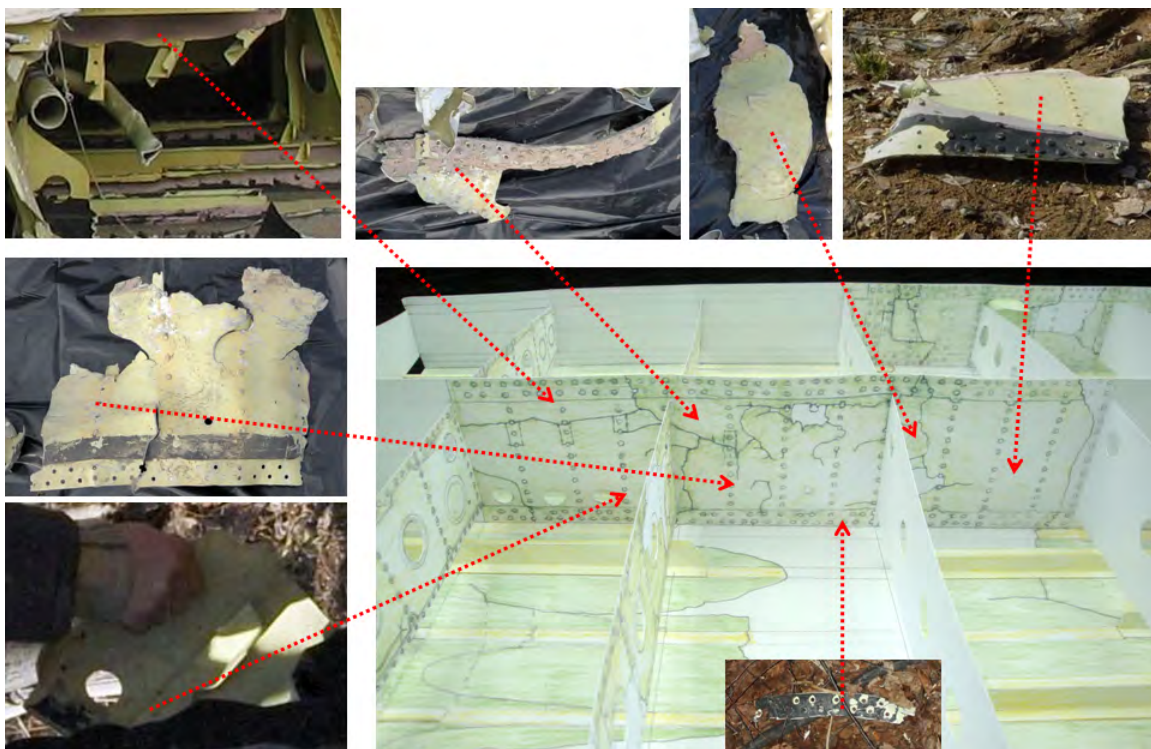
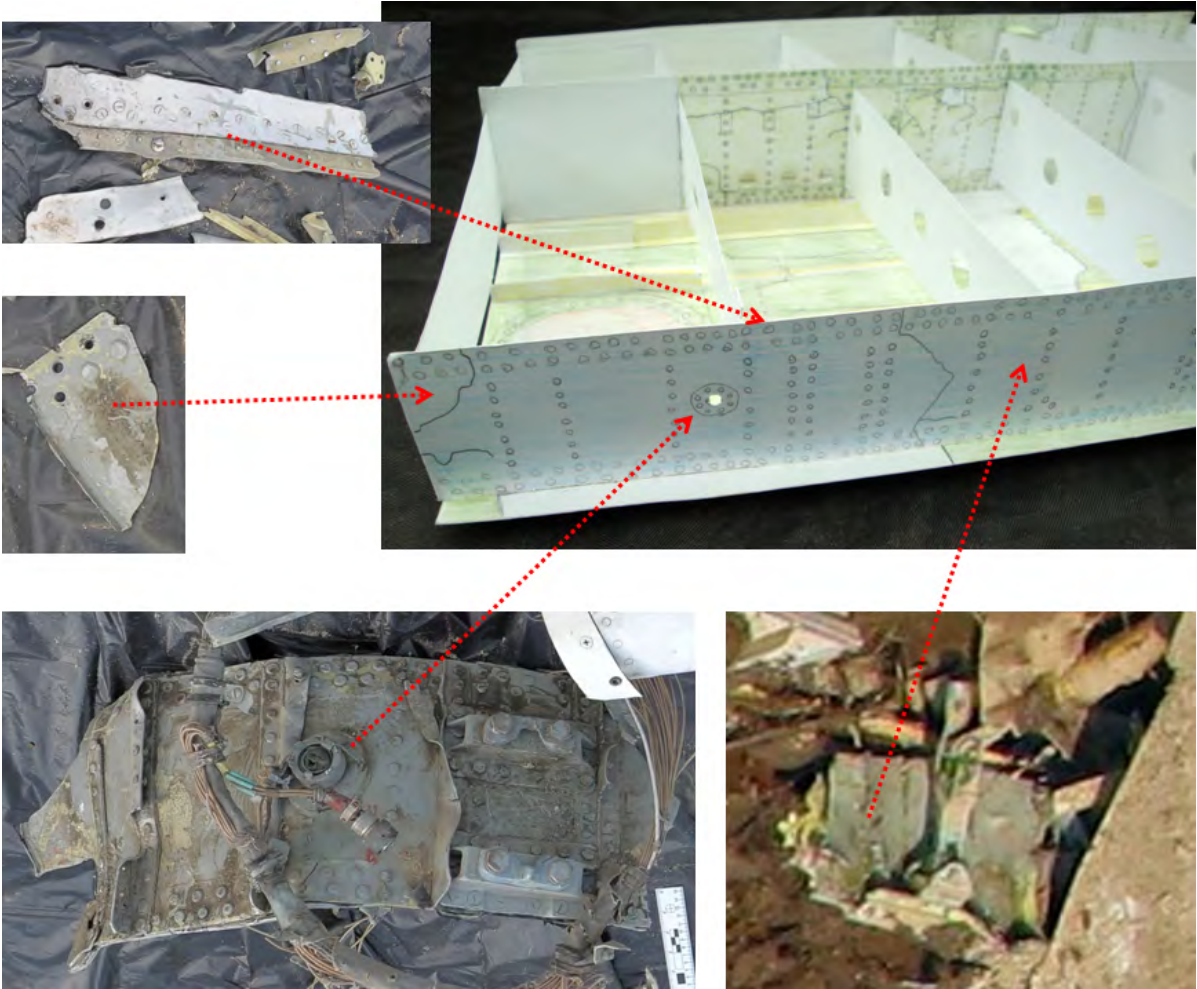
Some pieces of the wing spars from the detachable part of the left wing, which according to the MAK and Miller reports were supposed to have contact with the bb tree, are torn off or bent outwards (Fig. 12,13 and 14)

Fig. 12. Condition of spar no.1 of the left wing according to the reconstruction made by the Committee based on pictures and movies.

Fig. 13. Condition of spar no.2 of the left wing according to the model reconstruction made by the Committee, based on pictures and movies.

Fig. 14. Condition of the third spar of the left wing according to the model reconstruction made by the Committee.

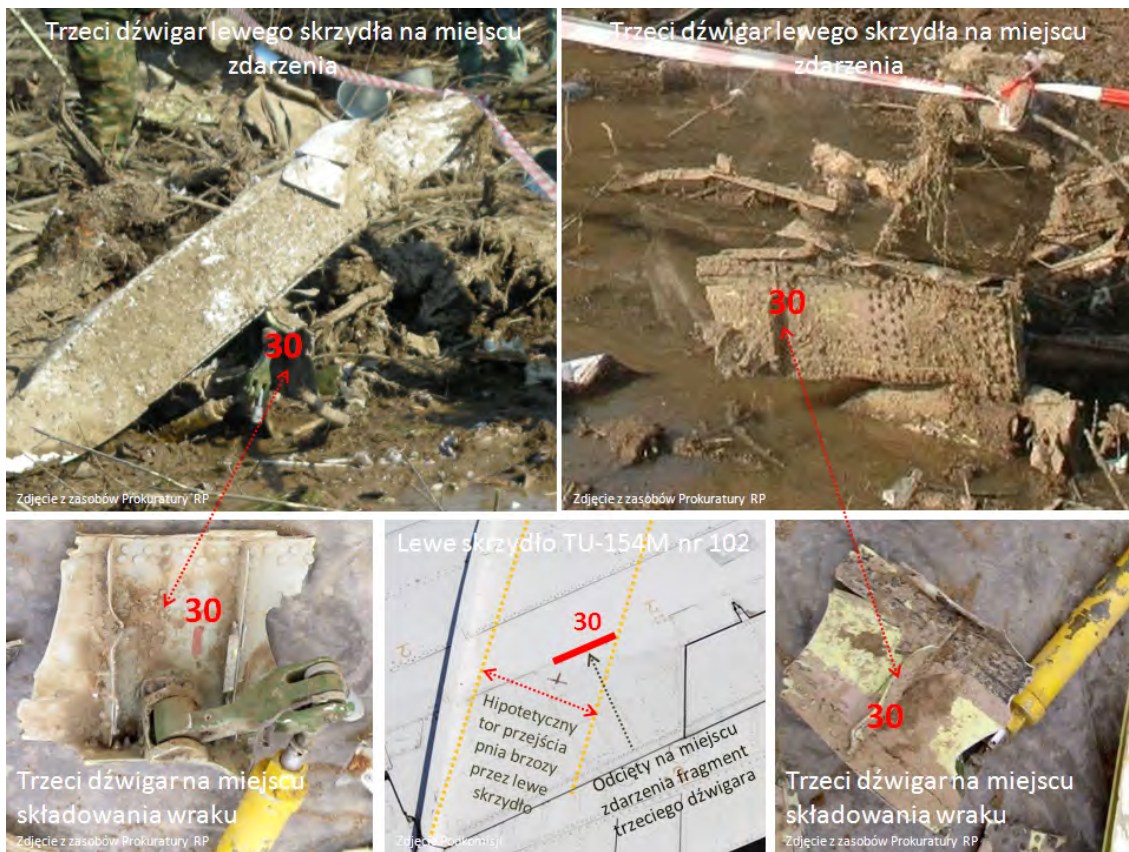
A fragment of spar no.3 of the left wing, which according to the MAK and Miller reports was supposed to be cut by the so called bb tree, was found on the main crash site 450m behind the birch tree and then cut. Its separated pieces were found in various places of the debris storage place (Fig. 15)

Fig. 15. View of the same part of spar no.3 from the detachable part of the left wing on the main crash site and place of storage of the debris.

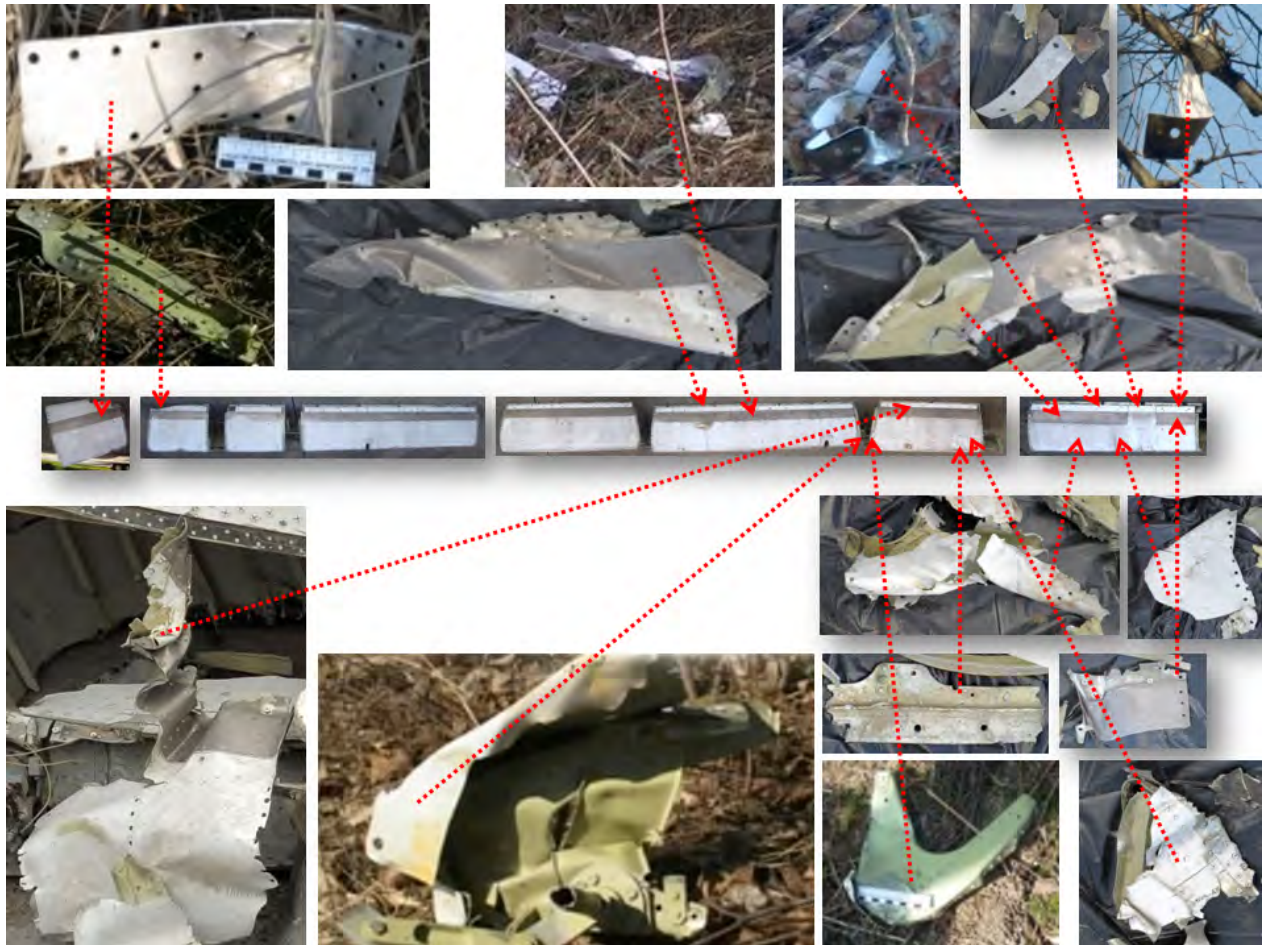
Some elements of the nose of the left wing, which according to the MAK and Miller reports were supposed to have contact with the so called bb tree, are torn off or bent outwards (Fig. 16)

Fig. 16. Condition of the nose of the left wing according to the model reconstruction made by the Committee

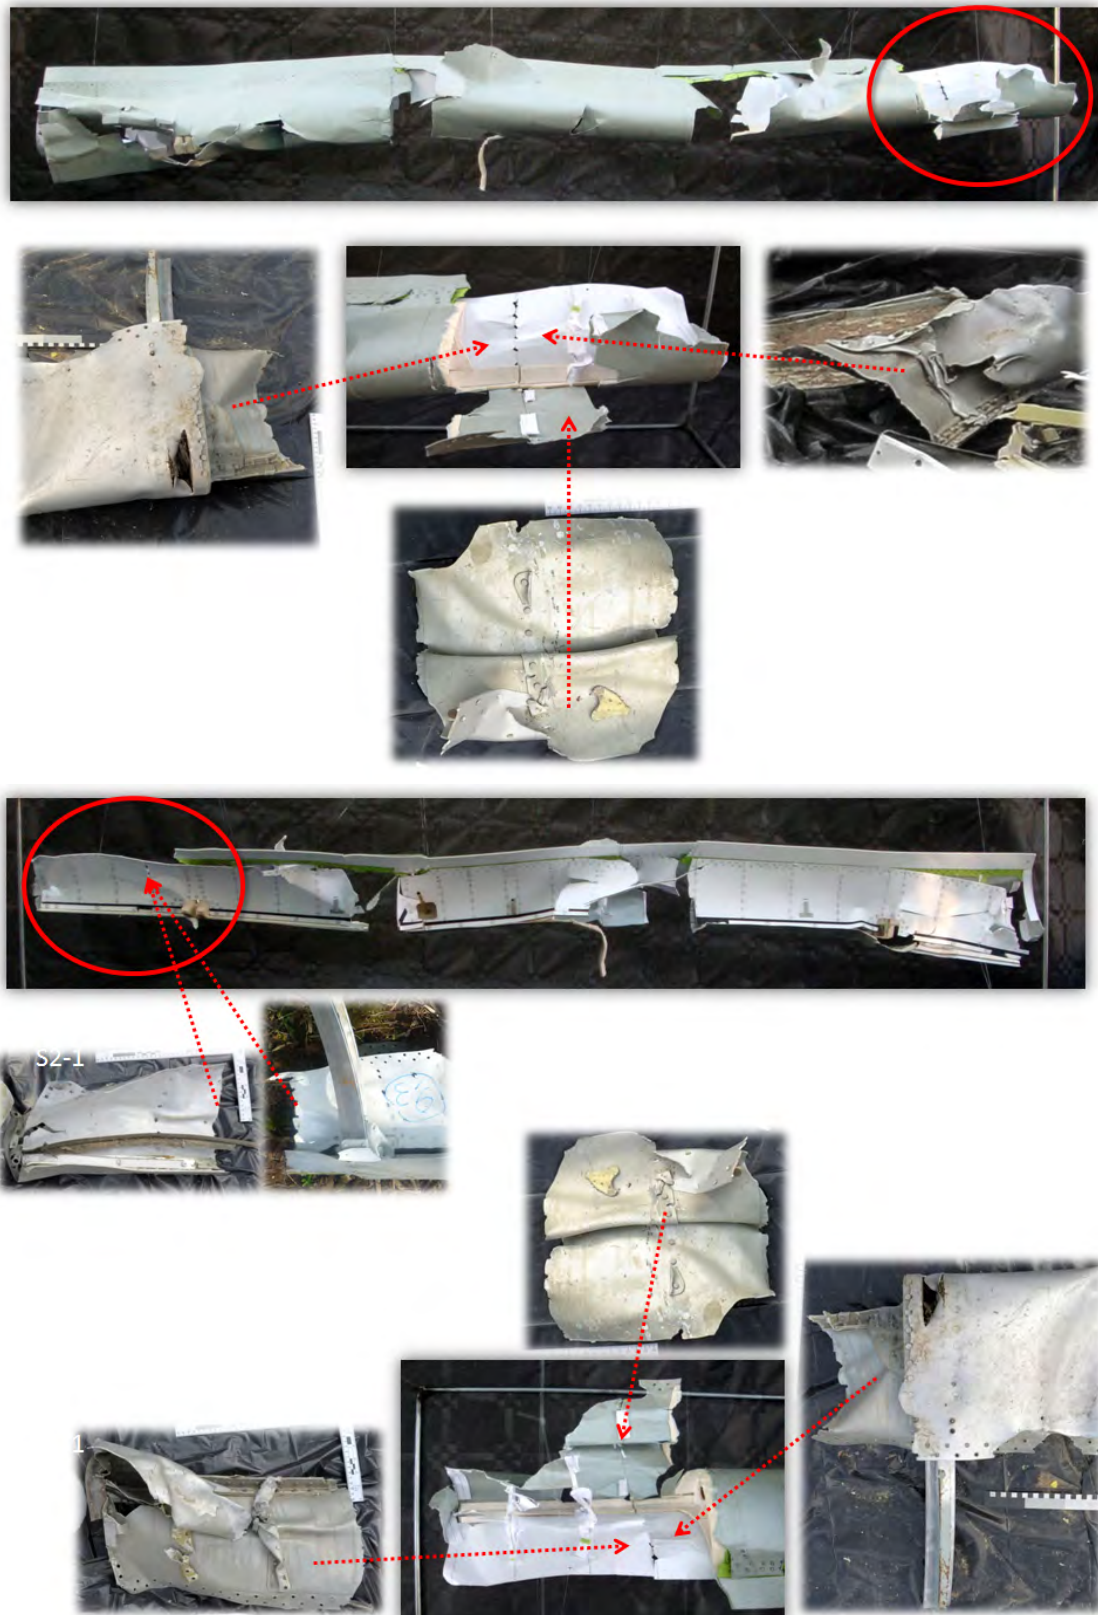
Some pieces of the second section of the left wing slats, which according to the MAK and Miller reports were supposed to have contact with the so called bb tree, are torn off or bent outwards; upper side upwards and bottom side downwards, and from the side of the angle of attack to the front (Fig. 17).

Fig. 17. Condition of the second section of the left wing slat according to the model reconstruction made by the Committee

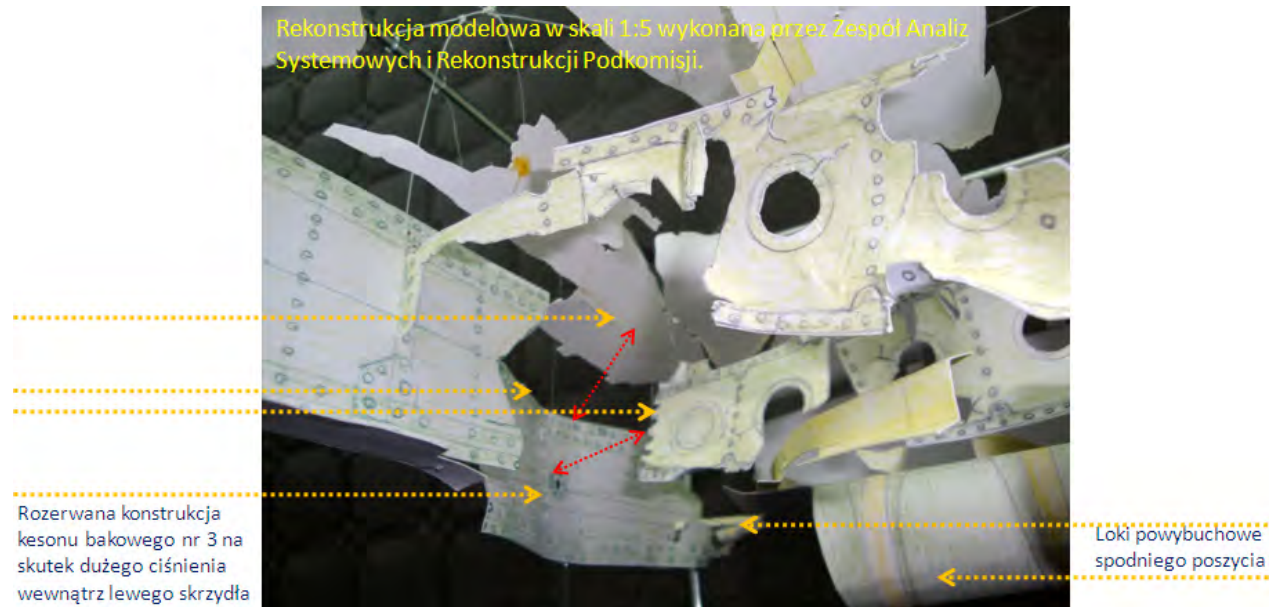
Fig. 18. Reconstruction of the console of the subtracted part of the left wing with elements of the internal structure, bearing traces of deformation through the impact of high internal pressure, whose epicenter is between the ribs No. 27-32.

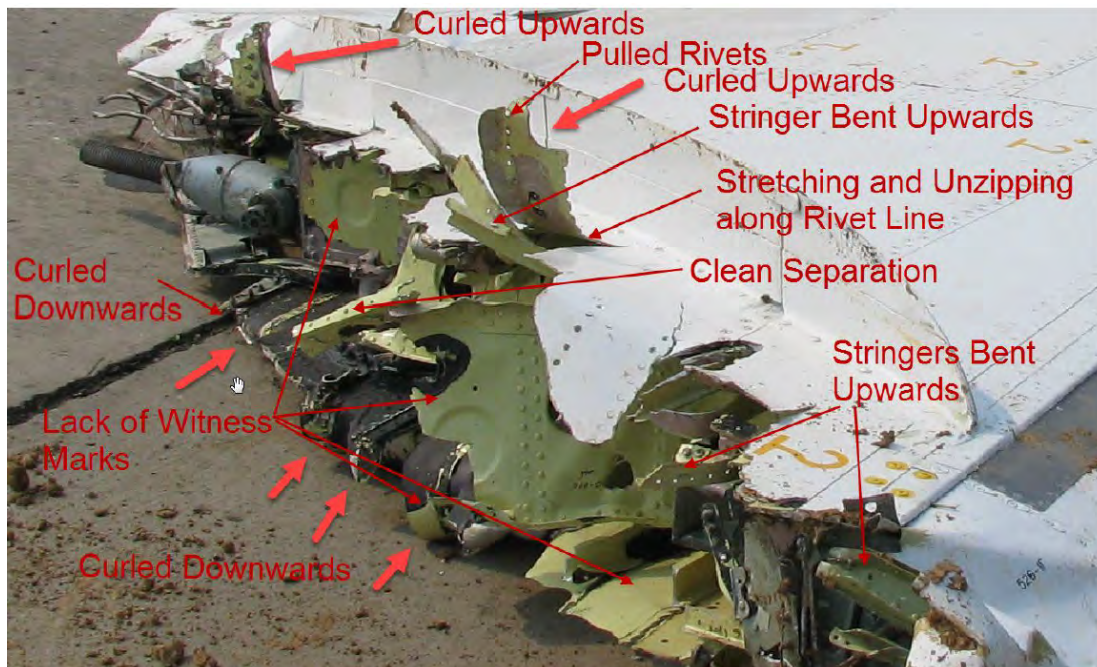
The separation place of the left wing tip shows classical post-explosive signatures typical for the use of explosive materials, like irregularly curled edges with more than one turn. The broken area of the left wing tip shows a large number of the characteristic signs compatible with high internal pressure such as zipping of rivet lines, pulling of rivets and clean separation of skin from the remaining parts. (Fig. 21 and Fig.22).

Fig. 21. The area of separation of the left wingtip of TU-154M, PLF101 showing the classic and significant signs of explosion and an additional number of characteristic signs of explosion.

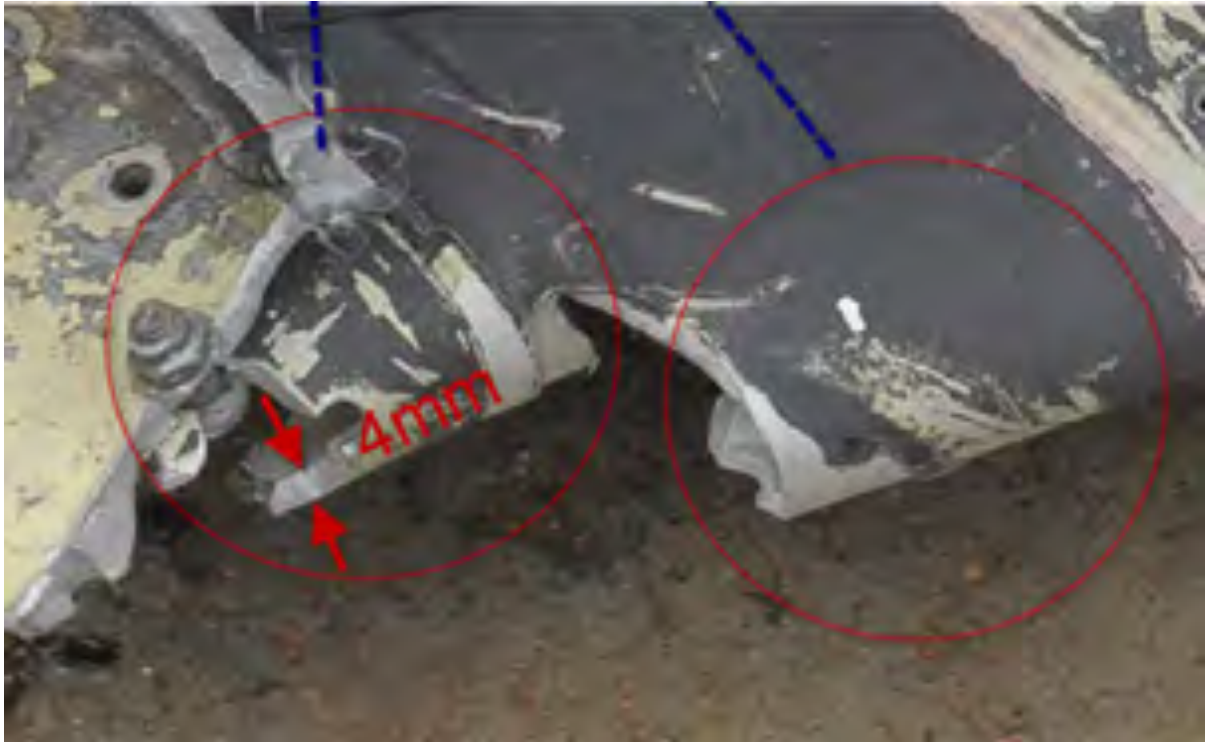
Fig. 22. A close-up of the photograph from Fig. 21 with visible post-shock curls with axis of curl in the direction of flight.

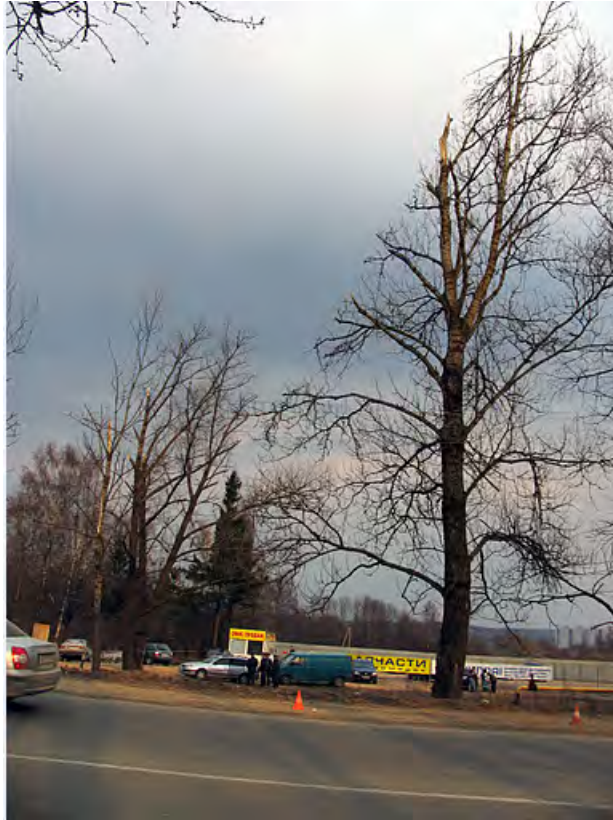
The treetop of one of the trees on the eastern side of the Kutuzov street, on the flight path of the TU-154M, was cut with a straight line with an angle of cut 120degrees from the line of horizon. (Fig. 28).

Fig. 28. A damaged tree on the East side of Kutuzov Street.

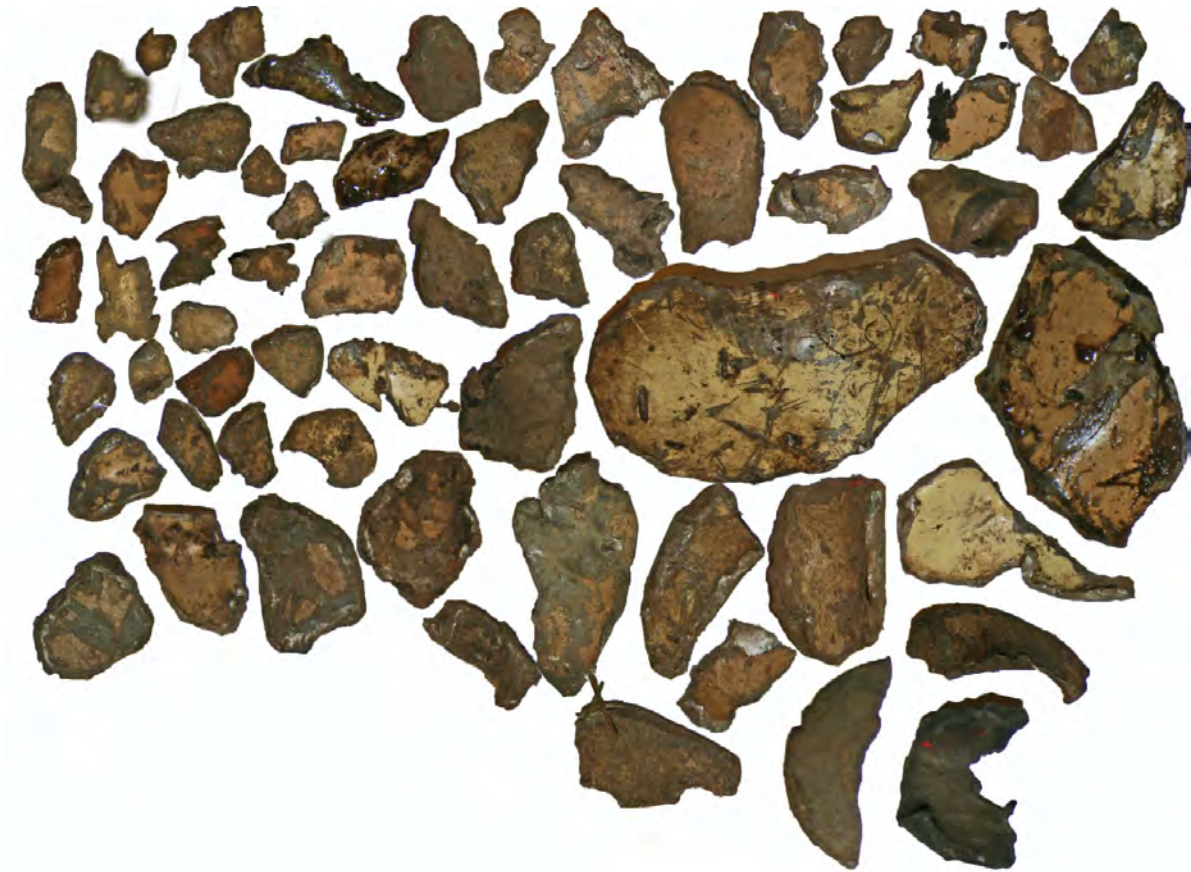
During a terrain analysis, done by Polish archeologists in Smolensk in October 2010 in sector 13 behind Kutuzov Street and before the main crash site, numerous pieces of plane were found (fig 32). Those pieces, sized from a couple to tens of square centimeters, had traces of thermal and mechanical effects (fig 33).

Fig. 33. Collected pieces of the Tu-154M taken from the ground 100m before the main crash site showing thermal traces.

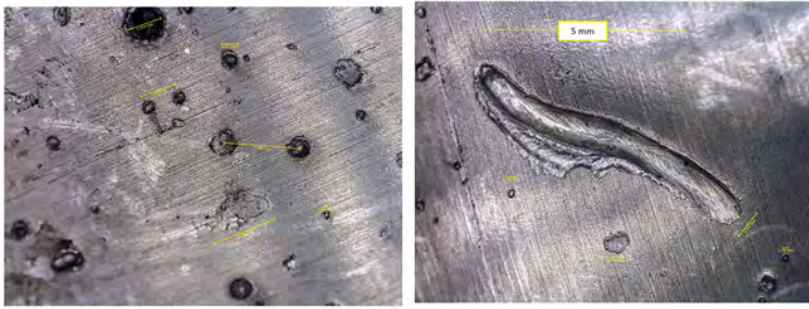
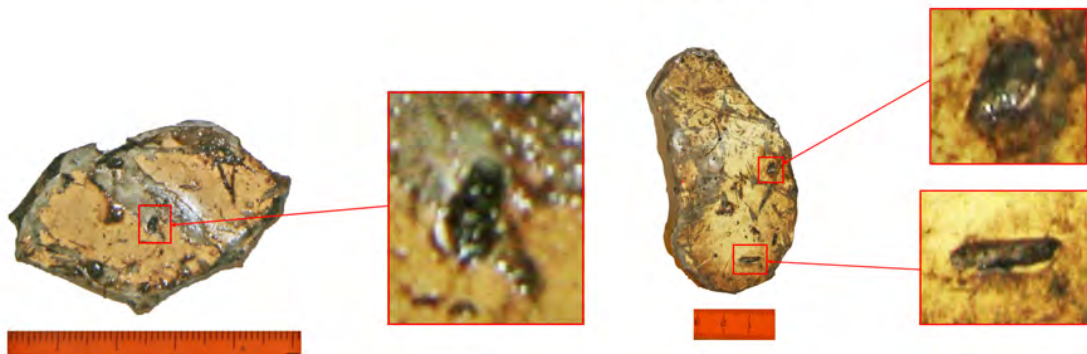
Fig. 34. Comparison of micro craters on the surface of the pieces found by archeologists and pieces created after pyrotechnical experiments.

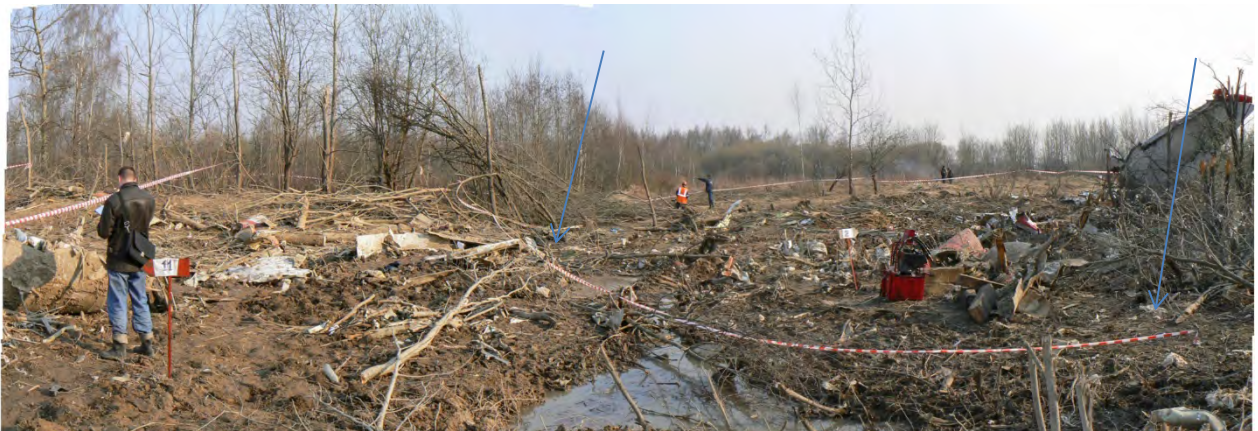
Fig. 36. A picture of the main crash site.

An explosion in the left part of the center wing caused a destruction of the majority of the outer skin, ribs and spar no.1 of the fuel box no.4. Those elements of the plane on the main crash site (Fig. 36) have clear shear marks and visible effects of the blast wave being the result of an explosion. The pictures below reconstruct the mechanism and scale of destruction of the left center wing.

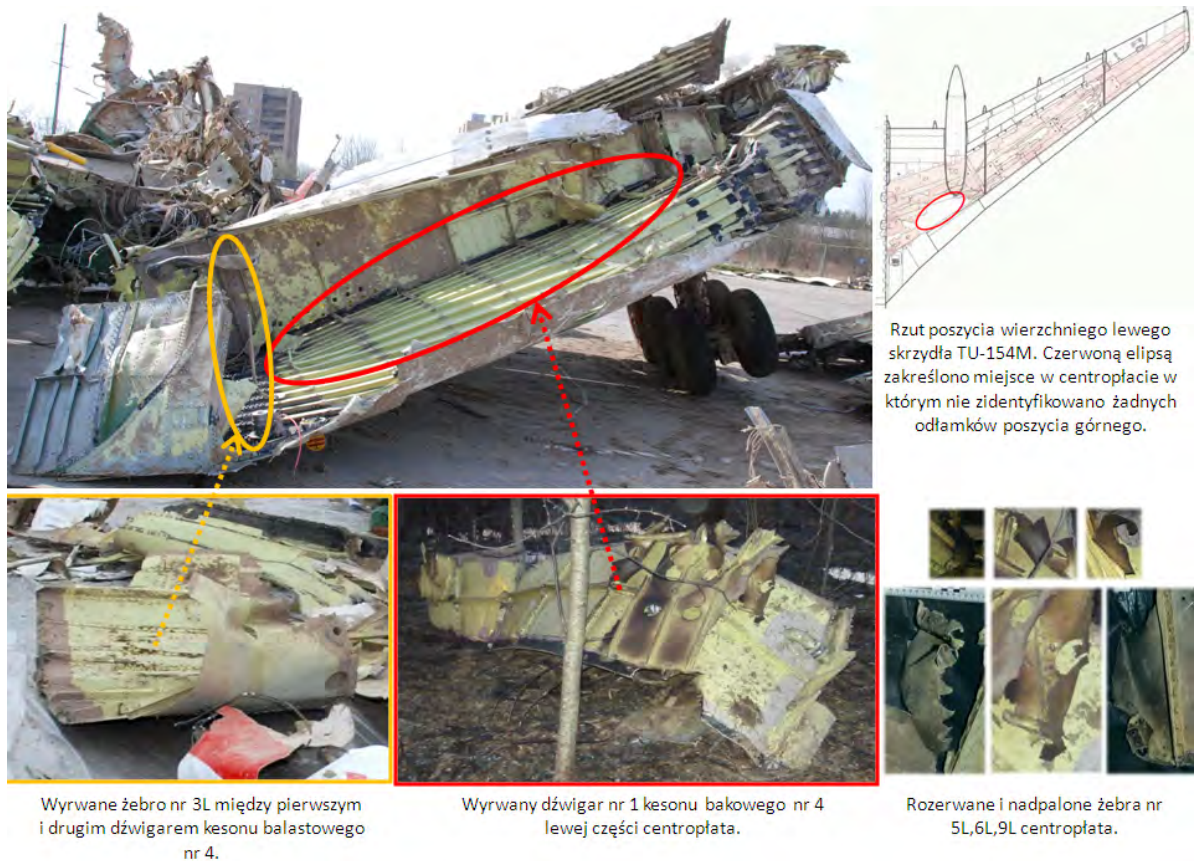
Fig. 37. Note the ripped spar no.1 of the fuel box no.4 of the left part of the center wing with clear signs of high temperature and destruction of burned ribs visible on the right side of the picture. Other parts from this area found outside the fire zones were also found with similar signs.

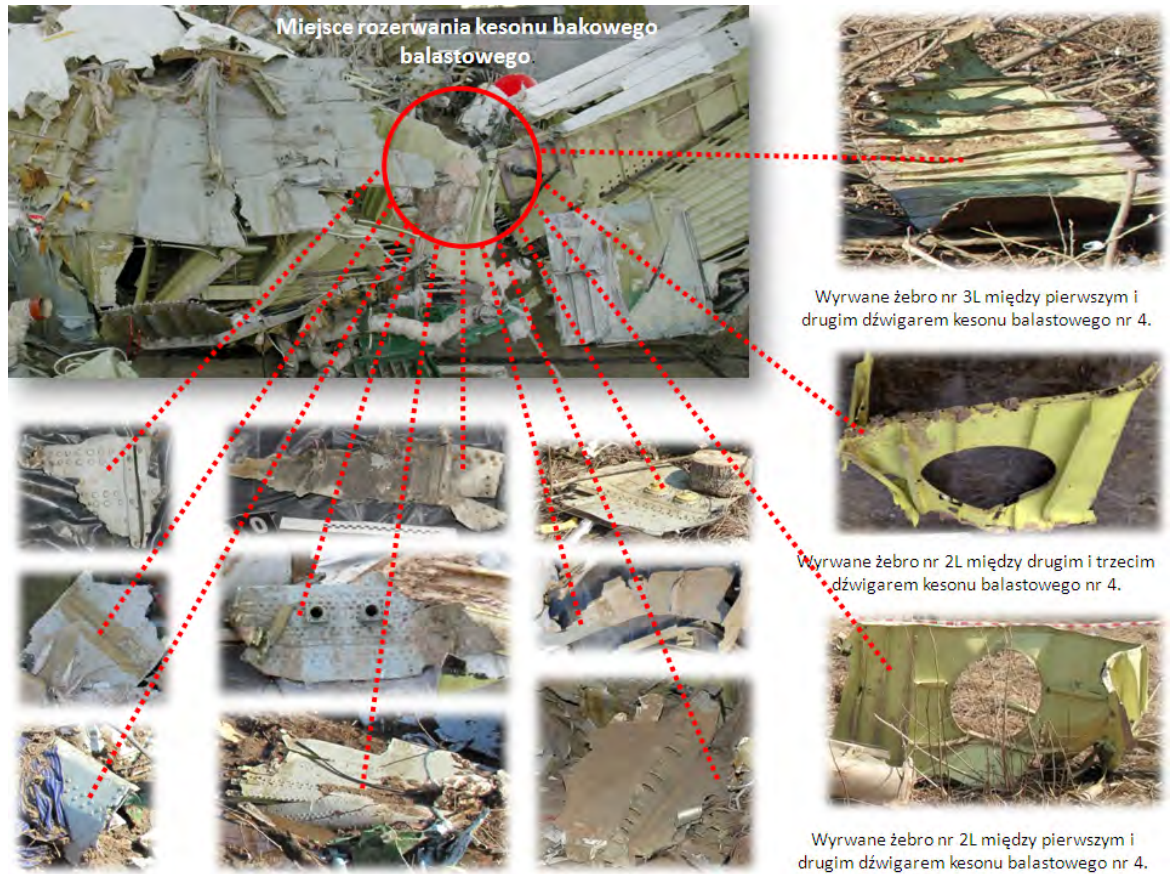
The tearing and the destruction of the fuel box could not have been a result of a hydraulic impact, caused by the impact with the ground, especially looking at the small amount of fuel and limited space. One has to consider the elements of the skin, ribs, rear spar, which were torn off likely due to high internal pressure. (Fig. 38 and fig. 40).

Fig. 38a. Place of the destruction of the ballast box and the destroyed elements.
