**COMMITTEE FOR THE RE-INVESTIGATION
OF THE SMOLENSK AIR CRASH**

TECHNICAL REPORT

**Facts regarding the crash of the TU-154M No. 101,
(Fight PLF101), that took place in Smolensk, Russia on the 10th of April 2010**

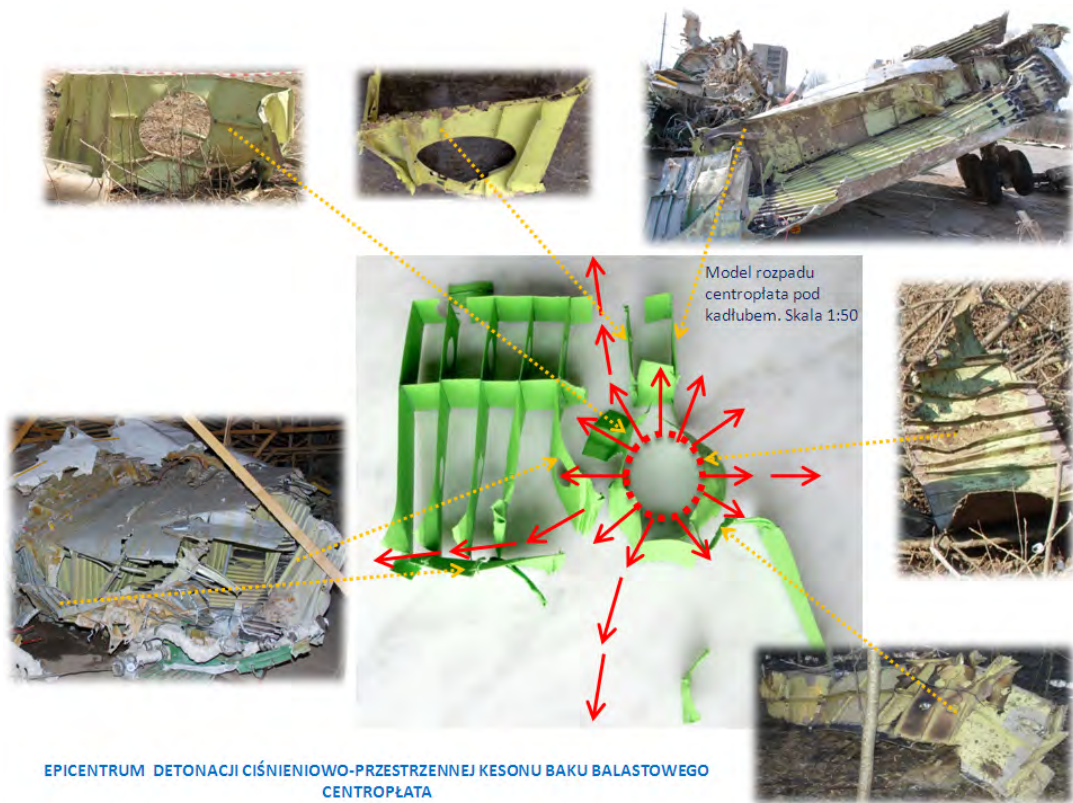
Fig. 38b. Epicenter of the wing box breakage. Study by the Committee.

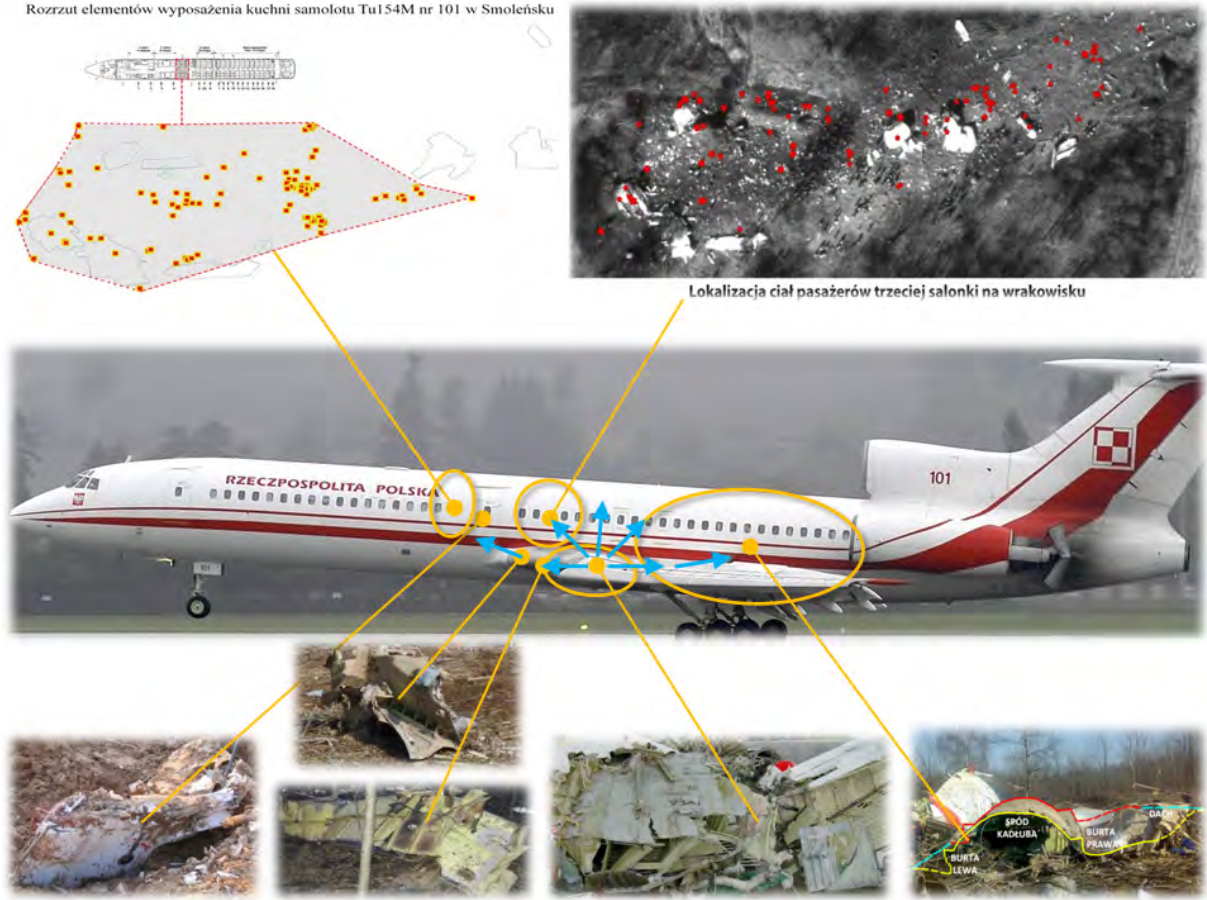
Fig. 42. The effects of the explosion of the ballast tank caisson. From the left of the top picture: galley area, left passenger door no 2. (823), third salon, fragments of the left part of the center wing, passenger compartment. The bottom left picture shows the left door rammed into the ground. The right bottom picture shows the rear fuselage after the crash with both sides opened outwards.
