Loss of Control
Sundance Helicopters, Inc.
Eurocopter AS350-B2, N37SH
Near Las Vegas, Nevada
December 7, 2011

Accident Report

NTSB/AAR-13/01
PB2013-103890

NTSB/AAR-13/01
PB2013-103890
Notation 8371A
Adopted January 29, 2013

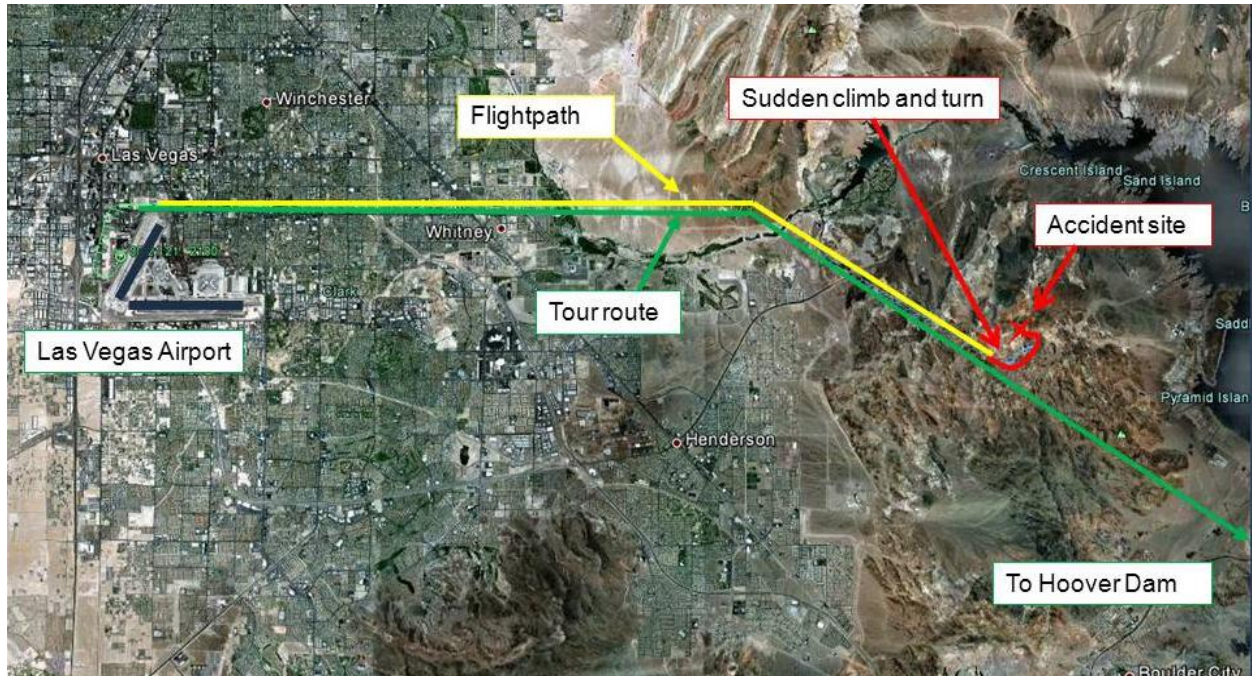
The accident occurred when the helicopter unexpectedly climbed about 600 feet, turned about 90° to the left, and then descended about 800 feet, entered a left turn, and descended at a rate of at least 2,500 feet per minute to impact. During examination of the wreckage, the main rotor fore/aft servo, one of the three hydraulic servos that provide inputs to the main rotor, was found with its flight control input rod not connected. The bolt, washer, self-locking nut, and split pin (sometimes referred to as a “cotter pin” or “cotter key”) that normally secure the input rod to the main rotor fore/aft servo were not found. The investigation revealed that the hardware was improperly secured during maintenance that had been conducted the day before the accident. The nut became loose (likely because it was degraded)¹ and, without the split pin, the nut separated from the bolt, the bolt disconnected, and the input rod separated from the linkage while the helicopter was in flight, at which point the helicopter became uncontrollable and crashed.

Figure 1. Accident flightpath (depicted in yellow) overlaid with the prescribed Twilight tour route (depicted in green).

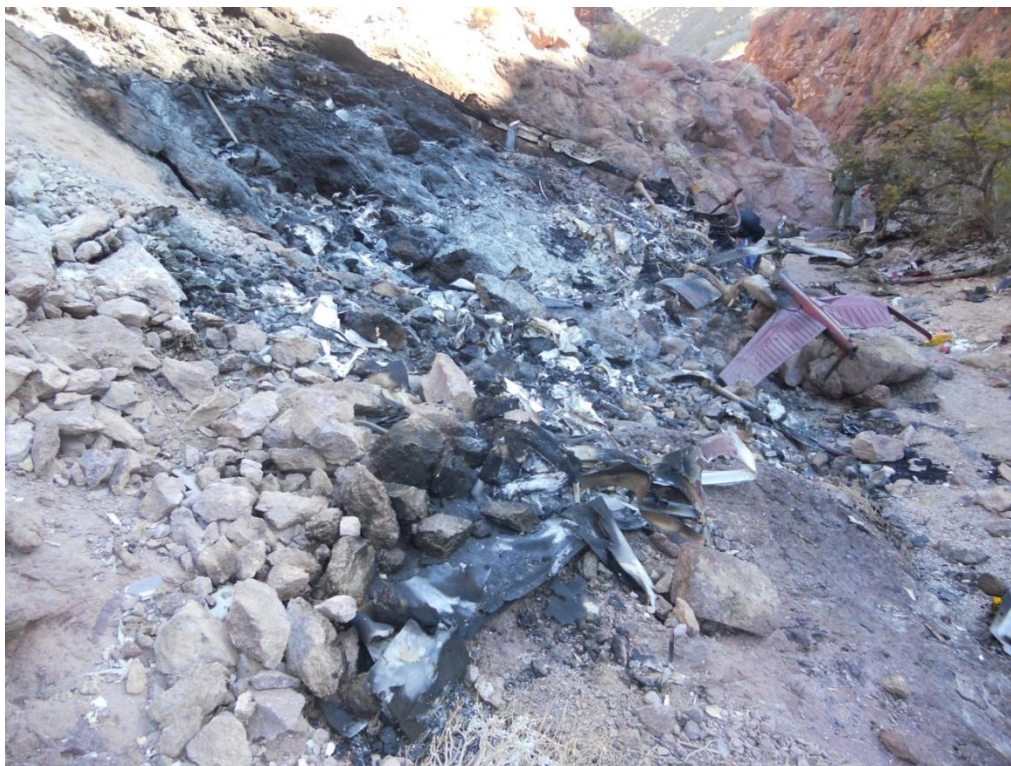
The helicopter crashed in a ravine between Henderson, Nevada, and Lake Mead.⁹ The helicopter impacted the terrain in a nose-low attitude on an approximate north-easterly heading. The cockpit area and predominate helicopter structure were found in the immediate wreckage area. A large amount of the structure forward of the horizontal stabilizer was consumed by postimpact fire. See figure 2 for a photograph of the main helicopter wreckage.

Figure 2. Photograph of the main helicopter wreckage.

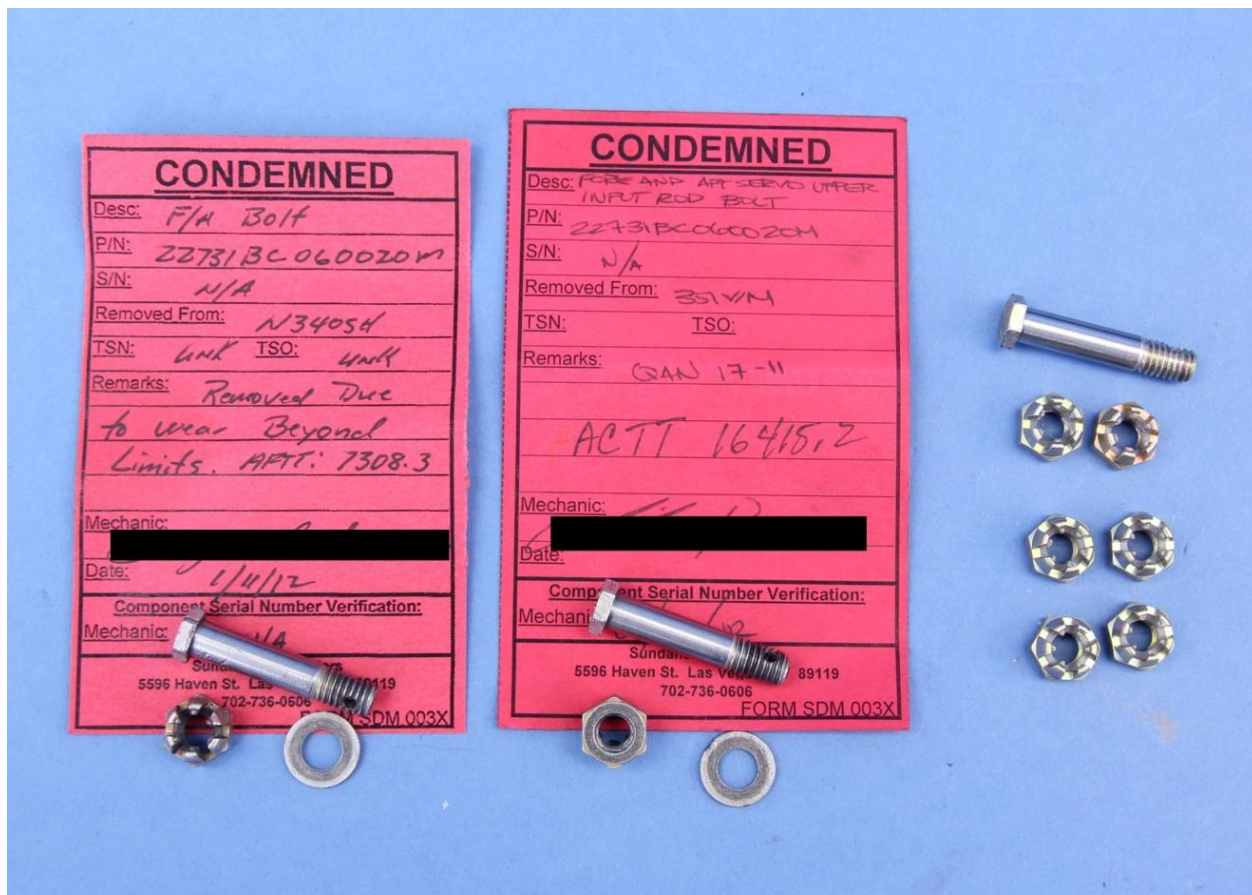
Sundance Helicopters provided the NTSB with self-locking nuts from two of the examined helicopters (N340SH and N351WM) that could be easily and fully tightened or loosened on the accompanying bolts with finger pressure. This indicates that the nuts from the two helicopters were not suitable for reuse because new nuts restrict movement by hand after two to three turns. In addition, torque measurements found that the turning resistance of the nuts on the bolts was about 1 in-lbf (inch pound force) or less in both directions. Figure 5 shows the nuts, upper input rod bolts, and washers removed from N340SH and N351WM next to a new bolt and nuts.

Figure 5. Photograph showing the nuts, upper input rod bolts, and washers removed from N340SH and N351WM next to a new bolt and nuts.

On the basis of this evidence, the NTSB concludes that at the time of the accident, Sundance Helicopters was not following Eurocopter and FAA self-locking nut reuse guidance, which led to the repeated improper reuse of degraded nuts on its helicopters.

helicopter with over 5,000 flight hours and that replacement of the hardware was to be accomplished at each 5,000 flight hours thereafter. Further, the alert notice stated that any time an input rod is disconnected from any of the servos, the nut must be replaced with a new nut.
