Aviation Investigation Report

In-Flight Fire Leading to Collision with Water

Swissair Transport Limited
McDonnell Douglas MD-11 HB-IWF
Peggy's Cove, Nova Scotia 5 nm SW
2 September 1998

Report Number A98H0003

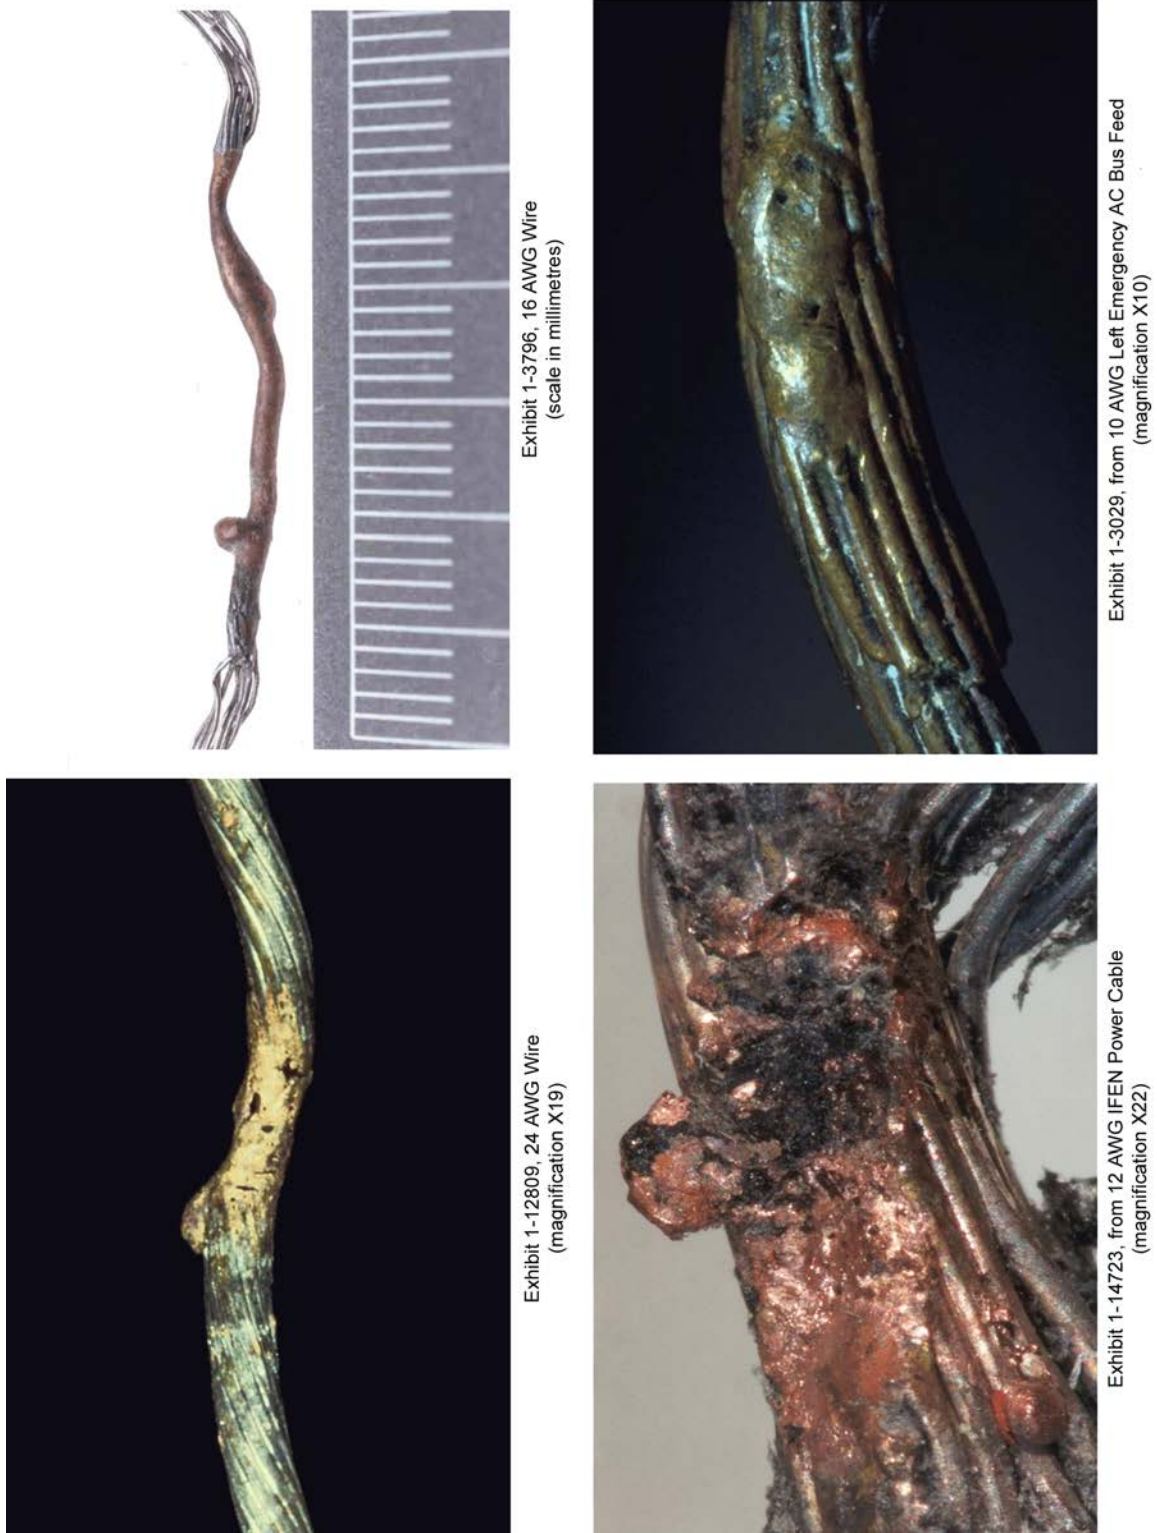
Figure 20: Wire segments with melted copper

All of the recovered wires were examined, primarily to identify any with signs of melted copper. As the fire did not reach temperatures high enough to melt copper,⁵⁰ any areas of melted copper would indicate that an electrical arcing⁵¹ event had occurred.

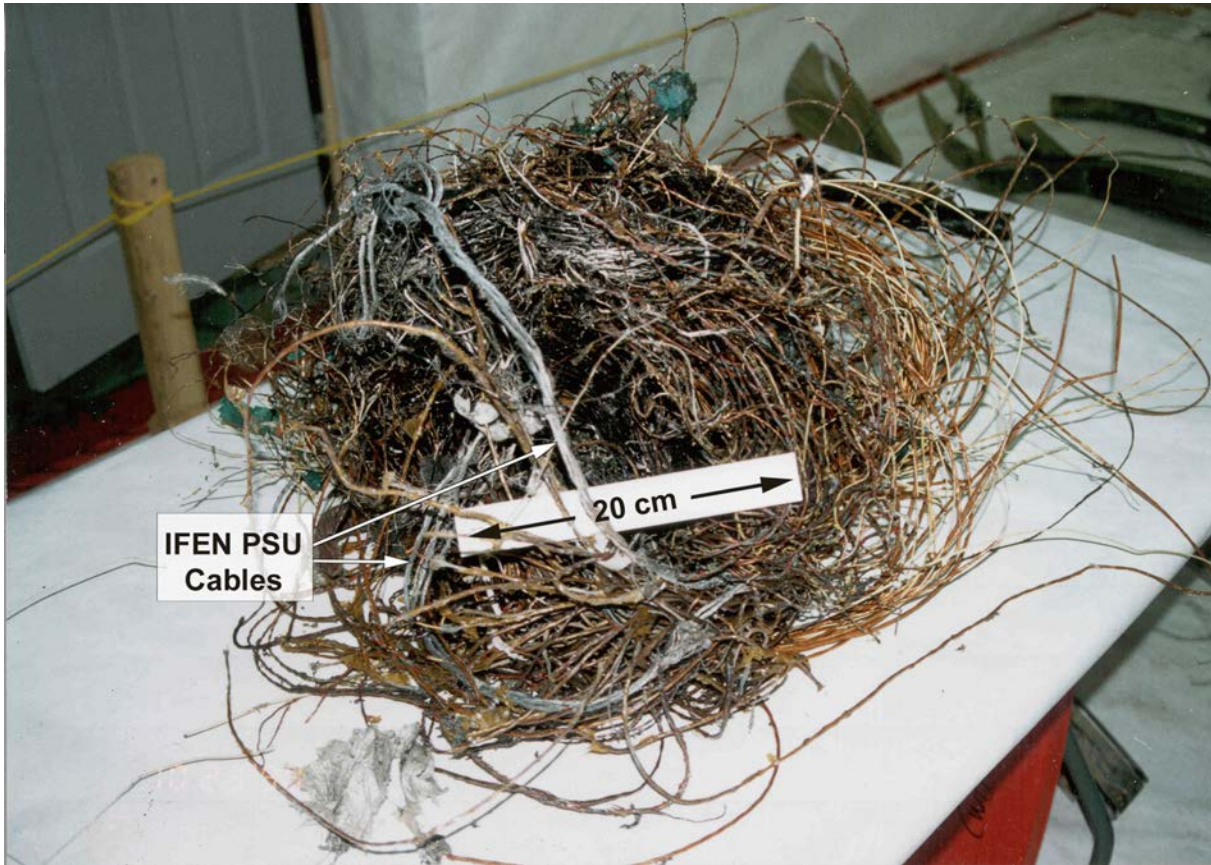
Figure 21: Exhibit 1-4372

Of the nine wire or cable segments with areas of melted copper that were recovered from Exhibit 1-4372, four were positively identified as being segments of the IFEN PSU cables (1-3790, 1-3791, 1-3792, and 1-3793) (see Figure 22). This identification was based on remnants of coloured ETFE insulation remaining attached to the wires. On each of these four segments, one end was heavily matted, or crushed together, and the opposite end was fractured and frayed. Exhibits 1-3790 and 1-3792 both had distinctive regions where the tin coating was missing from the wire strands on all three wires. Exhibits 1-3791 and 1-3793 did not have a similar region of missing tin.

Of the remaining five segments, based on adhering remnants of ETFE insulation, four (1-3794, 1-3795, 1-3788, and 1-10503) were identified as segments of the 16 AWG IFEN 28 V DC control wire used to control the PSU outputs. The total length of these four segments was 97 cm (38 inches). The fifth (1-3796) was a segment of polyimide-film-insulated, nickel-coated 16 AWG wire. This wire segment could not be associated with a specific circuit; however, because it was nickel coated, it is known that it was not from the IFEN system.

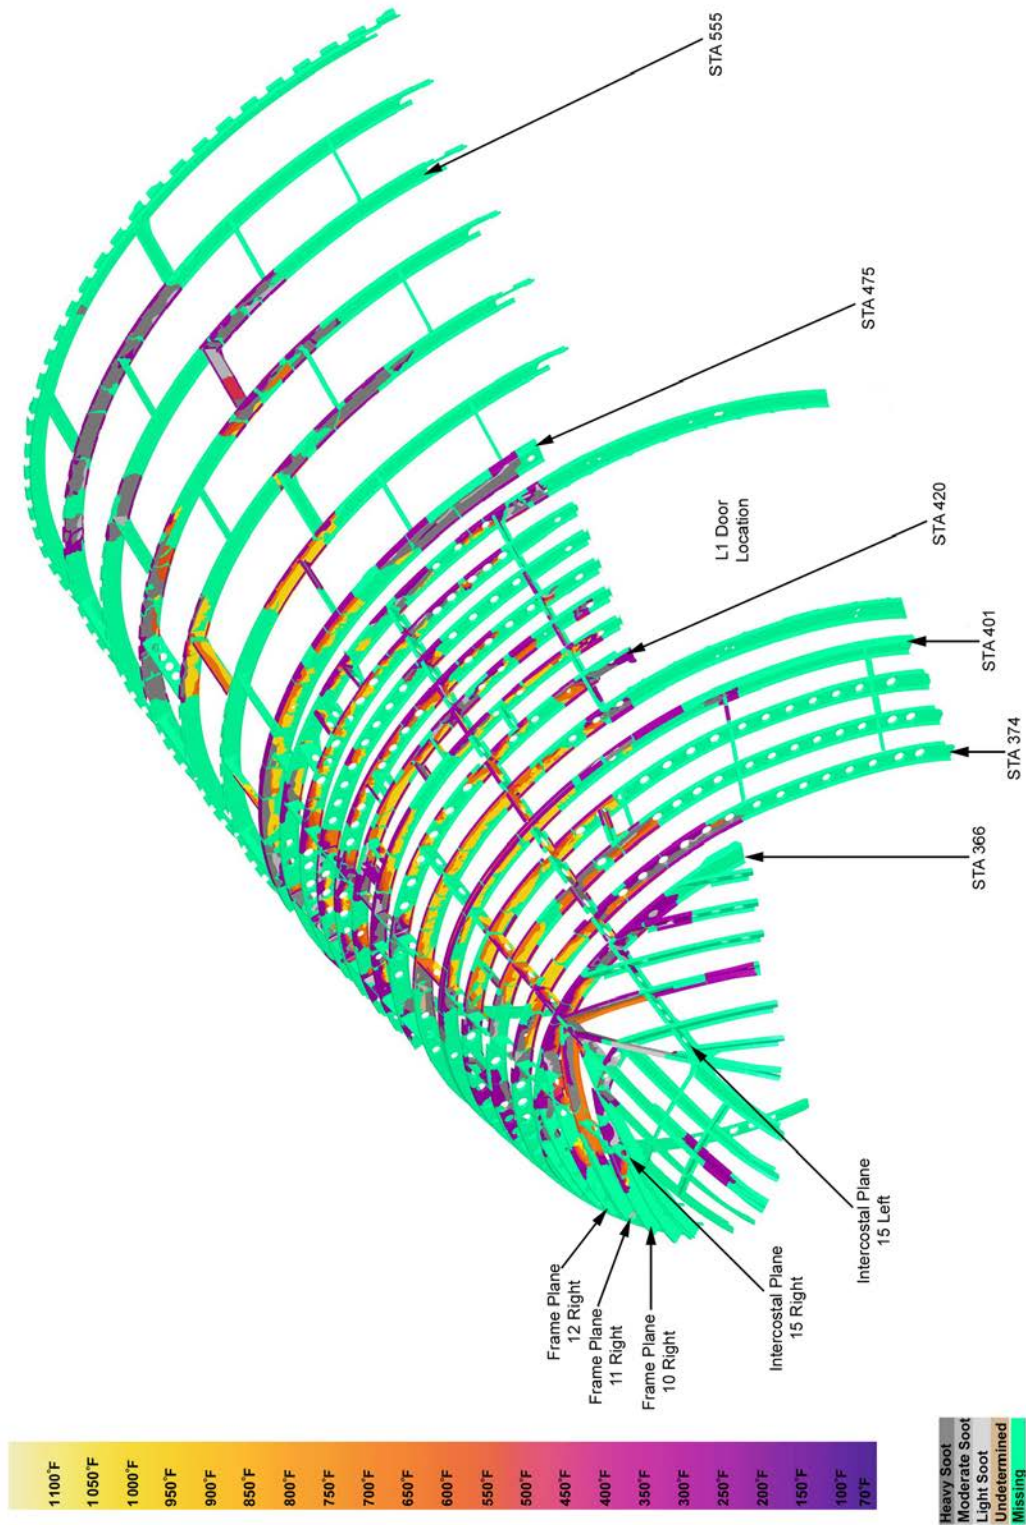
Figure 25: Heat damage – airframe structure

Damage to the riser duct assembly ranged from no heat damage to bare-metal heat damage. The vertical portion of this assembly had no heat damage. The first area of bare-metal damage to the riser duct assembly started at intercostal plane 15 right, where the lower surface had a region of bare-metal heat damage from $X = -30$ inboard to the joint at $X = -20$. This was in the vicinity of the Galley 2 vent end cap. There was bare-metal damage from approximately STA 395 to STA 442 between $X = 25$ and $X = -10$. A section of molded duct was installed in that area from STA 420 to STA 442 between $X = 5$ and $X = 25$. No portions of this molded duct were identified in the wreckage.

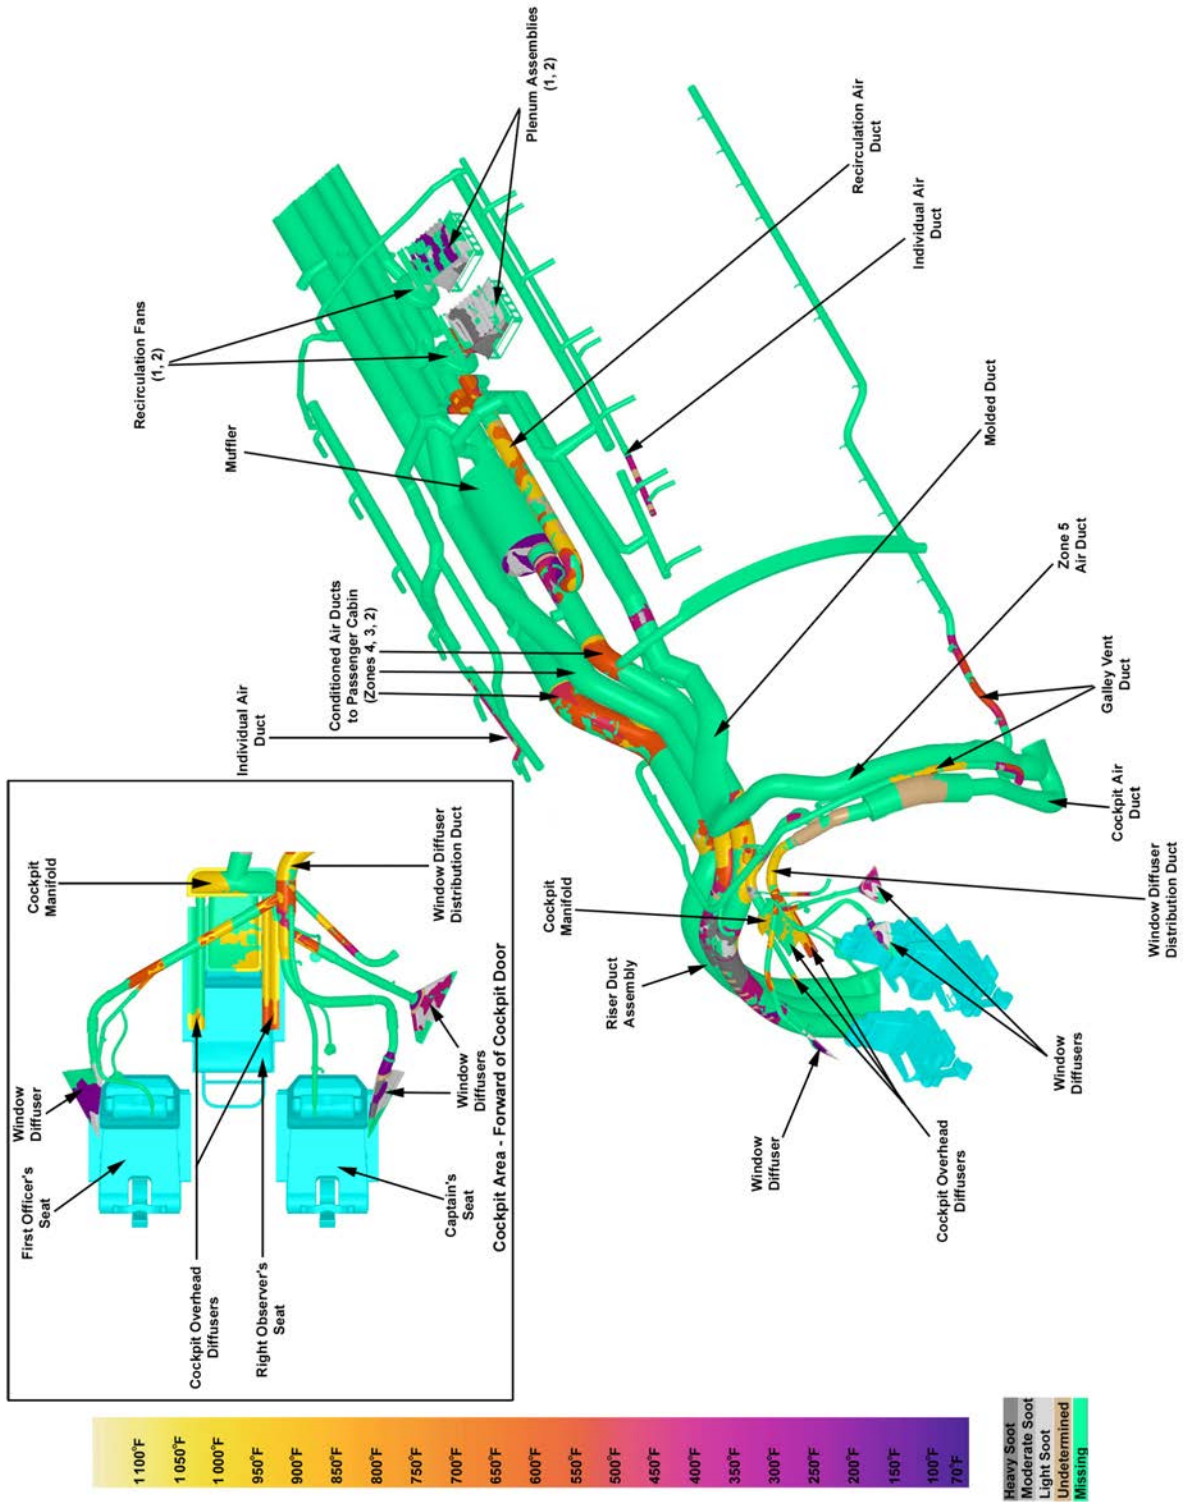
Figure 26: Heat damage – air distribution system

Between approximately STA 480 and STA 545, the main conditioned air ducts for zones 2, 3, and 4 transitioned from running near the top of the forward cabin drop-ceiling, upward to run near the crown of the aircraft. In this area there was bare-metal heat damage at places along the top of the ducts. The primer on the underside of these ducts was not damaged by heat. The recovered portions of two individual air ducts from approximately STA 555 to STA 595 at $X = 70$ and $X = -70$ had areas of light to moderate soot accumulation.

Forward passenger cabin individual air was supplied by a fan and plenum assembly identical to a recirculation air fan and plenum assembly. The fan was located at STA 990 at $X = -24$. The plenum assembly was between $X = -40$ and $X = -65$. The recovered portions of the plenum had no heat damage or soot accumulation. The individual air ducts were uninsulated and ran forward from STA 990 to a "Y" (split) at STA 750 at $Z = 91$, $X = -21$. One branch of the "Y" ran across the crown to the left side of the cabin at $X = 76$, and the other ran to the right side at $X = -76$. The recovered portions of these ducts had moderate to heavy soot accumulations on the exterior, with no heat damage. The aftermost section of individual air duct that was identified was from STA 934 to STA 955 at $X = -22$ and had light soot accumulation on the exterior.

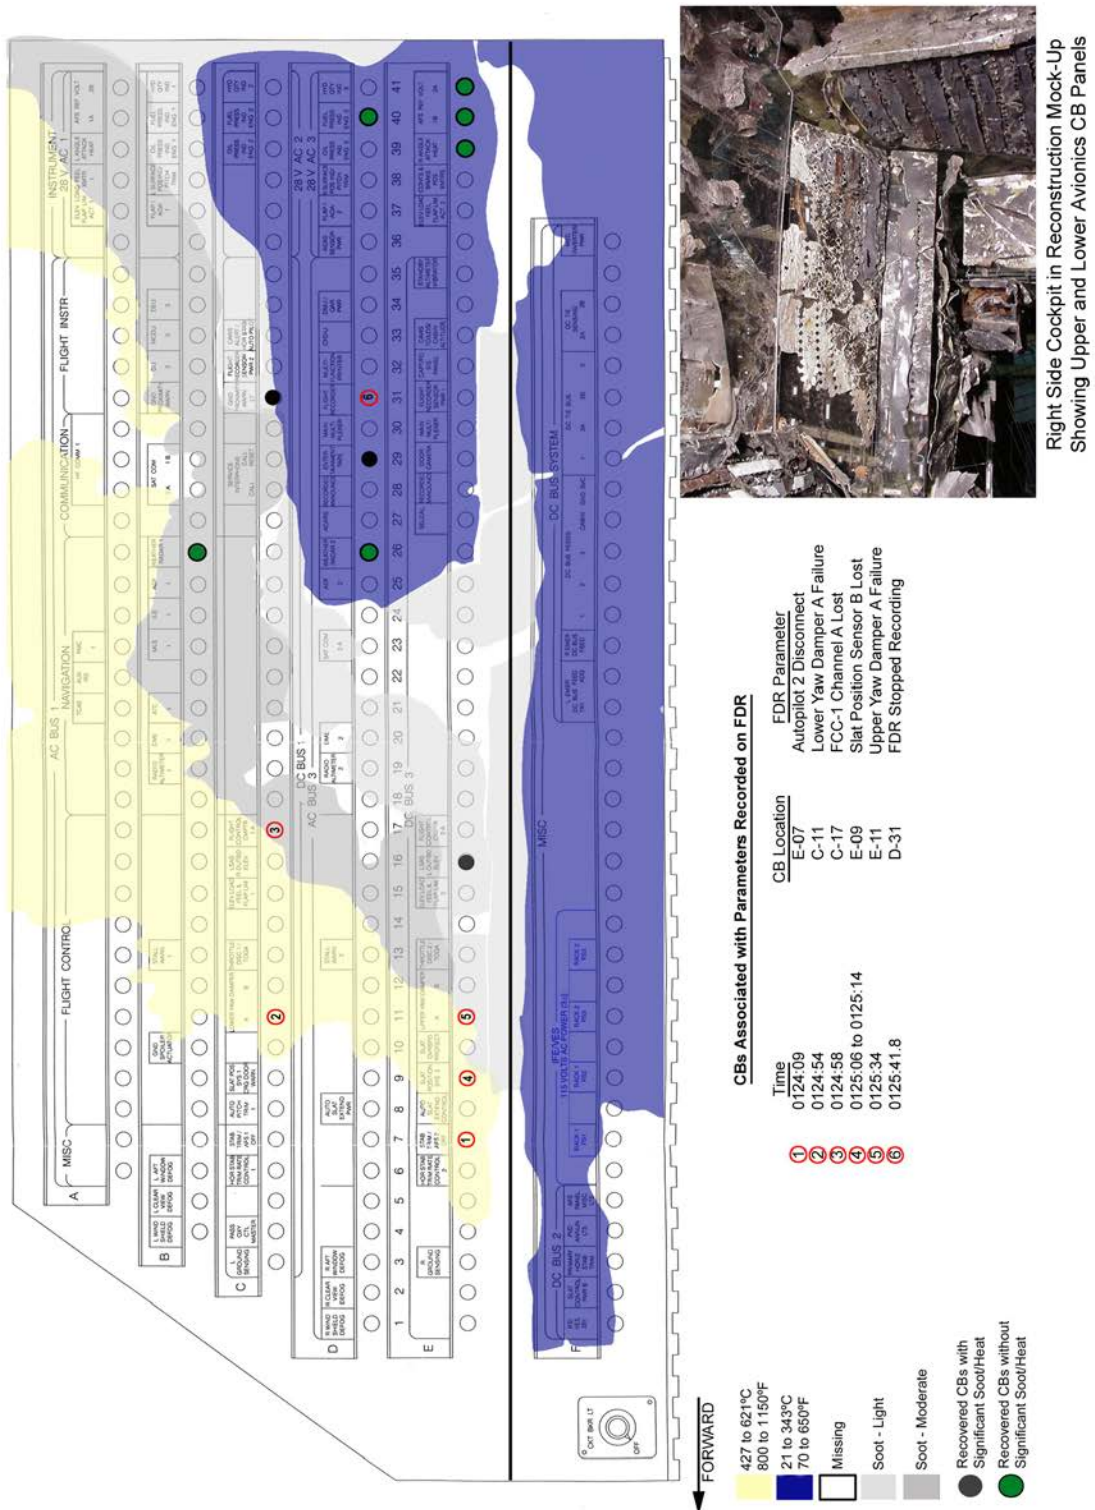
Figure 28: Heat damage – upper and lower avionics CB panels

side, particularly on those pieces near the forward end of the panel where the front side of the panel showed considerably more heat damage than the back side. Individual CBs showed soot on the white indicator ring; soot could only have been deposited if the CB had tripped and subsequently been exposed to combustion by-products. Details concerning the CBs on the avionics CB panel and wiring in the vicinity are included in separate sections of this report.

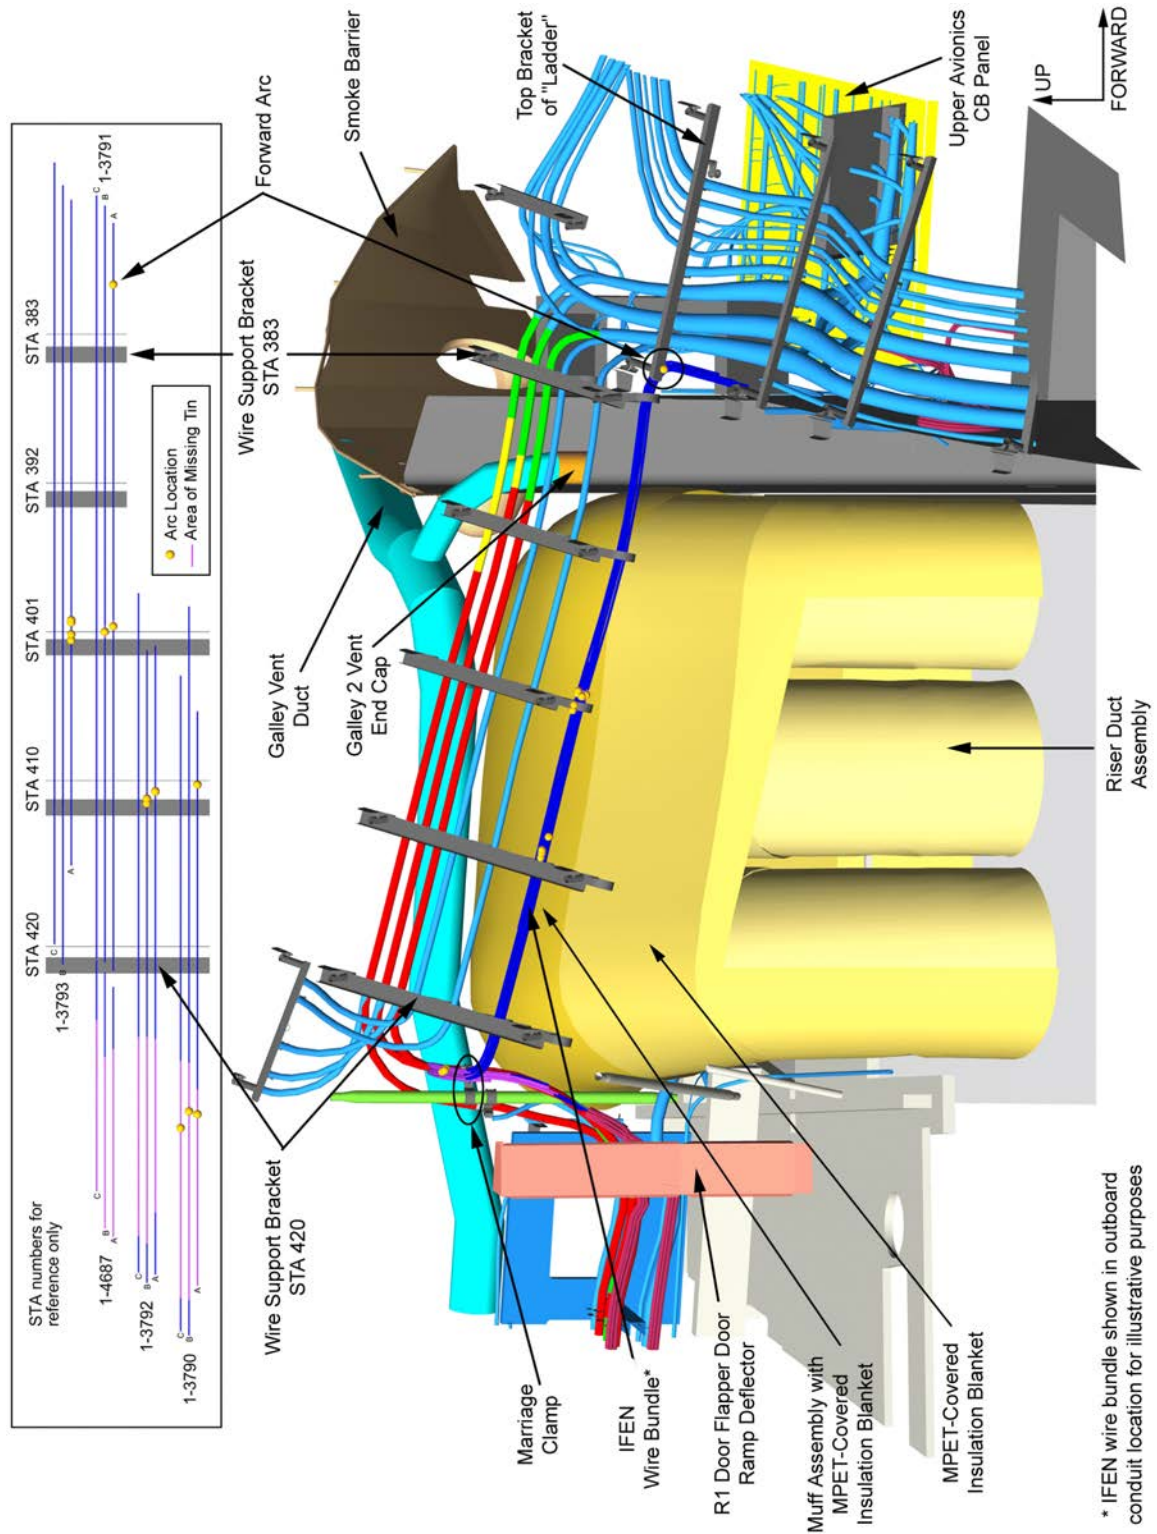
Figure 30: Position of recovered IFEN wires – outboard conduit

As indicated above, based on the layout of the cables and wires, it is possible to assess the direction of fire propagation based on the sequence of the arcing events. The aft arcs on exhibits 1-3790 and 1-3791 would most likely have tripped their associated CBs; therefore, the forward arcs must have occurred first, and not tripped their associated CBs. This strongly suggests that the fire was moving forward to aft.

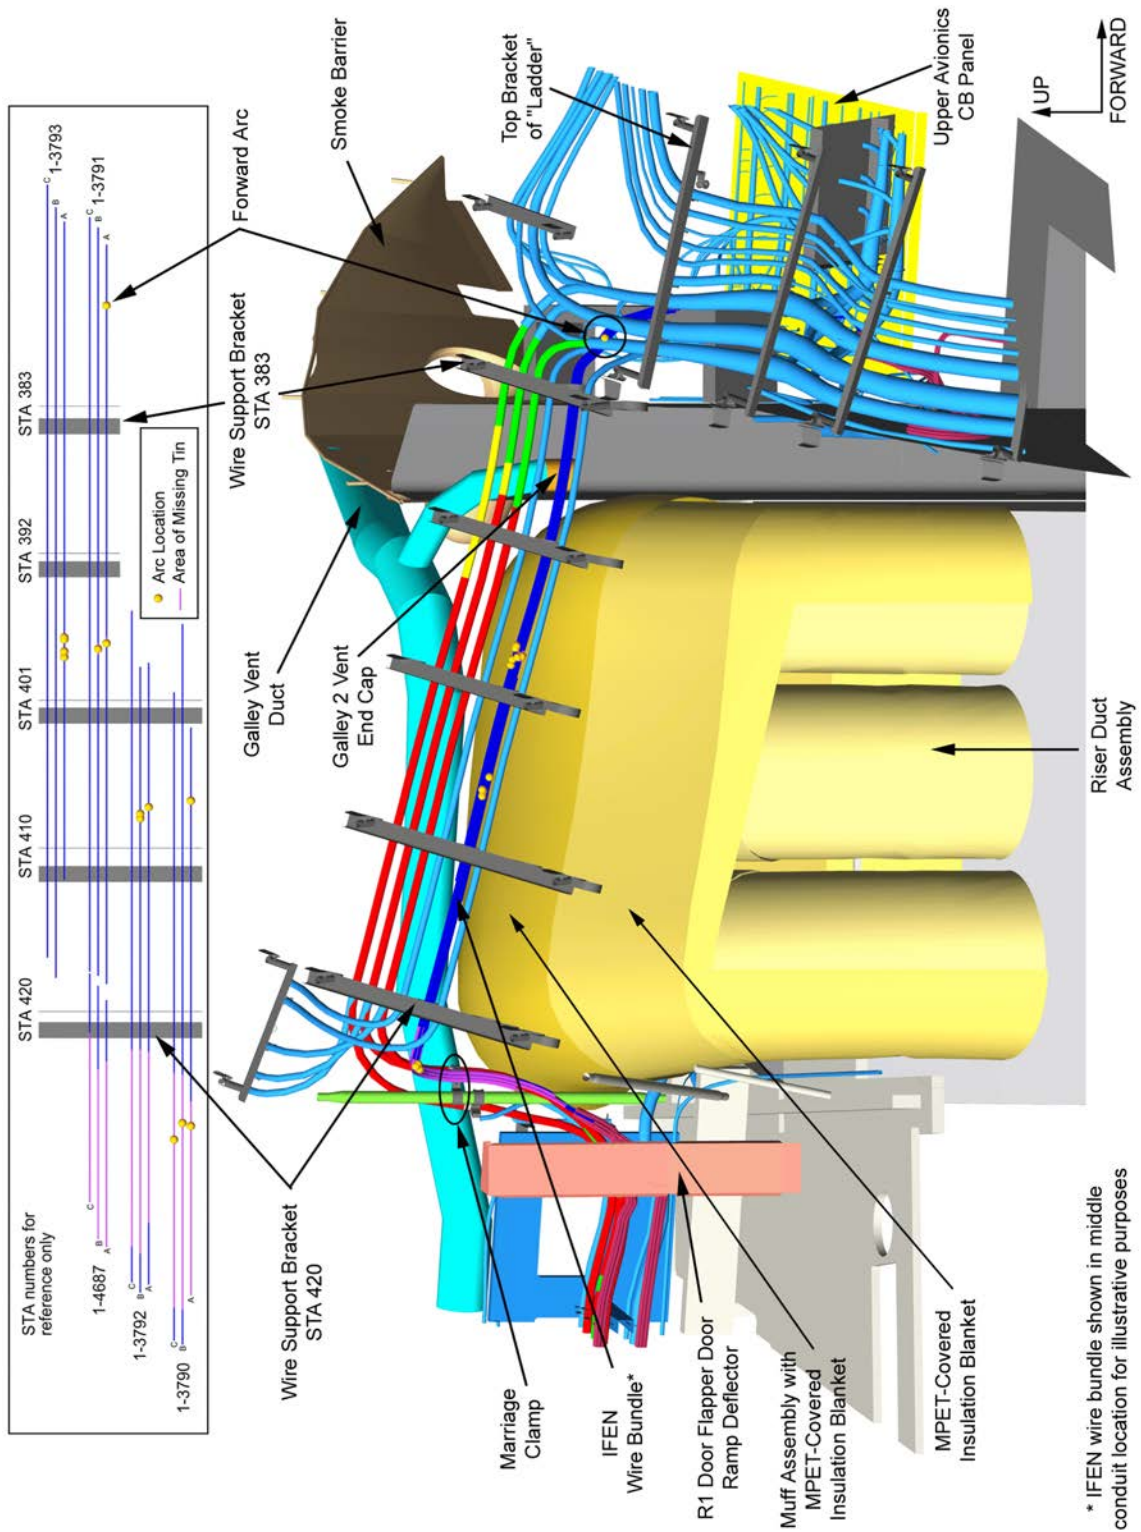
Figure 31: Position of recovered IFEN wires – middle conduit

The region of missing tin represented an area of higher heat. If this had been an earlier event, it is strongly suspected that all three cables would exhibit similar arcing events in the vicinity of 1-3790 outside the aft end of the conduit. With the cables and control wire laid out as described above, all of the regions of melted copper could be attributed to arcing events between phases on the same cable, between the cables and the control wire except for the arc event that took place at the forward end of 1-3791, or both. There was no matching arc damage on cable 1-3793 in this area. However, the continuation of exhibits 1-3790/1-3792 from approximately STA 401, along with the 16 AWG control wire forward, were not identified. Therefore, no determination could be made with respect to exactly what the single wire from 1-3791 had come in contact with at the forward end.
