INTERSTATE AVIATION COMMITTEE
AIR ACCIDENT INVESTIGATION COMMISSION

FINAL REPORT

Type of occurrence	Accident
Type of aircraft	Airplane, Boeing 737-500 (53A)
Registration	VQ-BBN (Bermuda)
Registered Charterer (according to the registration certificate)	AWAS (BERMUDA) LIMITED, Clarendon House, 2 Church Street, Hamilton HM 11, Bermuda
Operator	Tatarstan Airlines, JSC, Russia
Aviation Administration	Tatar ITO, FATA
Place of occurrence	Russian Federation, Kazan International Airdrome, coordinates: N 55° 36,5291' E 49°16,6111'
Date and Time	November 17, 2013, 15:24 UTC, 19:24 local time, night time

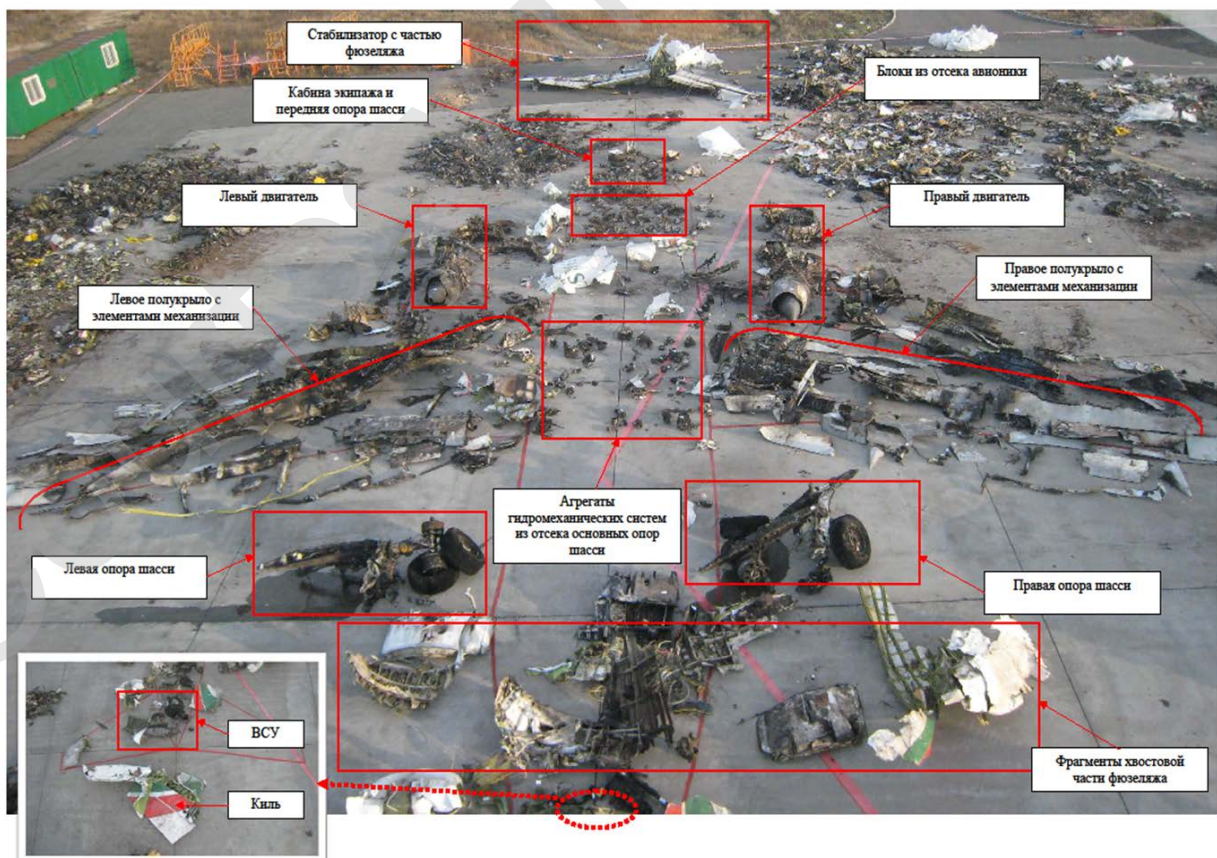
Figure 1 The layout of the remained fragments of the aircraft

The aircraft airframe was broken into a great number of fragmented parts. The biggest aircraft fragments, found at the accident site, are:

On impacting the ground, the aircraft was destroyed and postcrash fire occurred. The seat of fire was located in the area, where the fragments of the cockpit, the center wing section (with the landing gear wheel wells), and also of the left and right wings were found. On the other fuselage fragments, e.g. on the section from frame 360 to frame 500 (left side), horizontal stabilizer and vertical stabilizer, there were no signs of fire found.

Judging by the condition of the landing gear retraction/extension hydraulic actuators, one can conclude that all the landing gears were in retracted position.

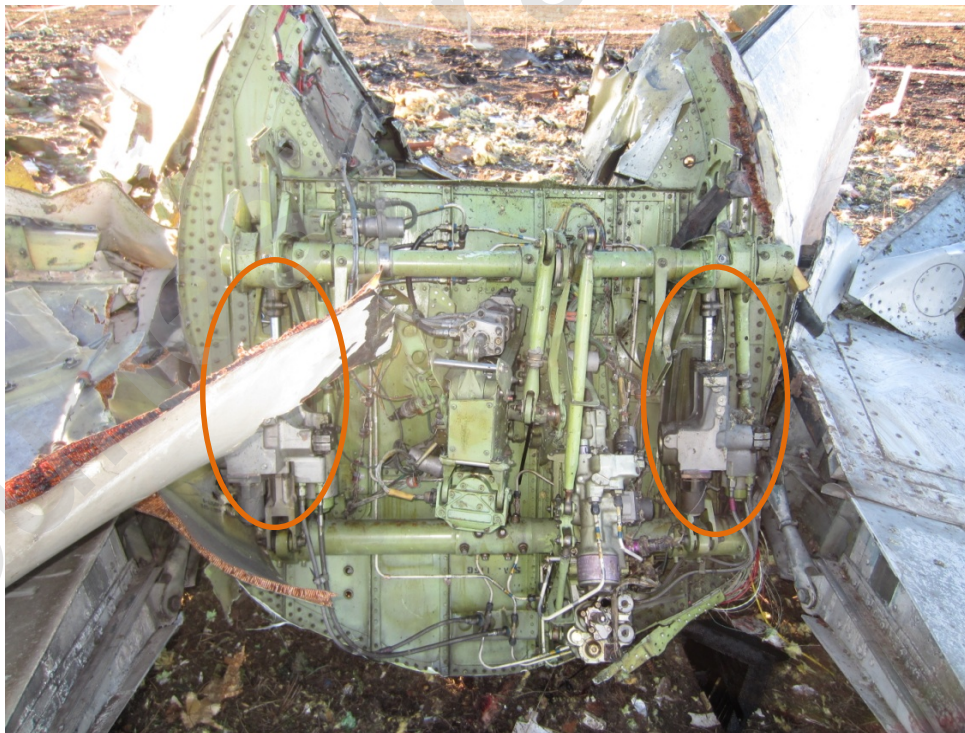
Figure 2 Appearance of frame 1156 on the air accident site (the elevators actuators are circled orange)

The elevators control moving elements, located on frame 1156, have visible deformation, caused by crash of the fuselage structure when the aircraft impacted the ground. There were no disconnections of the control system components and hydraulic lines, located on frame 1156.

- the right elevator PCU housing was not destroyed. The PCU input arm was at the bottom seat. There were no foreign objects found in the clearance, there were signs of dirt and peening;
- the bolts of the left elevator PCU housing head were destroyed, which led to separation of the head from the housing. The PCU input arm was at the bottom seat. There were no foreign objects found in the clearance, there were signs of dirt and peening.

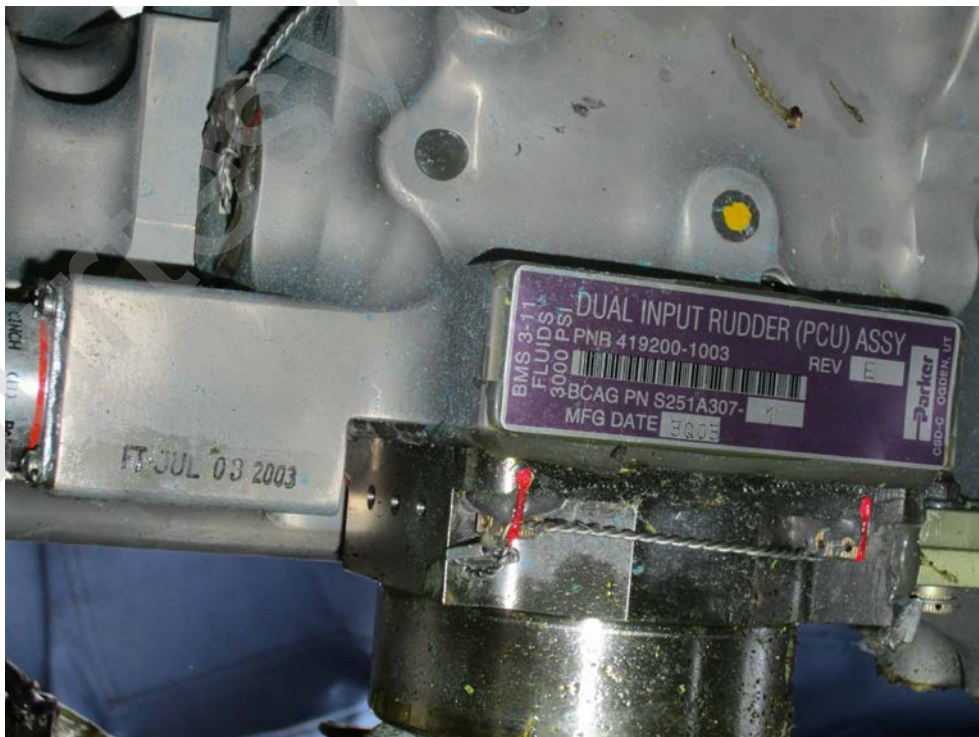
Figure 3 Main rudder PCU

The inspection of the main rudder PCU was performed (Figure 3). The rudder PCU had been torn off from its normal position as a result of the fin destruction. It was established that within the framework of the program of rudder control system modification, in accordance with the US FAA Airworthiness Directive No. AD 2002-20-07R1, the aircraft had been equipped with a new main rudder PCU.

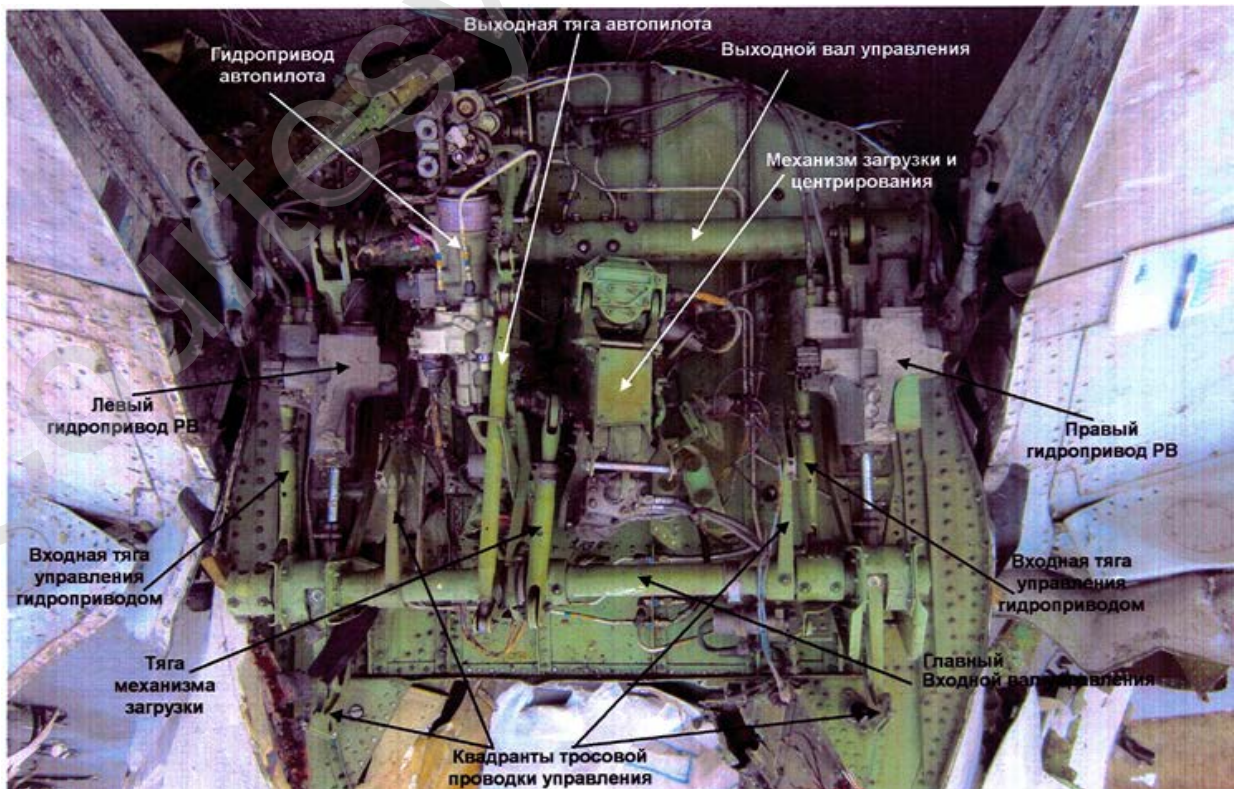
Figure 6b View of the elevator control system components on frame 1156 after the air accident

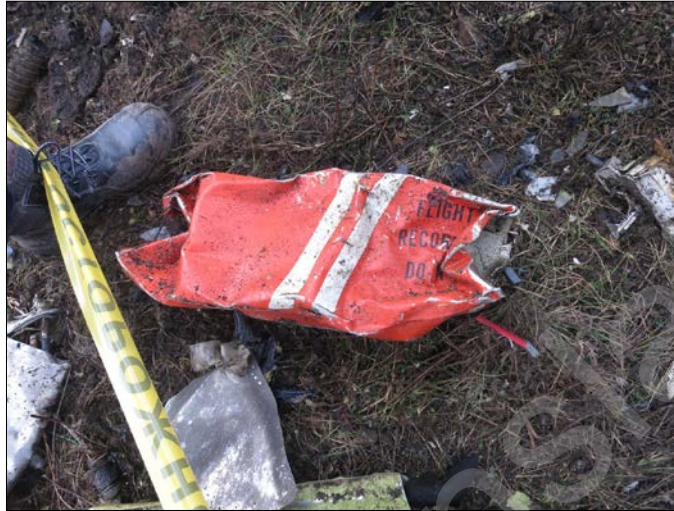
The aircraft was equipped with an FDR manufactured by L3 (Fairchild), model – F1000, p/n S800-2000-00, s/n 02109. It was found at the accident site with severe damage (Figure 10).

Figure 10 FDR at the accident site

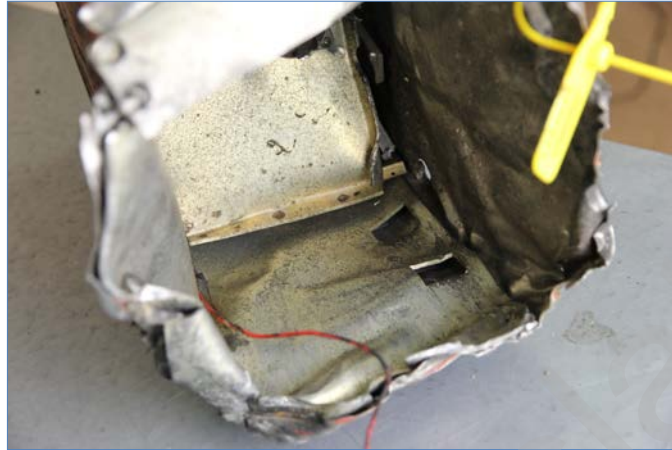
The aircraft was equipped with an A100S CVR manufactured by L3 (Loral/Fairchild). The CVR housing was recovered from the accident site with severe external damage. The protected memory unit was not present inside (Figure 13).

Figure 13 CVR housing without the memory unit

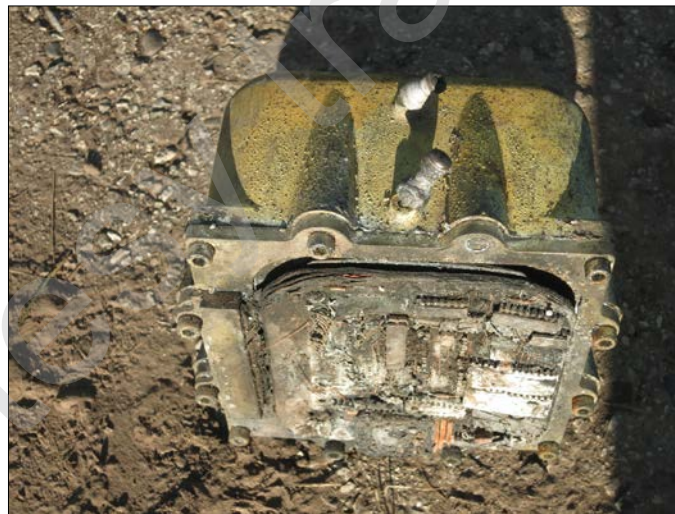
The protected memory unit was found at the accident site later (Figure 14) and provided to the IAC on November 20.

Figure 14 CVR memory unit at the accident site

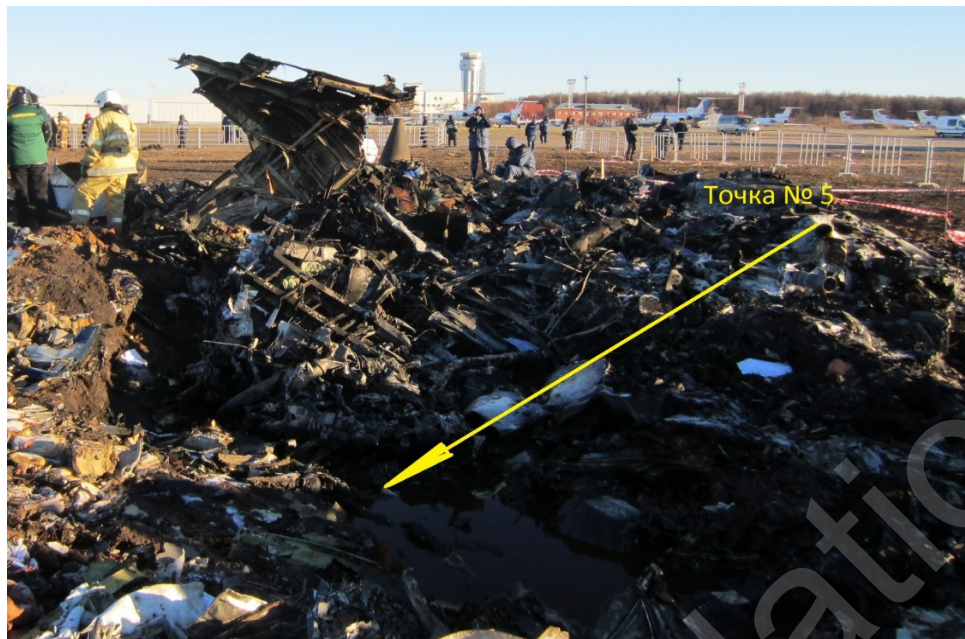
Figure 19 Impact crater

The presence of typical small fragments in the wreckage spread area proves that the ground collision occurred with a large speed (significant energy) and this the most probably caused the fuel tank rupture at the time of the impact, the fuel fire when the released fuel dropped on hot engine parts, and the ground fire.

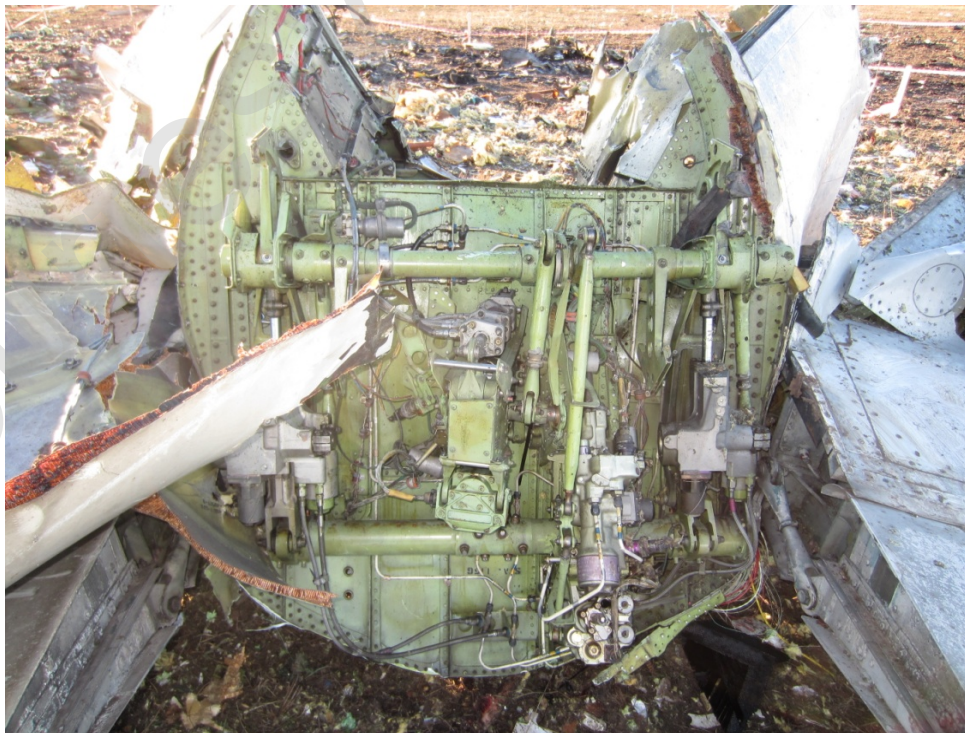
After the impact the fuselage was destroyed with the tail cone detached (Figure 20), the latter being found 20 m ahead of the impact point in the direction where the aircraft was heading (point 8, Figure 18).

Figure 20 Tail cone fragment

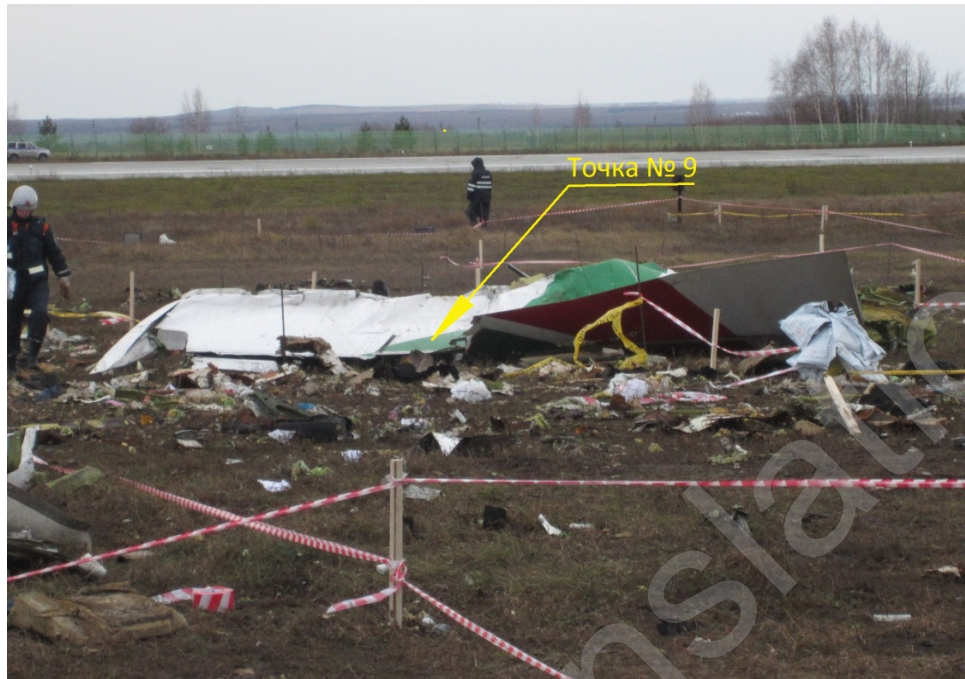
Forty meters ahead of the tail cone fragment in the flight direction (point 9, Figure 18) a rudder fragment was found (Figure 21).

Figure 21 Rudder fragment

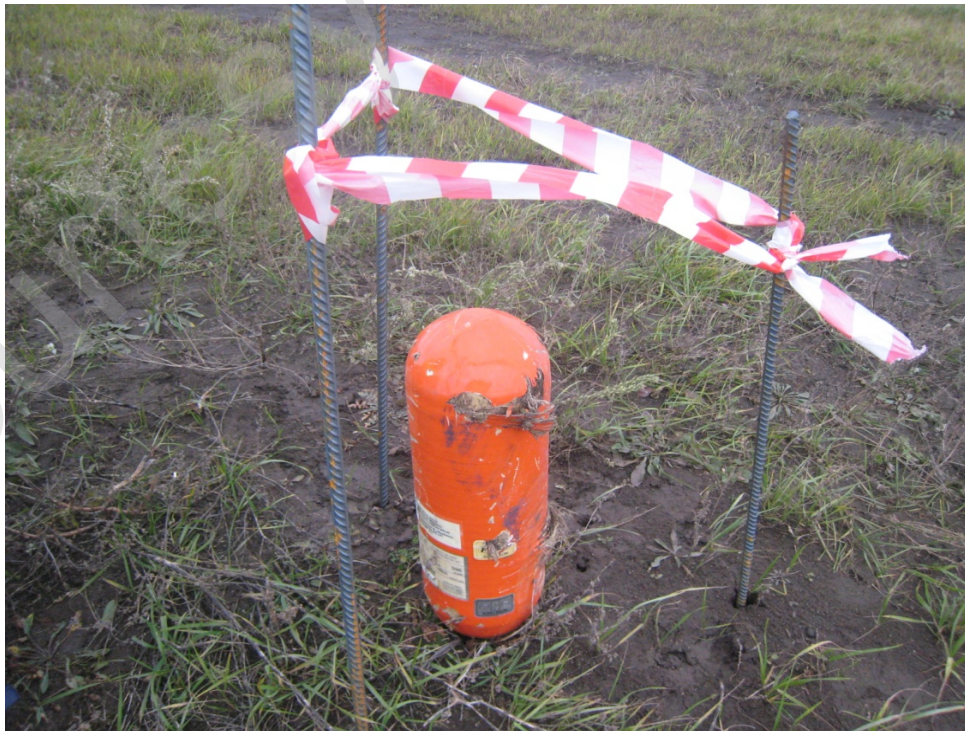
At distance of 120 m from the first impact point and 25 m from the right edge of RWY 29 (runway in use) (point 11, Figure 18) a red fire extinguisher bottle was found (Figure 22). This fragment was the closest one to the runway.

Figure 22 Fire extinguisher bottle

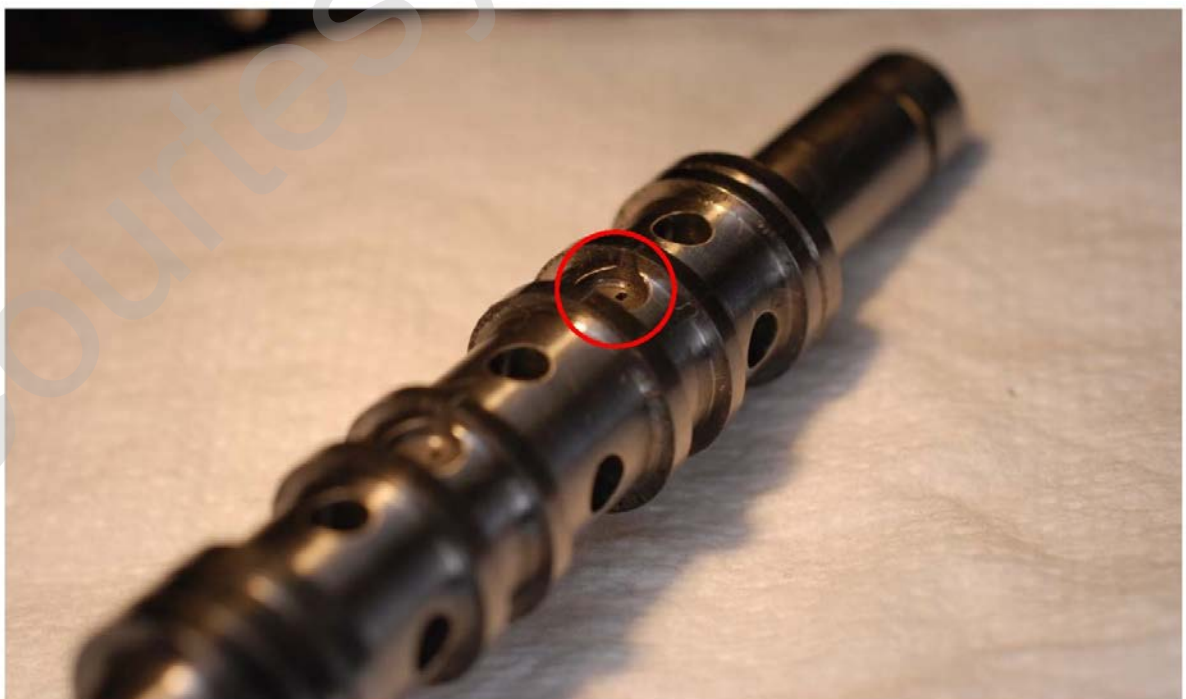
Figure 69 RH control valve secondary slide land edge deformation
