# **Aviation Occurrence Report**

**TransAsia Airways Flight GE235**

**ATR72-212A**

**Loss of Control and Crashed into Keelung River**

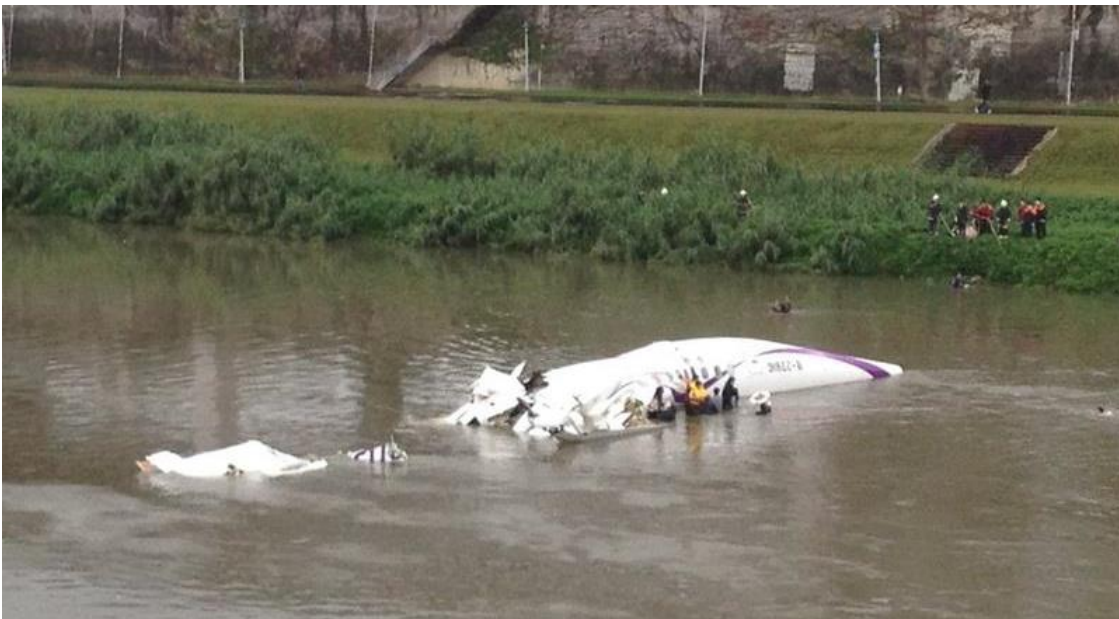
Figure 1.1-1 GE235 main wreckage

More than half of the main wreckage was submerged in the middle of the river (see Figure 1.1-1). As the aircraft flew over an overpass before impacting the water, its left wing collided with a taxi with two occupants. The taxi driver sustained serious injuries and the passenger sustained minor injuries.

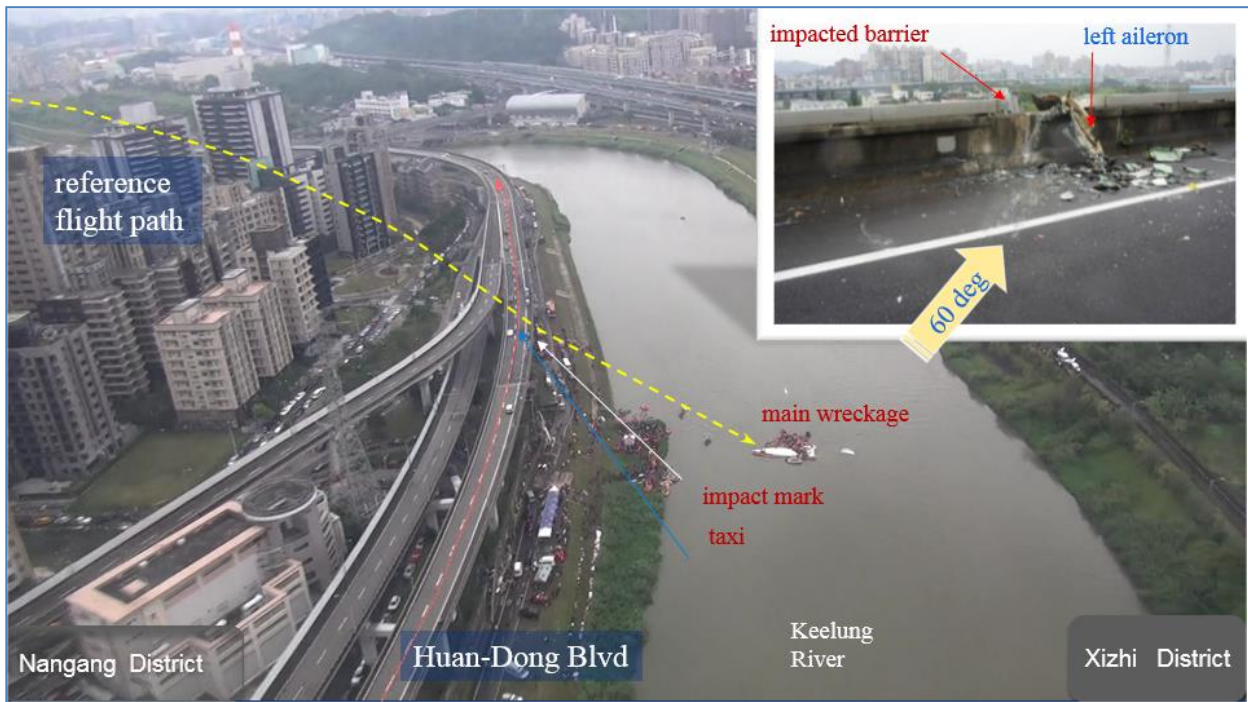
Figure 1.12-5 Aerial Photo of the GE235 crash site

Video footage and aircraft impact marks indicated that the aircraft had collided with a taxi, light pole and guard railing or barrier on the Huan-Dong overpass before impacting the Keelung River. Figure 1.12-5 presents an aerial photograph of the accident site. Keelung River is to the north side of the overpass. The depth of the river in this location is between one to two meters.

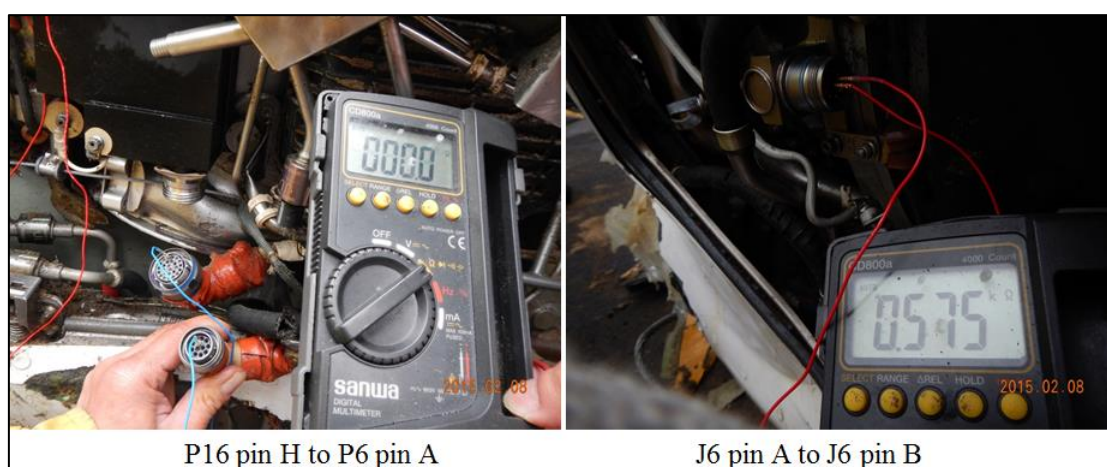
Figure 1.16-2 Continuity check of AFU No. 2 electrical circuit

Point-A	Point-B	Expected	Result
J6 pin A	J6 pin B	553-589 ohms	575 ohms
P16 pin H	P6 pin A	0-0.5 ohms	0 ohm
P16 pin J	P6 pin B	0-0.5 ohms	0 ohm
Insulation resistance (with reference to ground) of torque sensor No. 1 > 2 Mohms

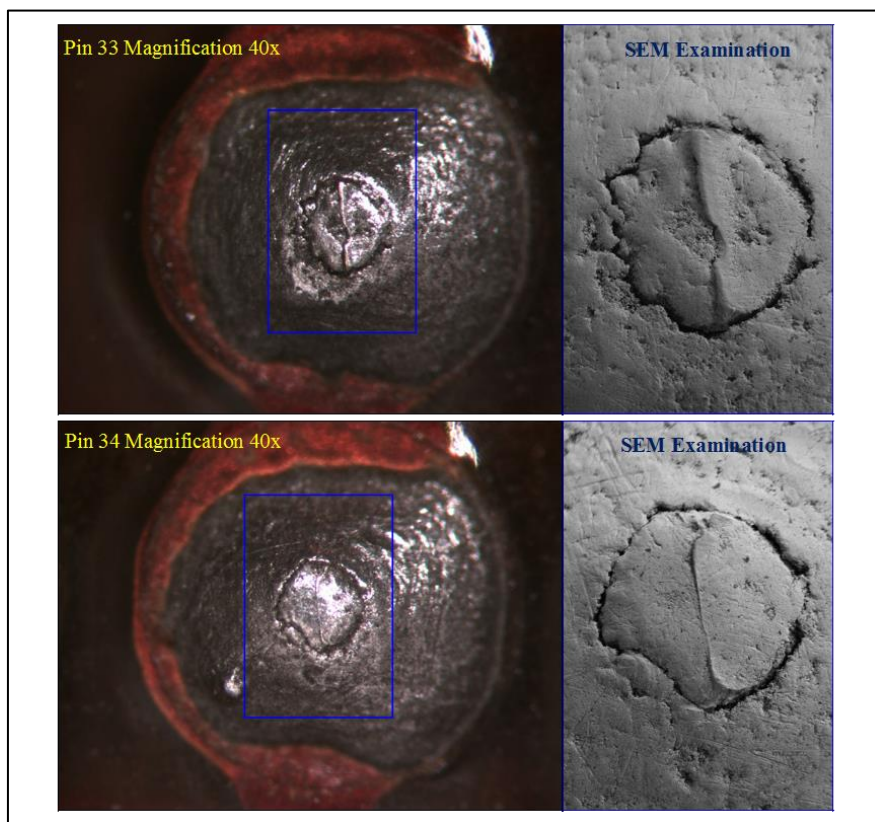
Figure 1.16-4 Microscope (40X magnification) and SEM images for Pins 33 and 34.

microscope and a scanning electron microscope (SEM). Figure 1.16-4 shows the microscope (40X magnification) and SEM images for Pins 33 and 34. The J2 flex circuit connector pins 33-42 were cross sectioned to the component centerline and examined. Figures 1.16-5 and 1.16-6 show the cross sectioned pin to flex solder joints of pins 33 and 34. In the optical cross-section images the lead-rich area was indicated by the grey particles dispersed within the white tin-rich area. In the SEM images the lead area is represented by white and tin by grey. The pin-flex solder joints displayed a coursing of the solder micro structure near the pin on each of the 10 pins in the strip. The condition was most advanced on pins near the end of the strip. The solder microstructure was consistent with enlargement, coarsening and cracking in a stress zone adjacent to the pin/solder interface. Away from this “stress zone” the solder microstructure was very fine.

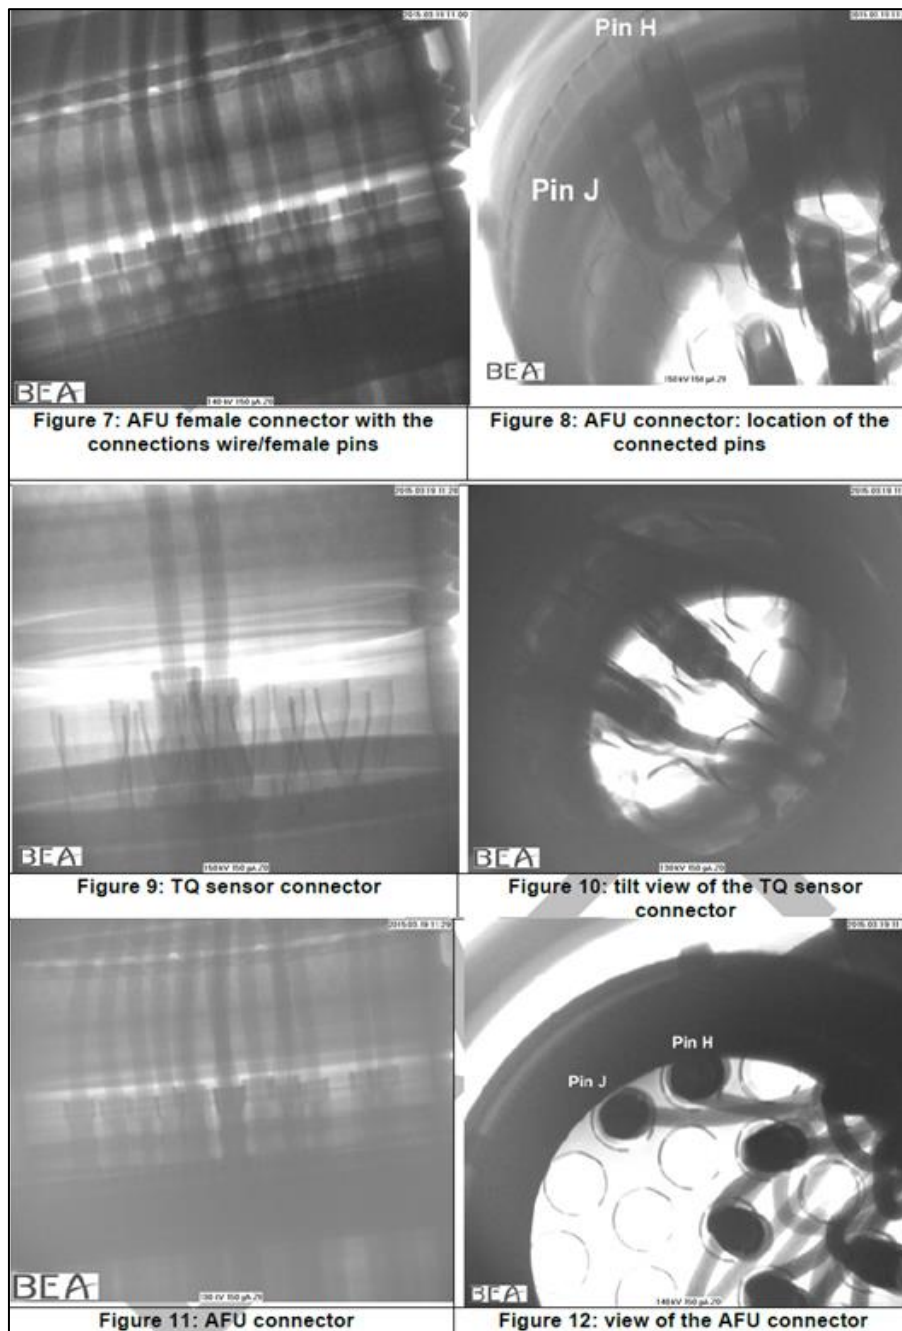
Figure 1.16-8 X-ray examination of AFU and torque sensor connectors

The X-ray examination of both harnesses showed no anomaly. The X-ray pictures of the connectors which connect AFU and the torque sensor of ENG 2 are shown in Figure 1.16-8.

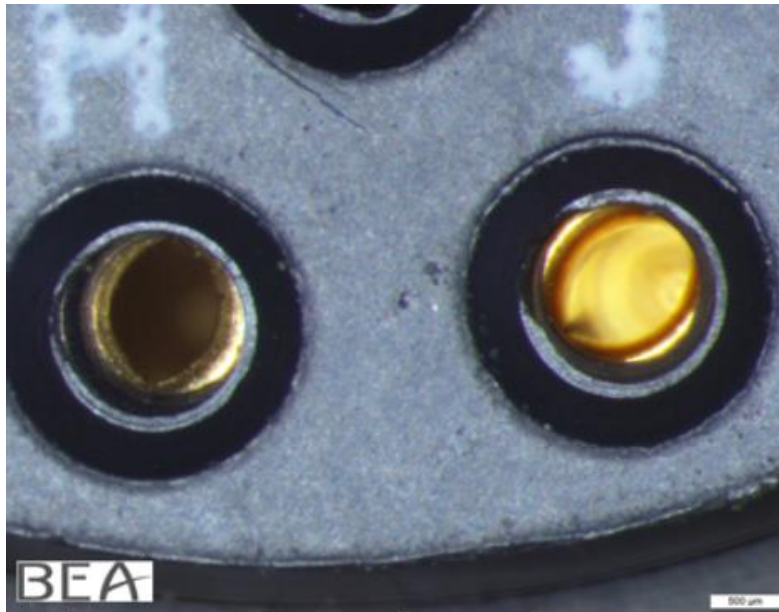
Figure 1.16-9 Connector pins H (left) and J (right) of AFU No. 2

The macroscopic examination identified a difference between pin H on ENG 2 AFU connector and the other pins on that connector. Figure 1.16-9 shows AFU No.2 connector pins H and J.

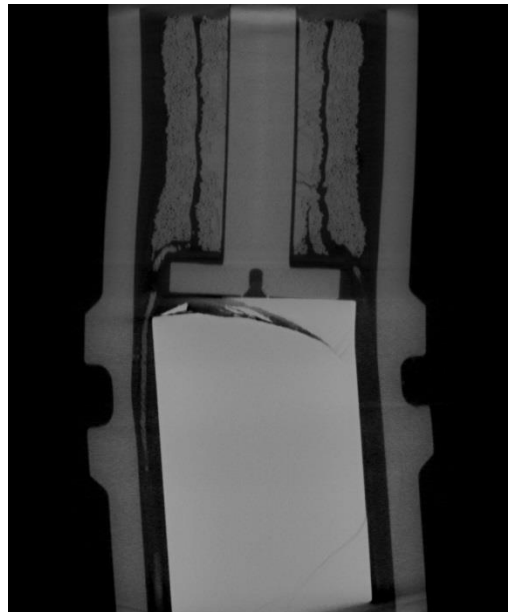
Figure 1.16-11 3D X-ray view of ENG 2 torque sensor left S/N CH1468

3D X-ray analysis (see Figure 1.16-11) of the sensor indicated that the coil wires had broken at the outside of the bend due to the impact.
