Aviation Investigation Final Report

Location:	Honolulu, Hawaii	Accident Number:	DCA21FA174
Date & Time:	July 2, 2021, Local	Registration:	N810TA
Aircraft:	Boeing 737-275C	Aircraft Damage:	Destroyed
Defining Event:	Loss of engine power (partial)	Injuries:	1 Serious, 1 Minor
Flight Conducted Under:	Part 121: Air carrier - Non-scheduled

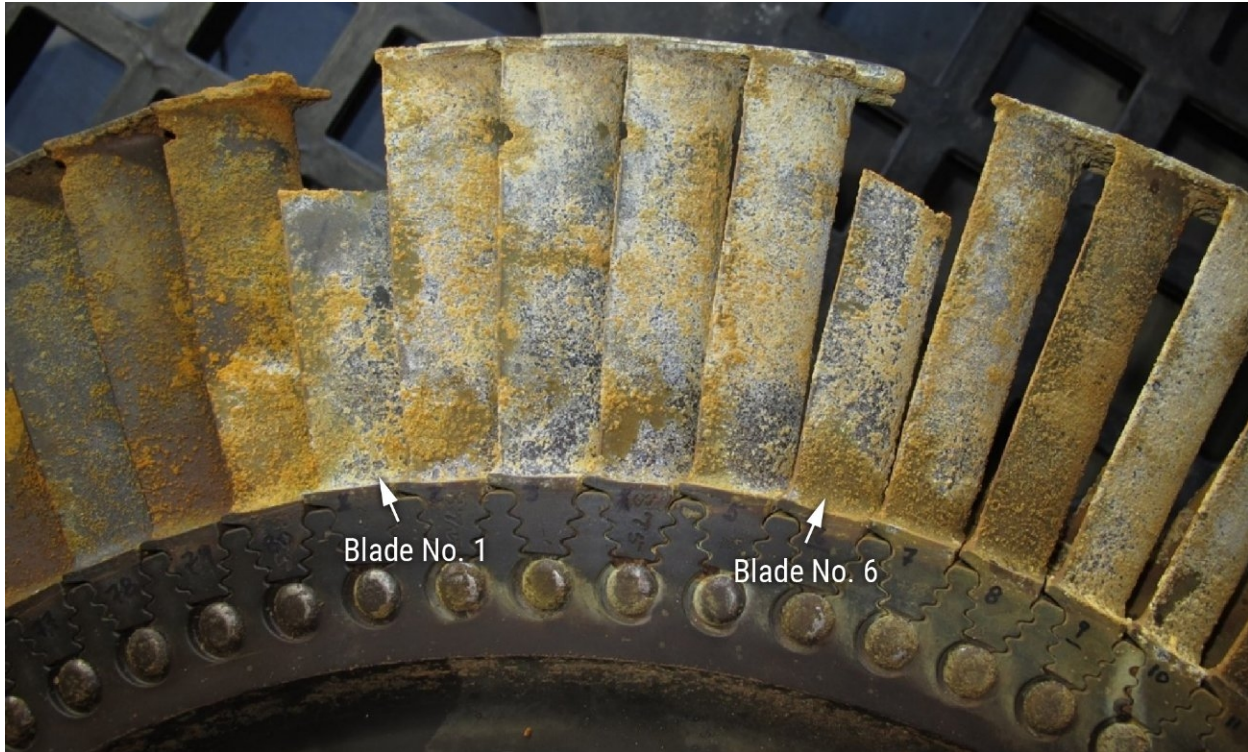
Figure 4. Fractured blades on the right engine high-pressure turbine.

The teardown of the right engine showed that two high-pressure turbine stage 1 blades were missing their outer spans and that both had failed from a stress rupture fracture due to oxidation and corrosion of the internal blade lightening (weight-reduction) holes, which resulted in a loss of load-bearing cross-section. The blade failures caused downstream (secondary) damage to the low-pressure turbine, resulting in a loss of thrust, which would have been presented to the flight crew as a decrease in EPR on the right engine (along with the thud sound recorded on the CVR and the yaw to the right).

Blade Nos. 1 and 6 were fractured transversely about 2.4 and 2.7 inches, respectively, above the platform trailing edge. Blade Nos. 3, 4, 79, and 80 exhibited trailing-edge outer diameter impact damage toward the outer span. Other blade trailing edges showed varying damage with missing material up to 0.04 inches radially. The blade fracture surfaces were heavily coated with ocean deposits.

The two fractured high-pressure turbine blades (Nos. 1 and 6) were examined at Pratt & Whitney's Materials and Processes Engineering Lab in East Hartford, Connecticut. The examination determined that the blades failed by stress rupture resulting from a loss of load-bearing material due to oxidation and corrosion. The oxidation occurred around the blades' internal lightening (weight-reduction) holes and had significantly reduced each blade's load-bearing cross-section. The fracture through the oxidized regions exhibited comparatively flat features, consistent with brittle fracture. The fracture across the remaining load-bearing blade material either exhibited a rough (intergranular) texture, which was consistent with stress rupture, or was covered by ocean deposits.

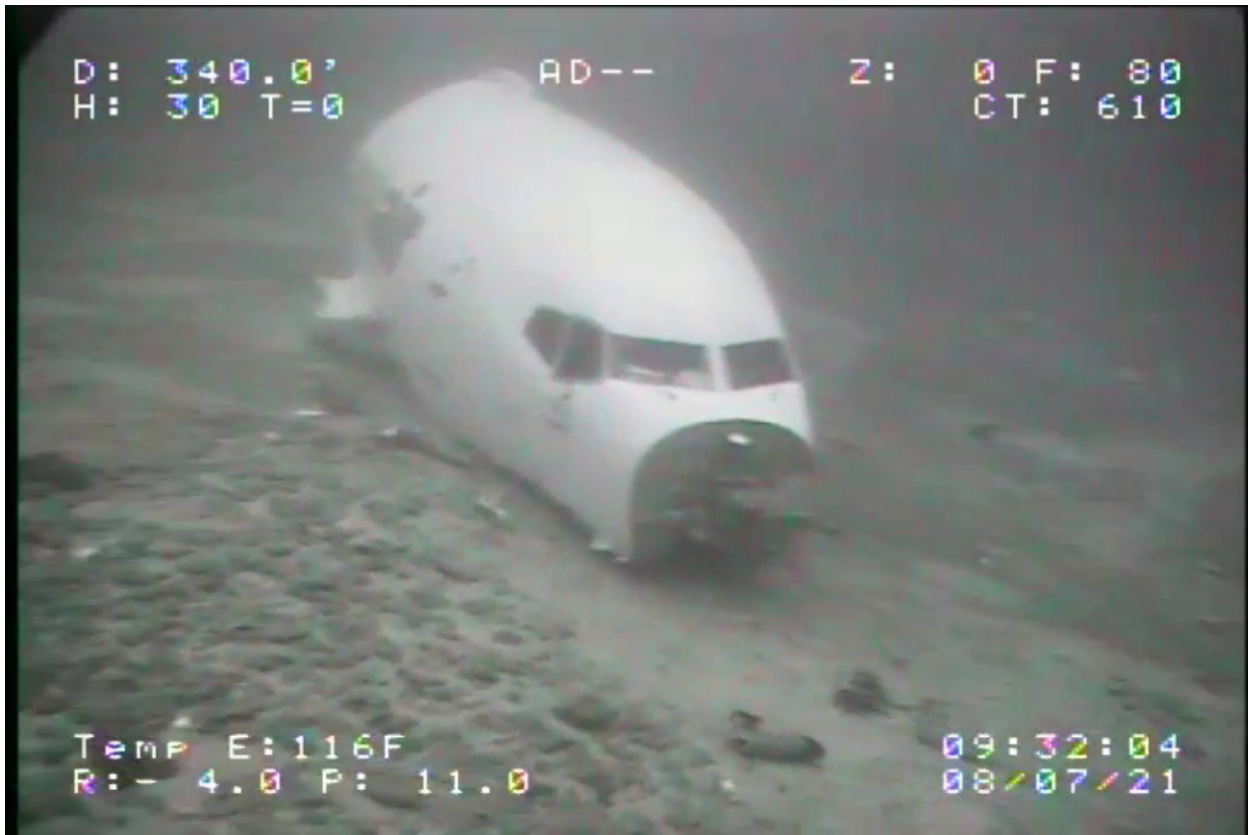
Figure 6. Forward fuselage (Source: Sea Engineering Inc.).

The airplane's forward fuselage section separated from the rest of the airplane near the leading edge of the wing. Most of the fuselage structure below the main cabin and cockpit floor separated from the forward fuselage. The separated structure below the floor was crushed and torn. The aft fuselage lower section was damaged, and portions of belly skin had separated from the airplane. The four cargo containers remained in the aft fuselage. Most of

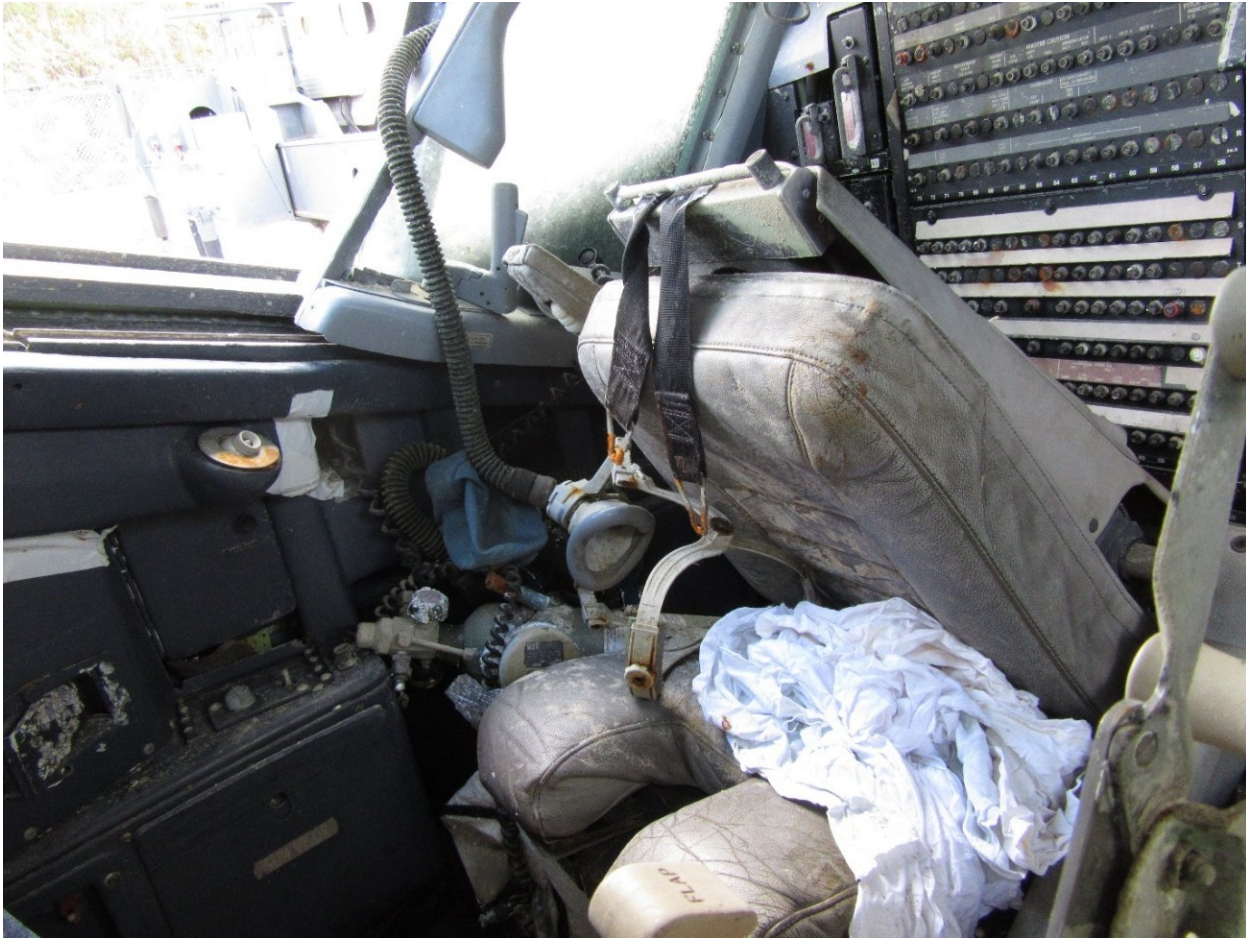
Figure 7. First officer's seat in cockpit after recovery.

Postaccident examination of the first officer's seat found that the seatback had collapsed. Subsequent examination by the NTSB's Materials Laboratory determined that the seatback collapse was due to the fracture of a jack nut that was part of a jackscrew assembly. The jack nut fractured in overstress due to loads that exceeded its load-bearing capacity.

The first officer's seat was intact and secured to the seat tracks. The seatback had rotated forward and collapsed, as shown in figure 7. The seat cushions and seat pan were not damaged, but the stowage compartment below the seat was damaged. The left bungee was broken with one-half missing; the right bungee was connected, but the elastic was broken in multiple places. The threaded rod and spring were fractured at the forward end.
