PB90-910401  
NTSB/AAR-90/01

# NATIONAL TRANSPORTATION SAFETY BOARD

## AIRCRAFT ACCIDENT REPORT

UNITED AIRLINES FLIGHT 811  
BOEING 747-1 22, N47 13U  
HONOLULU, HAWAII  
FEBRUARY 24, 1989

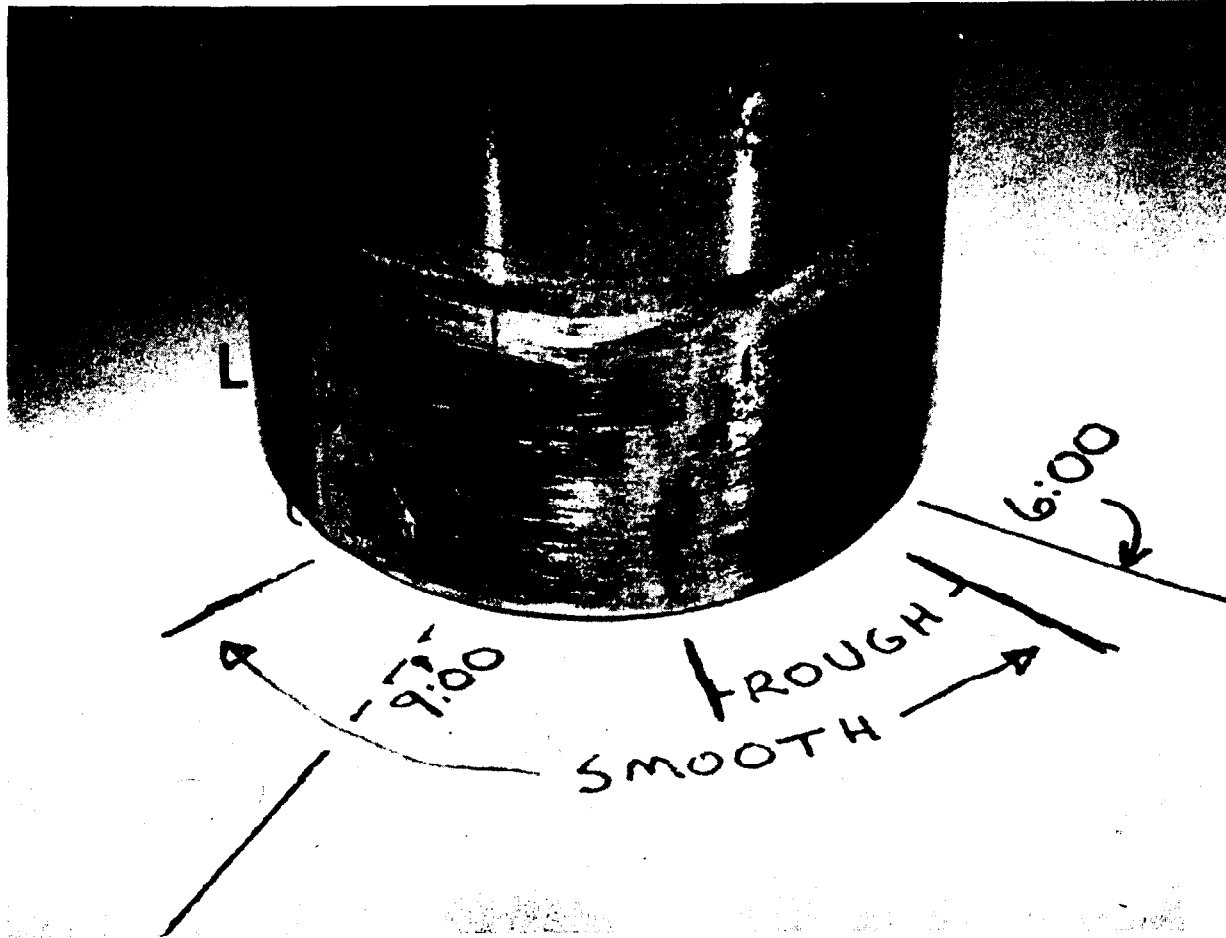
In general, all of the forward door cargo latch pins had smooth wear over the entire portion of the pin area contacted by the cams during normal closing and opening of the door. The pins also had distinct roughened (smeared) areas between the 6:15 and the 7:30 positions (See Figure 7). The roughened areas had evidence of "heat tinting" and transfer of cam material to the surface of the pins. On pins 1 and 8 the roughened areas extended past the pin bottom to the 5:00 position. The 7:30 position approximately corresponds to the area on the pin where the lower surface of the cam would be relative to the pin when the latch cams are in the unlatched or nearly unlatched position.

Figure 6. --Latch pin number 6. Note the rough and smooth areas and the steps indicating **the** contact area with the latch cam.

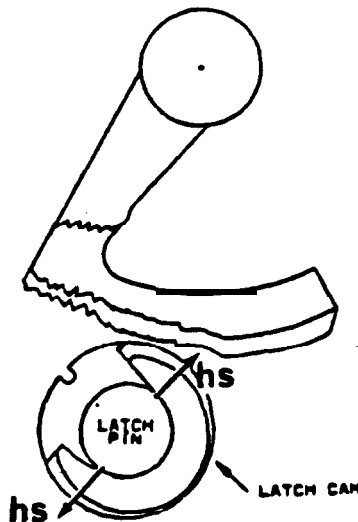
Probable position of cams (in or near fully unlatched) at the time of door separation. Arrows denote direction of hoop stress. (Lock sectors were bent or broken enough to pass over unlatched cams).

Figure 8. -- Relative positions of latch cam, latch pin, and lock sector in properly latched and unlatched, and in improperly locked position.
