## **NATIONAL TRANSPORTATION SAFETY BOARD**

# **INVESTIGATION SUMMARY**

**CEN21FA290**

Location: Cleburne, Texas  
Date: June 24, 2021  
Aircraft: N9261L; American Aviation (Grumman) AA-1A Trainer  
NTSB IIC: Joshua Lindberg, CEN

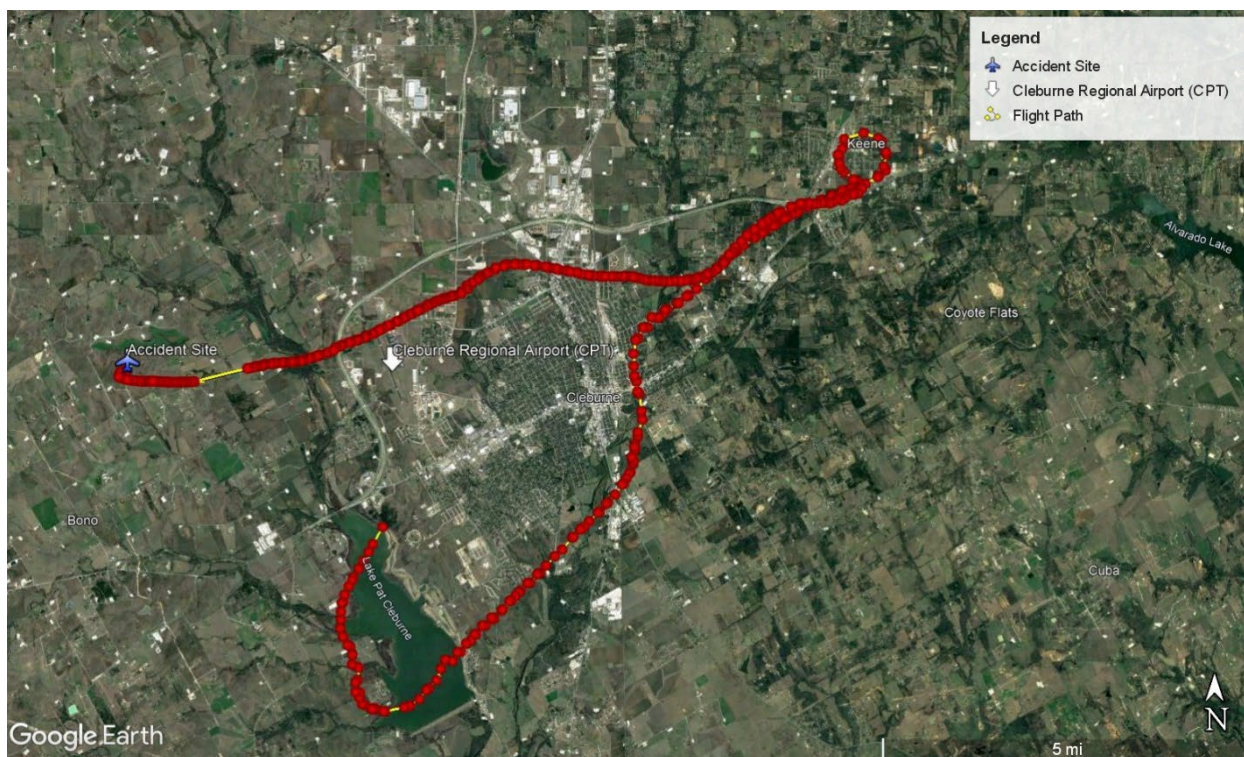
There were no recorded ATC communications. Flight track data showed that the airplane departed Cleburne Regional Airport (CPT), about 1658 and proceeded south then northeast toward Keene, Texas. After the airplane made one full circle over Keene, it proceeded west and overflow CPT. The airplane continued west about 2,600 ft mean sea level (msl) for another 3 miles. During the last 10 seconds of the recorded data, the flight tracked showed a hard right turn followed by a left descending spiral toward the ground. Figure 1 shows the flight path.

Figure 1. Flight Path

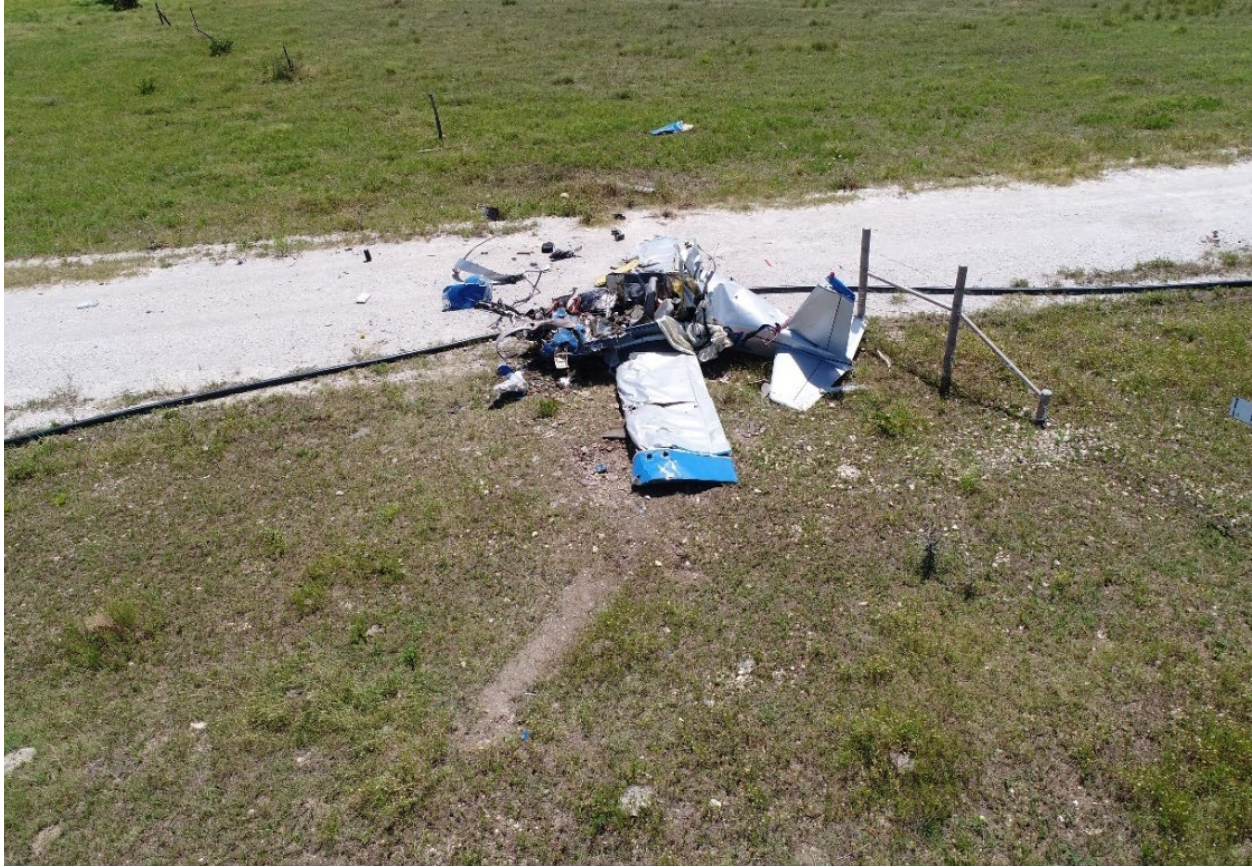
The airplane came to rest in a rural field and partially on a gravel road (Figure 2). The first impact area was a ~10 ft straight line disturbance in the dirt, which contained red glass near the outboard tip. The next impact areas were two small craters that contained paint chips and debris. The impact marks corresponded with the left wing, left landing gear, and engine/propeller. The airplane came to rest just to the right of the impact marks. All major components of the airplane were found at the accident site with the main wreckage.

Figure 2. Aerial view of main wreckage. Left wing impact mark noted
