Aviation Investigation Final Report

Location:	Cleburne, Texas	Accident Number:	CEN21FA290
Date & Time:	June 24, 2021, 17:14 Local	Registration:	N9261L
Aircraft:	American Aviation AA-1A	Aircraft Damage:	Destroyed
Defining Event:	Loss of control in flight	Injuries:	2 Fatal
Flight Conducted Under:	Part 91: General aviation - Personal

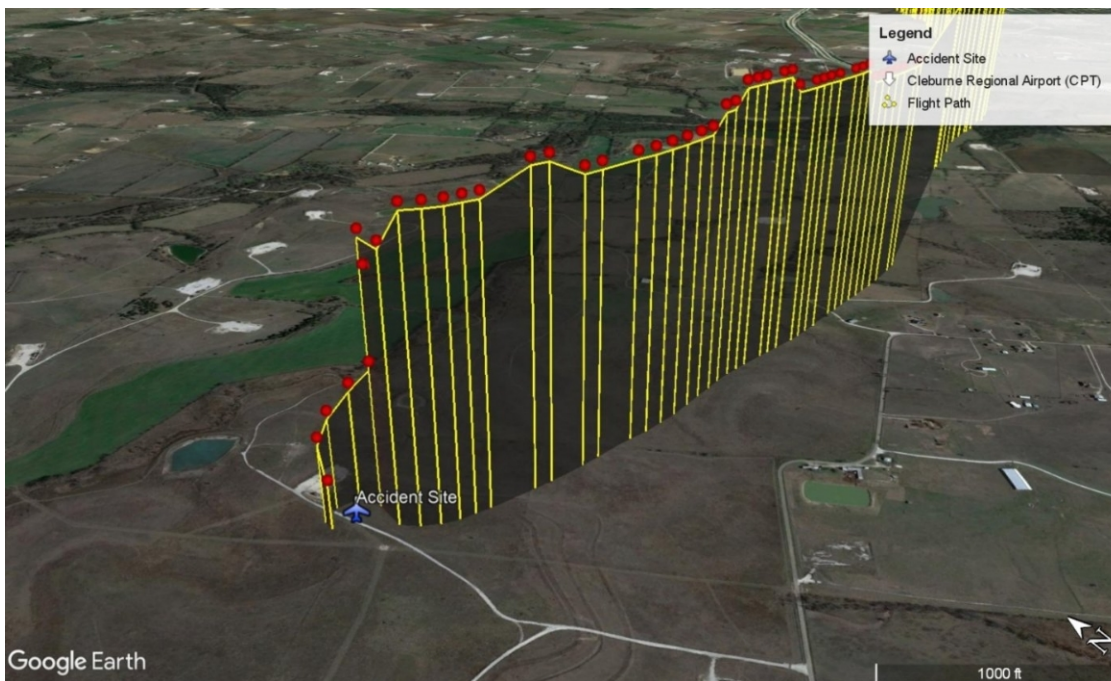
Figure 1. End of flight track and accident location

Flight track data showed that the airplane departed Cleburne Regional Airport (CPT), Cleburne, Texas, about 1658 and flew south then northeast toward Keene, Texas. After the airplane made a tight left 360° turn over Keene, it proceeded west and overflow CPT. The airplane continued west at an altitude about 2,600 ft msl for another 3 miles. During the last 10 seconds of the recorded data, the flight track showed a hard right turn, immediately followed by a left spiraling descent toward the ground (see figure). There were no recorded air traffic control communications during the flight.
