## Contents

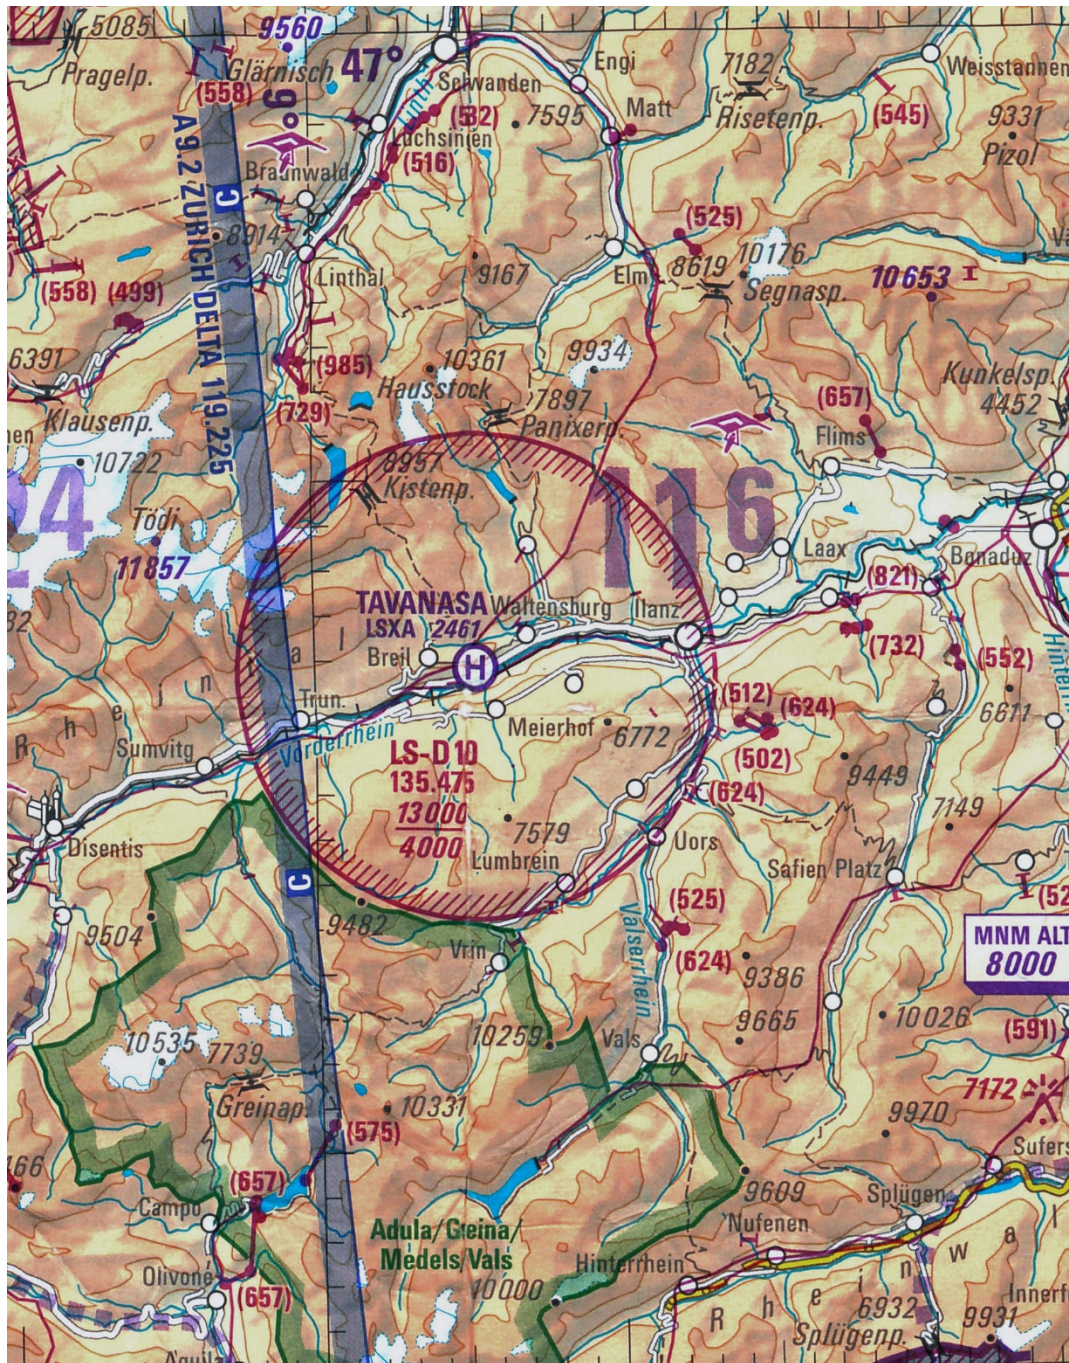
**Figure 6:** Excerpt (not to scale) from the ICAO aeronautical chart, 1:500,000, on board HB-HOT. Altitude information is given in feet.

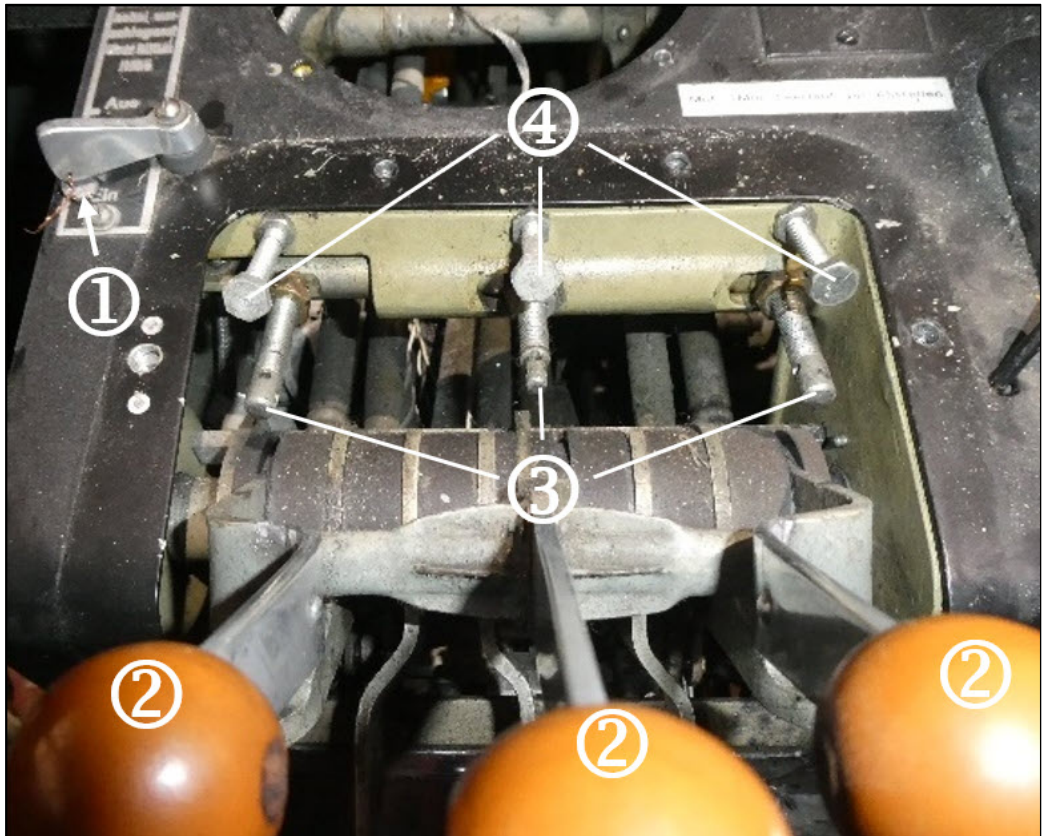
**Figure 16:** Full-throttle limiting mechanism in the 'on' position. Full-throttle limiter with lead-sealed wire lock (1); main throttle levers (2); stop bolts for full-throttle limiting (3); stop bolts for full throttle (4).

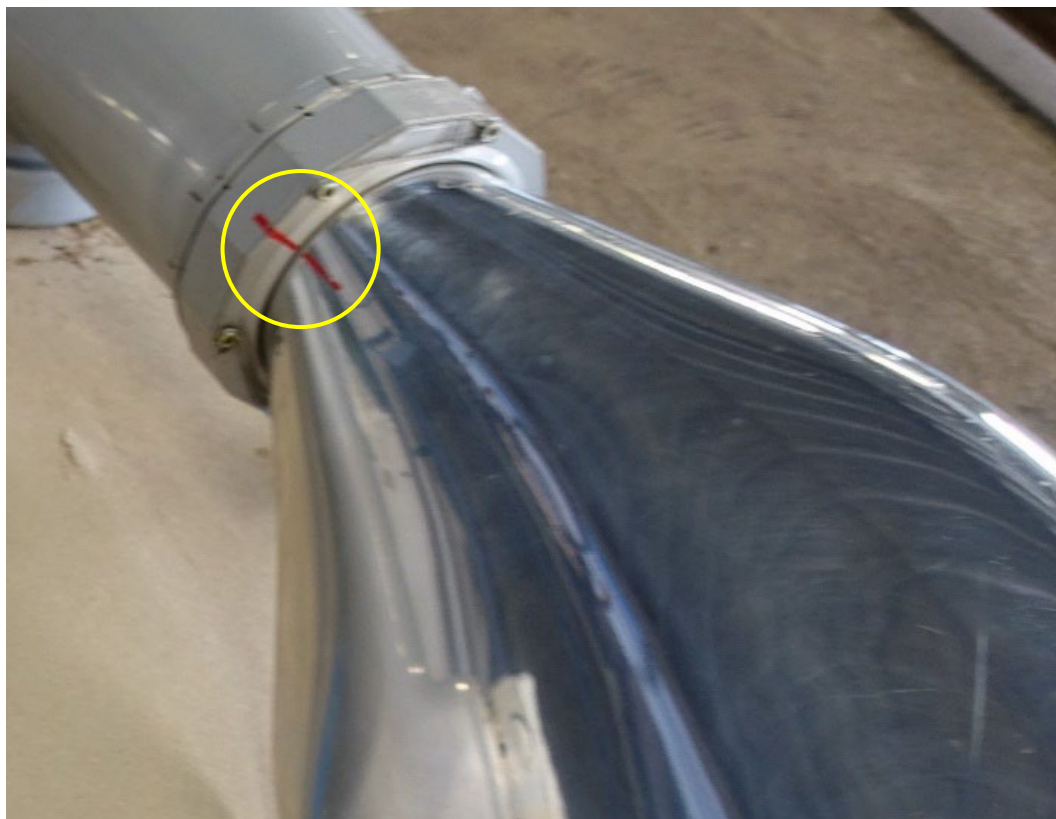
**Figure 37:** Red marking on the twelve-point nut and propeller blade (yellow circle).

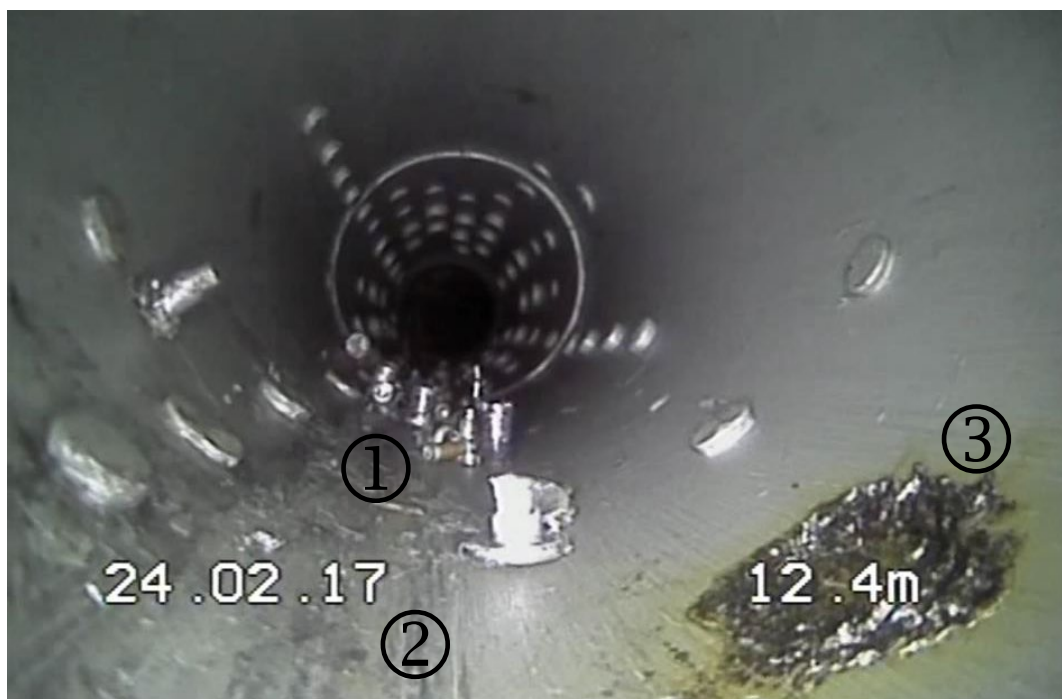
**Figure 40:** Left-hand outer wing, lower spar I – various rivets lying around (1), partly flaked off anti-corrosion paint (2) and dried ACF 50 corrosion inhibitor (3). Photograph provided by Ju-Air.

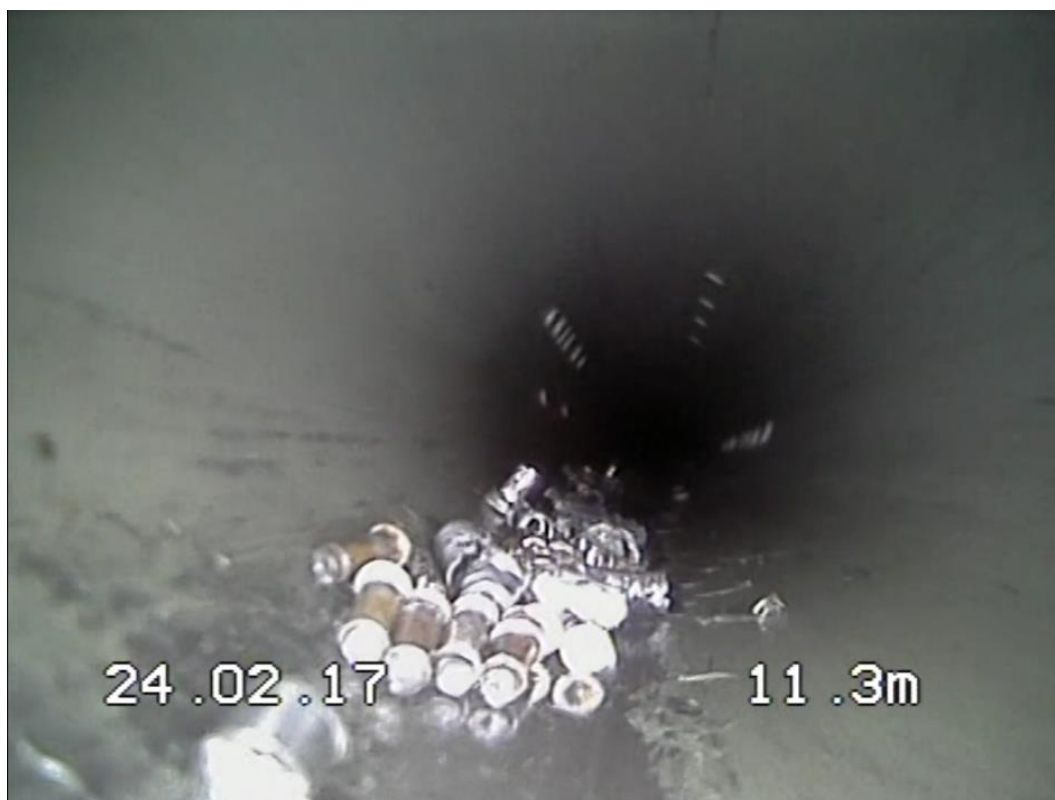
**Figure 41:** Left-hand outer wing, lower spar II – large quantity of rivets. Photograph provided by Ju-Air.

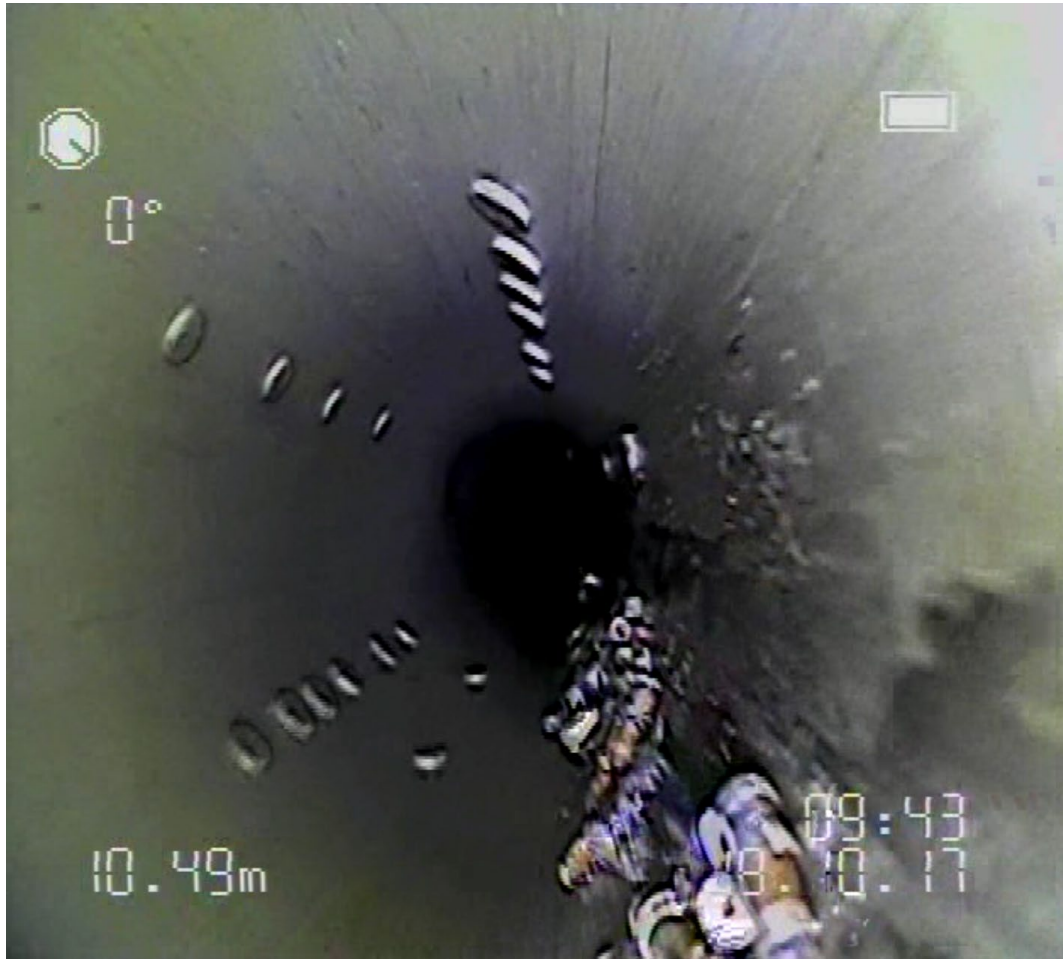
**Figure 43:** Left-hand outer wing, lower spar II. Photograph provided by Ju-Air.

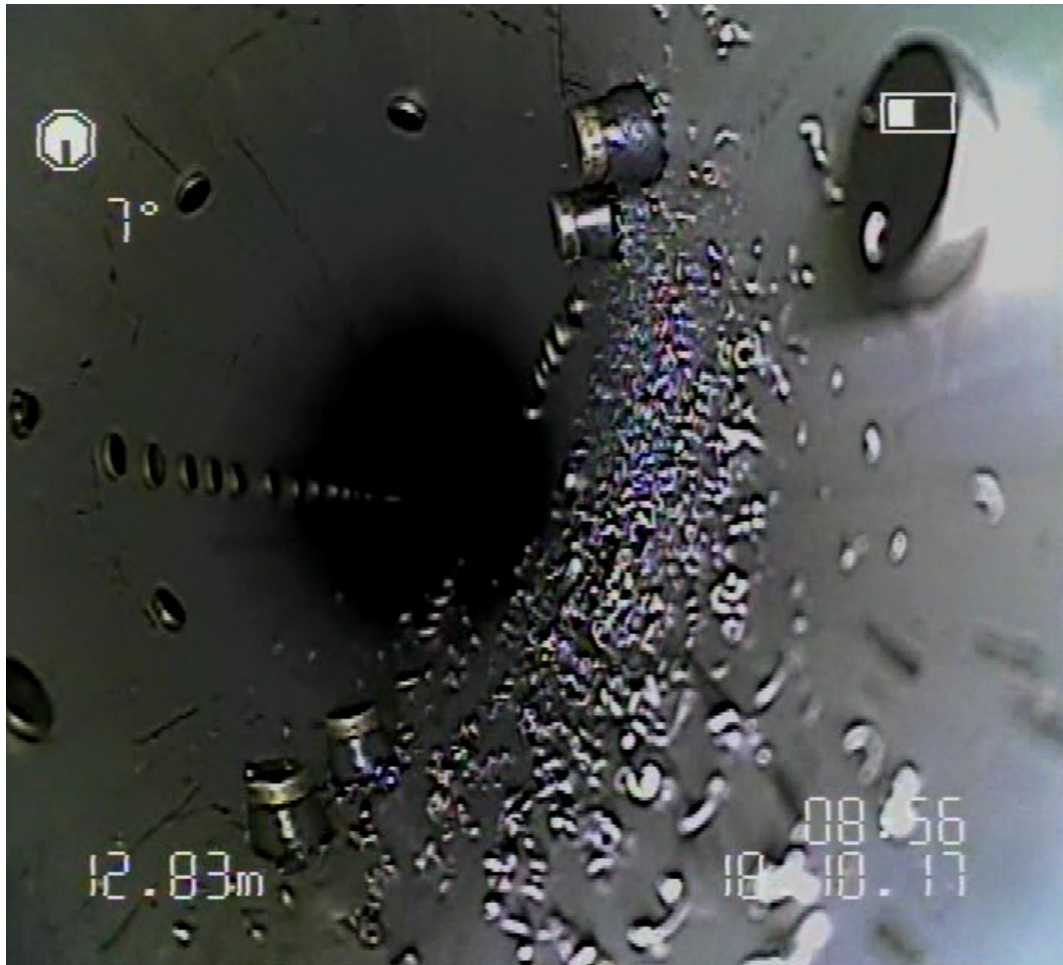
**Figure 44:** Centre wing, lower spar I, after repair. Photograph provided by Ju-Air.

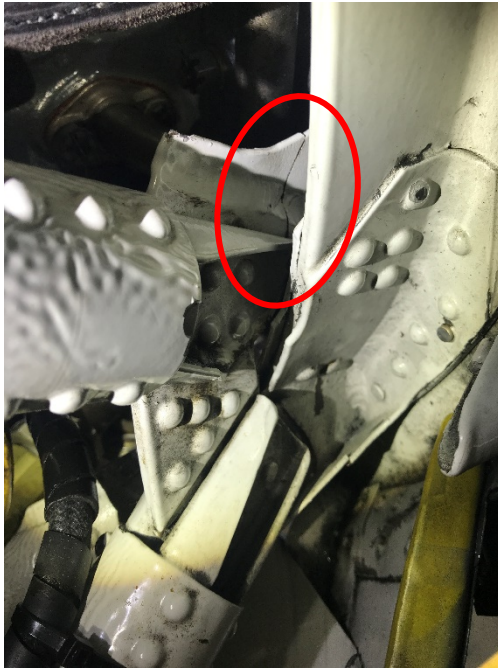
**Figure 45:** Crack in the mounting frame gusset plate (red circle). Photograph provided by Ju-Air.

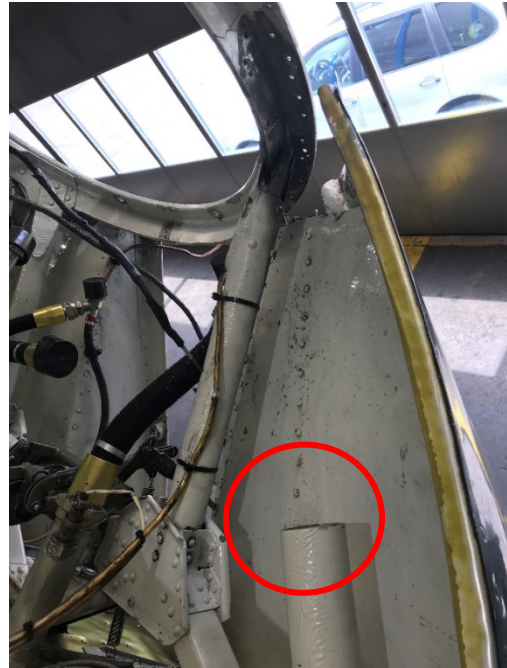
**Figure 46:** Cut strut tubing (red circle). Photograph provided by Ju-Air.

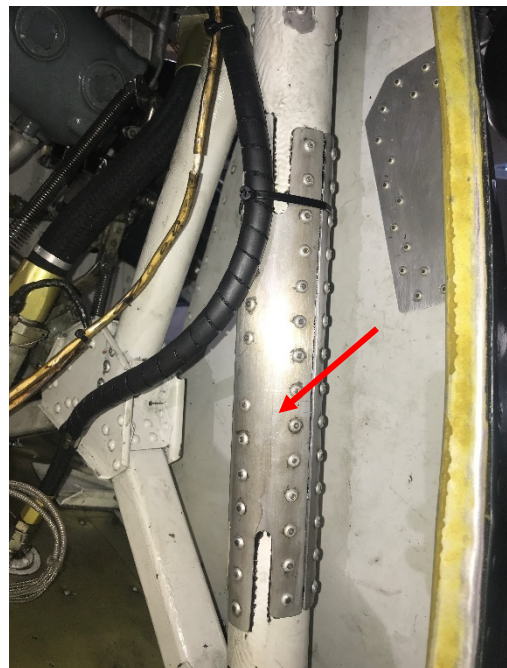
**Figure 48:** Tubular strut repaired with a doubler. Photograph provided by Ju-Air.

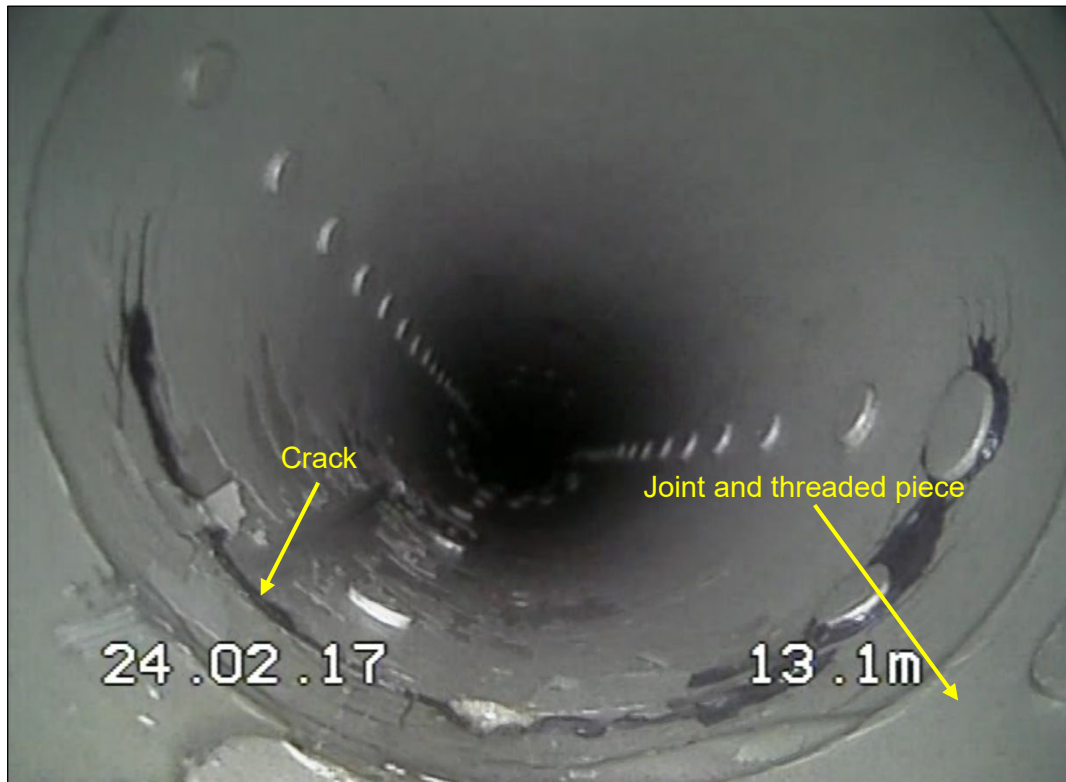
**Figure 49:** Interior view – crack in lower spar I of the centre wing, immediately next to the left-hand joint and threaded piece (borescope image). Photograph provided by Ju-Air.

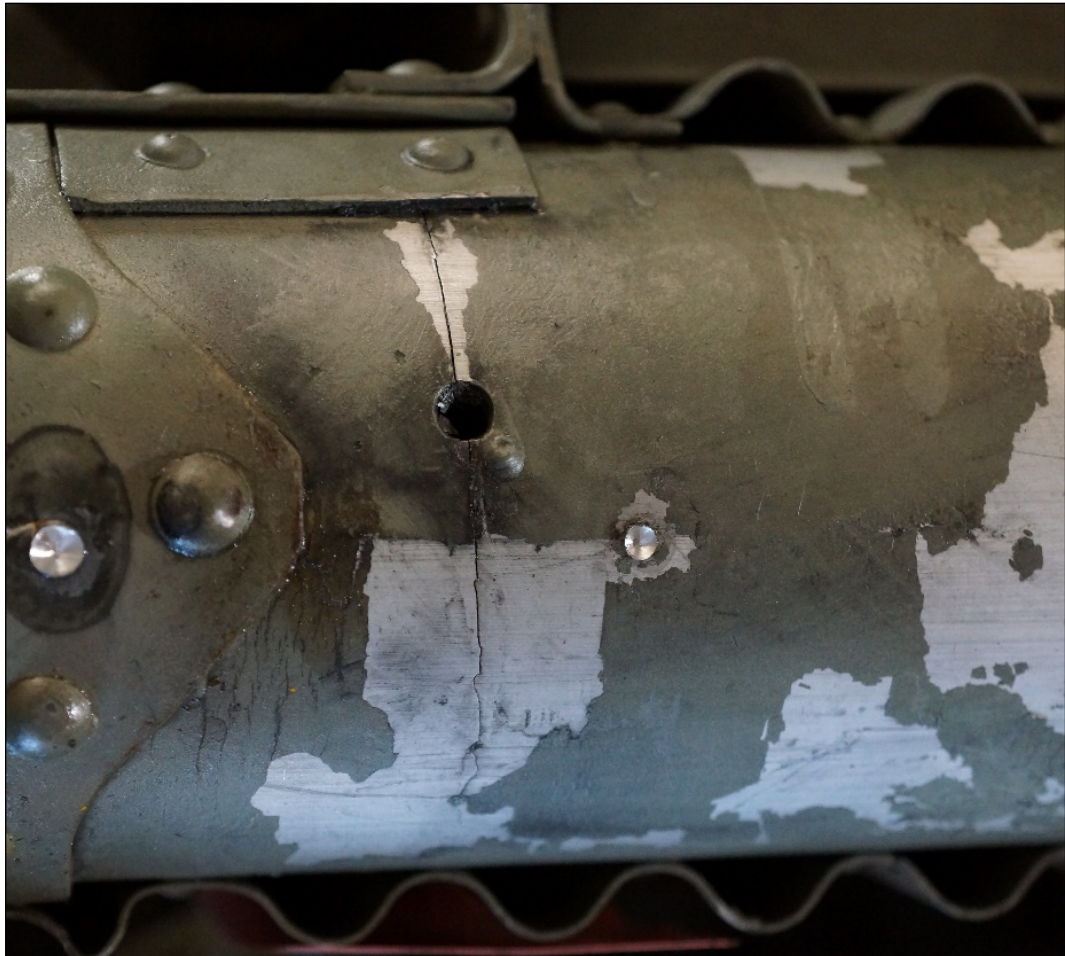
**Figure 50:** Exterior view – crack in lower spar I of the centre wing. Photograph provided by Ju-Air.

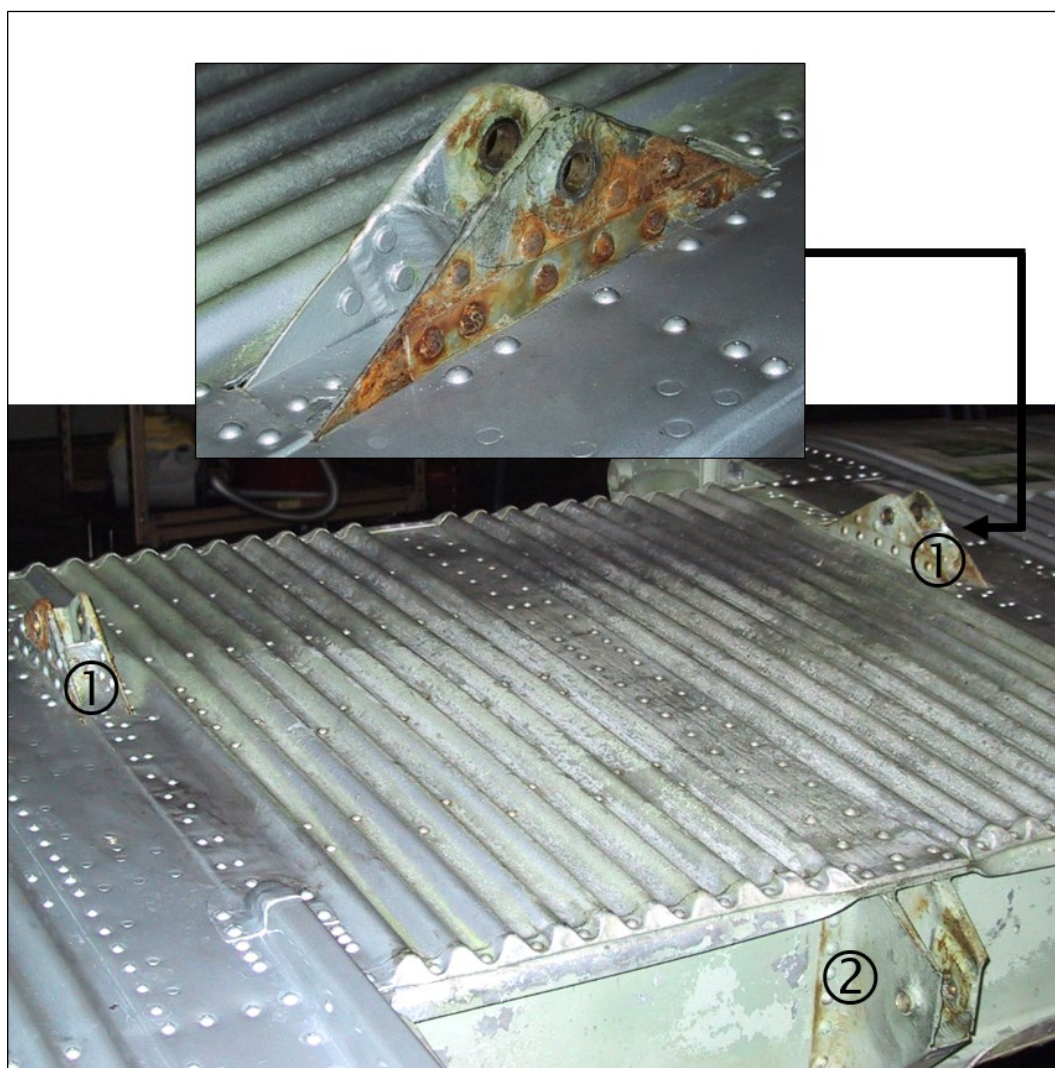
**Figure 52:** Horizontal stabiliser with severely corroded joints (1), bearing bracket (2) and panelling. Photograph provided by Ju-Air.

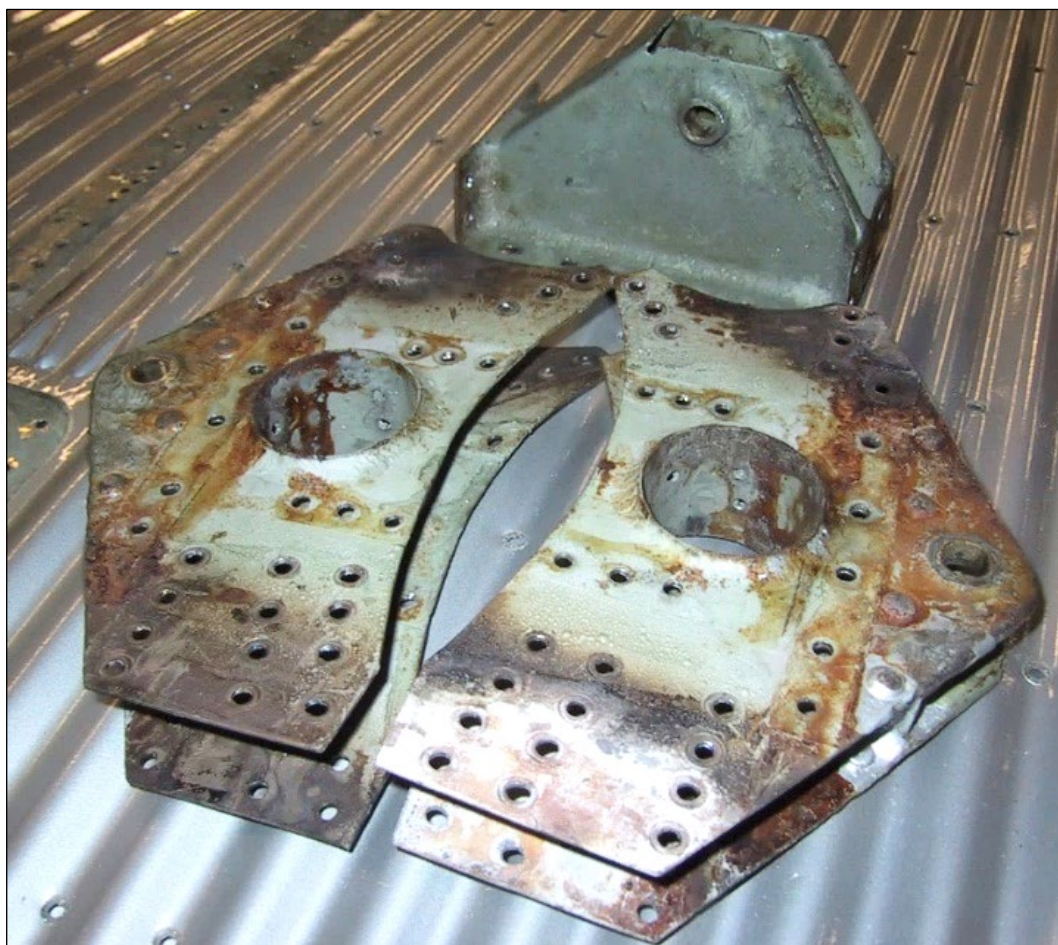
**Figure 53:** Removed, severely corroded components from the horizontal stabiliser. Photograph provided by Ju-Air.

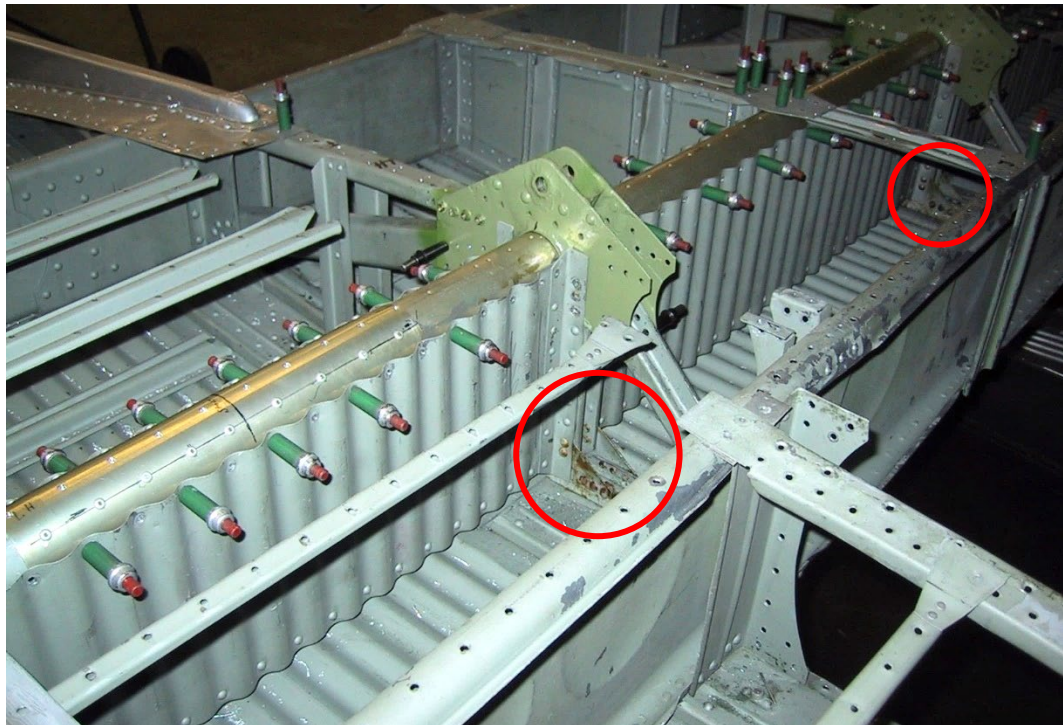
**Figure 54:** Reworked components in the horizontal stabiliser with new spar tubing. Circled in red are other severely corroded components that have not been treated or replaced. Photograph provided by Ju-Air.

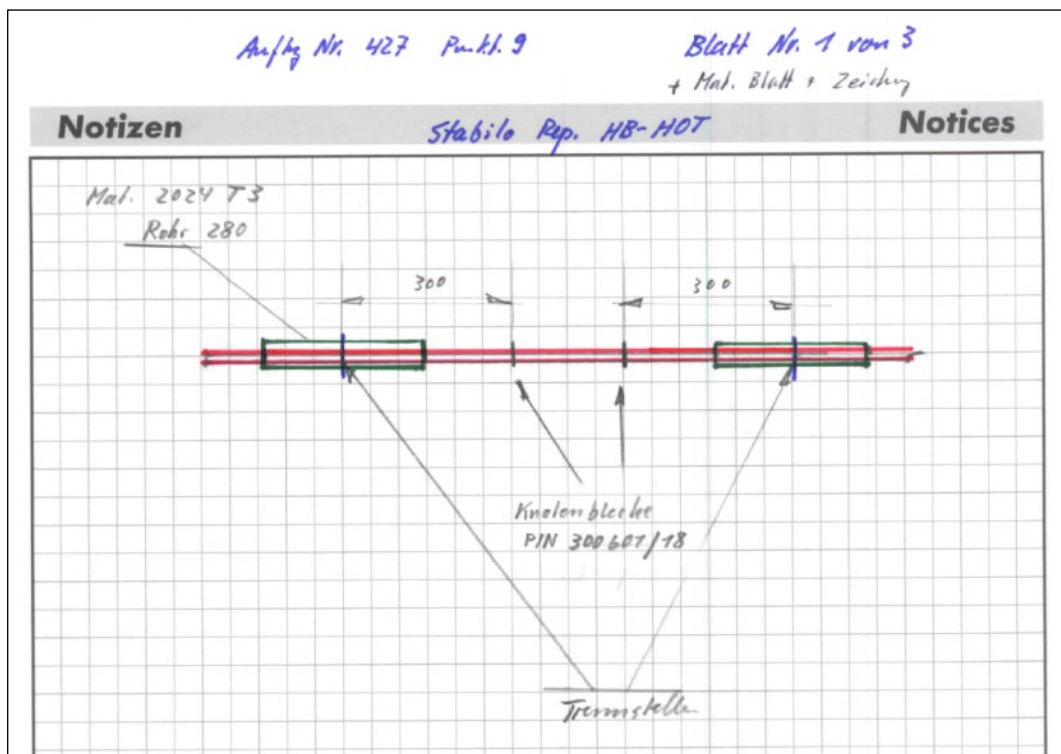
**Figure 55:** Repair work based on this hand-drawn sketch. Source: Technical records HB-HOT.

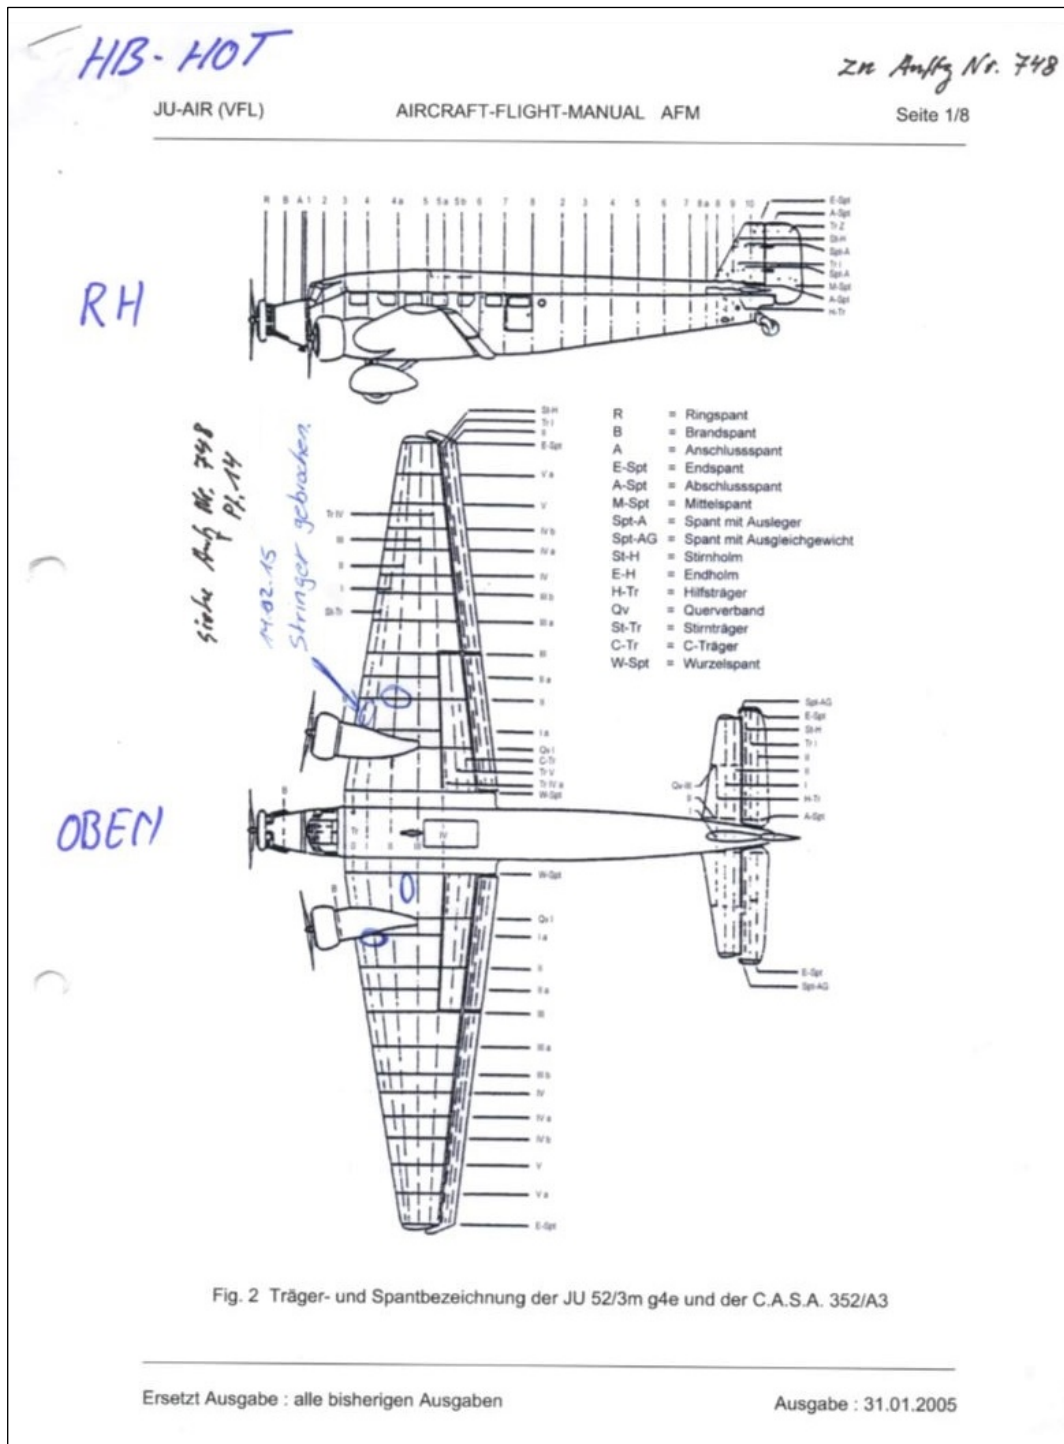
**Figure 57:** Ju-Air document where the broken stringer is noted. Names of persons and signatures removed by the STSB. Source: Technical records HB-HOT.

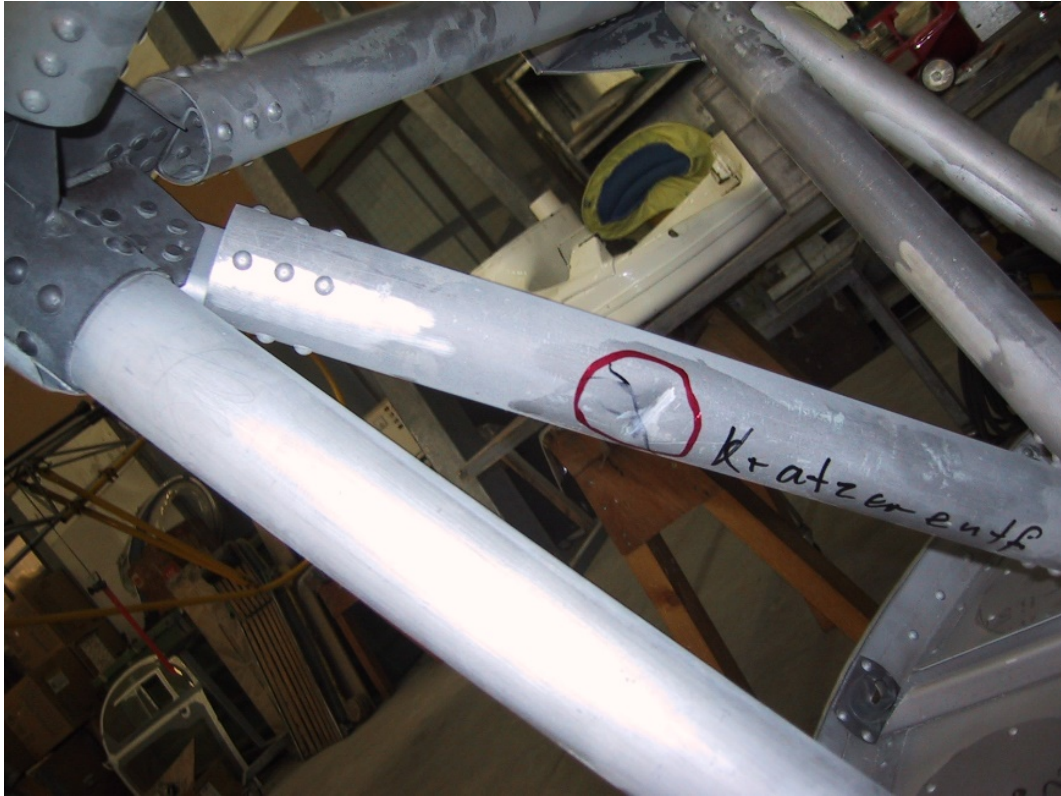
**Figure 58:** Damaged strut tubing (diagonal tube). Photograph provided by Ju-Air.

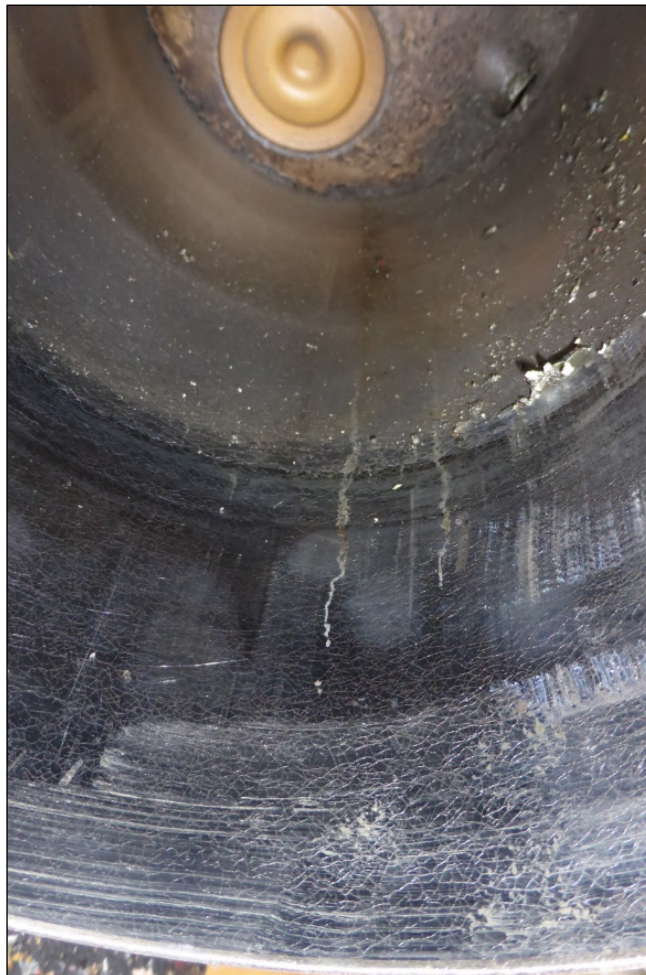
**Figure 59:** Example of a chrome-plated cylinder bore. The crack network typical for this method is clearly visible.

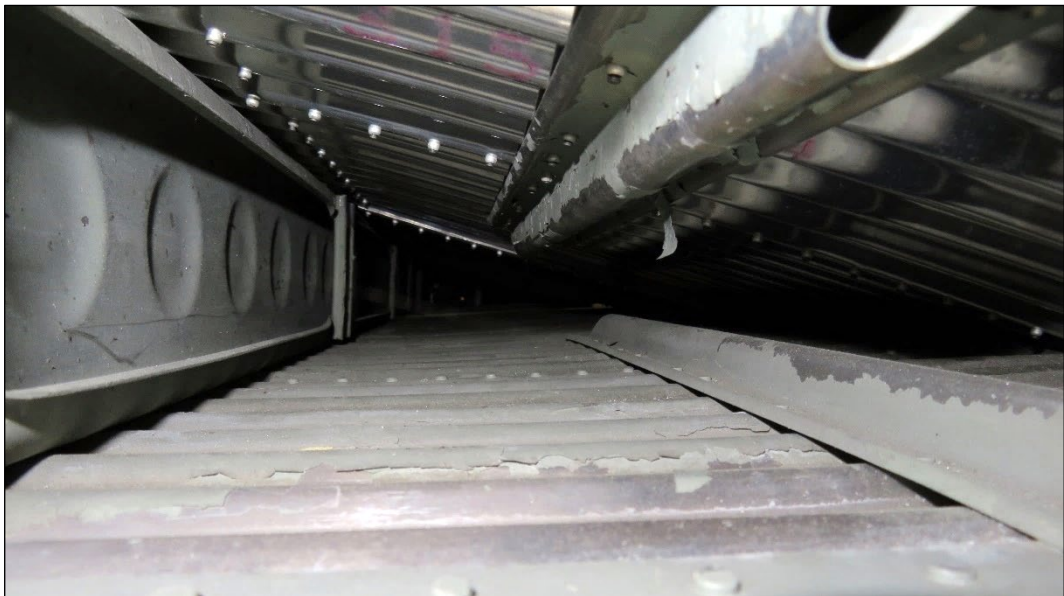
**Figure 66:** Surface flaking and a lack of anti-corrosion paint on the inside of HB-HOS's left-hand horizontal stabiliser.

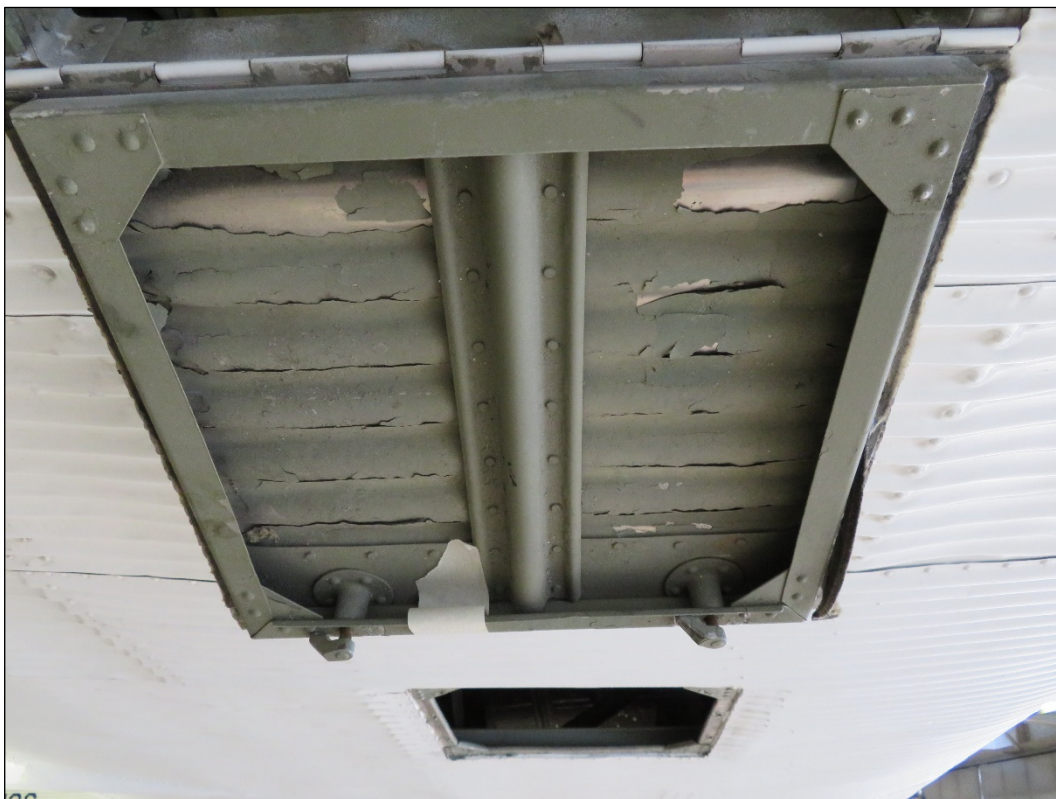
**Figure 67:** Surface flaking and a lack of anti-corrosion paint on the inside of HB-HOS's right-hand outer wing.

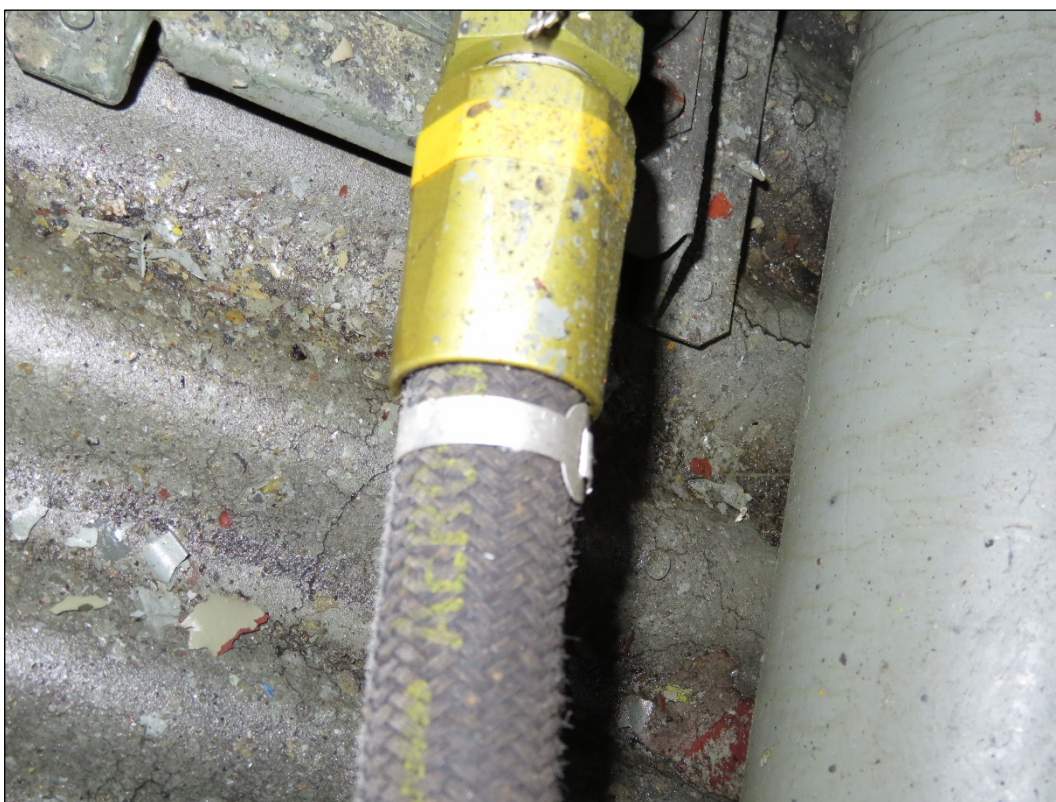
**Figure 68:** Flaking anti-corrosion paint and severe contamination on the inside of HB-HOP's left-hand outer wing, and fuel line from 1989.

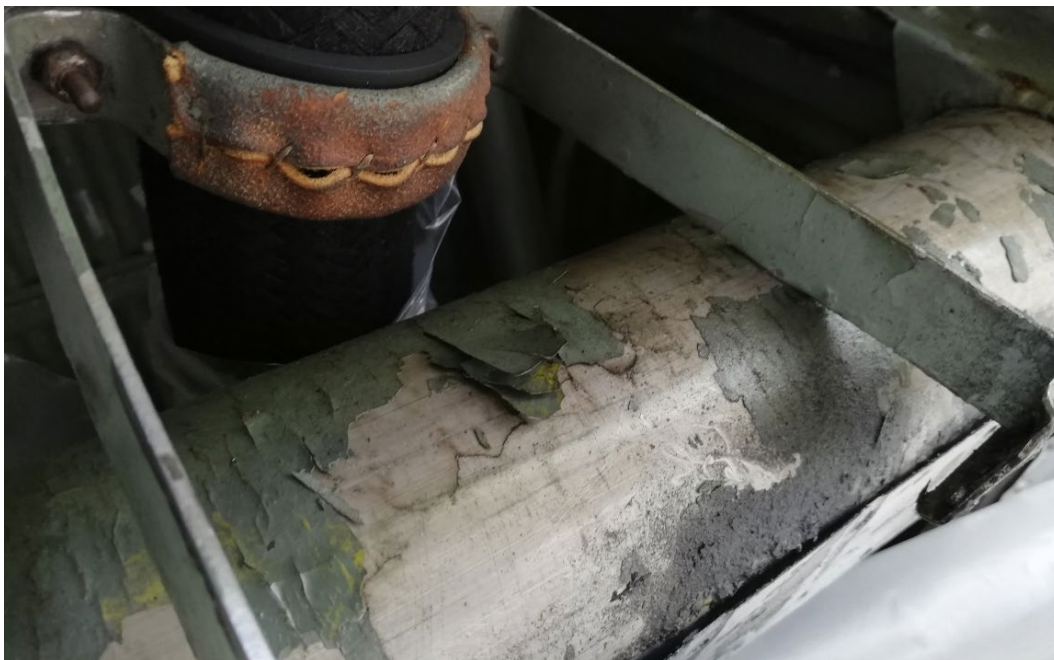
**Figure 69:** Lack of anti-corrosion paint on a spar tube in HB-HOP's left-hand outer wing.

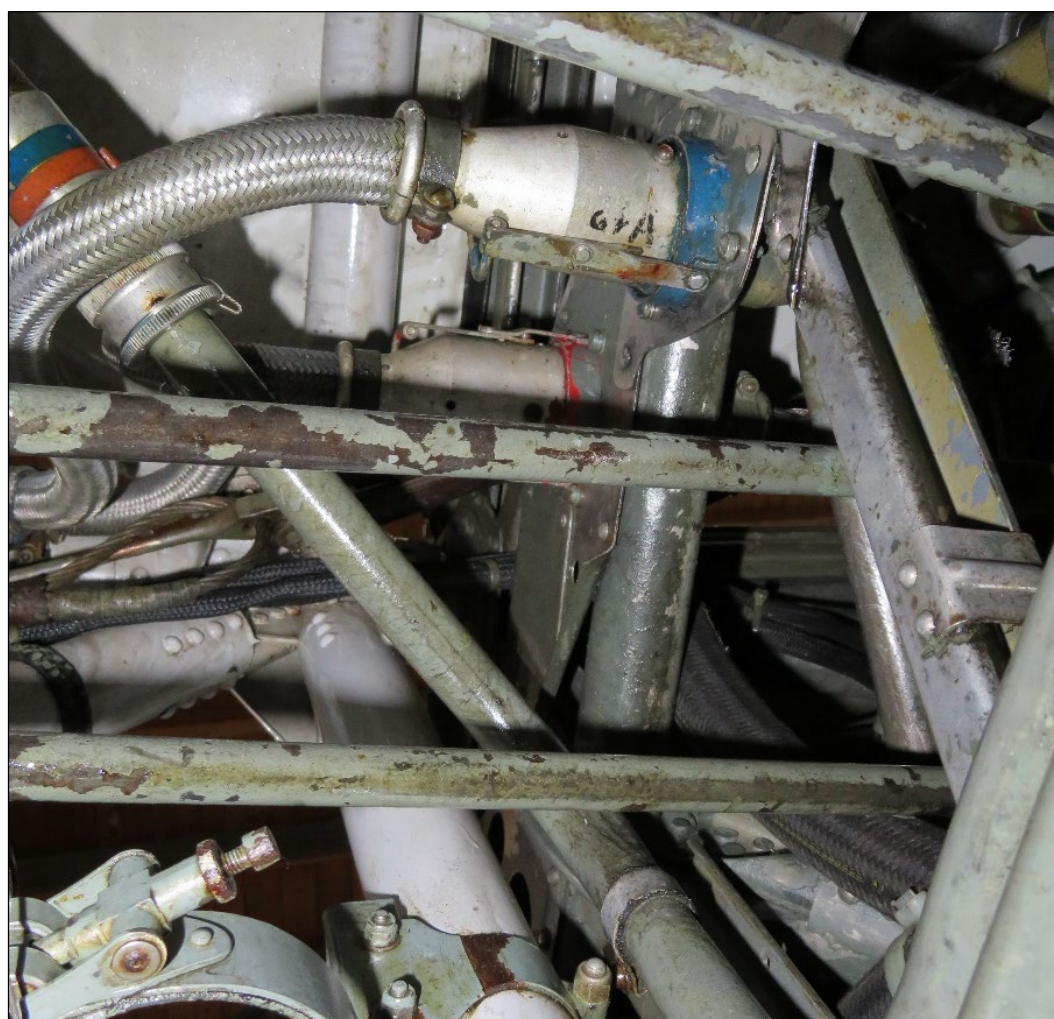
**Figure 70:** Corroded components and a lack of anti-corrosion paint on the inside of HB-HOP's left-hand outer wing.
