TECHNICAL REPORT

Accident to the Airbus A380
registered F-HPJE and operated by Air France
on 30/09/2017 en route over **Greenland**

October 2017 - June 2018
Searches **Phase I & II**

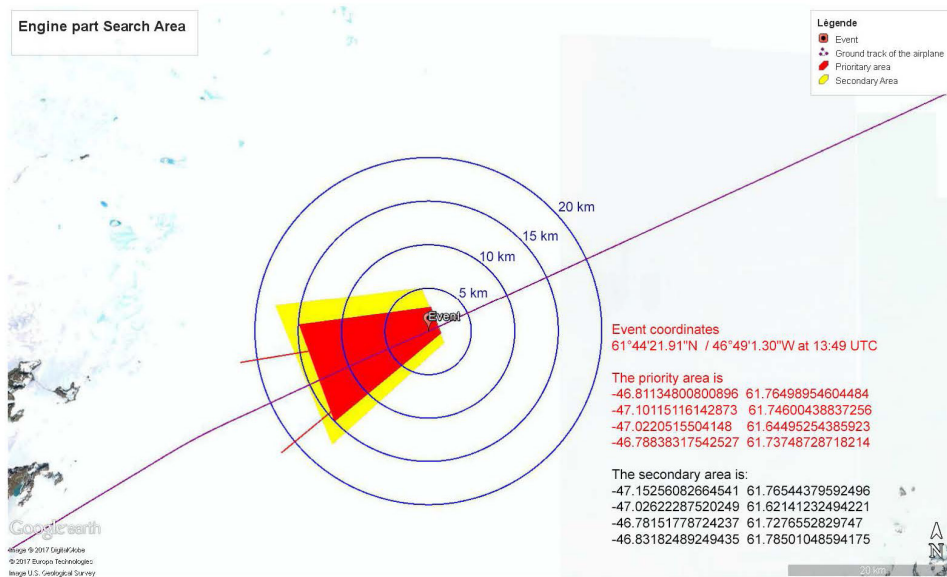
Fig. 3: **priority** and **secondary** search areas

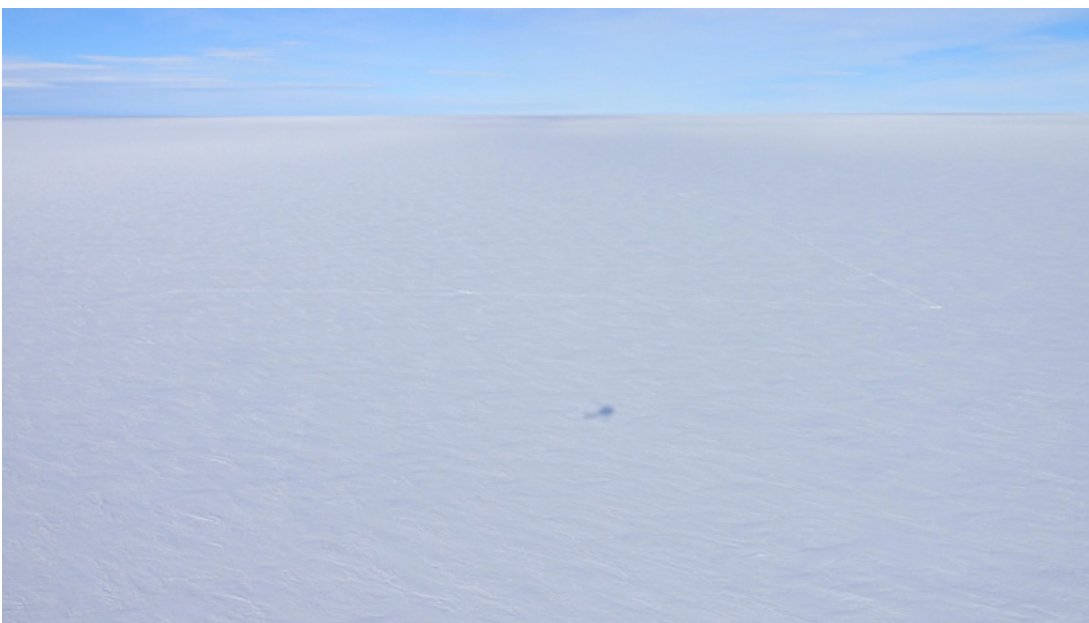
Fig. 4: view of area where first debris was located – straight lines are footprints

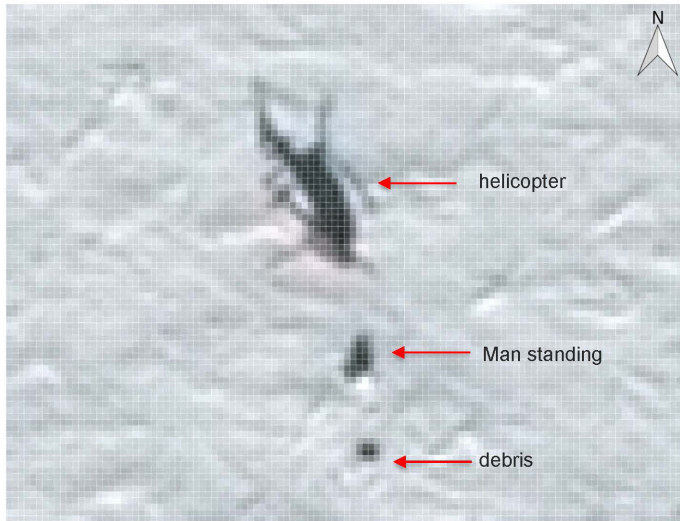
Fig. 15: detail of red box in Fig. 14 - 1 pixel size is 50 cm by 50 cm

Even so, October 11 images were looked at, without any findings being made. The only feature spotted is shown in Fig. 14. It corresponded to a helicopter, probably Air Greenland AS350 which was onsite for part recovery that day. One can probably distinguish a man standing by debris, south of the helicopter (Fig. 15).

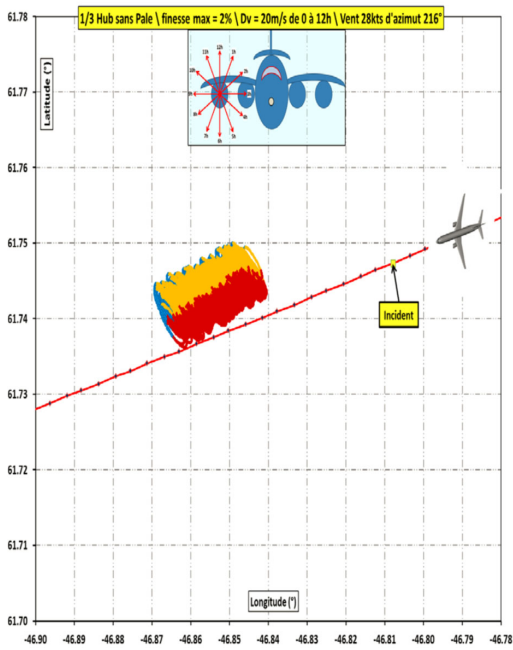
Fig. 20: 1/3 of a fan hub with an ejection speed of 20 m/s (courtesy of ArianeGroup)

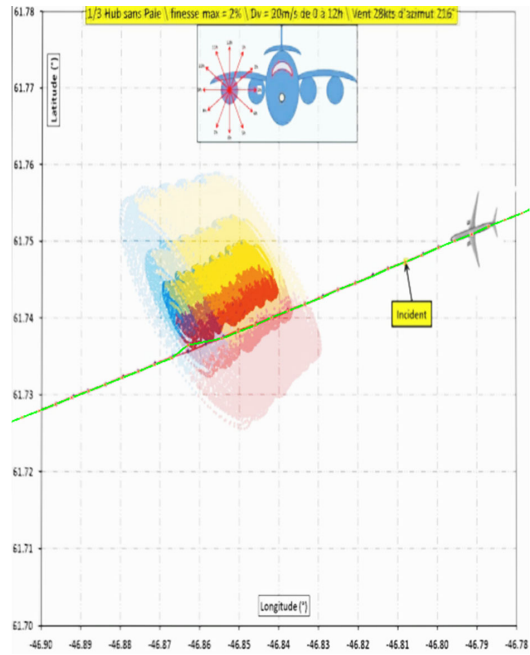
Fig. 21: overlay of the 3 computed ejection speeds for 1/3 of a fan hub (courtesy of ArianeGroup)

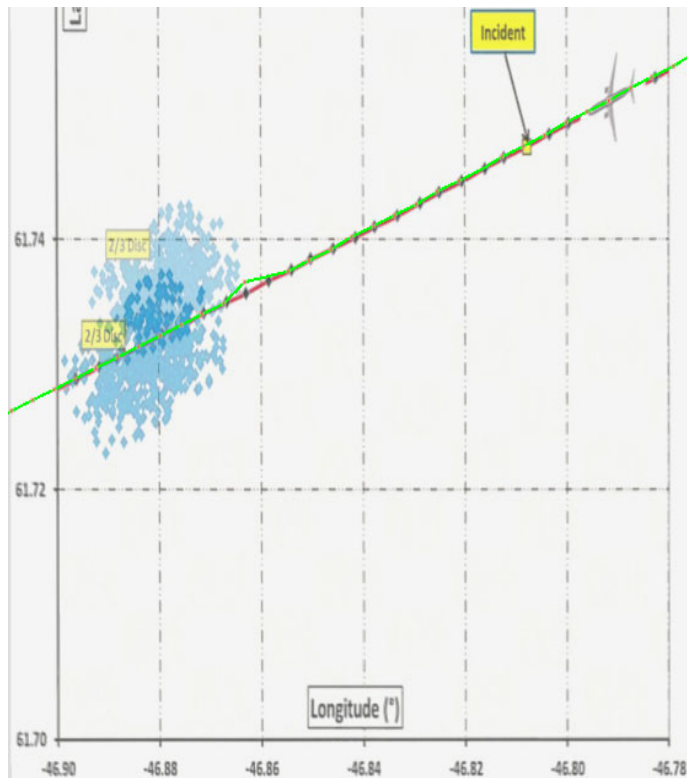
Fig. 22: impact location computations for 2/3 of a fan hub with an ejection speed of 0 and 105 m/s at 11 o'clock, lift/drag ratio from 0 to 5 % (courtesy of ArianeGroup)

From the computations, it can be noted that a larger fragment (2/3 of a fan hub for example) will fall further west than a smaller one for the same lift/drag ratio.

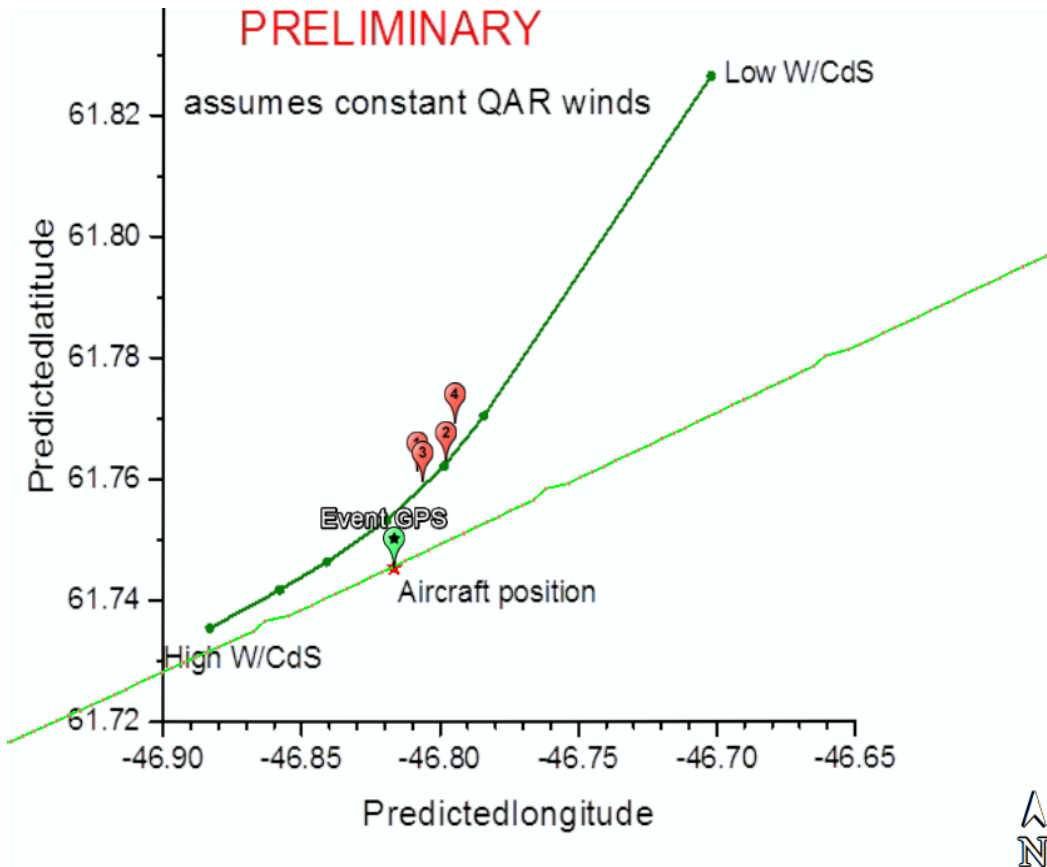
Fig. 24: ballistic locus considering constant wind, with no ejection angle (courtesy of NTSB)

Some uncertainty in the angle of exit was considered to determine two primary search areas, see Fig. 27. The loss of energy is taken into account with the secondary area, as 100% of loss of energy would result in the ballistic locus presented in Fig. 24.

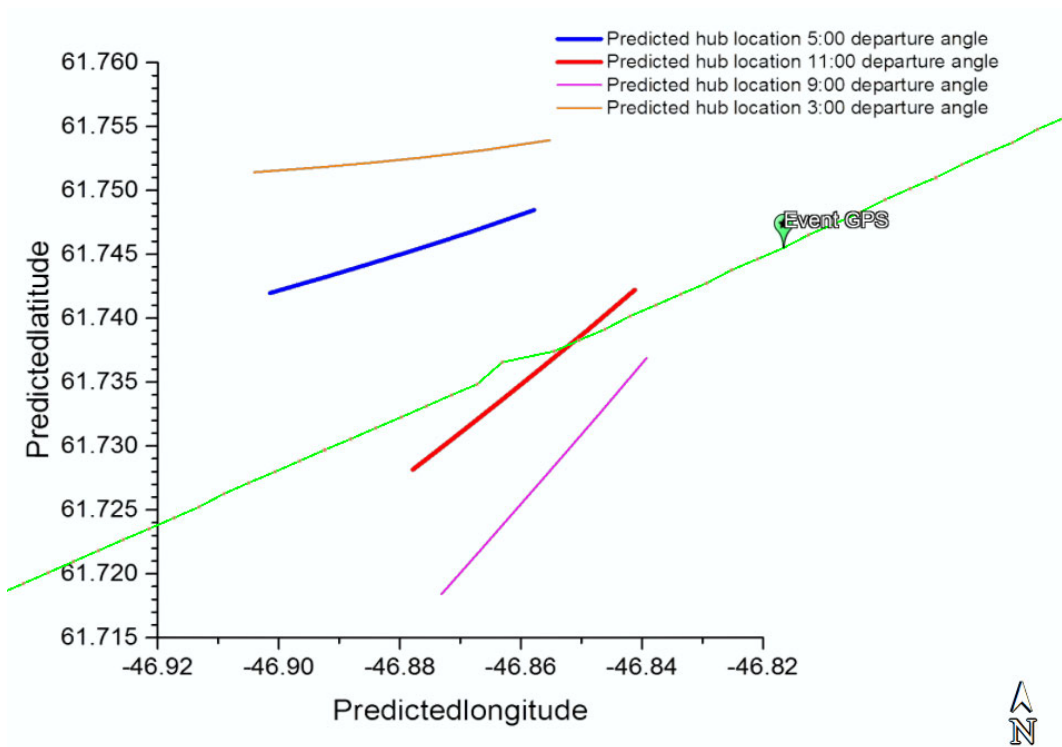
Fig. 25: predicted hub fragment location vs departure angle (courtesy of NTSB)

This adds ballistic locus segments as shown in Fig. 25. The length of the locus reflects the range of estimated ballistic coefficients for the fragments. A range of ballistic coefficients that covered variation in size/shape between the two fragments was considered. The 3 o'clock and 9 o'clock exit angles were used to bracket the problem with a pure sideways departure from the airplane (9 o'clock is not realistic as no fragment hit the fuselage).

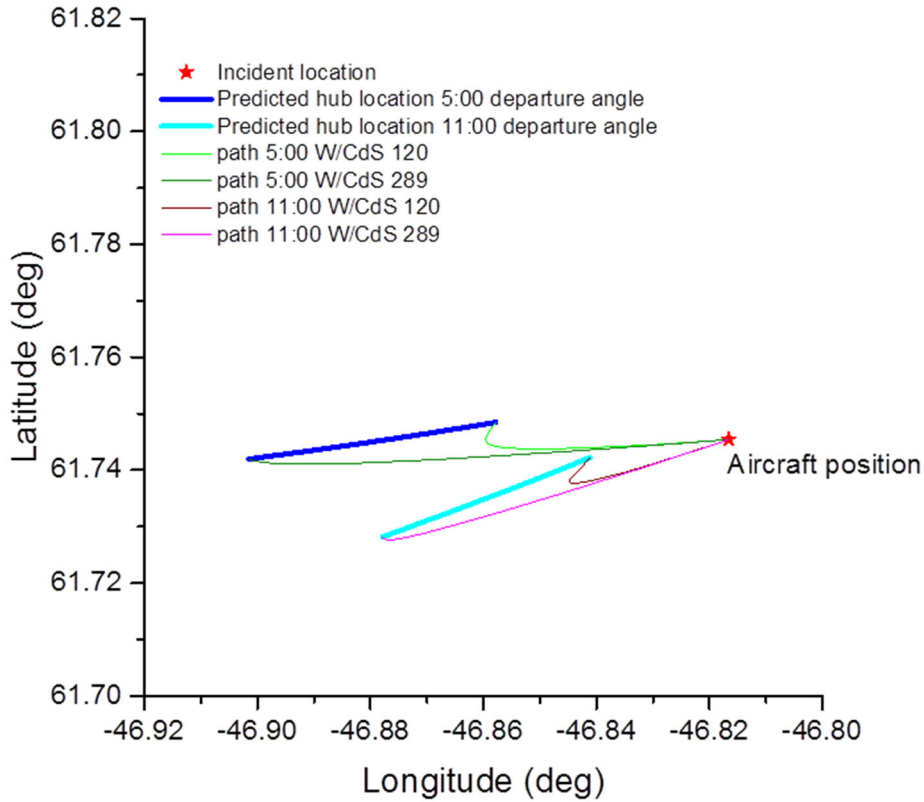
Fig. 26: effect of ballistic coefficient range on predicted hub location (courtesy of NTSB)

Fig. 26 shows the paths of the low and high ends of the ballistic range that were used for both the 5 o'clock and 11 o'clock engine exit angles.

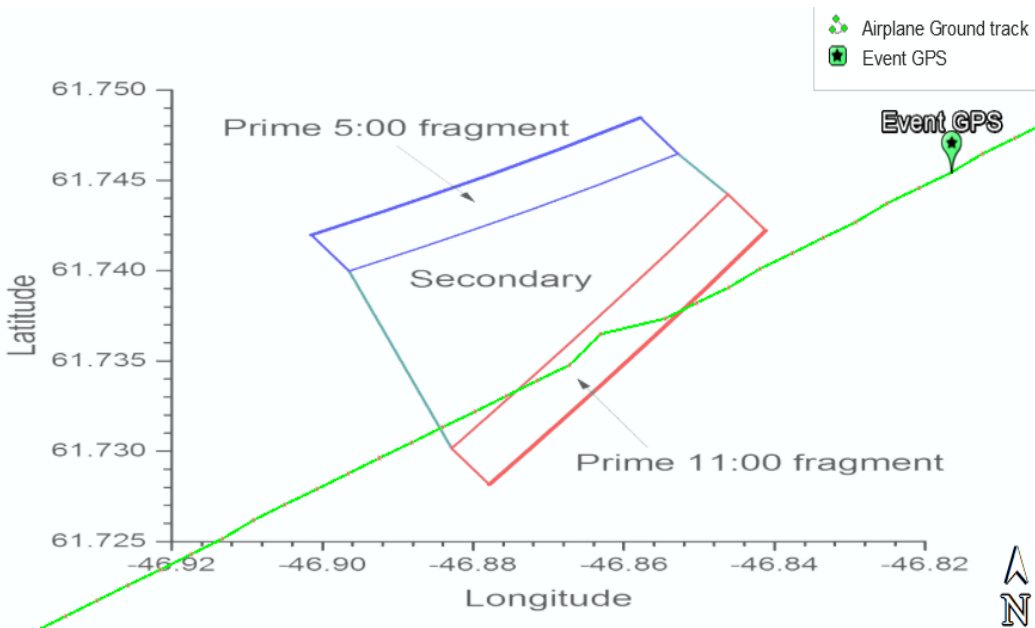
Fig. 27: NTSB primary and secondary areas (courtesy of NTSB)
