**A1. Factual information**

**A1.7 Meteorological information**

This annex to the final report discusses the meteorological aspects of the accident in more detail. The key points are referenced in the main report. Some discussions and figures might need specific knowledge for a full understanding. However, where possible, the descriptions are aimed at interested, but not necessarily specialised readers. The references in the footnotes will help readers find further useful information.

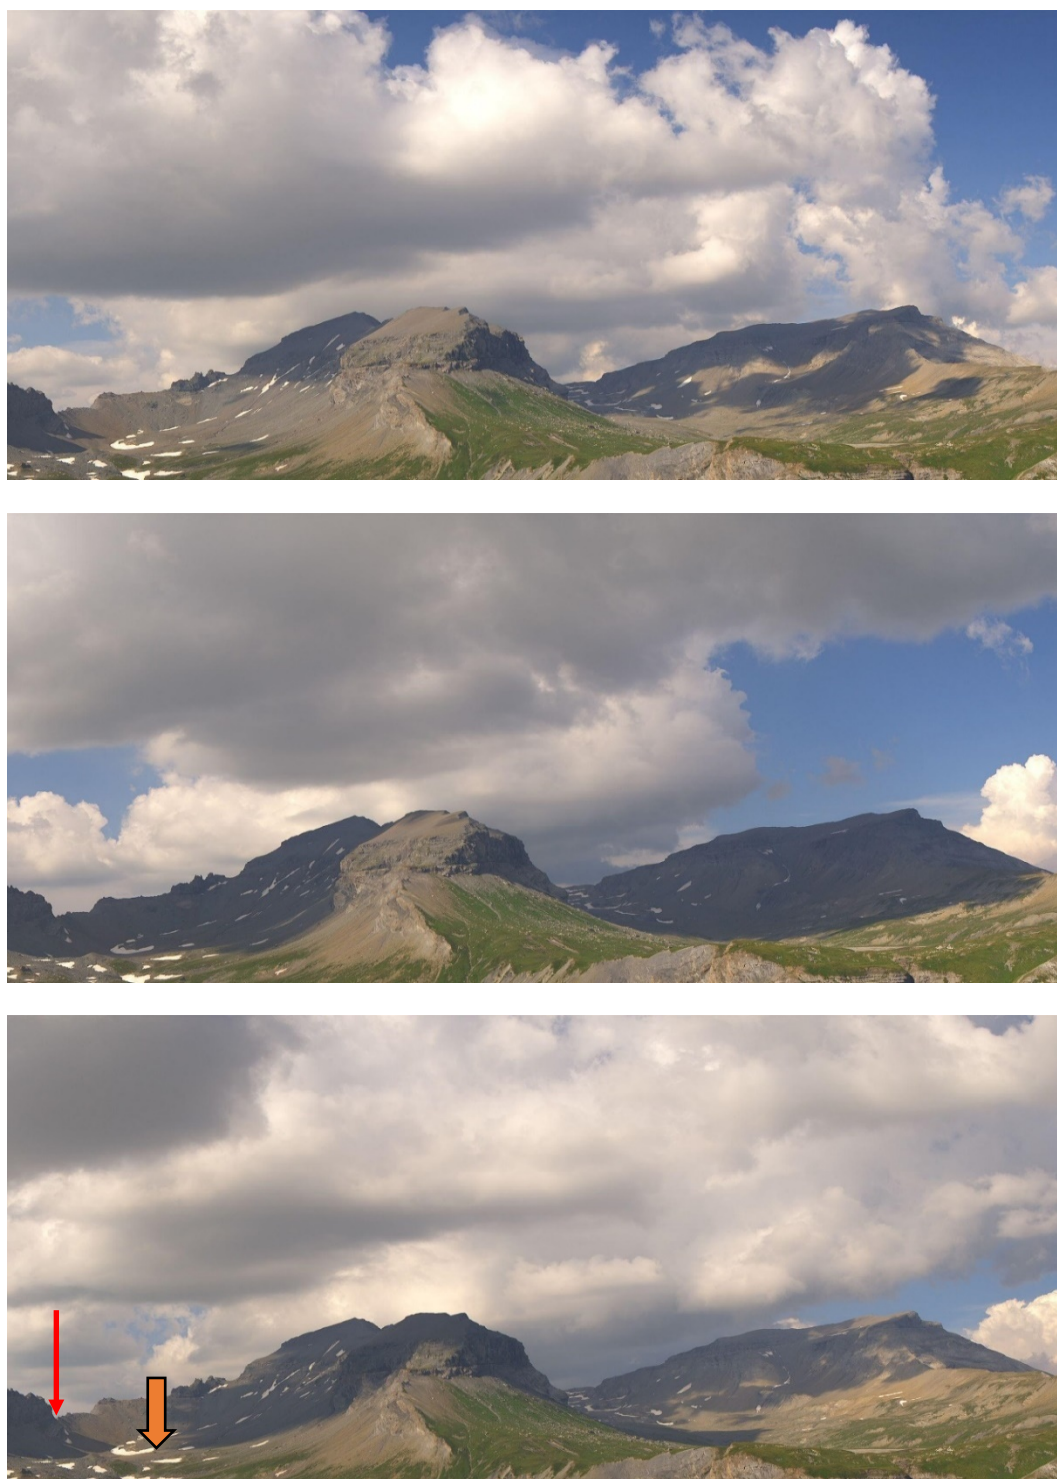
**Figure 3:** Three frames of the webcam on Mutta Rodunda<sup>13</sup> (see map in figure 4) viewing towards the north 17 minutes before the accident (16:40 LT, top frame) until three minutes after (17:00 LT, bottom frame). The orange pointer is marking the site of the accident, where the wreckage is faintly visible on the original image. The Segnes pass is marked by the red pointer. Left of the centre of the image is Piz Segnas with Atlas in front. On the right is the Trinserhorn (Piz Dolf) mountain (see map below).

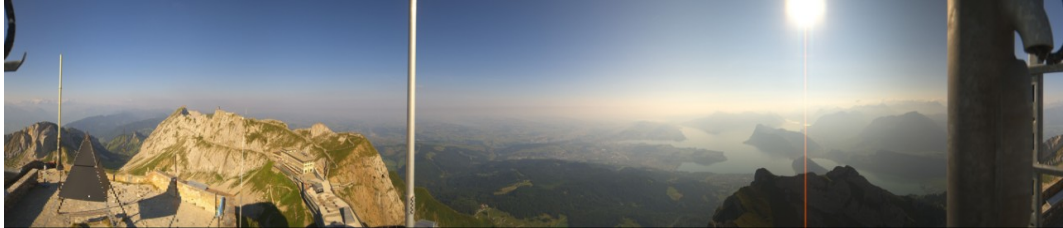
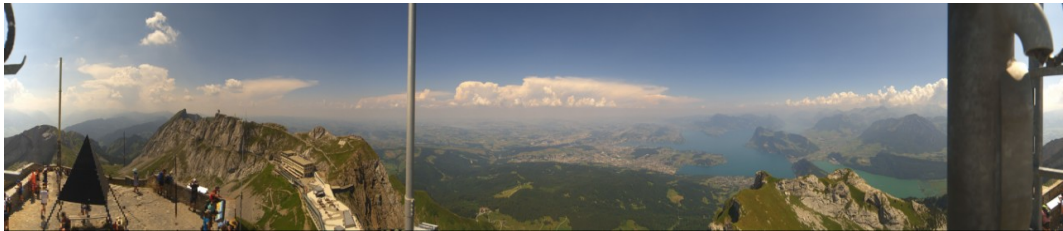
**Figure 6:** Roundshot webcam on Mount Pilatus<sup>14</sup> on 4 August 2018 between 07:00 and 17:00 LT. The images show the cloud development during the day in the wider Alpine area. The thin pole left of the centre roughly marks the north, whereas the south is behind the thick pole, i.e. the southern sector is split between the two edges of the images.

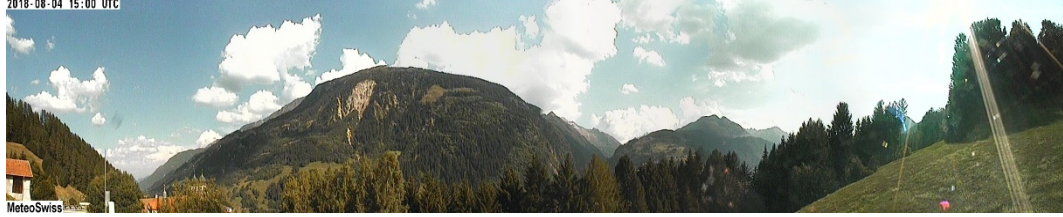
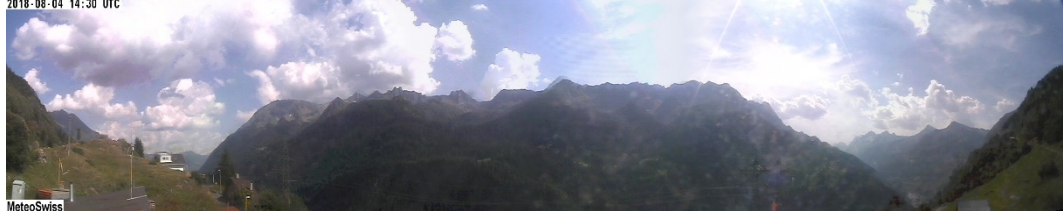
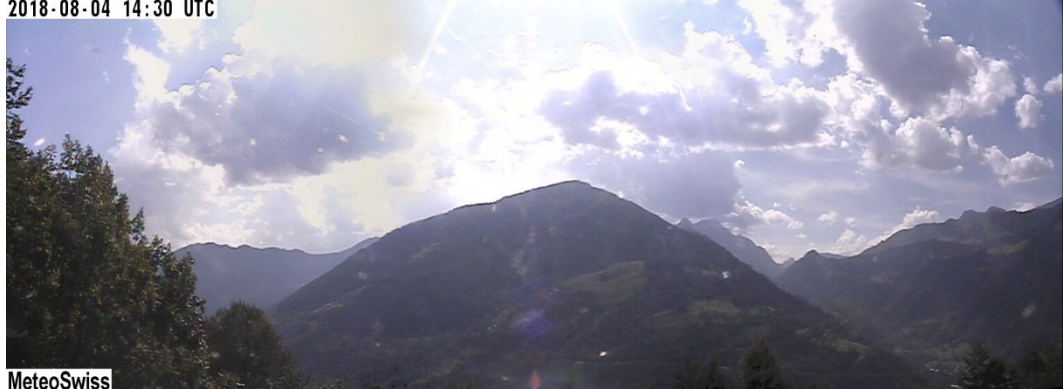
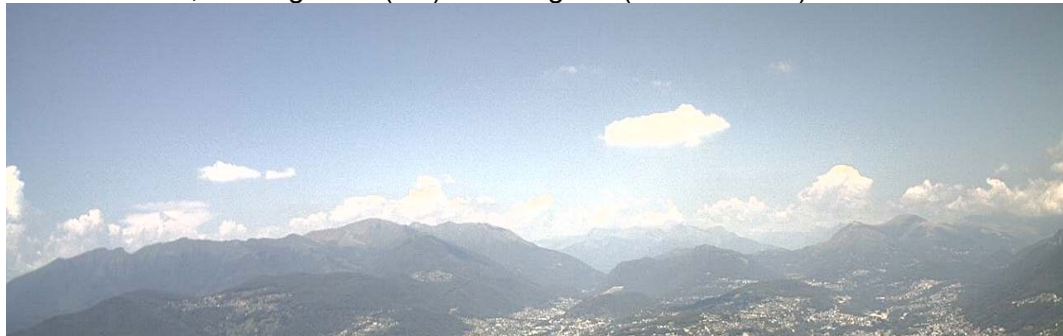
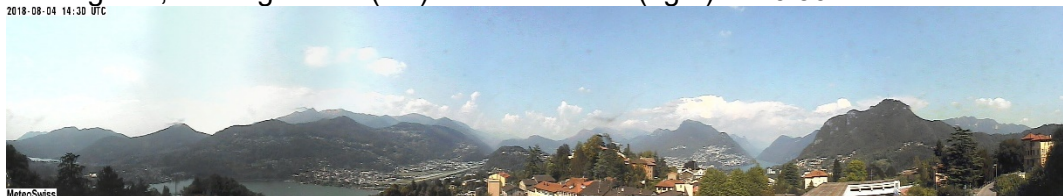
**Figure 7:** Webcams on the south side of the Alps at 16:30 LT, and from Disentis in the Rhine Valley at 17:00 LT. This large collection of images is archived every 10 minutes by the Federal Office of Meteorology and Climatology.

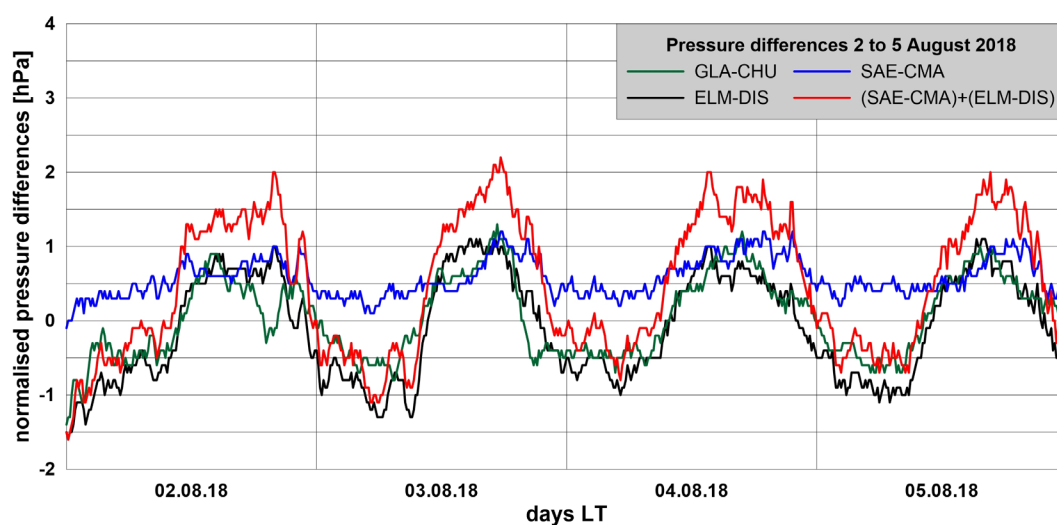
**Figure 21:** Diurnal pressure differences between selected stations in valleys and on mountains during four days around the day of the accident. See the map in figure 20 for the locations of the stations. Positive values show higher pressure in the north, i.e. from the Swiss Plateau towards the Alps. The pressure at Säntis (SAE) was reduced to the elevation of Crap Masegn (CMA); those at Elm (ELM), Glarus (GLA) and Chur (CHU) to the elevation of Disentis (DIS). The pressure difference SAE-CMA shows pressure differences at the altitude of higher mountains, where ELM-DIS and GLA-CHU show pressure differences between valley floors. The red curve shows the sum of the pressure differences at altitude and the ones between Elm and Disentis. For more information, see the text below.

A typical diurnal pattern can be observed for these days. The pressure differences between Elm in the north and Disentis south of the Segnes pass increase during

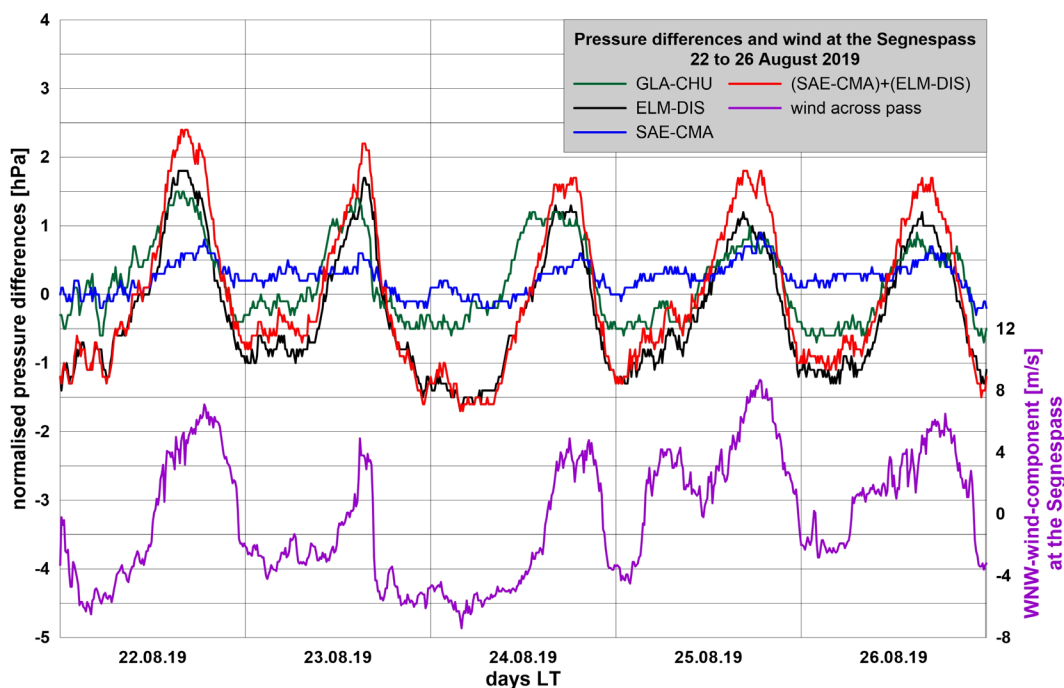
**Figure 23:** The pressure differences between the same stations as in figure 21, but for five comparable days in August 2019. Since the wind at Segnes pass was measured during that time in 2019, it can be shown in parallel. For more information, see the text below.

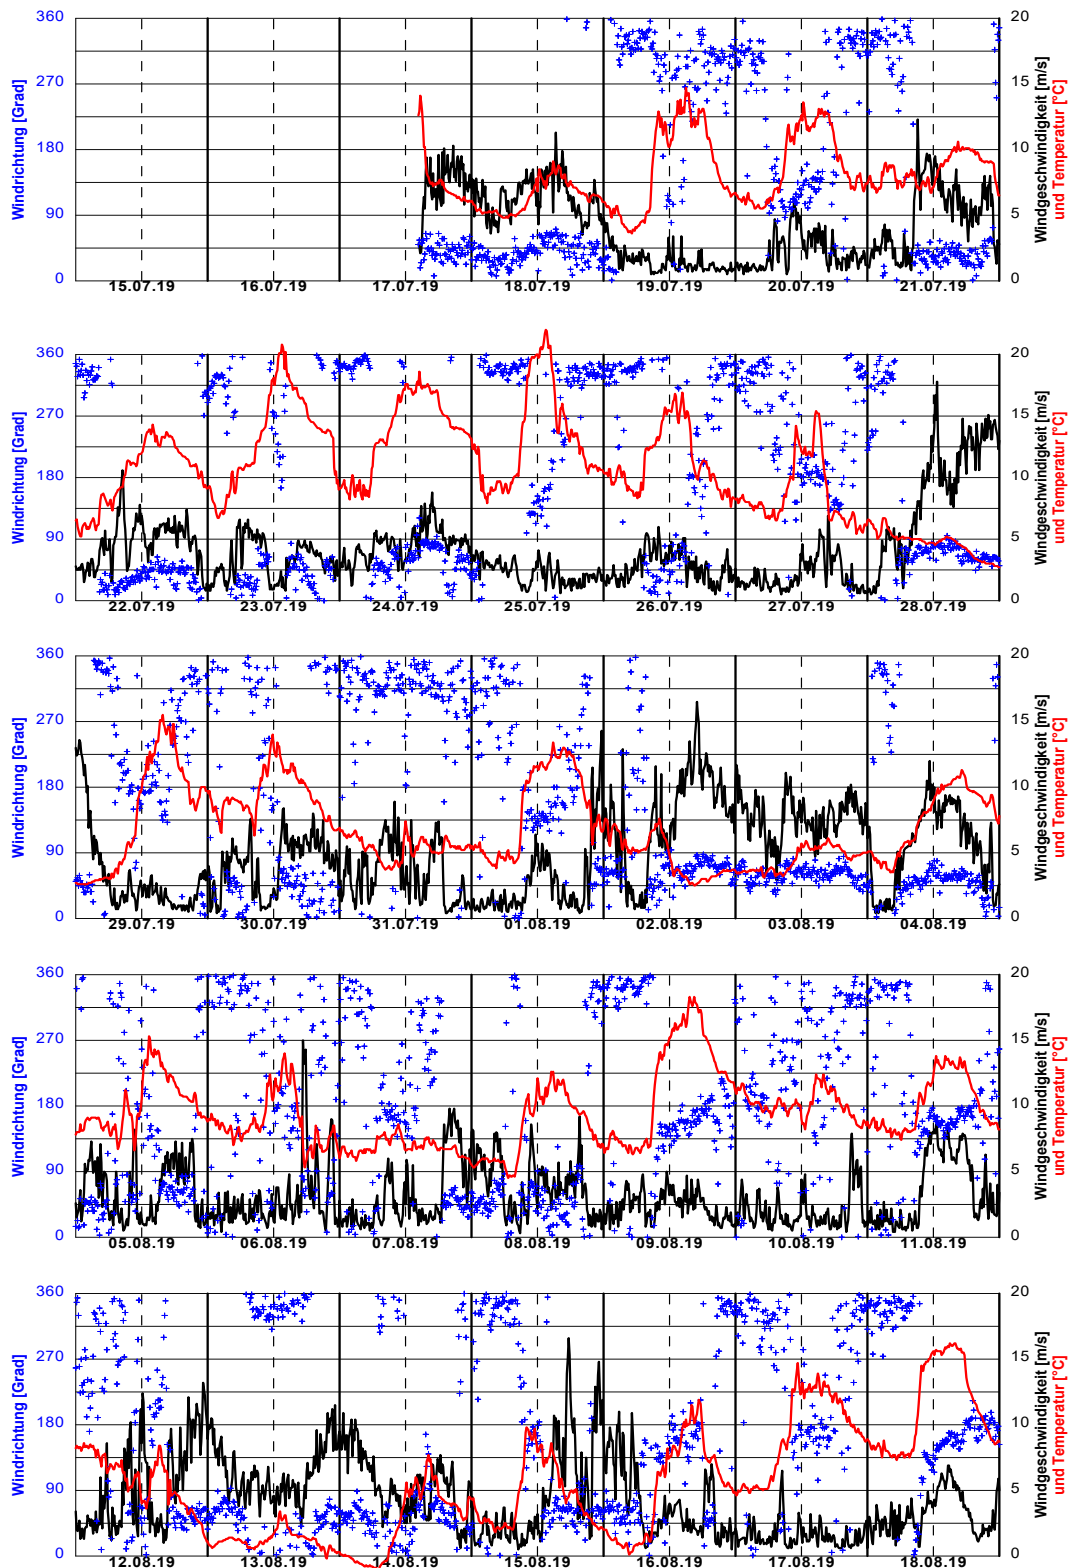
**Figure 27:** Seven weeks of measurements on the 2-m pole near the lidar (for weeks 6 and 7, see next page). The vertical dashed lines mark local noon (12:00 LT). The black curves show the wind speed ('Windgeschwindigkeit', ten-minute averages) on the right-hand scale (10 m/s corresponds to about 20 kt). The blue dots indicate the wind direction ('Windrichtung') on the left-hand scale. The red curve shows the temperature on the same scale as the wind speed.

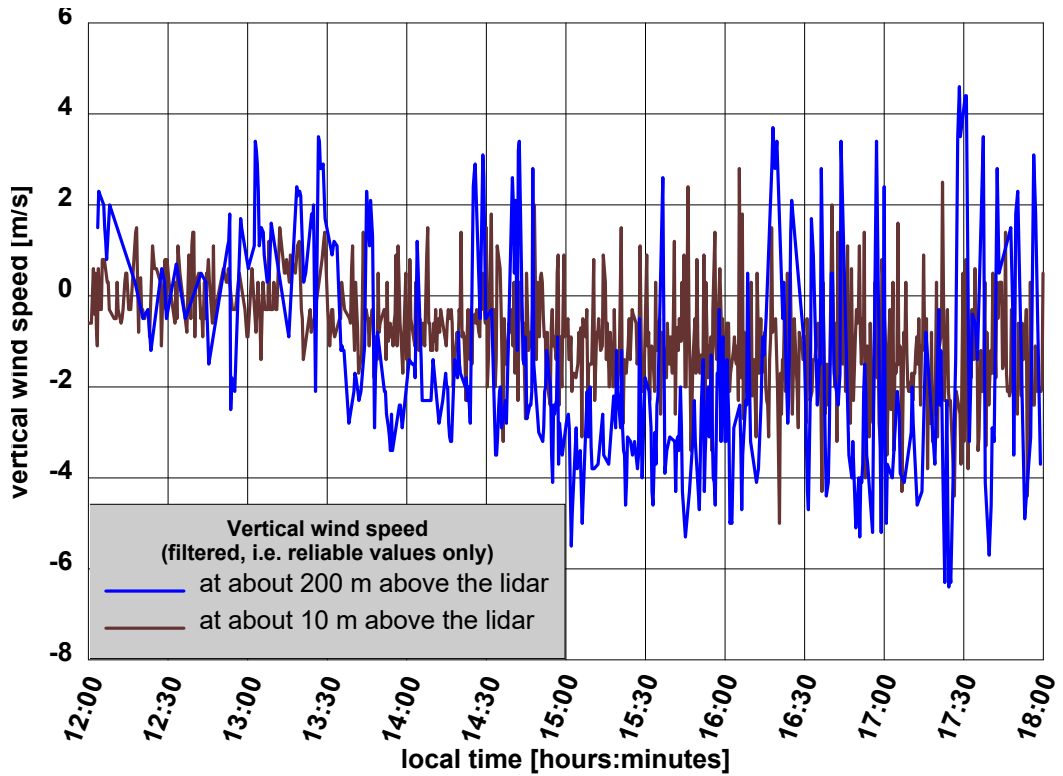
**Figure 28:** Time series of the vertical wind speeds (positive values are updraughts) at the lowest and highest altitudes measured during the afternoon of 25 August 2019. The 10 and 200 m above the lidar are at about 2,470 and 2,660 m AMSL respectively (8,100 and 8,700 ft AMSL, i.e. about 50 to 100 m below the flight track one year ago). In between these heights, five others were measured and processed. For further information, see the text below.

The vertical wind reflects the same diurnal evolution as discussed above for the wind near the surface. Shortly after noon, following a period with some turbulence caused by rising thermals (slope convection with positive vertical gusts between 1 and 3 m/s), stronger negative values were dominant. Based on the station readings from above, this was within the downslope flow from about 60° (see figure 27 for 25 August 2019). Between about 15:00 and 18:00 LT, the vertical wind varied between -6 m/s and +4 m/s.

The mechanisms generating this turbulence (thermals and rotors behind the ridges) during the afternoon suggest that the vertical wind speeds were not very sensitive to altitude, i.e. they would be the same 100 m higher. As such, the measurements taken one year later should not be projected directly to the day of the accident. The measurements describe typical conditions in a statistical way.

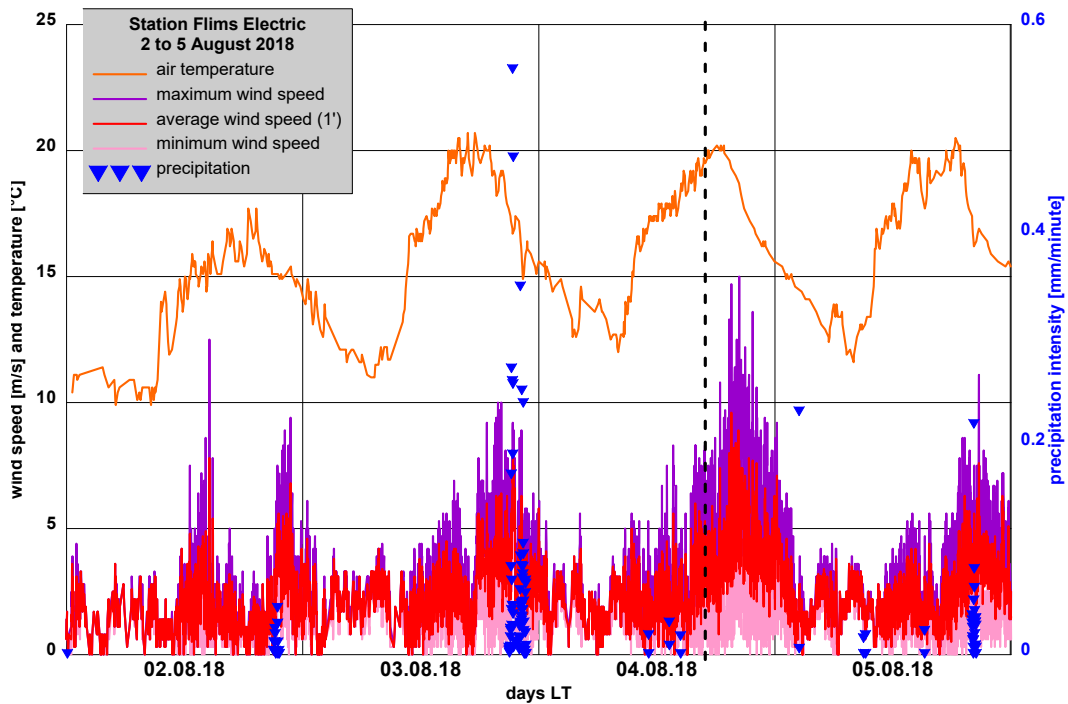
**Figure 31:** Wind, temperature and precipitation about 4 km south of the accident site at an elevation of 2,100 m AMSL (black dashed line at the time of the accident). The red curve shows the one-minute averages of the wind speed (5 m/s correspond to about 10 kt), whereas pink and purple indicate minima and maxima within the minutes. The wind direction was not recorded but confirmed by the operator to be downslope during the afternoons. The orange curve is for the temperature, and the blue triangles indicate rain according to the right-hand scale (mm/min to be multiplied by 60 for mm/h).

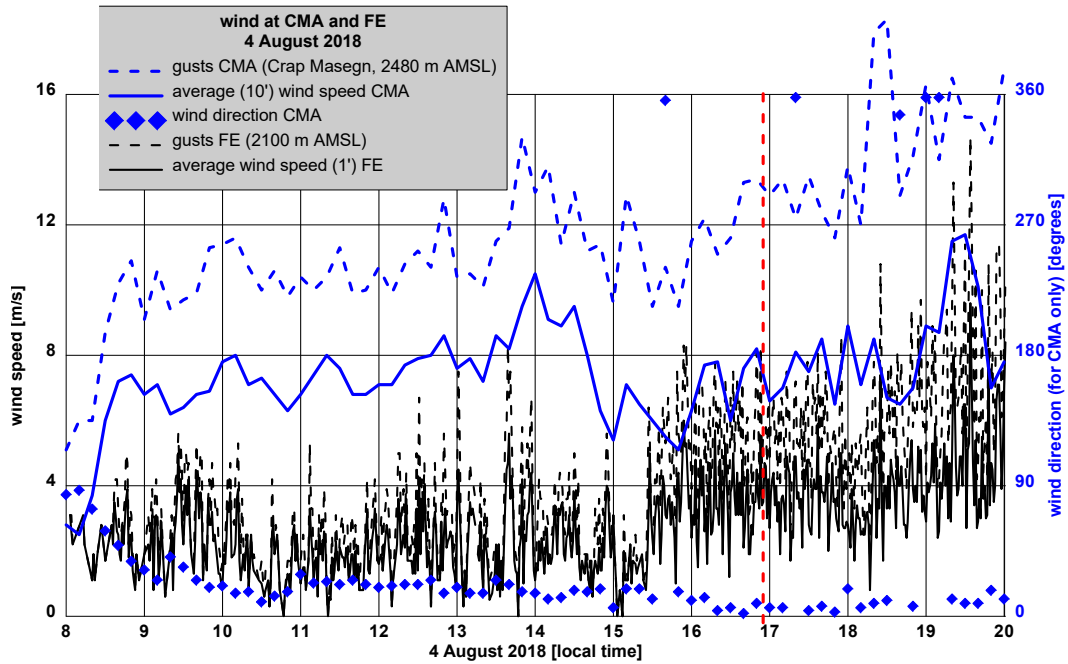
**Figure 32:** Wind at the two stations Crap Masegn (CMA) and Flims Electric (FE) on the day of the accident. The blue curves and points are for CMA (solid line: 10-minute averages of wind speed; dashed line: 1-second gusts; diamonds: wind direction on the right-hand scale). The one-minute averages and maxima are shown as solid and dashed lines in black. 8 m/s correspond to about 16 kt. Both the average wind speed and the gusts at CMA are about twice as high as at the FE station below the high plateau.

The FE station at the southern edge of the high plateau recorded about half of the wind speed observed at Crap Masegn during both days. This shows that the lower station is not fully exposed to the stronger downslope wind higher up in the valley. It decreases even more after 17:00 LT. The FE station would have been more important had the winds at the Segnes pass and at Crap Masegn not correlated so well. Then the wind at the Segnes pass could be estimated by doubling the speed measured at the FE station.

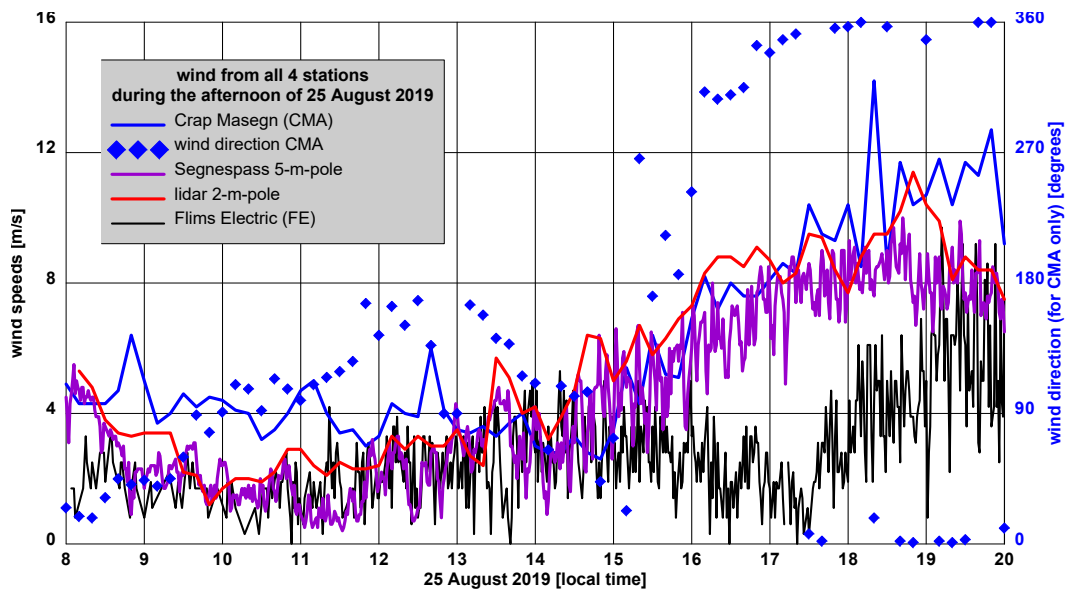
**Figure 33:** The average wind speeds of all the four stations discussed in this section (see figure 30). The 25 August 2019 was the day with the closest similarity to 4 August 2018. The gusts are not shown here in order to keep the graphics simple. They reached about 50 % above the 10-minute averages on both days (4 August 2018 and 25 August 2019).

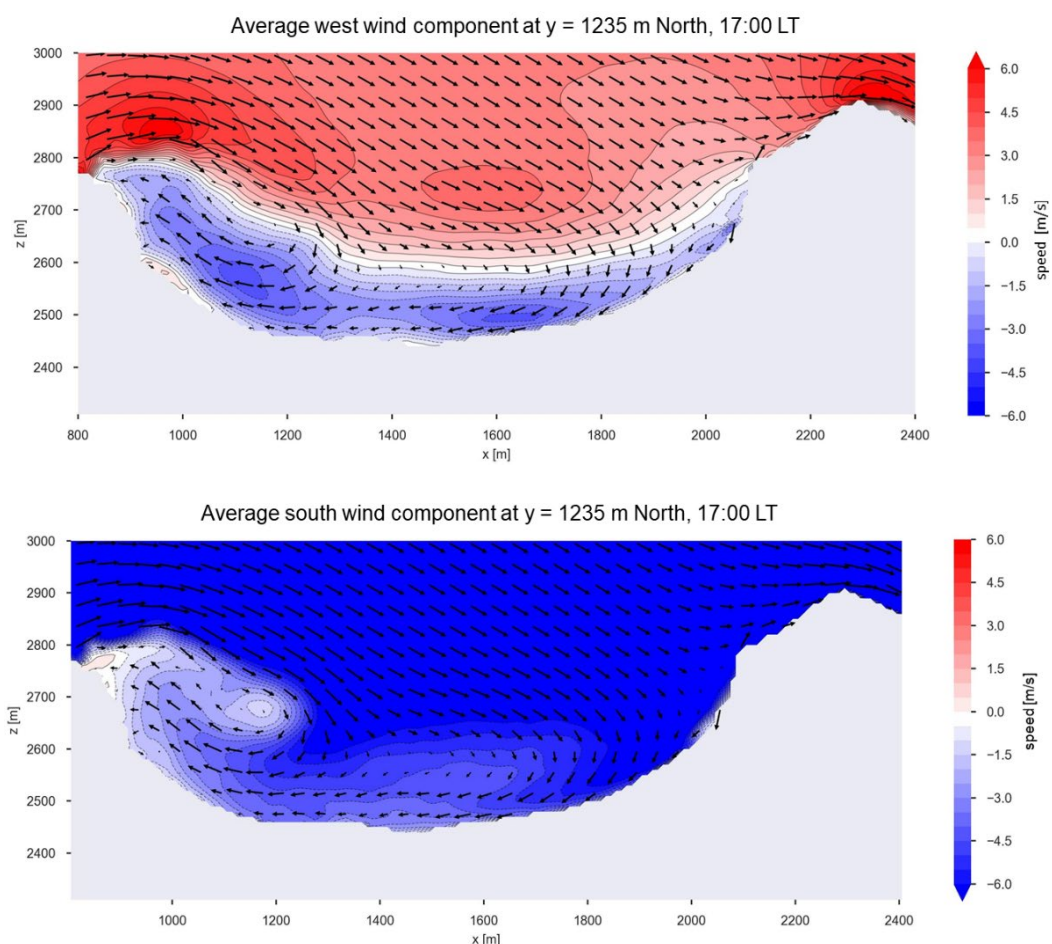
**Figure 36:** Vertical cross-section from west to east along the blue dashed line in figure 34. The arrows depict the flow on this plane in both frames, clearly showing the rotor behind the western crest (the Tschingelhörner range of mountain peaks on the map). The colours according to the scales on the right-hand side show the wind from the west (negative values from the east) in the upper frame, and the wind component from the north by the negative values in the lower frame. The wind components above the crest were about 7 m/s from the west and 8 m/s (outside of the colour scale) from the north, i.e. a north-westerly wind of about 21 kt above the basin. Near the western slope of Atlas in the east, the wind near the surface was from the north-east.

The two wind components near the surface in figure 36 are both about 5 m/s, resulting in roughly 15 kt from the north-east. This correlates with the wind observed<sup>39</sup> after the impact (17 kt from 060 to 070°), and is also in accordance with the descriptions of the eyewitnesses 15 minutes after the accident in section A1.7.7. The estimate of 60 km/h for the very local flow across the Segnes pass is plausible as well and is in the same order of magnitude as the maxima measured in 2019. The wind field shown in figure 35 is 75 m above the pass. For such comparisons, it is important to note that the results shown here are average wind speeds, whereas the observations are representative for shorter periods.
