A1. Factual information

A1.18 Additional information

A1.18.1 Flight over the Segnespass in 2013

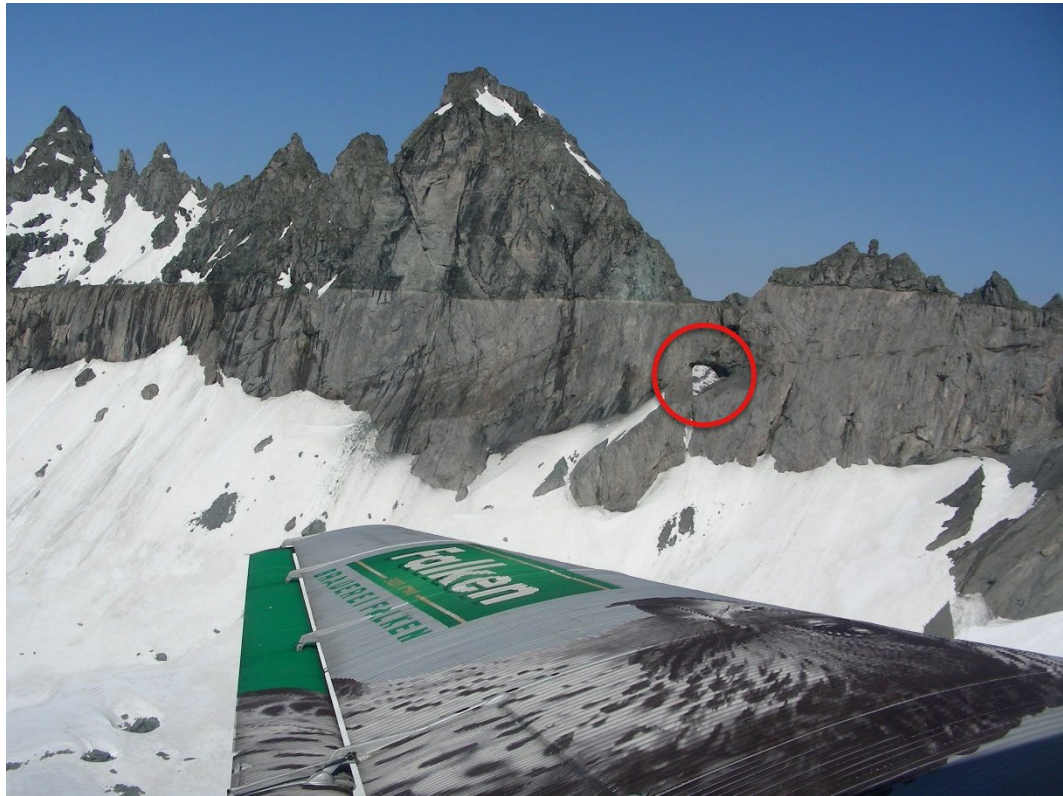
Three photographs taken from HB-HOP were available from a flight over the Segnespass on 6 July 2013. Figure 1 shows a flight past the Martinsloch. On board HB-HOP for this flight was the same crew as on the accident flight in HB-HOT on 4 August 2018.

Figure 1: The second of three photographs taken from HB-HOP on 6 July 2013 during a flight past the Martinsloch (red circle).

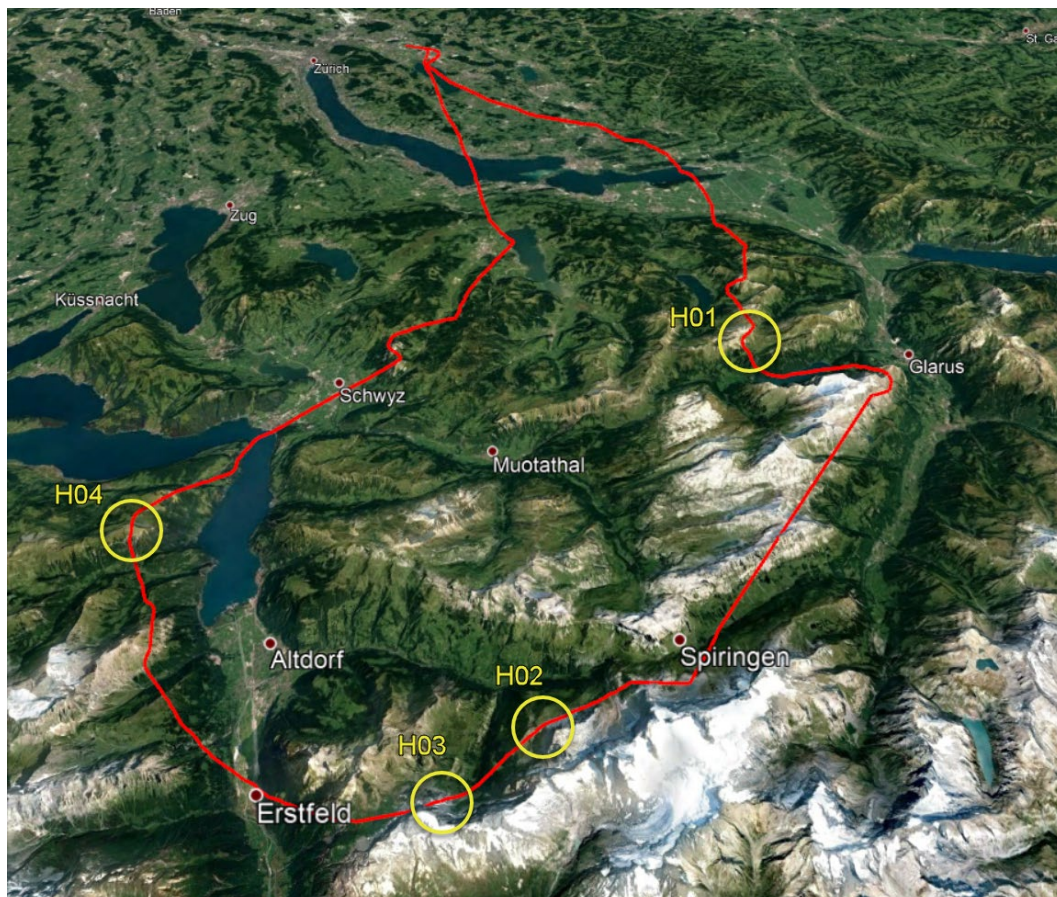
Figure 58: Overview of the flight path including hotspots H01 to H04 (yellow circles). Shown on Google Earth.

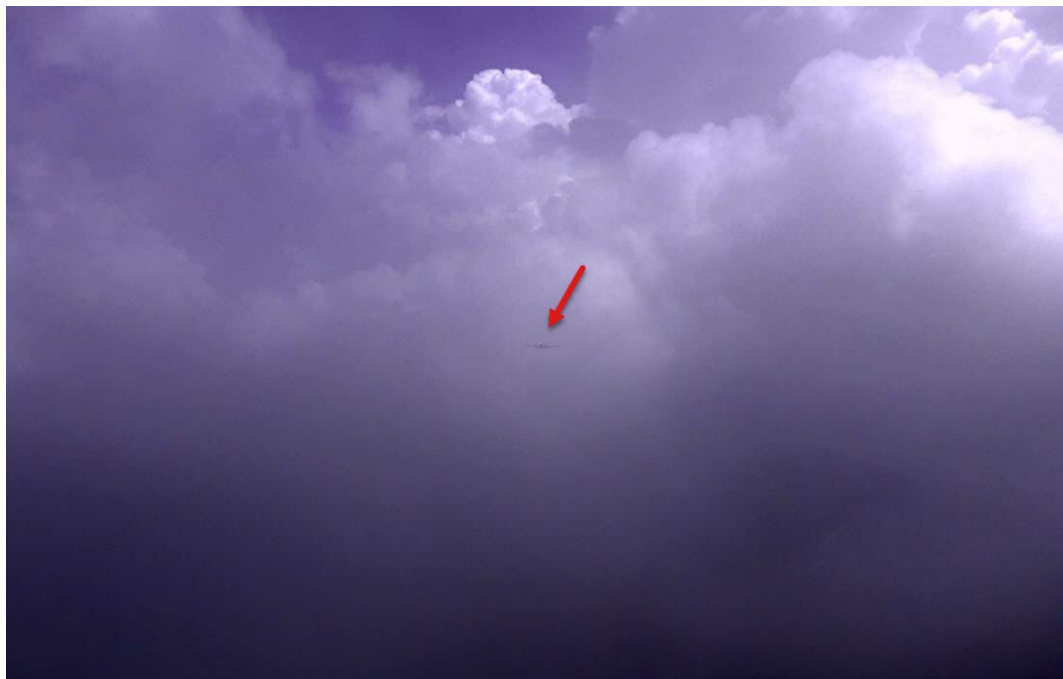
Figure 79: The faintly visible silhouette of an approaching Ju 52/3m g4e (red arrow) travelling towards Gross Mythen (image contrast increased). Footage provided by private individual.

The radar flight path (see figure 77) shows the climbing and very high-risk approach to Gross Mythen, with an approach up to the summit cross under temporary instrument meteorological conditions (IMC). A descent is initiated after passing the summit cross. In addition, screenshots from a video file show the level of visibility prevailing on that day and the Ju-52's near-terrain fly-by at Gross Mythen (see figures 79 and 80). During the daytime, visual flight rules (VFR) operations for aircraft in class Golf airspace are to be conducted in such a way that the aircraft is outside of the clouds with a constant view of the ground or water.

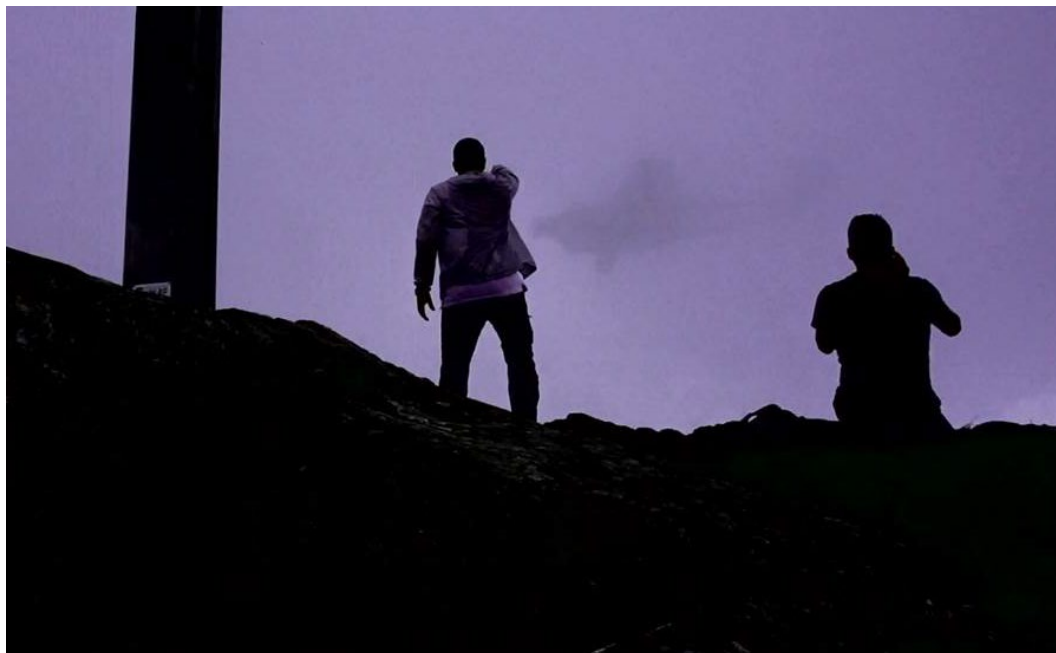
Figure 80: The Ju 52/3m g4e flying past the summit cross is only faintly visible due to the weather conditions at Gross Mythen (image contrast increased). Footage provided by private individual.
